# INSPECTION REPORT

1.4.1 This house is approximately 80 years old and was built in 1946

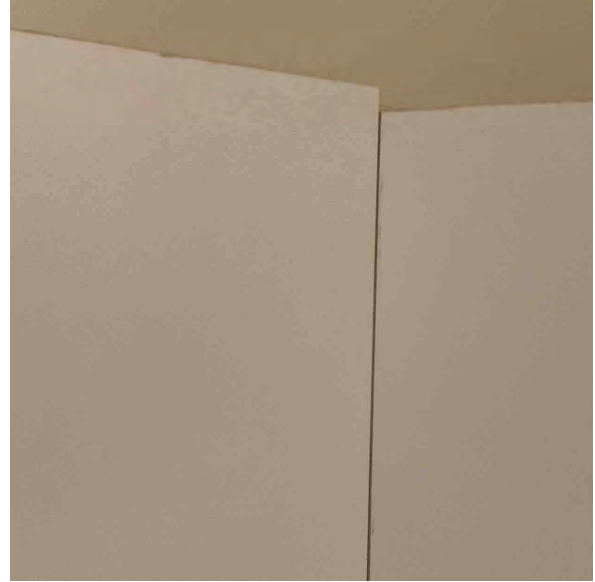
10.5.1 Corner cabinet door rubs against adjacent door when opening and closing. This could cause damage to the door. Have a qualified contractor correct as needed. (Kitchen)

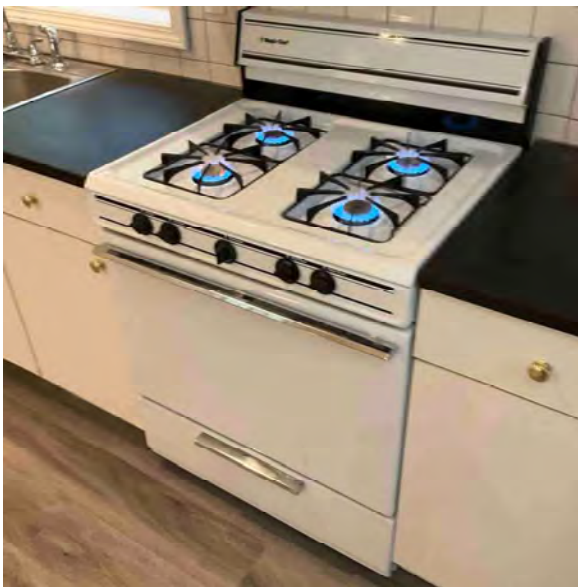
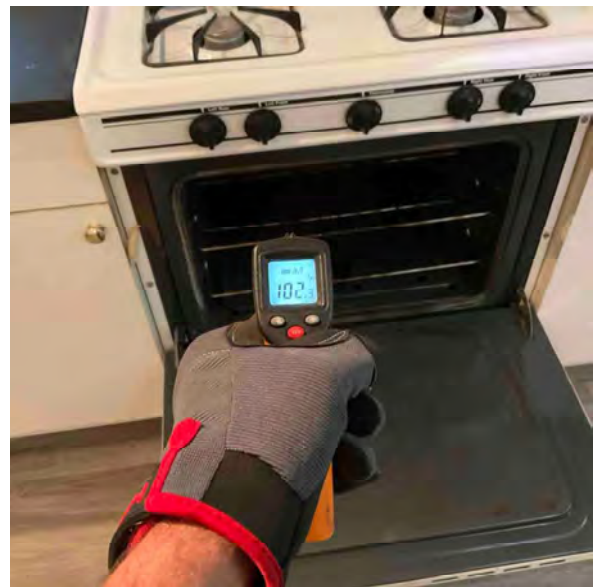
11.2.1 There was some heat coming from the stove prior to operation. This suggests that the gas stove may have a standing pilot light. Appliances don't typically have standing pilot lights anymore because it presents a waste of fuel in a higher gas leak or fire risk. This unit should be evaluated by an appliance technician to determine its functioning properly and or if replacement is needed. (Kitchen)

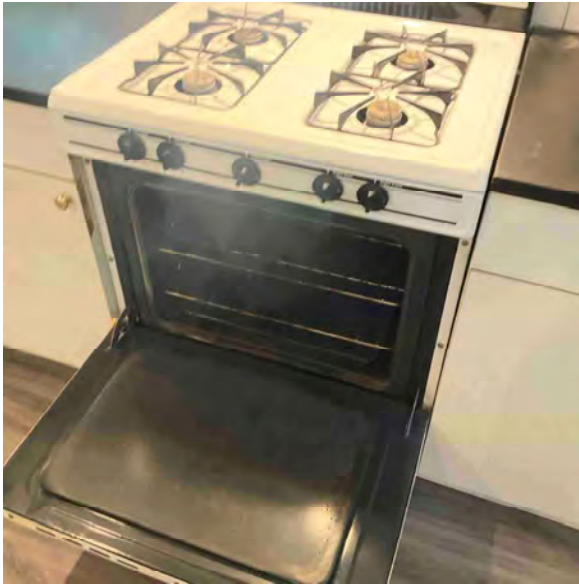
11.2.2 During operation, the oven smoked heavily. This could indicate improper function or a cleaning as needed. Have an appliance technician assess and correct as needed. (Kitchen)
