Re: Limited Structural Inspection  
6901 Woodmere Drive  
Raleigh, NC

At your request, a limited structural inspection of the above property was performed on June 28, 2022. The report that follows has been prepared based on that inspection. The inspection was performed by Sam Umstot, EI of Giles Flythe Engineers.

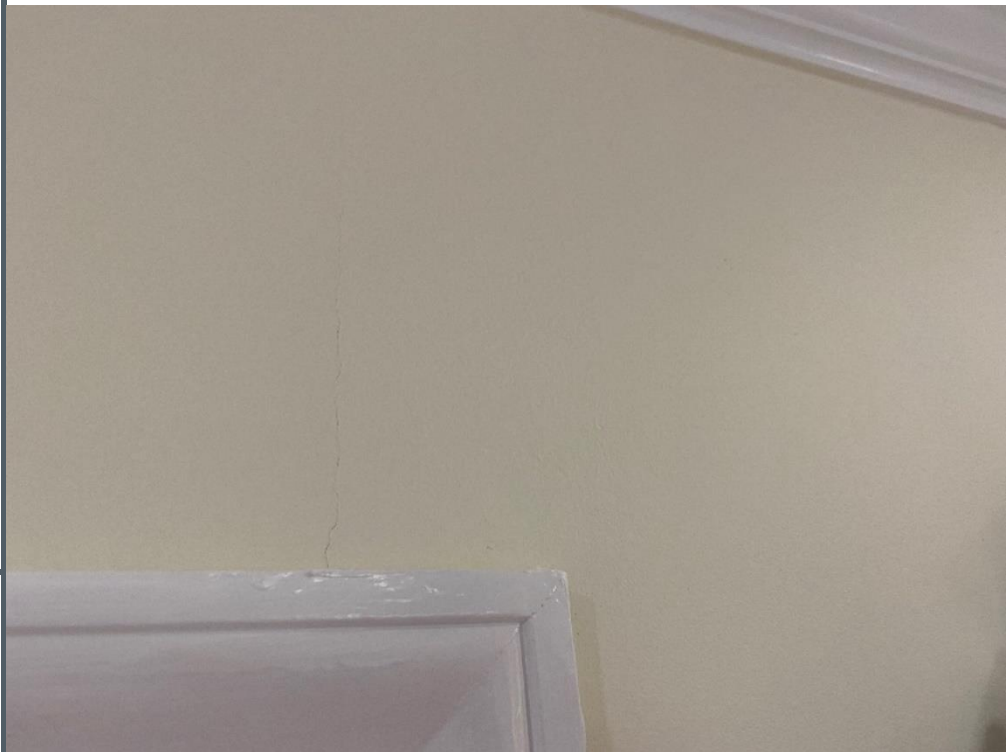
**Photo No.**  
**2**

1. Minor cracks (less than 1/16" wide) were noted in the drywall finish materials in multiple locations throughout the home, predominantly along the left perimeter wall of the original home.
2. Variable floor slope was measured in multiple locations throughout the home. Predominantly, observed floor slope was measured up to 3/4" vertical over 4' horizontal spanning left to right, approximately 15'-8" from the front perimeter wall and approximately 3'-0" to the left perimeter wall (original wall of the home).

The minor interior drywall cracks noted above are likely the result of a combination of the supporting members contracting/deflecting and limited foundation settlement discussed above. Minor drywall cracking and finish carpentry separations are typically associated with changes in weather, temperature, and humidity causing wood to shrink and swell with the seasons. When moisture is taken away from wood it has a tendency to contract thus resulting in deflection (or sagging). Any walls, windows, or doors bearing on the deflected members will also move. We do not consider contracting and deflecting wood members and the cracking/separation noted in the interior finish materials to be a significant structural concern at this time.

Typical crack noted in the drywall finish materials.

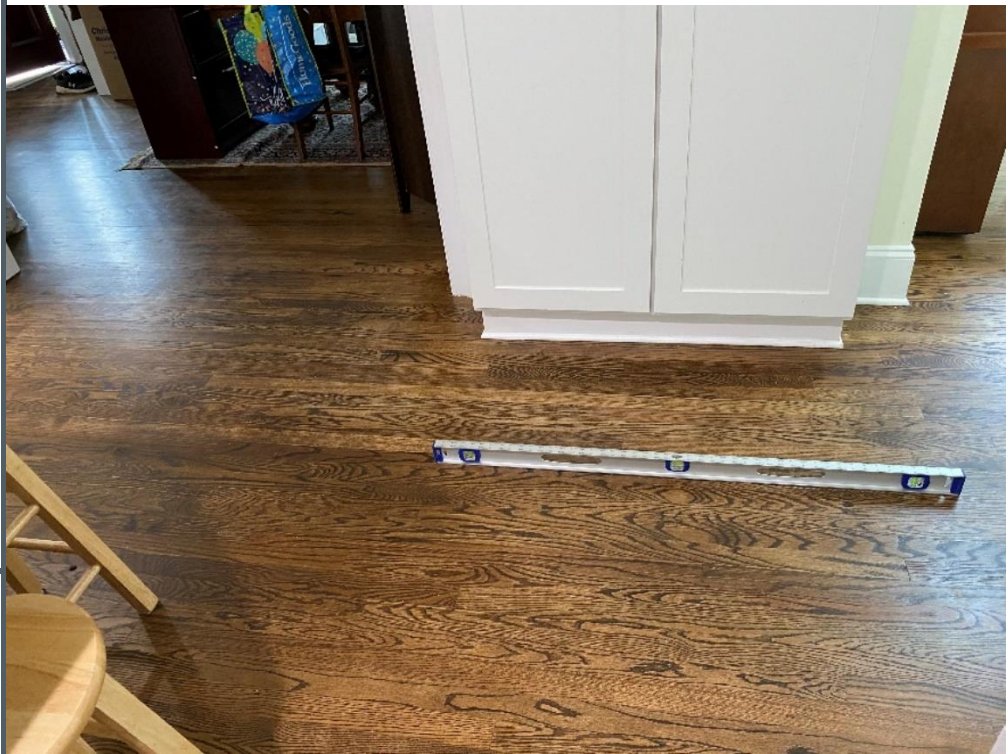
Photo No.  
3

The floor slope noted above is likely the result of limited deflection in the framing below and the framing configuration of the home. Deflection of supporting members can occur with sustained loads. The floor framing supports the weight of non-load bearing walls, kitchen island, heavy furniture, etc. Deflection of the floor framing will be greater in areas with sustained loads than areas with movable (live) loads. The floor slope noted in Observation #2 is likely due to a transition from a rigid component (foundation wall) to a less rigid component (floor joists). No significant structural concerns were noted in the framing and foundation in the visible areas along the left foundation wall. The auxiliary masonry piers noted in the front and rear spans were likely installed to help alleviate minor deflection or “bounce” in the floor and do not appear to be required for the structural integrity of the home. No structural repairs are required at this time.

General area of floor slope noted adjacent to the addition/original garage side of the home.

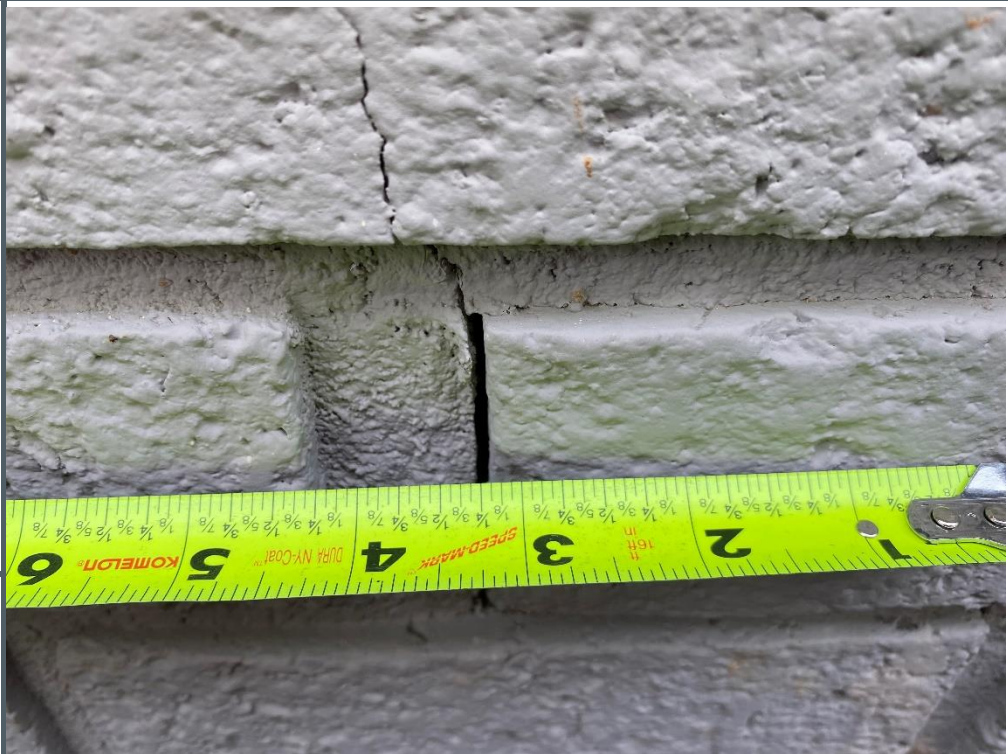
Photo No.  
4

3. A stair-step crack (approximately 1/16" wide) was noted in the brick veneer of the front perimeter wall, approximately 10'-0" from the right corner.
4. Gutters and downspouts (with leaders) were noted installed on the home. Grade was noted with relatively neutral slope away from the perimeter wall(s) of the home.

The cracks in the brick veneer noted above are likely due to limited differential foundation settlement. The clay soils in this area are considered "expansive" type soils and will typically expand and contract with fluctuations in the moisture content. This expansion and contraction of load-bearing soil materials can lead to soil consolidation and foundation cracking/movement. If conditions around the foundation remain relatively dry, the likelihood of future significant settlement will be reduced, but we cannot predict the extent of future settlement. The condition of the foundation wall does not appear to be a significant

structural deficiency and improving exterior drainage and monitoring cracks for additional propagation is an acceptable approach at this time.

Crack noted in the brick veneer of the front perimeter wall.

7. Monitor the crack in the brick veneer. If the crack widens significantly (expands by an additional 1/8") or additional significant cracks (greater than 1/4" wide) propagate, then further evaluation by a structural engineer may be needed at that time.

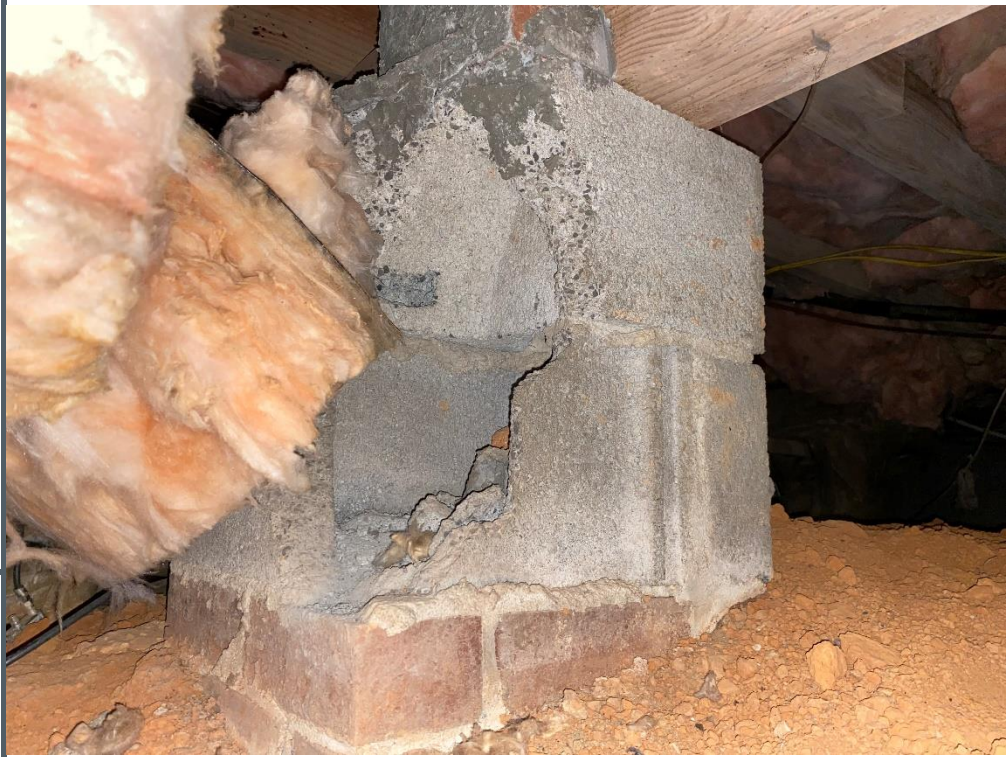
**Photo No.**  
**5**

5. A damaged/broken pier was noted approximately 5'-8" from the right foundation wall and approximately 13'-9" from the front foundation wall.
6. A notch (approximately 5-1/4" x 8-3/4") was noted in the rightmost span of the central girder, approximately 13'-9" from the front foundation wall.

The masonry pier (Observation #5) and girder (Observation #6) noted above were potentially damaged during HVAC component installation and/or repair. The condition of the pier and girder are structural concerns. We have provided recommendations below to address these issues.

Damaged CMU block pier.

1. We recommend removing the pier noted in Observation #4 and replacing with a new, mortared 16x16 CMU block pier. Fully the grout the pier or provide a 4" cap block. The existing footing may be utilized if is at minimum 20"x20"x10"-thick. Alternatively, the pier is to bear on a new 20"x20"x10"-thick concrete footing. Provide full width, pressure-treated blocking and/or metal shims between the top of the pier and the above girder to provide full-contact uniform bearing.

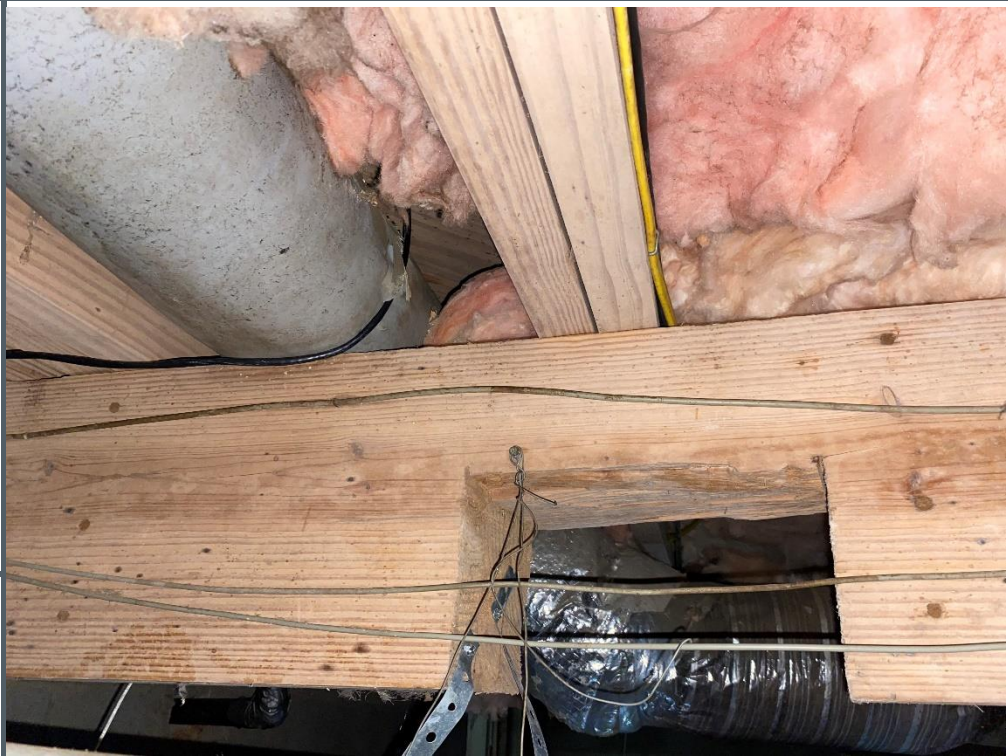
**Photo No.**  
**6**

Notch noted in the rightmost span of the central girder.

2. We recommend removing the rightmost span of the central girder and replacement with a new 3x2-10 girder. Provide flat, pressure-treated blocking and/or metal shims as needed to provide full-contact bearing between the piers and above girder.

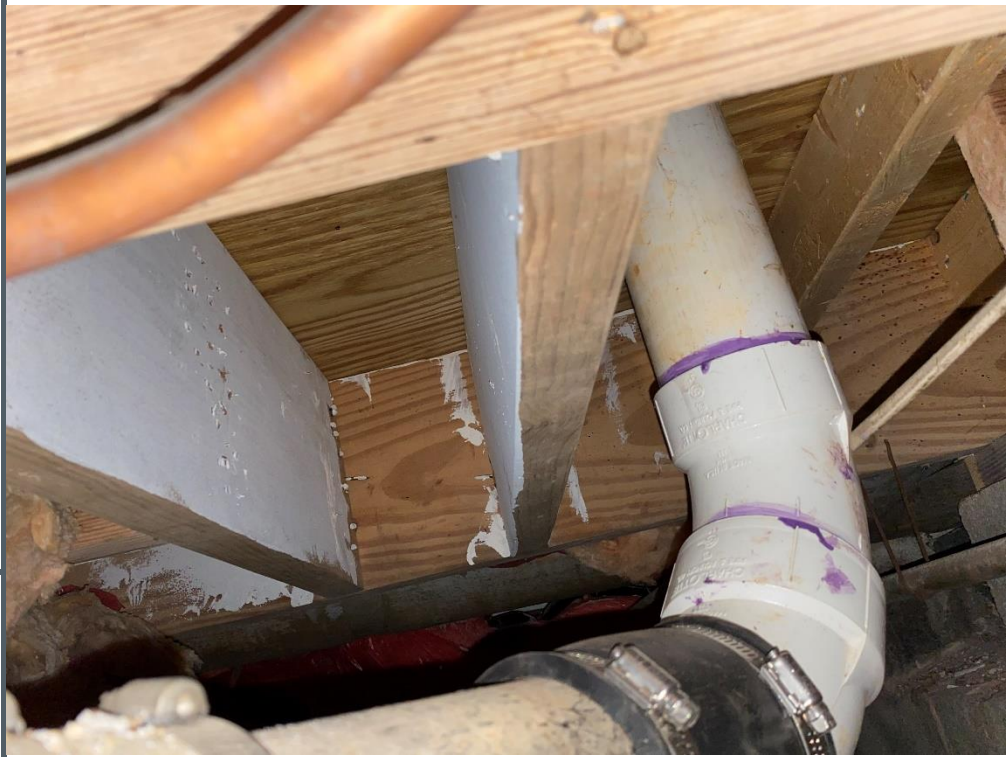
Photo No.  
7

7. A cut floor joist was noted in the rear span, approximately 19'-0" from the right foundation wall, in the immediate area of a plumbing component. 2x10 blocking was noted to be installed perpendicular in between the two cut sections of the joist, creating a "box-out" framing system in this area. Subfloor in this immediate area appeared to be replaced.

The joists noted in Observations #7 and #8 were potentially cut during installation of plumbing components in these areas. The current condition of the joists and associated repairs are structural concerns. We have provided recommendations below to address these issues.

General area of the cut floor joist and associated 2x10 blocking installed perpendicular to the joist.

3. We recommend installing a pressure-treated 4x4 post at both ends of the cut floor joist noted in Observation #7. The front-end post should be centered at the intersection of the two members. Each post should bear on a 12"x12"x10"-thick concrete footing and be positively attached at the top and bottom. Provide Simpson post caps and bases (or equivalent).

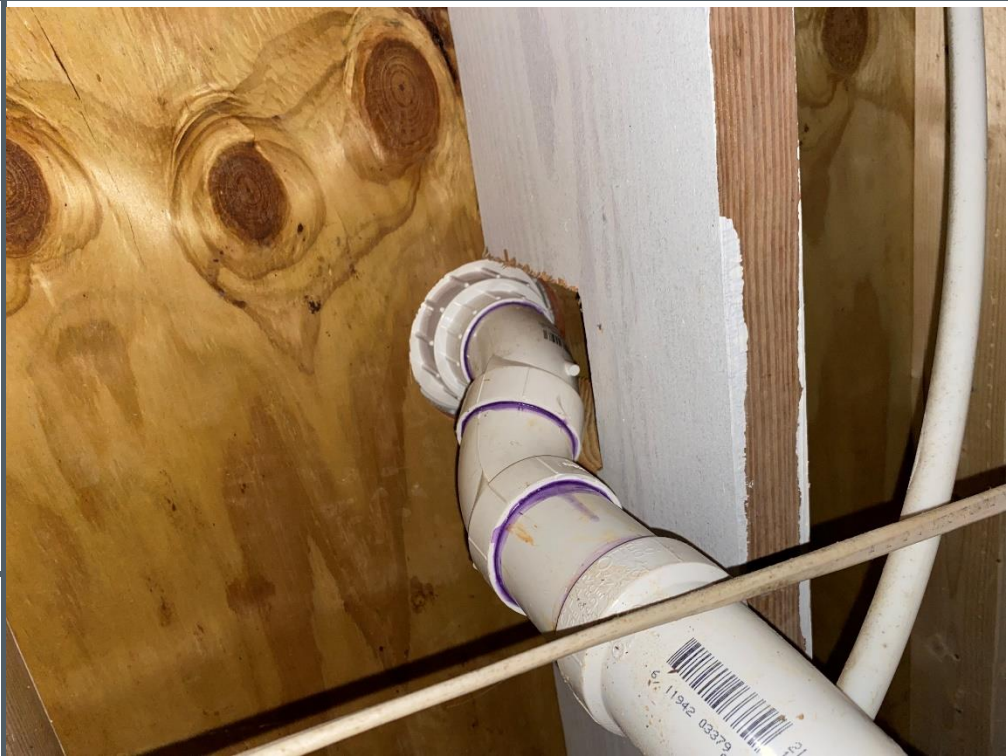
Photo No.  
8

8. A notched floor joist was noted in the rear span, approximately 16'-0" from the left foundation wall, in the immediate area of a plumbing component.

Additional cut/notched floor joist noted.

4. We recommend fully sistering the damaged floor joist noted in Observation #8 for the full length (bearing point to bearing point). The new sistered member should match the size of the existing joist and be attached with (3) 10d nails at 16" O.C.

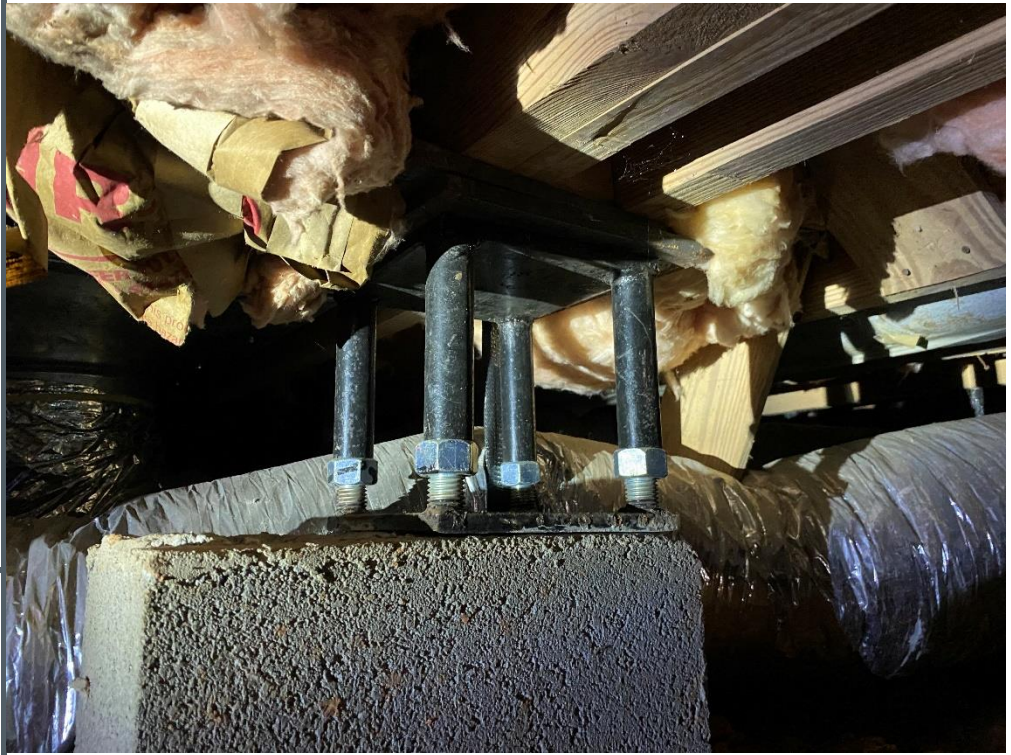
Photo No.  
9

9. A steel jack post support bearing on an 8x16 pier was noted in the front span, approximately 6'-0" from the front foundation wall and approximately 18'-6" from the right foundation wall.

The steel jack post noted to bear on a CMU block pier is not constructed properly and is not considered a permanent support. The condition of this post and pier is a structural concern. We have provided a recommendation below to address this issue.

Jack post support noted to bear on a CMU block pier.

5. We recommend removing the steel jack post support noted in Observation #9 and installing a new, mortared 8x16 CMU block. The existing footing may be utilized if it is a minimum 16"x20"x10"-thick. Alternatively, the pier is to bear on a new 16"x20"x10"-thick concrete footing. Provide flat, full-width pressure-treated blocking and/or metal shims between the top of the pier and the above floor framing to provide full-contact uniform bearing.
