**BUDDY WEST, P.E.**  
**STRUCTURAL ENGINEER**

December 08, 2016

As you requested, on Tuesday 12-06-16 I performed a site visit to the house at 2205 Kilburn Road in Raleigh. The purpose of my visit was to observe and evaluate the structural condition of several items that had been identified in the 12/01/2016 home inspection report by National Property Inspections as being potential structural issues. My observations and recommendations follow. "Item" numbers and "page" numbers are from the home inspection report:

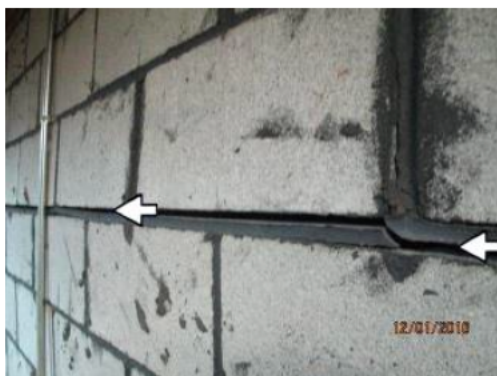
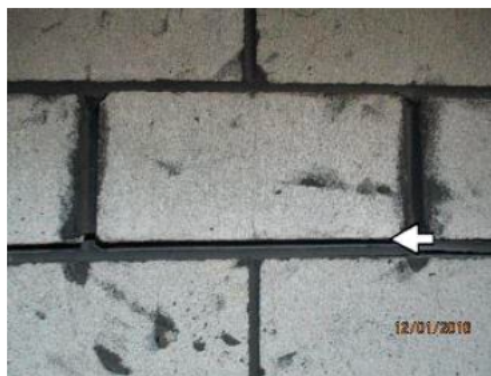
**3) Item 1 and both photos on page 38 of 50:**

The horizontal crack in the left-hand wall of the basement has been caused by the basement wall bowing inward by about 2" maximum at the height of the crack near the center of the wall length (according to my measurements). In my opinion, this inward bowing has been caused by horizontal pressure from the fill material (soil or crushed stone) on the other side of the wall, beneath the garage's concrete slab.

Note that this wall is a retaining wall, but has not been properly reinforced with steel rebars and grout to prevent cracking and movement, as the Code currently requires.

Note that one good thing does happen when retaining walls like this one move outward: the horizontal soil pressure on the wall is frequently significantly reduced, and wall movement often stops. Unless the conditions of the soil on the other side of the wall change, in my opinion the movement is not likely to continue.

Changed conditions could be either A) water getting into the retained soil, or B) a large increase in the loading on top of the garage slab. Both of these can cause an increase in the horizontal pressure on the wall. I don't believe that water will be a problem, since the garage is covered; and the owner indicated that he wasn't planning to park an unusually heavy vehicle in the garage, so the loading conditions on the slab are unlikely to change significantly.

1. Noted a horizontal to step crack in the left wall of the basement. Separation noted along the horizontal crack indicating movement, possible push of the wall inward from exterior force.
2. Noted a vertical crack / separation in the back left corner of the basement wall, running from floor and continuing to the top of the wall. The crack/separation widens toward the top. Due to the width of the cracks/separation further evaluation by a structural engineer is needed.

Interior Foundation: horizontal crack, note separation

For the above reasons, I recommend that no left-hand basement wall repairs be performed at this time.

I do recommend that the size/width of the horizontal cracks be measured and recorded about once a month for at least a year. If the cracks begin to get wider, please call me for further evaluation. Though I feel that significant further movement is unlikely, we will want to hire a foundation contractor to perform repairs if the crack width turns out to be progressive.

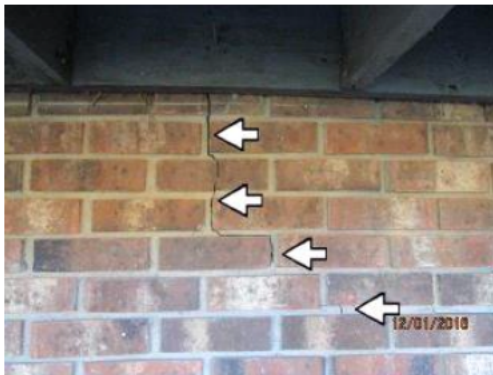
**1) Item 3 (1st sentence) and left-hand photo on page 35 of 50:**

The step-crack shown in the brick veneer photo is a maximum width of about  $\frac{1}{8}$ ". There has been about a  $\frac{1}{16}$ " outward movement of the veneer to the right of the crack. In my opinion, both the crack & the outward movement are most likely to have been caused by outward pressure on this wall, being exerted from the fill material that is behind the wall (under the garage slab).

3. Noted a step to vertical crack in the brick veneer between grade and the bottom of the garage service door. The brick veneer on the left wall appears to be suspended, not bearing on a footer or masonry foundation. Improperly supported brick veneer can lead to cracks, movement and or separation from the wall which is suspected at the back wall as indicated by gaps between the trim and the brick veneer at the service door, right side of the family room window and along dining room door threshold. Further evaluation by a structural engineer is needed.

Exterior Surfaces & Eaves: step to vertical crack

This crack is too small to indicate a structural problem at this location at this time. I do not recommend structural repairs.

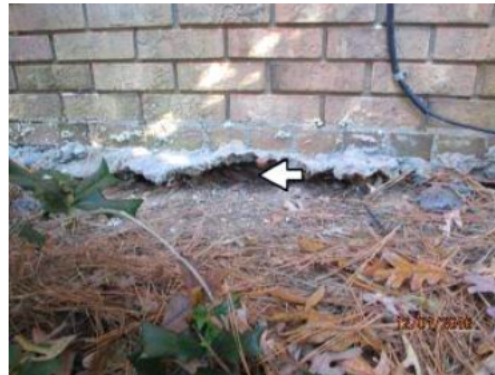
**2) Item 3 (second sentence) and right-hand photo on page 35 of 50:**

My observations beneath this exterior veneer show that there is another layer of brick veneer behind this one. The inner layer appears to extend well below the ground level, perhaps down to the wall footing. I cannot tell visually why the additional outer layer of veneer was added, nor why it is not properly supported on a concrete footing. Though this veneer is not a structural item and is not related to the structural stability of the wall, in my opinion the outer veneer does need to be supported on a new poured footing of 3000 psi concrete (minimum).

Exterior Surfaces & Eaves: brick veneer not supported

I recommend that the new concrete footing be installed under the full length of the

outer veneer, anywhere around the exterior wall of the house where this same unsupported condition is found. Shallow excavation at some locations along the walls will be required in order to determine where this condition exists. Before pouring the new footing, remove all of the existing uneven concrete from the bricks (a sample is visible in the photo).

The inside edge of the new footing can be poured directly against the face of the inner veneer, and the outside edge of the footing will need to be formed with 2X lumber. The new footing should extend at least 3" out beyond the outside face of the outer layer of veneer. The 2X lumber form needs to extend up at least 1" above the elevation of the bottom of the bricks, to be sure that the new concrete comes up to the bottom of the bricks. Stake or brace the forms properly; vibrate or "rod" the concrete.

The new footing should be a minimum of 6" thick, and needs to rest on thoroughly compacted soil. Since this veneer is not structural, in my opinion the bottom of the footing does not have to extend 12" under the ground in this particular case. I do recommend that the bottom of the footing extend at least 6" below the ground.

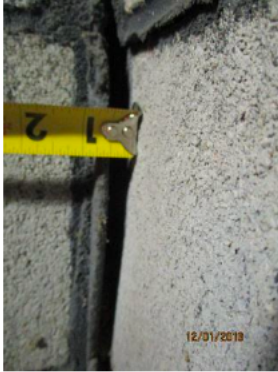
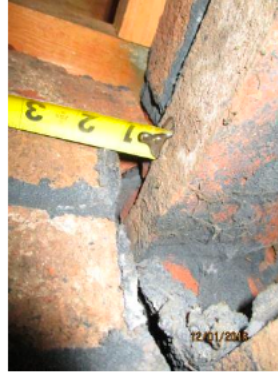
**4) Item 2 on page 38 of 50, and both photos on page 39 of 50:**

In my opinion, the separation of the back wall from the rear end of the left-hand basement wall was caused by the top of the rear wall leaning outward (to the rear). I measured the amount of leaning to be about 1" at this point in time. I believe that the rear wall is leaning outward due to the same horizontal pressure on the wall from the fill material (soil or crushed stone) beneath the garage slab, as discussed in paragraph 3 above.

Interior Foundation: crack/separation back left corner

For the same reasons called out in paragraph 3 above, I do not recommend wall repairs at this time. See that same paragraph for other recommendations about monitoring the amount of movement, and the implications of further movement.
