**THE PARAMOUNT CONDO  
OWNERS ASSOCIATION  
RALEIGH, NC**

**DATE:  
AUGUST 4, 2025**

**RESERVE STUDY  
UPDATE with Site  
Inspection**

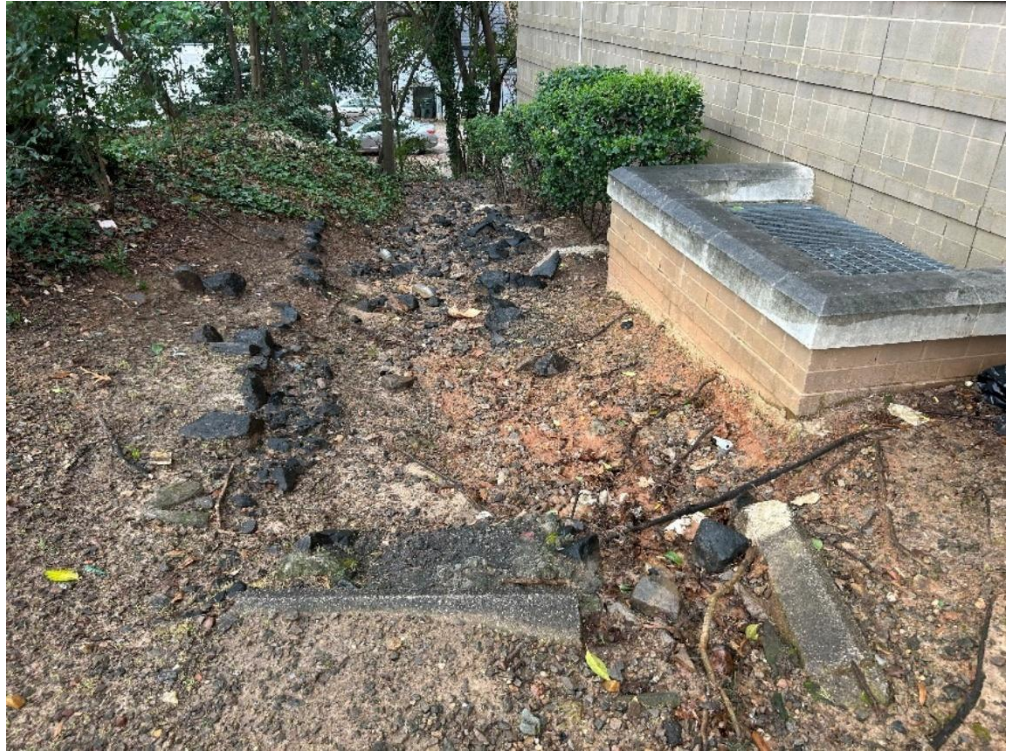
Photo No.  
1

Stormwater drains from the site via surface flow into graded swales which direct the flow of stormwater to catch basins in the public right-of-way. The swales appear to be functioning as intended; however, we observed soil erosion and sedimentation in the riprap armored swale on the northeast side of the building. Landscaped swales tend to accumulate sediment that settles out during storm events and will need to be periodically removed and regraded. Erosion concerns are likely to develop in steeper slopes, which would require stabilization repair. Future drainage improvements would likely include retrenching swales to improve flow, stabilizing steep or bare slopes, cleaning out debris from stormwater piping, repairing erosion, or possibly installing additional drainage devices such as French drains or other small drainage systems with buried piping and small catch basins. We have allocated funds for future drainage improvements on an 8-year cycle beginning in 2028.

Erosion and  
sedimentation in swale  
adjacent to the building

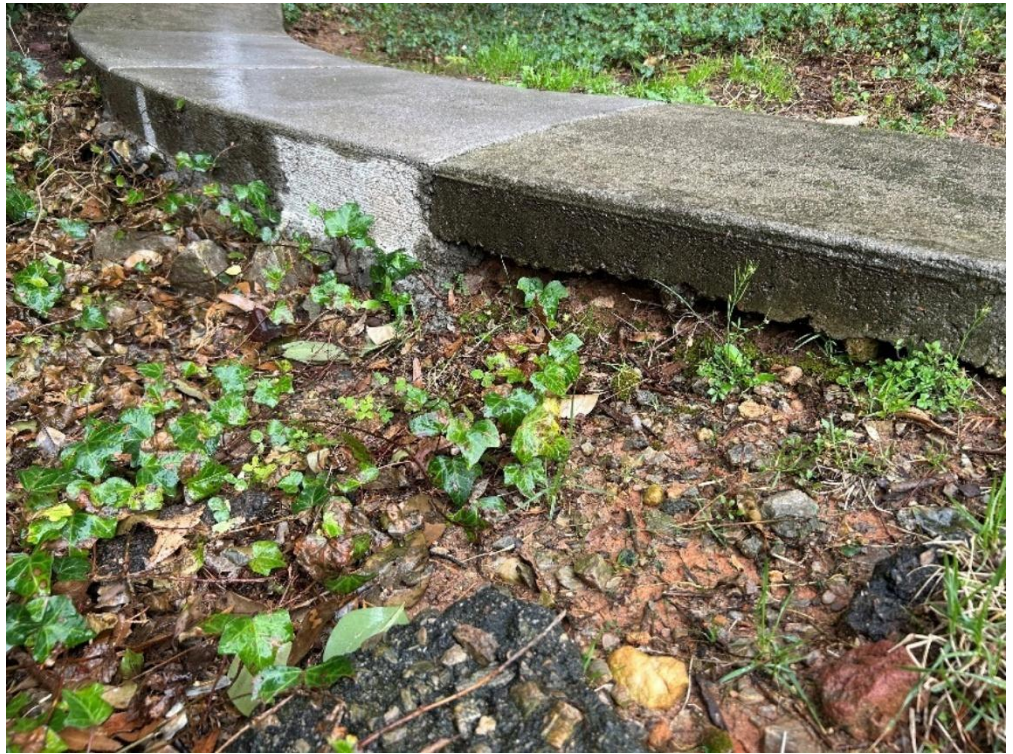
Photo No.  
2

The parking garage levels and associated driveways are paved in concrete. Concrete sidewalks at the main entrance and at the north and east sides of the property provide pedestrian access to the building entrances/exits. We observed areas of grinding and previous repairs where settlement has occurred near the northeast corner of the building. As cracking and displacement advance, it is likely that sections of the concrete surfaces will require periodic repairs/replacement. We have included funds every 8 years beginning in 2030 for periodic repairs and/or replacement of concrete surfaces as required.

Section of previous  
concrete repair, slight  
undermining still present

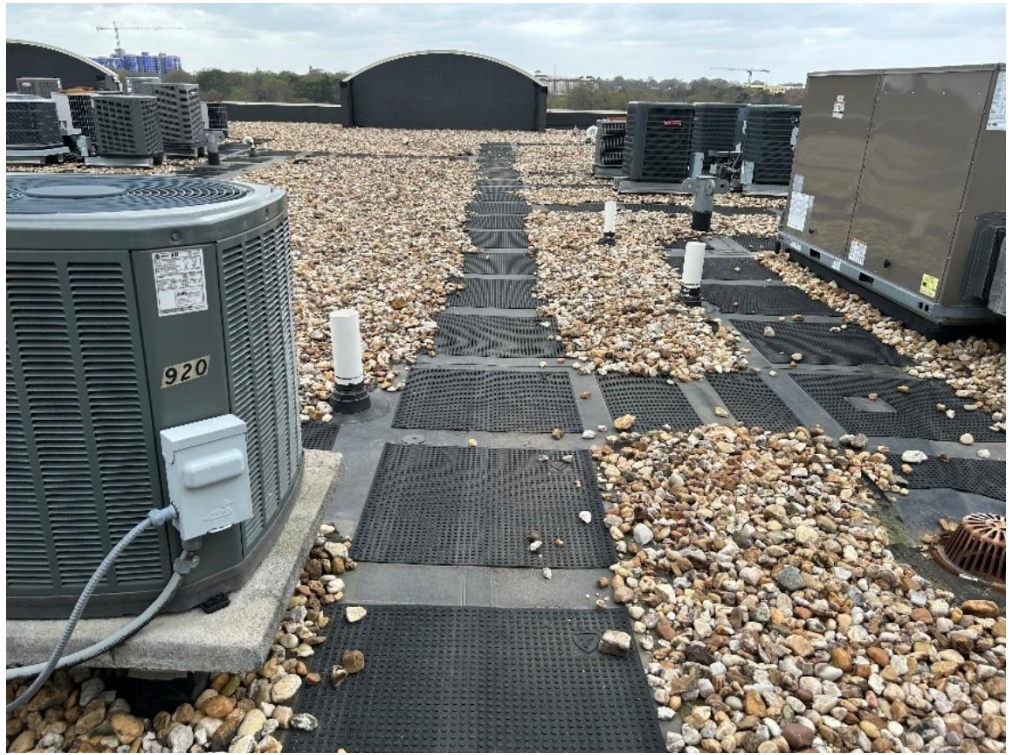
Photo No.  
3

The flat roof surfaces over the building are covered in a ballasted 60 mil EPDM (ethylene propylene diene monomer) roofing that was replaced after 2020. The vertical surfaces of the surrounding parapet wall appear to be covered in 90 mil EPDM roofing with metal parapet caps. Typically, this type of roofing system will last approximately 20 years. We have allocated funds to replace the roof every 20 years beginning in 2043.

General view of  
ballasted roof membrane

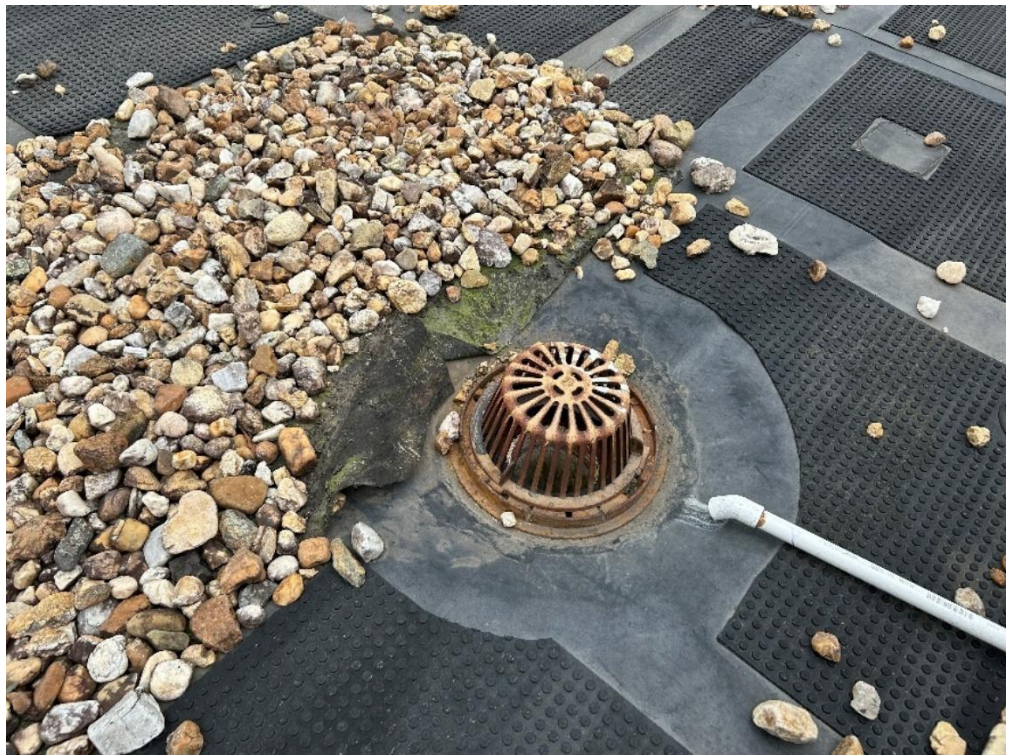
Photo No.  
4

Ballasted roof membrane

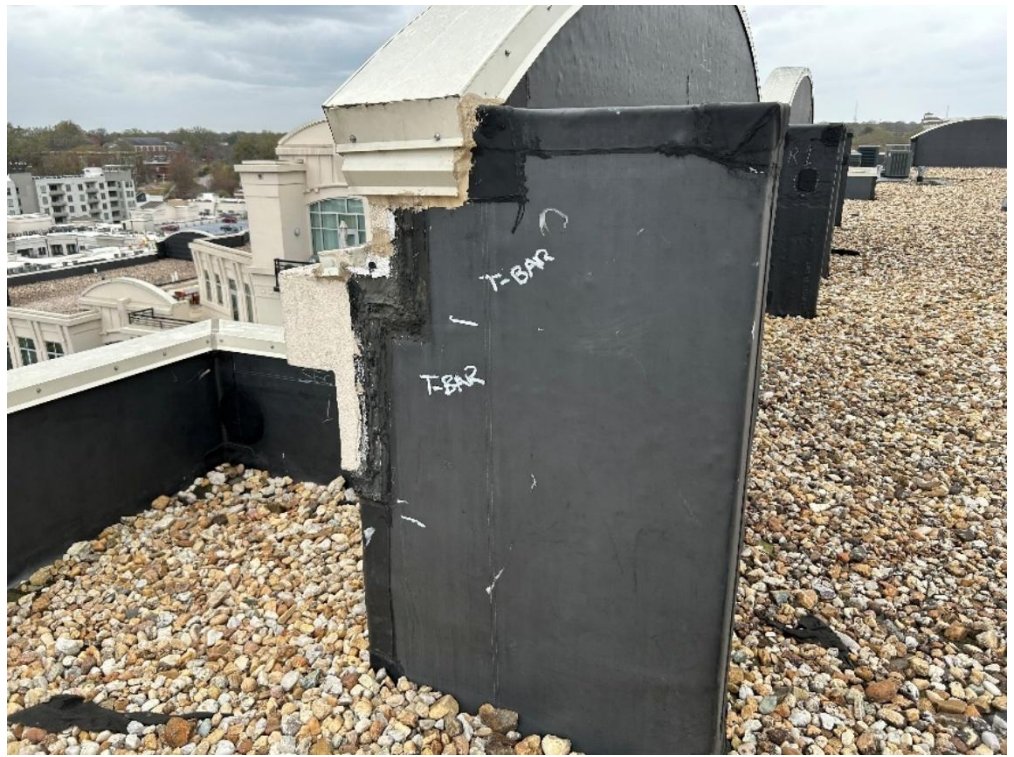
Photo No.  
5

Vertical roof membrane

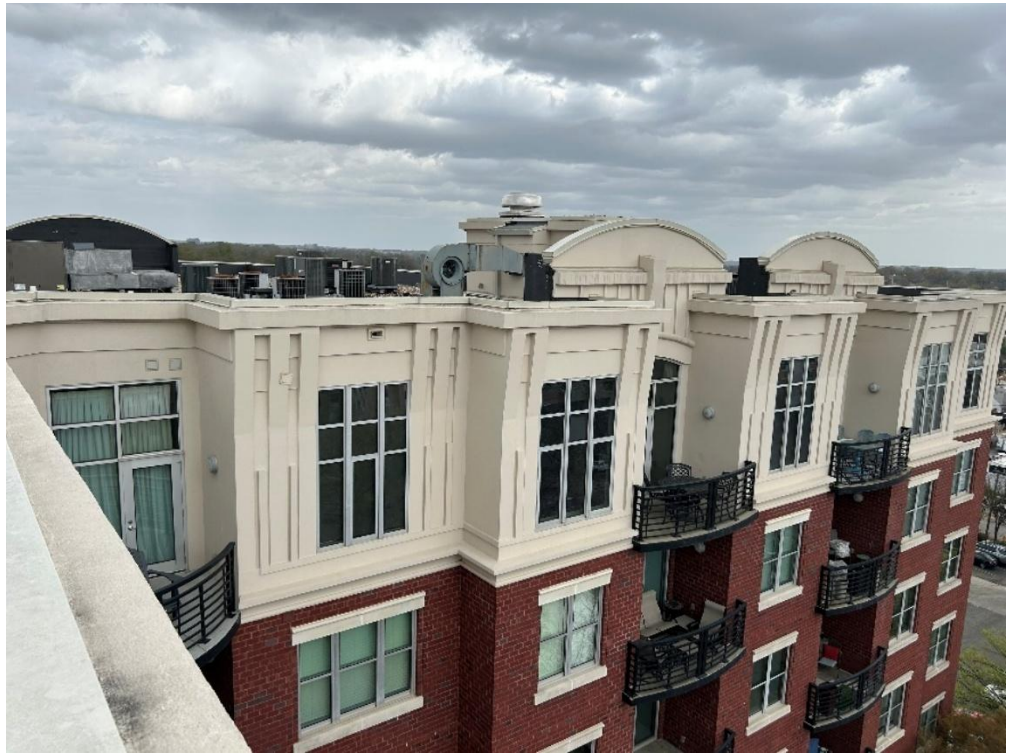
Photo No.  
7

The building exterior is clad in brick and masonry veneer with accent sections of EIFS/Stucco. Painted steel railing are located at the roof parapets and at the building entrance. A siding project was recently completed in 2023 to recoat and repaint all EIFS/Stucco surfaces, paint metal railings, and repair/repoint masonry. We have allocated funds to replace sealants, repair/recoat EIFS surfaces, paint railings, and paint/repair trim components on a 10-year cycle beginning in 2033. We have also included an allocation of funds for periodic repair/repointing of the exterior masonry on a 10-year cycle beginning in 2033.

General view of building exterior (EIFS and masonry)

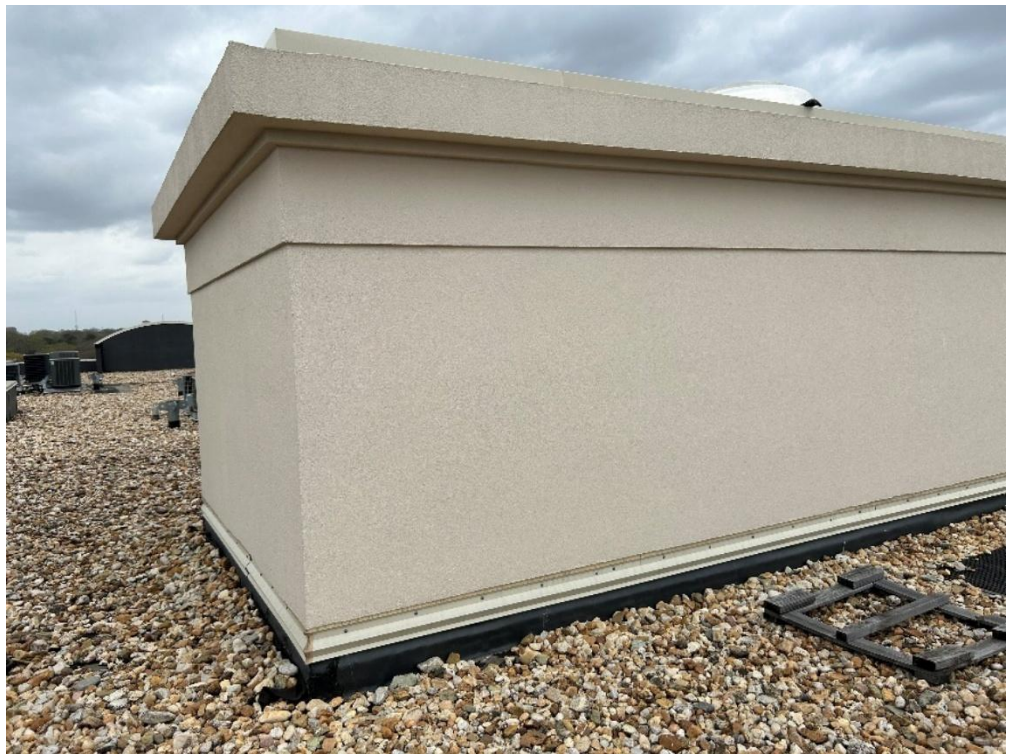
Photo No.  
8

EIFS coating on building exterior

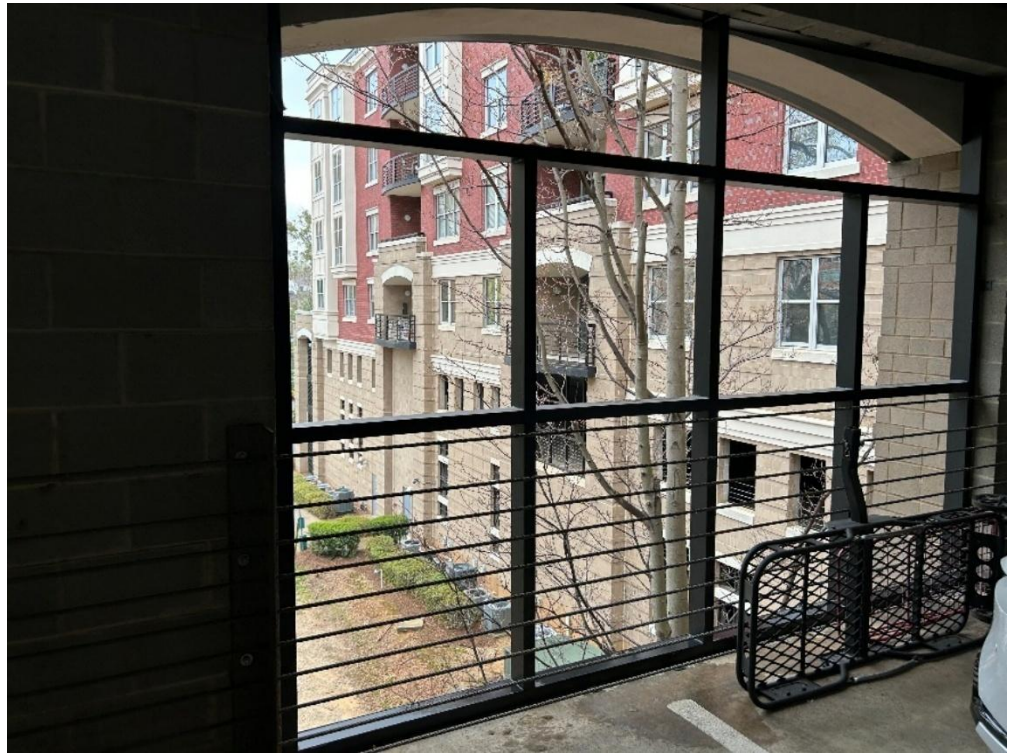
Photo No.  
9

The elevated balconies at each condominium unit are surrounded by aluminum guardrails, and access to the parking garage is controlled by steel gates. We understand that these railings, as well as the metal railings in the parking garage, were painted at the time of the siding repair project in 2023. We anticipate the rails and gates will require periodic recoating due to their continued exposure to the elements and have assumed that work would be completed along with each siding project. We have allocated funds to replace the aluminum railings throughout the building in 2051. We have also provided an allocation of funds to replace the parking garage gates every 30 years beginning in 2036.

Parking garage railings

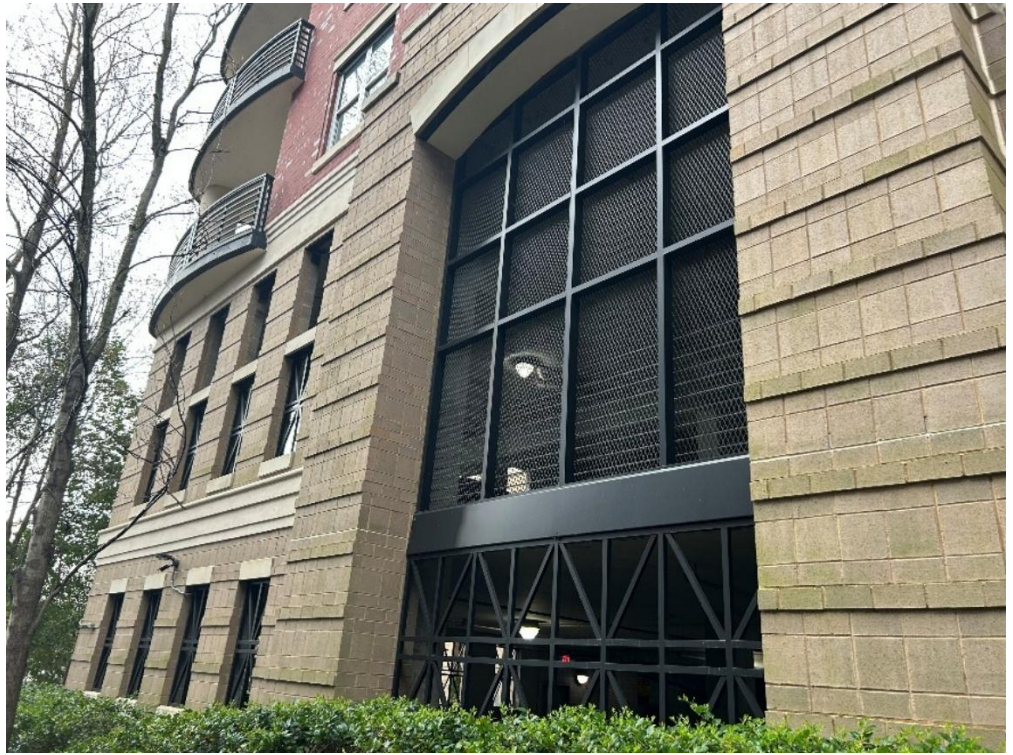
Photo No.  
11

Painted railings in  
parking garage

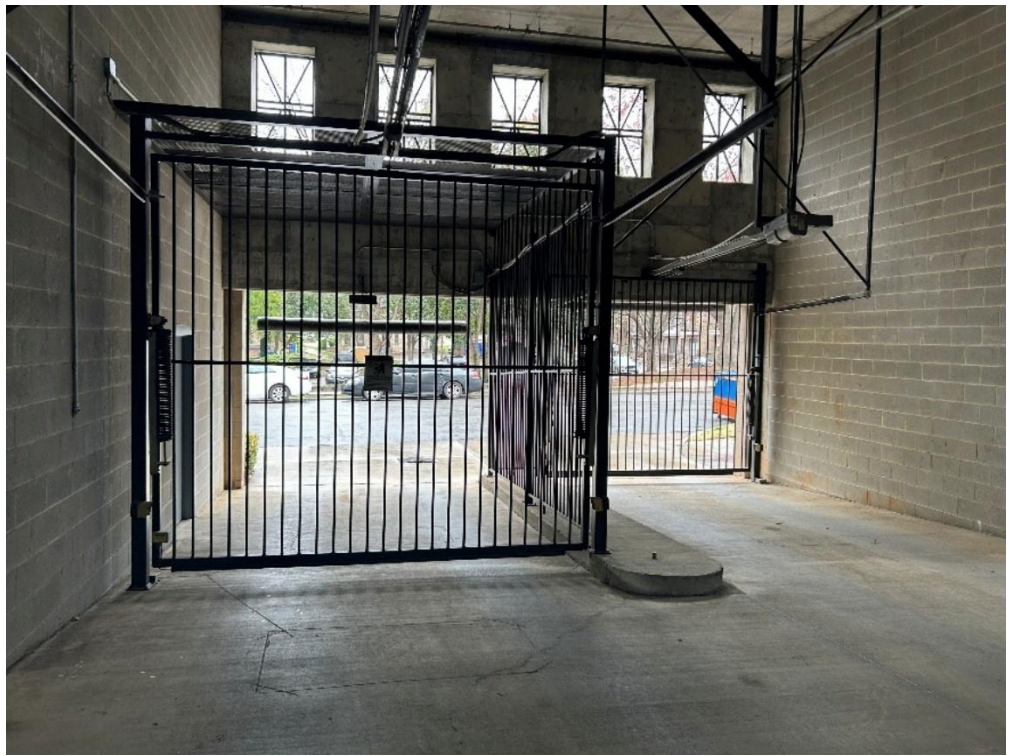
Photo No.  
12

The south parking garage entrance is equipped with motorized openers on overhead gates, and the west entrance is equipped with motorized openers on the sliding gates. The gates appeared to be operating correctly at the time of the site inspection and we are not aware of any issues. Due to the frequent cycling of the motors, we have allocated funds to replace the openers on a 15-year schedule beginning in 2027.

Parking garage gates and  
operators

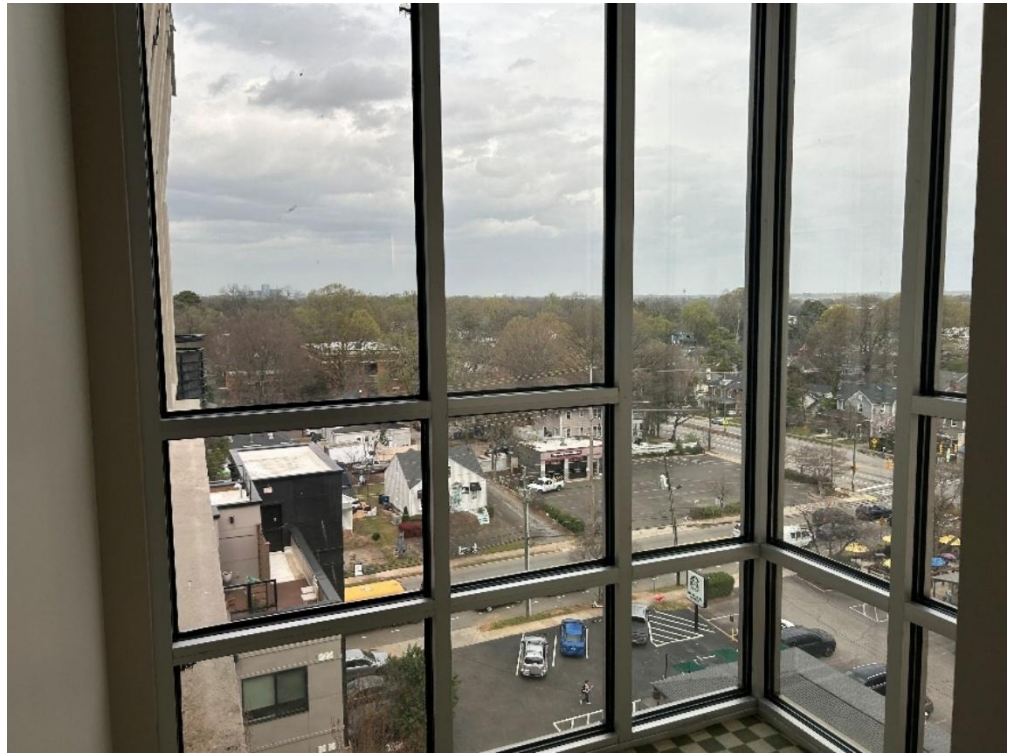
Photo No.  
15

The common area windows are comprised of aluminum-framed storefront units. Per the community manager, the Association has taken responsibility for all common area and unit windows and doors. The Association has replaced/repared portions of the windows annually for the last 5 years and plans to continue to do so. We have allocated funds to reseal the joints along window/door frames and the surrounding masonry/EIFS and included that work in the exterior painting schedule. Generally, these types of window systems have an expected useful life of approximately 30 years, after which time, built-up sealant over the gaskets becomes ineffective and the air space between glazing panes can begin to leak. We have allocated funds to replace approximately 1/5 of the unit and common area storefront windows and doors every 5 years beginning in 2031.

Typical aluminum-framed storefront windows in the common areas

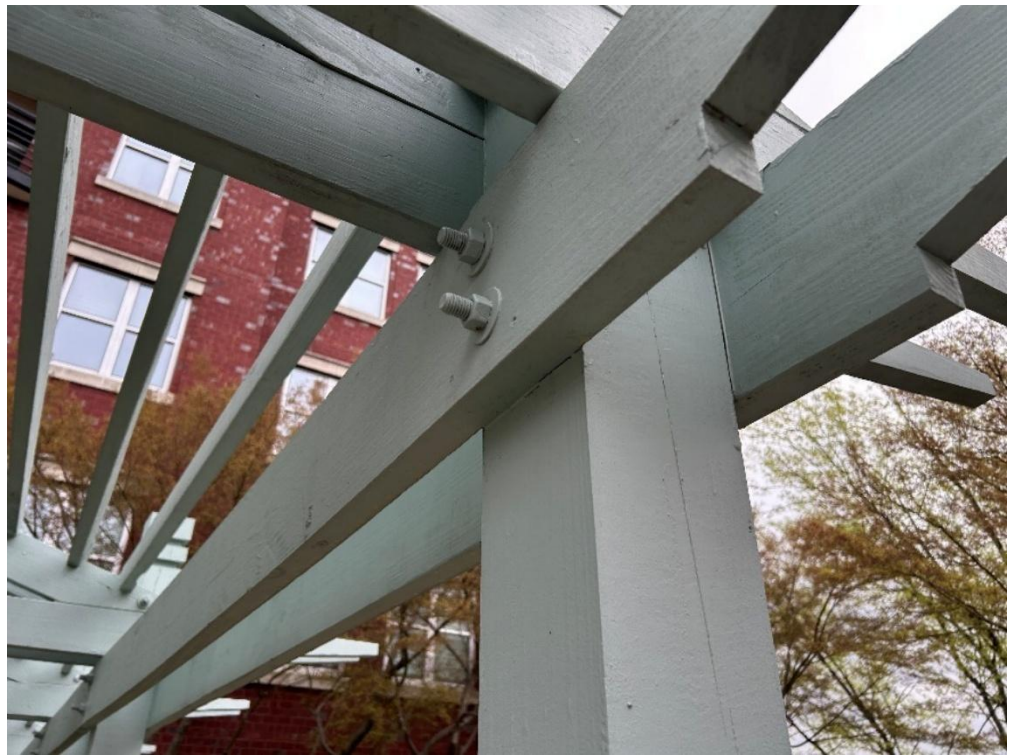
Photo No.  
16

A wood-framed pergola is located adjacent to the fifth-floor swimming pool. Per the community manager, the pergola was replaced in 2023 and appeared to be in generally good condition. Due to continued exposure to the elements, we recommend regular staining/painting of the pergola and have included funds to stain/paint the structure every 5 years beginning in 2029. We estimate the pergola will require reconstruction approximately every 15 years and have allocated funds for this work beginning in 2038.

Wood pergola structure on the pool deck

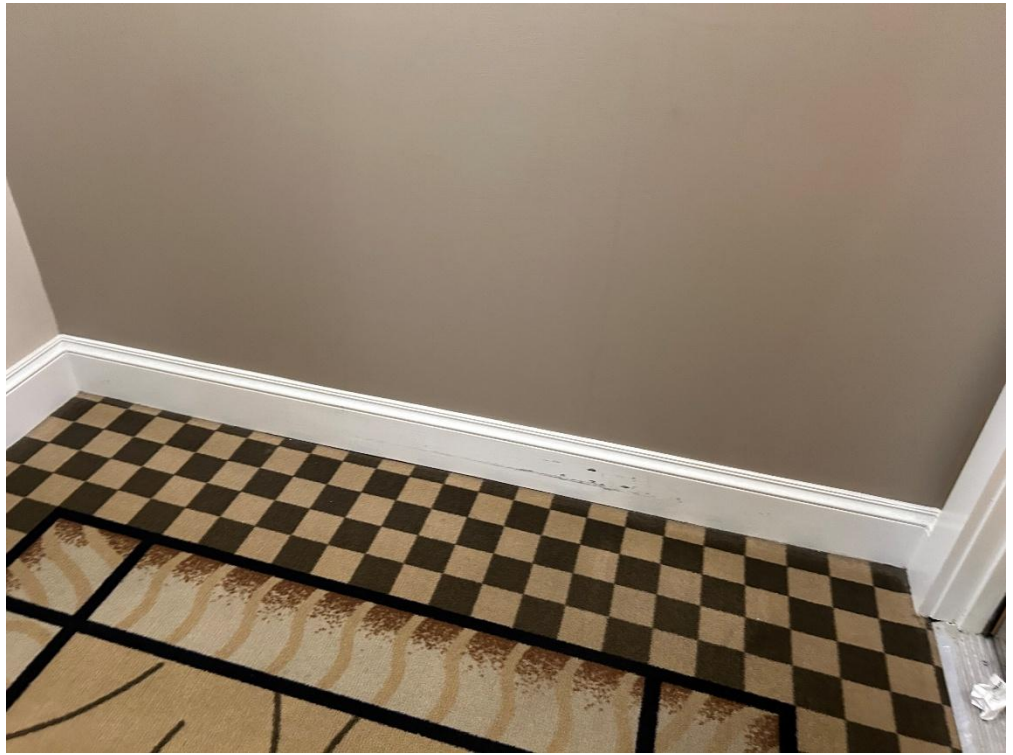
Photo No.  
21

The common area corridors on each level of the building are finished with painted gypsum board walls and ceilings. The main entrance lobby is also finished with a painted gypsum board ceiling. Common stairwells are comprised of steel framed stairs with concrete-filled metal pan treads without additional finishes. The interior surfaces appeared to be in generally good to fair condition, with scuffs and paint deterioration noted on corridor trim in heavily trafficked areas. Generally, interior surfaces require repainting on an 8-12-year cycle. We have allocated funds to repaint the common area interior surfaces and spot paint the stairwells on a 10-year schedule beginning in 2027.

Paint scuffing and  
deterioration in common  
area corridor

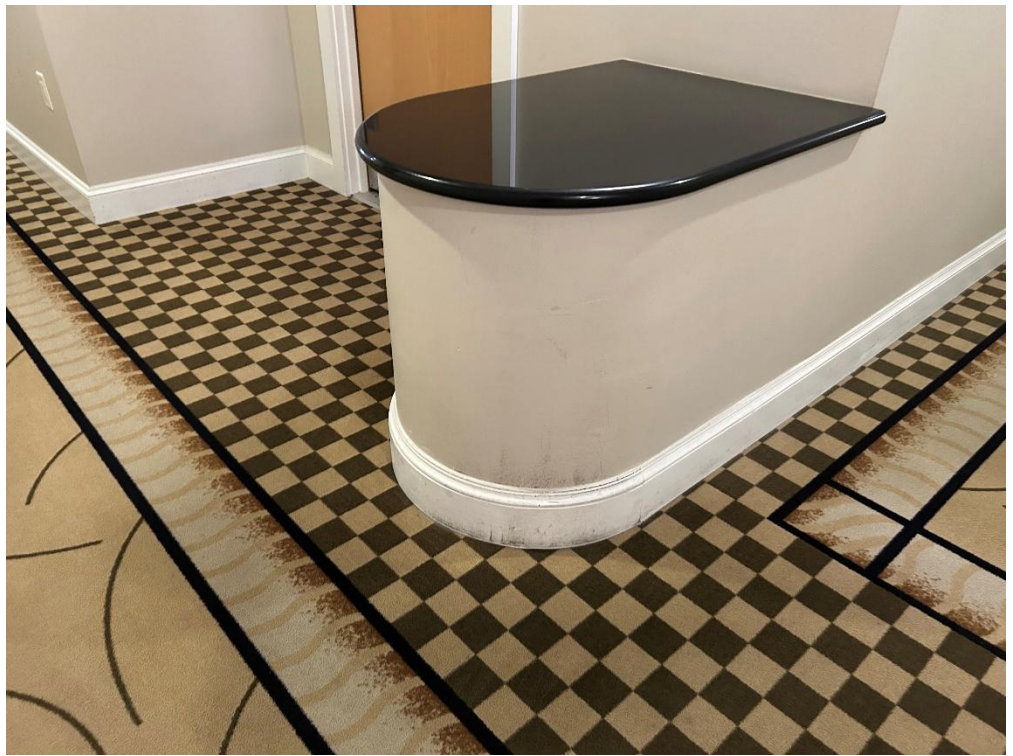
Photo No.  
22

Paint scuffing and  
deterioration in common  
area corridor

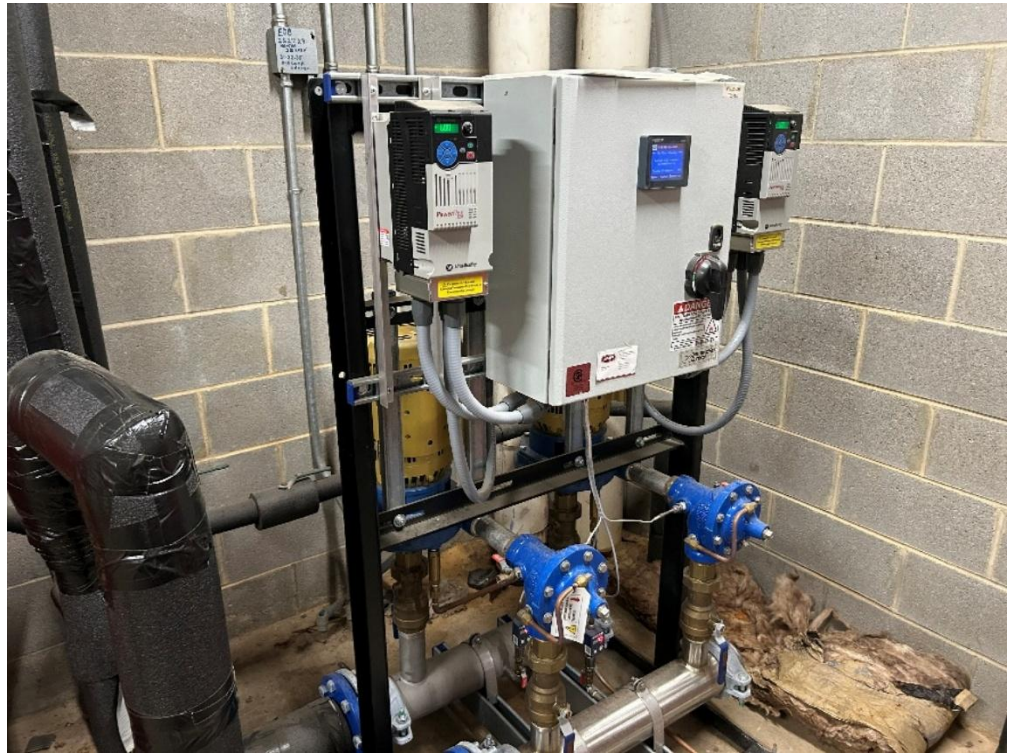
Photo No.  
27

A potable water booster pump system is located in a mechanical room on the second level of the parking garage. The system includes two 7.5 horsepower motors and a Hyfab DemandSet control system. Per the community manager, the system was replaced in 2021. We have allocated funds to replace the pump motors and control system skid on a 15-year cycle beginning in 2036.

Potable water booster  
pump

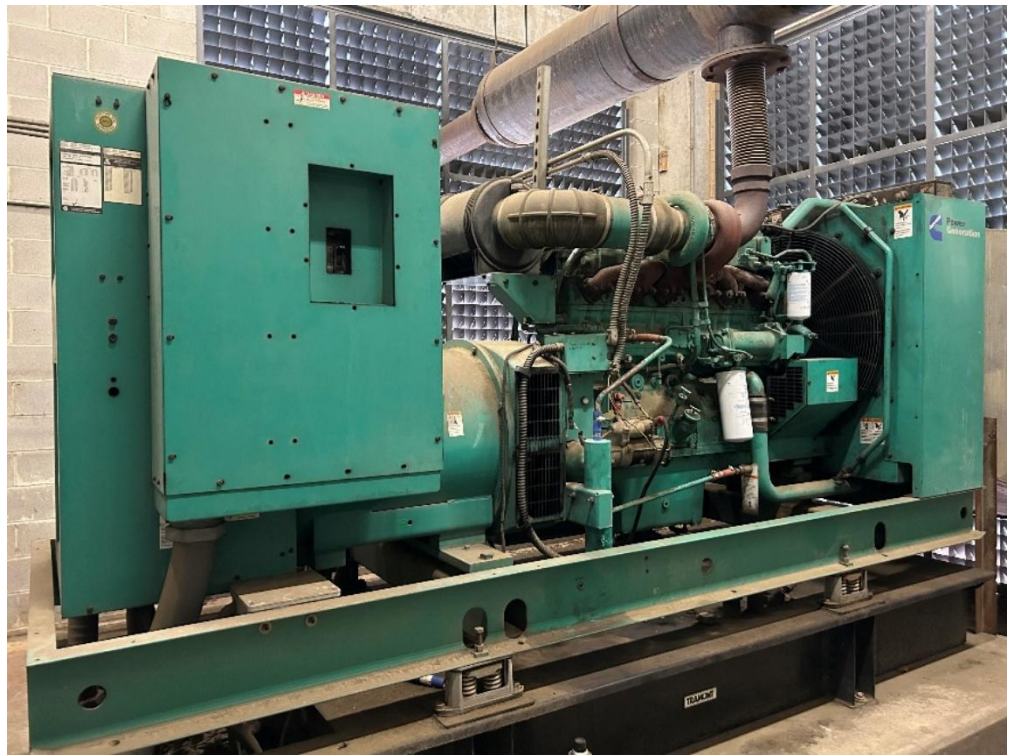
Photo No.  
34

A Cummins diesel powered back-up generator and automatic transfer switch are located in a mechanical room at the southeast corner of the lowest parking level. The 500 KVA generator is powered by a 6-cylinder, 605 horsepower diesel engine. This type of emergency generator typically has a useful life of approximately 30-35 years if properly maintained. We have included an allocation of funds to replace the emergency generator and transfer switch every 30 years beginning in 2036. We have also included an allocation of funds for interim repairs to the generator and associated systems on a 15-year cycle beginning in 2029.

Deisel emergency generator

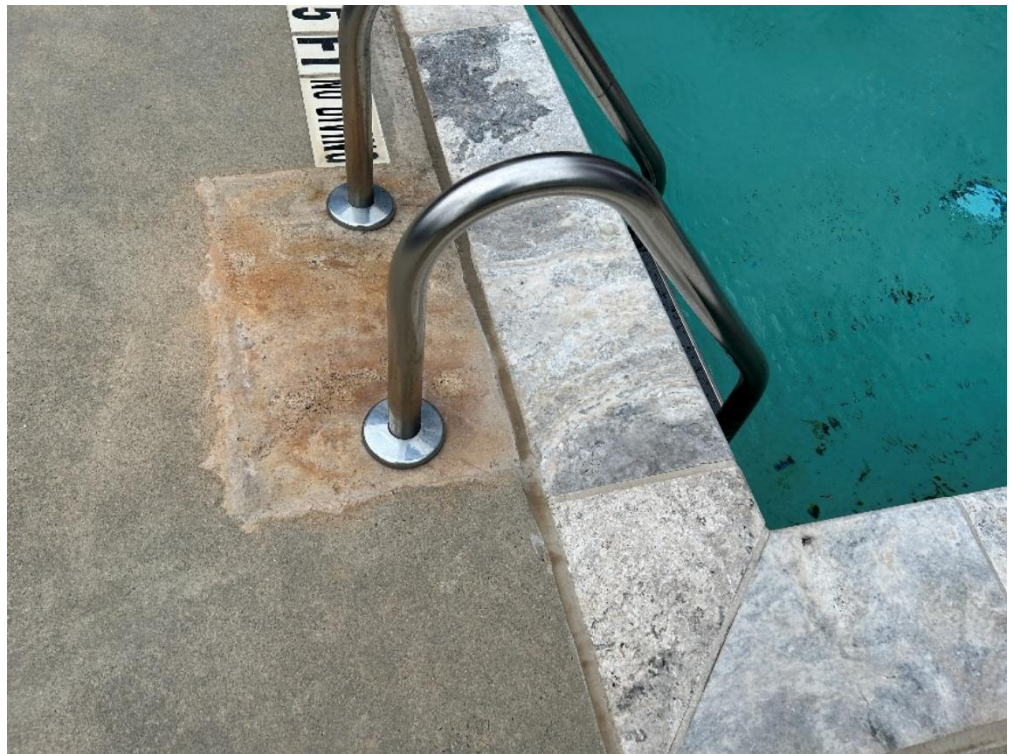
Photo No.  
36

Concrete patching and  
pool railings
