Ref: Structural Evaluation of:  
Truss Steel Plate Defect

Address: 713 Peakland Place  
Raleigh, NC 27604

I performed Visual structural inspection to the previously repaired roof trusses on April 23, 2026.

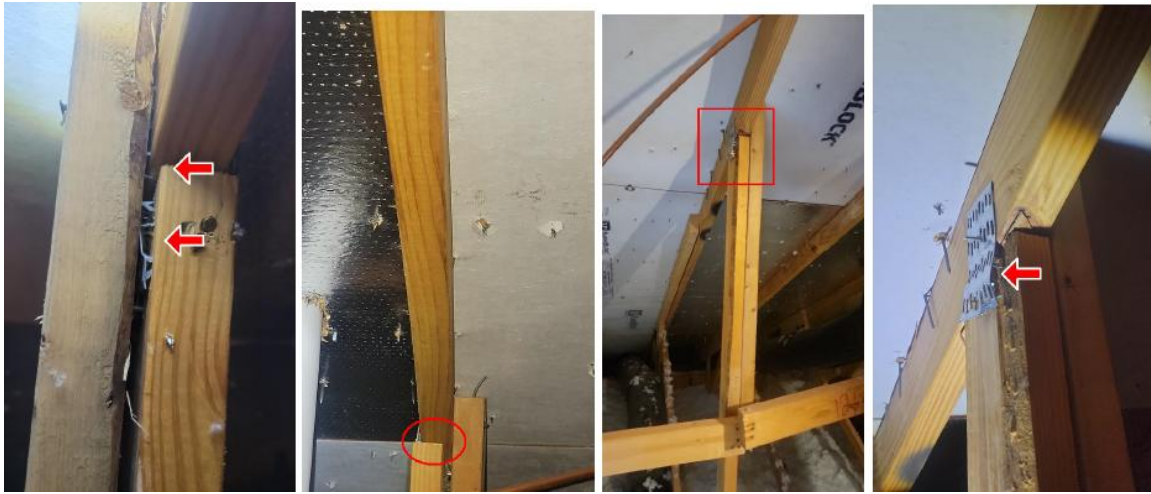
Figure 1

Three trusses in the attic had previously been repaired due to loosening of the upper steel plate between the web and chord. The existing repair consisted of a single 2x4 member, approximately four feet in length, fastened to one side of each affected roof truss (see Fig 1).

The separation of the truss steel plates occurred at both the front and rear sections of the attic. Based on my assessment, the repair performed was inadequate due to the materials and nails chosen, and the workmanship itself was substandard.

The repair procedure shall involve the removal of the 2x4 wood member from each affected truss, to be replaced with a 0.75 inch thick OSB board that covers both the web and chord on both sides, as illustrated in Figure 2.

or OSB, each with a thickness of 0.75 inches—must be installed to fully encompass all webs and chords in the area of the defect. Furthermore, the contractor is required to fasten the gussets using 8d nails at 4-inch intervals along both chords and webs on each side.
