# ++SEPTIC PUMPED MAY 2026++

## PHOTO LOG:

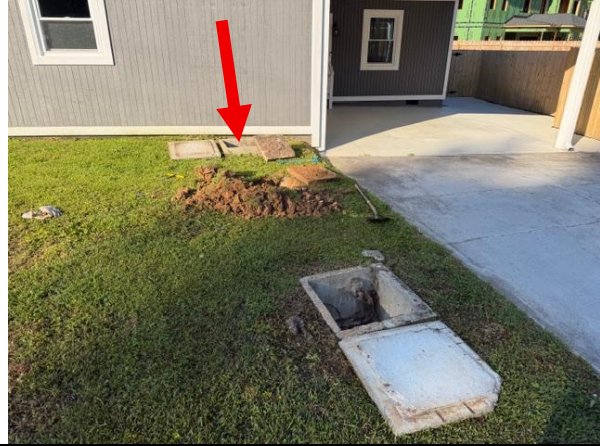
Inlet Chamber location shown

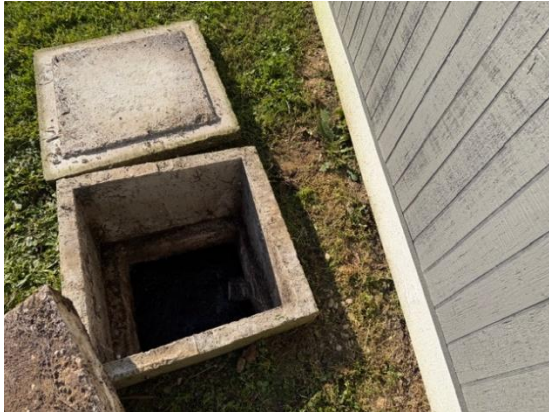
Home shown encroaching on septic tank

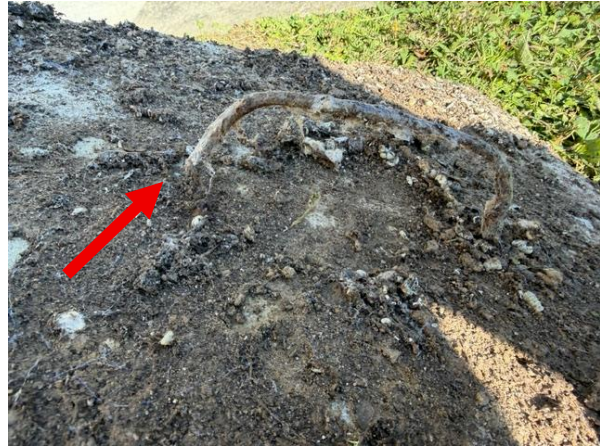
Inlet chamber lid handle shown broken

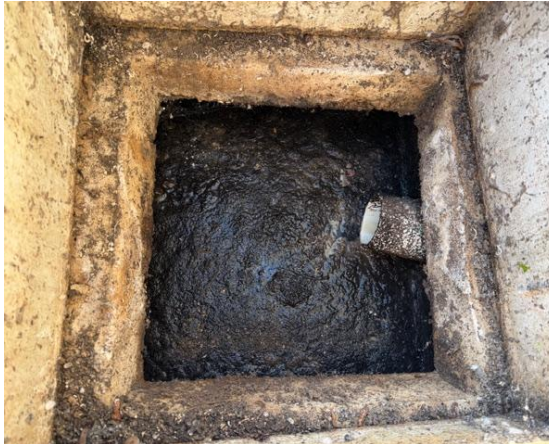
Inlet chamber shown open for inspection

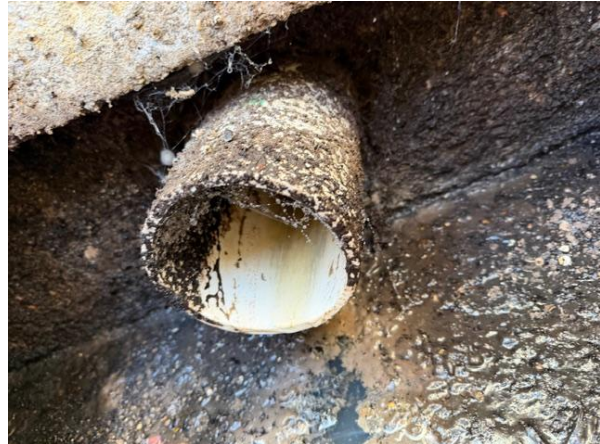
Inlet drain pipe shown

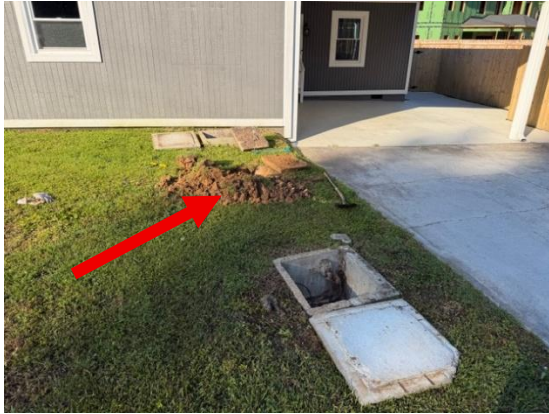
Outlet chamber location shown

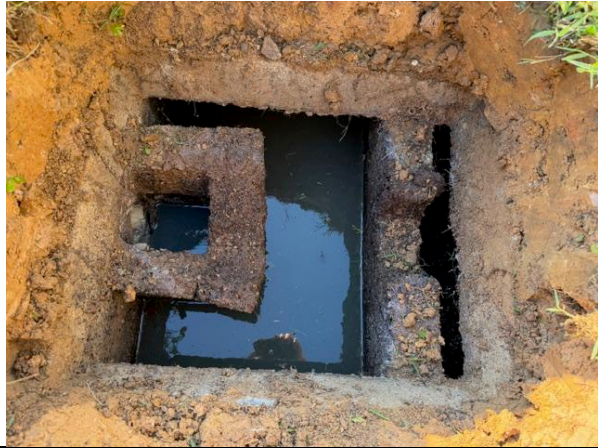
Outlet chamber shown open for inspection

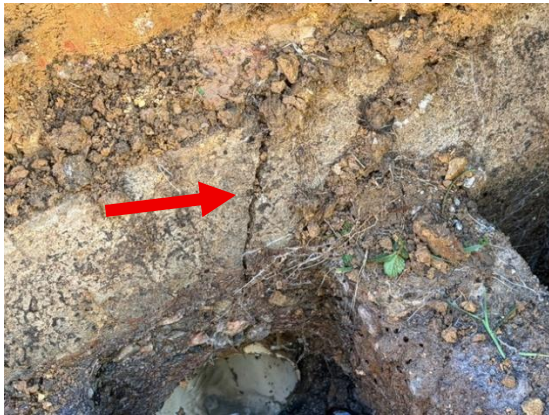
Crack shown on backside of septic tank

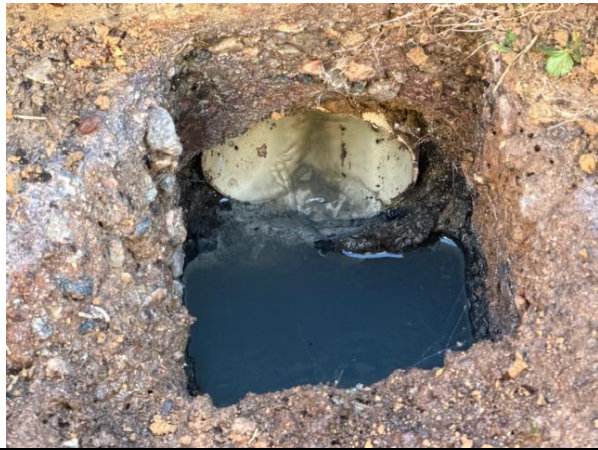
Normal effluent level shown

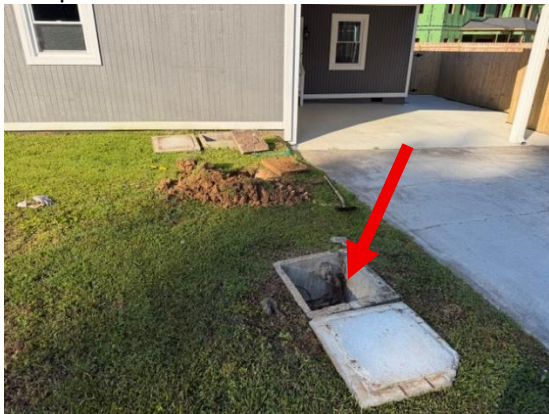
Pump chamber location shown

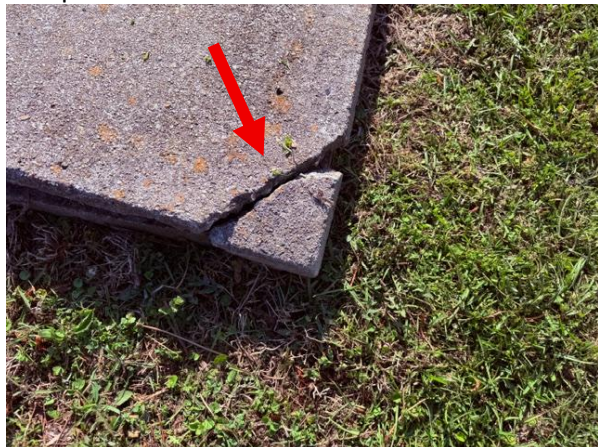
Pump chamber riser lid shown broken

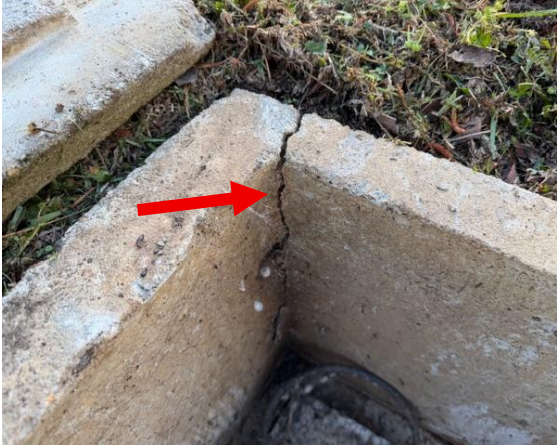
Pump chamber riser shown with crack

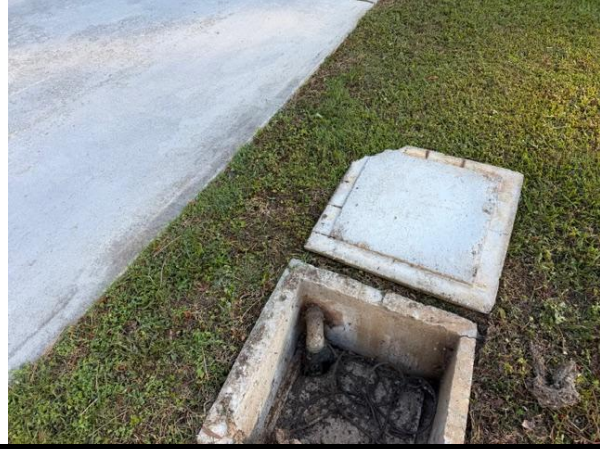
Driveway shown encroaching on pump tank. Supply line shown going towards driveway

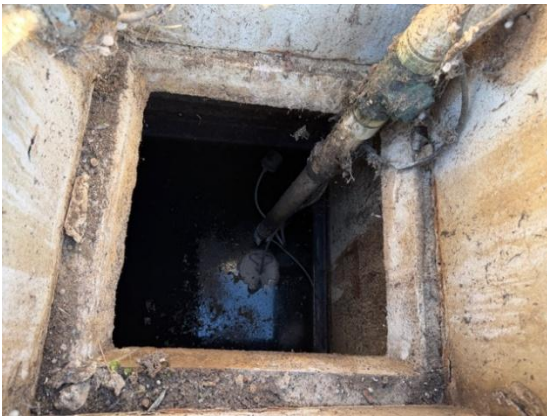
Pump chamber shown open for inspection

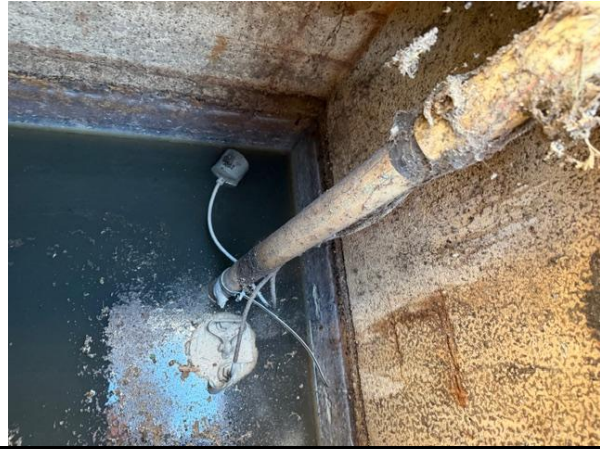
Pump float noted as not being properly attached to float tree

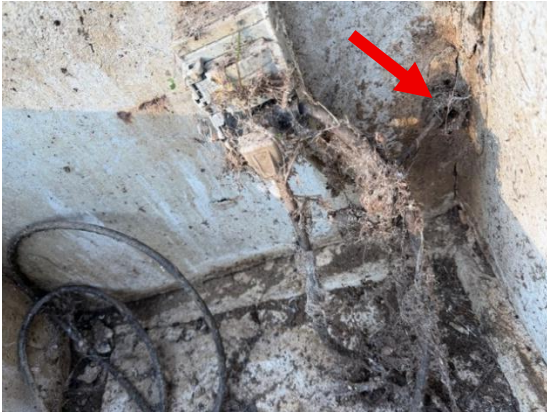
Pump chamber electrical junction box shown inside of pump chamber. Conduit not sealed

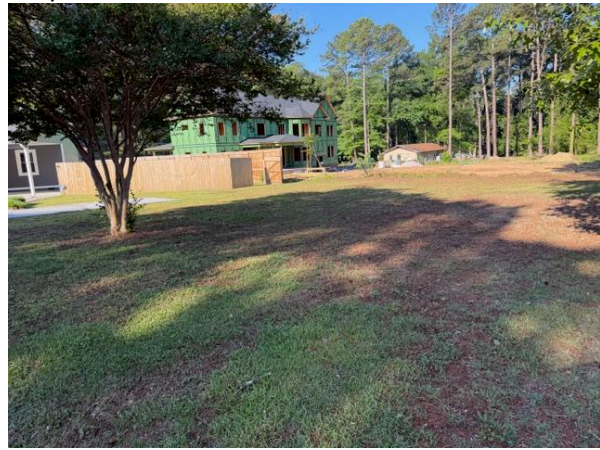
Suspected area of drain field shown
