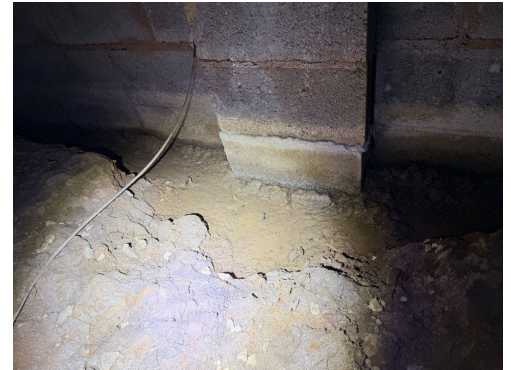
1. Needs Repair: Foundation Grading and Drainage - Standing Water Present - Standing water was observed inside the foundation of the home. Water can pass through a foundation, but when trapped, water can result in settlement concerns and increase moisture levels in the wood framing which can result in damage and/or increased fungal growth. Have a professional foundation moisture control contractor evaluate the crawlspace and make the necessary repairs to prevent water from being trapped under the home.

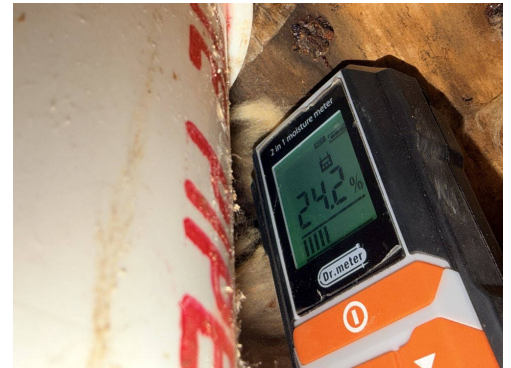
2. Needs Repair: Subfloor Decking - Moisture Damaged Present - Evidence of water intrusion and moisture damage to the floor decking is present. Continued moisture intrusion can further damage the surrounding areas of the sub floor/floor structure. Have a professional contractor fully evaluate the subfloor and make the necessary repairs to prevent further moisture intrusion and for long-term serviceability of the floor structure.  
\*\*\*Note - Damage may extend to surrounding components. Probing of the area did not reveal any additional damage via non-invasive limited probing.

Inspected by GC. Subfloor didn't need replaced. 2 small leaks under shower were repaired May 2026.

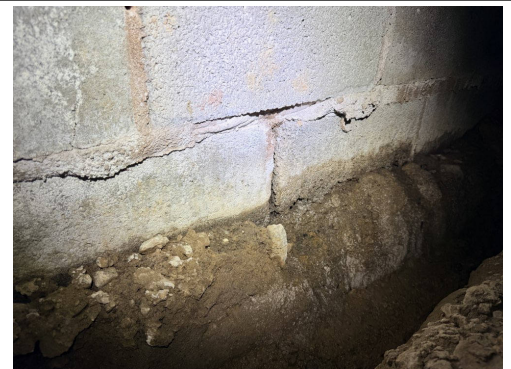
3. Needs Repair/Further Evaluation: Foundation Walls - Cracking in Foundation Wall - Observed stair step and/or shear cracks in the block foundation wall of the house. While some small cracking in the foundation and/or exterior wall cladding is an expected behavior, when openings are present in the wall surfaces greater than 1/4" the "standards of practice" of a home inspector would require that a structural engineer be recommended to evaluate in order to determine if cracking is a structural concern and what the repair for this failure would be. Due to the observed cracks in this wall exceeding 1/4" in width it is recommended that a structural engineer fully evaluate the foundation area of the home to determine if/what repairs are necessary. Any noted repairs should be completed by a professional contractor as stated by the engineer.

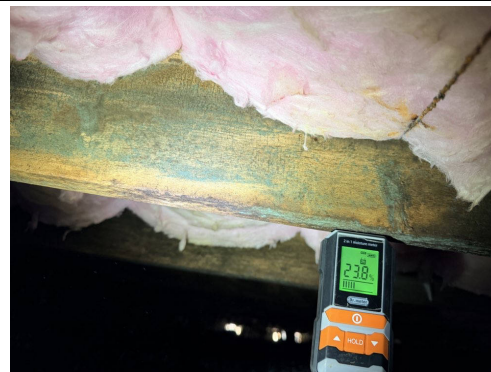
### 4. Needs Repair: Foundation Moisture - High Moisture/Fungal Growth Present -

High moisture levels were recorded inside the foundation on the frame members of the floor system at the time of the inspection, coupled with the presence of fungal growth observed at some areas on the framing members inside the foundation. Although this type of fungal growth is observed inside many crawlspaces, any presence of a fungal growth is an indicator of an adverse condition associated with high moisture having been present. Have a professional foundation moisture control contractor evaluate the foundation area and make any necessary repairs to control high moisture levels that may be attributed to the presence of fungal growth inside the crawlspace, as well as, cleaning/removal of any visible presence of the growth. Any additional concerns related to possible health issues associated with the presence of the fungal growth should be addressed through consultation and further evaluation from a mold/fungal growth specialist.

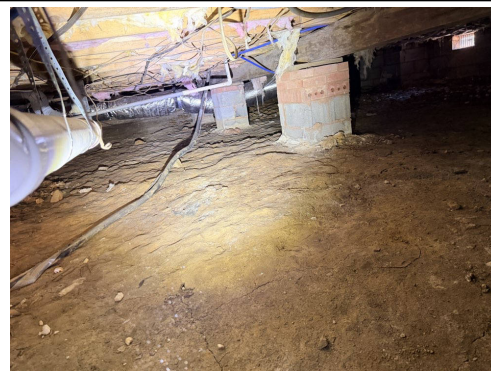
### 5. Needs Repair: Crawlspace Vapor Barrier - High Moisture/Incomplete Vapor Barrier -

High moisture levels (>23%) were observed in the foundation area at time of inspection. A limited amount of the foundation grade was properly covered with a vapor barrier which can allow for additional moisture exposure to the wood structure of the foundation area. Over time excessive moisture exposure can result in increased fungal growth, and structural concerns for the home. Recommend that a professional foundation moisture control contractor evaluate the foundation area and make the necessary repairs to the vapor barrier to help limit moisture exposure to the foundation area.

>>> Note: The current standard is 100% coverage of the dirt grade.

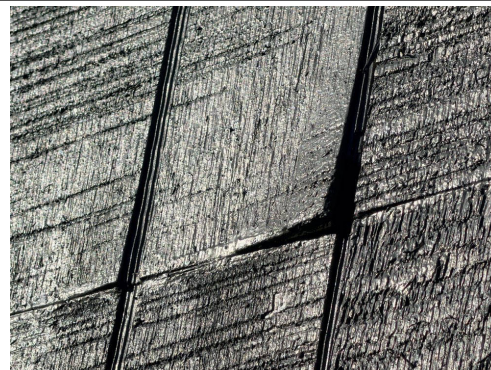
### 6. Needs Repair: Exterior Wall Cladding - Openings in Siding -

Observed openings present in the siding on the exterior of the home. These openings are capable of allowing moisture behind the siding which can lead to damage/rot of the wood structure. Have a professional siding contractor evaluate the home's entire siding application/installation and repair/replace as necessary. At a minimum, have the holes sealed with caulking to prevent moisture intrusion.

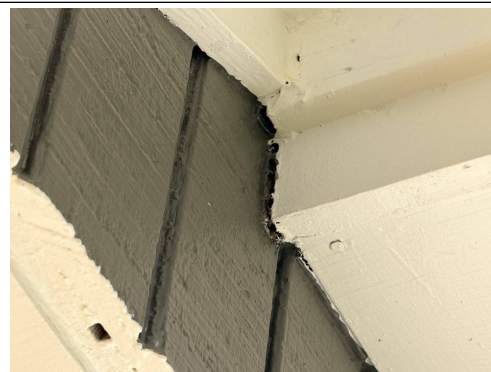
### 7. Needs Repair: Exterior Trim - Deteriorated Sealant -

Unions of doors/window frames/external trim to the exterior wall cladding have areas of sealant adhesion failure present. Caulked joints that have cracked and/or separated need to be sealed in order to prevent any possibility of water intruding into the walls where damage can occur. Have a professional contractor properly prepare/reseal all areas where joints have been compromised.

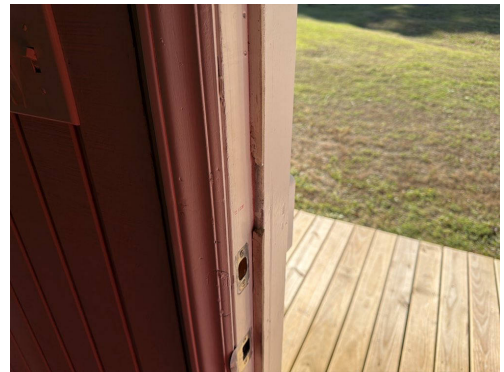
**8. Needs Repair: Exterior Door - Damaged Weather Strip Insulation -**

The exterior door is not making a good seal on the weather strip insulation at the door jamb where the insulation strip is deteriorated/missing. Have a professional contractor replace the damaged insulation strip on this door so that a complete seal is provided at this door.

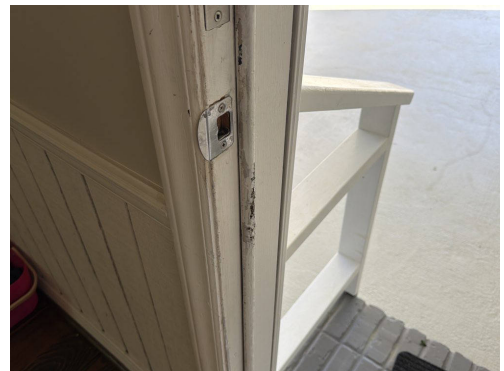
**9. Needs Repair: Exterior Door - Damaged Weather Strip Insulation -**

The exterior door is not making a good seal on the weather strip insulation at the door jamb where the insulation strip is deteriorated/missing. Have a professional contractor replace the damaged insulation strip on this door so that a complete seal is provided at this door.

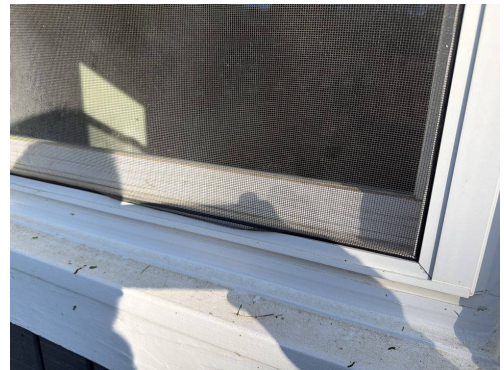
**10. Needs Repair: Windows - Damaged Window Screens -**

Observed some window screens that are damaged/torn and need repaired/replaced. Openings in the screens can allow pests to enter the home when the windows are open. Have a professional contractor check all of the windows around the home and repair/replace damaged or missing screens where necessary.

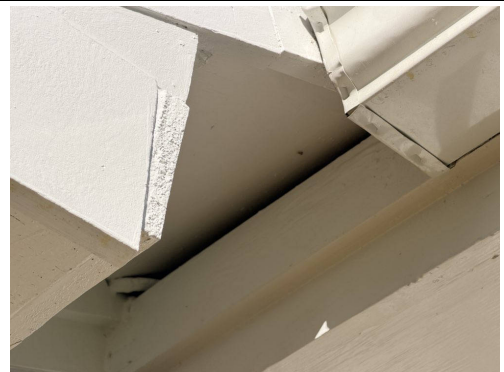
**11. Needs Repair: Soffit - Openings in Soffit -**

Observed some loose/shifted soffit around the exterior of the home. Openings in the soffit can allow pests to enter the attic/home. Recommend that a professional siding contractor evaluate the soffit around the home and make the necessary adjustments/repairs to prevent possible pest intrusion.

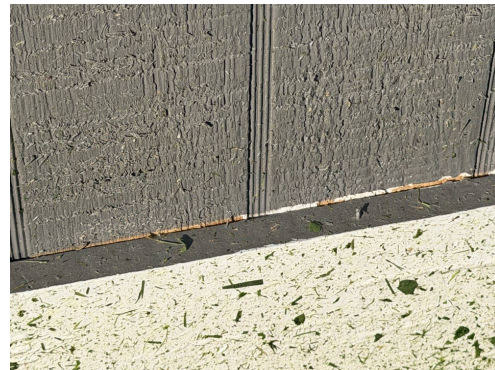
### 12. Needs Repair: Exterior Trim - Deteriorated/Missing Paint -

Observed the paint on some of the wood trim around the home to be missing paint. This exposes the wood trim to moisture which can result in damage. Recommend that a professional paint contractor prep and properly paint any areas where necessary to properly seal/protect the exposed wood trim.

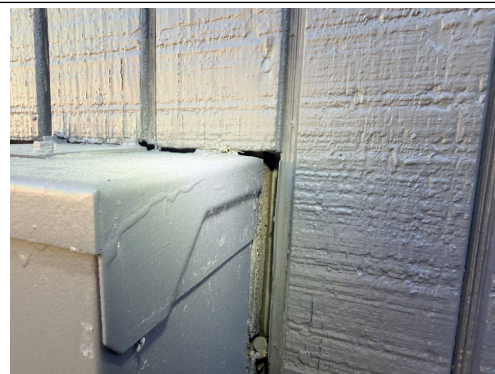
### 13. Needs Repair: Exterior Wall Cladding - Unsealed Openings -

Observed an unsealed penetration(s) into the exterior wall/foundation area of the home. Unsealed openings can allow moisture/pests access to the foundation area and damage wood framed walls. Have a professional contractor evaluate the entire home and seal all openings as necessary.

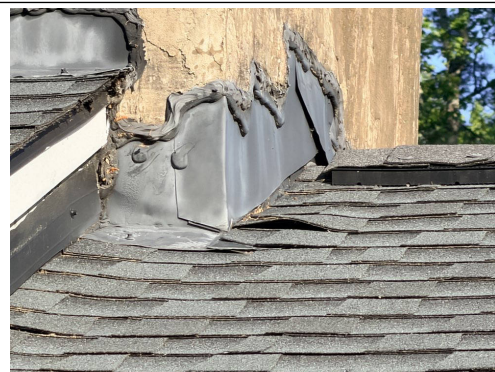
### 14. Needs Repair: Roof Covering - Raised Shingles -

Observed raised shingles on the roof. Raised shingles can allow moisture to penetrate under the roof covering that can result in damage, as well as exposing the shingle to further damage during high wind conditions. Have a professional roofing contractor evaluate the entire roof and make the necessary repairs for proper installation and long term serviceability.

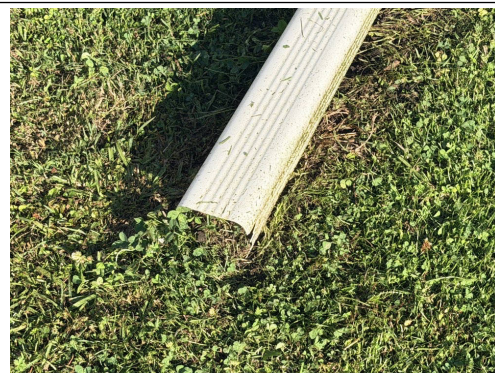
### 15. Needs Repair: Downspout - Buried Downspout Outlet -

There is a downspout that is buried at the outlet. This will trap water inside the downspout/gutter system. Recommend that a professional gutter installation contractor make the necessary repairs to allow for proper drainage.

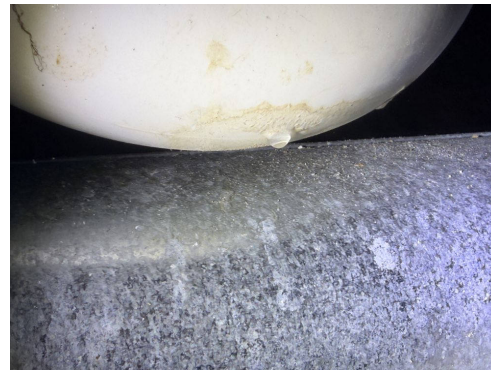
### 16. Needs Repair: Waste Plumbing - Leaking -

Observed a leak in the waste plumbing. The exact source of the leak was not determined during the inspection, but dripping was occurring at this location. Recommend that a professional plumbing contractor evaluate the area and make the necessary repairs to prevent further leaking.

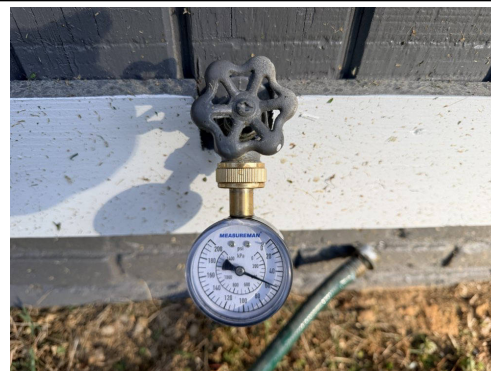
### 17. Needs Repair: Exterior Faucets - Loose Faucet -

Some of the exterior hose faucets around the home are not secured to the wall. Loose faucets are vulnerable to freezing weather conditions and present a possible leaking hazard when excessive movement from the hose that is attached to the faucet is pulled as a result of needed extra length. Have a professional plumbing contractor evaluate all of the exterior hose faucets and repair as necessary for proper installation.

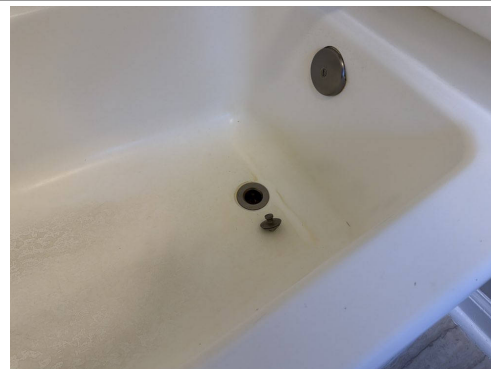
### 18. Needs Repair: Bathroom Bathtub Waste Drain Stop Not Operating Properly -

The bathroom tub/shower drain stop is not operating properly - does not seal when closed. This will prevent the tub from holding water. Have a professional plumbing contractor evaluate the tub/drain system and make the necessary repairs to allow for proper operation.

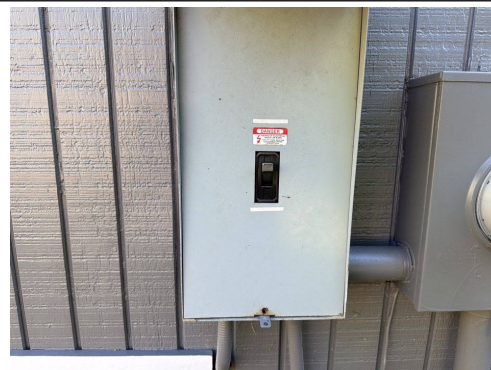
### 19. A: Needs Repair: Main Electrical Panel - Cover Panel Missing Screws -

The main electrical panel cover is missing some of the screws required to secure the interior cover. This can allow access into the panel. Have a professional electrical contractor replace missing hardware with the proper "flat" tipped machine screws due to personal safety concerns.

### B: Needs Repair: Main Electrical Panel - Breakers Not Labeled -

Observed the main electrical panel to not be labeled. Panels that are mislabeled or unlabeled are a safety hazard when repairs need to be made. Properly label the breakers in this panel box to prevent a possible injury.

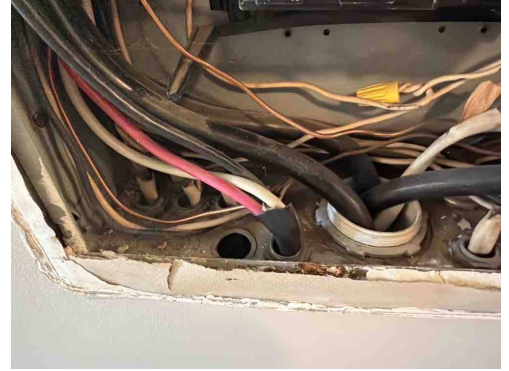
### 20. A: Needs Repair: Main Electrical Panel - Breakers Not Labeled -

Observed the main electrical panel to not be labeled. Panels that are mislabeled or unlabeled are a safety hazard when repairs need to be made. Properly label the breakers in this panel box to prevent a possible injury.

### B: Needs Repair: Sub Electrical Panel - Openings In Main Electrical Panel -

Openings were observed in the sub electrical panel housing/panel cover. Openings in the panel housing can result in contact with live electrical components. Have a professional electrical contractor make the necessary repairs to seal all openings.

### C: Needs Repair: Sub Electrical Panel - Double Tapped Neutral Lugs -

Observed double tapped neutral lugs in the sub electrical panel. An individual bus bar terminal is required for the connection of each branch-circuit neutral conductor. This can create electrical concerns during repairs to the system. Also, wires of differing sizes can become loose when attached to the same lug connection. Although this electrical practice was not put in place until 2002, it is still recommended that all neutrals inside an electrical panel box be isolated to their own terminal. Have a professional electrical contractor make the necessary repairs.

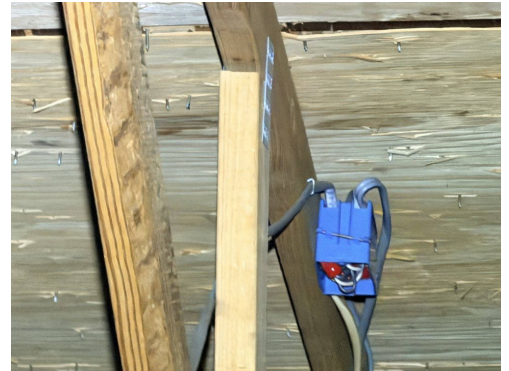
### 21. Needs Repair: Electrical Wiring - Open Electrical Junction Box -

Observed open junction boxes in the attic above the carport. Open junction boxes expose wire connections that can be an electrical hazard. Recommend that a professional electrical contractor provide proper covers for any uncovered junction boxes throughout the home.

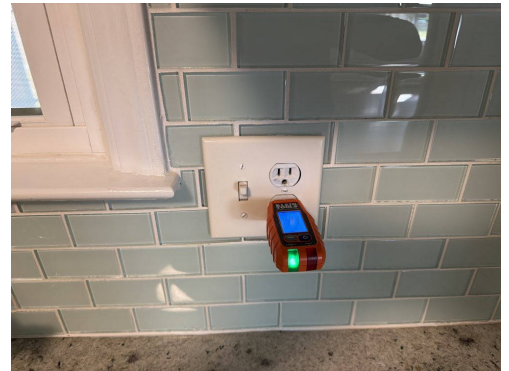
### 22. Needs Repair: Outlets - Loose Outlets -

Loose wall outlets were observed during the inspection. Loose wall outlets present a safety concern due to a possible shock hazard. Loose outlets may not be restricted to locations noted in the report. Have a professional electrical contractor properly check and secure all outlets so that safe operation conditions are ensured of being provided.

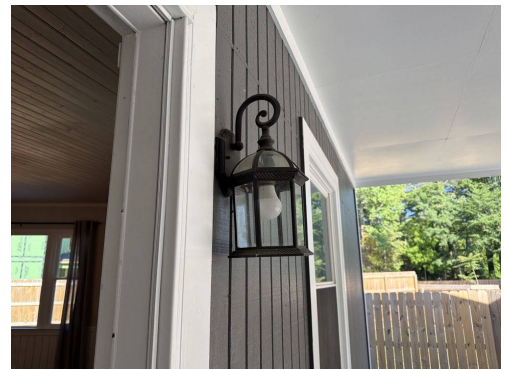
### 23. Needs Repair: Exterior Lighting, Fans & Switches - Lights Not Operating -

Some of the light fixtures on the exterior of the house were not operating when tested. This will prevent proper lighting when needed. Have a professional electrical contractor evaluate the light fixtures on the home and make the necessary repairs to ensure proper operation.

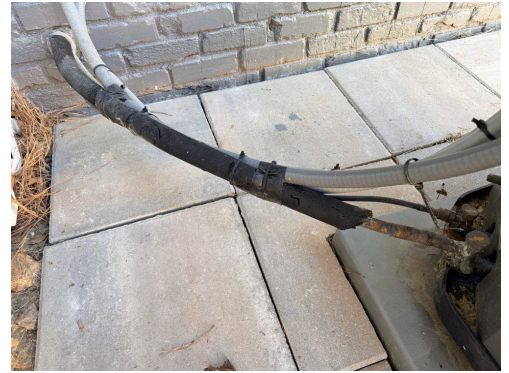
**24. Needs Repair: A/C - Torn, Deteriorated, and/or Missing Refrigerant Line Insulation -**  
Observed torn, deteriorated and/or missing insulation on the high pressure refrigerant line between the foundation wall and the outside A/C unit. Insulation that is not fully covering the freon lines can have an adverse effect on the overall performance of the system. Recommend having a professional HVAC contractor replace damaged insulation on the freon line at this location.

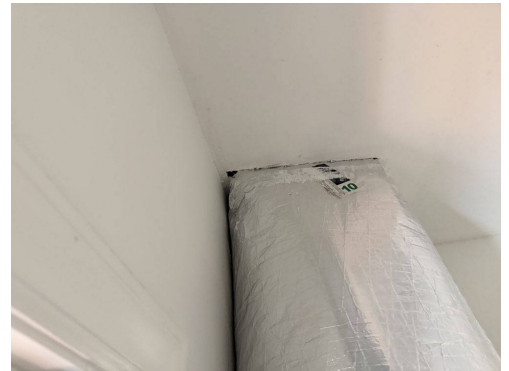
**25. Needs Repair: Walls/Ceilings - Openings -**  
Observed wall/ceiling openings in the 3rd bedroom from the right. Openings in the wall or ceiling can allow for the exchange of conditioned air from the interior of the house with unconditioned air of the crawlspace and or attic, and can allow faster spreading of a fire if present, as well as a possible access to the interior of the house for vermin. Recommend that a professional contractor evaluate the drywall throughout the home and repair as necessary to seal all wall openings.

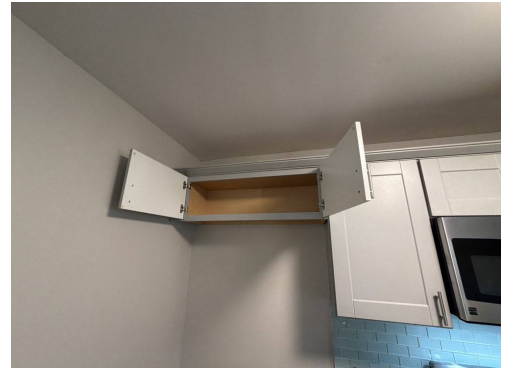
**26. Needs Repair: Counters/Cabinets - Cabinet Doors/Drawers Loose and/or Not Aligned Properly -**  
Some of the cabinet doors are improperly installed. Cabinet doors and/or drawers, when improperly installed can rub against each other restricting smooth operation and cause physical damage, or even fall out of position if repairs are not made. Have a professional cabinet installation contractor make the necessary adjustments/repairs so that unobstructed motion/safe operating conditions are provided at all of the cabinets.

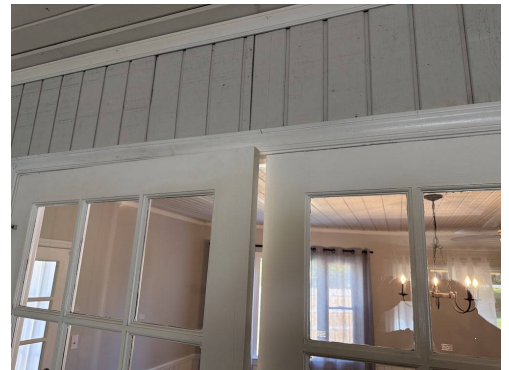
**27. A: Needs Repair: Interior Doors - Doors Not Latching -**  
Some of the interior doors throughout the home will not latch properly when closed. Doors that do not latch properly cannot be properly secured. Have a professional interior trim contractor evaluate all of the doors throughout the home and make any necessary repairs to allow for proper operation.

**B: Needs Repair: Interior Doors - Doors Rub -**  
Some of the interior doors throughout the home rub the jamb when operated. This restriction prevents the door(s) from closing properly. Have a professional interior trim contractor evaluate all of the doors throughout the home and make any necessary repairs to allow for unrestricted motion.

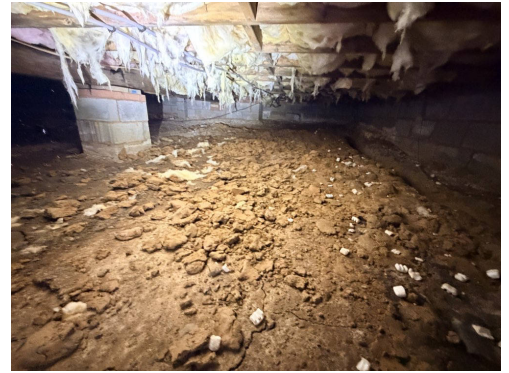
**28. Needs Repair: Crawlspace Insulation - High Moisture - Fallen/Moisture Laden Insulation -**  
Some crawlspace insulation is falling down or missing in various locations inside the foundation. The long term sustained high moisture levels inside the foundation crawlspace is attributed to causing the moisture laden insulation to either fall out of position between the floor joist or striate/shred/tear the insulation causing pieces of the insulation to hang down. This will reduce the "R" value across the floor. After measures have been taken to control noted high moisture levels, have a professional contractor evaluate all of the insulation in the crawlspace area and repair/replace insulation at any location where insulation is not properly installed or deteriorated.

**Vapor Barrier Installed. Crawlspace treated with a fungal bomb and trench was regraded MAY 2026 Sump pump is working**

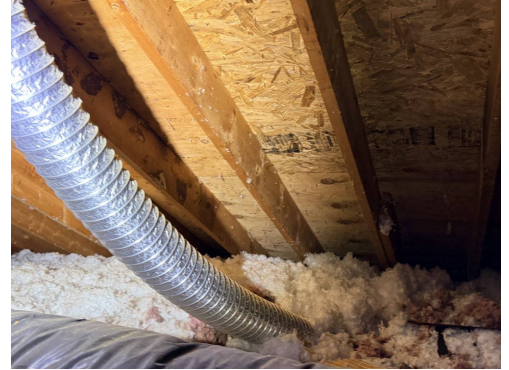
**29. Needs Repair: Dryer Vent - Improper Material -**  
The dryer vent hose is functional, but is a ribbed, corrugated type material. The interior of these ducts can trap lint, which also reduces airflow, and in extreme cases, overloads the motor and shortens the life of the dryer. Most importantly, an accumulation of lint is a fire hazard. It is recommended that the dryer duct line from the laundry room wall penetration to the duct exhaust vent be replaced by a professional contractor using currently required materials.  
>>> Note: Current standards require the use of a thin, fabricated metal pipe.

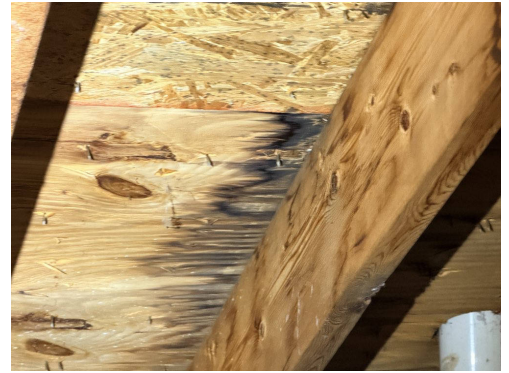
**30. Observation/Information:- Previous Water Infiltration Noted in Decking -**  
The roof sheathing has large areas of moisture staining when observed from the accessible areas in the attic. The recent shingled roof replacement had replaced some areas of the roof sheathing. It is speculated that the stained sheathing was exposed to water intrusion, but was not considered in need of replacement when the shingles were replaced. If any concerns with this observation are present, consider consulting a professional contractor for further evaluation.

OLD STAINING NEW ROOF WAS  
INSTALLED A IN 2020

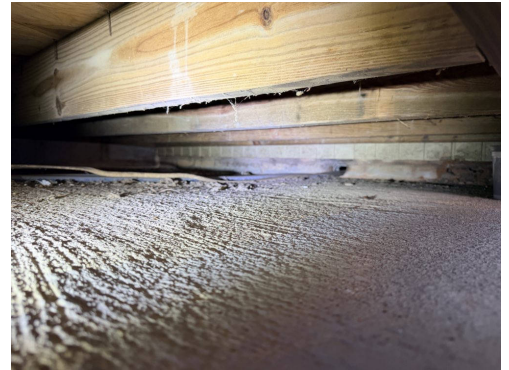
**31. Limited Evaluation: Structural - Floor Structure Not Fully Inspected -**  
Low clearance under the finished area that extends into the garage prevented full access into the area. While efforts were made to inspect from the outside edges, the inspection was limited.

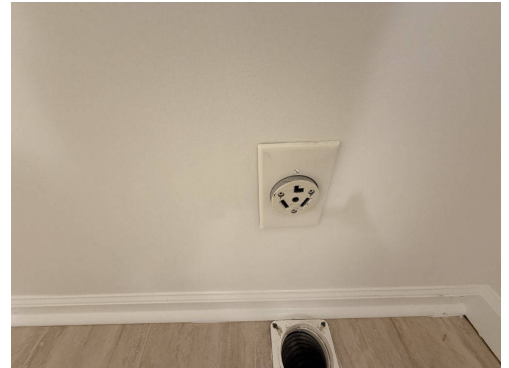
**32. Suggestion/Information: 3-Prong Dryer Outlet -**  
The current dryer outlet is an older three prong style that does not have an additional "neutral" wired to it. This outlet has not been upgraded to accommodate a newer appliance that uses a 4 prong plug. Although commonly observed, replacing the 4 prong wire/plug on a newer dryer with a 3 prong wire/plug, is not an electrically safe wiring configuration. Due to concerns for personal/appliance safety, if a newer dryer with a 4 prong plug is going to be installed in the laundry room, the original 3 prong outlet should be upgraded to a 4 prong outlet.

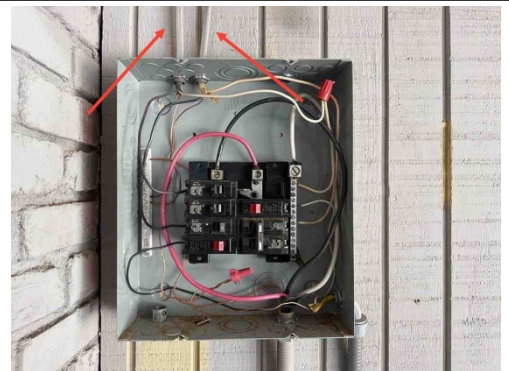
**33. Suggestion: Sub Electrical Panel - Exposed Electrical Wires -**  
Observed wires serving the sub electrical panel in the garage that are not protected. Wires not covered by a wallboard or enclosed in a conduit are exposed to damage from contact with items. Caution is advised when storing things in this area. Suggest that a professional contractor properly protect the exposed wires.

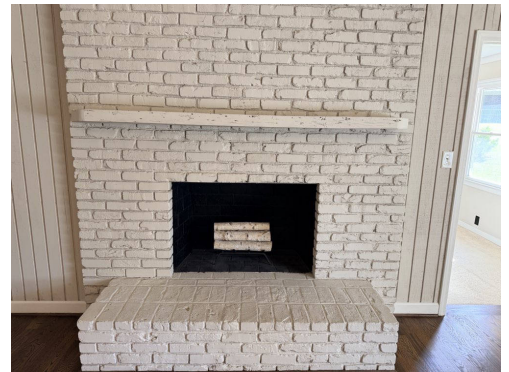
### 34. Information: Masonry | Prefabricated Chimney - Limited Flue Evaluation -

The inspector is unable to fully evaluate the fireplace flue due to limited visible areas above the firebox. It is suggested that the seller be consulted about the last time the flue has been inspected, cleaned, or scoped. The National Fire Protection Association (NFPA 211) recommends annual chimney inspections because creosote buildup and hidden flue damage are leading causes of chimney fires, which are a significant source of residential fires in the U.S.

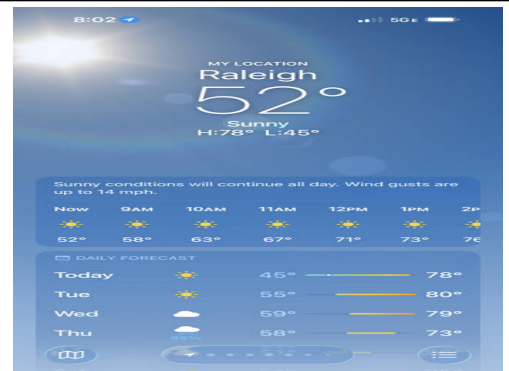
### 35. Limited Evaluation: A/C Equipment -

The A/C systems were visually inspected only. Cooling function was not tested due to manufacturer's recommendations not to operate when the outdoor temperature is less than 60 degrees.

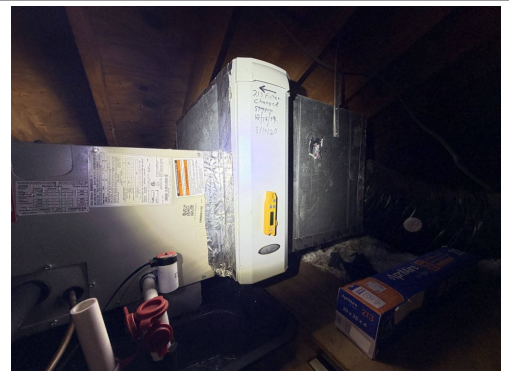
### 36. Suggestion: Whole System Filter w/ No Interior Filters -

No filters are present at the entrances to the HVAC return air ducts at the interior walls of the house. This will allow dust to build up in this duct system before the whole system cartridge filter. Suggest that filters be added in the return air grills at the beginnings of the return air ducts as a preliminary filtering system to help maintain a cleaner air duct system.

>>> Note: The whole system filter cartridge was pulled and viewed and appeared to be clean. This type of filter can only be properly tested for by evaluating the rate of air flow through the filter with an air flow meter and is not part of a general home inspection testing equipment. Refer to the manufacturer for expected times between replacement of this filter.
