# Inspection Report

03.12.26

3421 Oak Trail  
Clayton, NC 27520

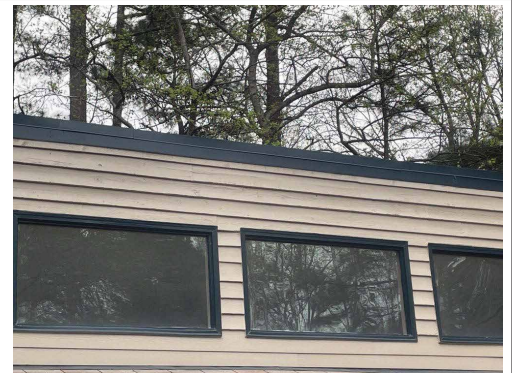
#### 1. A) Needs Repair: Exterior Cladding and Trim - Deteriorated Paint -

Observed the paint on some of the wood surfaces around the home to be deteriorated/flaking. This exposes the wood to moisture which can result in damage. Recommend that a professional paint contractor prep and properly paint any areas where necessary to properly seal/protect the exposed wood.

#### B) Needs Repair: Exterior Trim - Deteriorated Sealant -

Unions of doors/window frames/exterior trim to the exterior wall cladding have areas of sealant/adhesion failure present. Caulked joints that have cracked and/or separated need to be sealed in order to prevent any possibility of water intruding into the walls where damage can occur. Have a professional contractor properly prepare/reseal all areas where joints have been compromised.

#### C) Needs Repair: Exterior Trim - Wood Rot -

Observed moisture damaged wood around the exterior of the home. Determining the extent of each individual area of damage is not within the scope of this general home inspection. Damaged wood may not be limited to just the area noted in this report. Have a professional contractor evaluate all of the exterior wood around the house making repairs as necessary.

>>>> Note: Water damage at the noted areas may not be limited to the visible wood components. Damage may be present inside the walls/roof/overhangs as well. Evaluations in these areas should include opening up the areas to observe/repair any damage as a result of the moisture penetration.

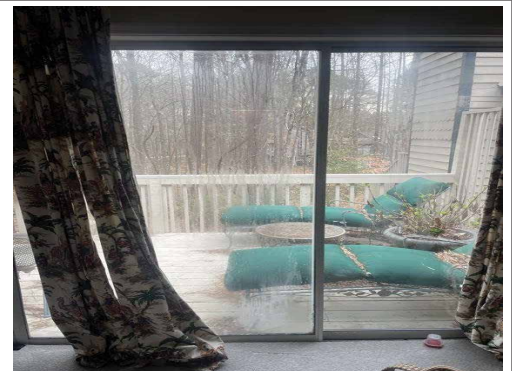
#### 2. Needs Repair: Sliding Glass Door - Sliding Glass Doors Difficult to Operate -

The sliding glass doors are difficult to move on track. This limits the operation of the doors, and can result in damage to the doors. Have a professional contractor evaluate all of the sliding glass doors and make necessary repairs to allow for proper operation.

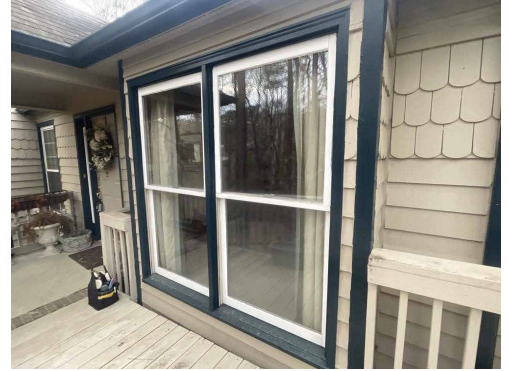
### 3. Needs Repair: Window Screens Missing -

Some of the windows around the home did not have window screens installed in the windows at time of inspection. Replace missing screens at all windows where not currently installed so that all window screens can be accounted for.

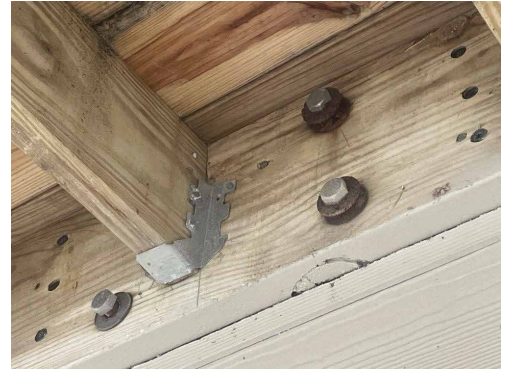
### 4. A) Needs Repair: Rear Deck - Flashing Missing/Not Visible -

The rear deck requires a flashing over the deck band attachment to the home. Typically this flashing is visible from the underside of the deck, but in this case was not observed. Missing flashing can result in moisture damage along the foundation wall/deck connection. Recommend that a professional contractor fully evaluate the deck connection/flashing and verify proper installation of the deck flashing or make the necessary repairs.

B) Needs Repair: Deck Bolts-Bolts Backing Out-Observed some of the bolts used to attach the deck to the home not properly installed. Some of the bolts have backed out and are not secured properly. Recommend a contractor that specializes in deck construction to evaluate the entire deck and make repairs to provide proper installation and long term serviceability.

Manufacturers of exterior wood products recommend preventive maintenance in order to extend the long term serviceability of the product. Deck boards have NOT been cleaned and sealed recently. Recommend that preventative maintenance be performed to help maintain the moisture resistant surfaces on the exterior wood components of the deck.

The building practices employed on this structure may have been consistent with the time of construction, but are not with current building standards. For personal safety and personal liability concerns, structures of this age are suggested to be evaluated by a professional contractor specializing in wood deck construction and repairs made as necessary to bring the deck up to current building standards wherever possible.

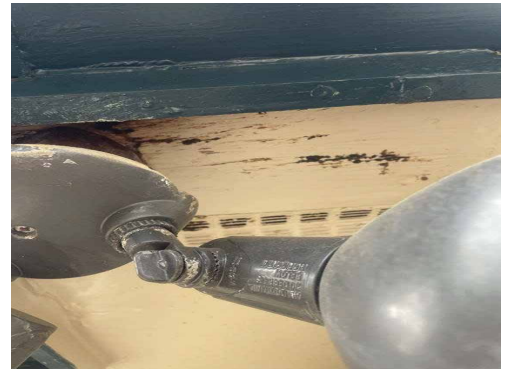
### 5. Needs Repair: Fascia - Deteriorated Soffit -

Observed a few areas of damaged soffits around the exterior of the home. Determining the extent of each individual area of damage is not within the scope of this general home inspection. Moisture damaged wood may not be limited to the area noted in the report. Have a professional contractor evaluate all of the exterior wood around the home and make the necessary repairs for long term serviceability.

>>> Note: Water damage at the noted areas may not be limited to the visible wood components. Damage may be present inside the overhangs as well. Evaluations in these areas should include opening up the overhang to observe/repair any damage as a result of the moisture penetration.

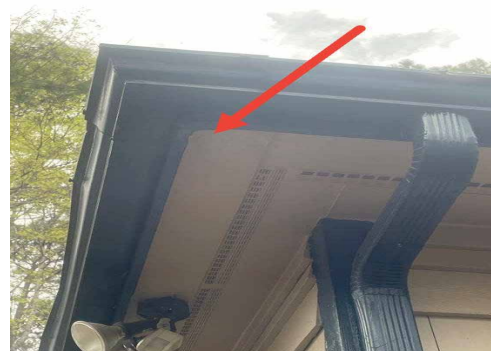
#### 6. Needs Repair: Fascia - Deteriorated Fascia -

Observed damaged fascia around the exterior of the home. Determining the extent of each individual area of damage is not within the scope of this general home inspection. Moisture damaged wood may not be limited to the area noted in the report. Have a professional contractor evaluate all of the exterior wood around the home and make the necessary repairs for long term serviceability.

>>> Note: Water damage at the noted areas may not be limited to the visible wood components. Damage may be present inside the overhangs as well. Evaluations in these areas should include opening up the overhang to observe/repair any damage as a result of the moisture penetration.

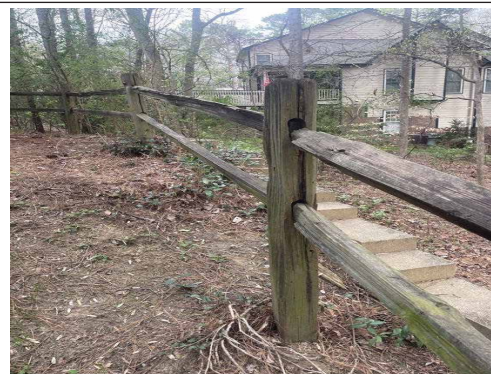
#### 7. Needs Repair: Retaining Wall - Damaged Fall Protection Rails -

The retaining walls around the exterior of the house have wood fall protection rails installed at the top of the wall systems. The wood rails are loose and have moisture damage. Have a professional contractor make repairs or replace railings due to personal safety concerns.

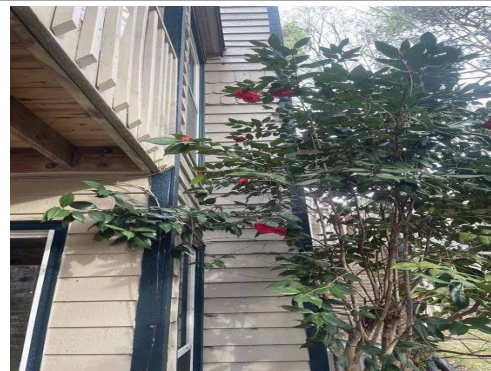
#### 8. Needs Repair: Tree/Shrub Limbs - Limbs In Contact With The House -

Observed tree/shrub limbs that are in contact/near contact with the home. Branches in contact with the house can cause damage to the shingled roof covering and water shedding off the trees can divert water toward the house. The canopy under large trees will hold higher moisture levels in them that will over time cause wood to deteriorate. Maintain large vegetation away from the house in order to prevent damage to the house and reduce higher moisture levels that can cause rot on wood surfaces.

>>> Note: Limbs over the fireplace chimney can cause poor drafting/back drafting in the fireplace.

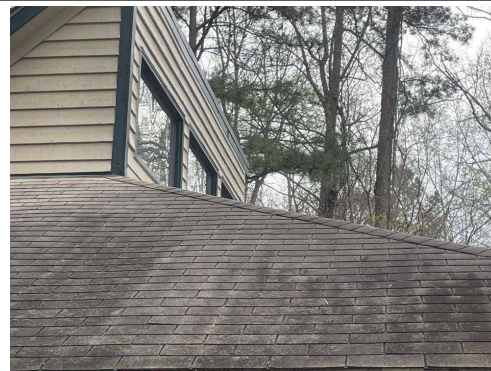
#### 9. A) Needs Repair: Roof Covering - Organic Growth on Shingles -

There is organic growth on the shingled roof. This growth can cause deterioration and possible water penetration through the shingles. Recommend that this growth be removed by a professional contractor.

#### B) Needs Repair: Roof Covering - Raised Shingles -

Observed raised shingles on the roof. Raised shingles can allow moisture to penetrate under the roof covering that can result in damage, as well as exposing the shingle to further damage during high wind conditions. Have a professional roofing contractor evaluate the entire roof and make the necessary repairs for proper installation and long term serviceability.

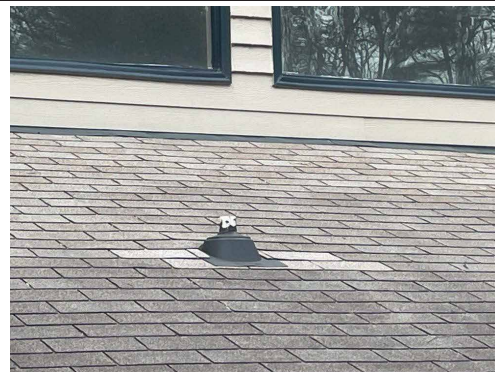
**10. Needs Repair: Roof Flashings - Deteriorated Plumbing Waste Pipe Boot Flashings -**  
The plumbing waste pipe flashings are deteriorated at the pipe penetrations in the roof covering. Rubber boots around plumbing vents last (depending on exposure to UV light) about 8 to 10 years before cracking. Have a professional roofing contractor evaluate all of the roof flashings and make any necessary repairs to properly seal all roof penetrations.

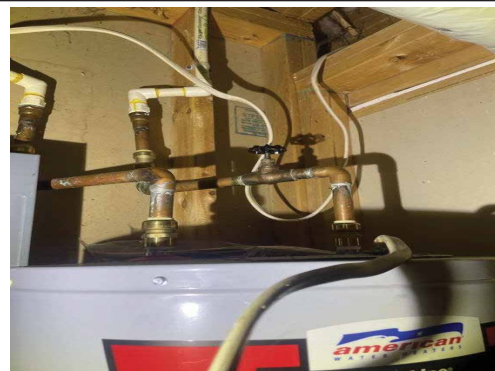
**11. Needs Repair: Water Heater Safety - No Thermal Expansion Tank Installed -**  
A thermal expansion tank was not observed on the water supply plumbing system. This tank compensates for increased water pressure due to heated water from the water heater and/or the public utility. At the most recent replacement of the water heater, requirements were in place for an approved thermal expansion control device, a thermal expansion tank (TET), to be installed on the water system as part of this water heater replacement. Have a professional plumbing contractor provide this pressure compensating device for added protection against high water pressure fluctuations in the water system.

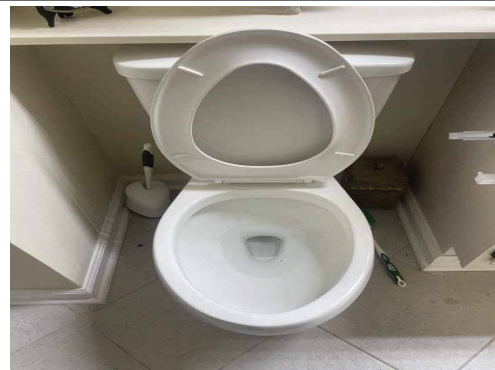
**12. Needs Repair: Bathroom Toilet Loosely Installed at Floor -**  
The first floor hall bathroom toilet is loosely connected to the floor. This can result in damage/leaking. Recommend that a professional plumbing contractor fully evaluate the toilet and make the necessary repairs for proper installation and long term serviceability.

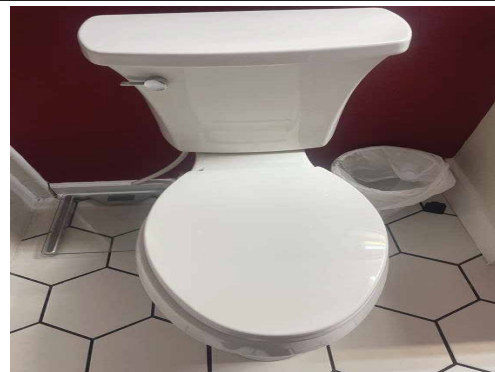
**13. Needs Repair: Bathroom Toilet Loosely Installed at Floor -**  
The primary bathroom toilet is loosely connected to the floor. This can result in damage/leaking. Recommend that a professional plumbing contractor fully evaluate the toilet and make the necessary repairs for proper installation and long term serviceability.

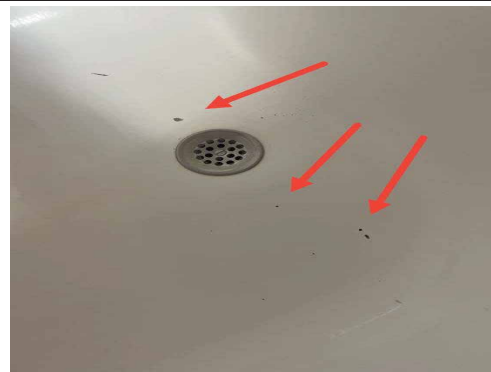
**14. Needs Repair: Bathroom Bathtub Surface Damaged -**

There is an area of surface damaged to the primary bathroom bathtub. Damaged tub surfaces can result in increased damage and/or leaking. Have an authorized manufacturers representative repair contractor evaluate the entire tub and make repairs so that the product warranty is maintained in effect.

**Needs Repair: Bathroom Tub/Shower Diverter Not Working Properly -**

The bathroom tub/shower valve does not fully divert water to the shower head. This can limit use and is inefficient. Have a professional plumbing contractor evaluate the fixture and make the necessary repairs for proper operation.

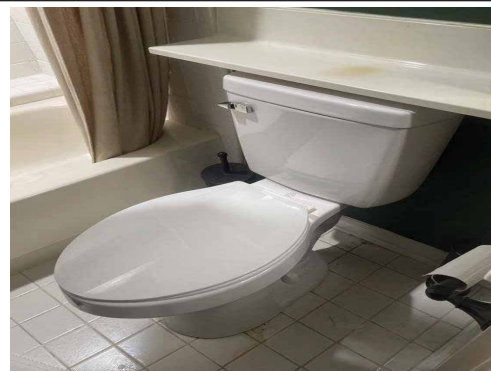
**15. Needs Repair: Moisture Stains Around The Base Of The Bathroom Toilet -**

Moisture stains are present around the perimeter of the basement ensuite bathroom toilet base. This may indicate that the toilet is or has leaked - typically at the toilet base/wax ring connection the the waste plumbing line. A lack of moisture, currently present, is not conclusive evidence that the leaking condition has been repaired as these leaks can be intermittent. If service records can not be provided by the seller indicating that the leaking condition has been repaired, have a professional plumbing contractor evaluate the toilet and make the necessary repairs to prevent further leaking.

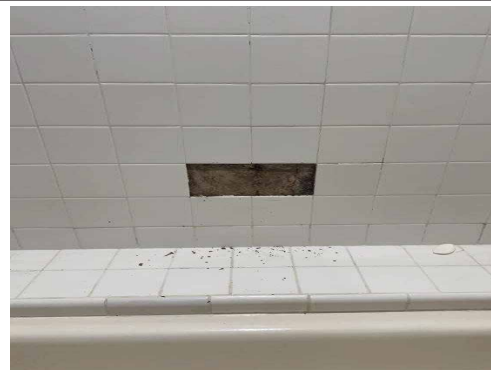
**16. Needs Repair: Deteriorated Shower Floor Tile/Grout in Bathroom -**

The basement shower floor tile has evidence of cracking/separation present. ( missing tile ) This can allow water to infiltrate behind the floor tile which can result in damage. Recommend that a professional contractor provide a full evaluation of the shower area and any repairs necessary to prevent possible water penetration. Hidden damage and fungal growth may be present.

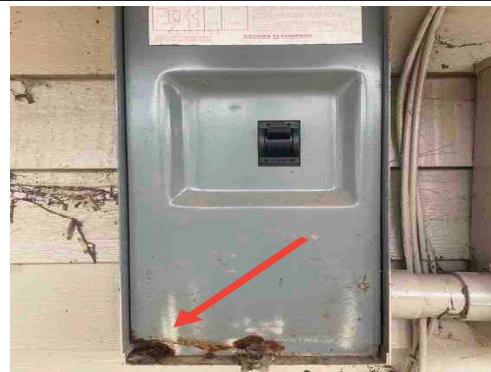
**17. Needs Repair: Main Electrical Panel - Openings In Main Electrical Panel -**

Opening observed in the main electrical panel housing/panel cover due to exterior rust. Opening in the panel housing can result in contact with live electrical components. Have a professional electrical contractor make the necessary repairs to seal all openings.

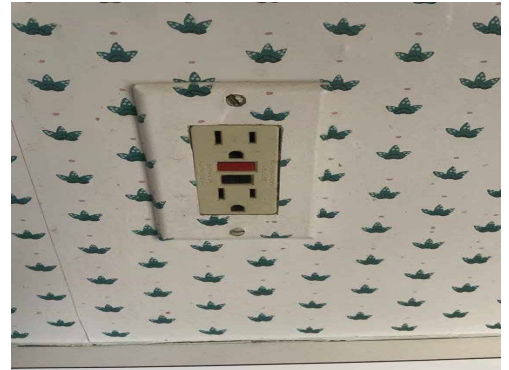
**18. Needs Repair: Ground Fault Protection - Not Tripping/Not Protected -**  
Ground fault circuits, where present and accessible, were tested by simulating a fault. The circuit outlets serving the exterior, the bathrooms and the kitchen would not trip when a fault was simulated. Have a professional electrical contractor service these ground fault circuits so that proper operation is known to be occurring when conditions are necessary.

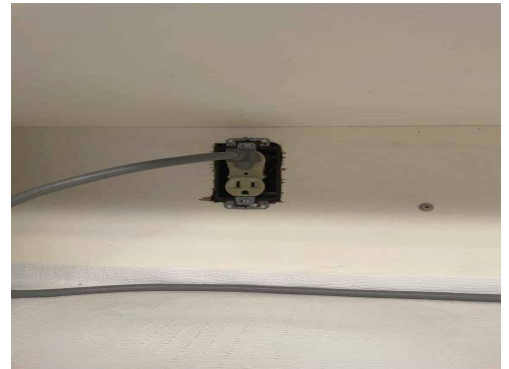
**19. A) Needs Repair: Outlets/Wall Switches - Missing Covers -**  
There are electrical outlets/wall switches throughout the home that are missing their covers. The missing covers expose wire connections which, if contacted, can result in personal injury. Recommend that covers be added at all outlets/switches throughout the home where not currently present.

**B) Needs Repair: Outlets - No Power -**  
Observed some outlets in the home without power. This limits use. Have a professional electrical contractor evaluate the outlets/circuits and make any necessary repairs to allow for proper operation.

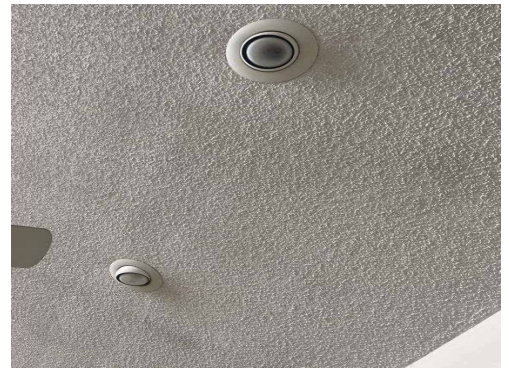
**20. A) Needs Repair: Lighting, Fans & Switches - Lights Not Operating -**  
Some of the light fixtures throughout the house were not operating when tested. This will prevent proper lighting when needed. Have a professional electrical contractor evaluate the light fixtures throughout the home and make the necessary repairs to ensure proper operation.

**B) Needs Repair: Lighting, Fans & Switches - Missing Globes -**  
Observed light fixtures to be missing globes over the light bulbs. Globes over the bulbs limit exposure to damage from contact. Recommend that a globe be installed at all light fixtures where not currently present.

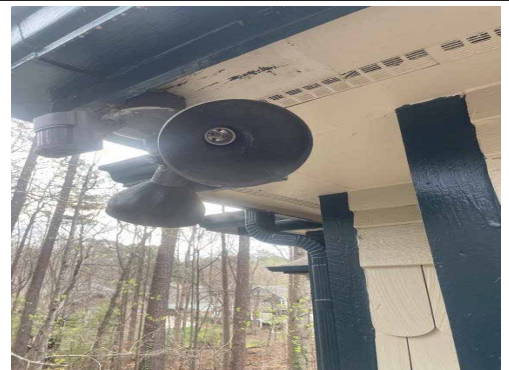
**21. A) Needs Repair: Exterior Lighting, Fans & Switches - Missing Bulb -**  
Observed light fixtures to be missing a light bulb. The missing bulb prevents proper operation. Replace the bulb and check for proper operation.

**B) Needs Repair: Exterior Lighting, Fans & Switches - Missing Globes -**  
Observed light fixtures to be missing globes over the light bulbs. Globes over the bulbs limit exposure to damage from contact. Recommend that a globe be installed at all light fixtures where not currently present.

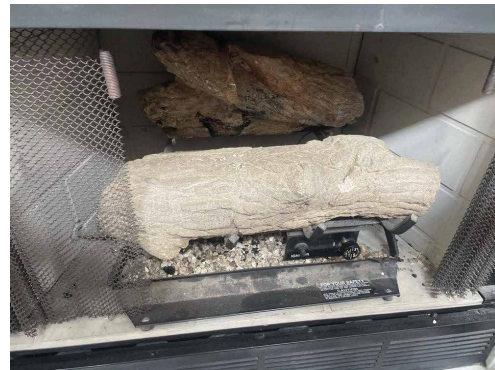
**22. Needs Repair: Fireplace Gas Log Set - Not Operational -**  
The fireplace gas log set was not operational at time of inspection. Have the homeowner verify proper operation or have a professional contractor evaluate the log set and make the necessary repairs.

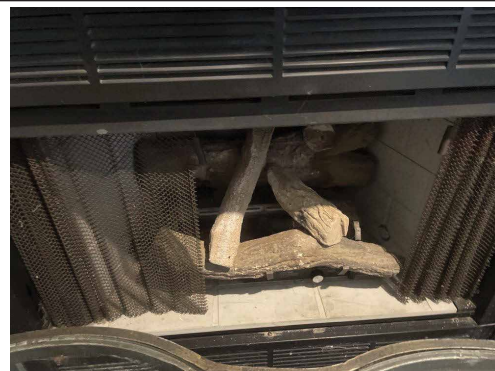
**23. Needs Repair: Fireplace Gas Log Set - Not Operational -**  
The fireplace gas log set was not operational at time of inspection. Have the homeowner verify proper operation or have a professional contractor evaluate the log set and make the necessary repairs.

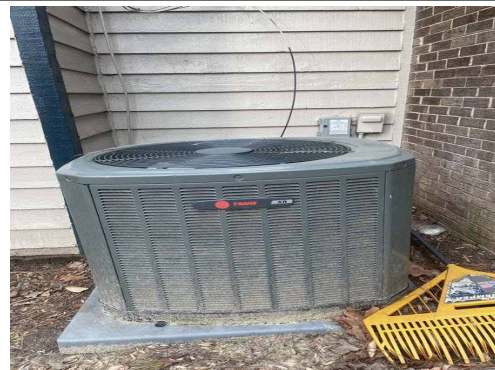
**24. Needs Repair: A/C - Tilted A/C Unit -**  
The HVAC condensing unit is slightly tilted. Oils in the bottom of the compressor can be prevented from circulating when units are not in a level position. Have a professional contractor evaluate the A/C unit installation and make any necessary repairs in order to provide for long term serviceability of the appliance.

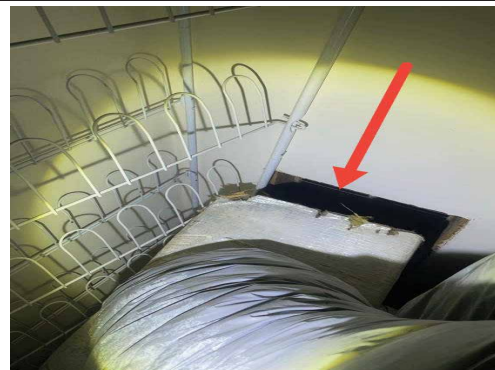
**25. Needs Repair: HVAC Filter - Loose HVAC Return Duct -**  
Observed the HVAC return in the basement closet to not be properly secured. The loose return could result in damage to the surrounding area. Recommend that a professional contractor make the necessary repairs to properly secure the return vent.

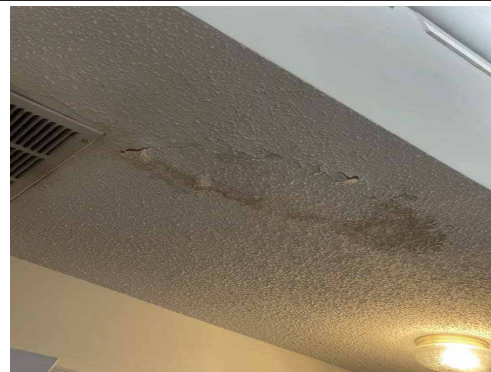
**26.** Needs Further Evaluation/Repair: Stains - Ceiling/Wall Stains - Observed ceiling and wall stains in almost every room throughout the home. Staining may be due to a one time occurrence, previously repaired leak, or an active leak. Continued leaking in these areas can result in significant hidden damage to the structure. Recommend a professional contractor fully evaluate the areas and make all necessary repairs to prevent further leaking/moisture penetration and any additional repairs necessary to restore any damaged materials. Hidden damage may be present.

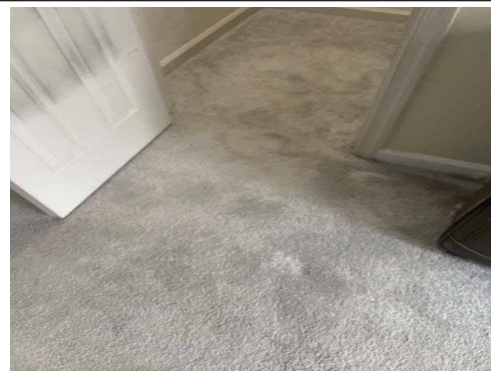
**27.** Needs Repair: Flooring - Excessive Floor Squeaking - Personal property, furnishings and floor coverings prevented full inspection of some floor surfaces. Where visible, floor condition is serviceable and typical for the age of the house. Observed areas in the first floor system where the subfloor is loosely secured to the floor trusses/floor joist. This results in some minor floor deflection and/or squeaking in the floor when walked on. This is a common occurrence in many floor systems and can be repaired by pulling up the floor coverings and adding additional fasteners (preferable screws) in the areas of the loose subfloor. Due to excessive floor noise noted at several areas, it is recommended that a professional contractor evaluate the entire home and repair areas where more excessive noise is present.

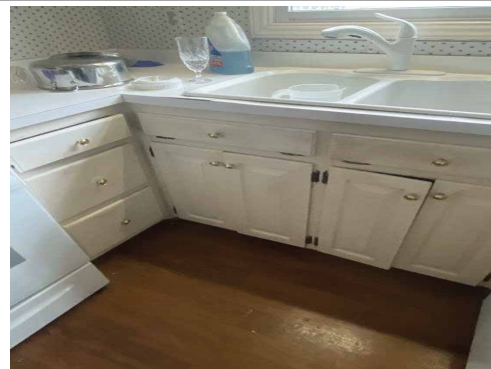
**28.** Needs Repair: Counters/Cabinets - Cabinet Doors/Drawers Loose and/or Not Aligned Properly - Some of the kitchen and bathroom cabinet doors/ drawers are improperly installed/missing components. Cabinet doors and/or drawers, when improperly installed can rub against each other restricting smooth operation and cause physical damage, or even fall out of position if repairs are not made. Have a professional cabinet installation contractor make the necessary adjustments/repairs so that unobstructed motion/safe operating conditions are provided at all of the cabinets.

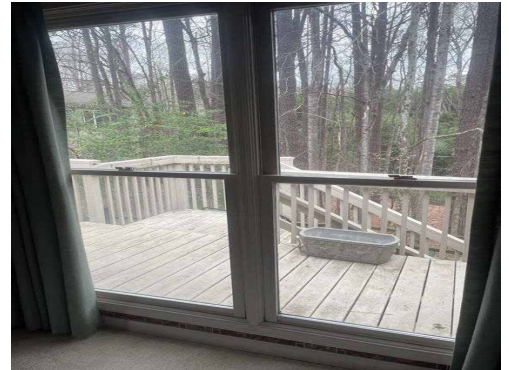
### 29. A) Needs Repair: Windows - Window/Door Glass Unit Seal Failure -

Glass unit (doors and windows) insulation seals were observed to be compromised in various locations throughout the home. ( windows and sliding glass doors) Compromised glass seals may not necessarily be limited to just the glass units noted. Signs of compromised glass seals can be masked by weather conditions, lighting, and cleanliness of glass at the time of the inspection. Have a professional window pane replacement company evaluate all of the glass units in the home and make the necessary repairs/replacement to restore the insulation integrity of any units determined to have bad seals.

### B) Needs Repair: Windows - Windows Difficult to Open -

Observed many of the windows that are hard to open/would not open (most likely from inactive use over long periods of time and or repainting of the interior trim that has bonded sashes to the side valances). Have a professional window installation/repair contractor service/check all windows for proper/smooth operation when using and make any repairs necessary for proper operation. At a minimum, due to concerns for personal safety, at least one designated window in every bedroom needs to be assured of operating freely so that emergency egress is known to be provided.

### C) Needs Repair: Windows - Windows Not Holding Position -

Observed some of the window sashes in the home to not hold position once the windows were raised/unlocked. Windows that will not stay in position can prevent use/result in damage to the windows. Recommend that a professional window installation/service contractor evaluate all of the windows throughout the home and make any necessary repairs to allow for proper operation.

### D) Needs Repair: Windows - Window Not Locking -

Observed a few windows in the home to not lock. The lock and catch appear misaligned which prevents the window from being properly secured. Have a professional window installation contractor evaluate all of the windows throughout the home and make any necessary repairs for proper operation.

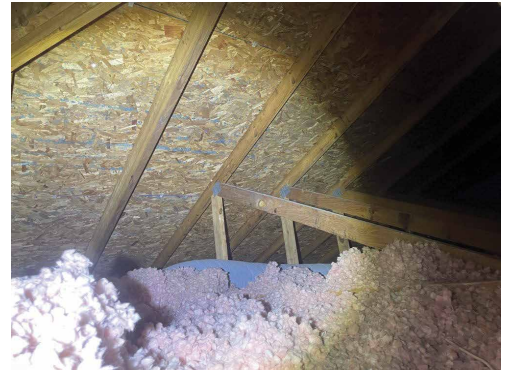
### 30. Needs Repair: Attic Insulation - Compressed/Displaced Insulation Present -

Insulation was packed down and/or displaced in several places in the attic. This is reducing the thermal efficiency in the attic at these locations. Recommend that the proper depth of insulation be replenished in order to provide a continuous "R" rating of insulation that was installed at the time of the installation.

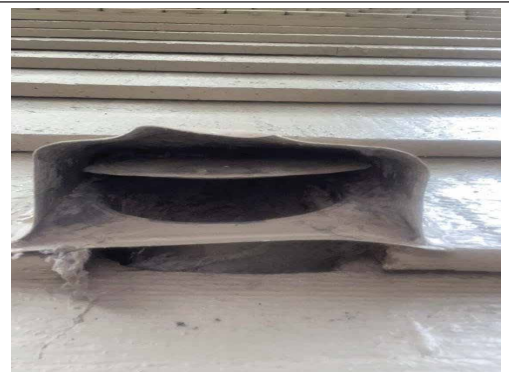
### 31. Needs Repair: Dryer Vent - Dryer Baffle Stuck Open/Broken -

The dryer exhaust vent end cap is not installed properly where it vents through to the exterior of the house. The baffle that closes when the dryer is not operating is partially open at all times. Being open all the time allows air exchange between the exterior and interior of the house, as well as the possibility of vermin getting in the exhaust duct. Have a professional contractor make repairs so that the baffle closes fully when not being used.

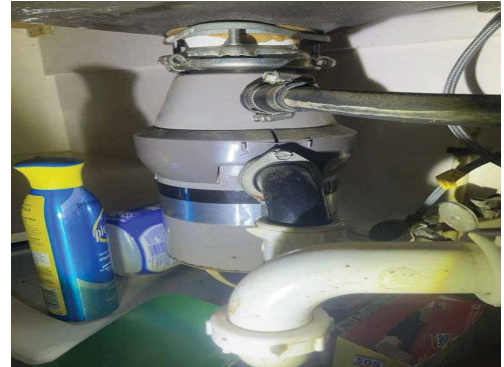
### 33. A) Needs Repair: Disposal - Noisy/Loud Operation -

### B) Needs Repair: Disposal - Missing Splash Guards -

The kitchen disposal splash guard that protects the operator from contents being thrown from the appliance during operation, located in the throat of the sink drain, is deteriorated/missing. This can allow debris to fly out of the disposal opening during use. Recommend that a professional contractor replace the missing safety device.

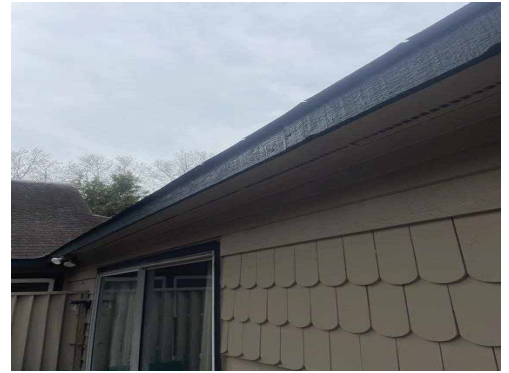
#### 35. Not Present/Recommendation: Gutter System -

No gutters are currently installed on the rear of the house. Gutters help direct water away from the foundation. Recommend installing gutters/downspouts to help with site drainage.

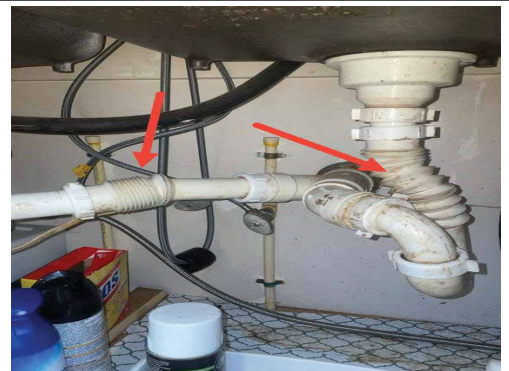
Observed flexible waste drain plumbing installed under the kitchen sink. Even though flexible waste pipe is sold to the general consumer, connections made with this material are considered improper as the national plumbing association does not recognize this type of flexible waste pipe as an appropriate plumbing material. No leaking was observed at this area at the time of the inspection but the ribbed inner wall surface is more prone to blockage than solid wall surface waste line material.

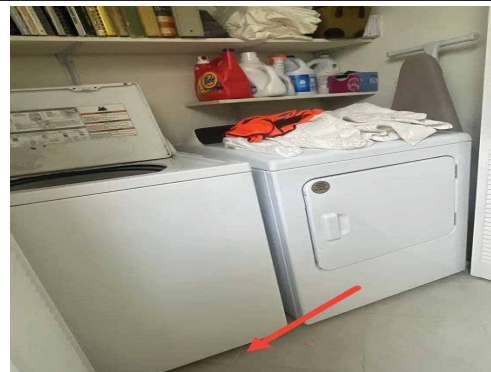
### 39. Suggestion: Missing Washing Machine Drain Pan -

There is no washing machine emergency drain pan installed for the washing machine. This can result in water damage to the floor/ceiling below this area should the washing machine or lines leak. Suggest that a drain pan be added so that protection against water damage from leaking appliance can be provided.

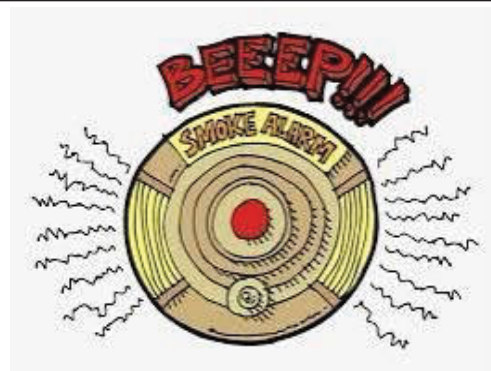
Current safety standards require smoke detection in every bedroom and a smoke detector and carbon monoxide detector to be installed within a reasonable distance outside all bedroom entrances. No CO detectors were observed in the home. Suggest installing additional detectors as needed for personal safety.

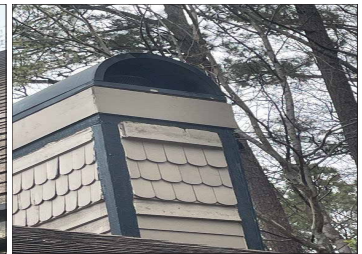
>>> Note: Water damage at the noted areas may not be limited to the visible wood components. Damage may be present inside the walls/roof/overhangs as well. Evaluations in these areas should include opening up the areas to observe/repair any damage as a result of the moisture penetration.

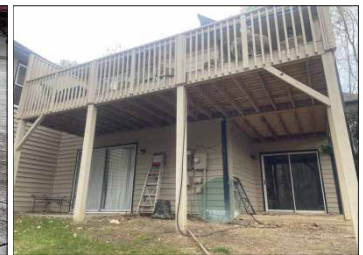
The building practices employed on this structure may have been consistent with the time of construction, but are not with current building standards. For personal safety and personal liability concerns, structures of this age are suggested to be evaluated by a professional contractor specializing in wood deck construction and repairs made as necessary to bring the deck up to current building standards wherever possible.

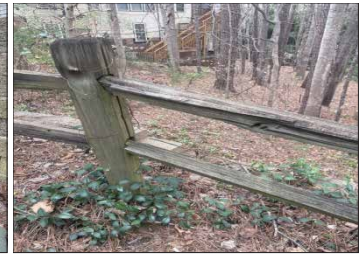
The retaining walls around the exterior of the house have wood fall protection rails installed at the top of the wall systems. The wood rails are loose and have moisture damage. Have a professional contractor make repairs or replace railings due to personal safety concerns.
