## SUMMARY

3421 Oak Trail, Clayton, NC 27520

July 20, 2026

Jason Ross  
NC License #3561  
New Leaf Home Inspections  
9105848502  
[jason@newleafinspections.com](mailto:jason@newleafinspections.com)

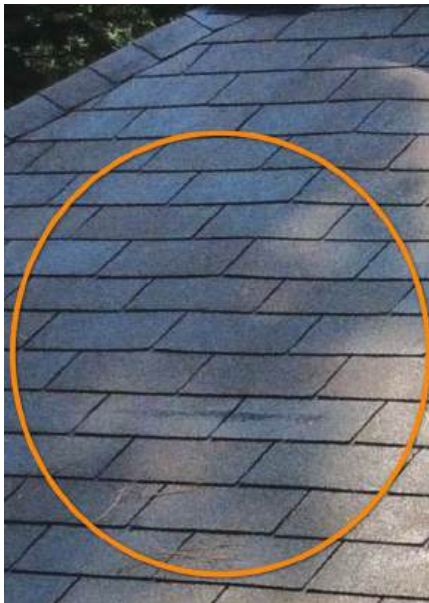
There was mineral granule loss on the roof coverings in several locations. Loss of granules can contribute to a shortened roof lifetime if found to be accelerated. There are many possible causes including, but not limited to, age, foot traffic, contact with vegetation, defective products, improper installation, hail damage, etc. We recommend monitoring this for future leaks or accelerated wear and contacting a qualified roofing professional for further evaluation if desired.

There was mineral granule loss on the roof coverings in several locations

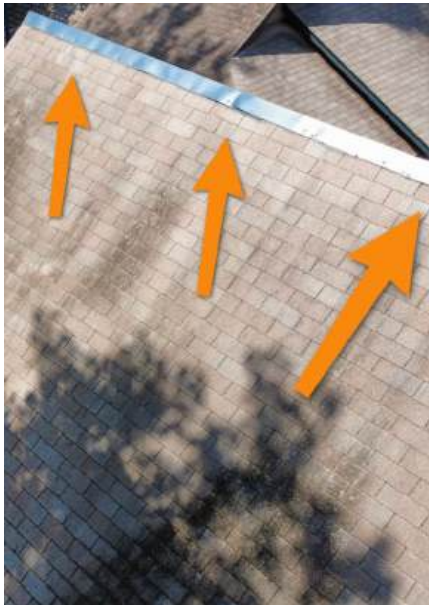
The flashing was either damaged, incorrect, or missing. This can indicate improper repairs, or allow moisture intrusion if not flashed properly. Recommend roofing or siding contractor evaluate and replace / repair as needed.

Uplift/gaps in areas of flashing on middle roofing of home

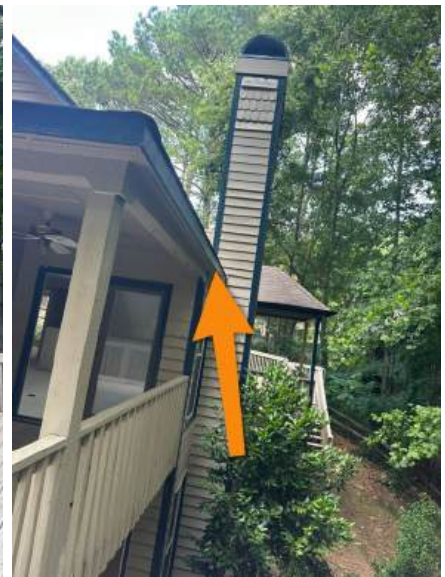
There are no or partial gutters present on the structure. This can allow water to impact the foundation of the home or increase moisture levels in crawlspace areas over time. We recommend a qualified contractor install gutters on the entire structure, or missing areas if so desired and possible.

No gutters installed on left side rear of home

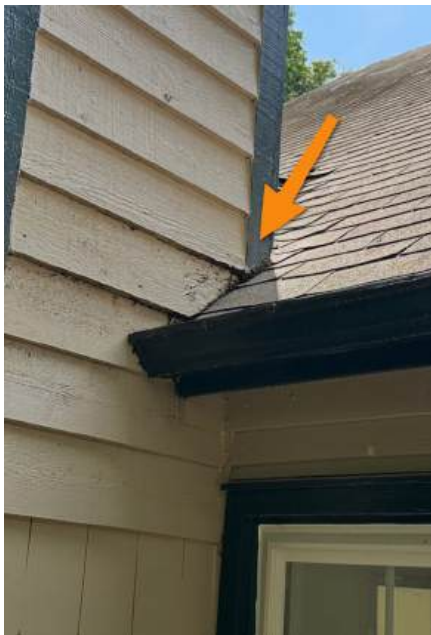
A component on the exterior of the home has signs of deterioration. This can indicate moisture intrusion, and can also damage underlying or surrounding components. Recommend qualified siding contractor further evaluate all exterior cladding components and repair or replace as needed.

Deterioration observed in areas of siding/trim on left side exterior of home (chimney chase)

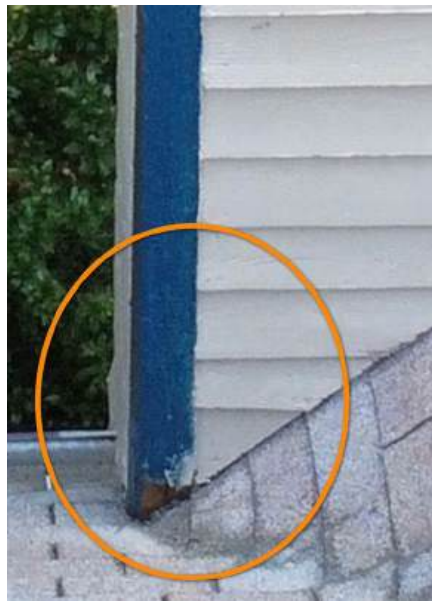
Deterioration observed in areas of siding/trim on left side exterior of home (chimney chase)

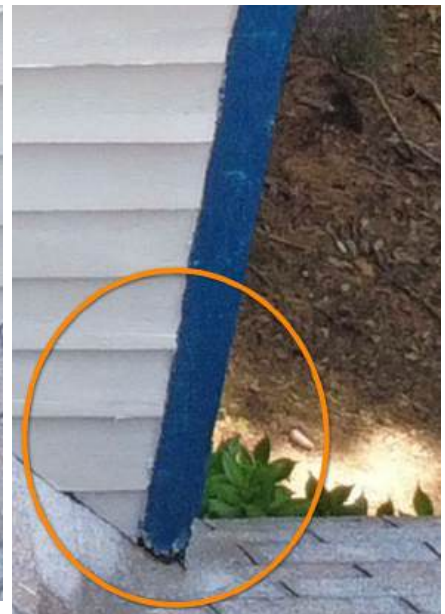
Deterioration observed in areas of siding/trim on left side exterior of home (chimney chase)

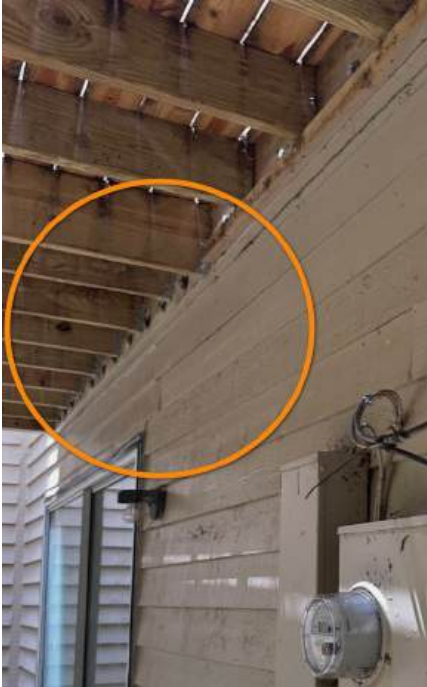
One or more components of the deck or porch were loose during the time of inspection. This can pose a safety hazard in some scenarios. Recommend qualified contractor further evaluate all decking and repair as needed.

Several ledger board anchor bolts are loose / pulling away on rear deck of home

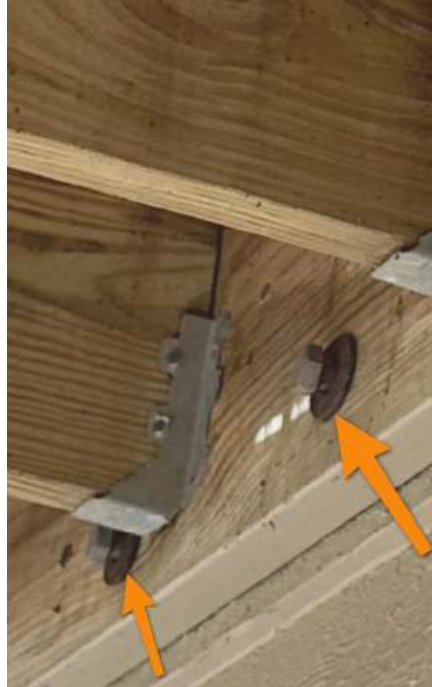
Several ledger board anchor bolts are loose / pulling away on rear deck of home

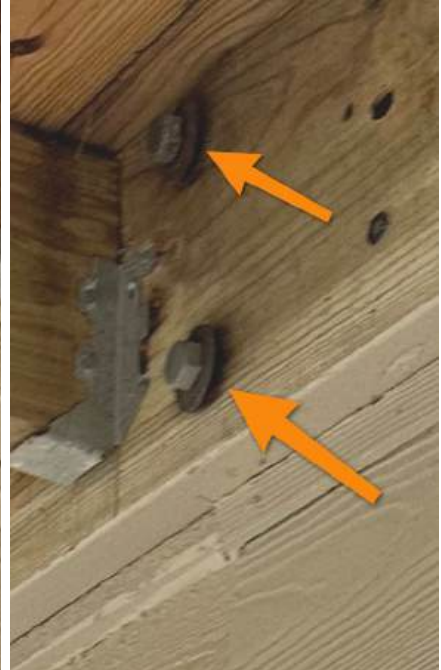
Several ledger board anchor bolts are loose / pulling away on rear deck of home

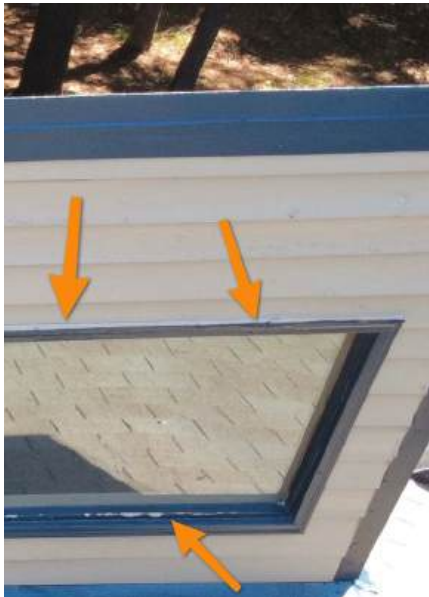
Members of wood around the exterior of the upper fixed windows on right side of home appear to be deteriorated in some areas. This is normally caused by moisture being allowed to enter the wooden members from lack of finish, damage, ect. Recommend qualified window contractor further evaluate all windows, and repair / replace as needed.

Members of wood around the exterior of the upper fixed windows on right side of home appear to be deteriorated in some areas

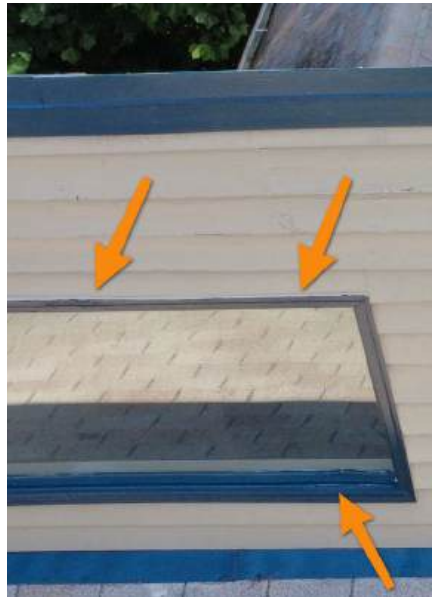
Members of wood around the exterior of the upper fixed windows on right side of home appear to be deteriorated in some areas

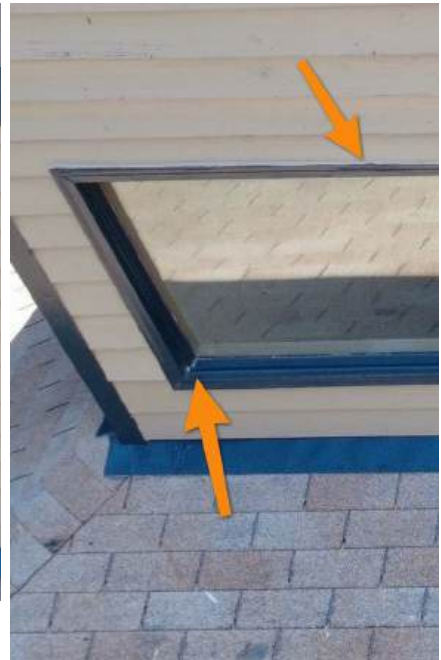
Members of wood around the exterior of the upper fixed windows on right side of home appear to be deteriorated in some areas

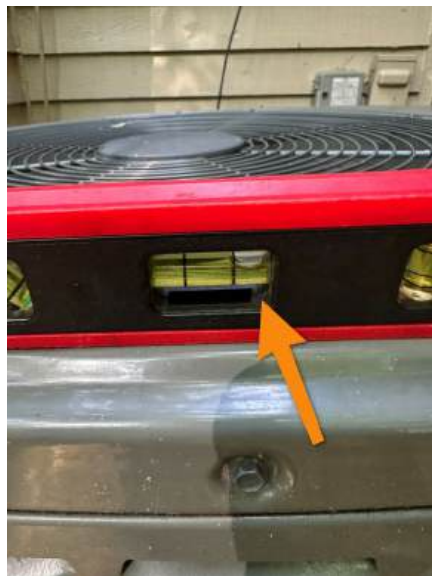
The HVAC unit is on an unlevel surface. The vibrations from running the unit can cause the unit to slide off damaging the unit. We recommend licensed HVAC technician or builder further evaluate and repair as needed.

Exterior HVAC condenser unit/heat pump is not sitting level

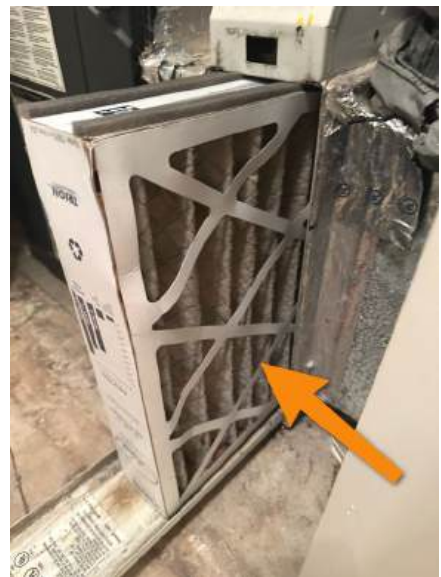
The HVAC in-line box air filter is dirty. This can put strain on the system and decrease the overall life span. Recommend filters are changed often to ensure proper operation.

The HVAC in-line box air filter is dirty

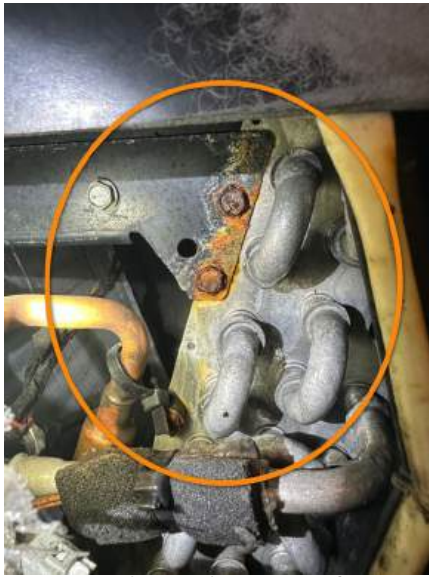
The system was corroded in one or more areas. This can shorten the life of the unit and in some scenarios may cause components to fail. Recommend a licensed HVAC contractor further evaluate and repair if needed.

Corrosion observed on areas of evaporator coil in HVAC air handler

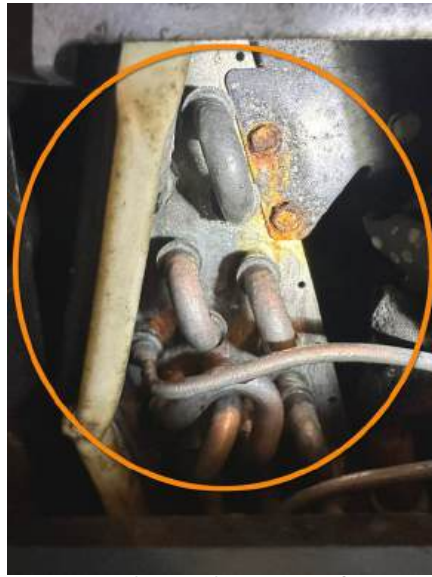
Corrosion observed on areas of evaporator coil in HVAC air handler

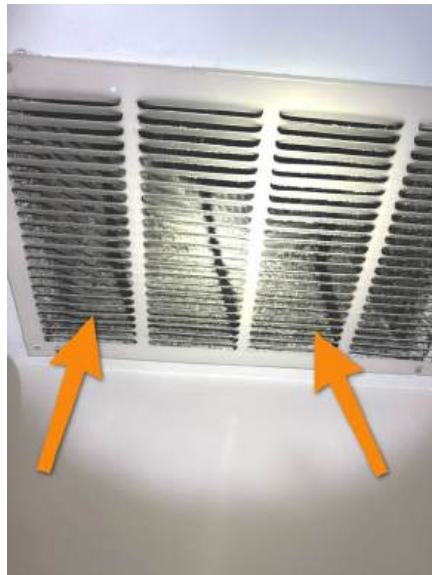
Dirt/debris and suspected organic growth was noted in ductwork at distribution registers and returns throughout home. This can affect indoor air quality or pose a health concern in some scenarios. Recommend air quality testing and consulting a licensed HVAC company for evaluation and cleaning or replacement as needed.

Dirt/debris and suspected organic growth was noted in ductwork at distribution registers and returns throughout home

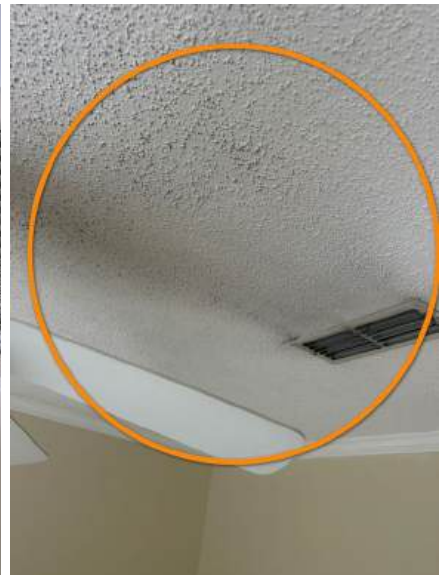
Dirt/debris and suspected organic growth was noted in ductwork and at distribution registers and returns throughout home

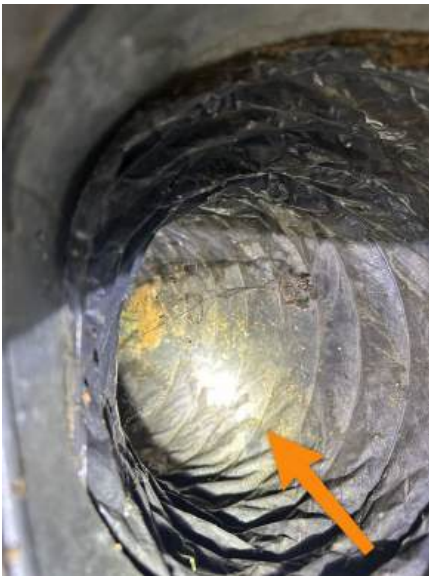
Dirt/debris and suspected organic growth was noted in ductwork at distribution registers and returns throughout home

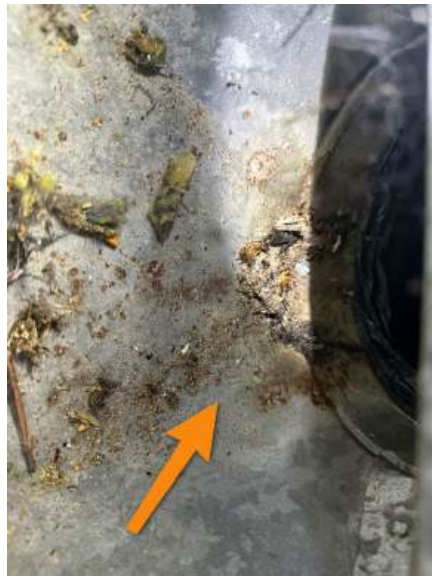
Dirt/debris and suspected organic growth was noted in ductwork and at distribution registers and returns throughout home

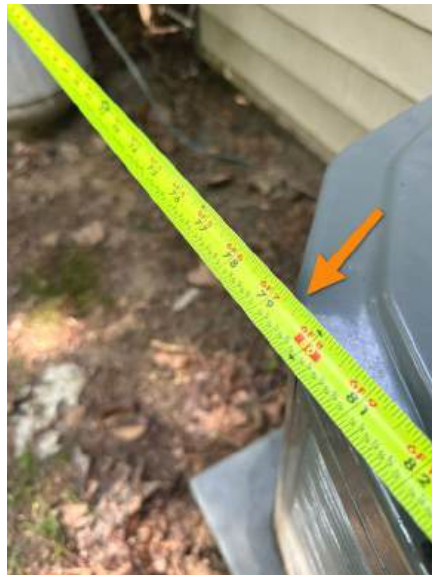
The propane tank has improper clearance from HVAC condenser unit on left side exterior of home (6' 8"). A stationary propane tank must be at least 10 feet away from an HVAC condenser unit. The National Fire Protection Association (NFPA) considers an air conditioner compressor to be a potential source of ignition (due to sparking relays or motors) and requires this 10-foot buffer. This is a potential safety concern. We recommend local rules are followed, and contacting the local service provider for relocation of tank as needed.

The propane tank has improper clearance from HVAC condenser unit on left side exterior of home (6' 8")

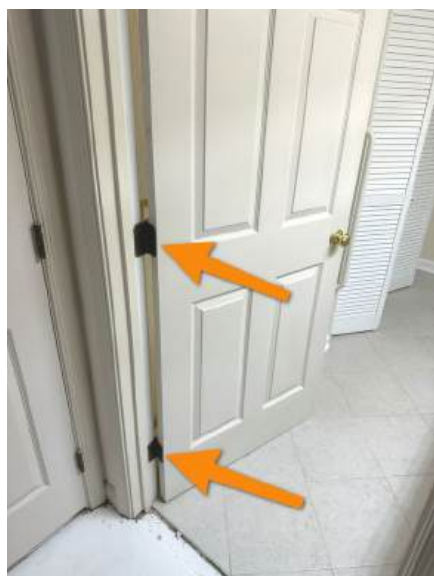
A component appeared to be loose during the time of inspection. This can hinder proper operation and worsen over time. Recommend a qualified contractor evaluate and repair / replace as needed

Hinges are loose/detaching on main level hallway bathroom door

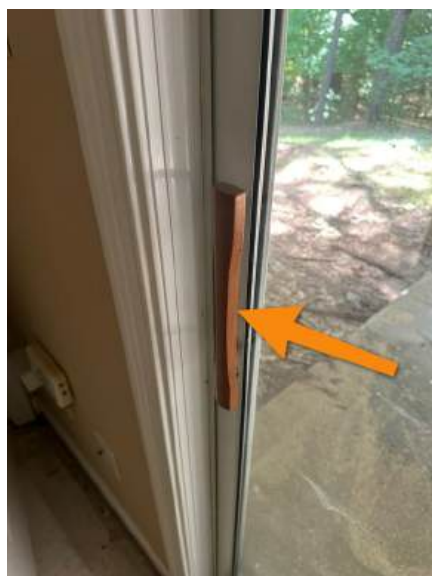
Handle is loose on rear exterior sliding glass door (lower level left rear family room)

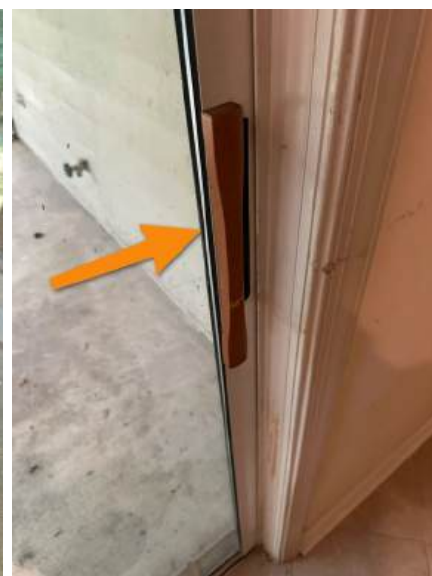
Handle is loose on rear exterior sliding glass door (lower level right rear bedroom)

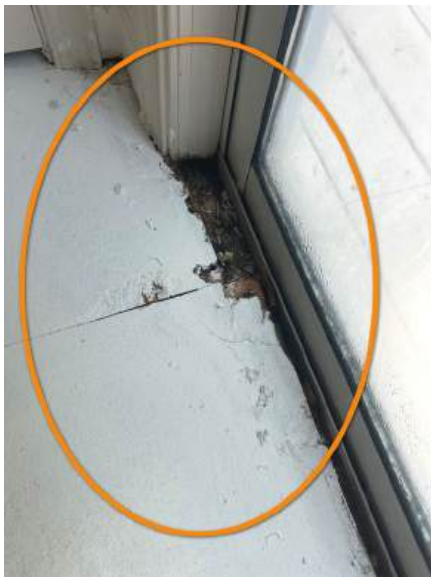
There was evidence of moisture intrusion near or at an exterior door. This can indicate multiple seal, or exterior issues. Recommend qualified contractor identify source of intrusion and remedy as needed.

There was evidence of moisture intrusion near or at an exterior door (main level rear exterior sliding glass door, primary bedroom)

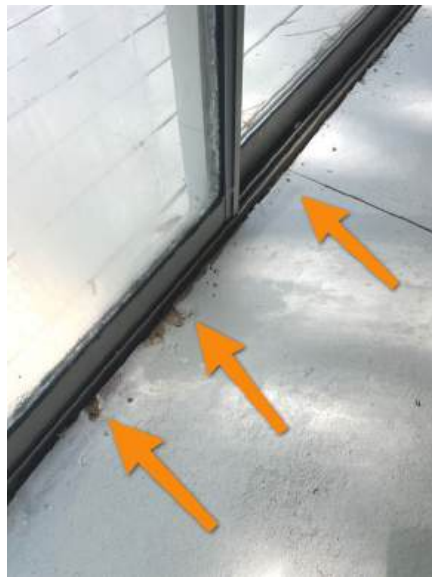
There was evidence of moisture intrusion near or at an exterior door (main level rear exterior sliding glass door, primary bedroom)

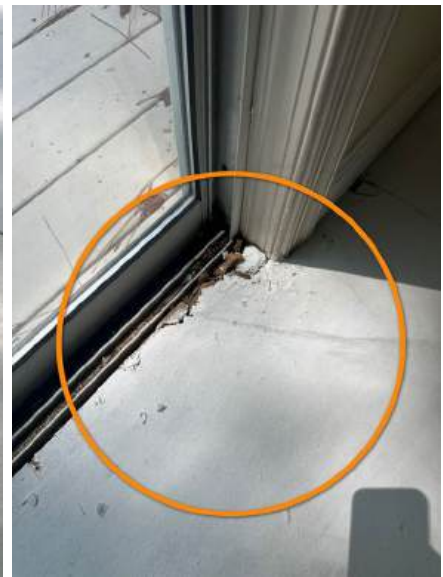
There was evidence of moisture intrusion near or at an exterior door (main level rear exterior sliding glass door, primary bedroom)

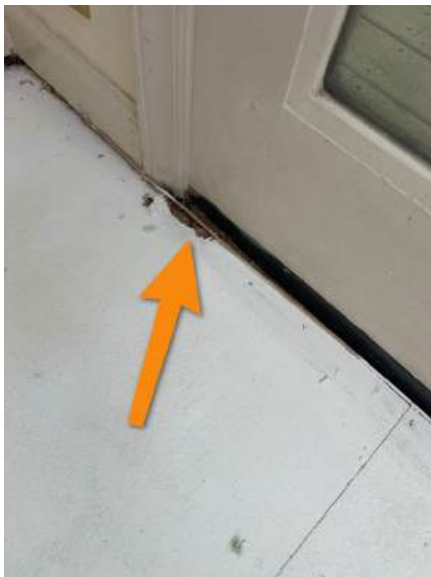
There was evidence of moisture intrusion near or at an exterior door (main level rear exterior door, living room)

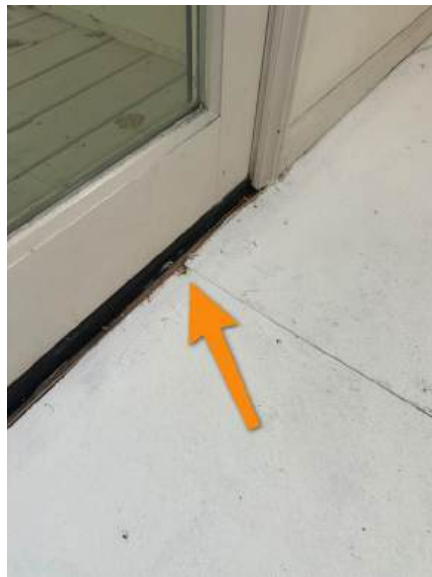
There was evidence of moisture intrusion near or at an exterior door (main level rear exterior door, living room)

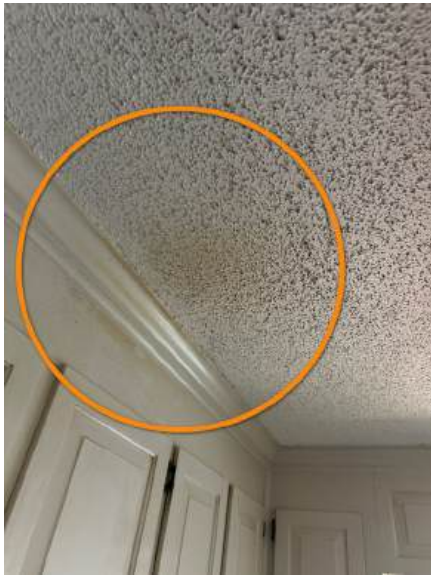
There was a moisture stain during the time of inspection. This could indicate current or past moisture intrusion within the structure, or from surrounding components. We recommend a licensed contractor further evaluate and make appropriate repairs as needed.

Moisture staining observed on ceiling and right side wall in kitchen

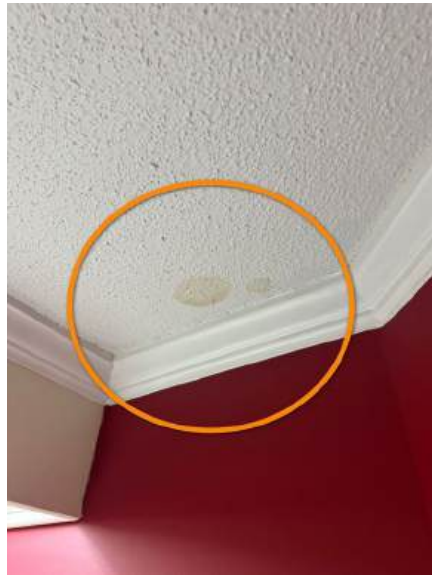
Moisture staining observed on ceiling in main level primary bathroom

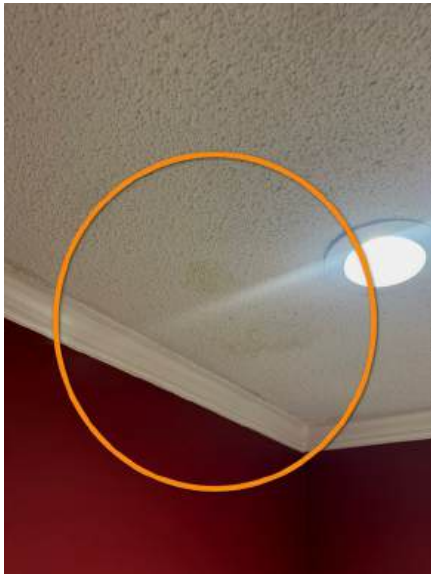
Moisture staining observed on ceiling in main level primary bathroom

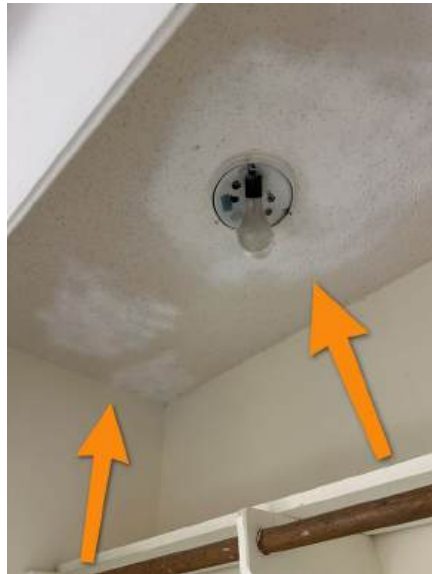
Moisture staining observed on ceiling in laundry area (main level hallway bathroom)

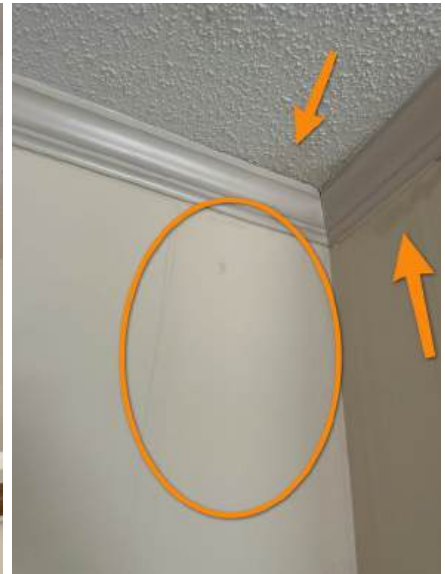
Moisture staining observed on rear wall and ceiling in main level right front bedroom

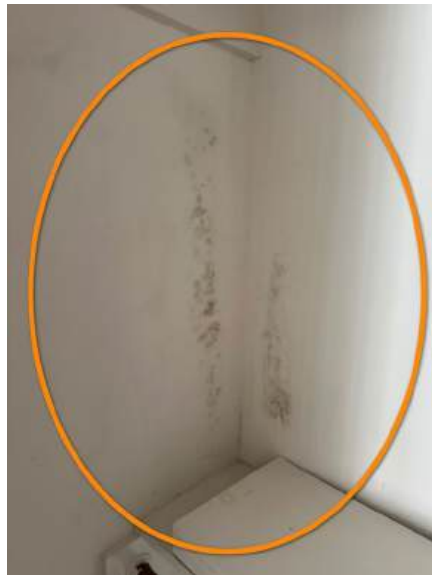
Moisture staining observed on wall in closet of main level right front bedroom

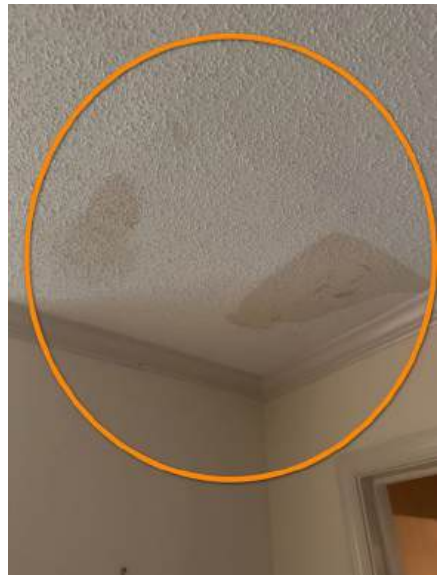
Moisture staining observed on ceiling in lower level hallway

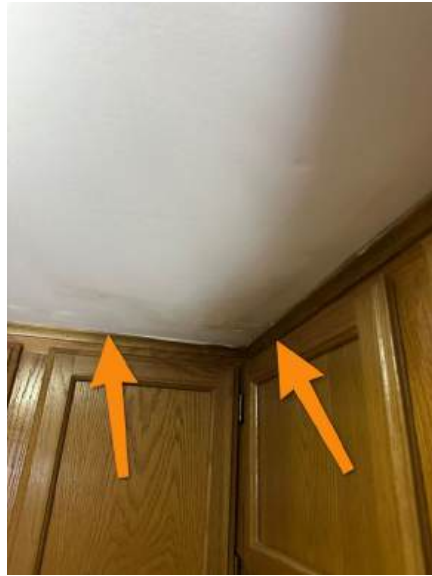
Moisture staining observed on ceiling in lower level front bonus room

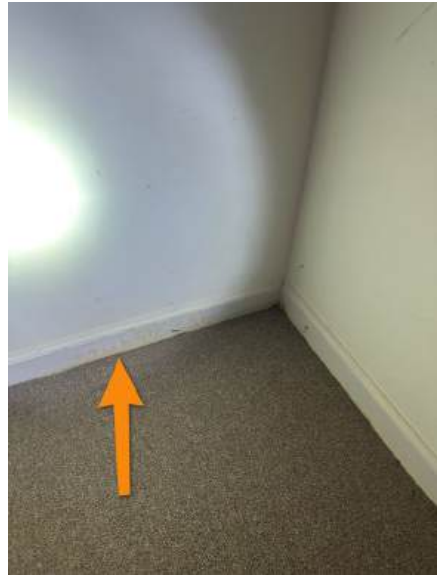
Moisture staining observed on baseboards in several locations throughout lower level of home

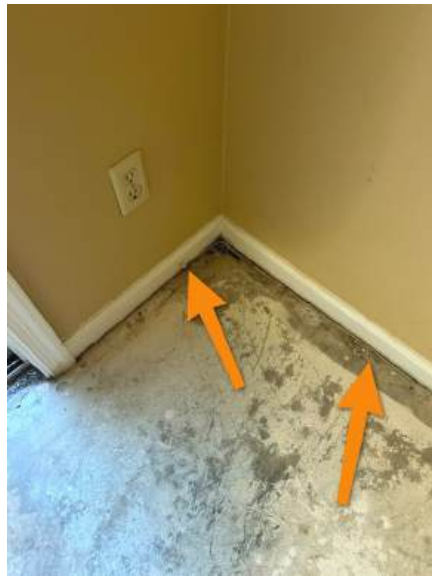
Moisture staining observed on baseboards in several locations throughout lower level of home

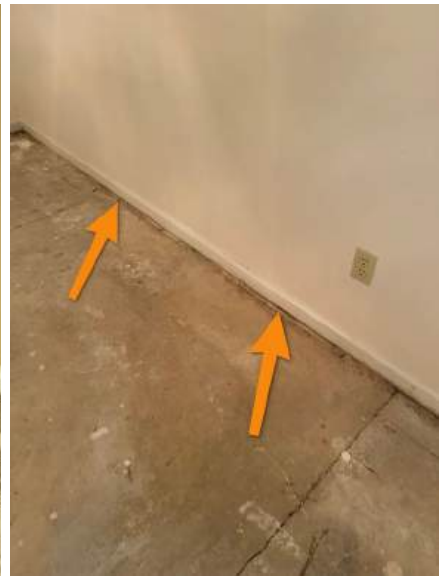
Moisture staining observed on baseboards in several locations throughout lower level of home

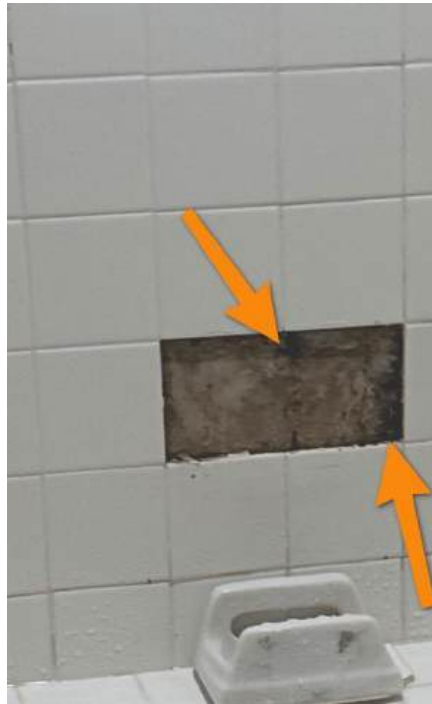
There appear to be signs of organic growth on the interior of the home. It is unknown if this is a safety hazard. We recommend an air quality test is performed and source of higher moisture is determined and mitigated to ensure the health and safety of occupants. **All areas of organic growth should be remediated by a licensed general contractor or qualified professional.**

Suspected organic growth of based on wall sheathing where tiles are missing in shower area of lower level bathroom

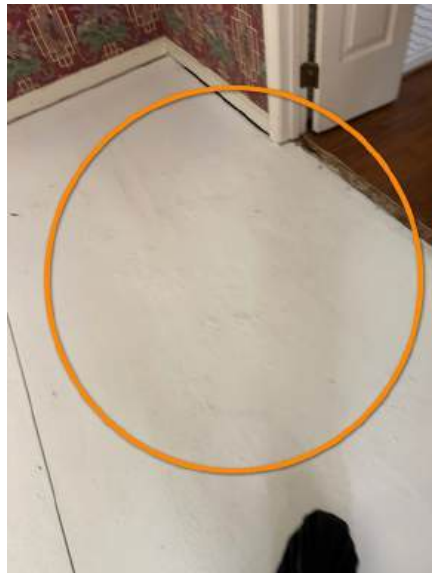
Subflooring had areas of possible moisture intrusion. This can accelerate deterioration and damage surrounding components over time. Recommend a qualified flooring contractor evaluate & repair areas affected as/if needed.

Subflooring had areas of possible moisture intrusion (Main level, dining room)

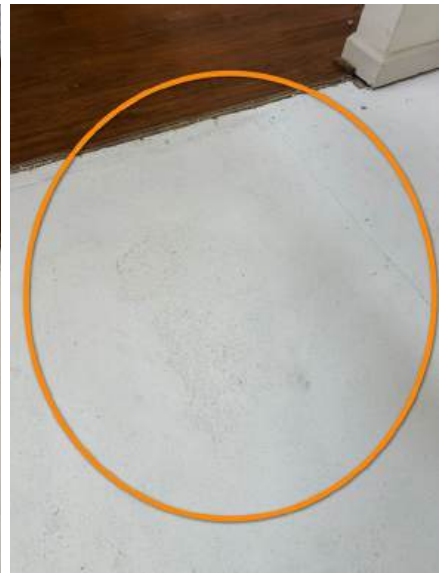
Subflooring had areas of possible moisture intrusion (Main level, living room)

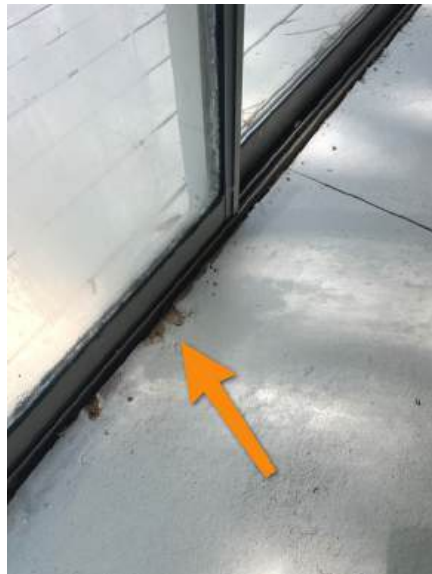
There was an area of deterioration in areas of the subflooring. This can indicate a moisture intrusion and can damage surrounding components. Recommend licensed contractor further evaluate to determine source of moisture intrusion and repair/replace all affected areas/components as needed.

There was an area of deterioration in areas of the subflooring (At rear exterior door, main level primary bedroom)

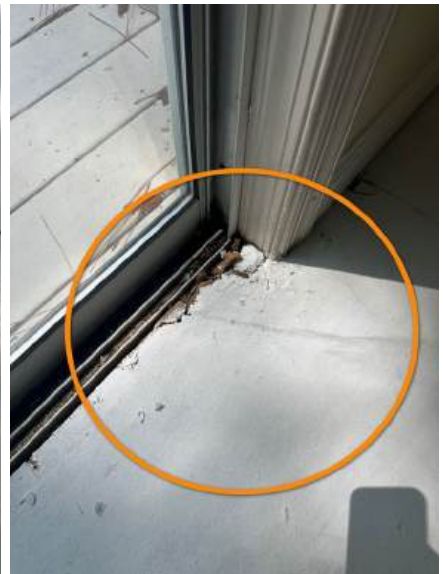
There was an area of deterioration in areas of the subflooring (At rear exterior door, main level primary bedroom)

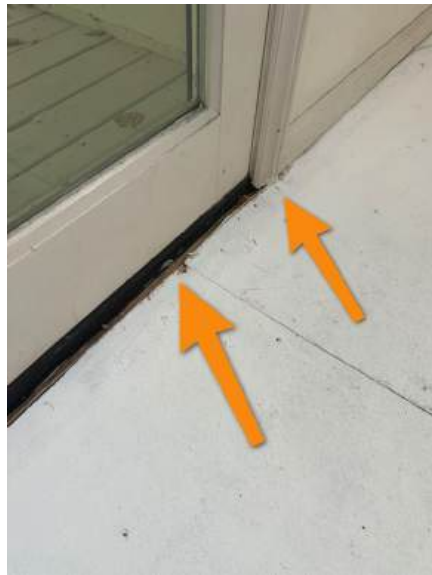
There was an area of deterioration in areas of the subflooring (At rear exterior door, main level living room)

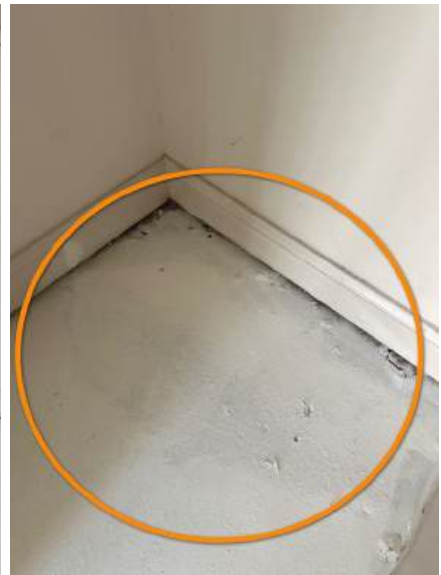
There was an area of deterioration in areas of the subflooring (in closet, main level right front bedroom)

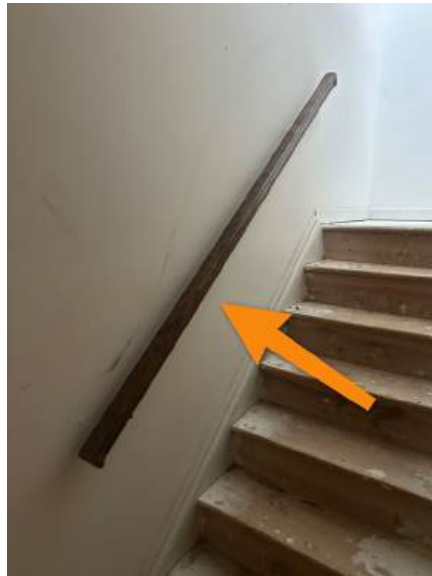
There was a loose component of the stairwell. This can worsen over time and could cause a fall hazard. Recommend loose component is tightened or replaced by a qualified professional.

Right side lower handrail is loose on interior stairwell

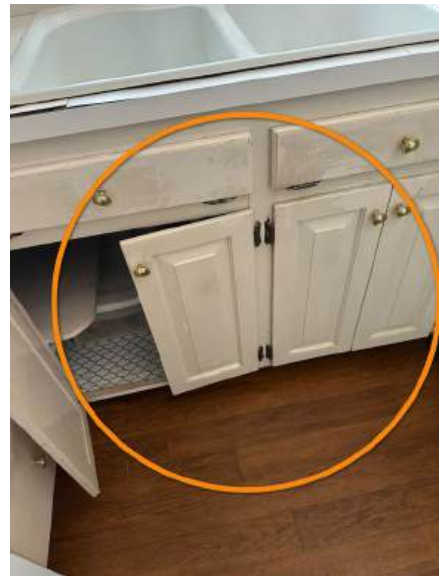
A component was loose or detaching during the time of inspection. This can worsen over time and prevent proper operation. Recommend qualified contractor further evaluate and repair as needed.

Front facing of cabinet underneath sink in kitchen is loose/detaching

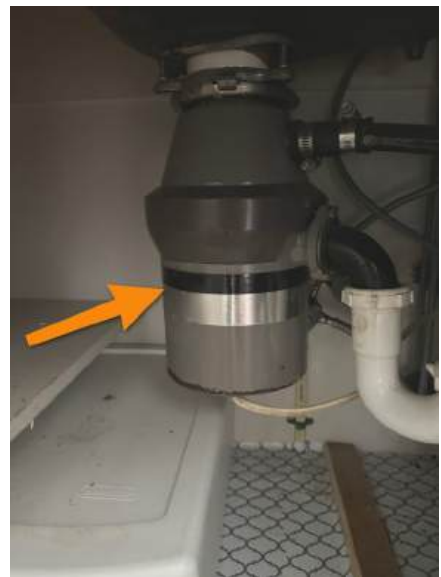
Garbage disposal was inoperable at the time of inspection. This can indicate failed or seized components. Recommend qualified handyman or plumber repair or replace.

Garbage disposal was inoperable at the time of inspection

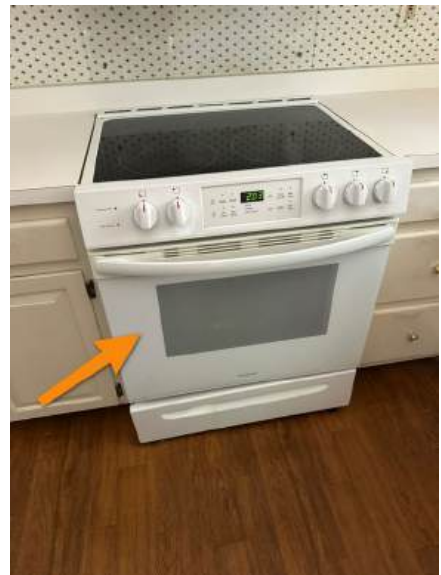
The range did not appear to have an anti-tip device installed. This can pose a tip hazard and cause harm to people or pets. Recommend an anti-tip device is installed by a qualified contractor.

The range did not appear to have an anti-tip device installed

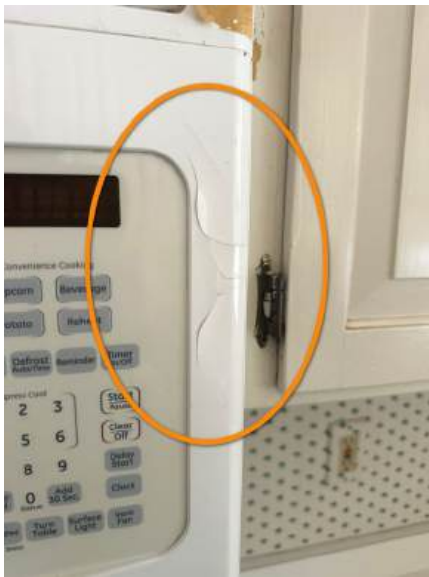
The microwave unit or component was damaged or detaching. This can prevent proper operation or not perform as intended aesthetically. Recommend qualified professional replace as needed.

Area of microwave main housing is damaged/cracked

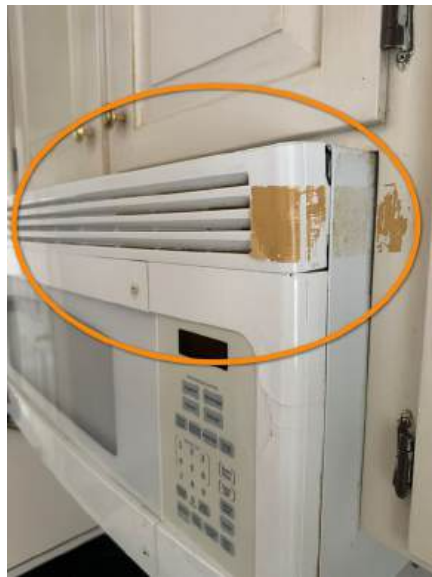
Microwave exhaust vent cover is damaged/detaching

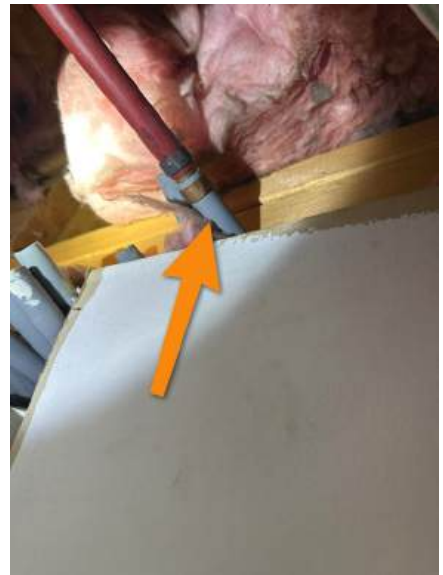
This home has a plumbing supply system that partially uses polybutylene plastic distribution lines and compression band fittings. Even though this plumbing system was installed in many homes from 1978 until mid-1990s, it is no longer an approved plumbing system due to a history of material failures. The failures were related to improper installation, improper handling, improper storage, and plastic deterioration due to chemical reactions with the water supply. Due to the nature of this latent defect, it was not possible to adequately assess the condition of the plumbing system during the home inspection. A licensed plumbing contractor should be consulted for a complete evaluation of the plumbing system to determine the significance of this concern.

This home has a plumbing supply system that partially uses polybutylene plastic distribution lines and compression band fittings

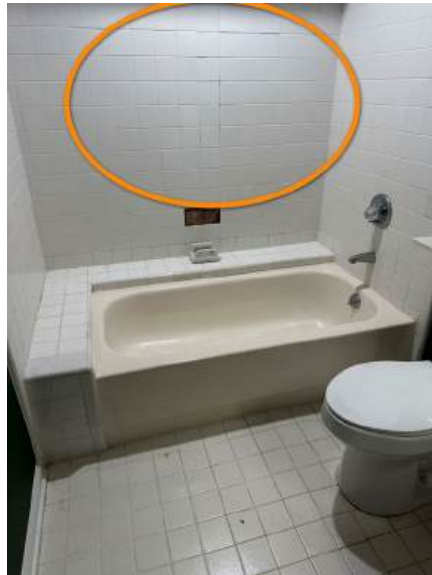
One or more fixtures, components, or Shower/Tub areas were damaged, missing, or detaching. This can hinder proper operation, allow moisture intrusion, or cause damage to surrounding components. We recommend a qualified contractor further evaluate to determine if moisture intrusion has occurred to components around fixture and to make appropriate repairs / replacements as needed.

Areas of tile are damaged / detaching and missing in lower level bathroom shower area

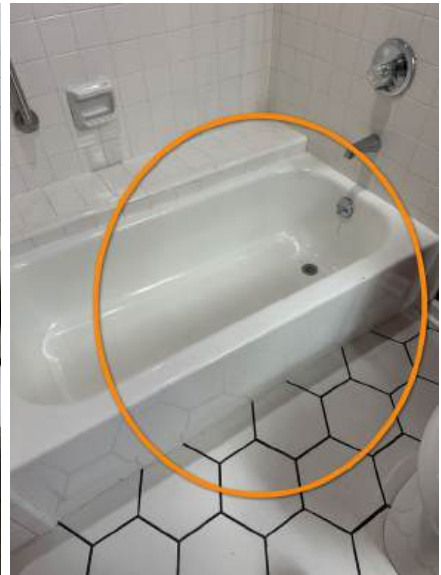
Damage (chipping) observed in areas of tub in main level primary bathroom

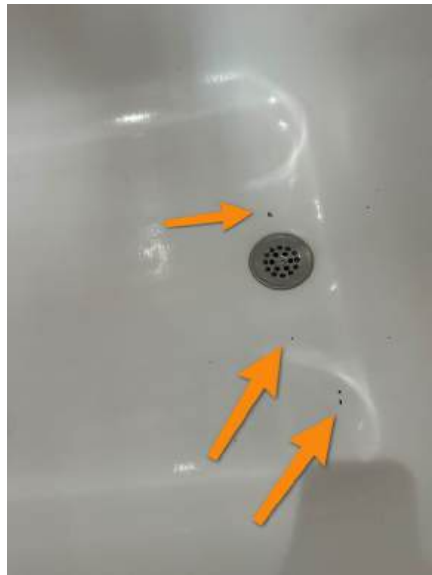
Damage (chipping) observed in areas of tub in main level primary bathroom

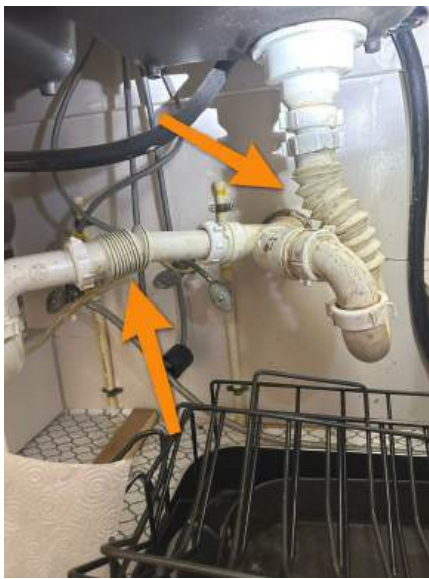
There was flexible drainage piping installed underneath kitchen sink. This can contribute to no or slow drainage to fixtures, as well as escaped gases if, "P" traps are not properly installed. We recommend a licensed plumber further evaluate and make adjustments as needed.

There was flexible drainage piping installed underneath kitchen sink

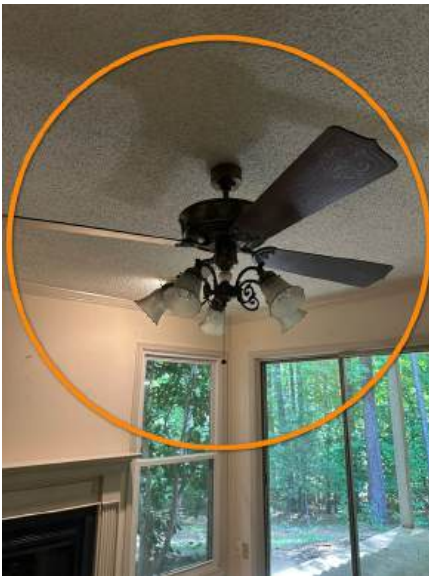
The ceiling fan did not operate in lower level left rear family room during the time of inspection. This can indicate a manufacturers defect or improper installation. Recommend qualified contractor further evaluate and repair or replace as needed.

The ceiling fan did not operate in lower level left rear family room during the time of inspection

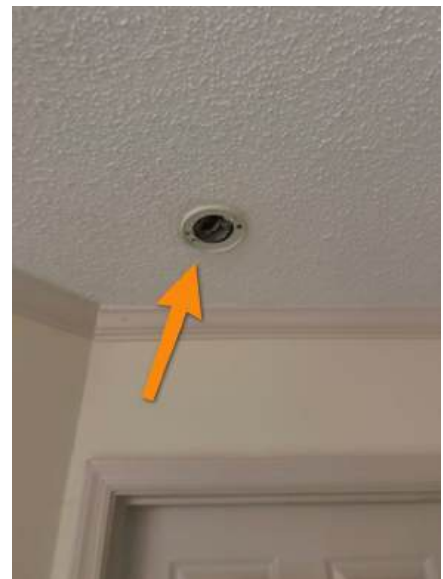
One or more smoke detectors were missing or have been removed in noted locations. This is a safety concern. We recommend installing detectors in all habitable spaces.

Smoke detector has been removed on ceiling in lower level family room

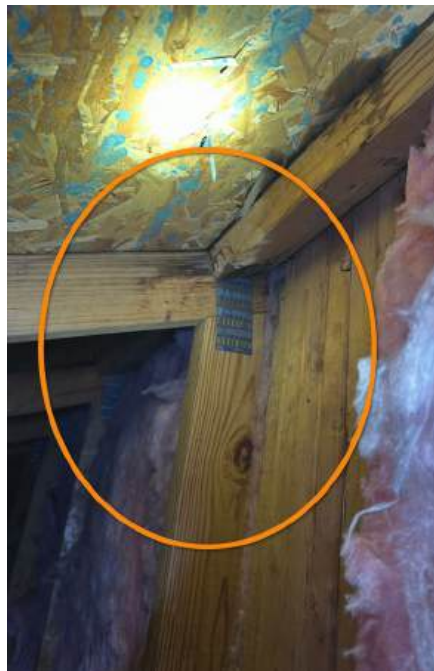
There was moisture staining on areas of roofing and side wall material. This can indicate a current or past leak and can damage roofing or surrounding components. Recommend monitoring the area and contacting a roofing contractor for further evaluation and to ensure proper repairs are made if needed.

Moisture staining observed on areas of roof and side wall framing in middle right area of attic

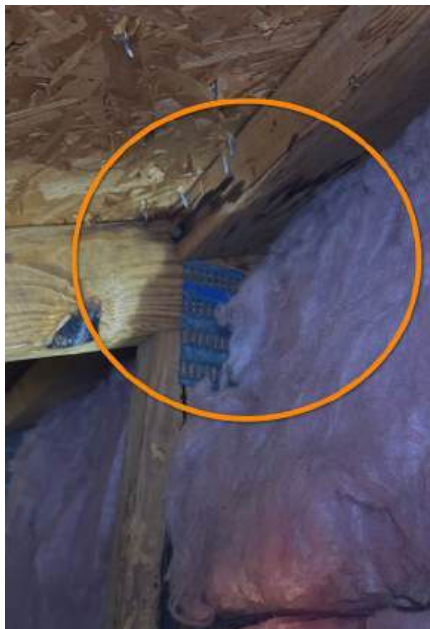
Moisture staining observed on areas of roof and side wall framing in middle right area of attic

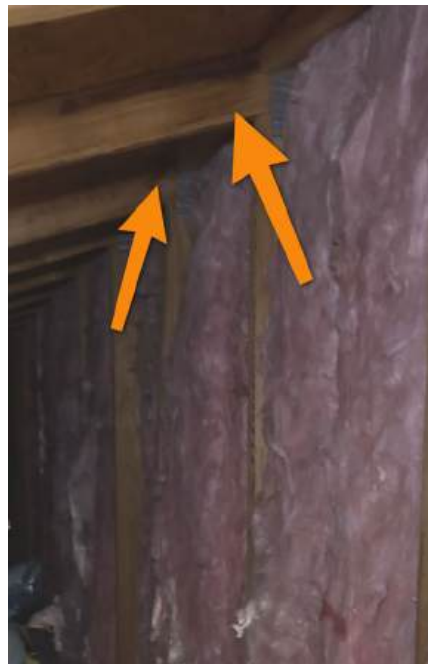
Moisture staining observed on areas of roof and side wall framing in middle right area of attic

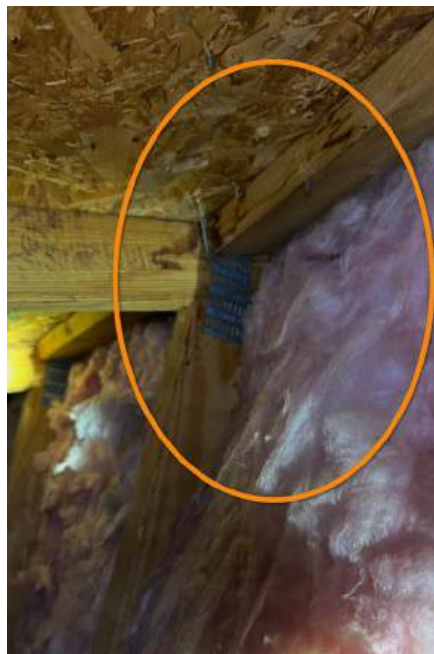
Moisture staining observed on areas of roof and side wall framing in middle right area of attic

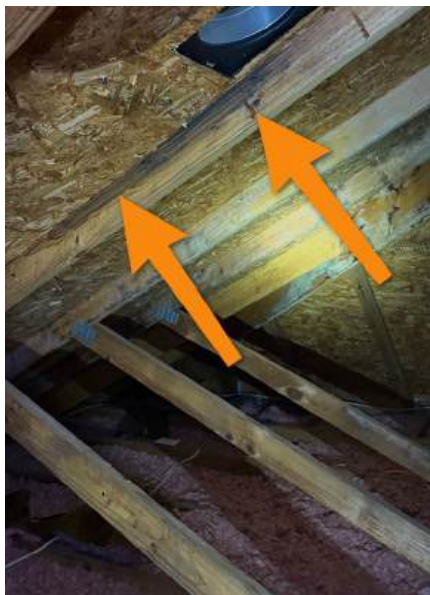
Moisture staining observed on areas of roof framing in front area of attic

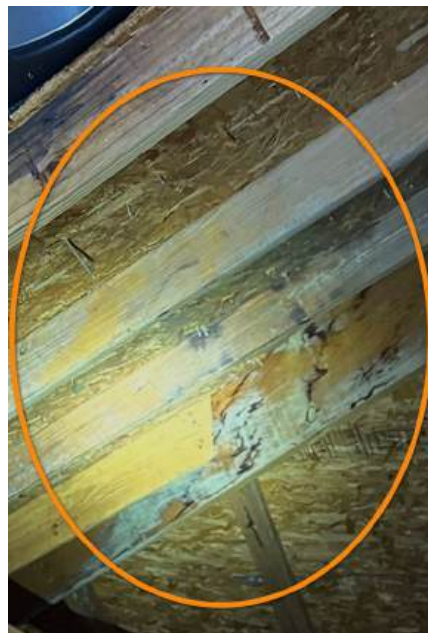
Moisture staining observed on areas of roof framing in front area of attic

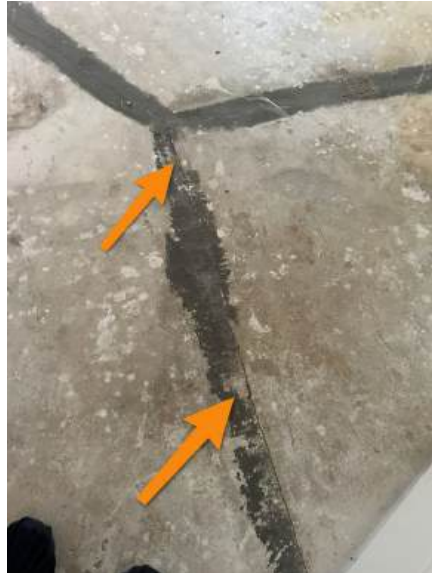
The interior foundation/slab flooring was cracked in noted areas. This can sometimes prevent proper installation of flooring, be noticeable once flooring is installed, or may indicate minor settlement in some scenarios. Recommend qualified professionals repair/seal as needed or further evaluation by a structural engineer if desired.

Interior foundation slab cracks observed in lower level right rear bedroom

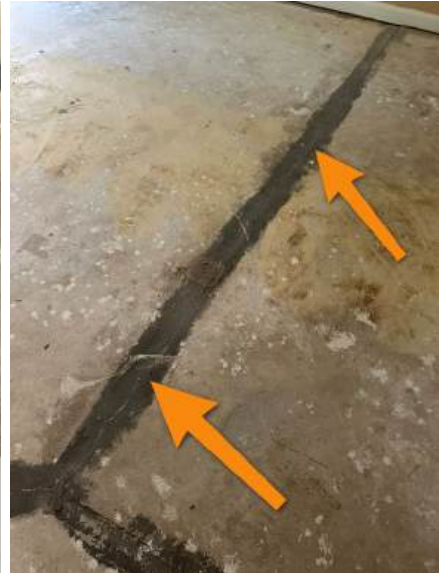
Interior foundation slab cracks observed in lower level right rear bedroom

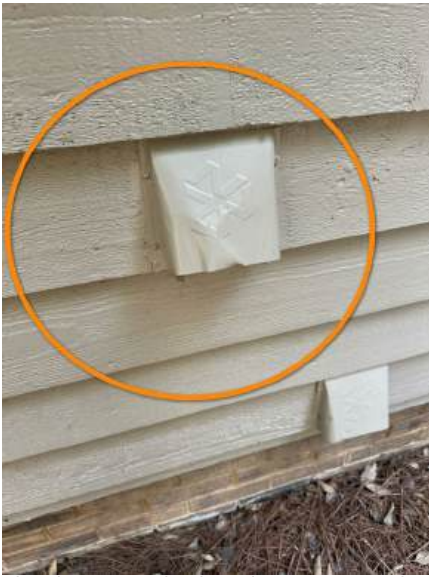
The dryer vent had lint built up on right side exterior of home. This can pose a fire hazard. Recommend a qualified contractor clean vents.

The dryer vent had lint built up on right side exterior of home
