June 30, 2026

Re: Limited Structural Inspection  
212 Mint Hill Drive  
Cary, NC

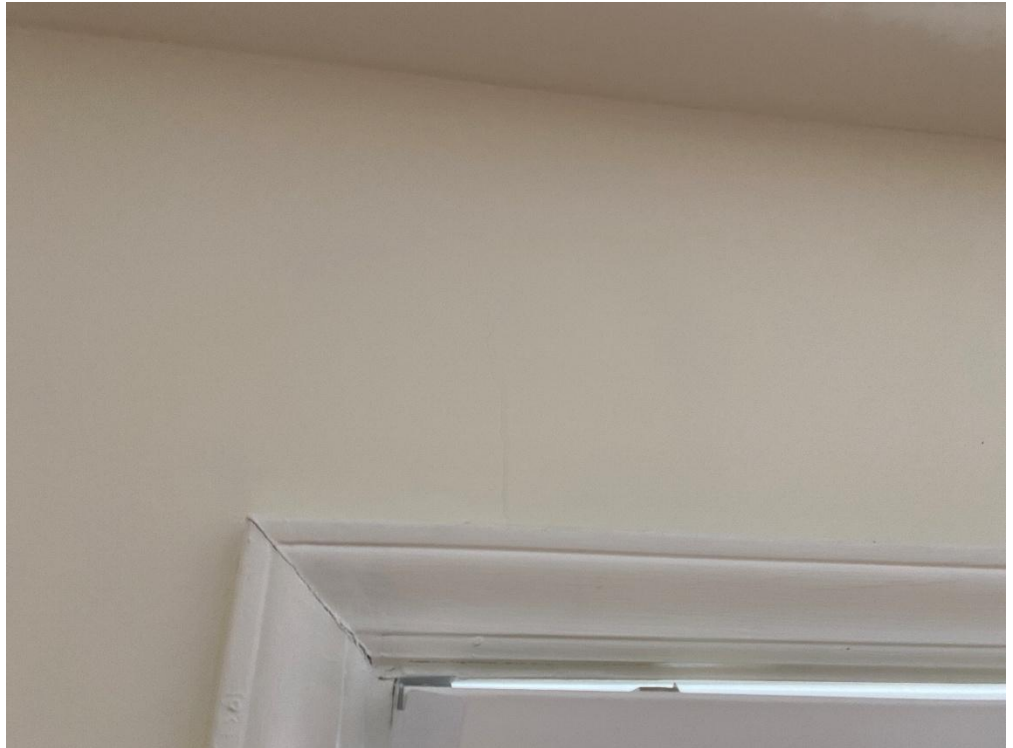
Photo No.  
2

1. A hairline crack (less than 1/16" wide) was observed in the finish materials at the front perimeter wall of the front right room located approximately 4'-0" from the right exterior wall.

The hairline interior wall finish material crack noted above (Observation #1) is likely the result of a combination of the supporting members contracting/deflecting and limited differential foundation settlement. Minor drywall cracking and finish carpentry separations are typically associated with changes in weather, temperature and humidity causing wood to shrink and swell with the seasons. We do not consider the interior wall finish material cracks to be a structural concern.

View of the hairline crack in the finish materials.

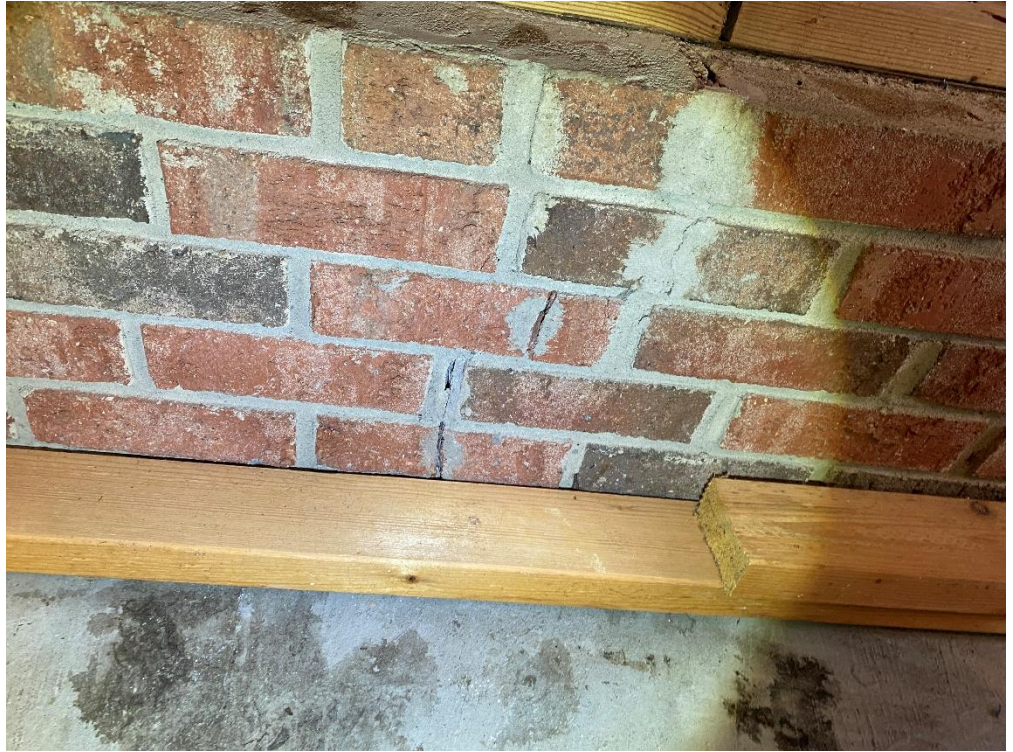
Photo No.  
3

2. A vertical/stair-step crack (up to 3/16" wide) was observed in the right foundation wall located approximately 13'-0" from the front perimeter wall of the garage.
3. A provided push pier certification report by *Stark Foundations* dated May 27, 2021 indicated that five (5) push piers were previously installed along the right and rear perimeter walls of the garage.
  - a. Note, Giles Flythe Engineers did not originally specify or certify these helical piers.

The cracks in the foundation walls noted above (Observations #2, #4, and #6) are likely due to limited differential foundation settlement. The clay soils in this area are considered “expansive” type soils and will typically expand and contract with fluctuations in the moisture content. This expansion and contraction of load bearing soil materials below foundations can lead to soil consolidation and foundation cracking. If conditions around the foundation remain relatively dry, the likelihood of future significant settlement will be reduced, but we cannot predict the extent of future settlement. Due to the lack of propagation in the sealed crack noted above (Observation #4a.i), we believe the push pier system is performing as intended at this time and monitoring cracks for additional settlement is an acceptable approach at this time. The condition of the foundation walls does not appear to be a significant structural deficiency at this time.

View of the vertical/stair-step crack in the right perimeter foundation wall of the garage.

1. No structural repairs are required at this time.
2. Monitor the cracks in the foundation walls noted above. If the cracks widen significantly (expand by an additional 1/8”) or additional significant cracks (greater than 1/4” wide) propagate, then further evaluation by a structural engineer is recommended.
3. We recommend ensuring that stormwater drains positively away from the home to minimize the risk of future water infiltration. This can be accomplished ensuring gutters, downspouts, and leaders remain clear of debris and properly functioning. Also, creating a positive grade, where possible, away from the perimeter of the home will aid in the stormwater evacuation.

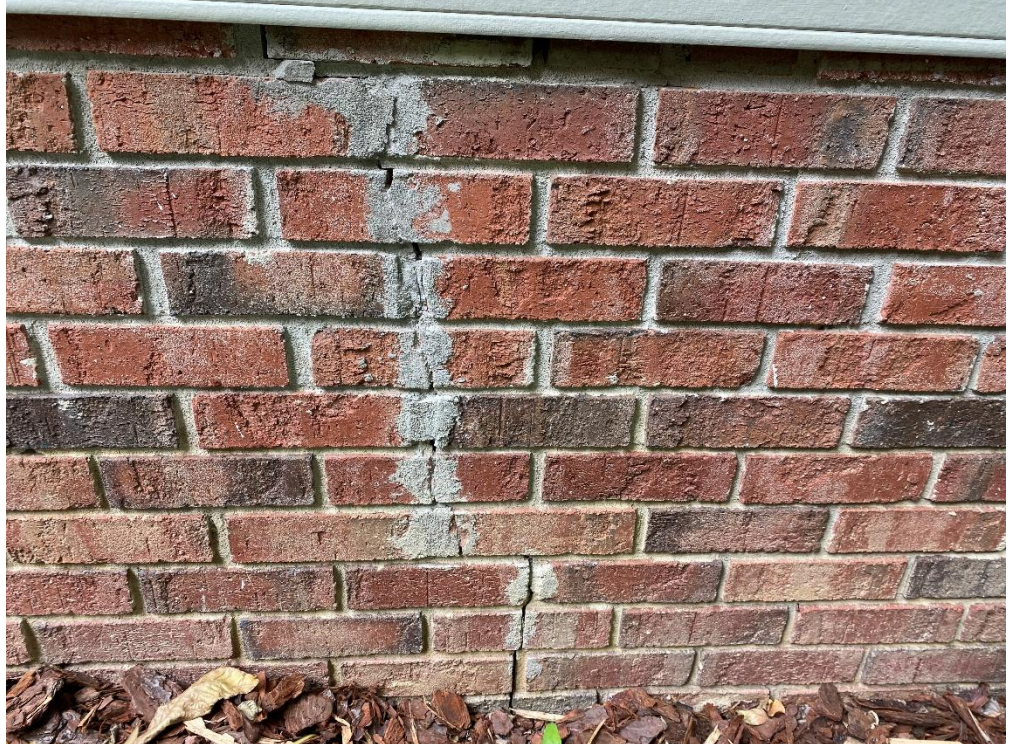
Photo No.  
4

4. Cracks/separations were observed in the perimeter foundation walls in the following locations:
  - a. A vertical/stair-step crack (up to 3/16" wide) was observed at the right perimeter foundation wall located approximately 13'-0" from the rear perimeter wall.

- i. This cracked was noted to be partially sealed with no signs of propagation.
    - ii. Note, this aligns with the crack in Observation #2.
  - b. A vertical crack (up to 1/8" wide) was observed in the rear perimeter foundation wall located approximately 9'-4" from the right perimeter wall.

View of the vertical/stair-step crack in the right perimeter foundation wall of the home.

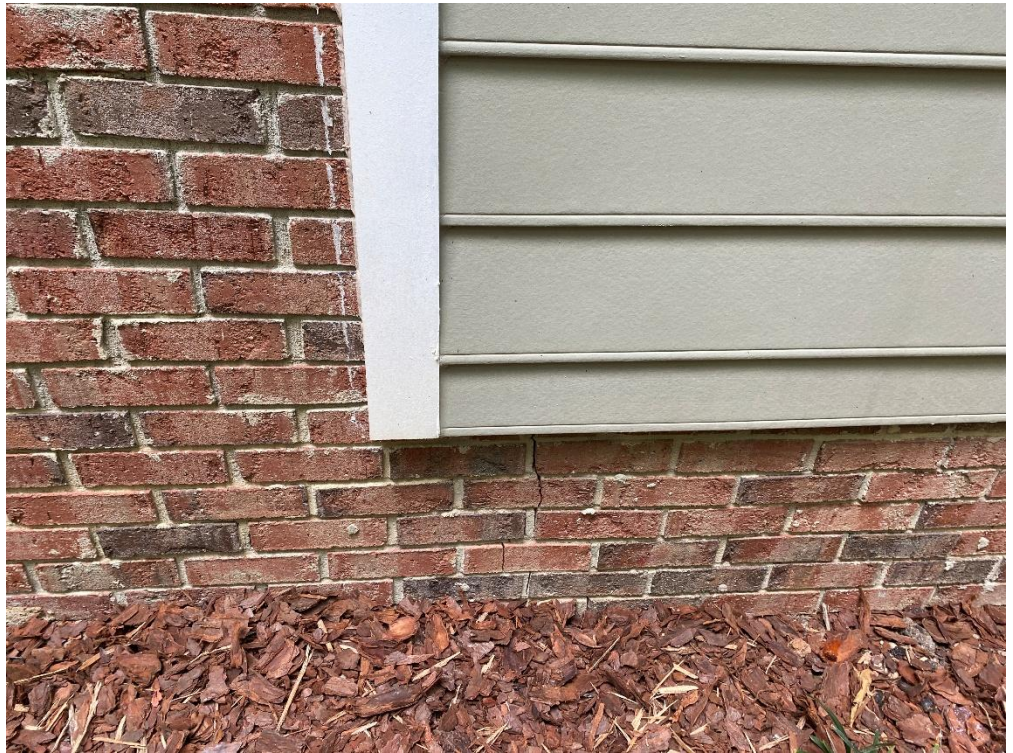
Photo No.  
5

View of the vertical crack in the rear perimeter foundation wall located approximately 9'-4" from the right perimeter wall.

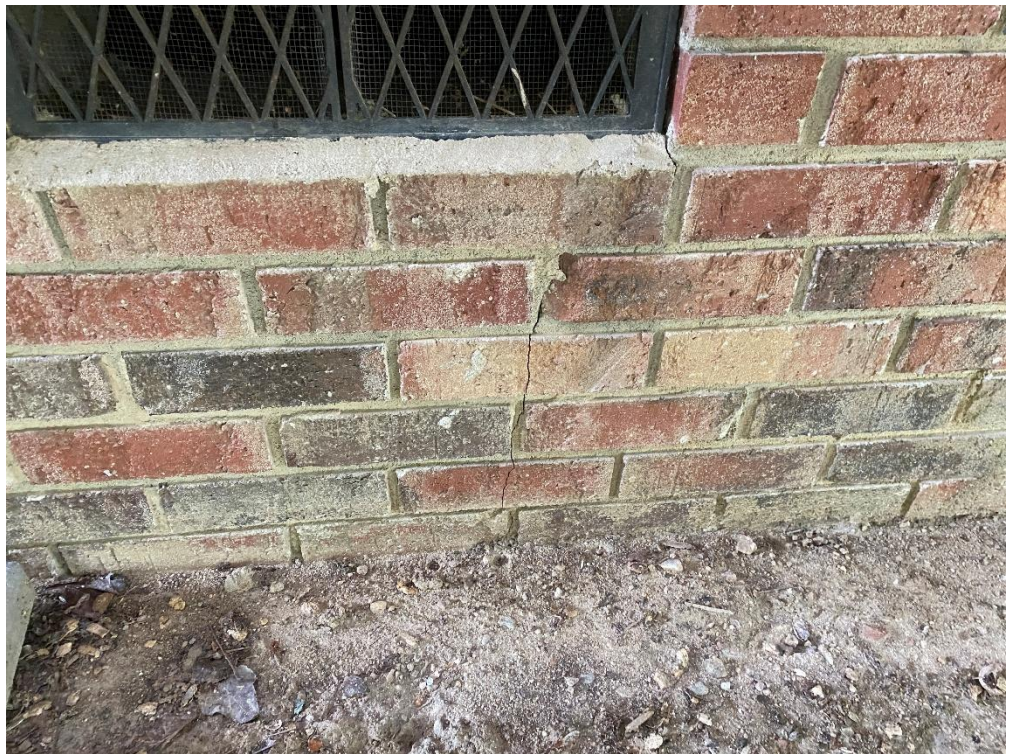
Photo No.  
6

- c. A minor vertical crack (less than 1/16" wide) was observed in the rear perimeter foundation wall located approximately 21'-10" from the left perimeter wall.

View of the minor vertical crack in the rear perimeter foundation wall located approximately 21'-10" from the left perimeter wall.

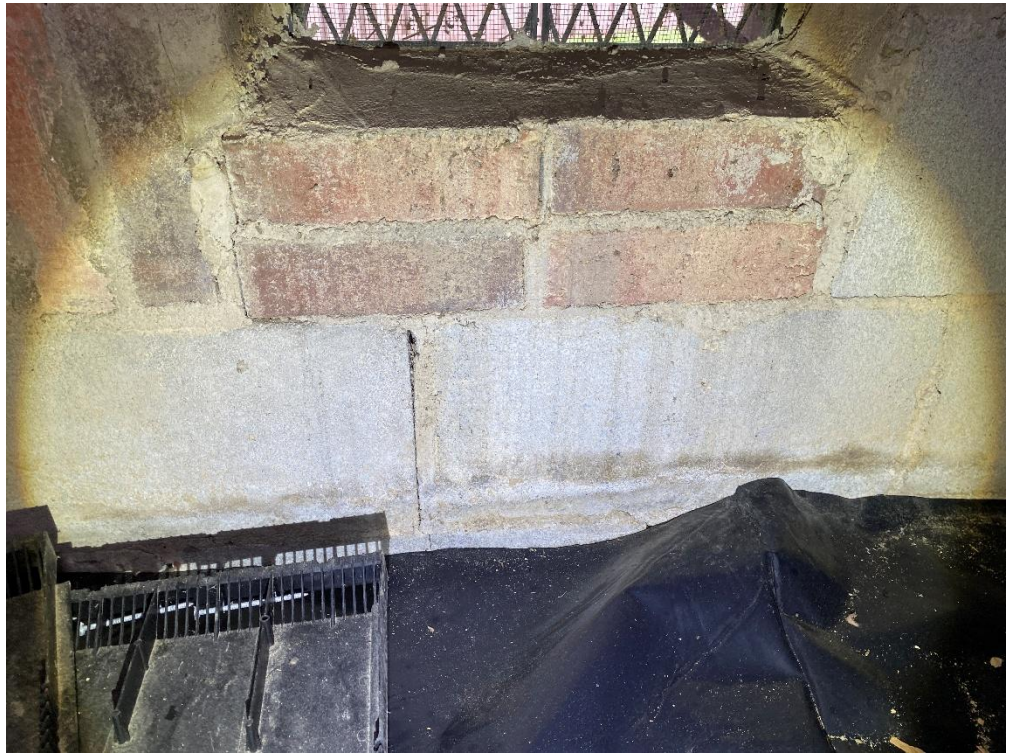
Photo No.  
7

6. Cracks/separations were observed in the perimeter foundation walls in the following locations:
  - a. A minor vertical crack (less than 1/8" wide) was observed in the rear foundation wall located approximately 21'-6" from the left foundation wall.

View of the minor vertical crack in the rear foundation wall located approximately 21'-6" from the left foundation wall.

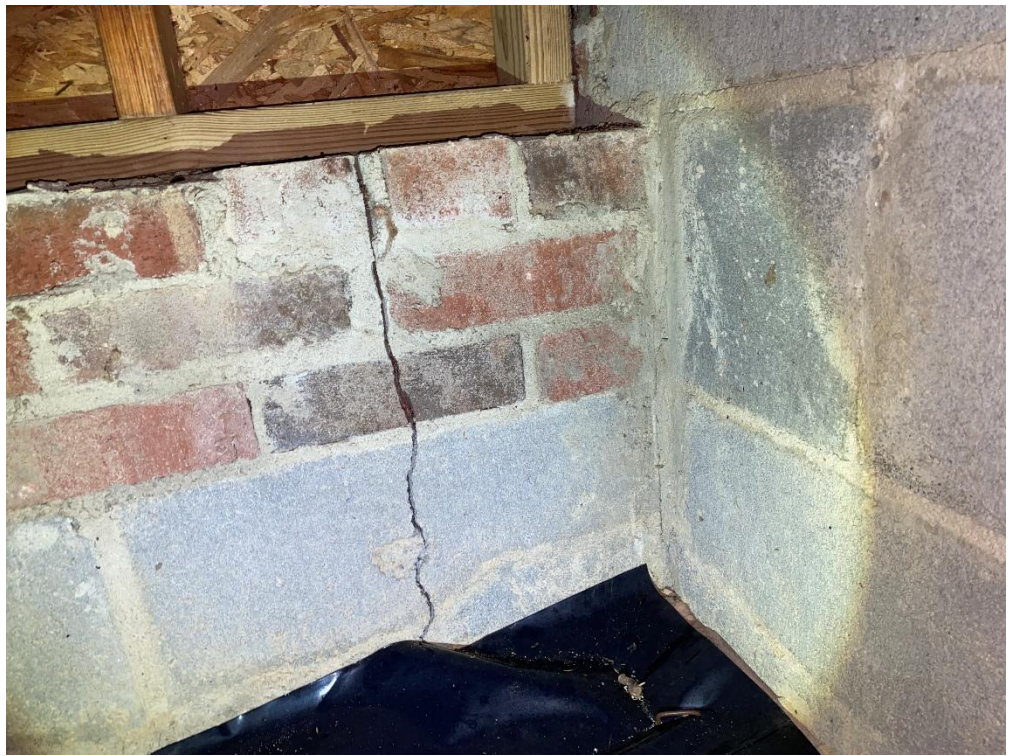
Photo No.  
8

- i. Note, this aligns with the crack in Observation #4c.
  - b. A vertical crack (up to 1/8" wide) was observed in the rear foundation wall located approximately 0'-8" from the right foundation wall.

View of the vertical crack in the rear foundation wall located approximately 0'-8" from the right foundation wall.

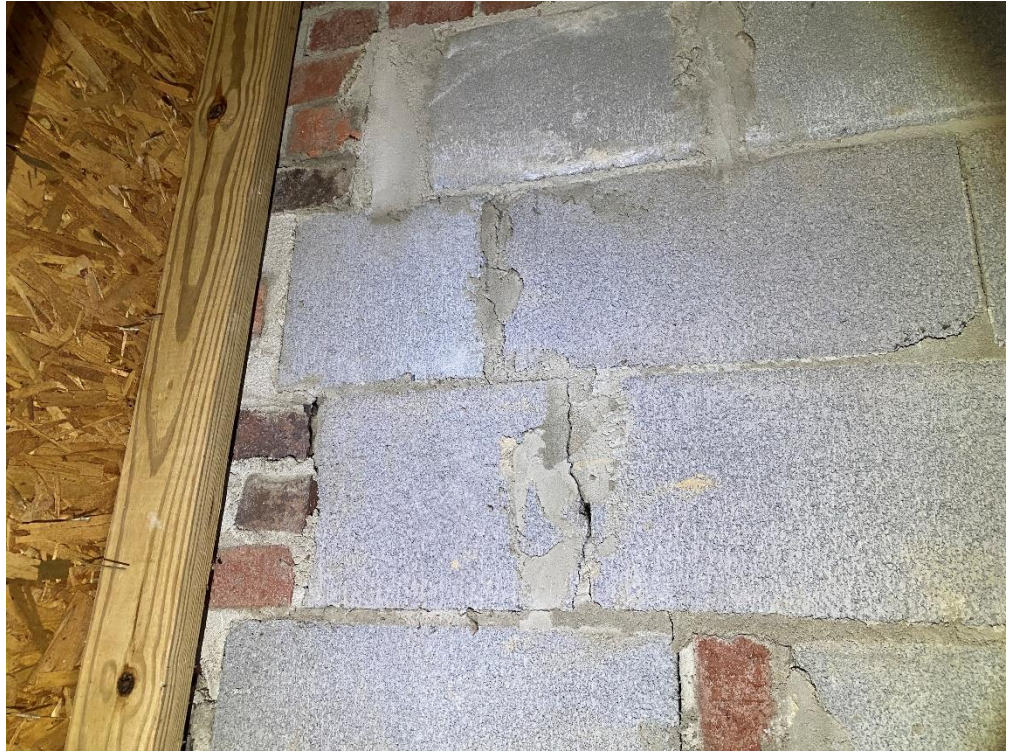
Photo No.  
9

- i. Note, this aligns with the crack in Observation #4b.
  - c. A minor vertical/stair-step crack (less than 1/8" wide) was observed in the right foundation wall located approximately 1'-6" from the rear foundation wall.

View of the minor vertical/stair-step crack in the right foundation wall located approximately 1'-6" from the rear foundation wall.

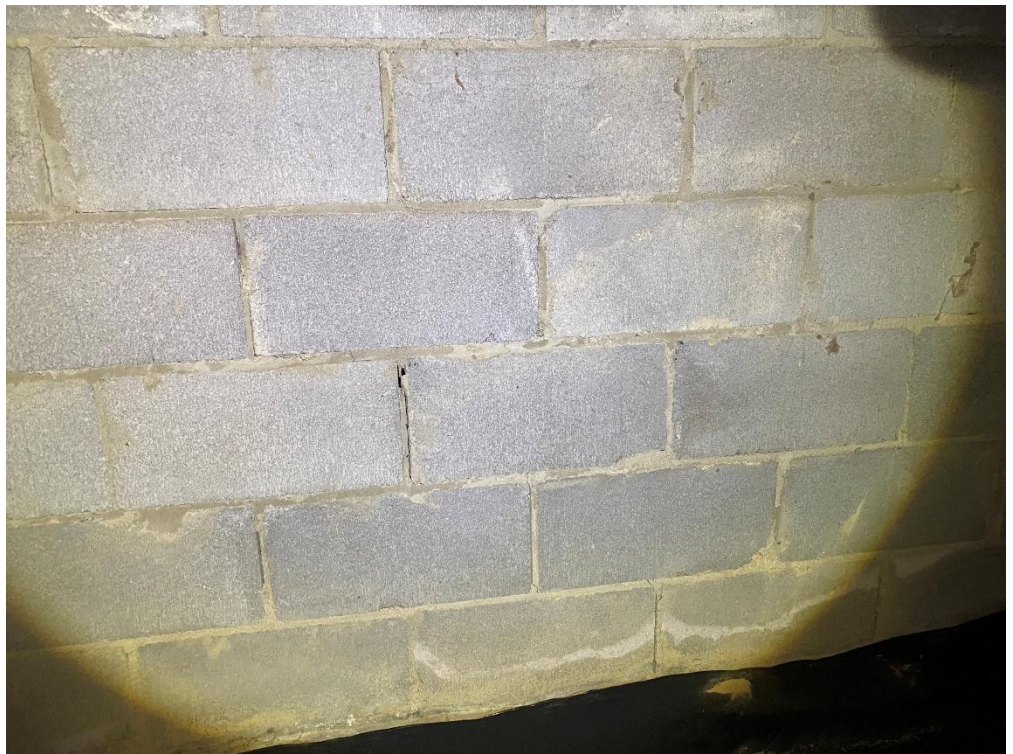
Photo No.  
10

- d. A minor stair-step crack (less than 1/8" wide) was observed in the right foundation wall located approximately 8'-6" from the rear foundation wall.

View of the minor stair-step crack in the right foundation wall located approximately 8'-6" from the rear foundation wall.

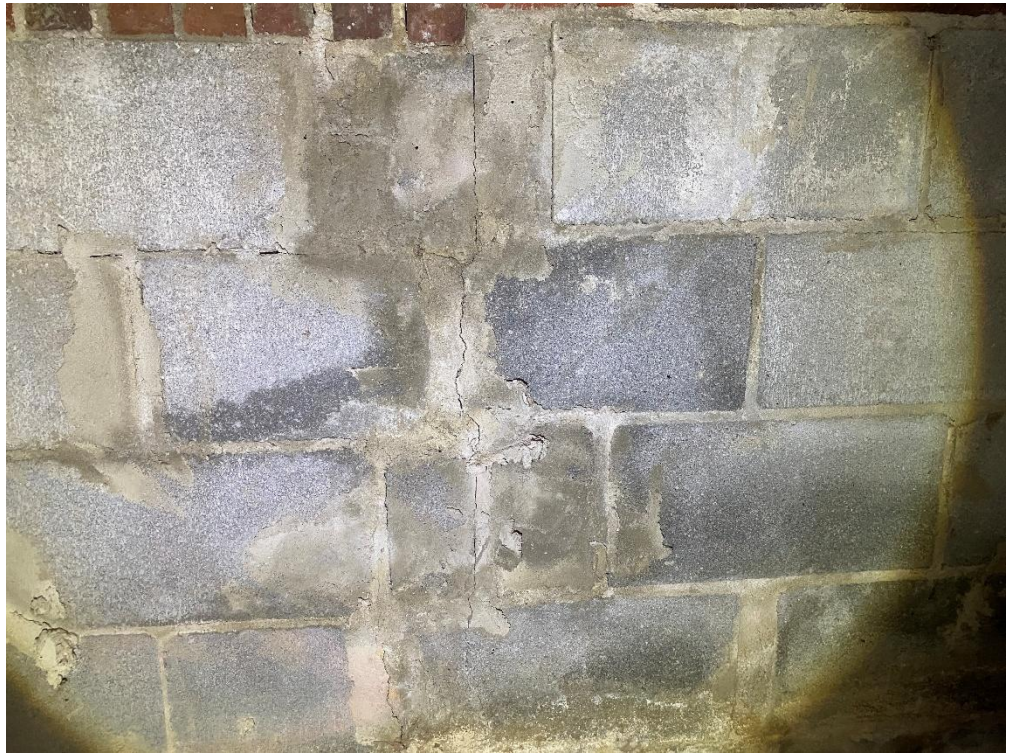
Photo No.  
11

- e. A minor vertical crack (less than 1/16" wide) was observed in the front foundation wall located approximately 9'-6" from the left foundation wall.

View of the minor vertical crack in the front foundation wall located approximately 9'-6" from the left foundation wall.
