GILES FLYTHE  
ENGINEERS

August 17, 2022

Re: Limited Structural Inspection  
2411 Fordcrest Drive  
Apex, NC

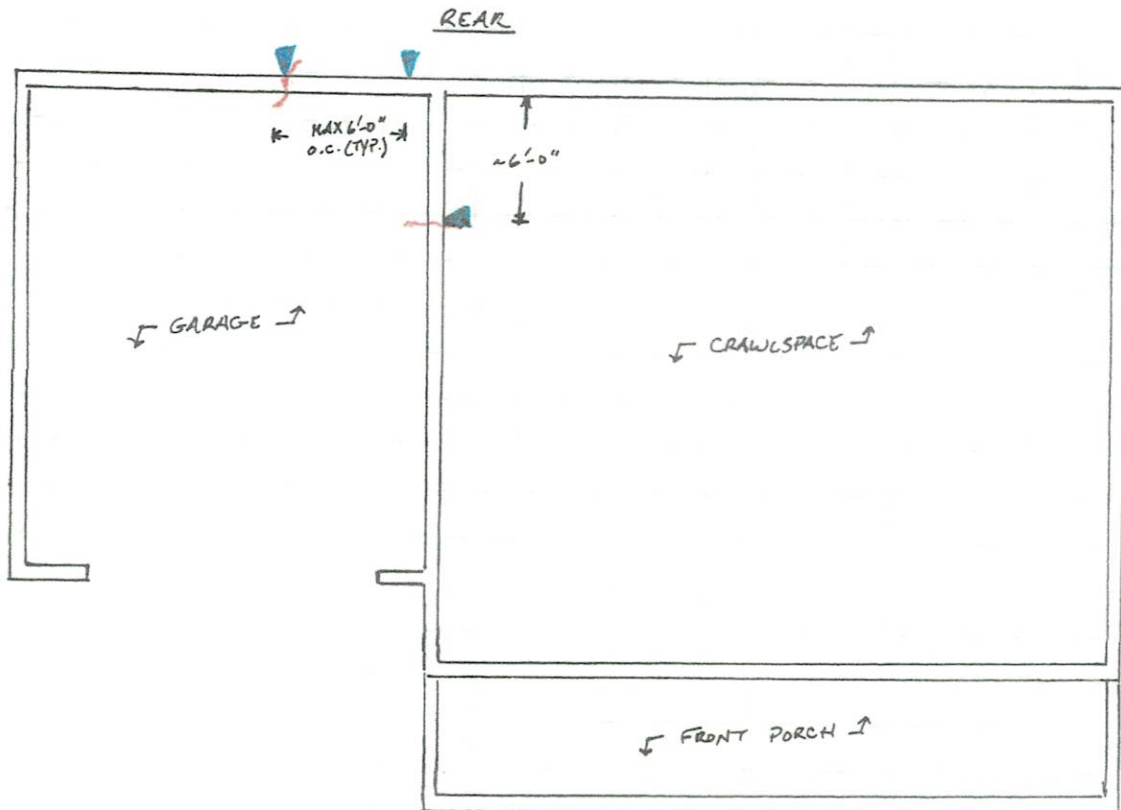
2411 FORDCREST DRIVE, APEX, NC (FOUNDATION STABILIZATION SKETCH)  
SCALE: NTS

- ▼ = NEW HELICAL STEEL PIER  
~ = FOUNDATION CRACK (TYP.)

1. We recommend hiring an experienced foundation contractor to install (3) new helical steel piers under the rear-right corner of the garage foundation (see attached sketch). Helical piers are to be installed up to 6'-0" O.C. and not be installed directly below doors and windows. Provide minimum of 15 kips allowable bearing capacity per helical pier. Installation of bridging (L6x6x3/8 steel angle or equivalent) between piers may be required depending on footing size. The contractor should also provide a lifetime transferable warranty on the stabilized portion of the foundation. Helical piers shall be installed concentrically below the subject bearing walls. This may require chipping/removal of section(s) of the concrete footing as needed such that the bearing bracket for each helical pier is not offset from the foundation wall. All steel angle bridging should be installed tight to the underside of the in-place concrete foundation and properly supported by the helical piers on each side.

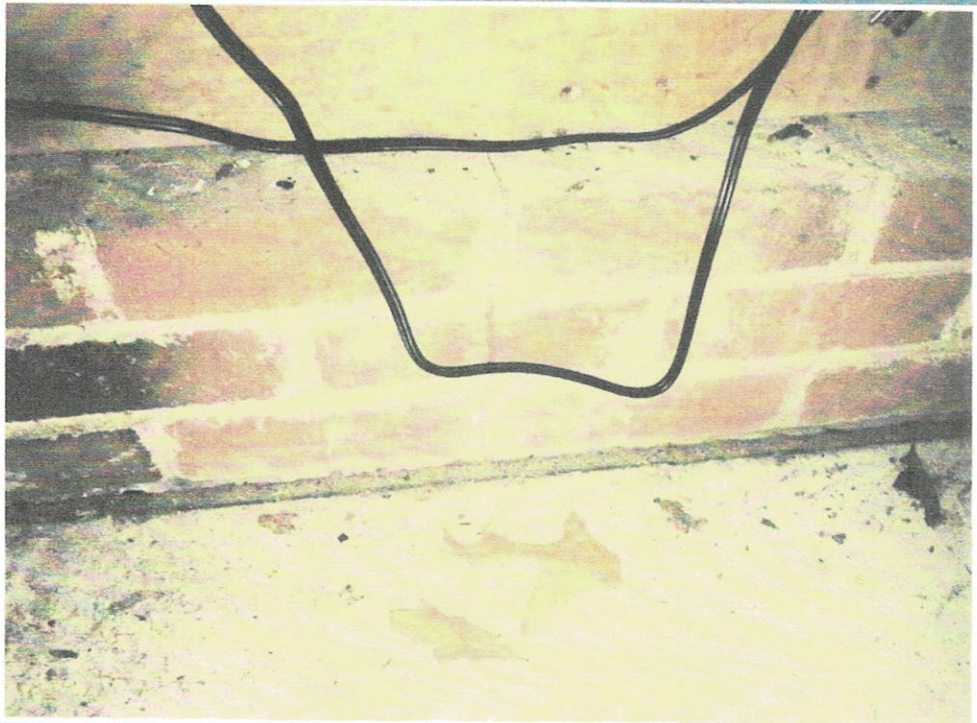
**Photo No.**  
**2**

1. A vertical crack (up to 1/8" wide) was noted in the rear perimeter foundation wall approximately 7'-0" from the right corner. This crack appears to have widened an additional 1/8" since our June 1, 2021 inspection.

Crack observed in the rear foundation wall of the garage.

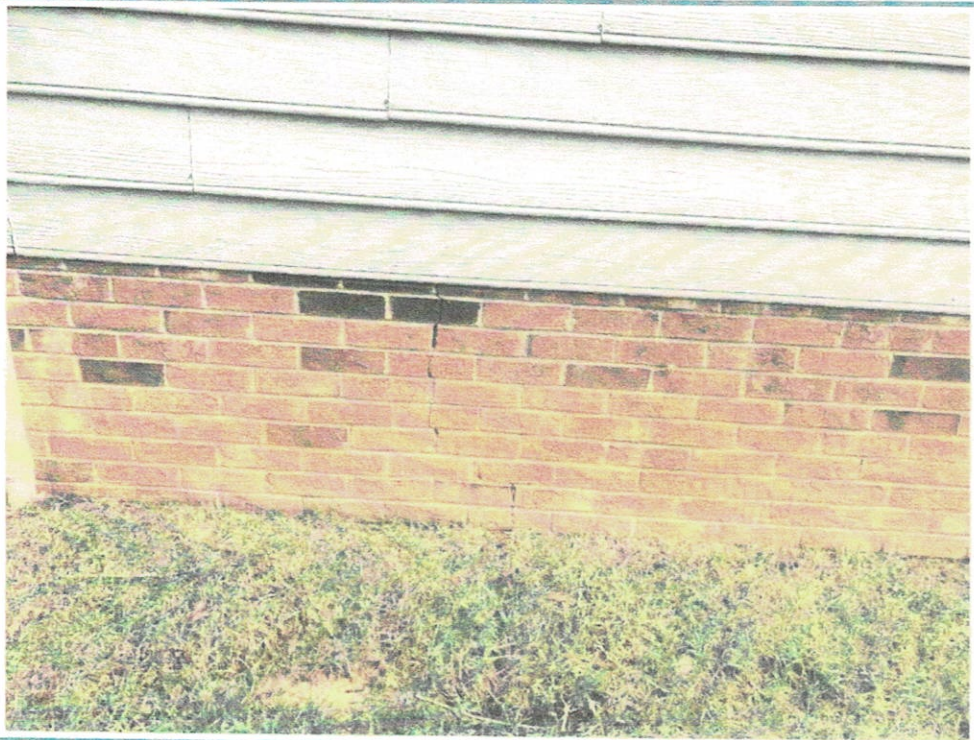
**Photo No.**  
**3**

Crack observed in the rear perimeter wall of the garage.

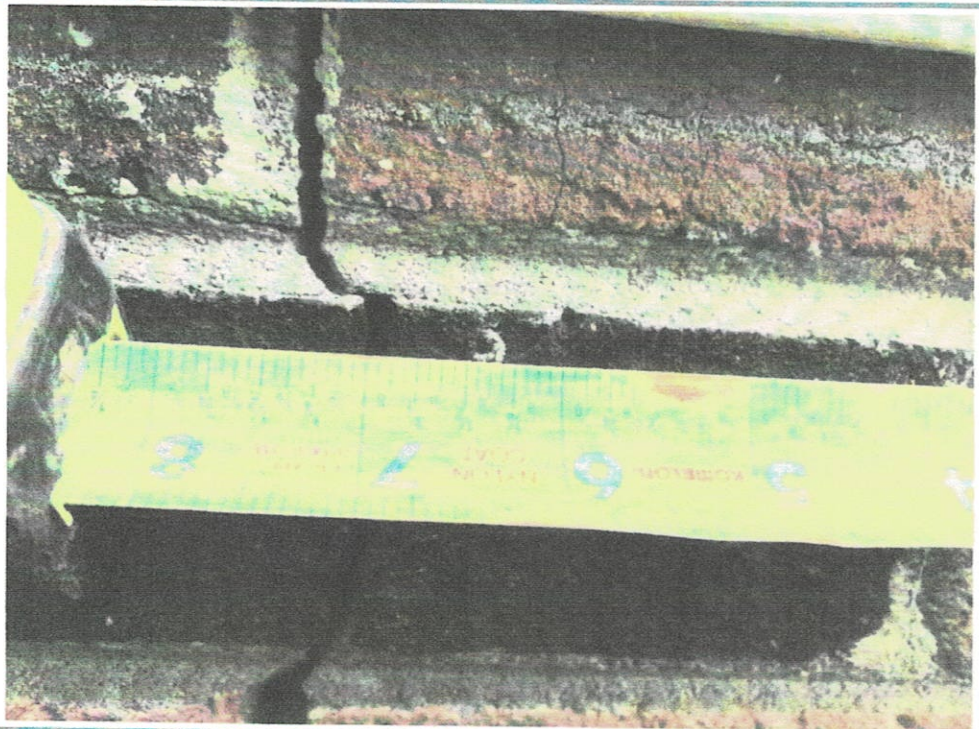
**Photo No.**  
**4**

Crack observed in the rear perimeter wall of the garage.

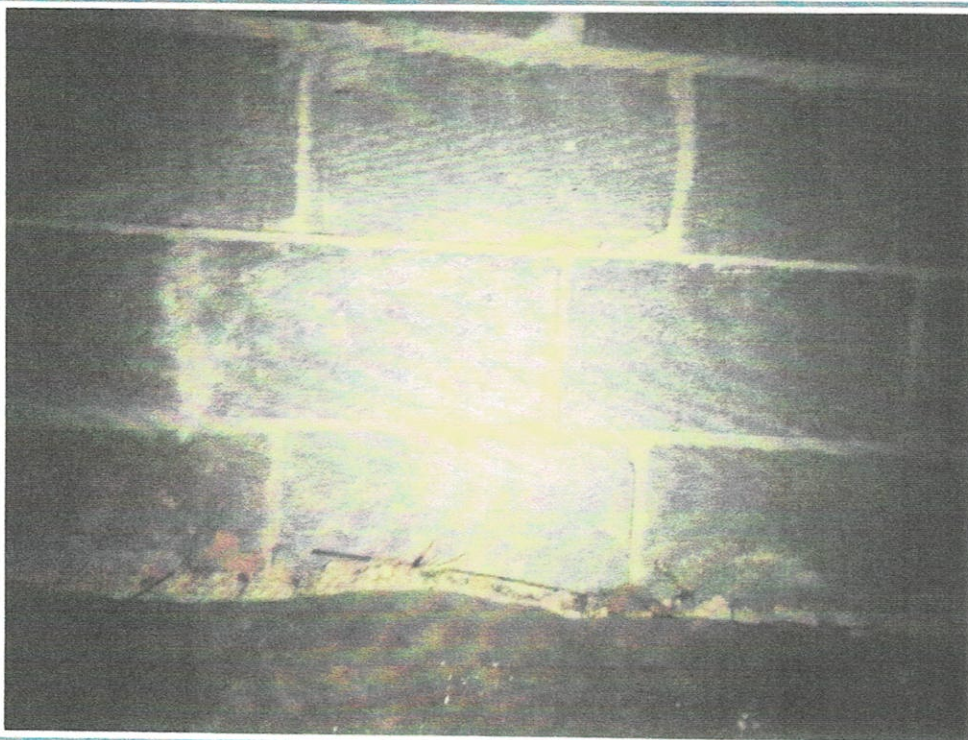
**Photo No.**  
**5**

Crack observed in the  
left foundation wall  
(adjoining garage).

2. Monitor the cracks in the brick veneer and foundation walls. If the cracks widen significantly (expand by an additional 1/8") or additional significant cracks (greater than 1/4" wide) propagate, then further evaluation by a structural engineer may be needed at that time.

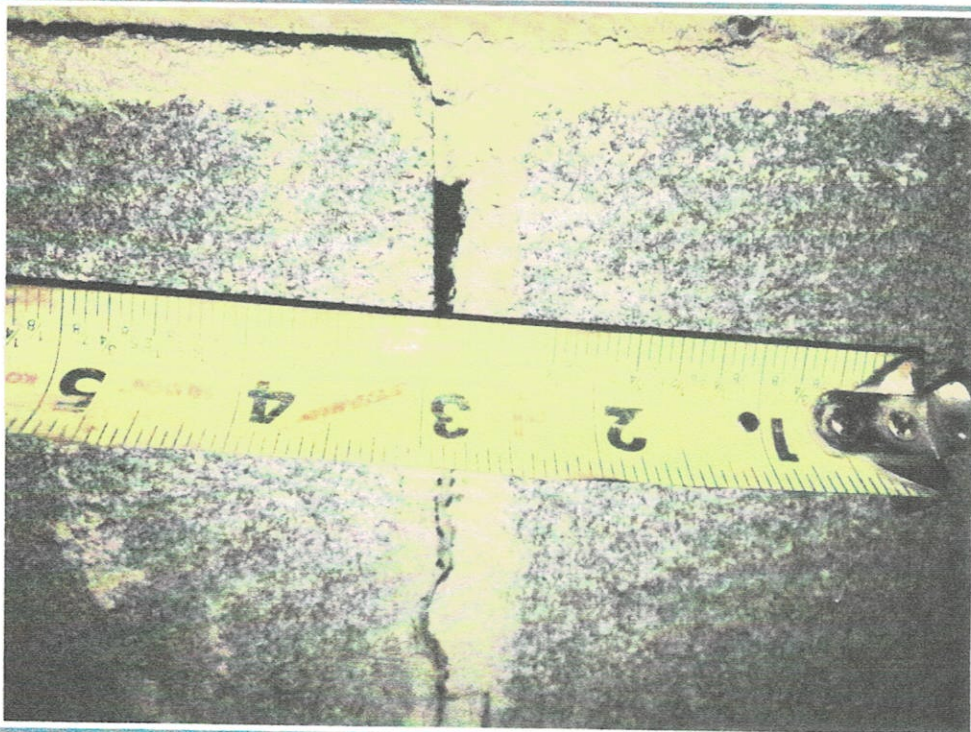
**Photo No.**  
**6**

Crack observed in the  
left foundation wall  
(adjoining garage).

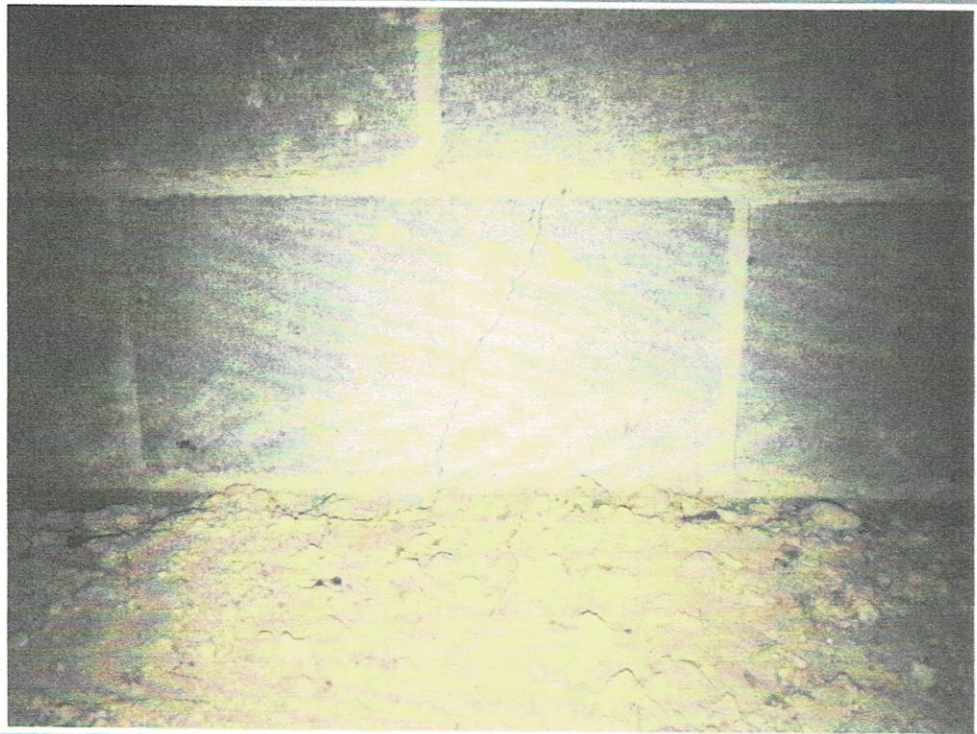
**Photo No.**  
**7**

Crack observed in the  
front foundation wall.

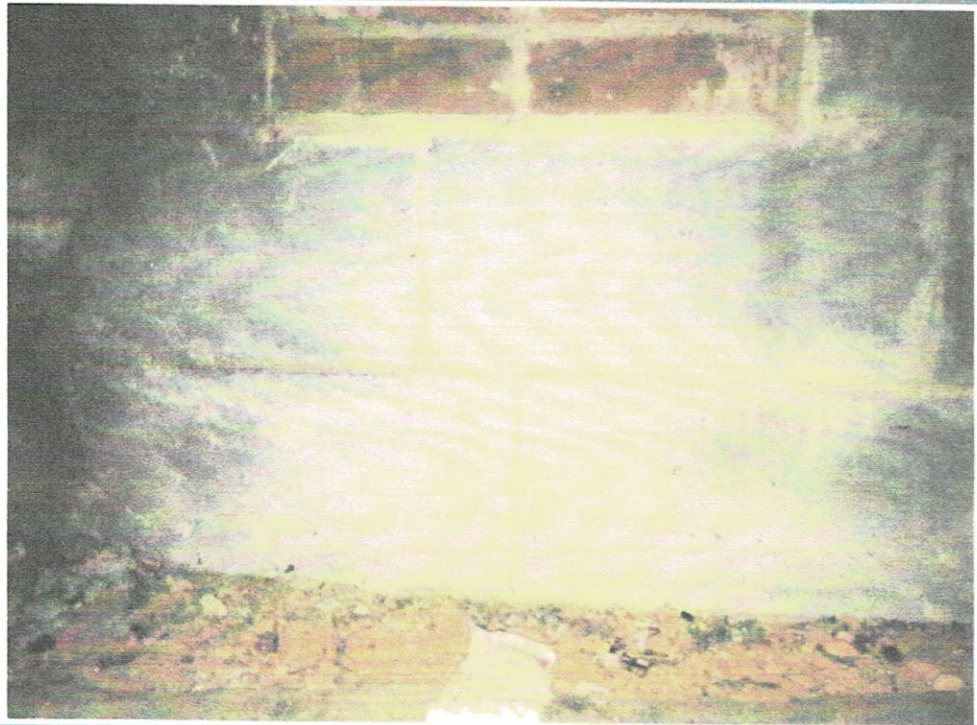
**Photo No.**  
**8**

Crack observed in the  
right foundation wall.

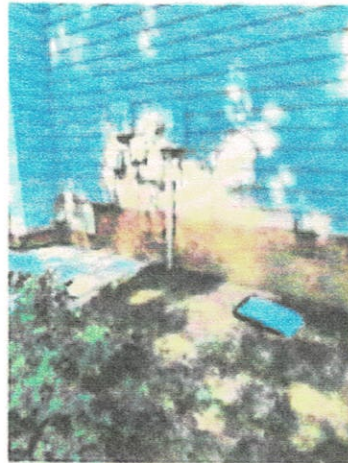
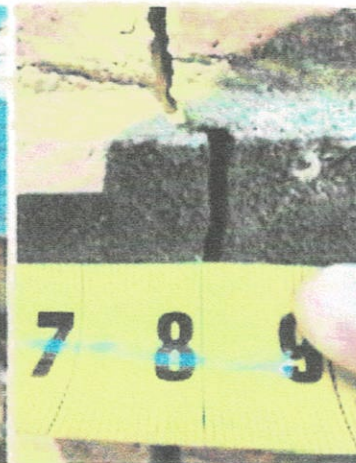
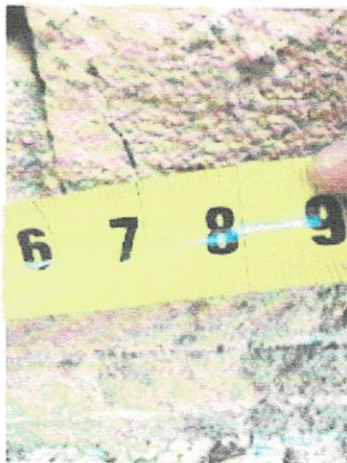
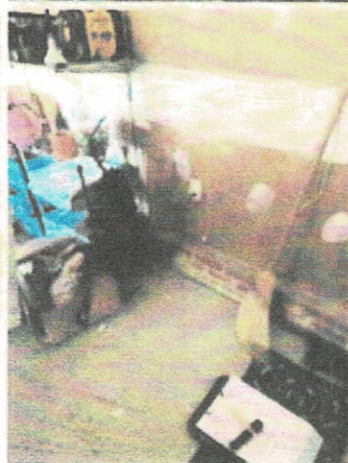
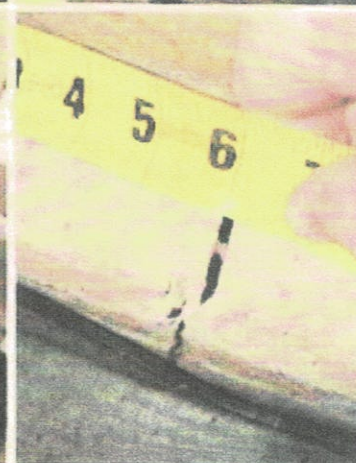
**FOUNDATION CRACKS - MINOR**

Minor cracking was observed at the foundation. This is a common occurrence and may result from the natural expansion and contraction of bearing soils, cementitious materials, or a combination of both. Recommend monitoring the cracks over time. If further movement or widening occurs, consult a structural engineer to assess the foundation's integrity and determine appropriate corrective measures.

Contact a qualified professional
