## Worldwide ERC Relocation Property Assessment

6/15/2026

Jianjun Wang  
1501 Paros Hill Ln  
Apex, NC 27502

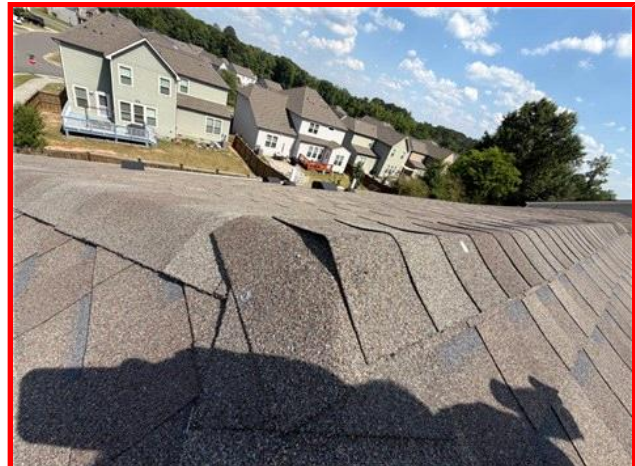
Lifted Ridge Cap Shingle

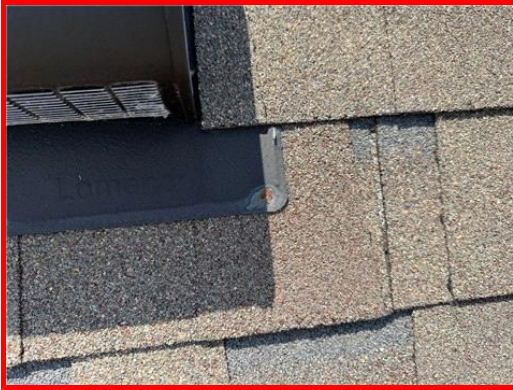
Exposed Nail Head at Dryer Vent

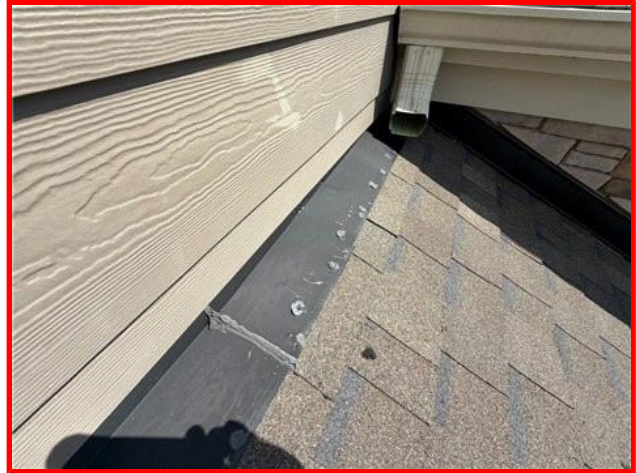
Exposed Nail Heads at Headwall Flashing

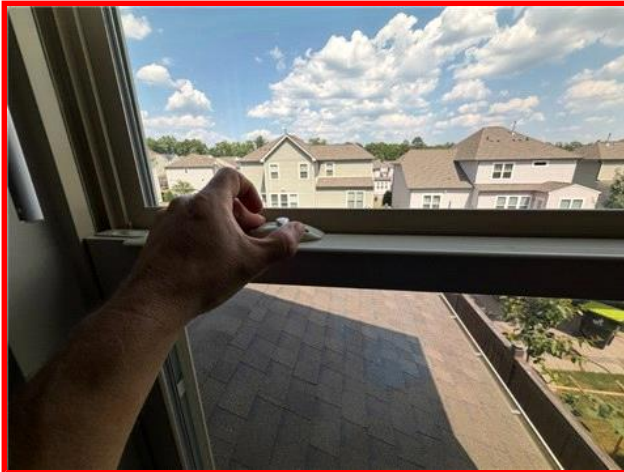
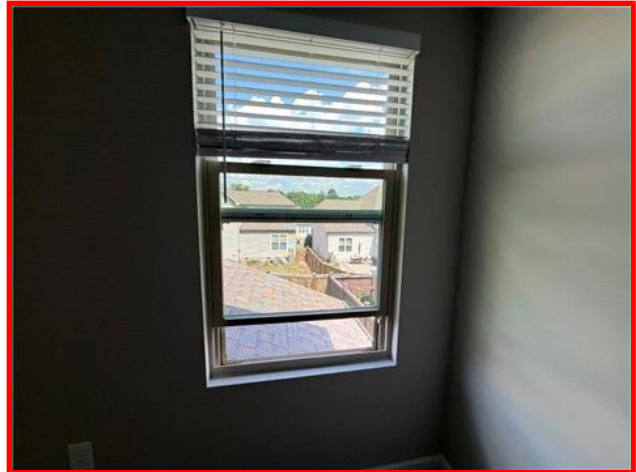
Windows Difficult to Lock / Secure

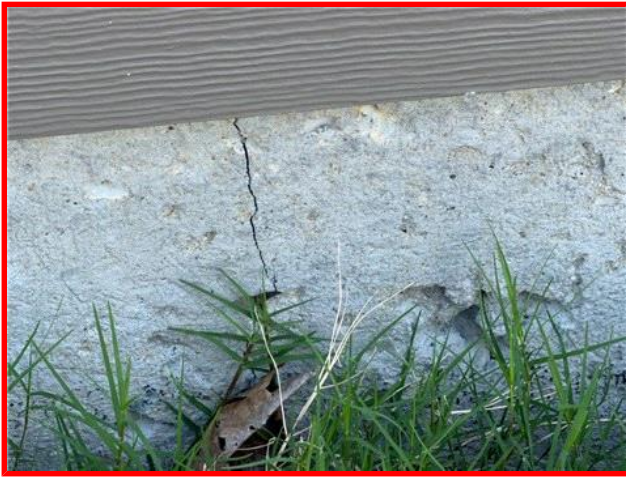
Crack in Left Foundation Wall

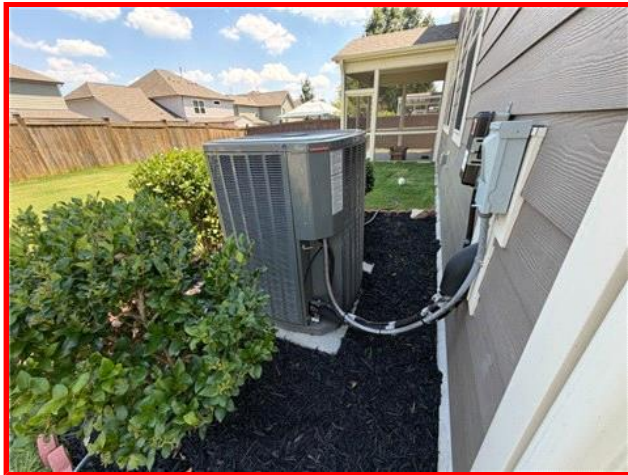
A/C Unit -Temp Diff too Low

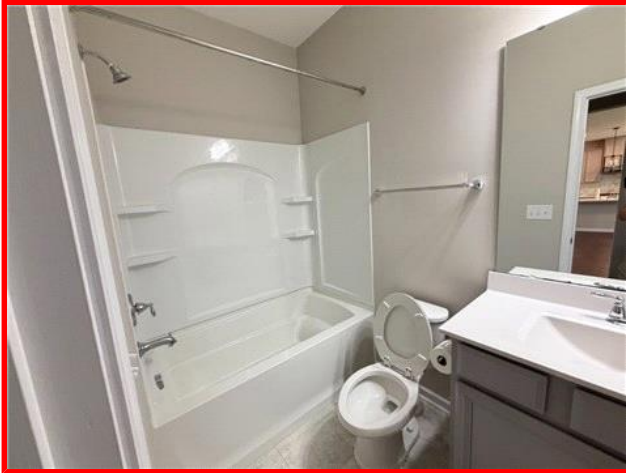
Toilet in Downstairs Bathroom Loose at Base
