403 Cranborne Lane

Pre Listing Inspection Report

## Home Inspection Report

Inspection No. 341641-29

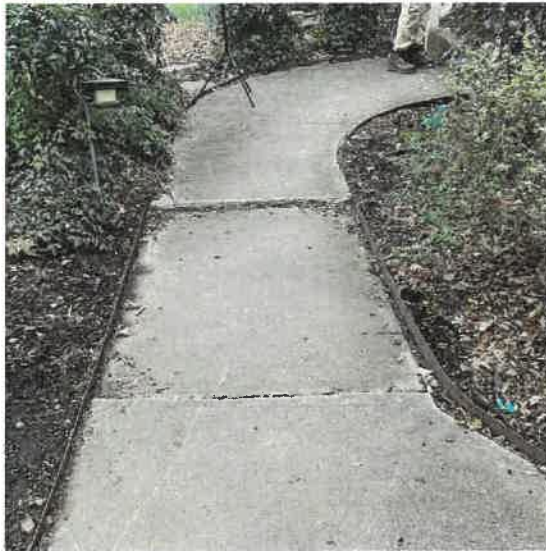
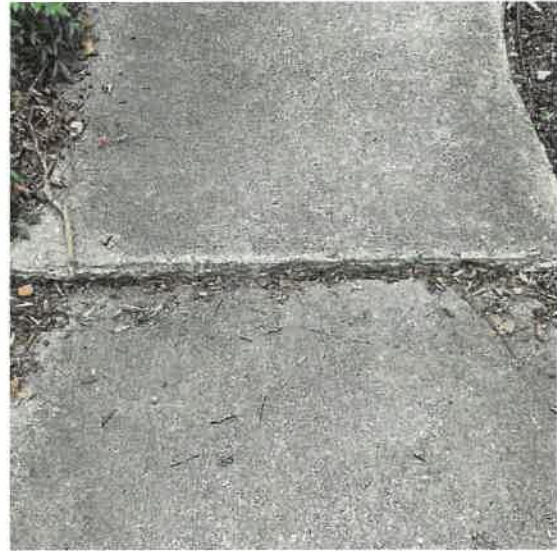
2.2.1 Walkway is heaving, probably due to soil movement. Due to the uneven surface, this can be a trip hazard. Further uneven settlement can also occur. Have a licensed contractor repair as required to reduce hazard and damages. (Exterior Front)

2.2 Uneven and cracked sidewalk repaired by Tar Heel Basement System (Receipt 0010)

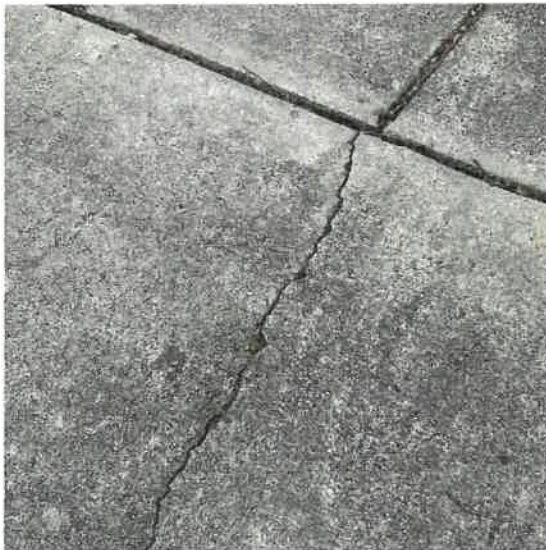
2.3.1 Cracks were visible in the driveway. Cracks allow water to penetrate under the slab and cause movement. Recommend having a licensed contractor repair cracks to reduce moisture intrusion and further damages. (Exterior Front)

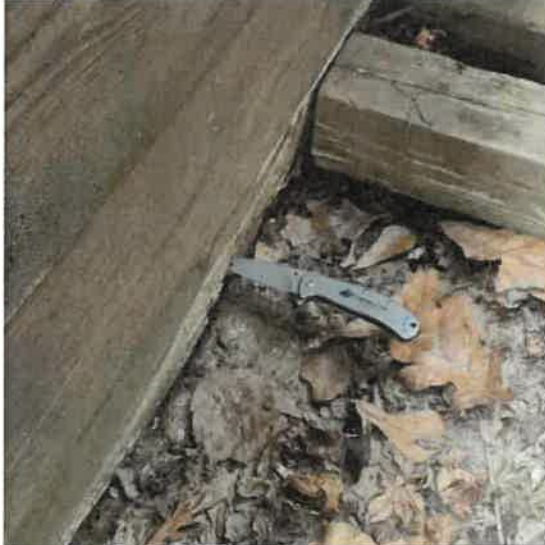
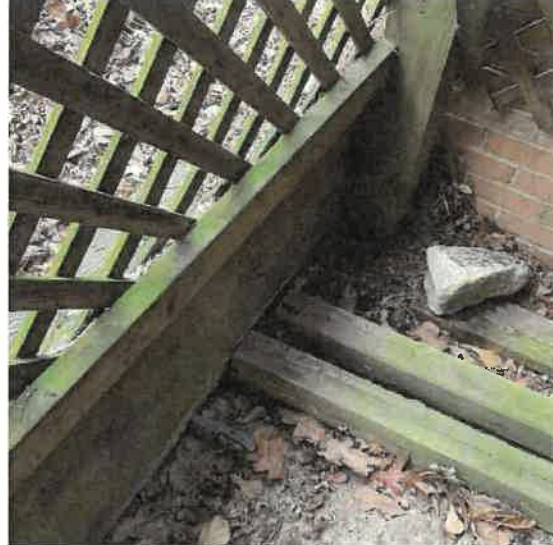
2.5.1 The retaining wall is rotted in areas. Recommend repairing rotted areas or replace as needed to prevent further deterioration of materials. **(Exterior Back)**

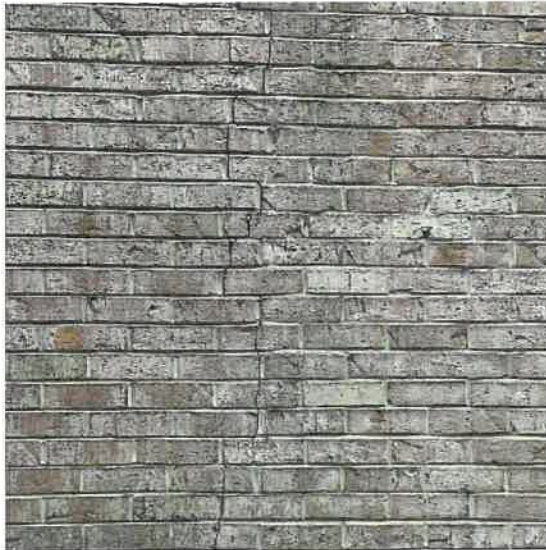
**3.2.1 Foundation crack was visible on the foundation wall. Cracks indicate settlement and can also result in water intrusion into the structure. A structural engineer should evaluate the crack to determine the significance of the crack and if repair or monitoring is needed. Have a structural engineer evaluate and repair as recommended to reduce structural damages. (Exterior Left)**

3.2 Foundation crack repaired by Triangle Reconstruction\* (Receipt R0011) -see Structural Engineer Report (Receipt R0008)

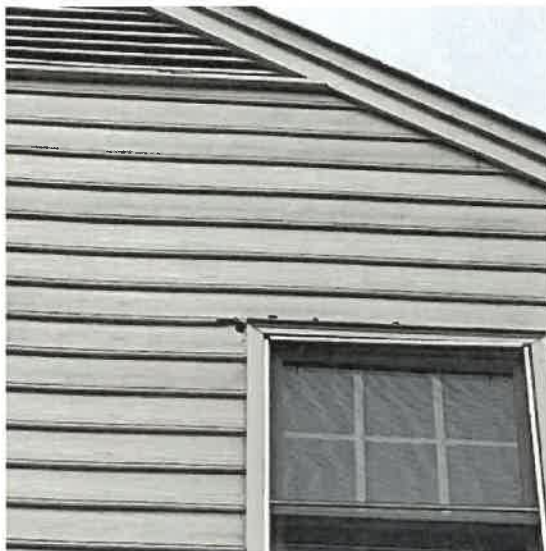
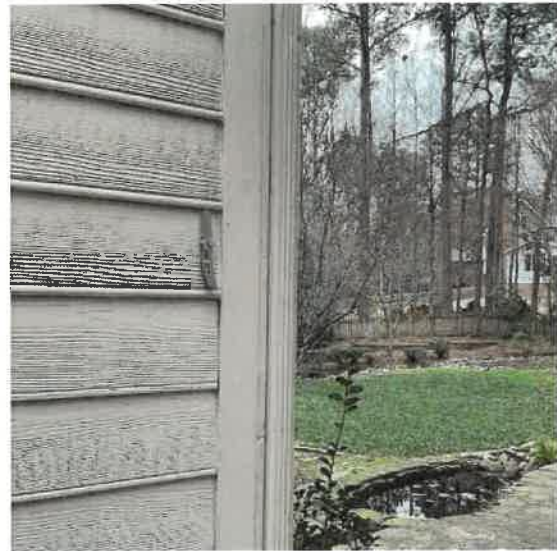
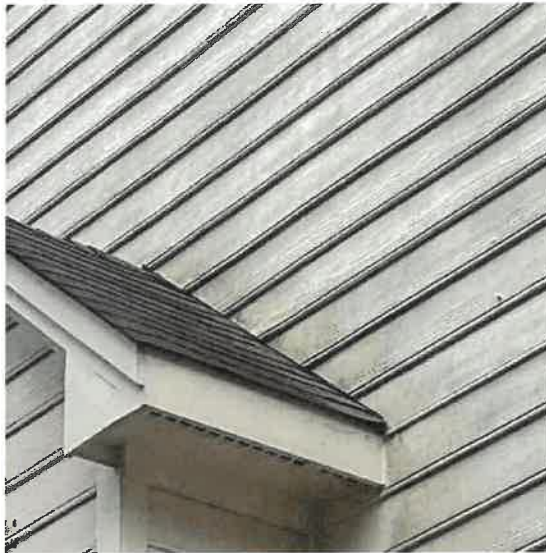
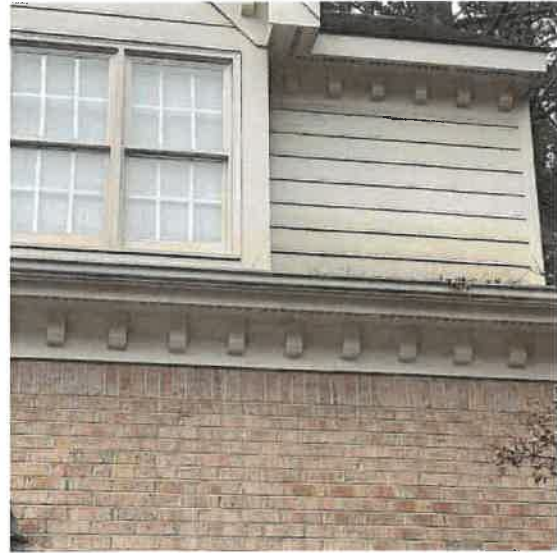
**3.3.1 Siding damage/rot noted on several areas of the home, including, but not limited to the areas listed below. Damaged/rotted siding can allow moisture to penetrate into the wall sheathing and cause wood rot and other moisture related damages. Have a licensed contractor repair/replace siding to reduce moisture intrusion and damages and do an exhaustive inspection of all siding and trim. Areas noted, front right corner, rear right side of garage, above garage roof around windows, left side of house near upper window. (Exterior Left)**

3.3 Several areas of siding damage and deterioration repaired by Superior Powerwashing and Home Maintenance (Receipt 0009)

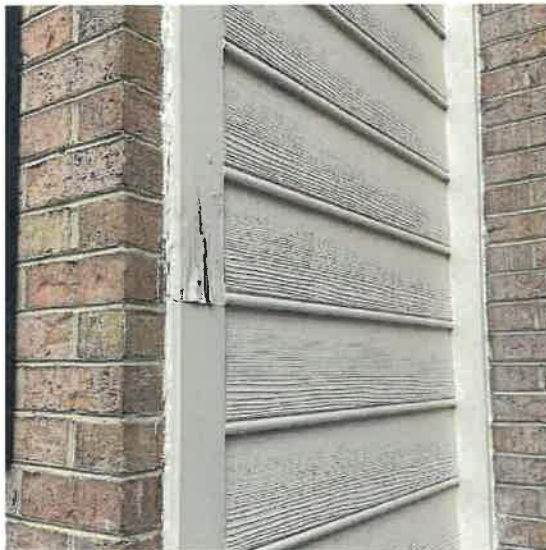
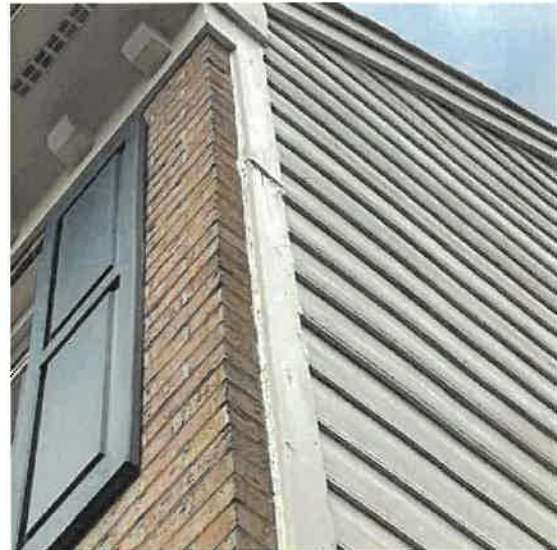
3.5.1 Rot was found in wood trim. Repair trim to prevent further damage. (Exterior Front)

3.6 Wood trim deterioration repaired by Superior Powerwashing and Home Maintenance (Receipt 0009)

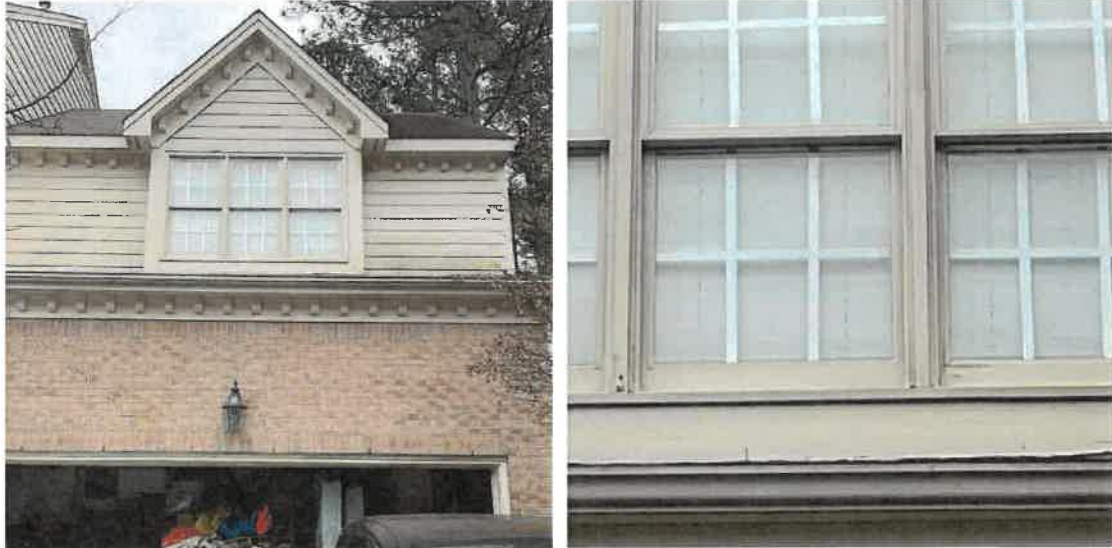
**3.6.1 Moisture damage noted in the window/jamb/trim/sill of the exterior window. Moisture damage can result in future water penetration, wood rot, and unseen damages within the jamb and walls. Have a licensed contractor repair as needed, replacing all damaged materials to reduce moisture intrusion and further damage. (Exterior Front)**

3.6 Moisture Damage around exterior windows repaired by Superior Powerwashing and Home Maintenance (Receipt 0009)

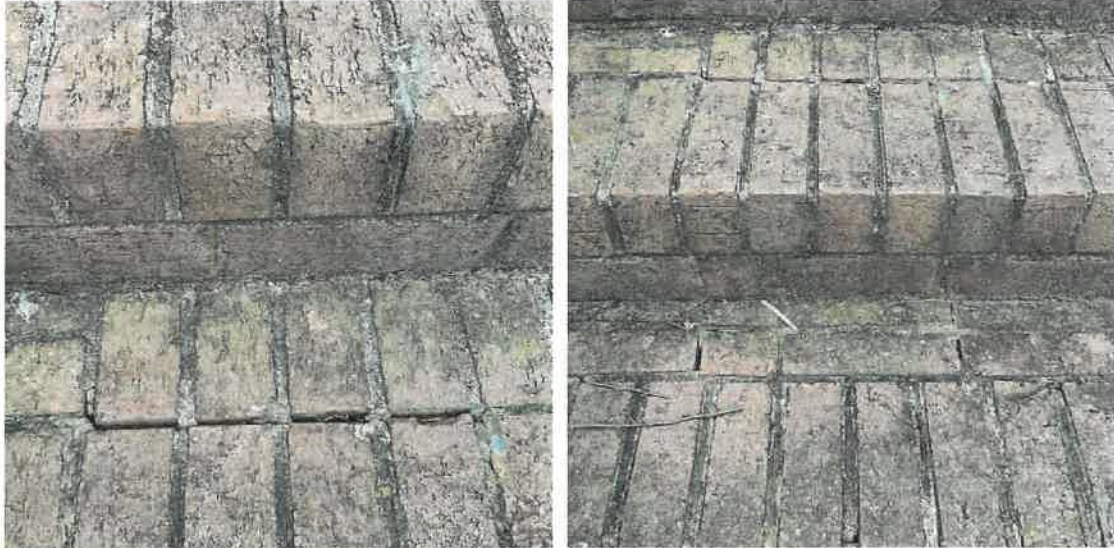
**3.8.1 Gaps were visible in the brick porch steps. This can allow water to penetrate which can cause the bricks to come loose once the moisture freezes/thaws. Have a licensed contractor repoint the missing mortar joints in the front porch steps to reduce moisture intrusion, resulting in the future damages from freeze/thaw conditions. (Exterior Front)**

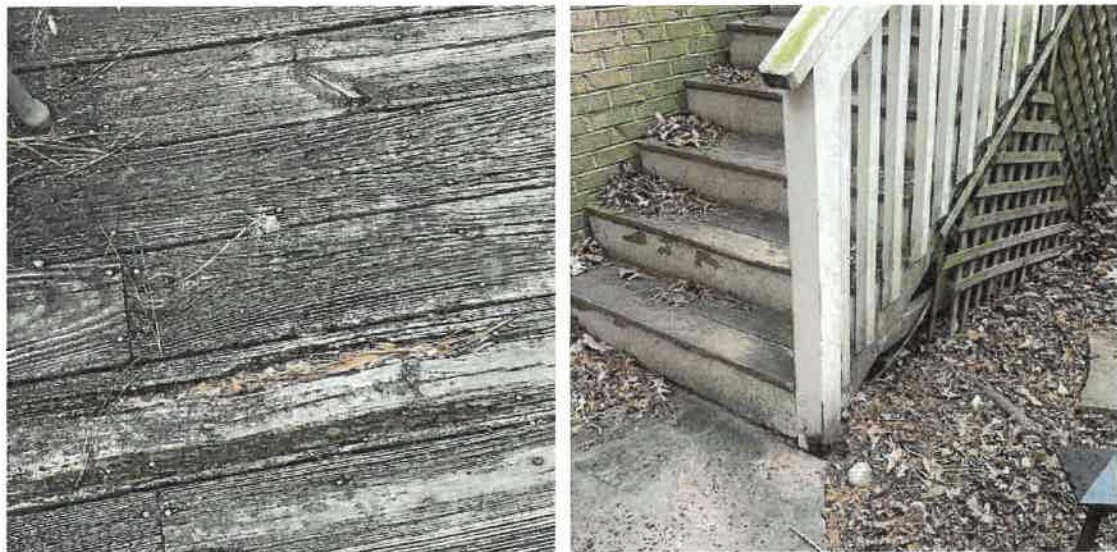
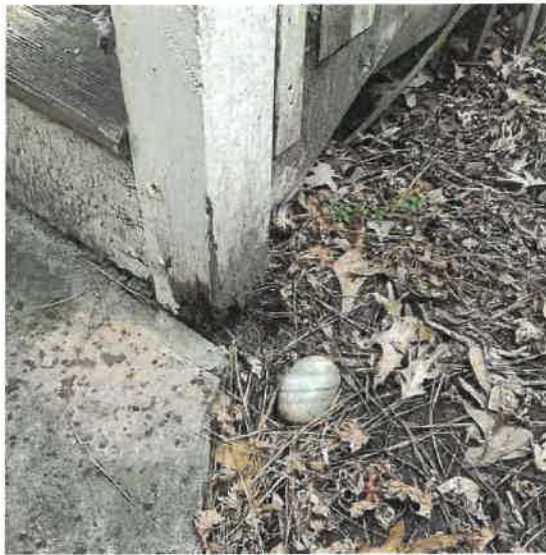
**3.9.1 Wood rot was visible at the rear deck railing. Further moisture damage can occur making the railing less stable. Have a licensed contractor replace all damaged materials to reduce further damages to the railing.**

**Wood rot was identified in many areas of the deck. General repairs are required. (Exterior Back)**

3.9 Wood deck deterioration repaired by Superior Powerwashing and Home Maintenance (Receipt 0009)

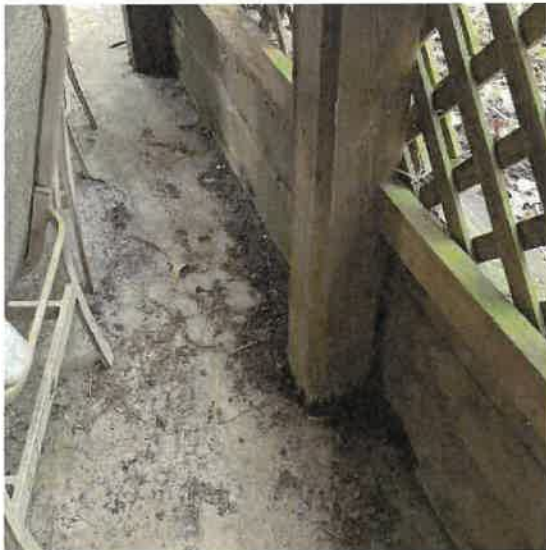
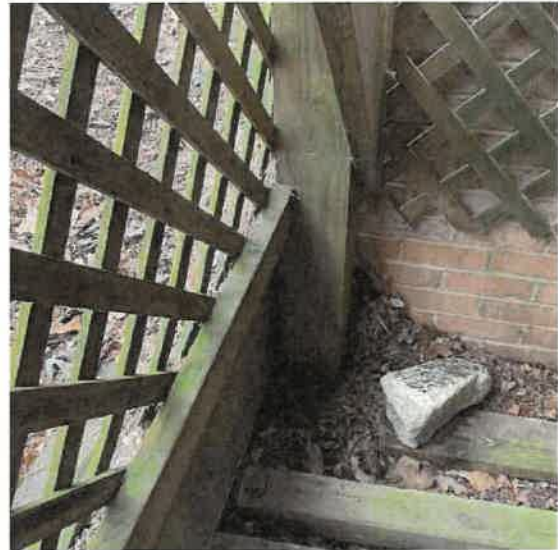
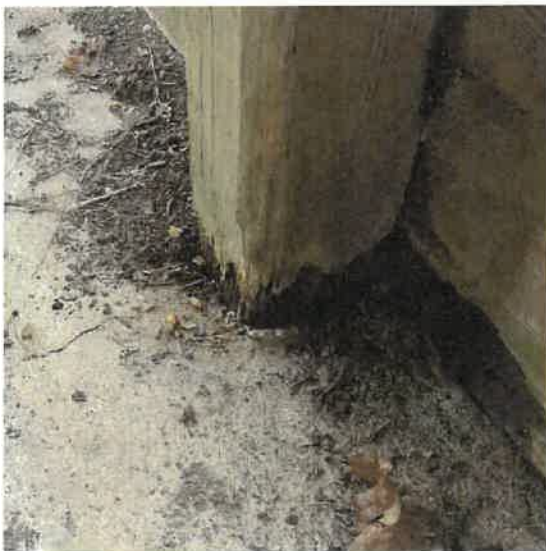
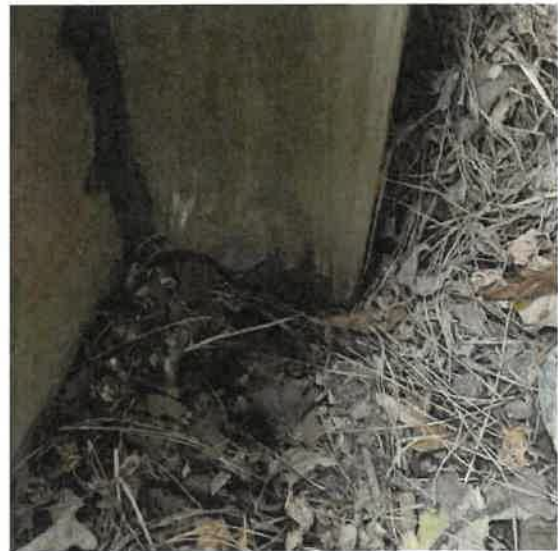
**3.9.2 The deck post show signs of rot/deterioration at the bottoms where they come in contact with the concrete slab. Continued deterioration could cause the deck to become unsafe. Recommend having a licensed and insured structural engineer evaluate for necessary repairs.**

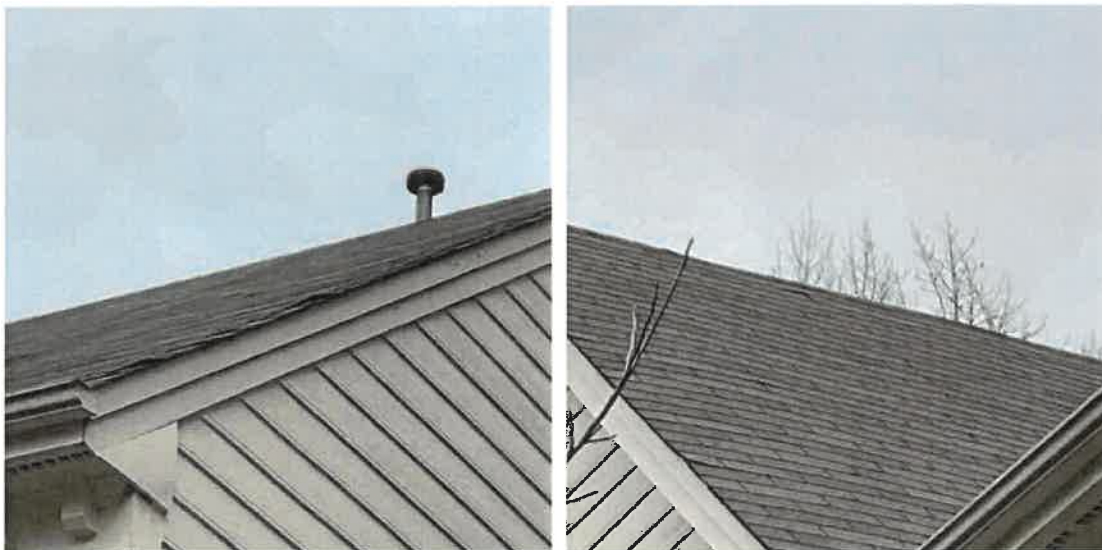
4.3.1 Some of the sloped roofing materials are damaged (cracking, splitting, missing, curling, lifting, etc.) Repair or replace as needed to prevent imminent water-related damage to structure and interior finishes. (Exterior Front)

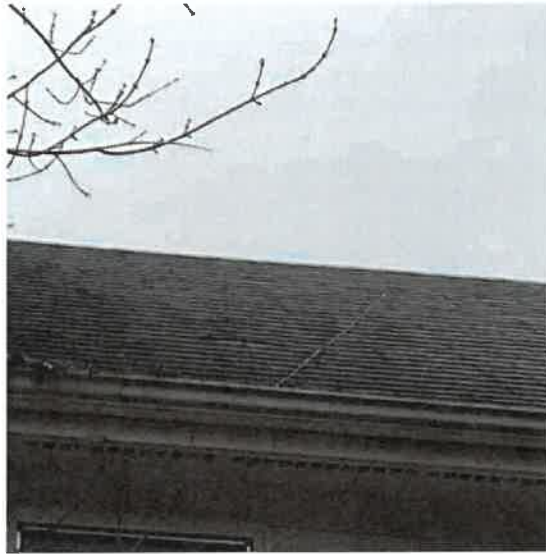
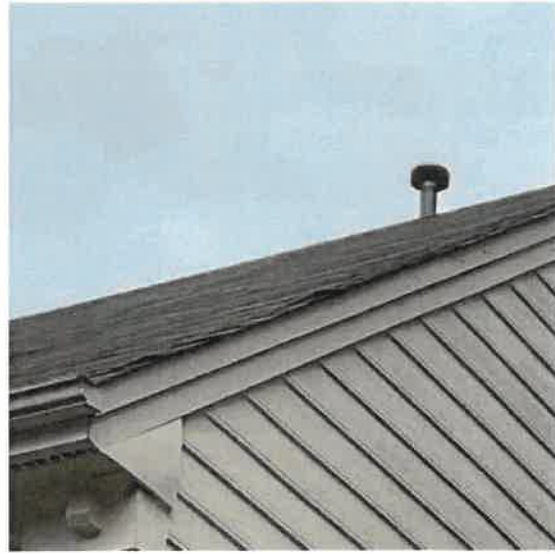
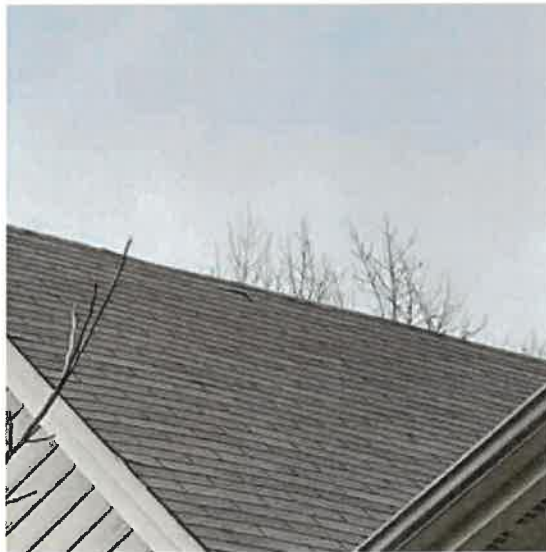
**4.3.2 Some of the sloped roofing materials are damaged (curling, lifting, etc.) Recommend having a licensed and insured roofing contractor repair or replace as needed to prevent imminent water-related damage to structure and interior finishes. (Exterior Back)**

4.3 Damaged roof materials repaired by Superior Powerwashing and Home Maintenance (Receipt 0009)

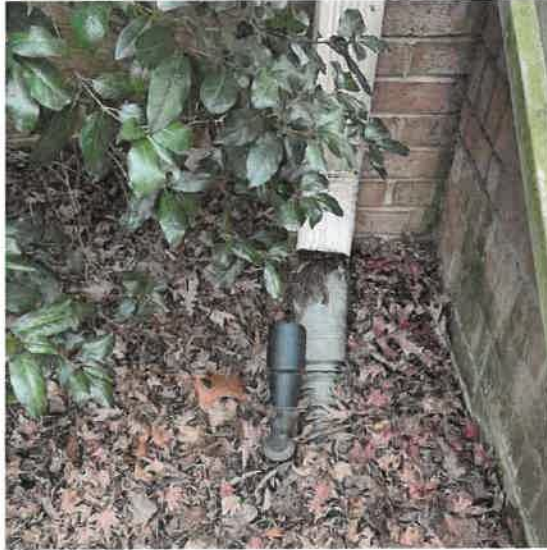
**4.4.1** Downspouts lead to underground drainage system. While this is allowed in this area, the condition of the underground portion cannot be assessed and is prone to blockage. It is recommended that it be modified to drain above ground, away from the foundation to ensure continued adequate drainage. **(Exterior Front)**

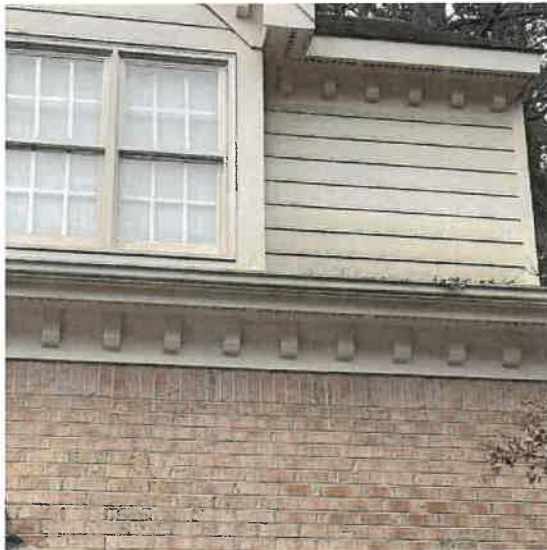
**4.4.2** Gutter slope appears insufficient to promote proper flow towards downspouts. Debris buildup can occur without proper slope adding more weight to the gutters. Remedy by having a licensed contractor re-install gutters with adequate slope. **(Exterior Front)**

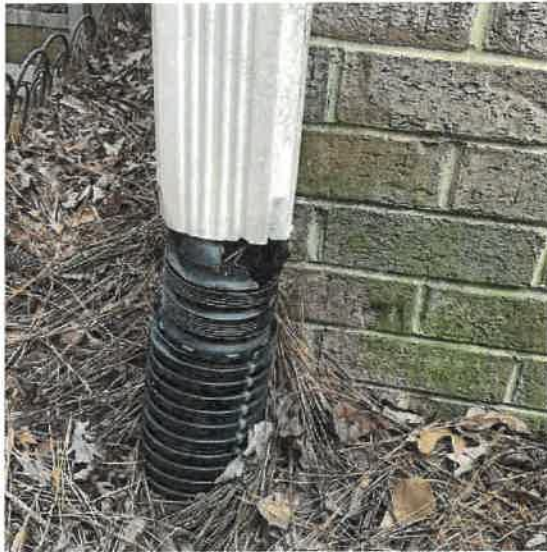
**4.4.3** Downspouts lead to underground drainage system. While this is allowed in this area, the condition of the underground portion cannot be assessed and is prone to blockage. It is recommended that it be modified to drain above ground, away from the foundation to ensure continued adequate drainage. **(Exterior Back)**

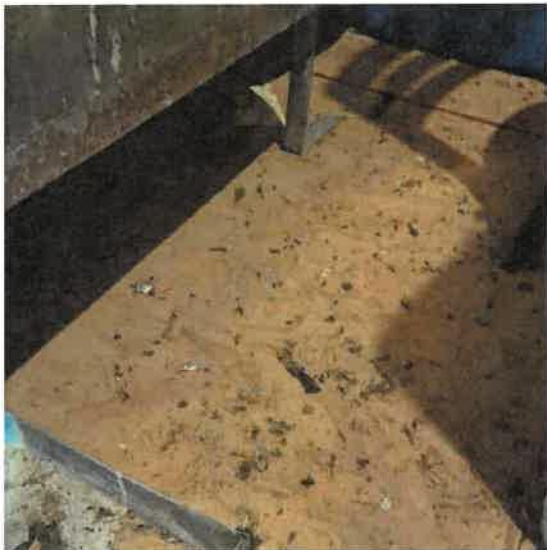
**5.2.1** Mouse droppings were visible throughout the attic indicating mouse intrusion. Mouse droppings can be a health hazard to the homeowner and any subcontractors servicing the home. Have a licensed contractor remove all droppings and replace all contaminated materials to reduce health hazard.

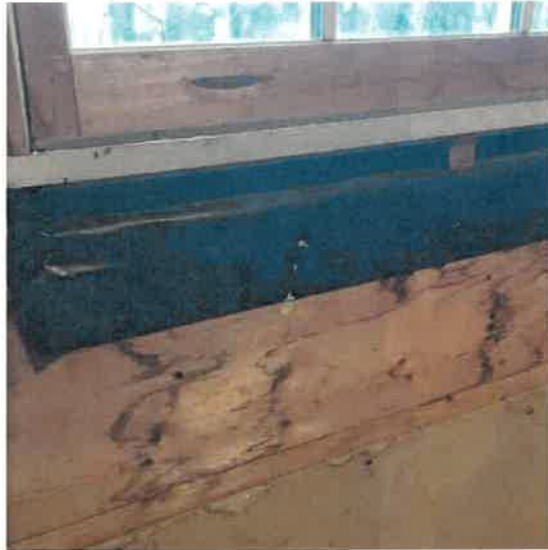
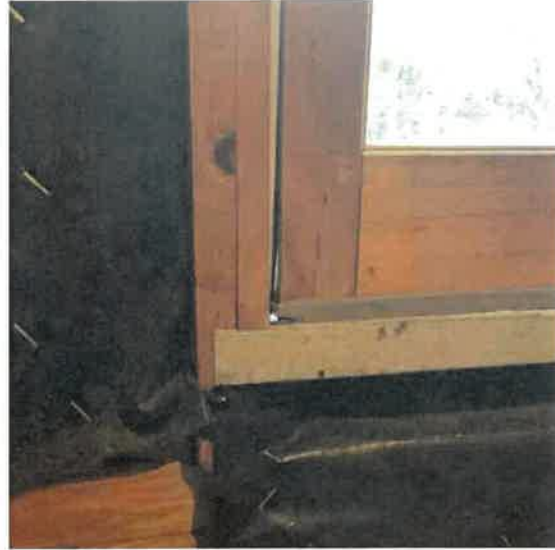
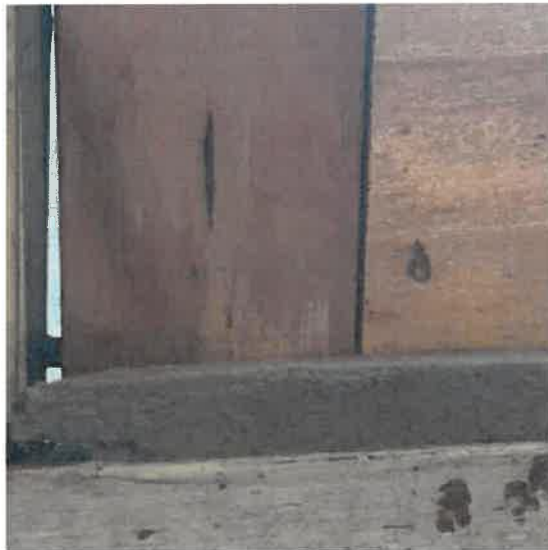
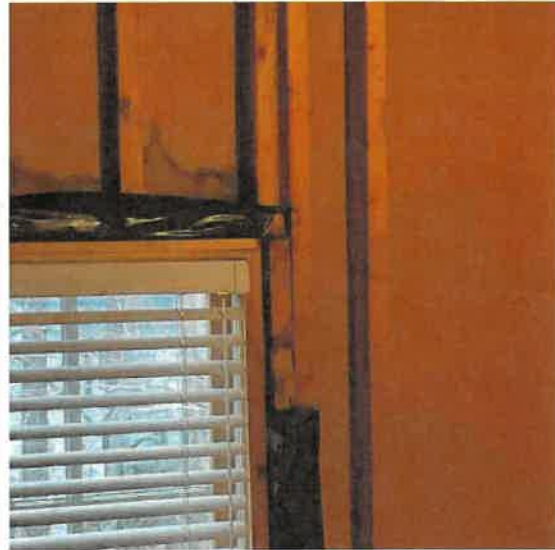
**5.3.1 Window in the attic has openings at the corners, allowing moisture into the attic space. The outside band has seen patterns of moisture and drying. Recommend having an engineer review the outside band for structural stability. Recommend sealing the gaps around the windows to prevent further moisture damage.**

5.3 Window inspected by B.A. McCurry Engineering-No structural deficiencies noted -see Structural Engineer Report (Receipt R0008)

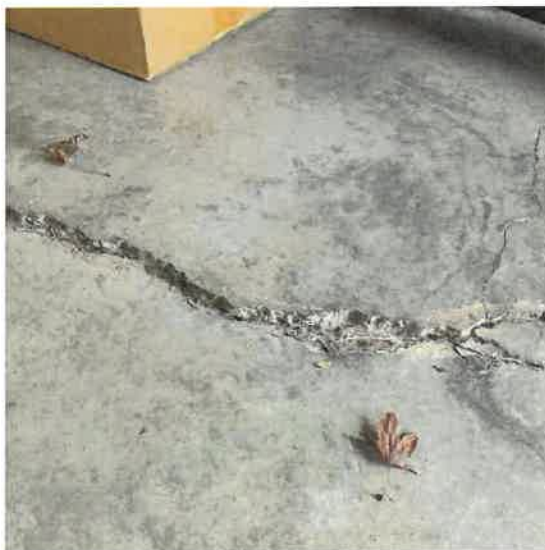
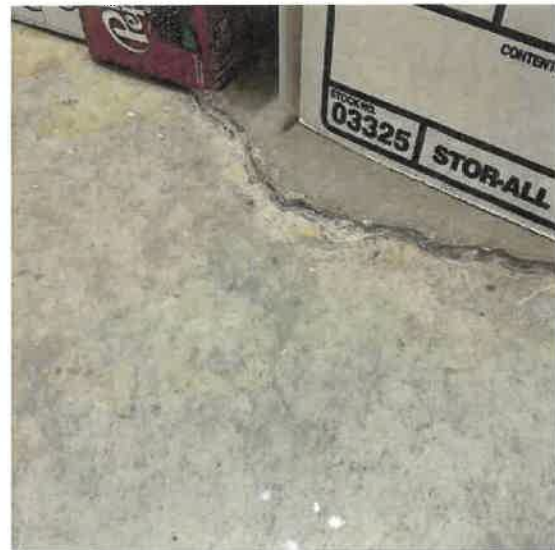
6.7.2 Noted excessive cracking in the garage slab. These cracks are indicative of settlement or improper compaction. Have a concrete specialist evaluate and repair/replace as needed. (Garage)

6.7 Cracking in garage slab repaired by Triangle Reconstruction (Receipt R0012)

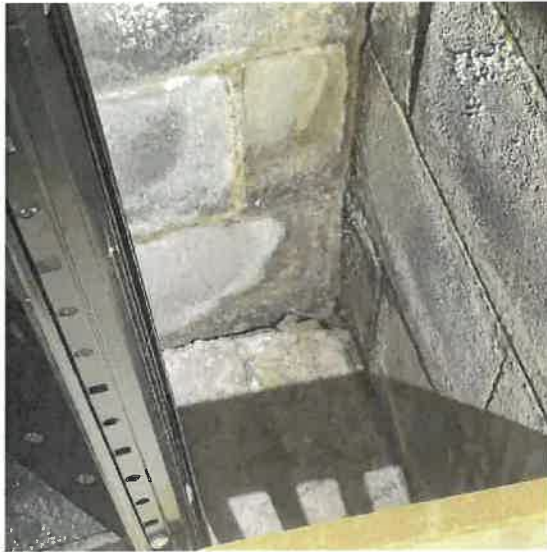
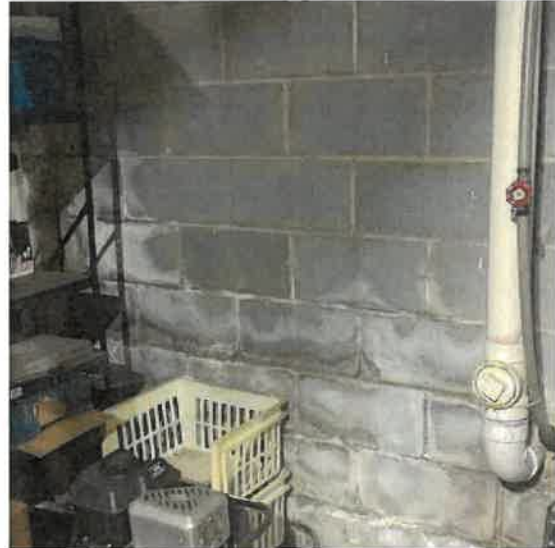
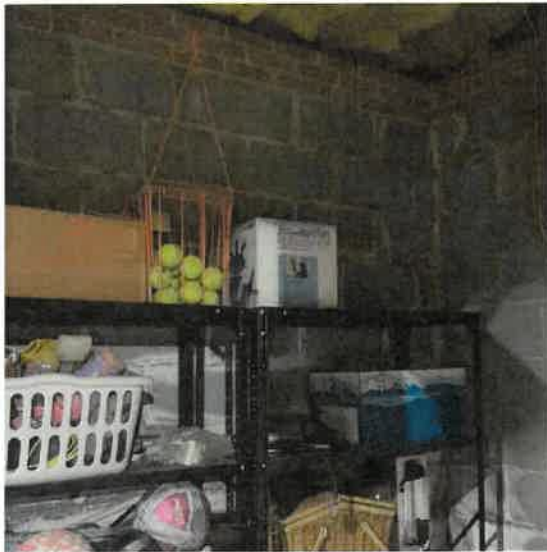
**7.9.2 Efflorescence noted on the inside of the wall at the front right of the basement indicating moisture intrusion through the masonry. Moisture was detected at the time of inspection. Properly clean area and monitor for possible future moisture intrusion. The concrete slab at the front right corner is also showing moisture damage and deterioration. Recommend having a licensed and insured structural engineer evaluate for necessary repairs to prevent further water intrusion and floor slab repairs.**

7.9 Efflorescence, and moisture in basement repaired by Triangle Reconstruction (sump-pump system installed, drains, and dry-lock damp proofing the walls) (Receipt R0011)

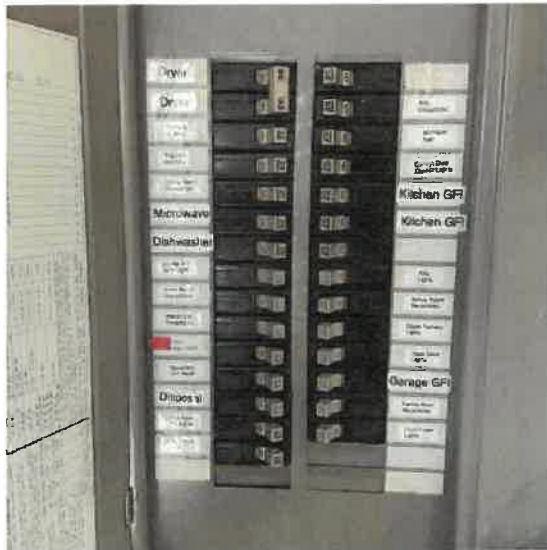
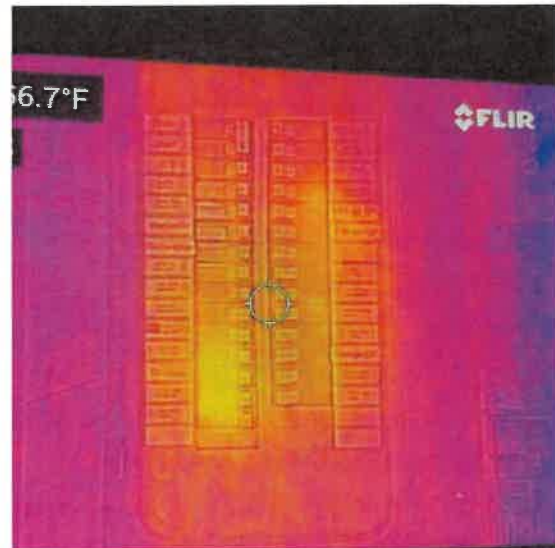
8.6.1 This infrared image of your distribution panel shows that the temperature under load is within normal operating range.

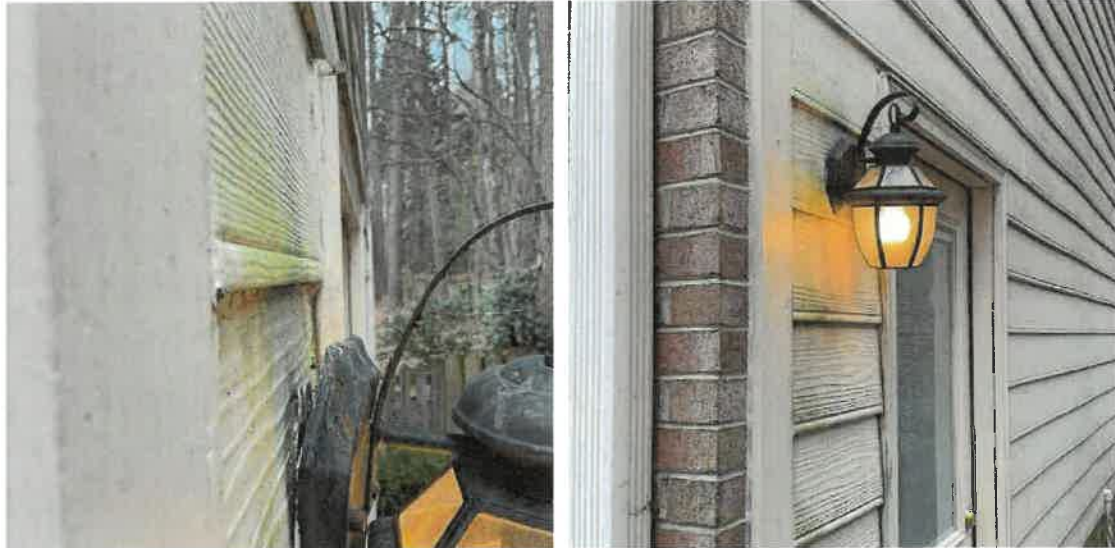
**8.9.1 Light fixture beside the exterior pedestrian door in the garage is loose from the wall. With the top of the light box exposed, water can enter the box causing an electrical fire hazard. Recommend having a licensed electrician repair to reduce damages to light. (Exterior Right)**

8.9 Light fixture replaced by Williams Construction (Receipt R0014)

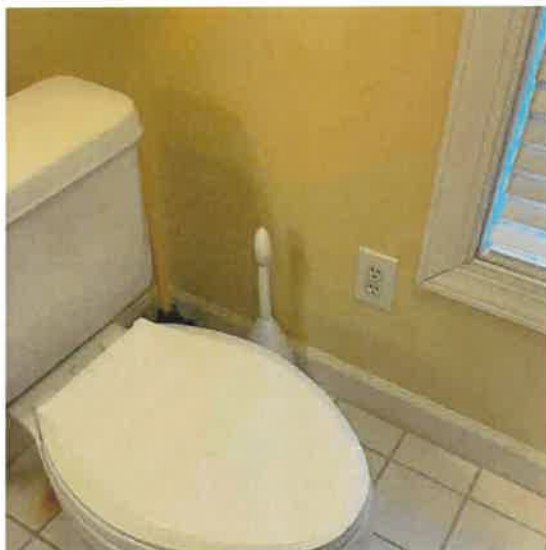
**8.11.1 The outlet beside the toilet in the upstairs hallway bathroom did not trip the GFCI indicating either a problem or the outlet may not be GFCI protected. Outlets within 6 feet of a water source should be GFCI protected to protect against electrical shock for safety. Recommend having a licensed and insured electrical contractor inspect the outlet and make necessary repairs. (Second Floor Guest Bathroom)**

8.11 GFCI outlet replaced Williams Construction (Receipt R0014)

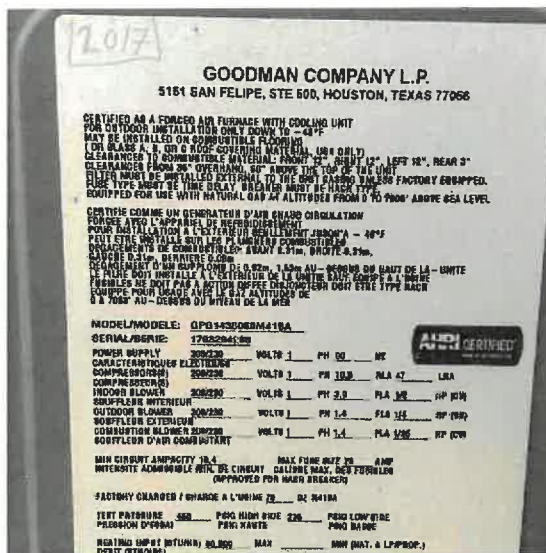
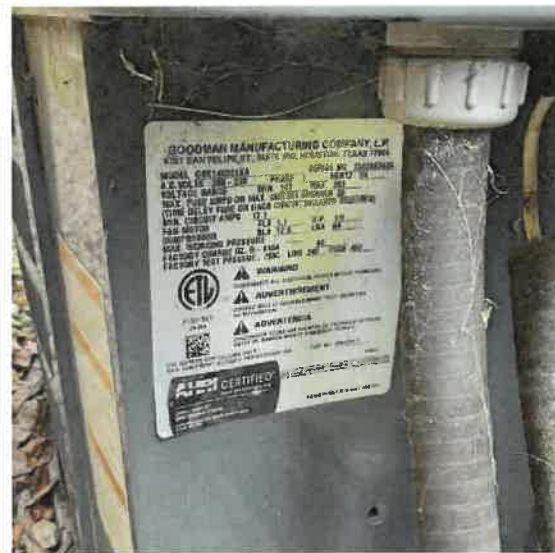
9.2.1 The average life expectancy of a forced air furnace is 20-30 years. This unit is approximately 12 years old. Recommend budgeting for repair and / or replacement as necessary.

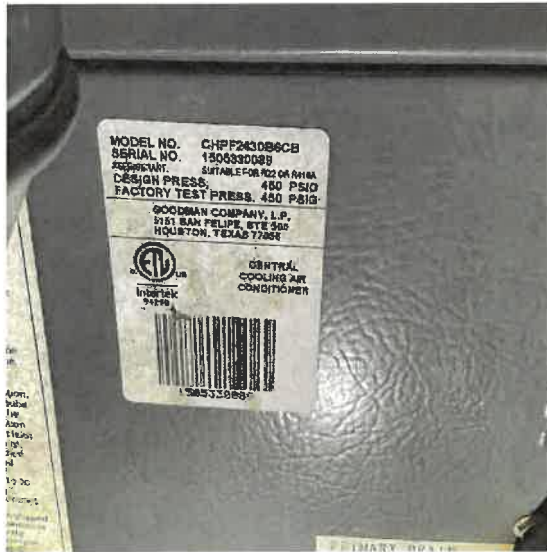
9.2.2 The average life expectancy of a forced air furnace is 20-30 years. This unit is approximately 10 years old. Recommend annual maintenance to see the benefits of full life expectancy. (Attic)

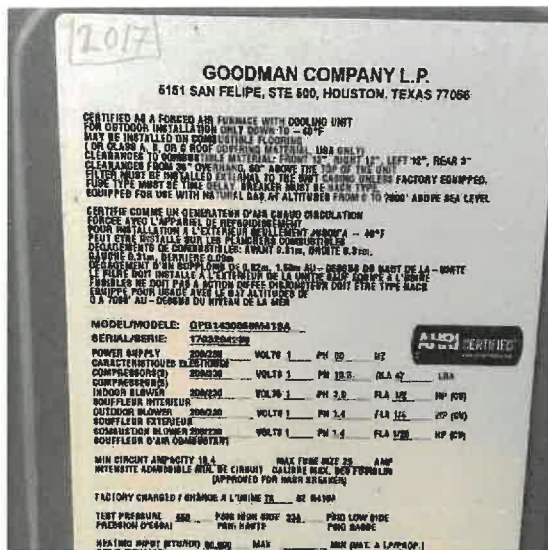
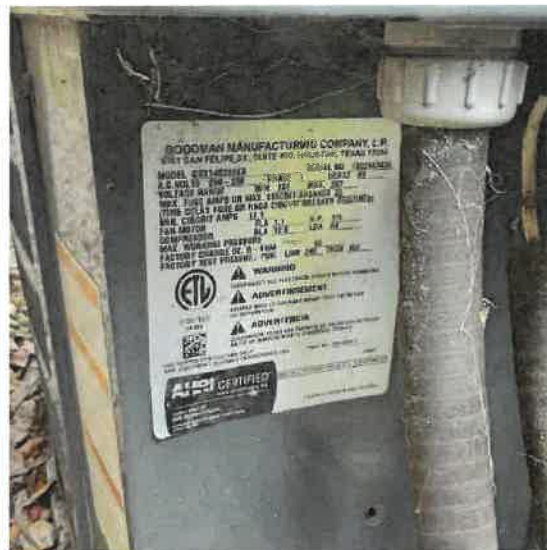
**9.5.2 The unit is 8 years old. The average life expectancy for this type of unit is 20 - 25 years.**

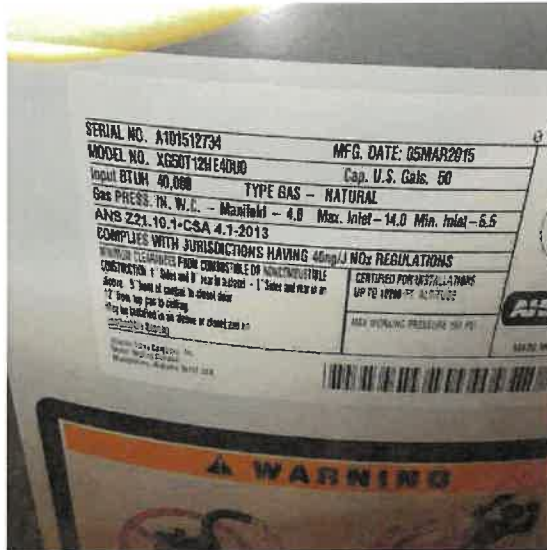
10.5.1 This unit is almost 11 years old. A traditional tank-type water heater has an average life expectancy of between 8 and 12 years under normal operation. The water heater is reaching the end of its typical life expectancy. Recommend budget to replace when the unit becomes inoperable or is not cost effective to maintain/repair.

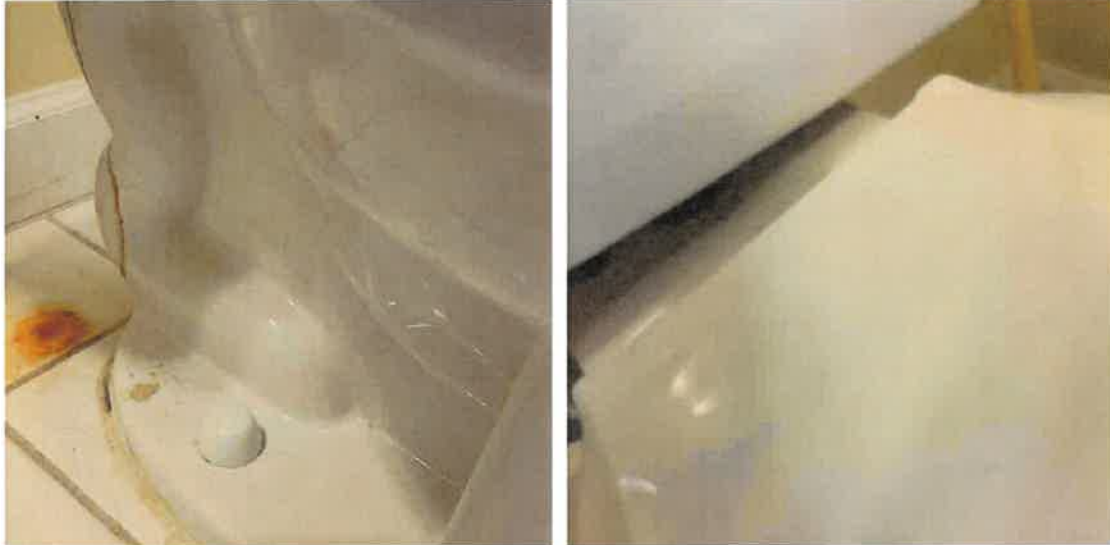
10.10.1 Leak was visible at the toilet/tank connection. Any leak at the toilet can result in damages to the flooring. Recommend having a licensed plumber repair to reduce future damages.

The tank for the bathroom toilet was loose from the toilet. This can cause stress on the water lines which can cause them to come loose. Recommend having a licensed plumber secure tank to reduce water related damages. (Second Floor Guest Bathroom)

10.10 Toilet replaced by Paramount Plumbing (No receipt obtained)

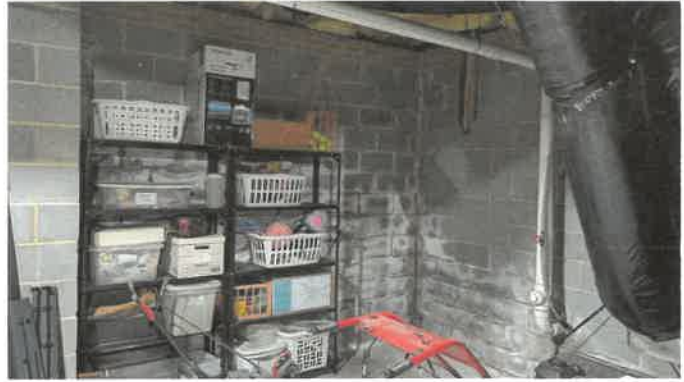
Basement slab moisture
