Professional Engineer Inspection and Evaluation  
25.028 – 1009 Mondavi Place, Apex, NC

Armen Armenakyan, PE with JSM Engineering PLLC performed site inspection on October 20, 2025, to evaluate multiple concerns at the residence.

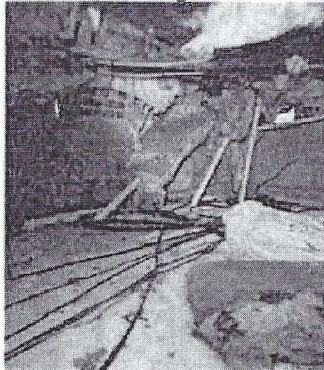
1. At the back right hand side corner of the house floor insulation had fallen off

1. Reinstall floor insulation.
2. Open the closed vents. If natural ventilation is not adequate, install dehumidifier in the crawl space.
3. Tuckpoint the exterior masonry above the front door and below the window on the right of the door.
4. and 5. Foundation wall cracks are indication of a settlement. Obtain services of licensed foundation repair company and install helical piers at 6' on center at the front of the house and right-hand side back corner of the house to an ultimate bearing capacity of 18 KIPS. Continue monitoring the cracks in the foundation wall around the house. If new cracks appear over time in different locations, additional helical piers will need to be installed.

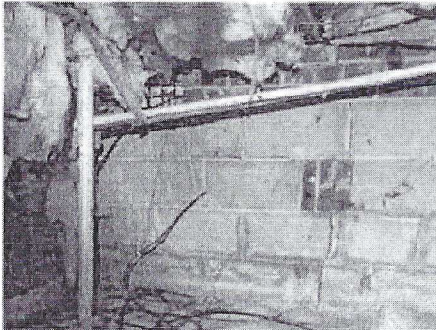
2. At the front wall the vents were closed shut.
3. Exterior masonry cracks above the front entrance door and below the window to the right of the front entrance
4. Crack in the foundation wall at the right-hand side back corner of the house

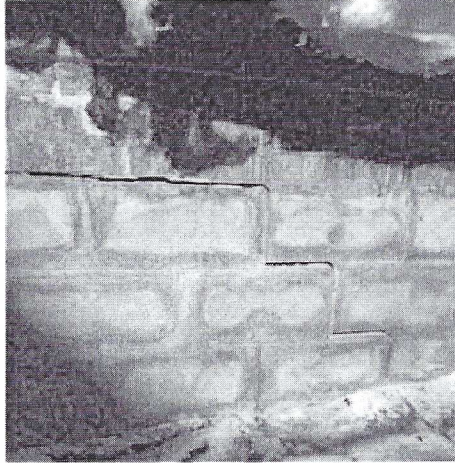
5. Crack in the foundation wall at the front of the house
