Inspection report for the property at  
228 Kelso Ct, Cary, NC 27511

This report is prepared exclusively for **Sam Watson**  
Inspected On: **05-19-2026**

Matthew Betts, NCHILB #4129

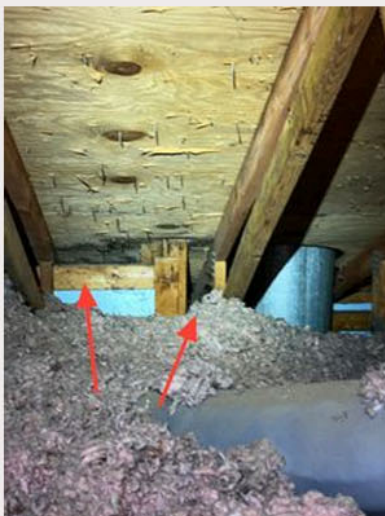
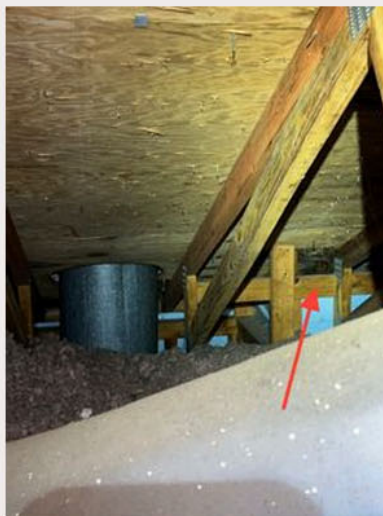
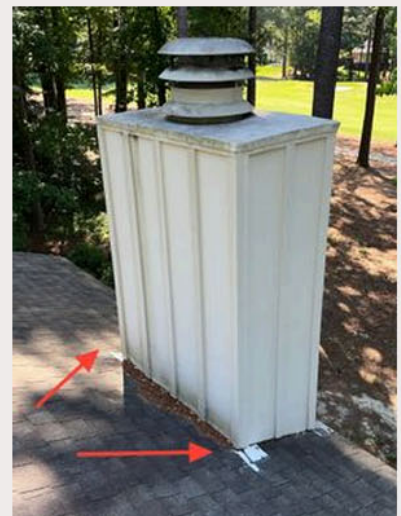
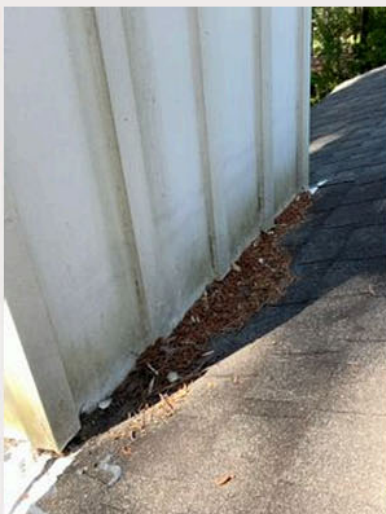
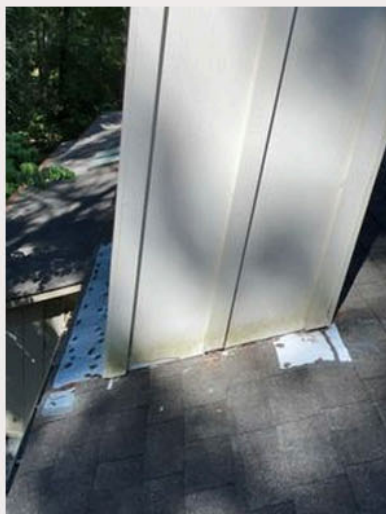
**SC-2** **Structural Components - Roof Structure:** Water stains were noted in the attic underneath the chimney chase. These are likely due to the the roof design where no "cricket" is installed (see diagram). This should be corrected whenever the building is reroofed. Some sheathing may need to be replaced. This is for your information. Consult with the home owners association regarding maintenance responsibility and plans for improvements prior to putting the house on the market as questions will likely arise during subsequent inspection.

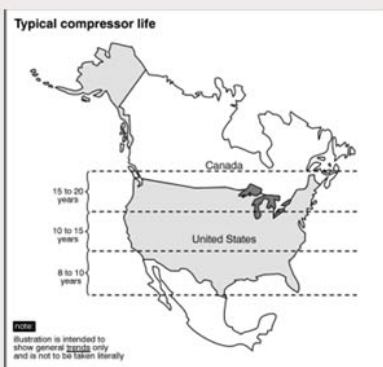
This air conditioning system was operating at the time of inspection, but it is **old** and should be considered unreliable. Air conditioning systems in our area have life expectancies of 10 - 15 years. This unit is beyond that time frame. Service life can depend on keeping a proper refrigerant charge and reliable return air flow as well as the amount the system has been used. Our inspection is not technically exhaustive, latent defects may exist. You should have this equipment **serviced** prior to putting the house on the market to confirm that it is in good working condition. Expect age related concerns to be raised by a buyer.

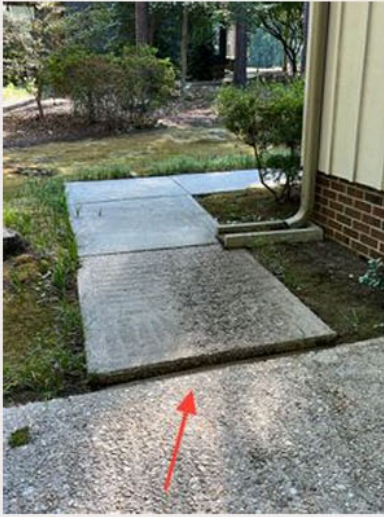
Front walkway

The raised edge between the front entry walkway and driveway presents a possible tripping hazard. This is a potential **safety issue** for your information. Exercise caution here, especially if aging adults or young children will occupy or visit the home. Consult with a home maintenance specialist for additional advice and improvement estimates prior to putting your home on the

market if this issue is of concern to you.

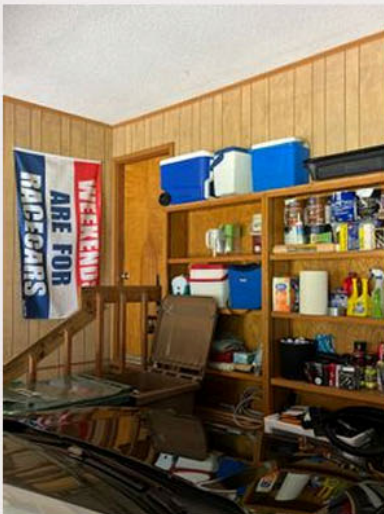
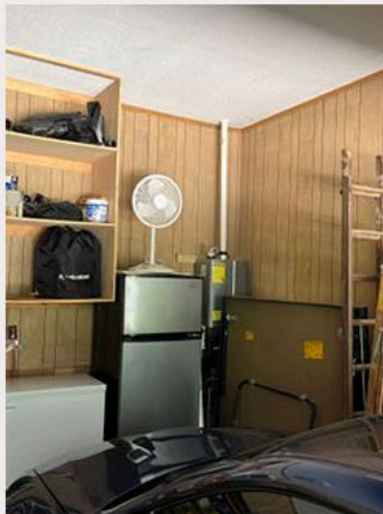
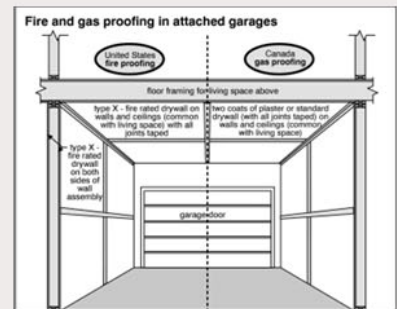
**E-7 Exterior - Garage(s):** The use of sheetrock or gypsum board is recommended to make a fire separation between the garage and the house. This will improve the safety of the house in the event of an accidental fire in the garage. It is common in older homes to have wood paneling in the garage. This would not be considered safe by modern fire standards. Consult with a licensed general contractor for additional advice and improvement estimates prior to putting your home on the market if this issue is of concern to you.

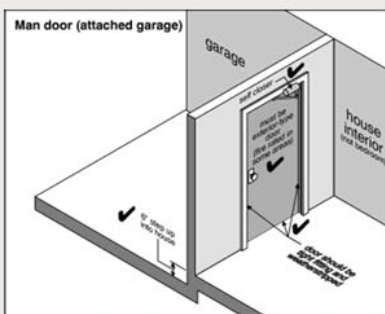
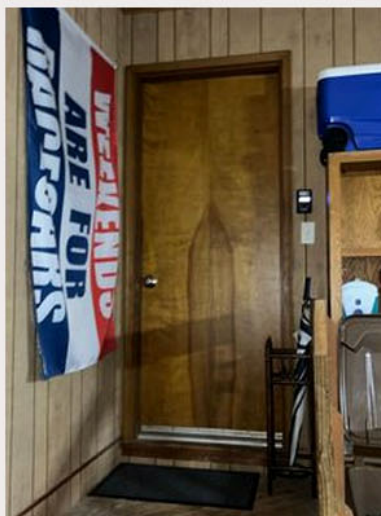
**E-8 Exterior - Garage(s):** The door between the house and the garage is not a listed fire resistant door and does not appear to meet the recommended minimum requirements for a door between the house and the garage. This is a fairly common condition at homes of this age. Standards are for the door to be steel or solid wood - min 1 and 3/8 inches thick or a 20-min rated door. Raised panel wood doors or doors with glass panes typically do not meet

this requirement. This should be updated for improved safety.

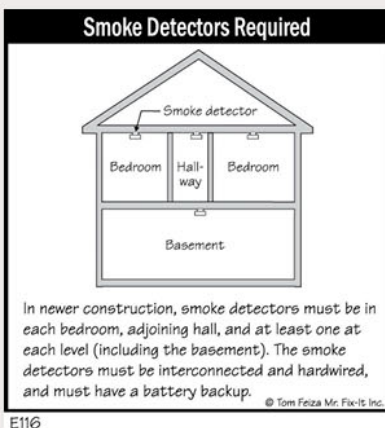
E116

Modern standards recommend smoke alarms in all bedrooms, in all hallways outside bedrooms and at least one on each floor of the home. At the time of inspection smoke alarms were missing in the bedrooms. This is a potential **safety issue** for your information. Make improvements as necessary.

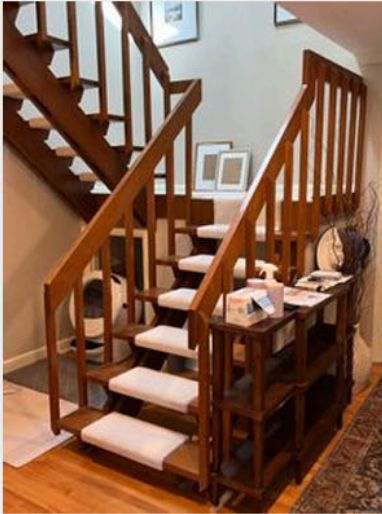
The stairs to the second floor are old non-conforming systems. Modern stairs have specific safety requirements regarding the size and configuration of the stair treads, risers, guardrails and handrails. Older stairs seldom meet modern safety standard and it may not be cost-effective to correct or improve. Use caution when navigating these stairs. Improvements can often be made to the handrail system to improve the safety of the stairs. Consult with a qualified general contractor about options for improvements as feasible.

- Large openings in the guard system which exceed the maximum 4-inches recommended by today's safety standards
- Openings between stair risers exceed 4-inches. This can pose a safety hazard for small children

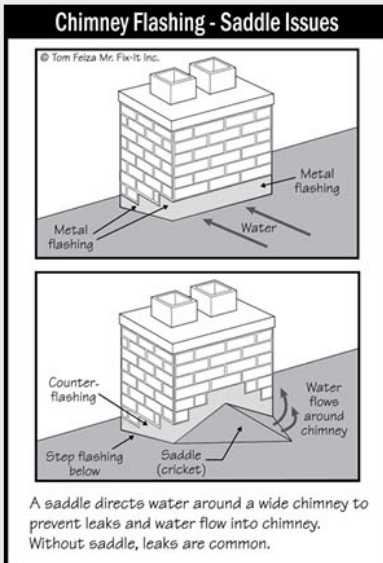
ROB3

**RFCG-1 Roof, Flashings, Chimney and Gutters - Chimneys:** A cricket or saddle flashing should be installed for this chimney to divert water around the front side of the chase (see diagram). The current installation is vulnerable to leaks where the roof slope drains against the chimney. Modern standards require a cricket when the chimney is at the bottom of a roof and more than 30 inches wide. The siding is deteriorating along the roofline and some leakage evidence was noted in the attic around the chimney. A professional roofing contractor should **evaluate** this situation further prior to putting the unit on the market and provide you with recommendations and estimates for any necessary repairs or improvements. Consult your home owners association regarding maintenance responsibility and plans for improvements.

Add a "cricket" when reroofing

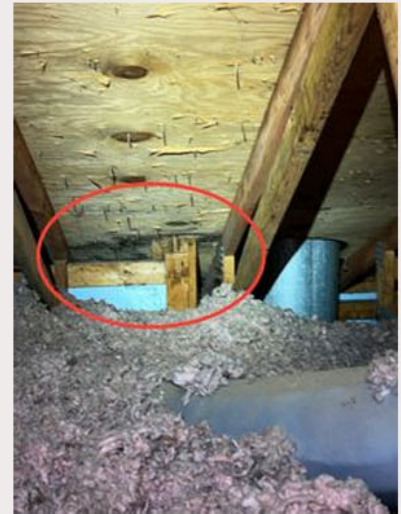
Stains - may be active

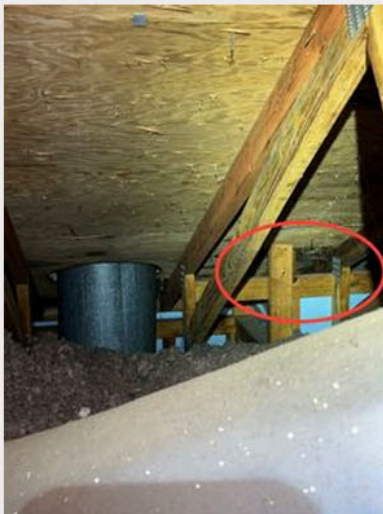
Stains - may be active

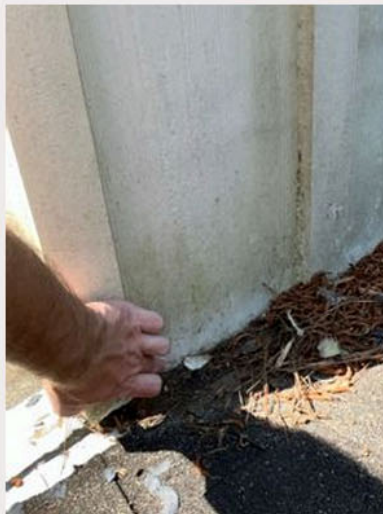
Damaged siding/trim

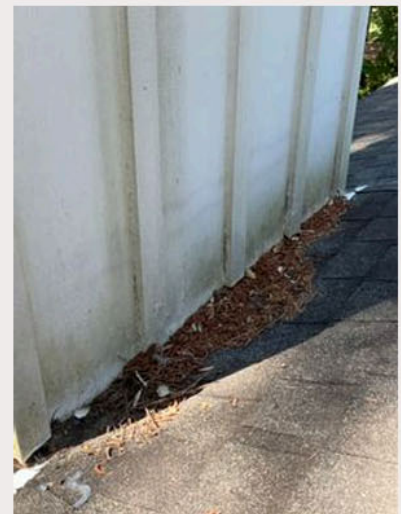
Debris along the roofline holds moisture

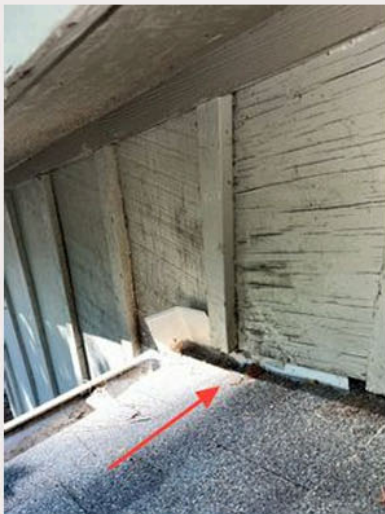
*Left rear corner of unit*

**E-1 Exterior - Wall Cladding, Flashing and Trim:** Localized rot repairs are needed to the exterior siding and trim at a few locations. Damage may spread to adjacent materials if not corrected. A professional home maintenance specialist should evaluate this situation further and **repair or replace** all damaged and decaying exterior wood as needed. Please note that this condition can indicate additional concealed damage that is not visible to inspection. Consult your home owners association regarding maintenance responsibility. During inspection, I noted:

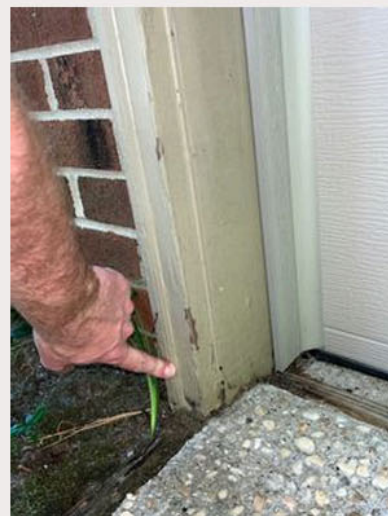
*Left corner of Garage - siding/trim should not contact the ground*

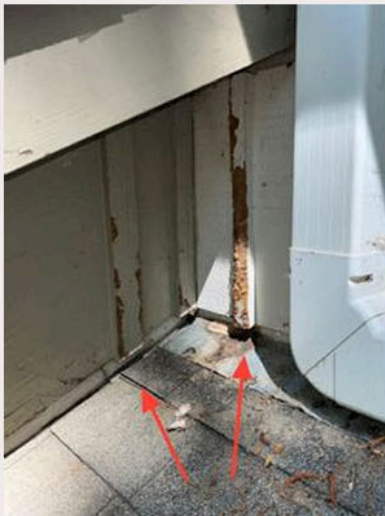
*Squirrel damage at rear side of house*

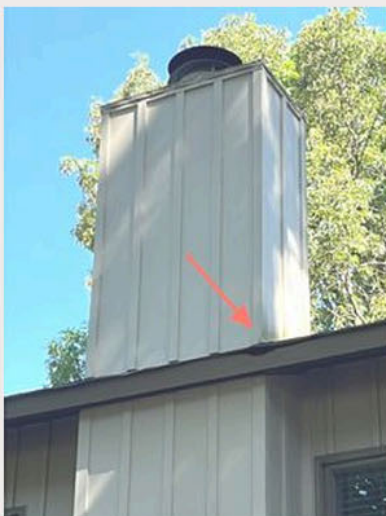
*Rear side of unit*

**E-2 Exterior - Eaves, Soffits and Fascia:** Localized wood rot was noted at the rake and fascia trim at a few second floor locations. Damage may spread to adjacent materials if not corrected. A professional home maintenance specialist should **repair** or **replace** as necessary. Consult your home owners association regarding maintenance responsibility.

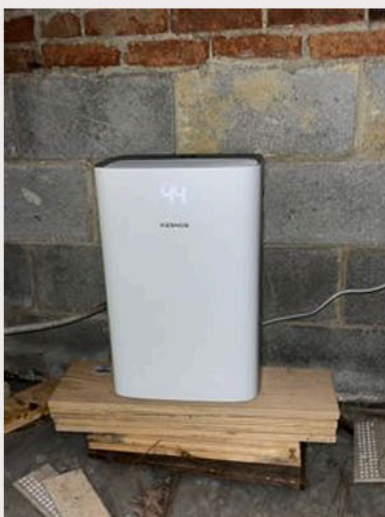
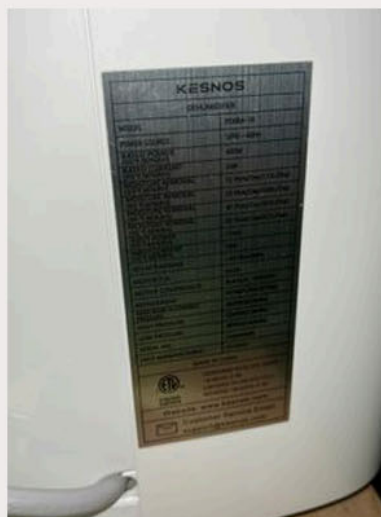
**IV-5 Insulation and Ventilation - Ventilation of Crawl Space:** The foundation wall vents at this home have been sealed off and a plastic vapor barrier installed. An inexpensive "interior-use" type dehumidifier installed to condition this space is not intended

for this application. Many of these dehumidifier types have been the subject of consumer protection recalls due to **safety** concerns. An inspection of this equipment is outside the scope of a standard home inspection. I recommend that this unit be replaced with one designed to be used in a crawl space or use conditioned air from the HVAC system. A licensed general contractor who is familiar with proper procedures for closing crawl spaces should **evaluate** this installation further and provide you with recommendations and estimates for repairs prior to putting your home on the market if this is of a concern to you. Learn more about closing crawl spaces here: [Advanced Energy](#)

*Kesnos dehumidifiers have not been recalled, however, this unit is not designed or intended for use in a crawl space.*

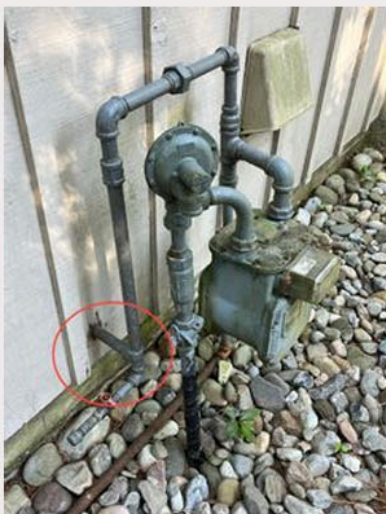
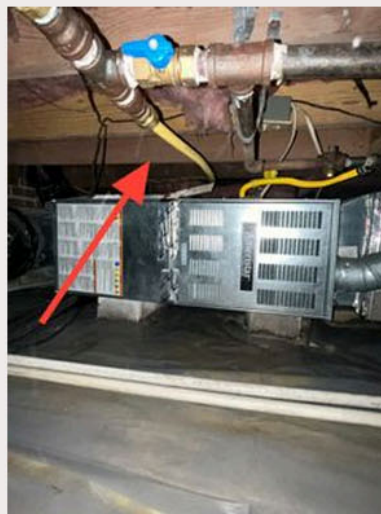
**Device:** The gas (or LP) piping system at this home includes corrugated stainless steel tubing (CSST). This flexible gas line system has specific installation requirements related to electrical bonding, designed to reduce the potential for lightning-related electrical arcing that can perforate the tubing and result in gas leaks or fires. During the home inspection, the CSST could not be verified to be integrally bonded or to have a bonding attachment. This is a potential safety issue for your information. A licensed electrical contractor should **evaluate** the CSST installation further prior to the expiration of your due diligence period to ensure the presence of an electrical bonding path. Repairs may be needed.

*The installation of "CSST" gas piping (flexible steel pipe with a yellow cover) requires a bonding connection to the house ground*

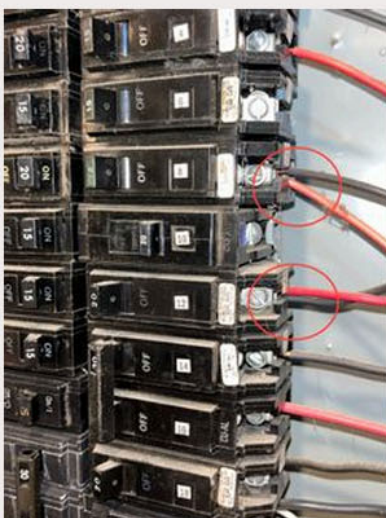
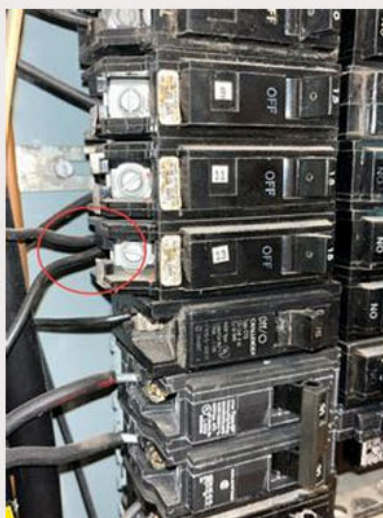
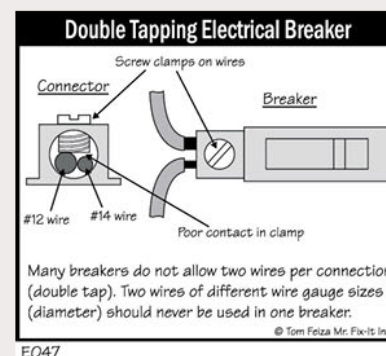
**ES-2** **Electrical System - Main Electrical Distribution Panel and Overcurrent Devices/Compatibility of Voltage and Amperage:** Double taps were noted in the main panel. This is a potential safety issue for your information. The breaker lug may not equally tighten on both wires. Many circuit breaker manufacturers do not allow two conductors/breakers. Arcing and overheating can occur due to this situation increases the risk of fire. A licensed electrical contractor should **evaluate** this situation further prior to the expiration of your due diligence period and provide you with recommendations and estimates for any necessary repairs or improvements.

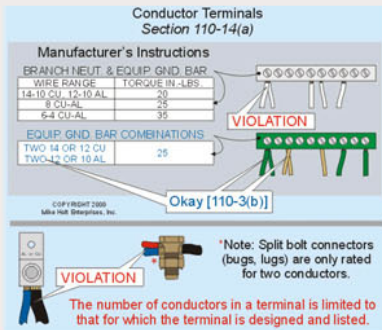
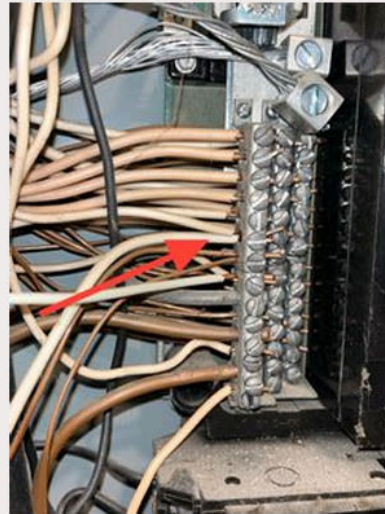
**Devices/Compatibility of Voltage and Amperage:** Double lugged neutrals were noted in main panel. This is a common problem at homes of this age in our area. Double lugged neutrals (1) violate the panel's UL listing which requires one neutral connector per lug and (2) may loosen over time which affects their function and increases the risk of arcing and a fire occurring. This is potential **safety issue**. A licensed electrical contractor should evaluate this panel further and **repair** necessary to ensure that safe conditions exist.

*Neutrals (white wires) should have their own unique lug connection - just one per lug.*

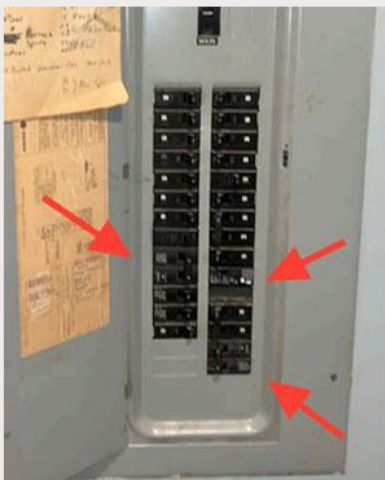
There is a different brand of breaker installed in the electric panel. Electric panels are only rated to have certain types and brands of breakers installed by the panel manufacturer. Determining proper breaker use can necessitate referring to the manufacturers listing. A licensed electrical contractor should evaluate this condition further and make simple **repairs** as necessary. Consult with the panel manufacturer for additional advice as necessary.

*Siemens breakers should not be installed in a GE panel*

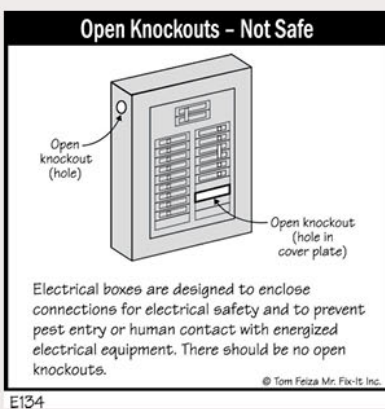
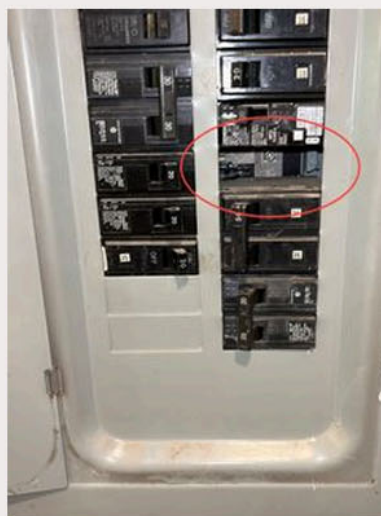
**ES-5** **Electrical System - Main Electrical Distribution Panel and Overcurrent Devices/Compatibility of Voltage and Amperage:** Openings were noted in the electric panel that have not been covered. This is a potential **safety issue** for your information. An injury could occur if not corrected. A licensed electrical contractor or qualified person should **repair** as necessary to ensure that safe conditions exist.

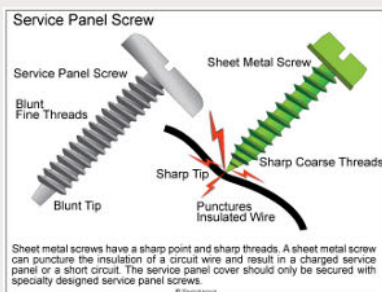
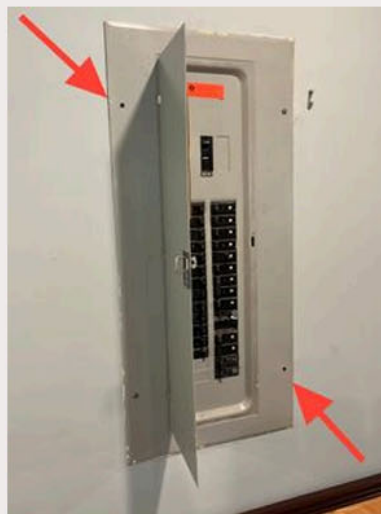
**ES-6** **Electrical System - Main Electrical Distribution Panel and Overcurrent Devices/Compatibility of Voltage and Amperage:** The dead front cover is missing the screws needed to adequately secure the cover. Install missing screws as needed for improved safety and please note that screws with sharp ends are not recommended. A licensed electrical contractor or qualified person should make a simple **repair** as necessary.

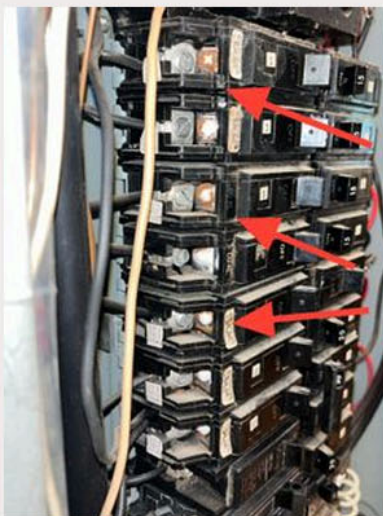
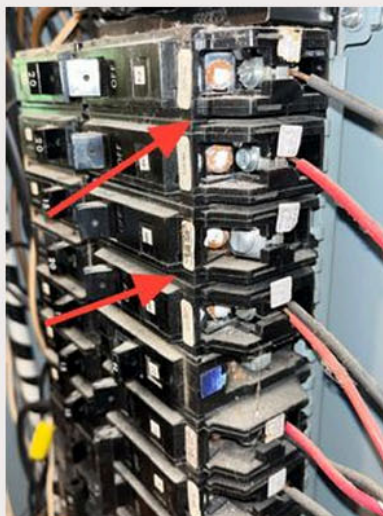
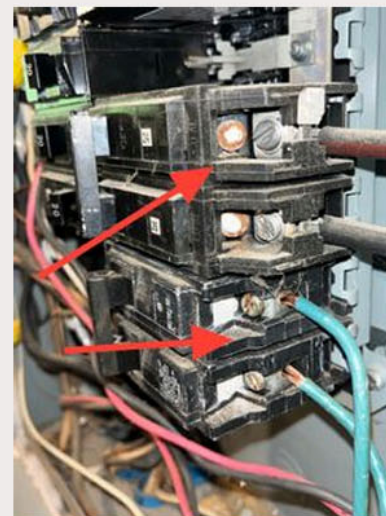
**ES-7 Electrical System - Main Electrical Distribution Panel and Overcurrent Devices/Compatibility of Voltage and Amperage:** Evidence of rust or corrosion was noted on circuit breaker lug connections in the main electrical panel along the left wall of the dining area. Moisture on electrical components increases the risk of damage and overheating if not corrected. A licensed electrical contractor should **evaluate** these breakers further in conjunction with other necessary repairs and provide you with recommendations and estimates for any necessary improvements.

*Some corrosion was noted on the older circuit breakers*

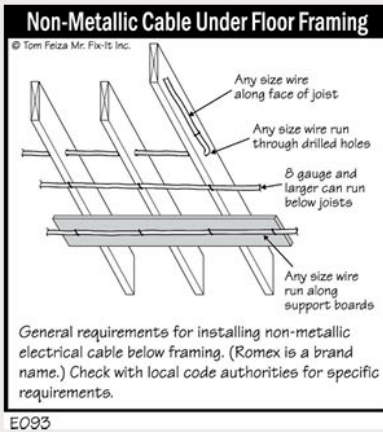
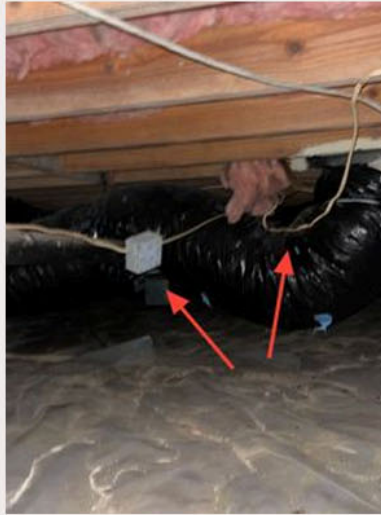
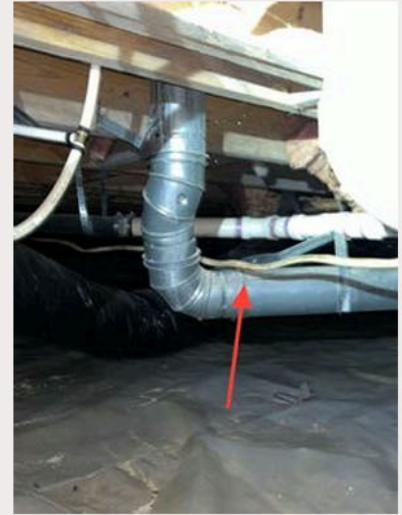
**ES-8 Electrical System - Branch Circuit Conductors (wiring):** The branch circuit wiring is poorly supported and requires staples or hangers for additional support and strain relief - see crawl space. This type of wiring should be supported every 4 feet and within 2 feet of junction boxes. This issue risks damage for pests such as mice if not corrected. A licensed

*Should not contact the metal flue!*

electrical contractor should make a **simple repair(s)** as necessary.

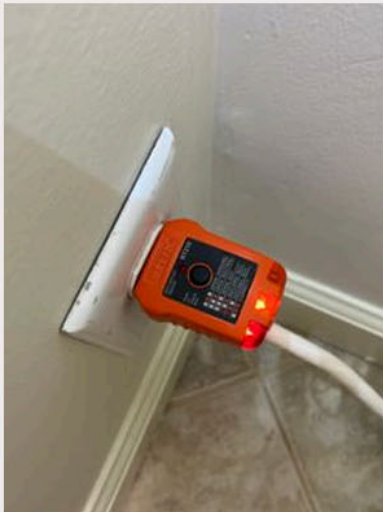
*Master bathroom*

Reverse polarity was noted at one of the electric receptacles in the master bathroom by the toilet. This is when the hot and the neutral wires have been wired backward. This is a potential **safety issue** for your information. A licensed electrical contractor should **repair** as necessary to ensure that safe conditions exist.

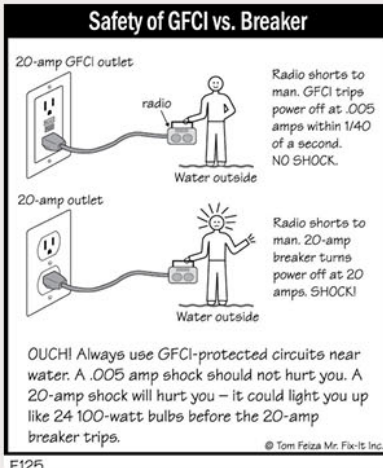
E125

(GFCI's): GFCI (Ground Fault Circuit Interruption) protection is recommended for the electrical receptacles:

- in the garage

GFCI's protect against electrocution by limiting the duration of an electrical shock. This is a potential **safety issue** for your information. An injury could occur if not corrected. A licensed electrical contractor should improve as necessary to ensure that safe conditions exist..

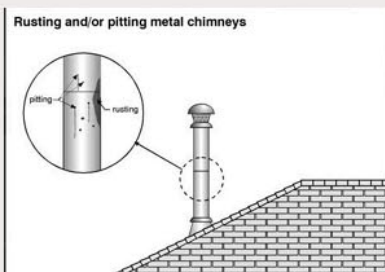
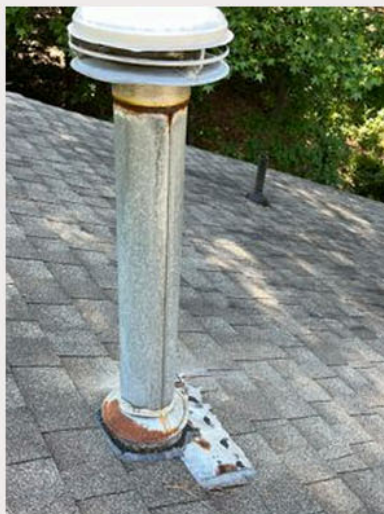
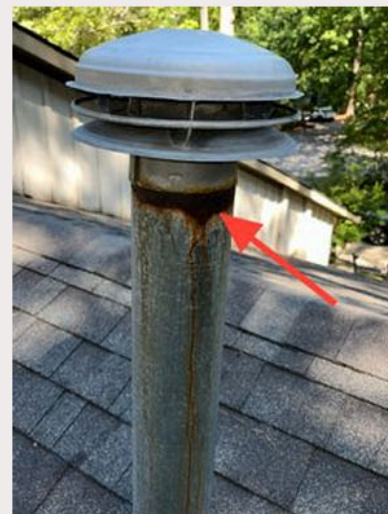
✂ **RFCG-2 Roof, Flashings, Chimney and Gutters - Chimneys:** The furnace flue is old and corroded above the roof line. These conditions increase the risk of leakage occurring which can cause hidden damage to the flue if not corrected. This is a potential **safety issue** for

your information. See additional comments and concerns regarding this flue installation in the "Heating" section of this report. A licensed mechanical contractor Should **evaluate** this situation further before your due diligence period expires and provide you with recommendations and estimates for any necessary repairs or improvements.

*This is a very old furnace flue that should be replaced*

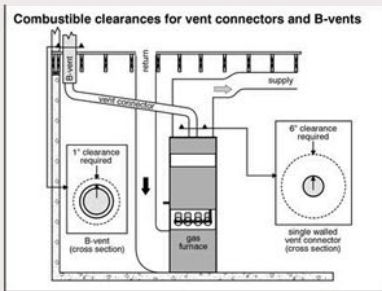
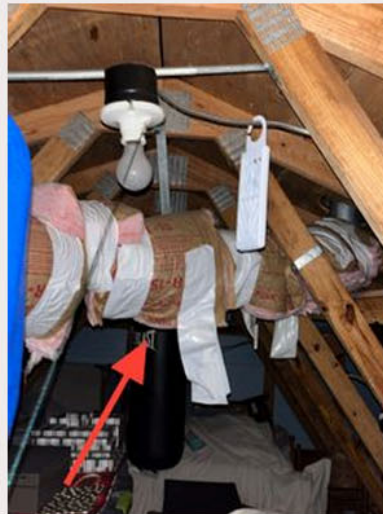
**Cooling and Heating Systems - Heating System:** The furnace flue installation has several defects that present safety concerns:

- Insulation has been installed on the flue in the attic - this is a non-standard installation. This flue has a double wall with an air space between them, insulating the flue can cause it to overheat which can cause hidden damage to the interior lining.
- The flue is in direct contact with combustible materials (1) in the attic (a wood truss)

*The furnace flue should not be insulated*

A licensed mechanical contractor should evaluate this installation further and **repair or replace** as necessary to ensure that safe conditions exist. See an additional comment regarding the condition of this flue above the roof-line above.

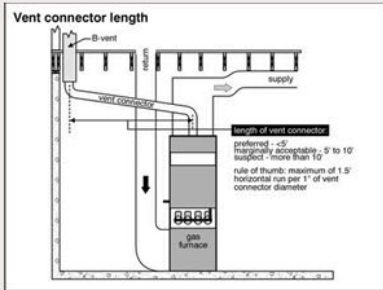
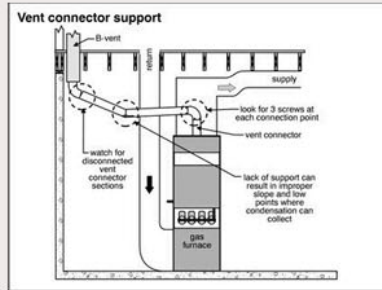
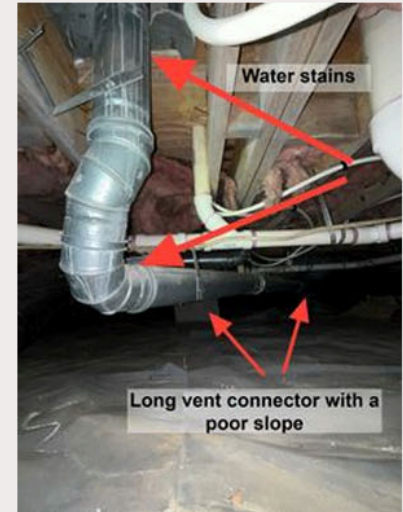
and (2) in the crawl space (ductwork).

- The vent connector on the flue is quite long in the crawl space and may not have a sufficient rise to vent properly. Some staining was noted on the outside of the vent where it passes through the subfloor. These stains imply condensation or leakage is occurring. There could be a risk of concealed damage inside the flue. See an additional comment regarding the condition of the vent above the roof.

*Furnace flue contacts ductwork in the crawl space*

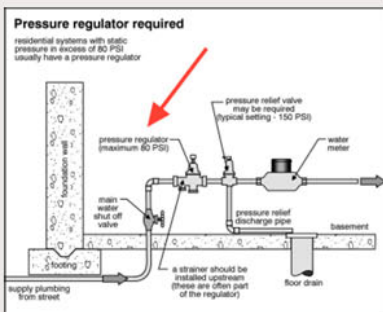
**PS-2** **Plumbing System - Water Service Supply: High water pressure noted:** When static water pressure exceeds 80-psi (pounds per square inch), a pressure reducing valve is recommended to prevent accidental damage to the supply plumbing system. No reducing valve was found during inspection and water pressure was measured in excess of 80-psi, at roughly 100 - psi. High water pressure is typically due to high pressure delivered from the water utility into the house. It can also be caused by malfunctioning water heaters, overheating the water. A licensed plumber should **repair** or **replace** as necessary prior to putting your home on the market if this is of a concern to you.

*Not present at this house*

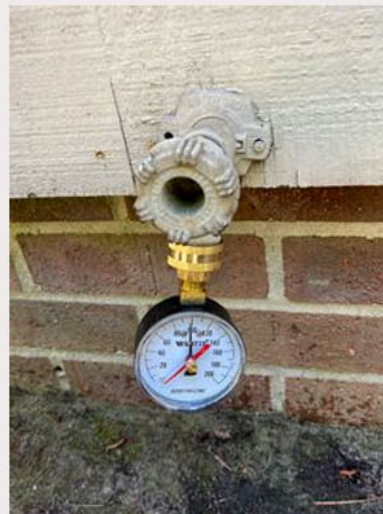
*100 PSI*

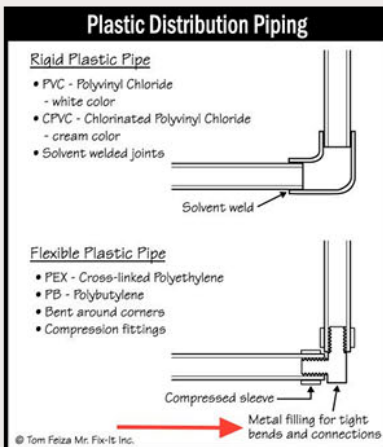
POB7

**PS-3 Plumbing System - Distribution Pipe:** Some of the supply piping installed at this home is cross-linked polyethylene (PEX) with brass fittings installed at plumbing piping joints. Some brass fittings produced between 1996 and 2010 were manufactured with increased levels of Zinc. When chemically treated or soft (low pH) water flows through these fittings, Zinc can leach out of the brass and onto surfaces (inside or out) as a white powder. This can obstruct the fittings reducing water flow and weaken their structure risking obstructions, leakage, or failure. This process is known as dezincification. Some corroded fittings were noted in the crawl space (see photos). The water should be tested the water, replace failed fittings with DZR brass or plastic types, and address the water chemistry as needed. A licensed plumber should evaluate this situation further and repair or replace as necessary.

*Brass fittings are problematic at homes of this age*
