EMB Home Inspections

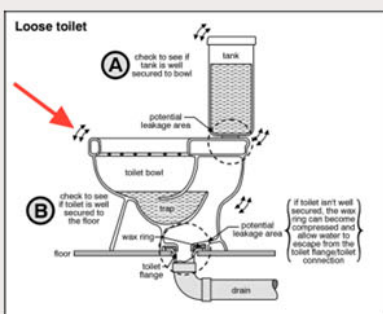
- Master bathroom
- Powder room
- Hallway bathroom toilet is excessively loose

problems may exist. A licensed plumber should **evaluate** this situation further and provide you with recommendations and estimates for any necessary repairs or improvements if this issue is of concern to you.

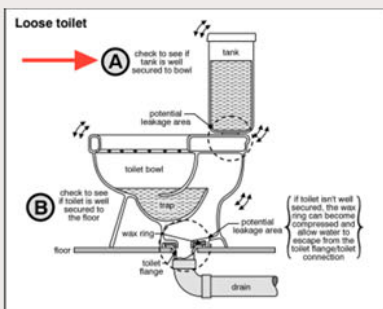
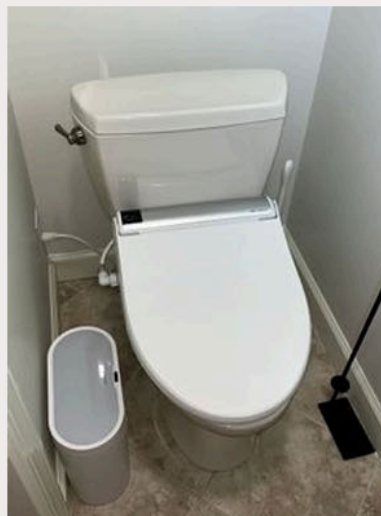
*Master bathroom*

**PS-5 Plumbing System - Fixtures:** The toilet tank is loose. This condition risks damage to the toilet(s) and leakage if not corrected. A licensed plumber or professional home maintenance specialist should evaluate the toilet and **repair or replace** as necessary. Compare to other toilets in the house for reference as needed.

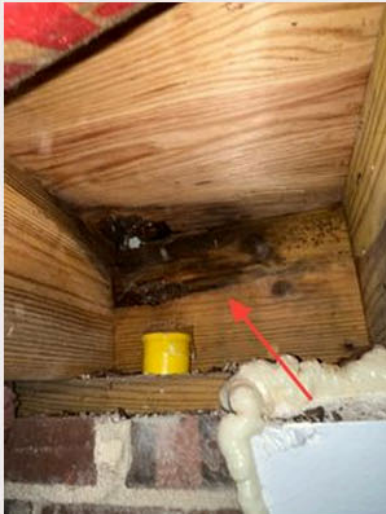
✂ **SC-1** 🏠 **Structural Components - Floor Structure:** Water stains and localized areas wood rot were noted at the subfloor and band joist underneath the sliding glass door frames serving the living and master bedrooms at the rear side of the unit. Additional damage could occur if not corrected. A professional home maintenance specialist should **evaluate** this situation further prior to putting your home on the market and provide you with recommendations and estimates for any necessary repairs or improvements.

*Under sliding glass door in the living room*

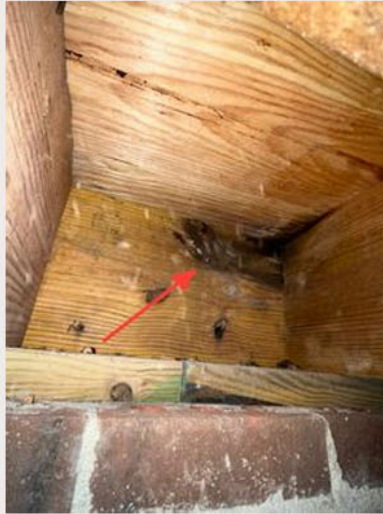
*Under sliding glass door in the living room*

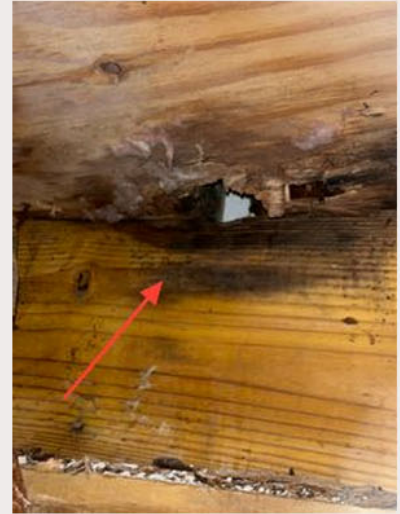
*Under sliding glass door in master bedroom*

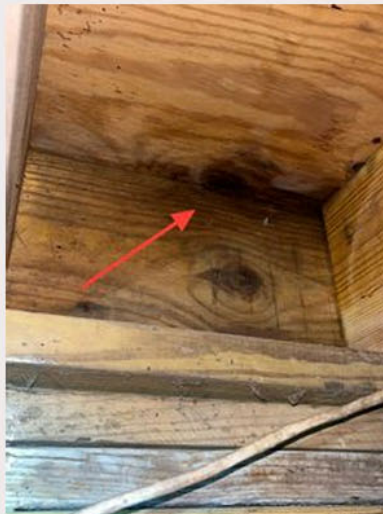
*Under sliding glass door in master bedroom*

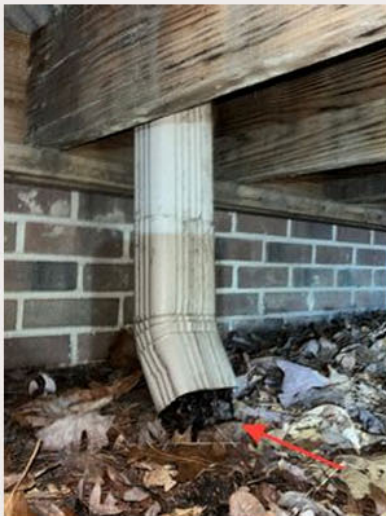
✂ **RFCG-3** **Roof, Flashings, Chimney and Gutters - Roof Drainage System:** A downspout underneath the rear deck is clogged with organic debris and requires cleaning. This is important regular maintenance to ensure reliable drain paths off this roof. Clogged

gutters increase the risk of overflowing/leakage which can cause damage to components and moisture intrusion into the crawl space if not corrected. A professional home maintenance specialist or qualified person should make a simple **repair(s)** as necessary. Once cleared, be sure to have an extension installed to drain water four to six feet away from the foundation. Consult your home owners association regarding maintenance responsibility.

*Under deck at rear side of unit*

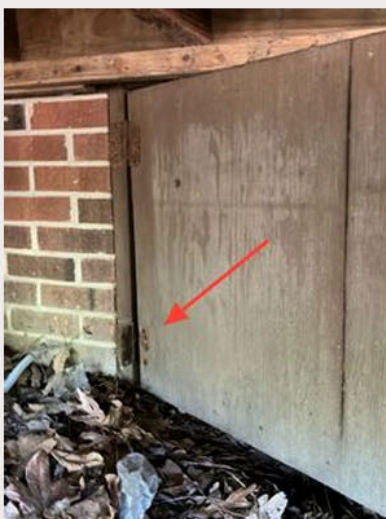
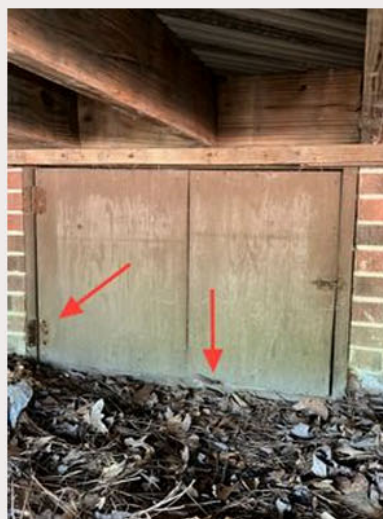
🔧 **E-3** 🏠 **Exterior - Exterior Doors, Frames and Trim:** A hinge for the crawl space access door is damaged at the rear side of the unit. A professional home maintenance specialist or qualified person should make simple **repairs** as necessary. Eliminate soil contact in conjunction with this work.

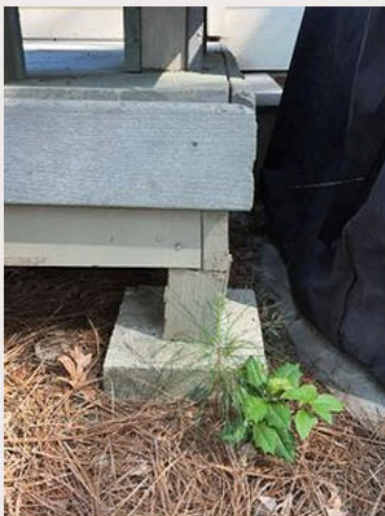
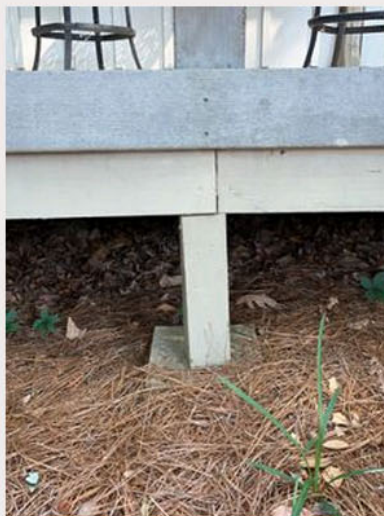
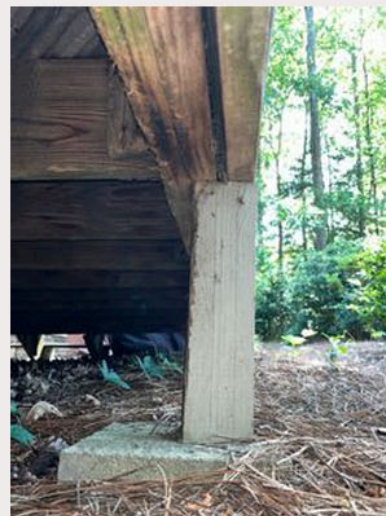
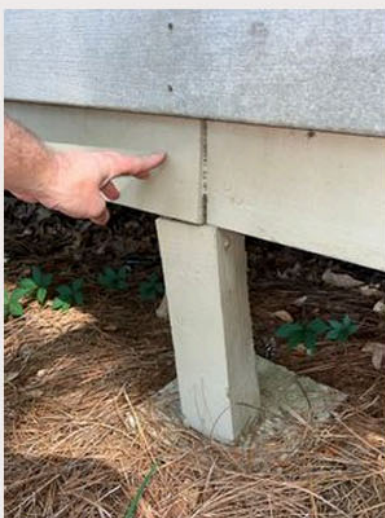
🔧 **E-5** 🏠 **Exterior - Deck(s)/Screened Porch:** Some of the supporting posts are not well connected to the deck framing at the rear side of the unit and have settled out of vertical. Additional damage may occur if not corrected. A professional home maintenance specialist

should **evaluate** this situation further before you put the house on the market provide you with recommendations and estimates for any necessary repairs or improvements. Consult your home owners association regarding maintenance responsibility.

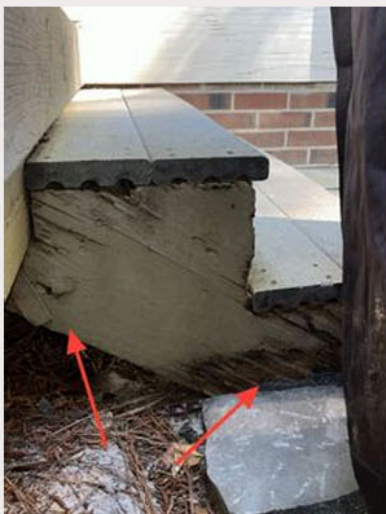
*Rear deck steps*

Stair stringers have deteriorated at the deck. Additional damage will occur if not corrected. A professional home maintenance specialist should evaluate this situation further and **repair or replace** as necessary. Consult your home owners association regarding maintenance responsibility.

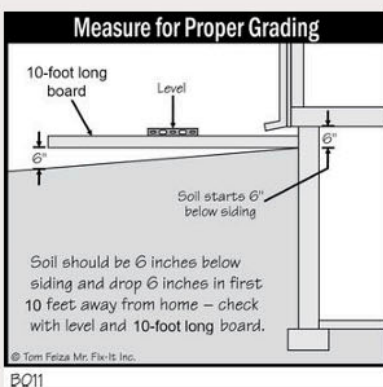
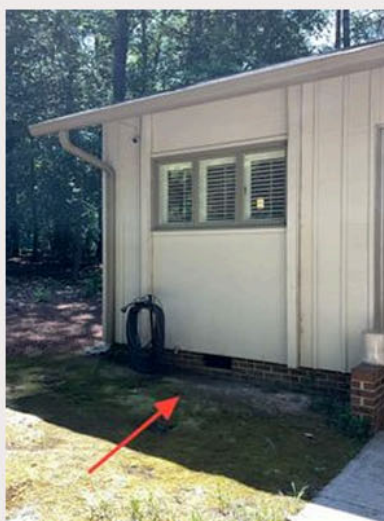
*Front side of unit*

**Exterior - Grounds:** The grading is mildly reversed at the front side(s) of the unit. This may allow water to collect near the foundation rather than draining away. Proper grading requires the ground to slope away from the house at a rate of 1 inch per foot for at least the first 10 feet around the home's perimeter. Additionally, a minimum clearance of 6 inches between the soil level and the first course of siding is recommended. Insufficient grading increases the risk of moisture intrusion into the crawl space (or basement), as well as soil saturation or water ponding near the exterior, potentially leading to structural damage and other moisture-related issues. A professional landscaping contractor or home maintenance specialist should **evaluate** this condition before putting your home on the market and provide you with recommendations and estimates for any necessary repairs or improvements. Consult your home owners association regarding maintenance responsibility.

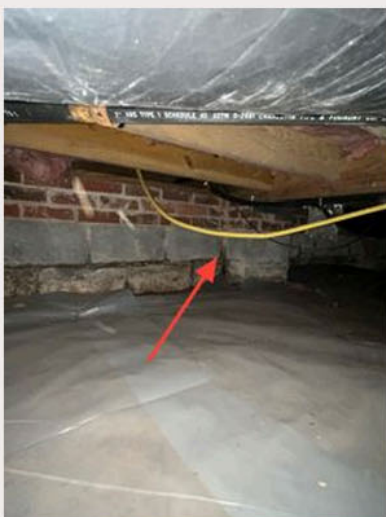
The CSST gas pipe is poorly supported in the crawl space. This pipe typically requires support or hangers every 4' for 3/8" pipe, every 6' for 1/2", and every 8' for anything larger, though this specification is manufacturer specific. Loose piping may be vulnerable to damage and leaks if not corrected. A licensed plumber, home maintenance specialist or qualified person should evaluate this situation further and **repair or replace** as necessary.

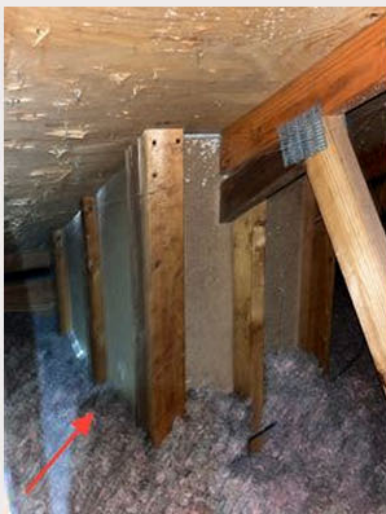
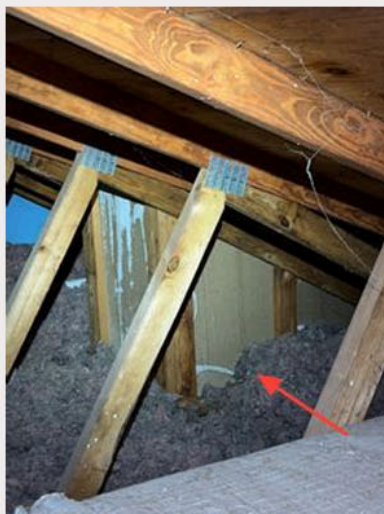
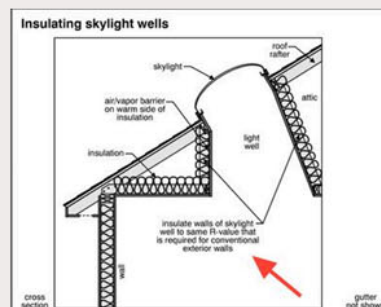
✂ IV-1 ☀️ 🏠 Insulation and Ventilation - Insulation in Attic: Insulation is not present at the skylight chambers in the attic. Some energy loss is occurring due to this condition. The entire chamber/well should be insulated. A professional home maintenance specialist should make a simple **repair(s)** as necessary.

*The skylight well is not insulated!*

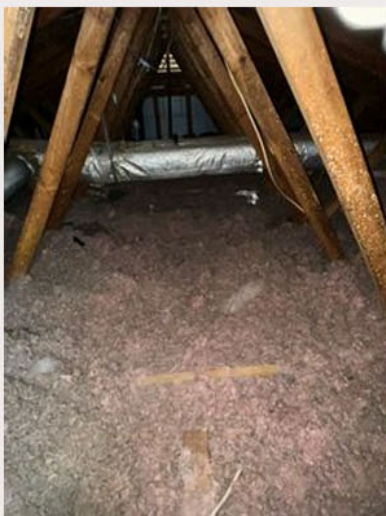
Some of the blown insulation has been disturbed by people walking in the main attic. Blown-in insulation relies on its "fluff" to function as intended. The original thermal barrier has been compromised by these conditions and is not functioning as intended. A professional maintenance specialist should make a simple **repair** as necessary.

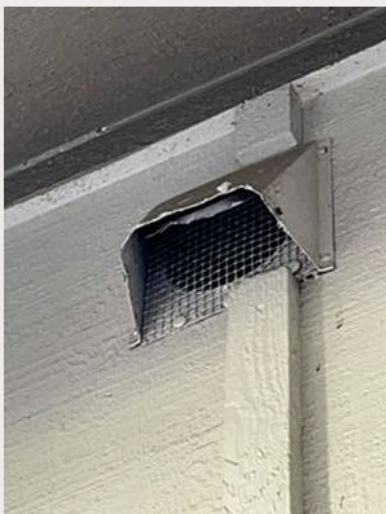
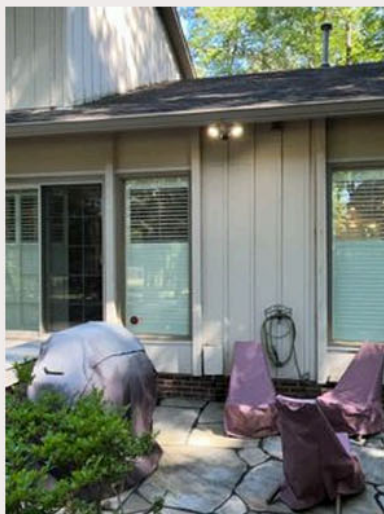
✂ IV-7 ☀ Insulation and Ventilation - Bathroom Venting Systems: A vent hood flap is ajar at the rear side of the unit underneath the eave along patio. This condition will allow air infiltration to occur if not corrected. A professional home maintenance specialist or qualified person should make simple **repairs** as necessary.

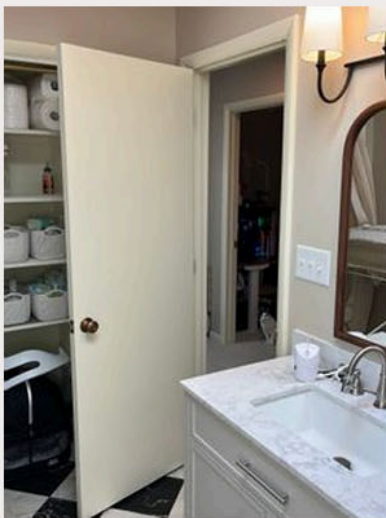
*Hallway bathroom entry door*

✂ **I-1 ■ Interior - Interior Doors:** Doors rub on the frame when closing. This condition risks damage if not corrected. A professional home maintenance specialist should evaluate this situation further and **repair** or **replace** as necessary.

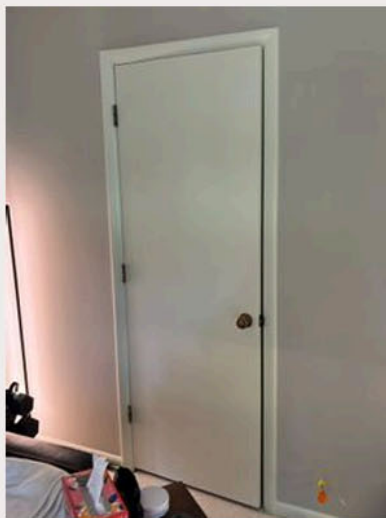
*Closet door right rear bedroom door excessive*

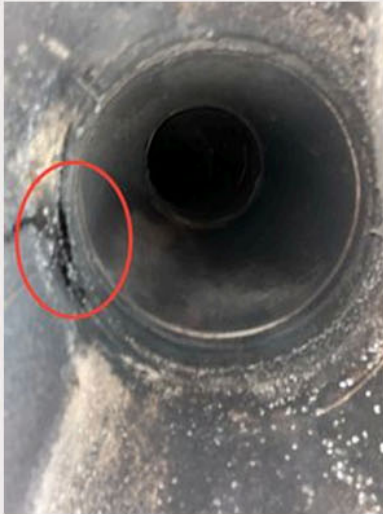
A gap was noted at the top of the fireplace where the flue is connected. This condition might allow flue gases to bypass the flue if not corrected. A professional chimney sweep, home maintenance specialist or fireplace specialist should **evaluate** this situation further and seal any open gap with an appropriate fire rated material as necessary to ensure that safe conditions exist.

*Seal this gap as necessary.*

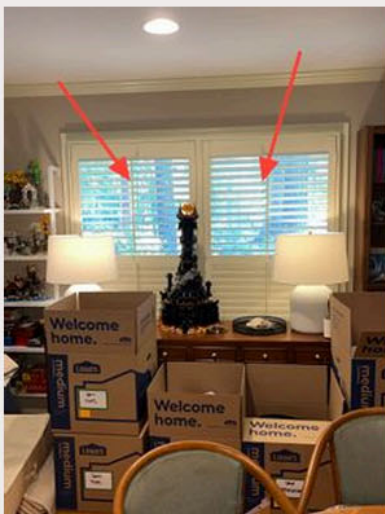
*Rear wall of dining room*

Windows have condensation or cloudiness/haze between the panes. Heat is conducted through water and vapor (condensation/cloudiness), so the insulated glass units are no longer able to perform their function as intended. The insulated glass pane units will need to be replaced in order to correct this condition. This is a common occurrence. Some additional undiscovered problems may exist and you should expect more windows to lose their seal over time. A professional window specialist should evaluate this situation further and **repair or replace** the insulated window units as necessary.

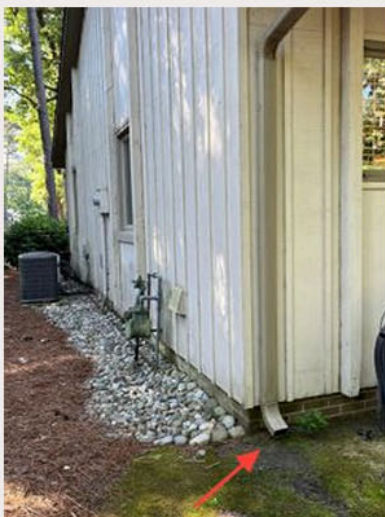
*Left front corner*

Downspouts discharging above grade at the front side of the building need extensions installed to carry water away four to six feet away from the building to reduce the risk of moisture intrusion and damage to components if not corrected. See an additional comment in the "Structural Components - Crawl Space" section of this report regarding efflorescence and dark stains on the foundation walls that is likely related to this issue. This is a simple **repair** for your information.

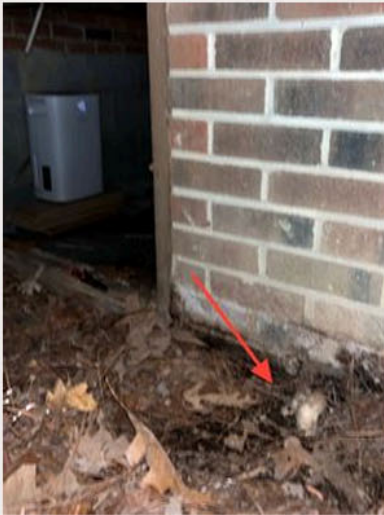
**Exterior - Grounds:** The discharge location of the drain line(s) is improper under the deck where water is draining too close to the foundation. Proper drainage requires water to be directed four to six feet away from the foundation to prevent excessive moisture buildup near the structure. Insufficient drainage increases the risk of moisture penetration into the crawl space (or basement), potentially leading to structural damage, mold growth, or other issues. Recommend improving the discharge location by extending the drain line(s) with drainage tile or corrugated piping to direct water further away from the foundation. Make improvements as necessary to mitigate moisture risks effectively.

*Condensate drain for air conditioning system*

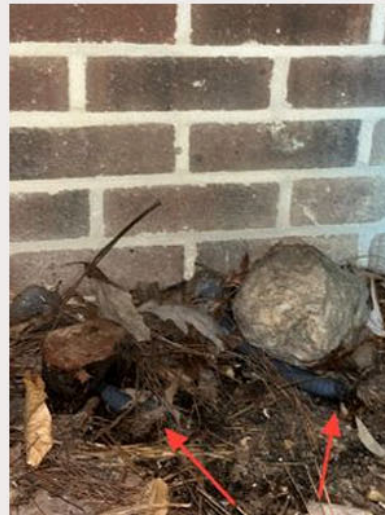
*Condensate drains for ductless heat pump*

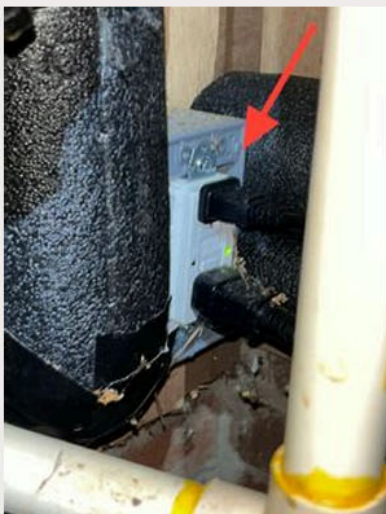
*Garage at tankless water heater*

**Electrical System - Outlets and Receptacles (observed from a representative number):** Any missing cover plates should be re-installed or replaced at electrical outlets. All access to live electrical connections should be covered. This is a potential **safety issue** for your information. An injury could occur if not corrected. Make simple **repairs** as necessary.

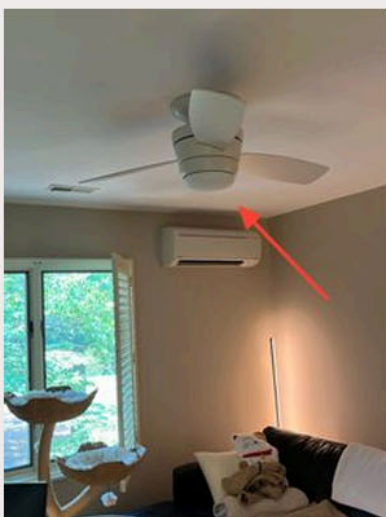
Inoperative lights were noted at the bedroom ceiling fans. This is likely due to bulbs being burned out but could be due to an inoperative fixture, circuit, or switch. Replace bulb(s) or repair light(s) as needed as a first step, then consult with a licensed electrical contractor as necessary. You should confirm that the fixtures are functioning as intended prior to putting your home on the market.

*Both upstairs bedroom fan lights*

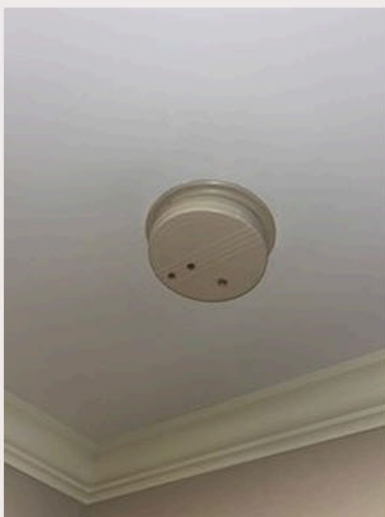
*First floor*

**ES-14** **Electrical System - Smoke Detectors:** An old smoke alarm is installed. Fire marshals recommended updating smoke alarms every 10 years to ensure reliable performance. These should be replaced prior to putting the house on the market. The link below includes important information about smoke alarms that could save lives in the event of

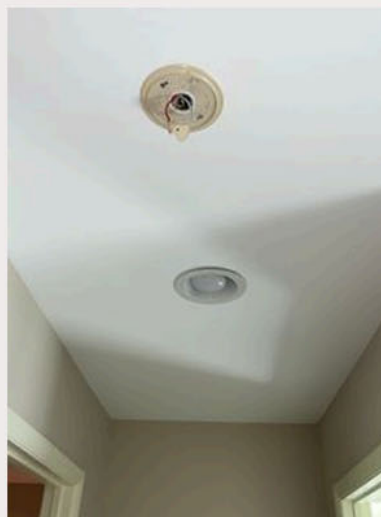
*Missing smoke detector at  
second floor hallway.  
Combination smoke/CO  
detectors should be installed at  
each floor in the hallways  
outside bedrooms.*

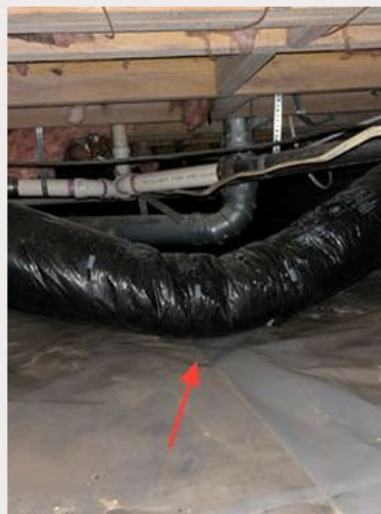
*Under powder room*

**Systems:** A duct is sagging in the crawl space. Improperly supported ductwork increases vulnerability to blockages caused by moisture, debris, or physical damage, which can impact system efficiency and performance if not corrected. A licensed mechanical contractor or qualified person should evaluate the ductwork further and make simple **repairs** as necessary. General building standards recommend that ductwork should be supported with strapping every 4', should not sag more than ½" per foot of support spacing (2") and should have a minimum clearance of 4" from the ground (see diagram).

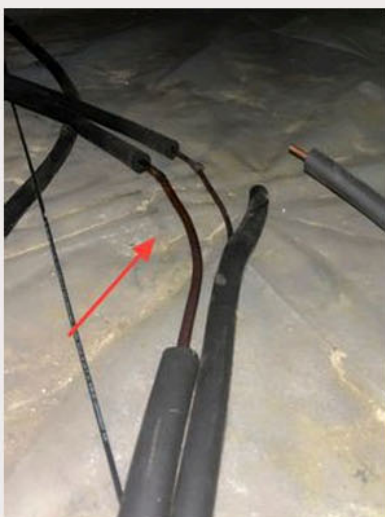
*Ductless heat pump*

The refrigerant line insulation for the ductless heat pump system is damaged/missing in the crawl space and in need of improvements (see photos/bullets). Proper insulation is essential for maintaining efficient performance of the heat pump, as damaged insulation can lead to energy losses and reduced system efficiency. If not addressed, the system may operate less effectively, potentially increasing energy costs and wear on components over time. Recommend having a professional home maintenance specialist repair the insulation promptly to restore efficiency. This is a simple fix that can help ensure the system functions optimally.

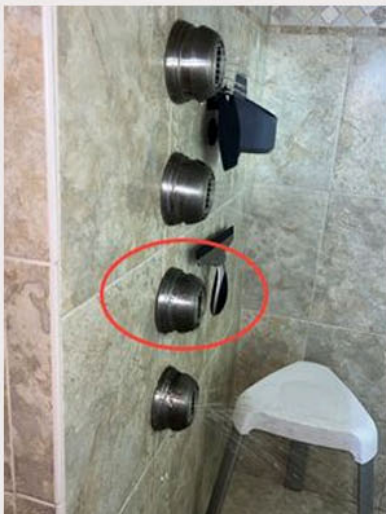
A nozzle at the wall in the master bathroom shower is clogged by mineral build-up. The sprayer is not fully functional due to this condition. Cleaning is recommended. A professional

home home maintenance specialist or qualified person should make simple repairs as necessary prior to putting your home on the market.

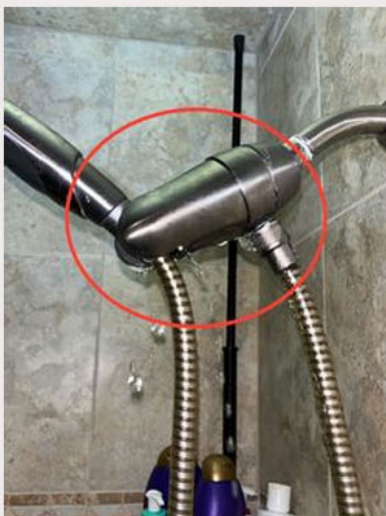
*Master bathroom*

The shower head in the master bath is leaking from the threaded connection and requires repair. Leaky shower heads are common and not a significant concern, however, under certain conditions drywall damage may occur from excessive spray or splashing. A licensed plumber or qualified person should make a simple **repair(s)** as necessary.

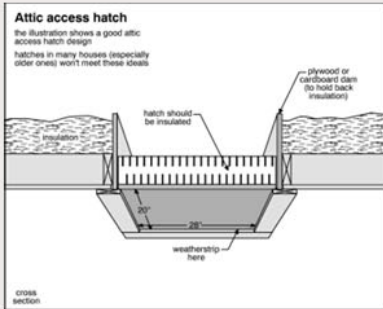
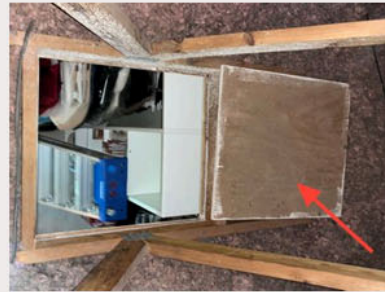
**Insulation and Ventilation - Insulation in Attic:** The attic access hatch should be insulated. This condition can decrease comfort levels and increase heating and cooling costs. A qualified person should make simple **repairs** as necessary.

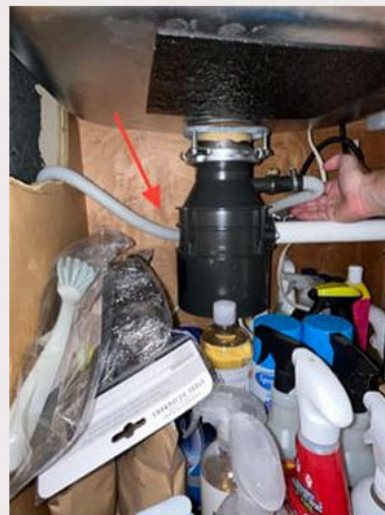
**BKA-1 Built-In Kitchen Appliances - Dishwasher:** The dishwasher drain line should be secured by an appliance technician or qualified person to ensure proper drainage to avoid cross-contamination from possible back siphoning of dirty water into the dishwasher. Low-hanging areas are not allowed. Simple **repairs** will correct this condition (see diagram).

*Elevate and secure*
