# ***CLB Home Inspections, LLC***

## **Home Inspection Report**

9208 Holly Springs Rd, Apex, NC 27539  
Inspection prepared for: Jon L'eplattenier & Rebecca Russell  
Date of Inspection: 6/26/2026 Time: 8:00 am  
Age of Home: 48 Years / Built 1978 Size: 1,964 sq ft

Inspector: James Gillie  
License #2741

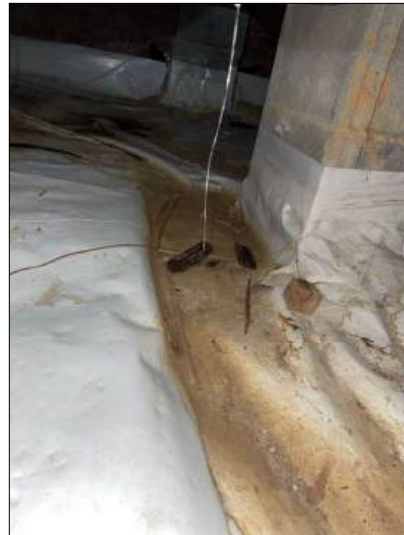
| Page 14 Item: 2 | Crawlspace | <ul style="list-style-type: none"><li>• There is evidence of water entry, in the form of sporadically located mud stains on the vapor barrier liner. Water entry into the crawlspace is harmful in that it can encourage elevated moisture levels in the exposed framing, as well as fungal growth. Water entry can also soften the soil around the foundation footing, thus encouraging foundation stress. A licensed general contractor or otherwise qualified repair contractor needs to determine the sources of water entry into the crawlspace and make repairs as necessary.</li><li>• The crawlspace has been modified from being exterior ventilated to closed/encapsulated. When a crawlspace is converted to be closed, several measures must be taken in order to ensure the functionality of the enclosed crawlspace system. Among those measures are water control. I noted evidence of previous standing water in the crawlspace. In addition, the foundation access should be insulated and air sealed. This creates a weak point at which moisture can enter. The lack of proper detailing can result in trapped moisture, and subsequent damage. A licensed general contractor who is experienced in closed/encapsulated crawlspace systems, needs to evaluate and make recommendations/repairs as necessary.</li></ul> |

Mud stained vapor barrier liner is indicative of previously puddled water.

| RCS Crawlspace came out on 7/28 to remediate all growth, repair, replace, and clean vapor barrier where needed. | | |

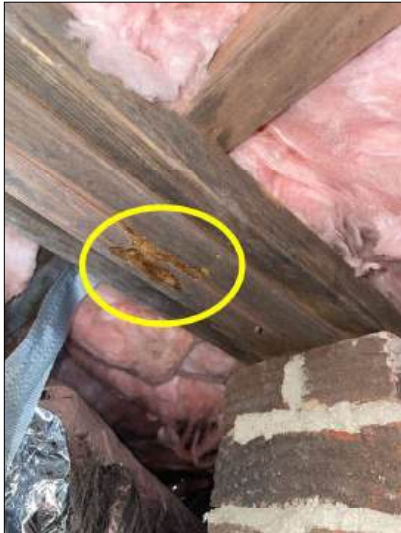
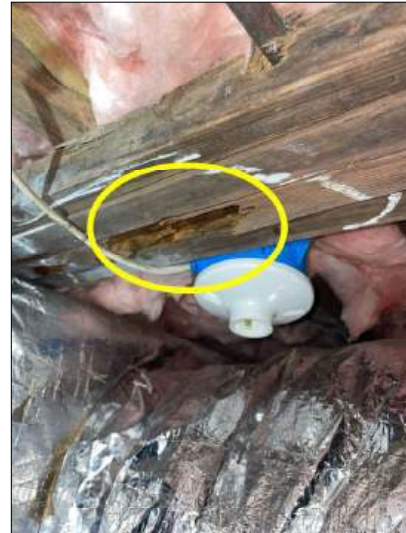
• There is a discolored and brittle girder in the left crawlspace. Girders are foundation components that provide support to the floor structure and other structural weight from above the floor structure. Damaged wood weakens the girder, thereby compromising the structural integrity of the girder. A licensed general contractor should evaluate and make repairs/recommendations as necessary.

Probing reveals some degree of wood damage.      Probing revealed some degree of wood damage.

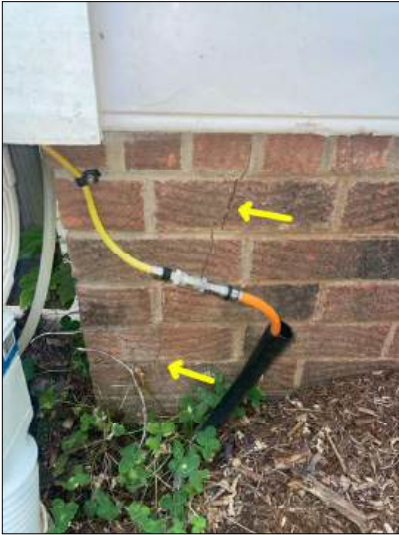
• There are cracks in the foundation wall at the following locations...(1) the left rear corner (2) two cracks on the left side, middle area (3) the front side right. Cracks of these widths are typically indicative of initial minor settling and/or masonry shrinkage. However, the cracks needs to be closely monitored by the homeowner, as any cracking in the foundation wall may also be indicative of foundation stress. In order to effectively monitor a crack for any movement, a crack monitor should be utilized. If additional movement/expansion of the any of the cracks is observed to have occurred, a structural engineer will need to evaluate and make recommendations as necessary.

Foundation wall crack at the left side rear corner

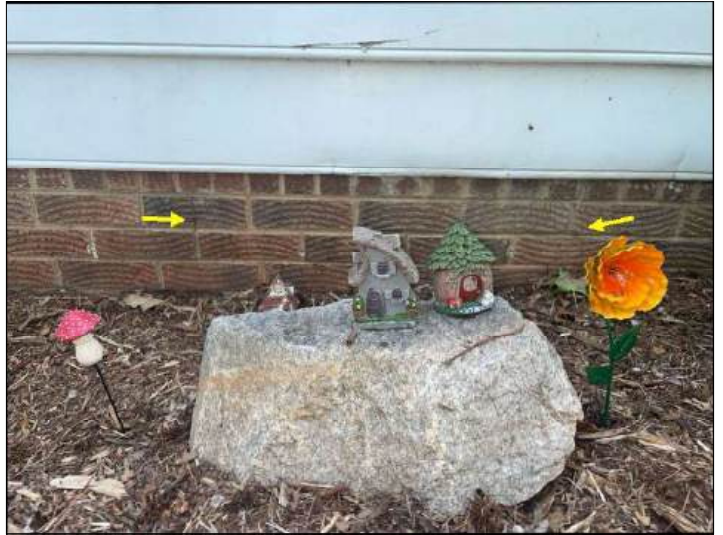
Two cracks at the left side middle area

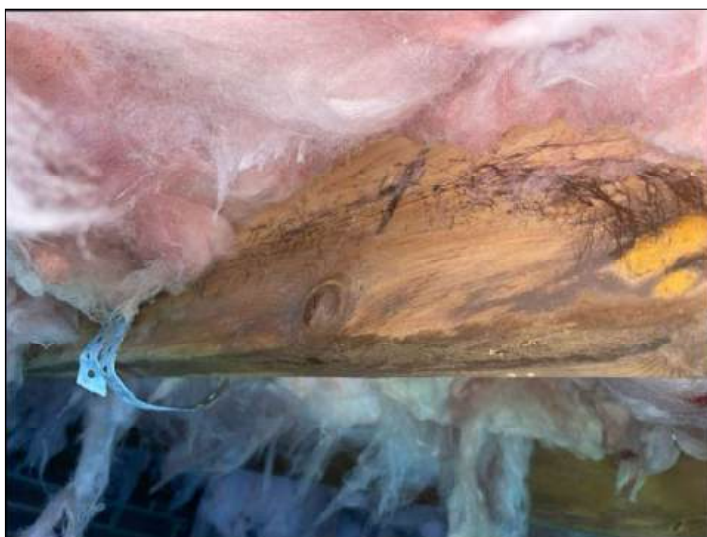
• There is sporadically located discoloration and light fungal growth on floor structure framing members and girders, which indicates a history of periods in which the floor structure framing had elevated moisture levels. Elevated moisture levels encourage fungal growth and potential damage to the structural framing. A licensed general contractor who is experienced in foundation moisture control needs to evaluate and make recommendations as necessary. As decay of structural wood components is possible as a result of elevated moisture levels, a licensed general contractor should evaluate the structural framing and wood foundation components for damage, and make repairs/recommendations as necessary. When wood framing/interior components have surface discolorations and/or decay typical of growths such as mold, mildew, and wood destroying fungi, the home inspector is concerned with the moisture concerns and evidence of wood damage; however health related issues concerning mold are beyond the scope of the home inspection. If the buyer has additional concerns related to the presence of fungal growths such as mold, an industrial hygienist should be consulted.

The veiny pattern is indicative of previously active wood destroying fungus.

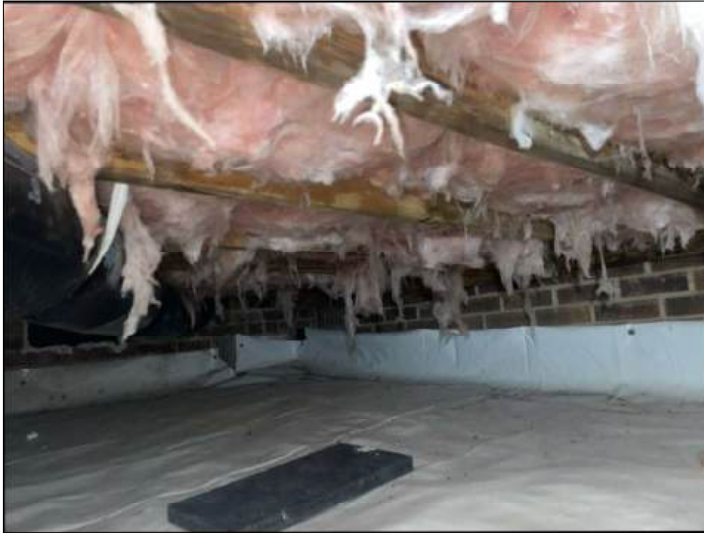
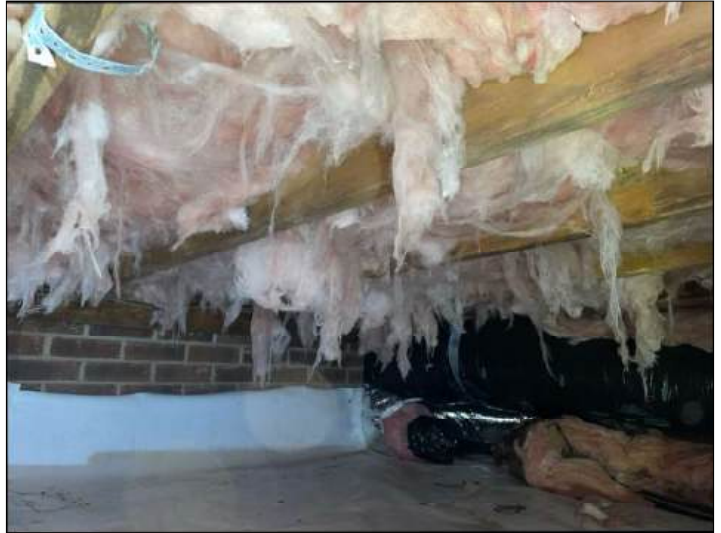
• Insulation in the right crawlspace is stripped and hanging, which is indicative of moisture exposure. Moisture can reduce the thermal value of insulation and render it useless. Wet/damp insulation can transfer moisture to structural framing, encouraging fungal growth and subsequent damage to structural framing. A licensed general contractor or otherwise qualified repair contractor needs to evaluate and make repairs as necessary.

Stripped insulation in the right crawlspace

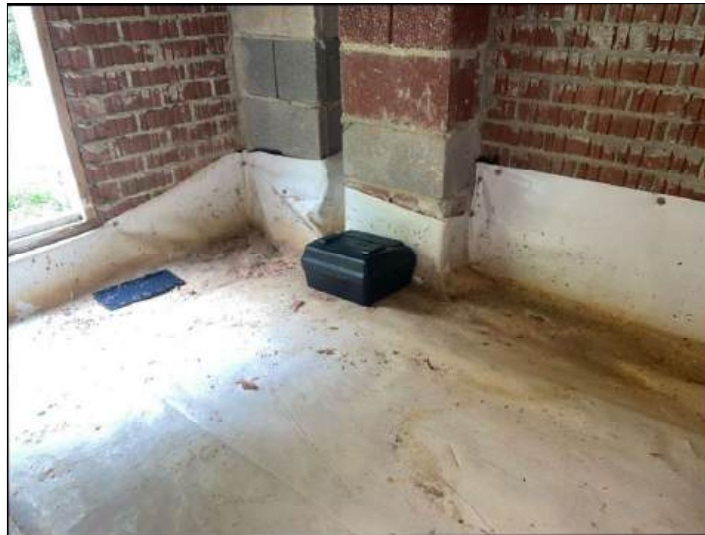
• I was unable to locate the foundation gravity drain. The gravity drain should be located at the lowest area of the crawlspace(s). The plastic at these points are pinned into the corner. If a drain exists under the plastic, water would be obstructed from entering the drain pipe and thereby become trapped. If no drain is present in this area, water would puddle and become trapped. Foundation systems need to be equipped with a functional drain, in order to provide a means for water escape in the event that water enters the crawlspace. Trapped water in the crawlspace can saturate the soil next to and below the foundation footer, thereby encouraging foundation stress. A licensed general contractor needs to evaluate and make recommendations as necessary.

A foundation gravity drain should be located at the lowest point of the crawlspace.

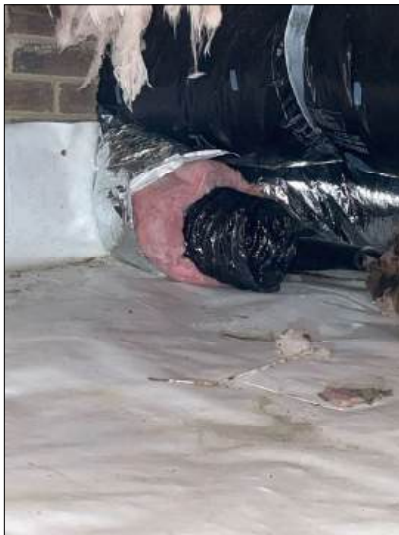
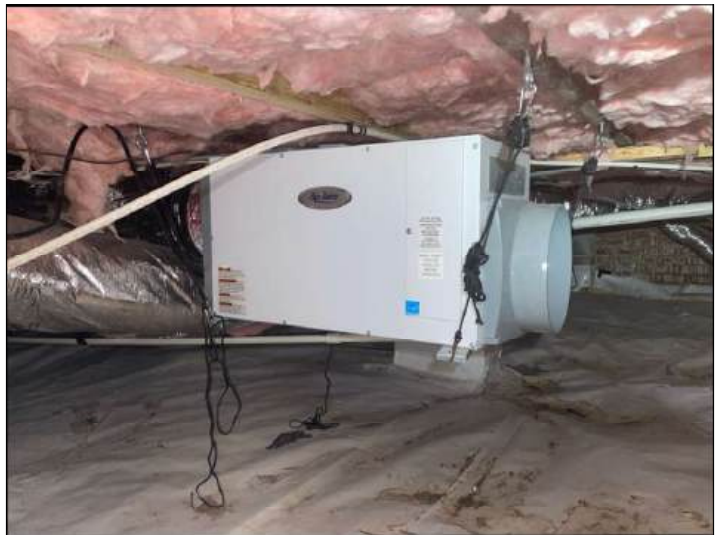
• Based upon the stripped/hanging insulation, there is limited ventilation/air flow through the right side crawlspace. Poor/limited ventilation can result in elevated moisture levels, fungal growth, and subsequent structural damage. A licensed general contractor who is experienced in foundation ventilation and moisture control, needs to evaluate and make recommendations/repairs as necessary.

There is a duct extension from the dehumidifier to the right crawlspace. The dehumidifier is located in the left crawlspace.

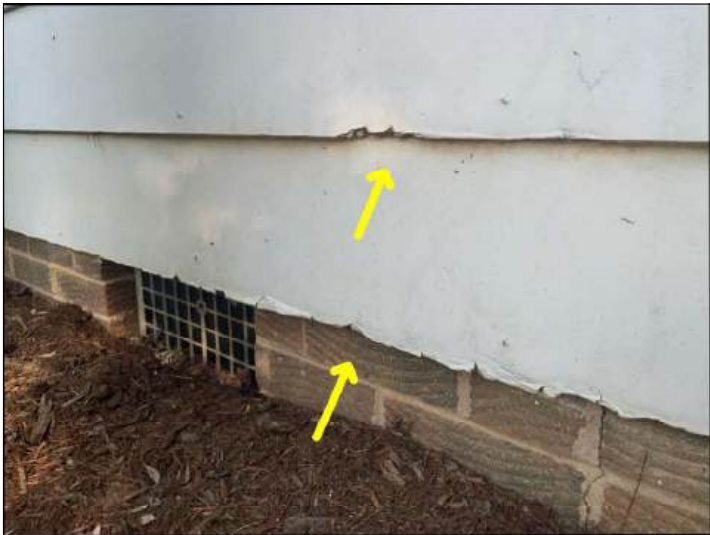
- There is rotted hardboard siding at the following locations...(1) the front side right lower two courses (2) the right side front upper section of the wall (3) the right side middle area (4) a few impacted courses at the rear side right. Rotted hardboard siding needs to be replaced by a licensed general contractor, as it is a progressive problem that can spread to and damage other building components including structural framing members. Due to the progressive nature of water damaged hardboard siding, damage which was not visible at the time of inspection may be present. The attending contractor needs to inspect for hidden damage adjacent to the listed damaged siding area(s) as well, and make repairs as necessary.

Damaged siding at the front side right

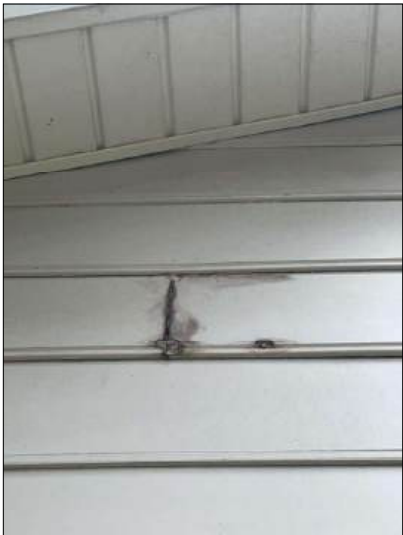
Damaged siding at the right side front

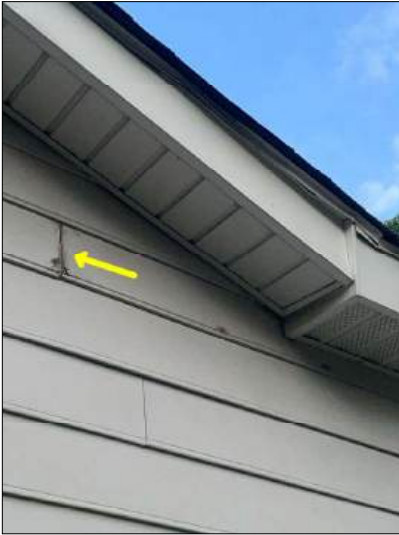
Damaged siding at the right side middle area

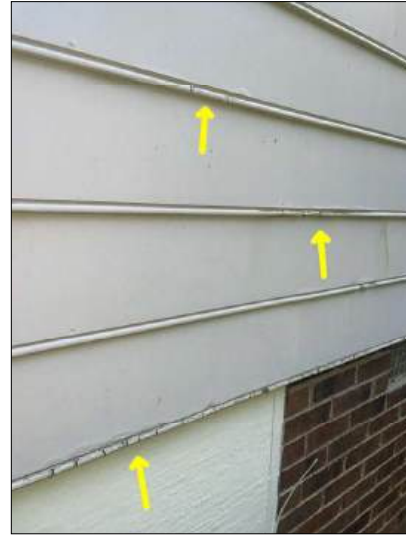
Damaged siding at the rear side right

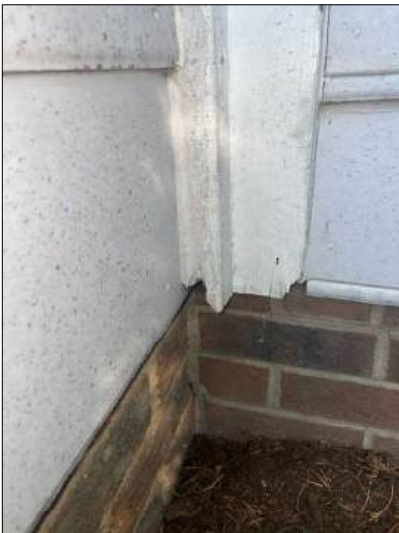
• There is verifiable or suspected rotted and/or decayed wood trim at the following locations...(1) the inside corner trim at the front side right (2) the right front corner. Rotted wood trim needs to be replaced by a licensed general contractor, as it is a progressive problem that can spread to and damage other building components including structural framing members. Decayed wood which may be currently dry, is in a weakened condition, and is vulnerable to further decay as a result of water exposure. Due to the progressive nature of rotted and/or decayed wood, damage which was not visible at the time of inspection may be present. The attending contractor needs to inspect for hidden damage adjacent to the listed damaged trim area(s) as well, and make repairs as necessary.

Damaged trim at the front side right

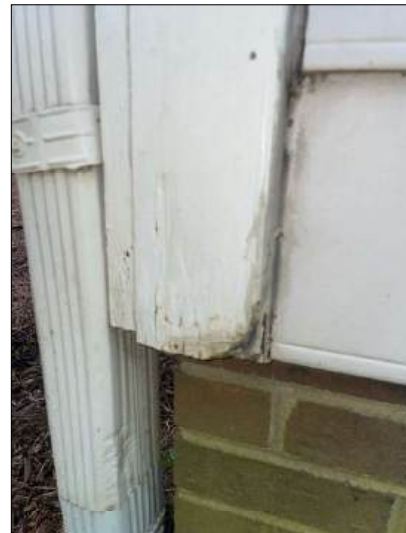
Damaged trim at the right front corner

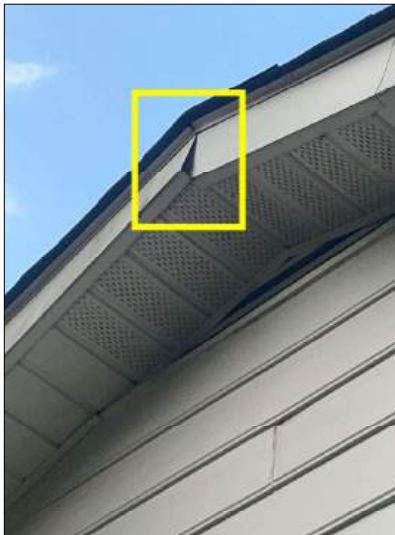
- There is loose aluminum fascia located on the right side of the house. The wood framing and roof structure behind the aluminum is vulnerable to moisture exposure and subsequent damage. A licensed general contractor needs to make repairs as necessary.

Loose metal fascia on the right side

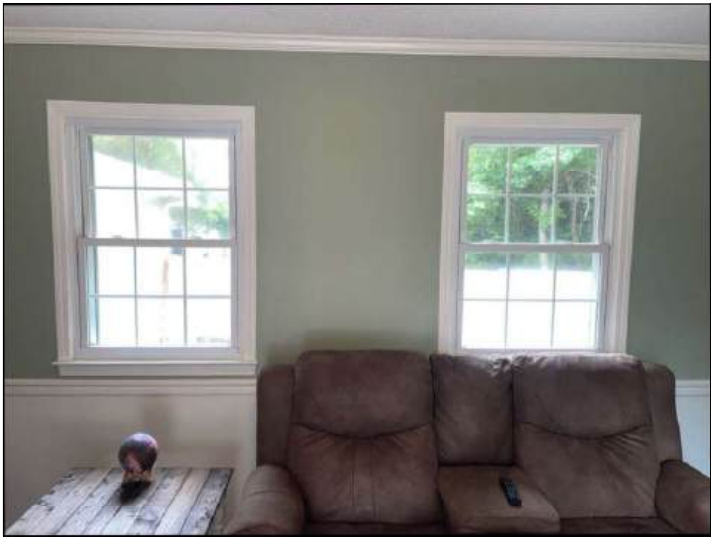
• There is condensation, cloudiness, and/or mineral deposits between the glass panes of the following windows...(1) the frontmost window, located on the left wall of the rear left sitting room (2) the rearmost window, located on the left wall of the rear left sitting room (3) the upper sash of the window located on the front wall of the front side leftmost bedroom. This is indicative of a failed seal, which causes a reduction in the thermal performance of the window (less efficient). Moreover, the fixed glass picture window located on the front wall of the dining area appears to have a defective hermetic seal as it is hazy. I am unable to say for sure due to the fact that the window is dirty, and as such need to be cleaned in order to make a proper assessment. The impacted windows are more vulnerable to heat gain during hot weather periods, and heat loss during cold weather periods. Heat gain/loss encourages the HVAC system to operate for longer and more frequent periods of time, in an effort to maintain the desired thermostat set-point temperature. These longer HVAC run times can cause the system to experience otherwise unnecessary wear and tear, which may shorten the usable life of the HVAC system. The windows need to be evaluated by a qualified window installer/repair contractor, or otherwise qualified licensed general contractor, and repaired or replaced as necessary. Due to age and material similarities, it is reasonable to expect that other windows have defective hermetic seals as well, but may not be currently exhibiting visual indication, or may not be clean enough to make a definitive assessment. I recommend that the attending contractor evaluate all windows, and make recommendations as necessary.

Cloudiness, mineral deposits, and/or condensation between the glass panes is indicative of a failed hermetic seal.

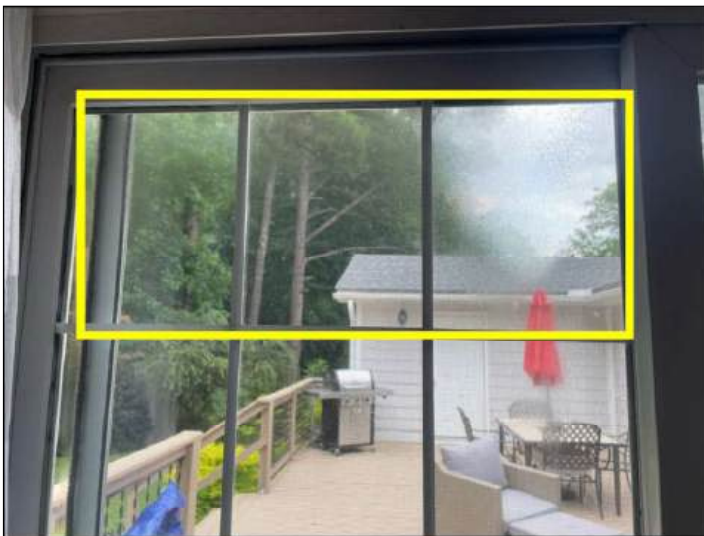
• There is condensation and/or mineral deposits between the glass panes of the sliding glass door rear panel. This indicates a failed seal, which results in a loss of thermal performance and efficiency of the door. As such, this door is more vulnerable to heat gain during hot weather periods, and heat loss during cold weather periods. Heat gain/loss encourages the HVAC system to operate for longer and more frequent periods of time, in an effort to maintain the desired thermostat set-point temperature. These longer HVAC run times can cause the system to experience otherwise unnecessary wear and tear, which may shorten the usable life of the HVAC system. A licensed general contractor needs to evaluate and repair or make recommendations as necessary.

Condensation between the glass panes is indicative of a failed hermetic seal.

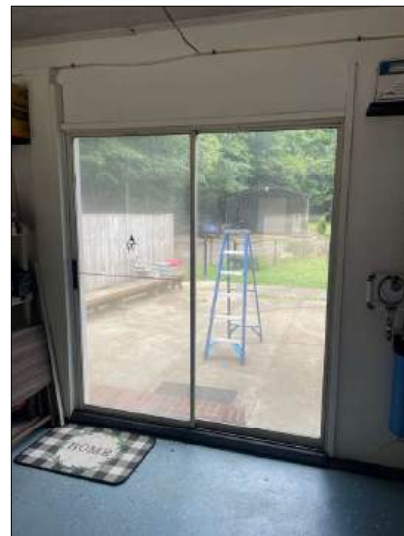
The garage to exterior sliding glass door panes appear to have a defective hermetic seal.

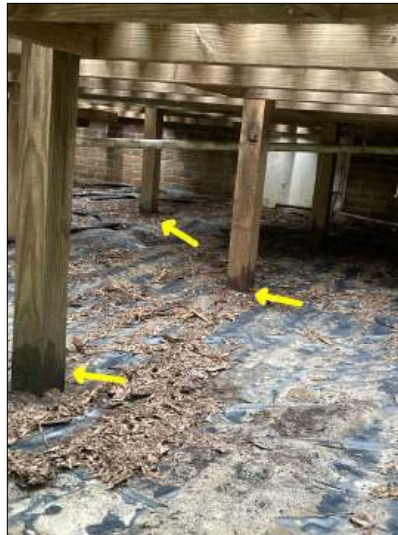
- There appears to be some level of wood decay at the base of deck floor structure stiff knee support columns. Rotted/decayed wood is a progressive problem that weakens the structural integrity of the columns, and will eventually lead to their failure. A licensed general contractor needs to evaluate and make repairs. Due to age, material and location similarities, it is probable that other wood foundation support columns have experienced a level of decay that can compromise their structural integrity as well. As such, the attending contractor should evaluate all sides of all deck related columns, and make repairs/recommendations as necessary.

There appears to be some level of wood decay at the base of stiff knee supports.

| Page 28 Item: 11<br><br>New beams and new footings installed on 7/25/26 | Deck Columns | <ul style="list-style-type: none"><li>• There appears to be some level of wood decay at the base of deck floor structure stiff knee support columns. Rotted/decayed wood is a progressive problem that weakens the structural integrity of the columns, and will eventually lead to their failure. A licensed general contractor needs to evaluate and make repairs. Due to age, material and location similarities, it is probable that other wood foundation support columns have experienced a level of decay that can compromise their structural integrity as well. As such, the attending contractor should evaluate all sides of all deck related columns, and make repairs/recommendations as necessary.</li></ul> |

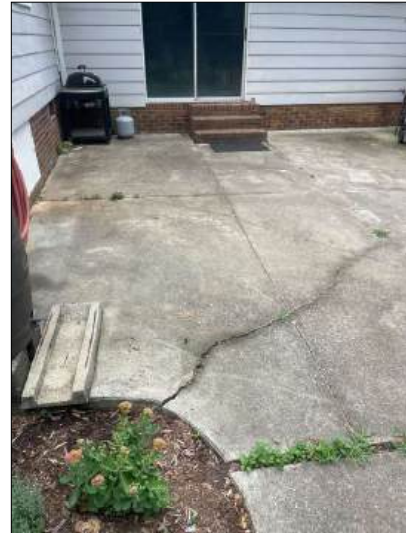
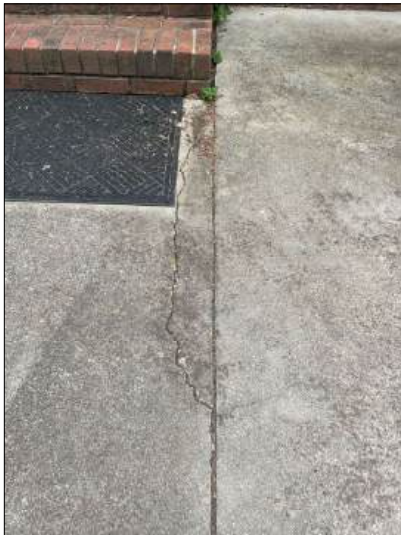
- There is a concrete patio located at the rear side of the house.
- There is cracking in the patio. The cracks should be sealed in order to deter water penetration, which can wash away and/or shift soil under the slab, thereby further encouraging patio slab stress. Moreover, the most significant crack has translation. As such, the standing edge presents a safety concern. A licensed general contractor or otherwise qualified repair contractor needs to evaluate and make repairs as necessary.

Patio cracks should be sealed

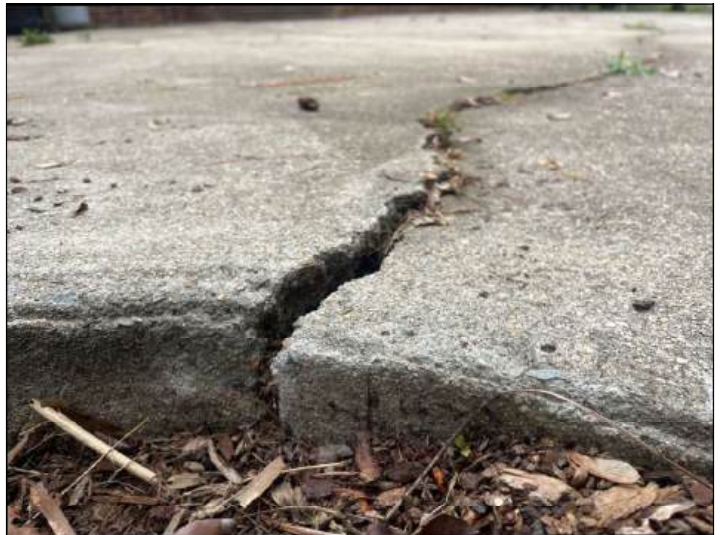
The most significant patio crack has translation.

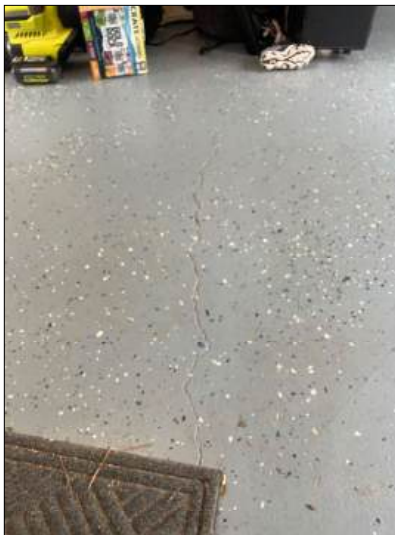
- There is a crack in the garage slab, with an approximate width of hairline to 1/16". Ongoing observation by the homeowner is necessary. Expansion of the crack may be an indication of slab stress, which can weaken the slab, as well as skew the slab plane. If additional movement of the crack is observed to have occurred, a licensed general contractor or otherwise qualified concrete contractor should be consulted for evaluation and recommendations made as necessary.

Garage slab crack

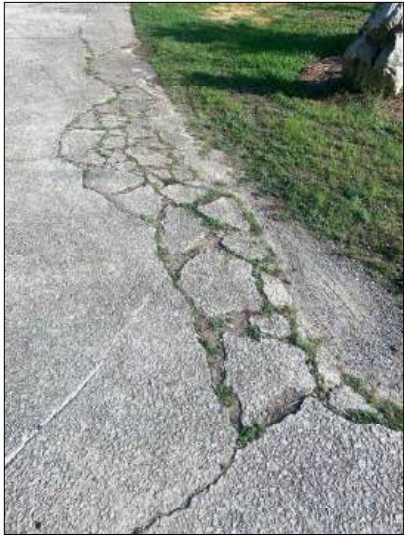
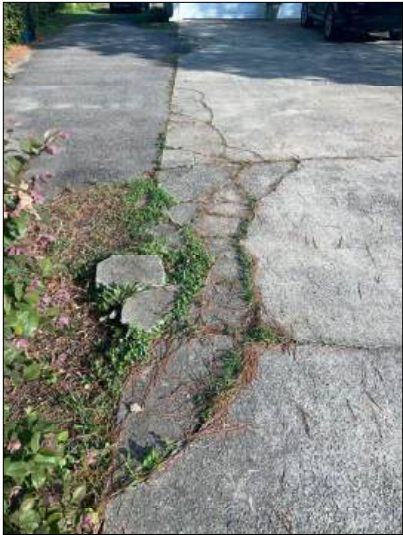
• The concrete driveway has areas that are broken into a myriad of small pieces. This results in many gaps through which water penetration occurs, primarily during rainy weather conditions. Water penetrating through the driveway saturates the soil below the driveway, thereby reducing the bearing capability of the soil, and subsequently encouraging sinking of the driveway. This should be considered to be a progressive problem, as sinking of the driveway results in low areas at which further water puddling occurs. I recommend evaluation by a qualified concrete contractor.

Broken concrete

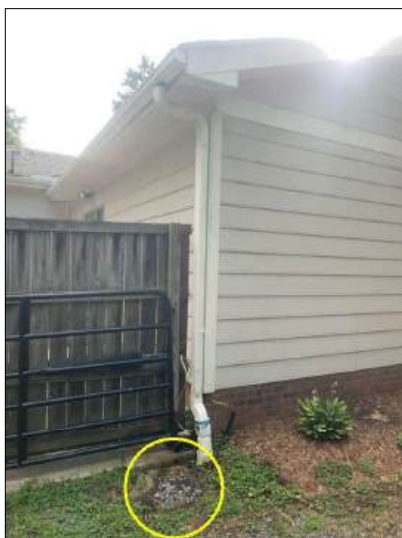
• There is evidence that gutter overflow or gutter leaks occur at the following locations...(1) the left rear corner (2) the front right corner area. Water that washes over the gutter is then deposited at areas close to the foundation wall. The soil around the foundation footing can become saturated and soft, thereby encouraging foundation stress and water penetration into the crawl space. In addition, gutter over wash can cause damage to exterior cladding components and adjacent structural framing. A licensed general contractor or otherwise qualified gutter installer/repair contractor needs to evaluate and make repairs as necessary.

The ground depression at the rear left corner.

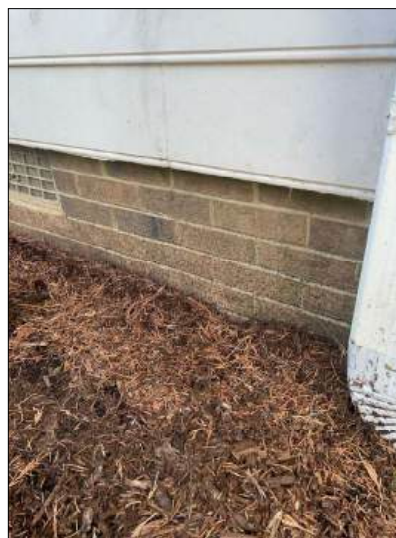
Organic debris splattered onto the foundation wall at the front right corner, is indicative of gutter overflow.

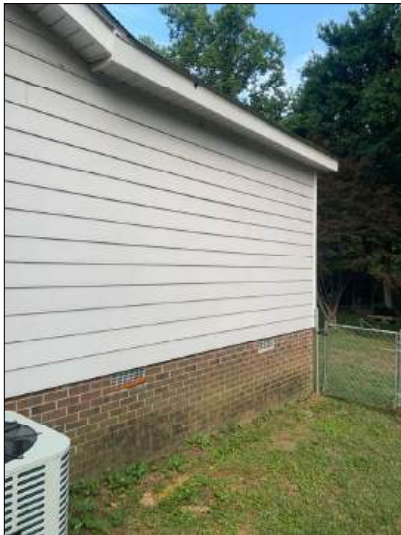
There is no gutter installed on the right side rear. Note the elongated ground depression and the foundation wall staining. These are the result of water deposited onto the ground and splattered against the foundation wall.

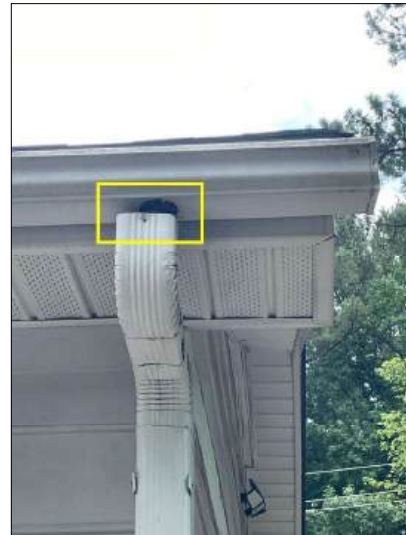
Disconnected downspout at the rear left corner

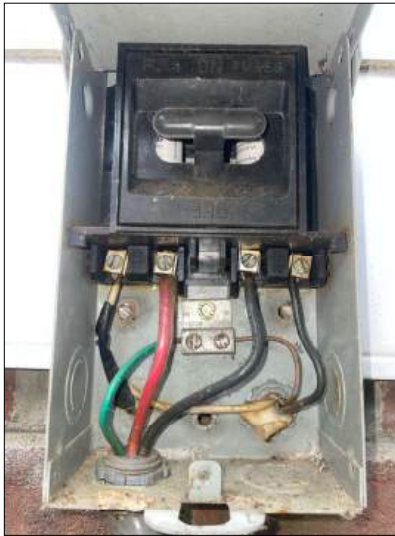
• The HVAC electrical disconnect box, which is an electrical box installed within close proximity to the outside coil unit, that contains a device which can be easily removed in order to shut off power to the outside coil unit, contains no hand shield. Energized electrical conductors and contacts are accessible within the box, which presents an electrical safety hazard. A licensed electrician should install hand shield in order to prevent an electrical shock.

Energized conductors and contacts are accessible

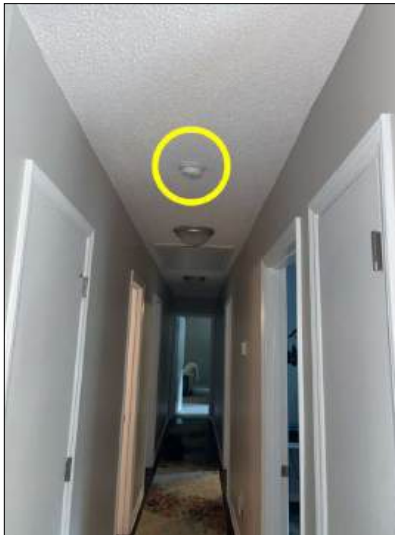
• This home has poor smoke/fire alarm coverage. Preferably, smoke/fire alarm coverage should be provided at areas adjacent to and/or inside each sleeping room; as well as living room areas where a fireplace, gas logs, laundry, garage and/or kitchen is located close by. Functional smoke/fire alarms are an invaluable safety device inside the home. When functioning properly, alarms alert home occupants to smoke and fire danger. I recommend having a licensed electrician evaluate and replace/install alarms in concurrence with present/modern standards.

There is one smoke/fire alarm (battery operated) present, which is located at the left end of the interior hallway.

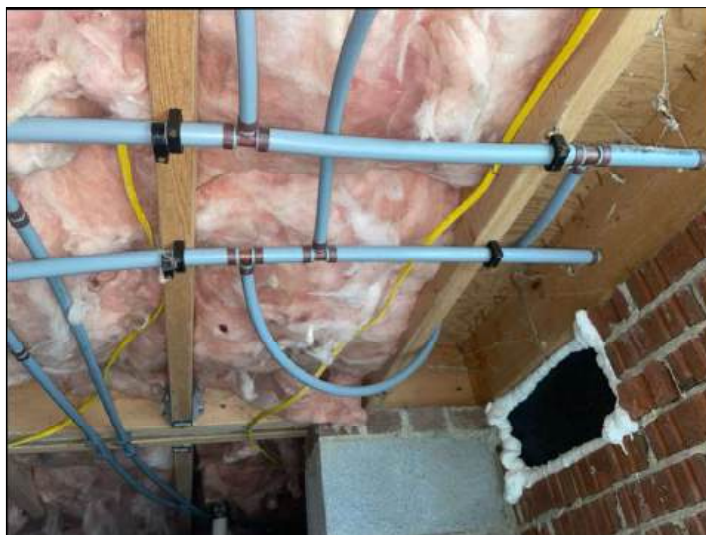
• **This home has a plumbing supply system that uses polybutylene plastic distribution lines, copper directional fittings and copper compression band fittings. Even though this plumbing system was installed in many homes from 1978 until the mid 1990's, it is no longer an approved plumbing system due to a history of material failures. The failures were related to improper installation, improper handling, improper storage, and plastic deterioration due to chemical reactions with the water supply. Due to the nature of this latent defect, it was not possible to adequately access the condition of the plumbing system during the home inspection. A licensed plumbing contractor should be consulted for a complete evaluation of the plumbing system to determine the significance of this concern.**

PB piping with copper directional fittings and copper compression band fittings

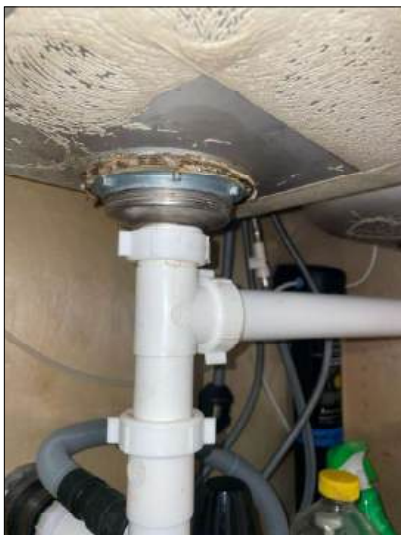
• There are water leaks underneath the kitchen sink left basin basket fitting. Water leaking underneath the kitchen sink causes damage to the wood cabinet and can create an environment which is conducive to fungal growth. The water can then penetrate into the floor structure, causing rot damage. A licensed plumber needs to evaluate the source of the leak and make repairs as necessary.

There are leaks around the kitchen sink left basin basket fitting.

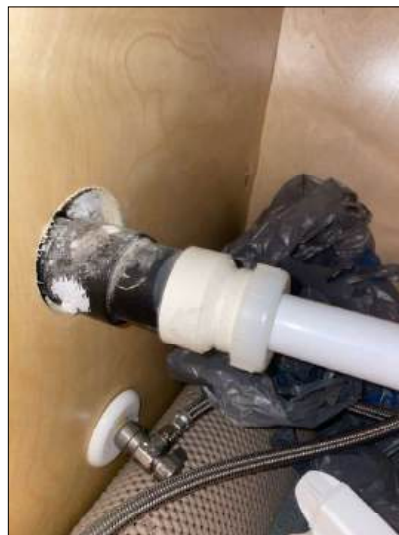
PVC to ABS pipes should be mated using a coupler fitting, as opposed to being glued together.

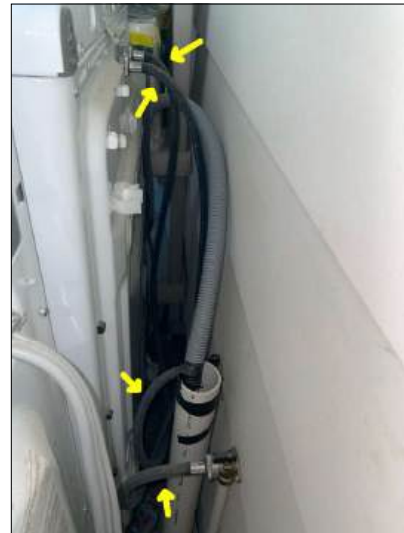
I recommend proactive replacement of the rubber fill lines, with stainless steel braided flex lines.

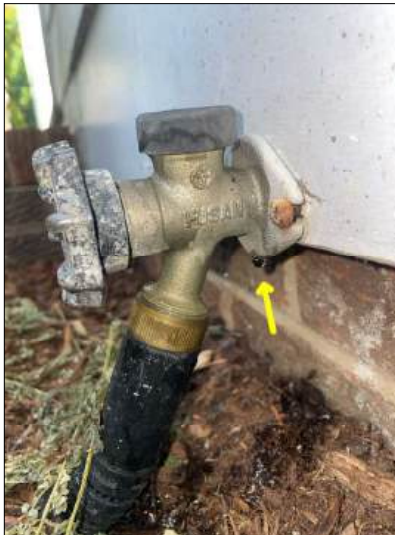
| Page 54 Item: 9<br>Repairing on 8/12/26 | Exterior Fixtures | <ul style="list-style-type: none"> <li>There is a water leak from the supply line to the back of the exterior hose bib spigot, at the right of the front entry stoop. This can result in water exposure and subsequent damage to the adjacent floor structure framing. A licensed plumber needs to evaluate and make repairs.</li> </ul> |

Water leaks from the supply line to the back of the fixture.

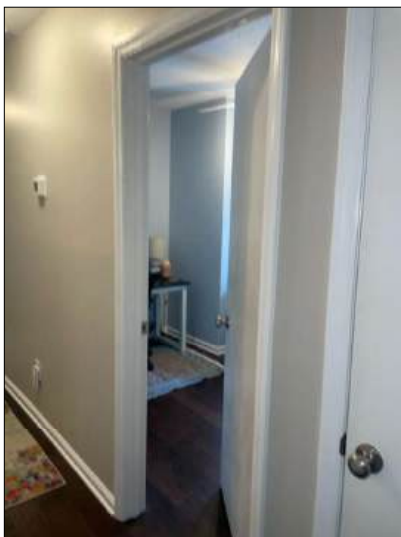
| Page 62 Item: 6<br>Repaired<br><br><br>Repaired | Doors | <ul style="list-style-type: none"> <li>The entry door for the front side leftmost bedroom does not latch closed, and therefore does not function properly. This presents an issue of privacy as the door can be opened without the use of the knob, when the room is in use. A licensed general contractor or otherwise qualified repair contractor needs to evaluate and make repairs as necessary.</li> <li>The rear side middle bedroom entry door drags along the floor. This can result in damage to the interior floor covering as well as difficulty in operating. In addition, this hinders the HVAC system from pulling air out of the room, through the air return system. Moreover, the door does not close completely, as it contacts its frame. This issue results in an interruption of privacy within the bedroom. A licensed general contractor or otherwise qualified repair contractor needs to evaluate and make repairs as necessary.</li> </ul> |

The front left bedroom entry door does not latch closed.

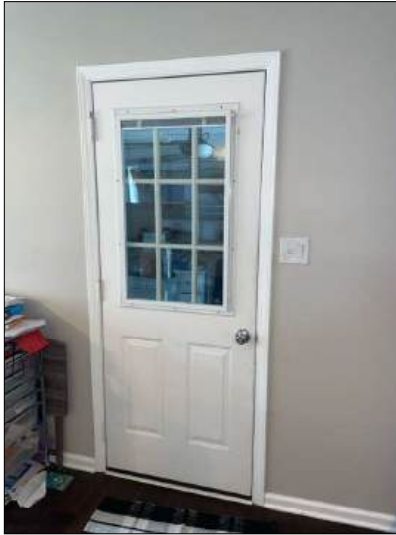
| Page 62 Item: 8 | Interior Spaces | <ul style="list-style-type: none"><li>• The garage to home entry door has glass panels (glazing). Although this door may be original to the home, or among the same general style of other doors for the home, it is strongly not recommended for garage to home entry doors to contain glass panels. This is due to the reduction in the fire resistant properties of the door. I recommend that this door be replaced with a solid core exterior door, that meets current fire safety recommendations and guidelines. A licensed general contractor should be consulted for evaluation and recommendations.</li></ul> |

Glass panels in the garage to house entry door, reduce its fire rating.

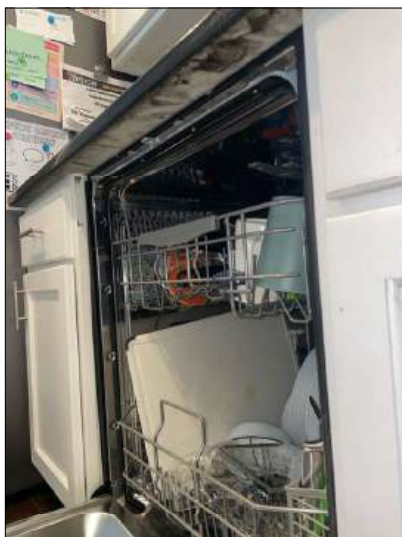
There are no attached anti-tip brackets
