## 4: HVAC

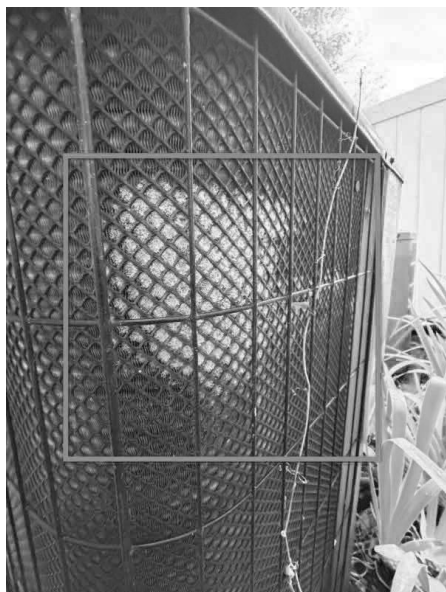
The HVAC system(s) should be cleaned and serviced periodically, especially in older units to ensure proper chemical levels and operation as a typical home inspection can only determine proper operation with the use of normal controls. Recommend a qualified HVAC contractor clean and service to ensure proper operation if seller cannot confirm when unit was last serviced.

Older exterior condensing unit

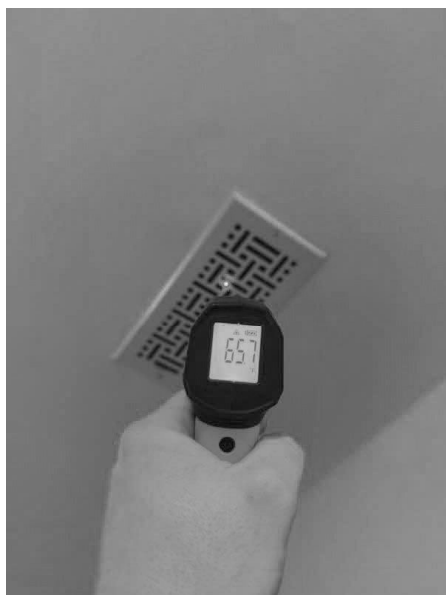
Unit was operating in cooling mode at the time of inspection, however, very little conditioned air was produced. Recommend a qualified HVAC technician evaluate and repair or replace as needed.

1st floor cooling. Higher than typical supply temp

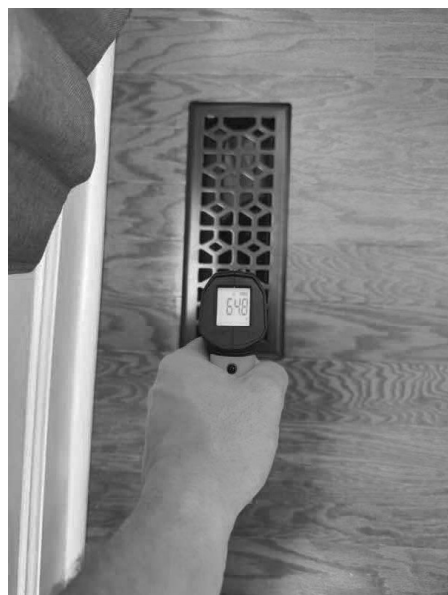
2nd floor. Higher than normal supply temp

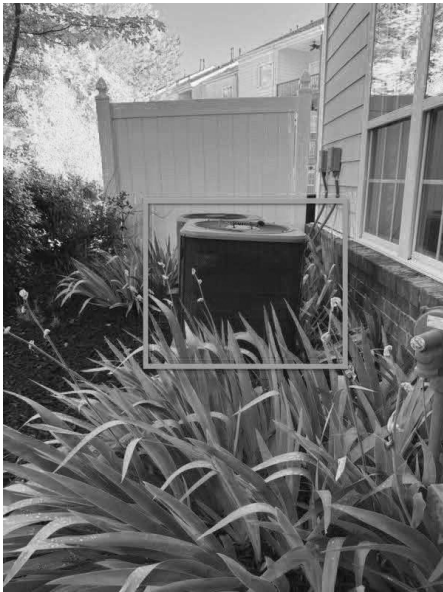
The HVAC unit is on an unlevel surface. The vibrations from running the unit can cause the unit to slide off damaging the unit. We recommend licensed HVAC technician or builder further evaluate and repair as needed.

Older unit not level

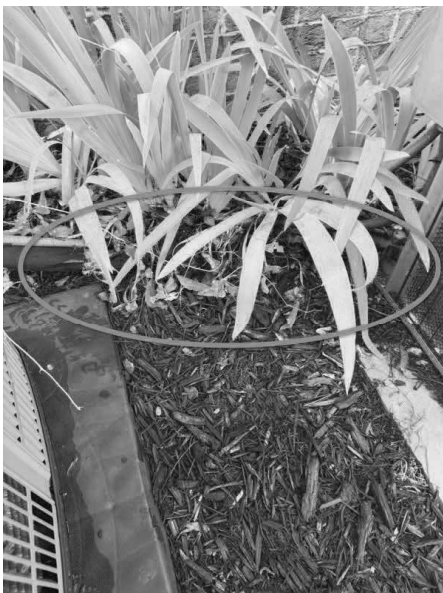
Older unit line set

The grading or mulch is covering the unit or lines in a way. This can accelerate deterioration of these areas. Recommend qualified contractor further evaluate and re grade area, or uncover components as needed.

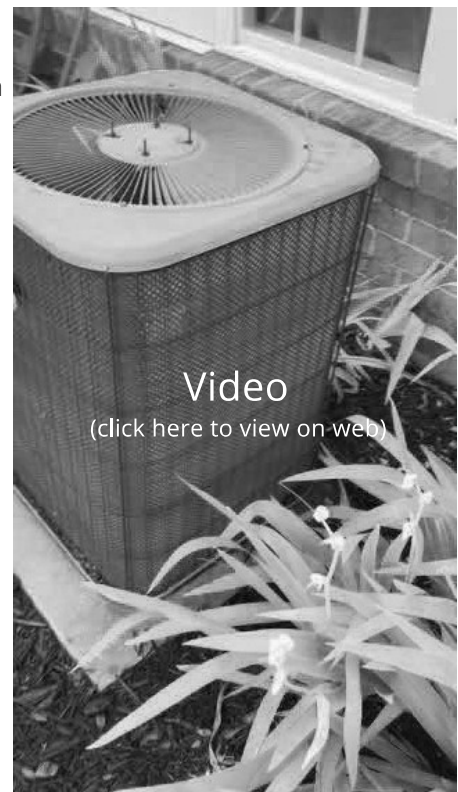
VIDEO1- EXTERIOR UNIT MAKING ABNORMAL SOUNDS UNDER OPERATION

The HVAC unit was not operating properly in some way. This could indicate failure of components, incorrect installation, or can indicate the need for a normal servicing. Recommend licensed HVAC technician further evaluate and recommend repairs or replacements.

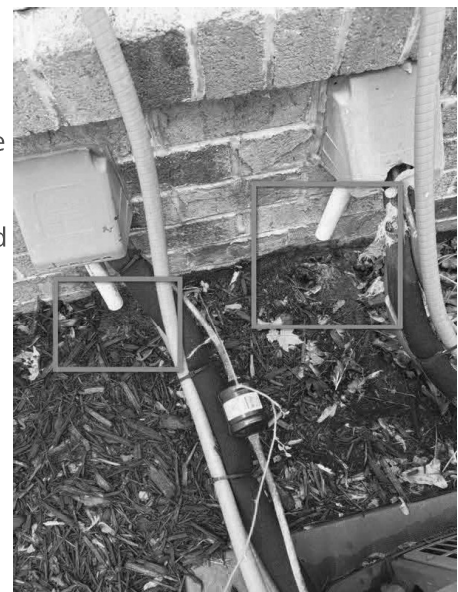
Rear exterior

The condensate line for the HVAC system is draining closely to the foundation or into the crawlspace area. Over time this could accelerate shifting to the surrounding soil and foundation. If this is new construction, the builder has installed this correctly. It is good practice to divert water farther away from the home or HVAC pads. Recommend a qualified contractor further evaluate and direct water away from the structure if so desired.

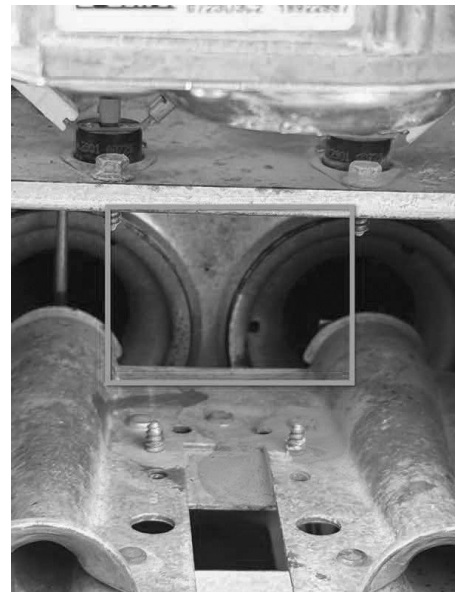
1st/2nd floor furnace

The system was corroded in one or more areas. This can shorten the life of the unit and in some scenarios pose a carbon monoxide concern. Recommend a licensed HVAC contractor further evaluate and repair if needed.

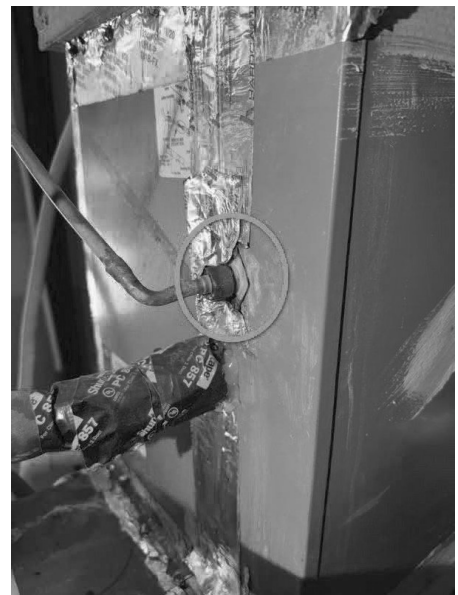
The unit is leaking conditioned air into an unconditioned space. This can lessen the efficiency of the unit, and also allow for condensate to form and damage surrounding components. This also can pose a safety concern if this air interrupts proper ventilation of a gas unit. Recommend licensed HVAC technician evaluate and repair as needed

Garage utility room furnace. Leaking conditioned air

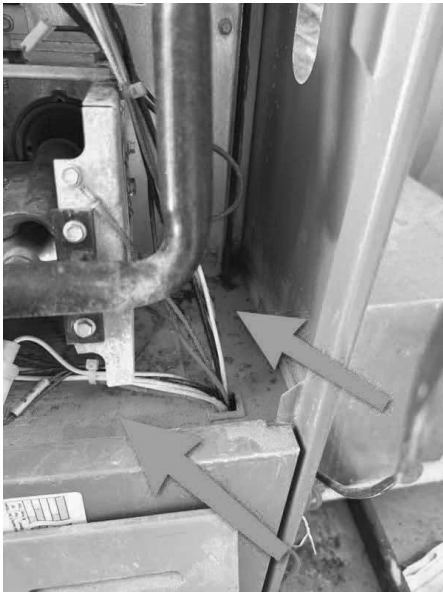
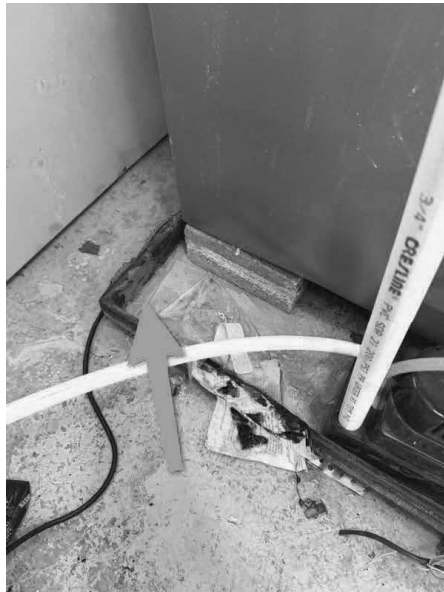
Garage utility room furnace

There was moisture staining in and around the furnace. . This normally indicates a previous blockage in the primary condensate line, but can also indicate a loss of conditioned air in these areas. Due to pan rust in some scenarios, it is not possible to determine the integrity of the pan itself or protection from future leaks. Recommend licensed HVAC tech further evaluate and repair as needed.

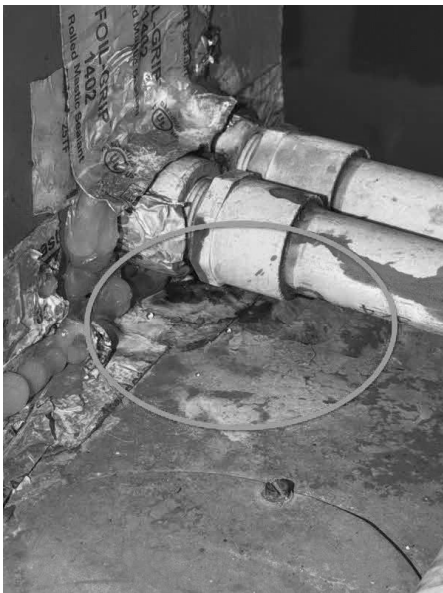
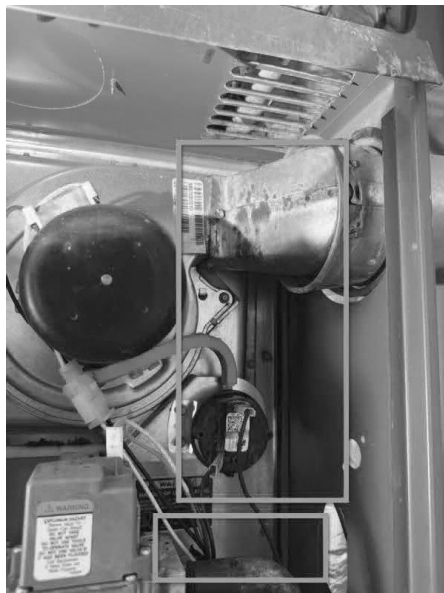
1st floor furnace

The unit is condensating in the surrounding areas. This can contribute to moisture build up, and damage surrounding components. Recommend licensed HVAC technician further evaluate and recommend path to repair.

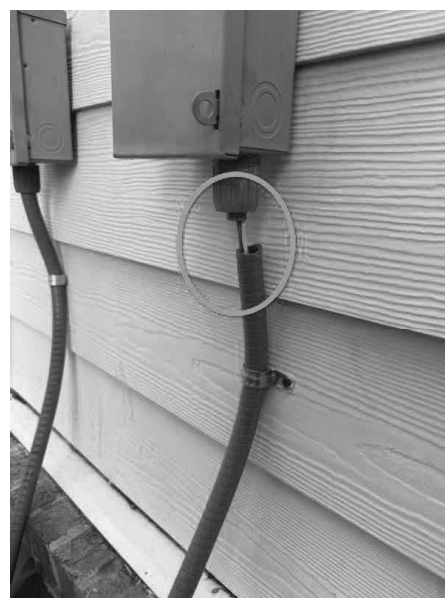
There were exposed wires during the time of inspection. This can pose a shock hazard. We recommend proper installation of wire covers, outlet boxes, ect. installed by a licensed electrician.

Rear exterior, hvac disconnect wiring/flex conduit

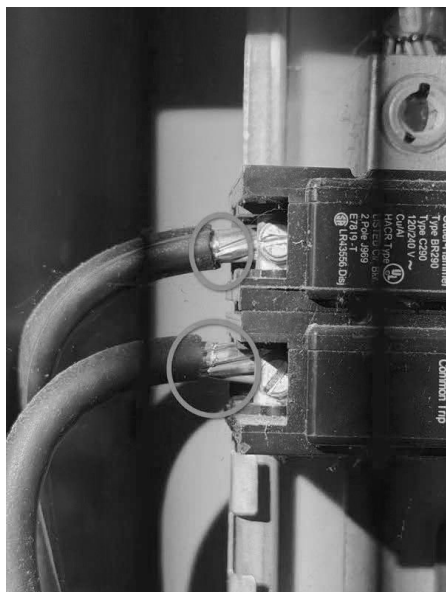
Rear exterior panel box

The breaker wiring or conductor was damaged/cut in some way. This can prevent proper operation, allowing for arcing or overheating of circuit. Recommend licensed electrician further evaluate and repair as needed.

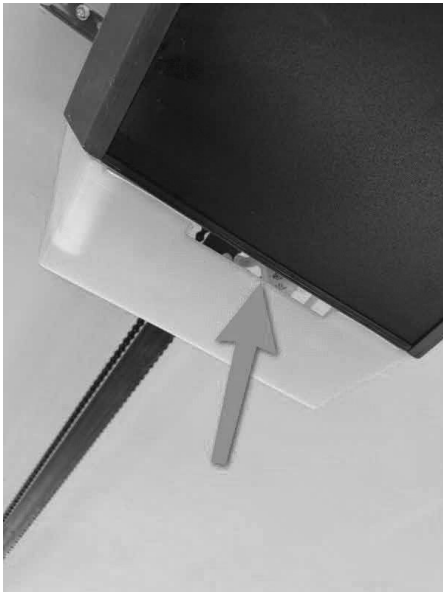
Garage door motor light bulb

One or more lights or switches are not operating. This could indicate an improper installation, or possibly a missing or expired bulb. Recommend a qualified contractor further evaluate and repair / replace.

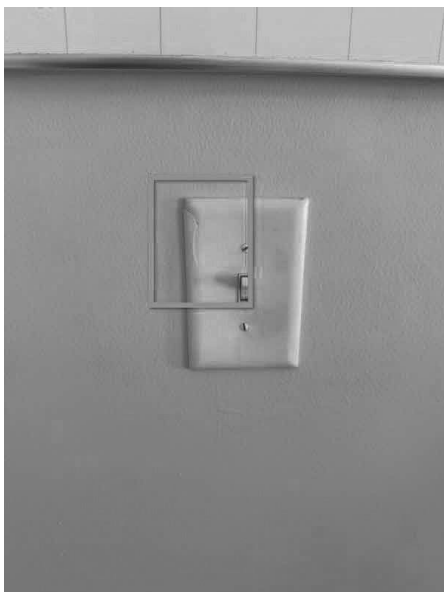
3rd floor front bedroom

The fixture/receptacle/control had general damage. This can hinder proper illumination or operation of desired areas. Recommend qualified contractor repair / replace as needed.

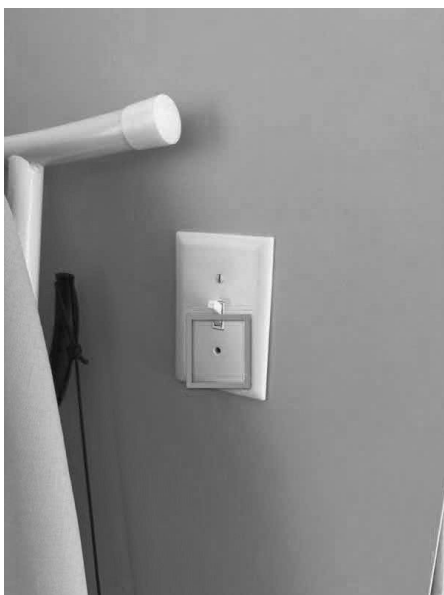
3rd floor front bedroom

One or more receptacle / switch covers were missing a screw. This could potentially pose a shock hazard if the cover is completely removed. Recommend qualified contractor replace screws as needed.

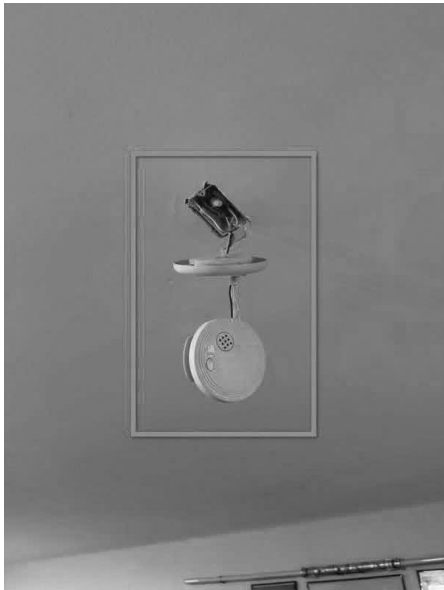
Lower level.

The smoke or carbon detector was not attached properly. This may impede proper operation and pose a safety hazard. Recommend installing all smoke and carbon detectors properly.

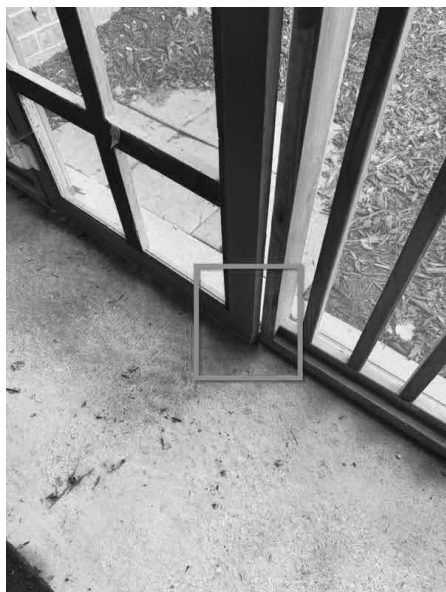
A door, or component of it, was not operating correctly in some way. This can worsen over time if not corrected or damage surrounding components. In some scenarios this is only an aesthetic concern. Recommend qualified contractor repair / replace.

Rear deck screen door. Hitting frame

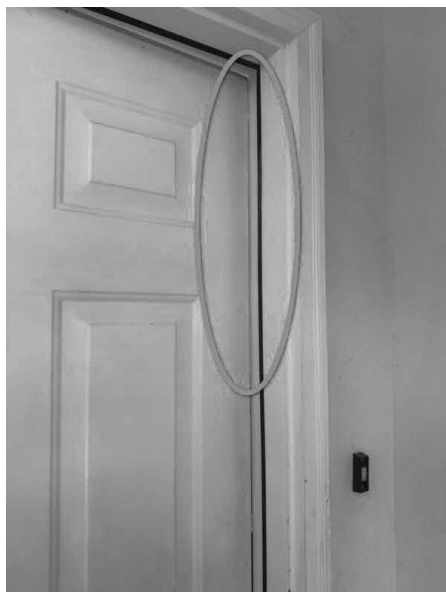
Garage entrance door. Rubbing frame

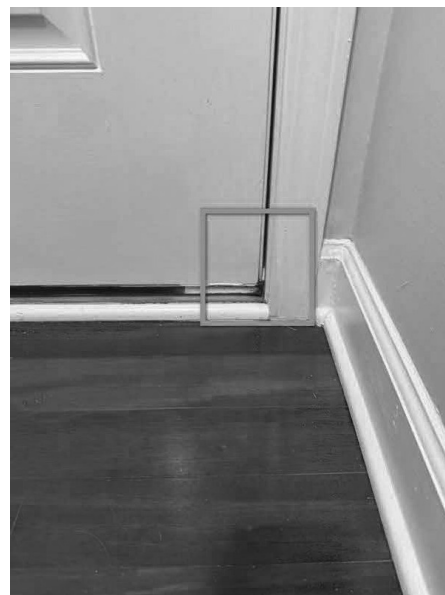
Front door

The seal on one or more exterior doors revealed daylight when shut. This could indicate a poor seal and contribute to energy loss as well as insect intrusion. Recommend a qualified contractor evaluate and repair / replace.
