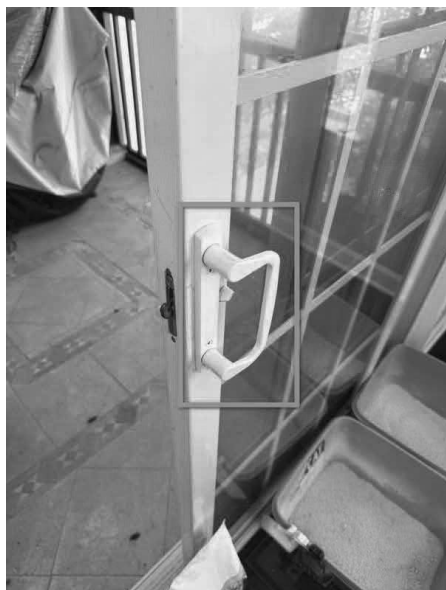
2nd floor. Rear sliding door handle

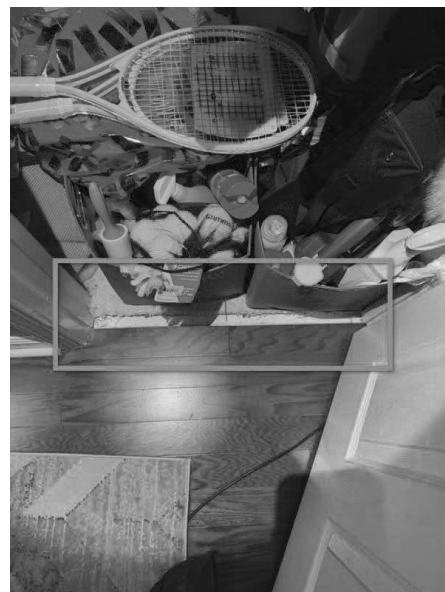
One or more areas of the flooring appeared to not be installed in the most effective manner. This can sometimes cause a trip hazard, or not perform as intended aesthetically. Recommend qualified flooring contractor evaluate and repair / replace as needed.

2nd floor hall closet. Transition strip missing

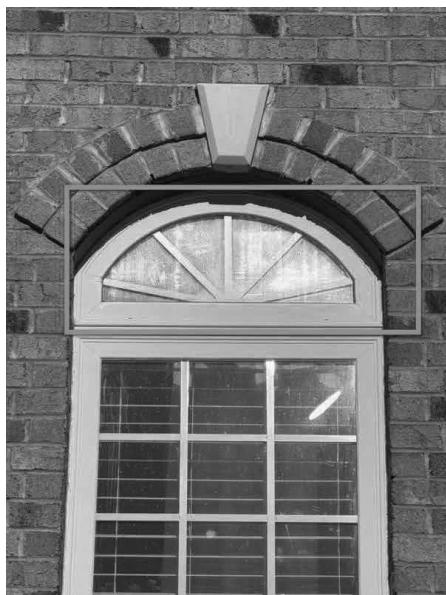
Front window

The seal appears to be broken in one or more windows. This may impact the energy efficiency of the window itself and may be a cosmetic bother in certain areas. Thermal seals are sometimes difficult to identify. A qualified window contractor should evaluate all windows for broken seals and replace or repair if desired.

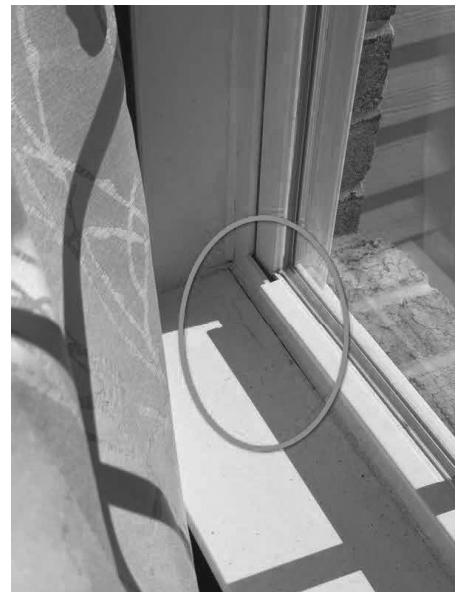
3rd floor front bedroom windows

Caulking is missing or cracked around interior of windows in several locations throughout home. This can not perform as intended aesthetically, or possibly allow a decrease of energy efficiency. Recommend qualified contractor evaluate all windows and repair as needed.

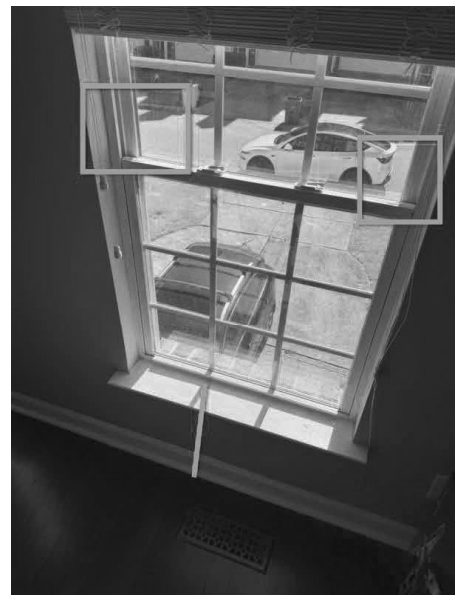
One or more windows were easily accessible by occupants and high enough off the ground to be a safety concern if a fall occurred. Recommend evaluation by a contractor to ensure proper installation where needed.

Multiple windows throughout home missing safety locks

Contact a qualified professional.

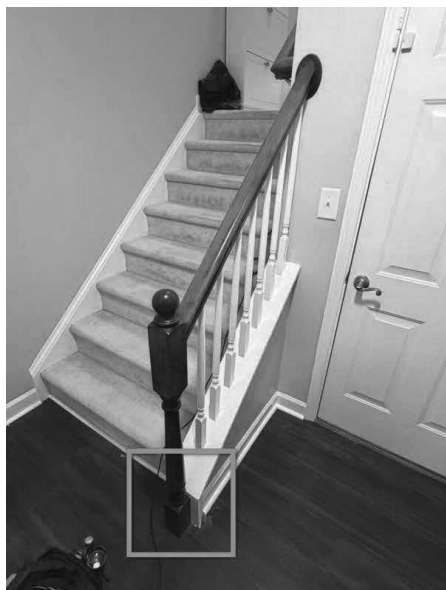
There was a loose component of the stairwell. This can worsen over time and could cause a fall hazard. Recommend loose component is tightened or replaced by a qualified professional.

1st floor staircase. Loose at base attachment

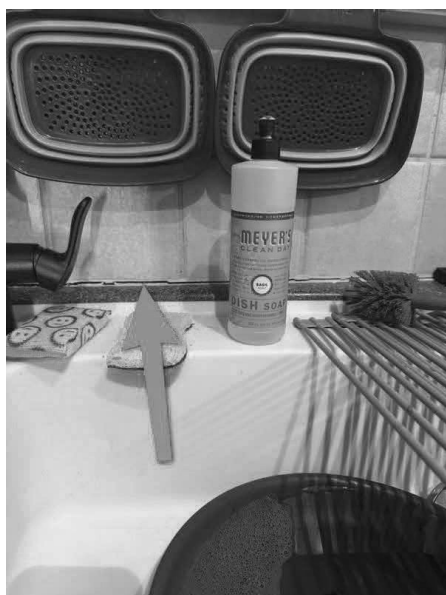
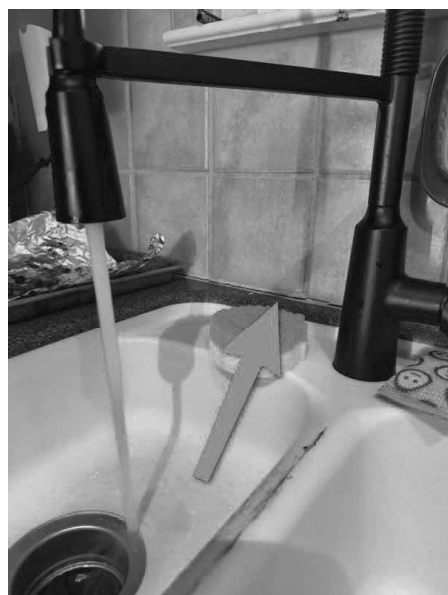
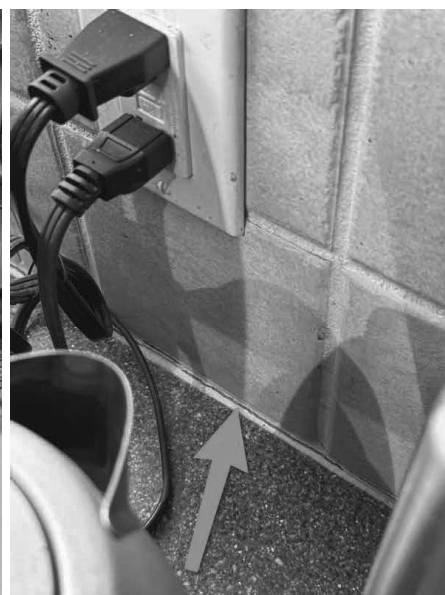
Kitchen

The countertop or wall was missing sufficient caulk/sealant/grout. This can lead to water damage in some scenarios. We recommend a qualified professional evaluate and repair as needed.

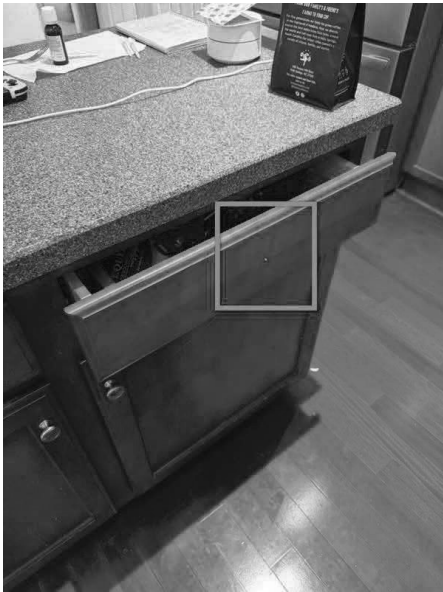
Kitchen island drawer

The cabinet appeared to have a missing component. This could hinder proper operation or not perform as intended aesthetically.

Recommend qualified cabinet contractor install, repair as needed

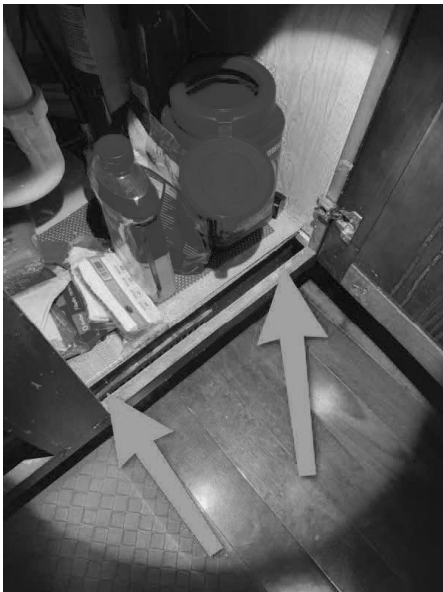
A component of the cabinet or countertop was damaged. This can prevent proper operation in some scenarios, and also present an aesthetic concern. We recommend a qualified cabinet contractor further evaluate and repair as needed.

Kitchen sink cabinet front panel and base

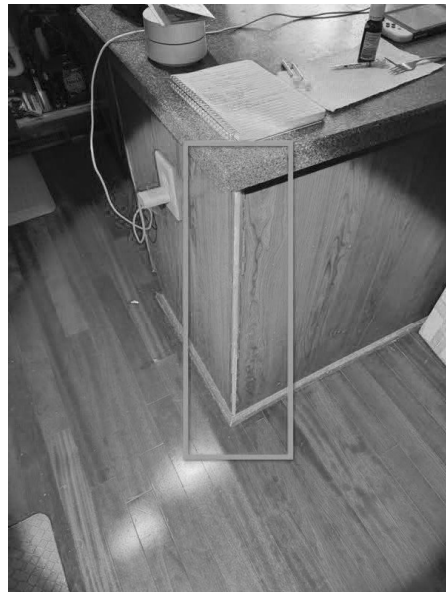
Kitchen island corner trim

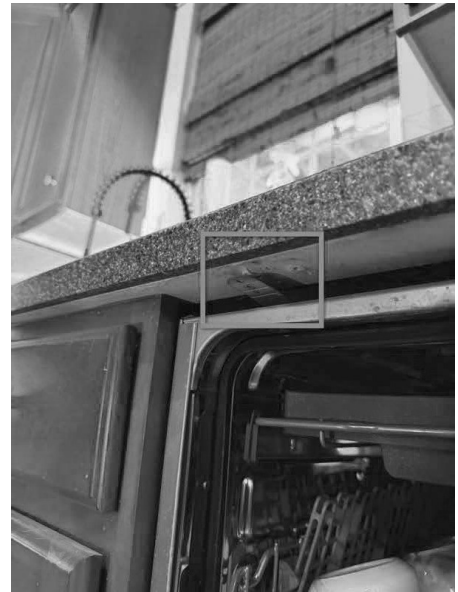
The dishwasher did not appear to be secured properly below the countertop. This can worsen over time, and possibly damage surrounding components. Recommend plumber further evaluate and repair as needed.

Left side bracket

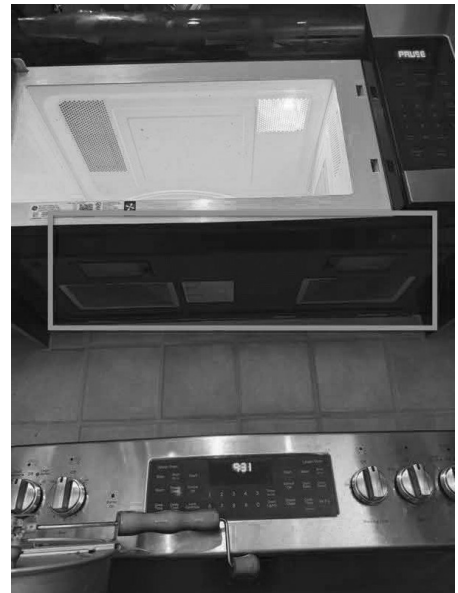
The lighting for the vent area is not operating. Recommend qualified contractor further evaluate and repair as necessary.

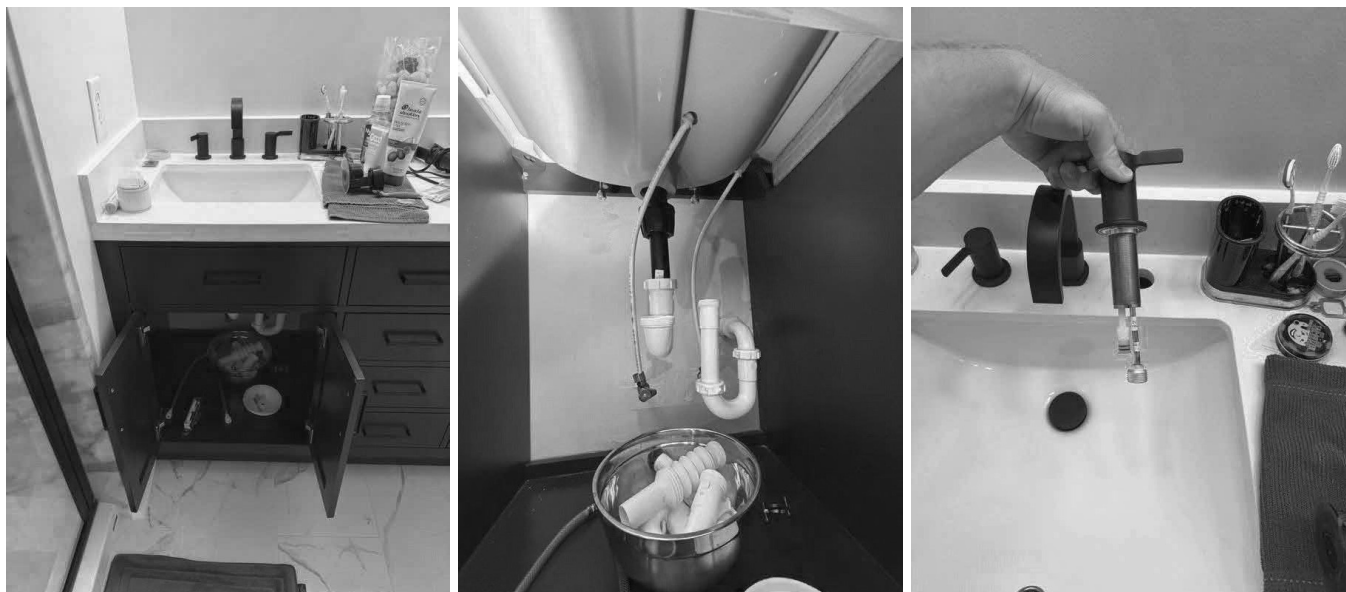
PRIMARY BATH LEFT SINK

The fixture was not operated during the time of inspection. We recommend a licensed plumber or builder representative of new construction gain access or power to this area to ensuring proper operation prior to closing.

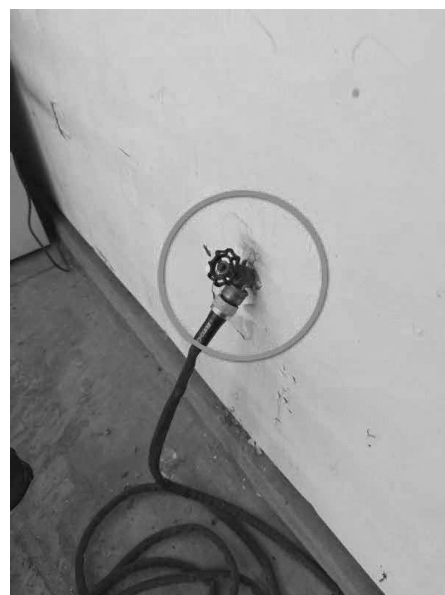
One or more fixtures or components were loose. This can hinder operation, and cause damage to surrounding components in some scenarios. We recommend repair / replacement by a licensed plumbing contractor.

Garage area hose bib

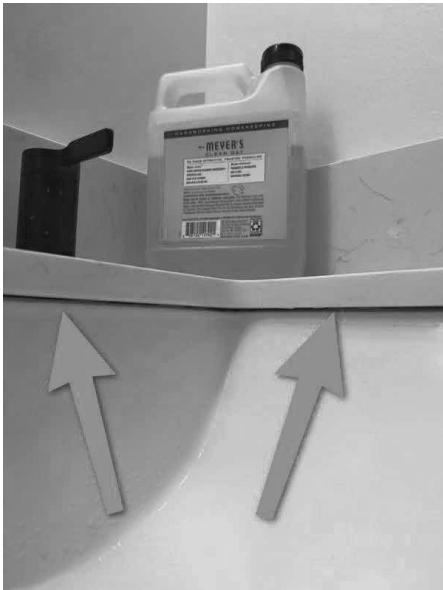
There was cracking / missing grout or caulk at a transition. This can allow water intrusion and cause damage to surrounding components. We recommend a qualified plumber evaluate and repair / replace as needed.

Primary bath sinks. At countertop transition

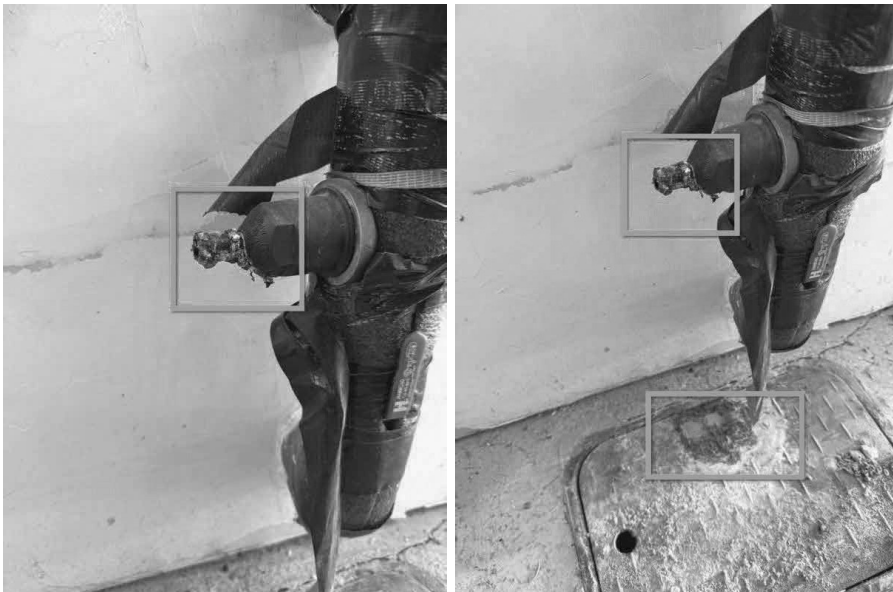
There appeared to be a leak at a plumbing fixture during the time of inspection. This can potentially cause unseen damage to the surrounding area and indicate underlying issues with the fixture itself. Recommend a plumber replace/repair as needed.

Prv leaking in garage utility close

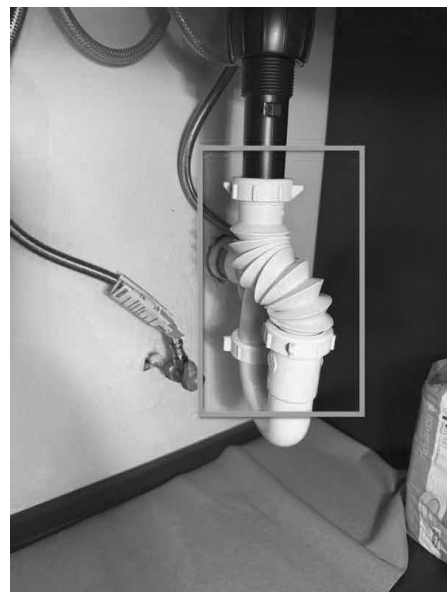
3rd floor hall bath sink drain

There was flexible drainage material used during the time of the inspection. This can contribute to no or slow drainage to fixtures, as well as escaped gases if, "P" traps are not properly installed. We recommend a licensed plumber further evaluate and make adjustments as needed.

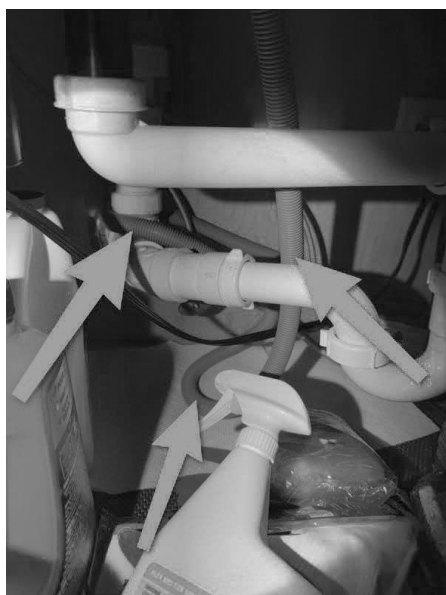
Dishwasher drain

No high loop was installed on the dishwasher drain line. Some models do not require this kind of installation. If this is a requirement and not installed, backflow of water is possible at the drain. Recommend a licensed plumbing professional ensure proper requirements of installation method.

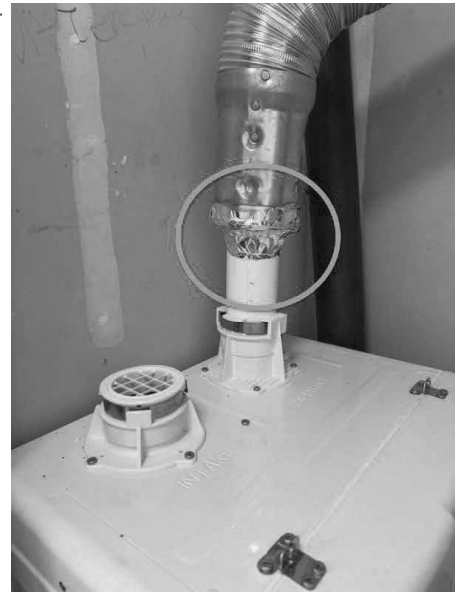
The vent is not properly installed in some way. This can prevent proper operation and also pose a safety concern in some scenarios. We recommend a licensed plumber further evaluate and repair or replace as needed.

Questionable install of vent/exhaust. Typically a pvc to metal adapter is needed.

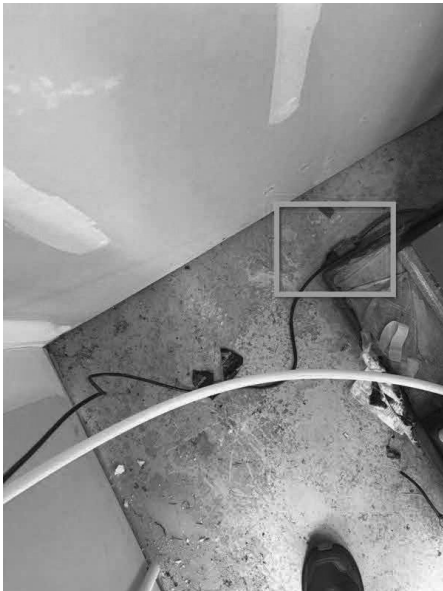
The switch/disconnect on the hot water heater has been installed in a manner that may not be to today's standards. Recommend a qualified professional for further evaluation and/or repair.

water heater is powered via extension cord

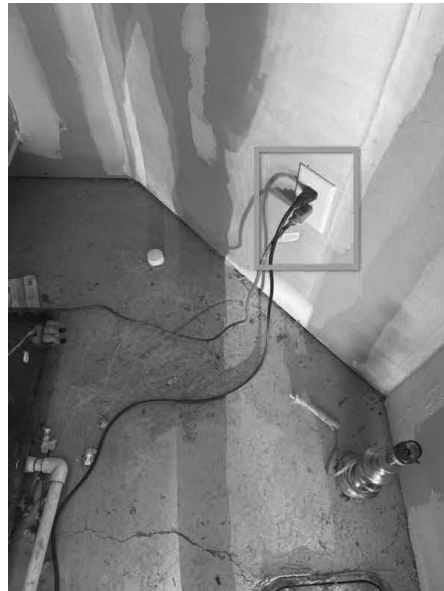
Typically recommended to have a dedicated circuit for water heater plug

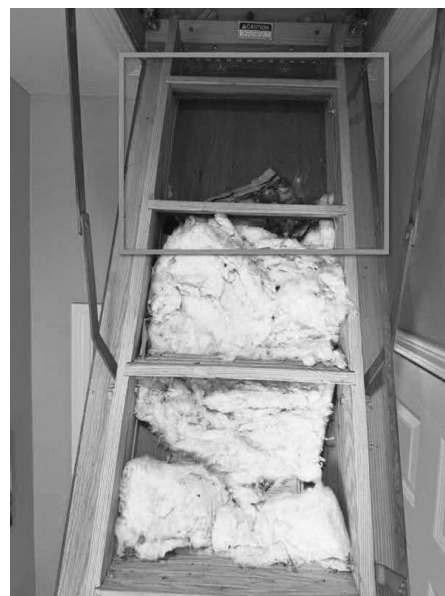
There was no insulation on the attic access or the door did not appear rated for unconditioned space usage. This allows for energy loss through the ceiling or door area. Recommend qualified insulation contractor evaluate and repair as needed.

Missing insulation at drop down staircase

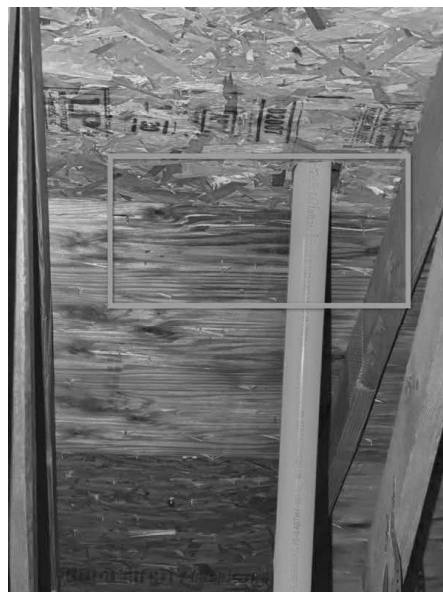
There was moisture staining on an area of roofing material. This can indicate a current or past leak and can damage roofing or surrounding components. Recommend monitoring the area, or contacting a roofing contractor to ensure proper repairs are made.

Rear roof, at plumbing vent penetration. Tested dry at time of inspection

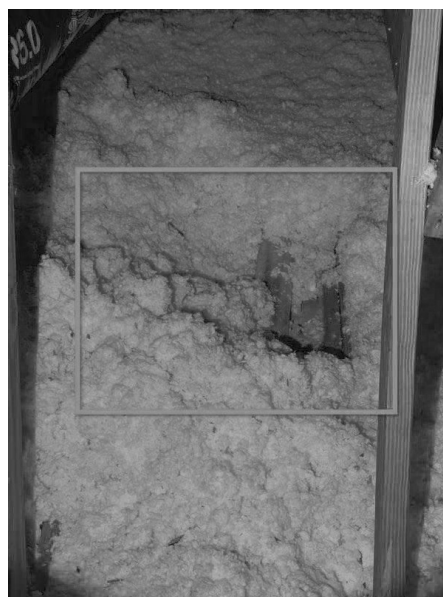
The insulation in the attic was low or missing in areas. This decreases the energy efficiency of the home. Recommend insulation is added to the recommended levels by a qualified contractor.

Low spot in middle attic area

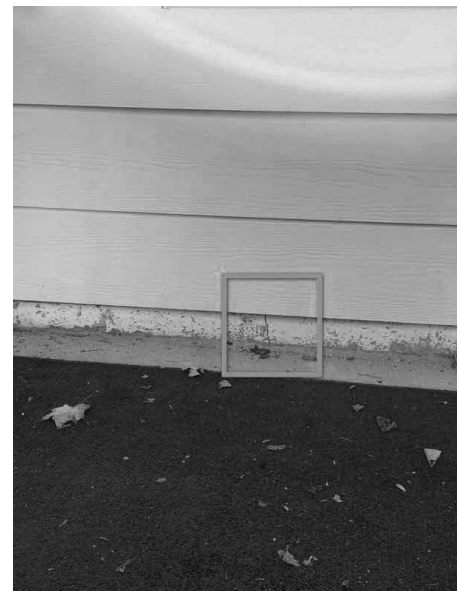
There are one or more typical cracks in the foundation. Normally, these are only aesthetic, and do not indicate a structural concern. Recommend sealing and monitoring for further movement or contacting a qualified contractor or structural engineer for a second opinion.

Rear patio area, vertical crack at slab

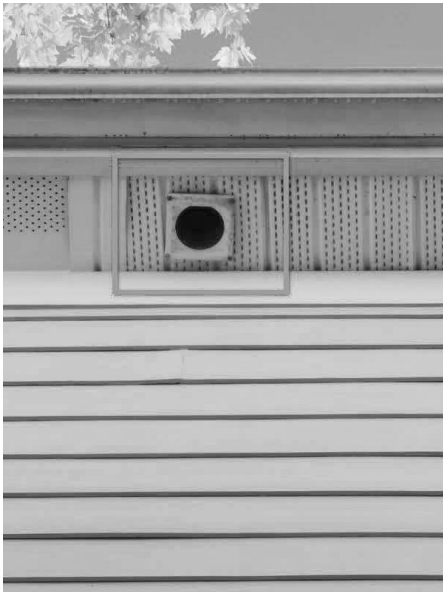
Rear soffit area

An exterior vent was obstructed, damaged, or missing in some way. This may prevent moist or exhaust air from exiting the structure as intended, leading to countless issues in surrounding components, or potentially becoming a safety concern. This may also allow moisture intrusion around the vent area at the exterior if not mounted correctly. Recommend qualified contractor evaluate and repair / replace as needed.

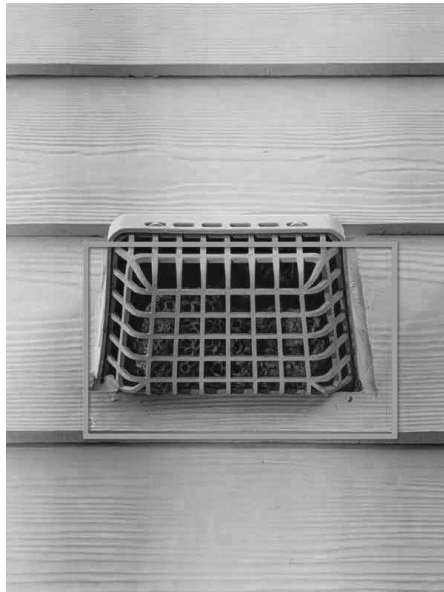
Rear exterior vent. Pest nest blocking flap
