# Inspection Report

04.23.26

520 Findhorn Lane  
Wake Forest, NC 27587

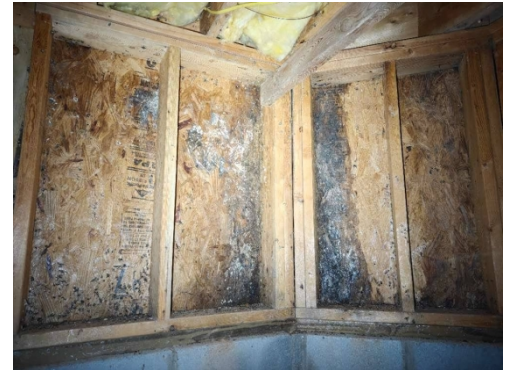
#### 1. \*\*Needs Repair: Structural - Wood Rot and Water Damage at Deck Attachment -\*\*

Significant staining and deterioration were observed at the rear of the home in the area beneath the door and along the deck attachment. Evidence of prior repair attempts was noted; however, these repairs appear insufficient to address the underlying issue. The deck band/ledger is not properly flashed, allowing water to infiltrate into the wooden components of the foundation wall, resulting in wood rot and widespread moisture-related damage. If left unaddressed, this condition can continue to compromise the integrity of the structure and lead to further deterioration. Recommend comprehensive evaluation and repair by a qualified contractor, including correction of the flashing and replacement of all damaged materials.

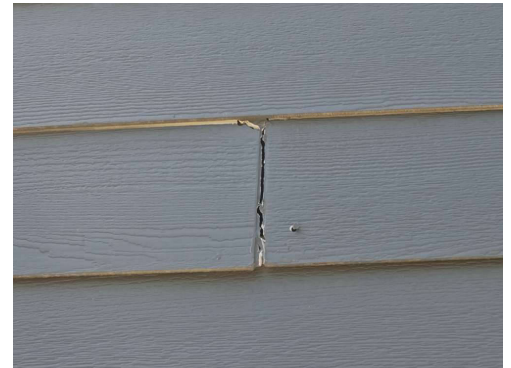
#### 2. Needs Repair: Exterior - Damaged and Loose Siding with Failed Sealant -

Fiber cement siding on the right elevation exterior shows multiple deficiencies, including loose panels and deteriorated caulking with visible cracking and separation. Although the home appears to have been recently painted, the underlying siding and sealant conditions indicate ongoing movement or improper adhesion in these areas. Compromised siding and failed sealant joints can allow moisture intrusion behind the cladding, which may lead to damage of underlying materials over time. Recommend evaluation and repair of the affected siding and sealant by a qualified exterior contractor to restore proper weather resistance and durability.

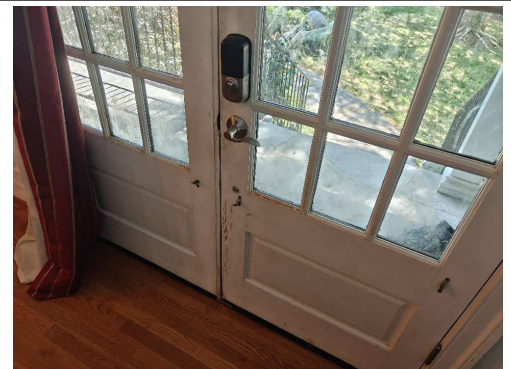
#### 3. Information/Observation: Exterior - Cosmetic Damage at Entry Door -

The front entry door shows cosmetic damage on the interior-facing surface consistent with pet activity, including scratching and surface wear. The condition appears superficial and does not impact the overall function or operation of the door at this time. While primarily cosmetic, continued wear may further affect the appearance if left unaddressed. Recommend repair and refinishing by a qualified contractor as desired to improve appearance.

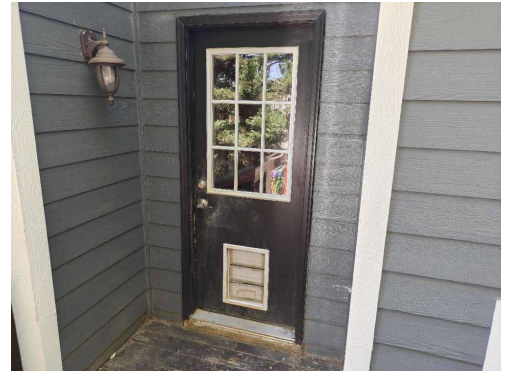
### 4. A. Needs Repair: Exterior - Door Compromised by Pet Door Installation -

The rear exterior door has been modified with a large pet door opening. This type of modification can weaken the structural integrity of the door and reduce its ability to properly seal against the elements. If left unaddressed, this condition may allow air, moisture, and pests to enter and can impact overall energy efficiency and security. Recommend evaluation and repair or replacement of the door by a qualified contractor to restore proper function and durability.

### B. Needs Repair: Exterior - Damaged Door Frame and Weatherstripping -

Damage was observed at the rear door frame and weatherstripping consistent with repeated pet activity. The deterioration of these components can prevent the door from sealing properly, allowing air and moisture infiltration and contributing to energy loss over time. Continued wear may further degrade the door assembly if not addressed. Recommend repair of the damaged components by a qualified contractor to restore proper sealing and function.

### C. Needs Repair: Exterior - Deteriorated Door Threshold -

The wood threshold at the rear exterior door shows signs of deterioration due to weather exposure and lack of maintenance. Damaged threshold materials can allow water intrusion beneath the door, potentially leading to rot and damage to adjacent flooring or framing. Recommend repair or replacement of the threshold by a qualified contractor to help prevent moisture intrusion and restore proper condition.

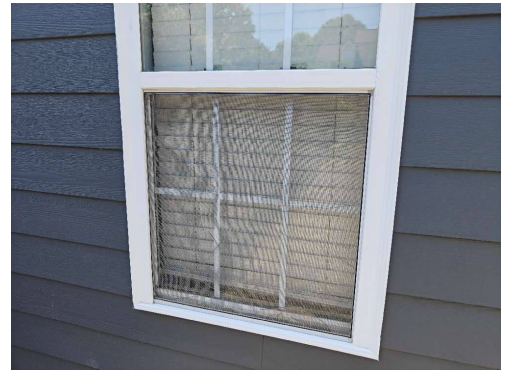
### 5. Needs Repair: Exterior - Broken Window -

A window at the garage on the right side of the home is broken. Damaged glazing can allow water intrusion, air infiltration, and pest entry, and also presents a safety concern due to sharp edges or compromised glass integrity. Recommend replacement of the damaged window by a qualified contractor to restore proper protection and function.

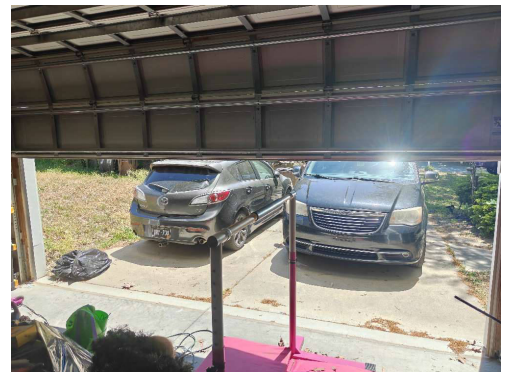
### 6. Needs Repair: Garage - Garage Door Opener Down Force Adjustment Needed

The garage door did not reverse motion when a small amount of resistance (three fingers alone used to stop downward motion) were applied to the door while closing. Improperly set door openers can result in damage to the door/personal property, or personal injury. Have a professional garage door installation contractor adjust the downforce on the automatic garage door opener auto-reverse function so that less resistance is required in order to reverse downward door motion.

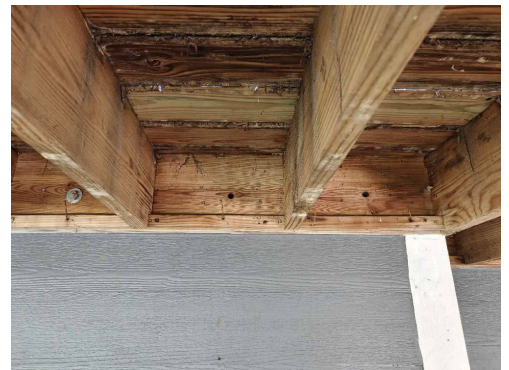
### 7. A. Needs Repair: Exterior - Missing Fasteners at Deck Ledger Attachment -

The deck ledger board at the rear of the home has drilled holes where lag bolts or structural fasteners were intended but not installed. Missing fasteners can reduce the strength of the connection between the deck and the home, which may compromise the structural stability of the deck over time. If left unaddressed, this condition can increase the risk of deck movement or failure under load. Recommend evaluation and installation of proper fasteners by a qualified contractor to ensure a secure and properly supported attachment.

### B. Needs Repair: Exterior - Missing Flashing at Deck Ledger -

Flashing was not observed at the deck ledger board where it attaches to the home. Proper flashing is critical to prevent water intrusion between the deck and the structure. Without flashing, moisture can enter and remain trapped against the building materials, potentially leading to rot, deterioration, and concealed damage over time. Recommend installation of appropriate flashing by a qualified contractor to help protect the structure from moisture intrusion.

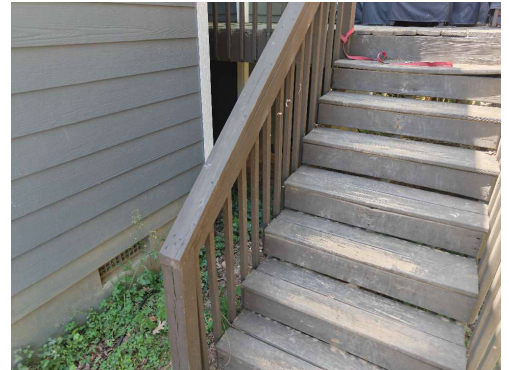
### 8. Needs Repair: Exterior - Deteriorated Deck Railings -

The deck railing system at the rear of the home shows signs of long-term weathering and lack of routine maintenance, with components appearing worn from prolonged exposure to sunlight and the elements. The railings were observed to be loose, which reduces the effectiveness of the guard system. If left unaddressed, this condition can pose a fall hazard and may continue to worsen as materials deteriorate. Recommend evaluation and repair or replacement of the affected railing components by a qualified contractor to restore safety and stability.

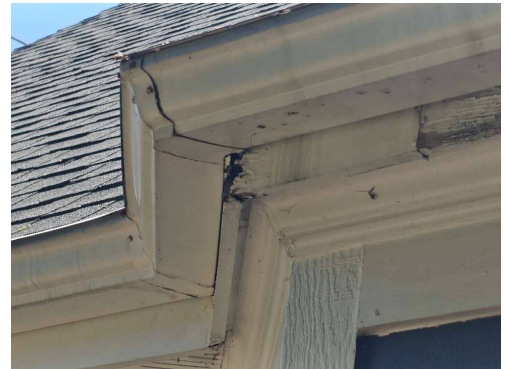
### 9. Needs Repair: Exterior - Deterioration at Fascia Below Upper Gutter Discharge -

At the rear of the home above the deck, a short upper gutter discharges onto the lower roof near the fascia. Evidence suggests water is bypassing the lower gutter in this area, resulting in moisture exposure and deterioration of the fascia. Rotting fascia can worsen over time and may allow water intrusion into adjacent structural components if not addressed. Recommend evaluation and repair of the affected fascia, along with correction of the gutter discharge configuration, by a qualified contractor to ensure proper water management and prevent further damage.

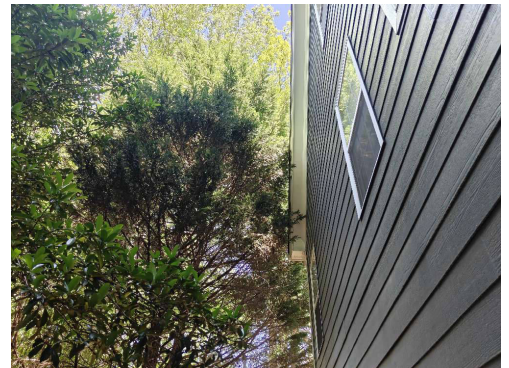
### 10. Needs Repair: Exterior - Tree Branches Contacting Structure -

Tree branches were observed in contact with the exterior of the home. Direct contact can lead to damage to siding and other exterior components, contribute to moisture retention, and provide a pathway for pests. If left unaddressed, ongoing contact may result in accelerated wear and potential deterioration of exterior materials. Recommend trimming the trees back by a qualified landscaping professional to maintain proper clearance from the structure.

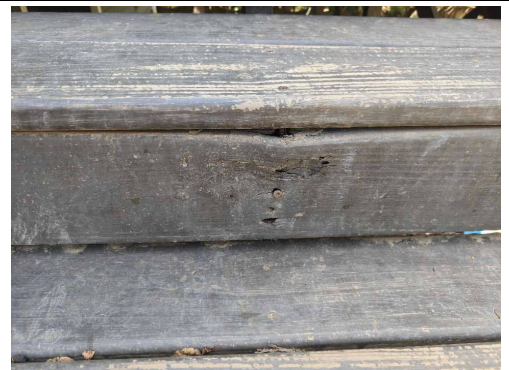
### 11. Needs Repair: Exterior - Deteriorated Deck Boards -

The deck boards at the rear of the home show significant deterioration consistent with long-term weather exposure and lack of routine maintenance. Observed conditions include wood rot, holes, and lifting or warped boards. Deteriorated decking can reduce structural reliability and create safety concerns, including a tripping hazard and potential for board failure under load. Recommend comprehensive evaluation and repair or replacement of the affected deck boards by a qualified contractor, along with proper sealing or finishing to protect the deck going forward.

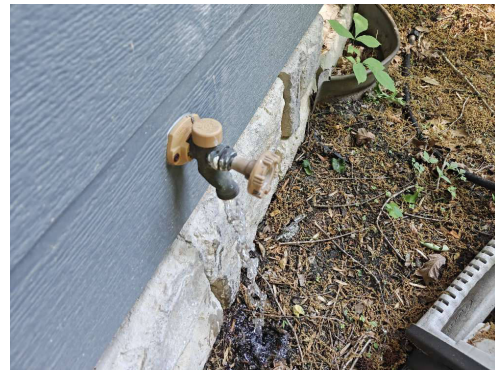
### 12. Needs Repair: Plumbing - Loose Hose Faucet -

The hose faucet at the front of the home is loose and is missing a mounting screw. A loose faucet can place stress on the connected plumbing and may lead to leaks or damage to the piping over time. Recommend securing the faucet and replacing the missing fastener by a professional plumber to ensure a stable and properly supported installation.

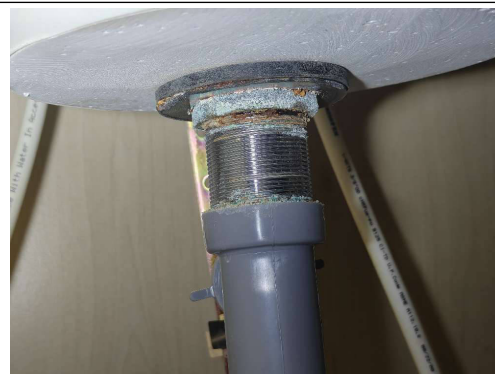
#### 13. Needs Repair: Plumbing - Corroded Drain Tailpiece -

Corrosion was observed on the drain tailpiece at the sink in the first floor hall bathroom. Deterioration of this component can lead to leaks and eventual failure, which may cause damage to surrounding cabinetry or finishes. Recommend replacement of the affected drain component by a professional plumber to ensure a watertight and reliable connection.

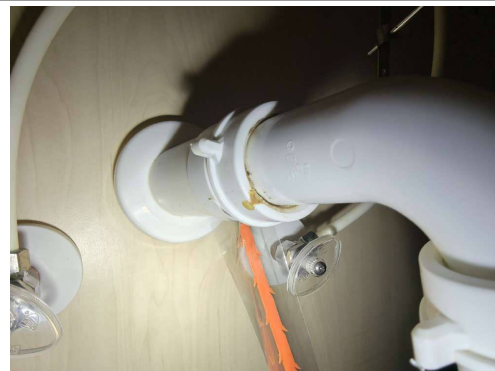
#### 14. Needs Repair: Plumbing - Defective Sink Drain Assembly -

Multiple deficiencies were observed at the drain assembly pipes for the left sink in the first floor primary bathroom, including an improper connection, corrosion, and signs of a developing leak. These conditions indicate the drain system is not properly sealed and may fail, allowing water to escape and potentially damage surrounding cabinetry and finishes over time. Recommend evaluation and repair of the drain assembly by a professional plumber to ensure proper installation and a watertight connection.

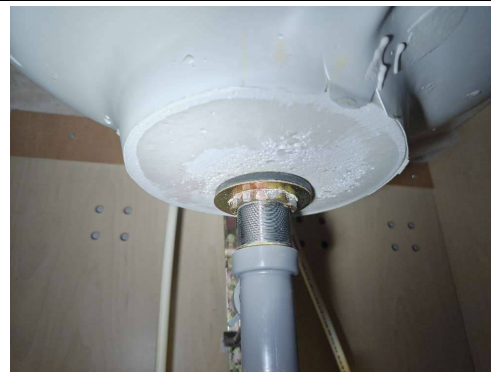
#### 16. Needs Repair: Plumbing - Corroded Drain Tailpiece -

Light corrosion was observed on the drain tailpiece beneath the right sink in the first floor primary bathroom. Corrosion can progress over time and may lead to leaks or failure of the component if not addressed. Recommend replacement of the affected drain tailpiece by a professional plumber to ensure a reliable and watertight connection.

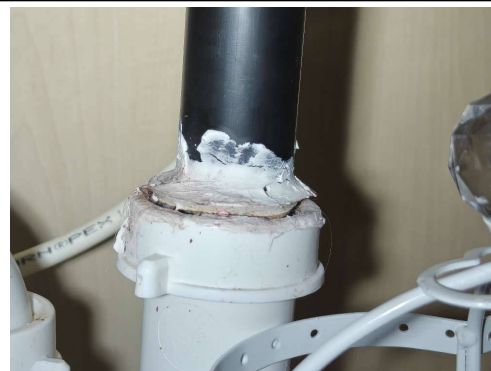
#### 17. Needs Repair: Plumbing - Improper Repair at Sink Drain -

An improper repair was observed at the drain piping beneath the sink in the second floor hall bathroom, likely associated with a previous leak. Improperly repaired plumbing connections may not provide a reliable seal and can lead to recurring leaks or further deterioration over time. Recommend evaluation and correction of the drain assembly by a professional plumber to ensure proper installation and a watertight connection.

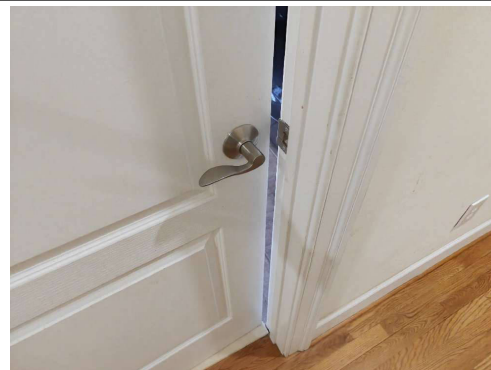
#### 18. Needs Repair: Interior Doors - Doors Not Latching -

Some of the interior doors throughout the home will not latch properly when closed. Doors that do not latch properly cannot be properly secured. Have a professional interior trim contractor evaluate all of the doors throughout the home and make any necessary repairs to allow for proper operation. See photo captions for specific locations.

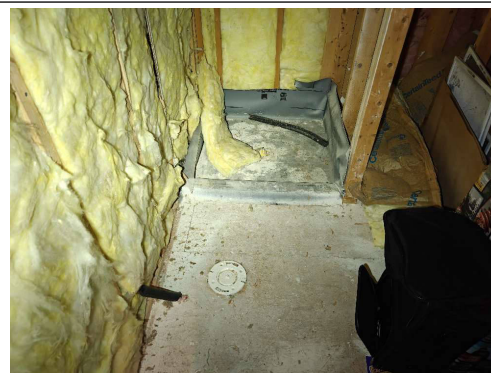
#### 19. Needs Repair: Insulation and Ventilation - Improperly Configured Attic/Conditioned Space -

An area at the front/left portion of the home appears to have been intended for future conversion to a bathroom but is currently functioning as an attic space. The area is not properly insulated or configured for either a conditioned interior space or an unconditioned attic, resulting in an inconsistent setup. This condition can lead to energy inefficiency, temperature imbalances, and potential moisture-related concerns depending on how the space is used. Recommend evaluation by a qualified contractor to determine the intended use of the space and to properly insulate and configure it accordingly.

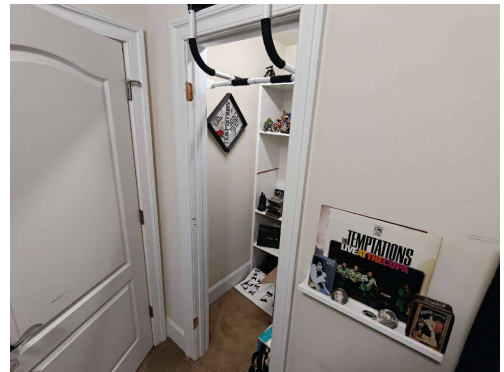
### 20. Needs Repair: Interior - Closet Door Removed -

The closet door in the second floor front bedroom has been removed and was observed stored nearby rather than installed on the frame. A missing door can affect functionality, privacy, and overall finish of the space if not reinstalled. Recommend reinstallation and adjustment of the door by a qualified contractor to restore proper operation.

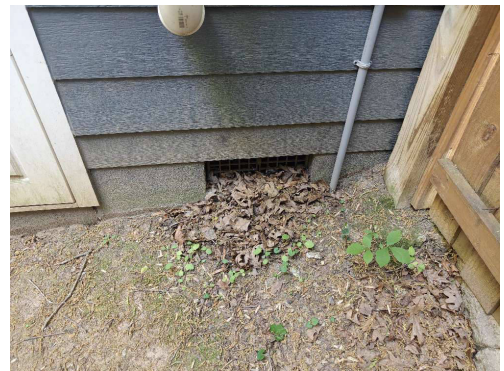
### 21. Needs Repair: Crawlspace Ventilation - Foundation Vent Well(s) Needed -

Some of the foundation vents around the home are installed such that a vent well is required - the bottom of the vent is at, near, or below the surrounding dirt grade. More than 3" of clearance above the surrounding dirt grade is required or a foundation vent well needs to be installed. Have a professional contractor install vent wells around vents in contact with ground in order to reduce the potential for surface water penetration.

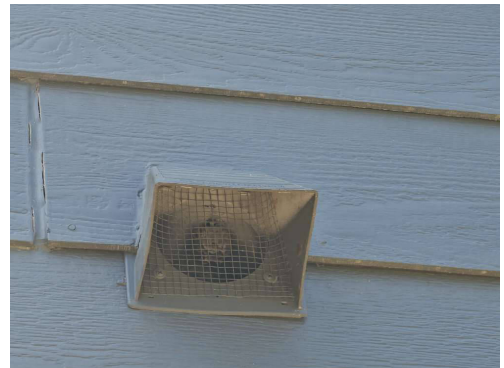
### 22. Needs Repair: Exterior - Missing Flappers at Bathroom Exhaust Vents -

Multiple bathroom exhaust vent terminations at the exterior are equipped with screening only and do not have proper flapper-style dampers. This condition allows pests such as wasps to enter the vent openings and build nests, and debris can become trapped behind the screening, restricting airflow. Obstructed or compromised vent terminations can reduce ventilation effectiveness and may contribute to moisture buildup within the home. Recommend replacement or upgrade of the vent terminations with proper flapper-style covers by a qualified contractor to improve performance and help prevent pest intrusion.

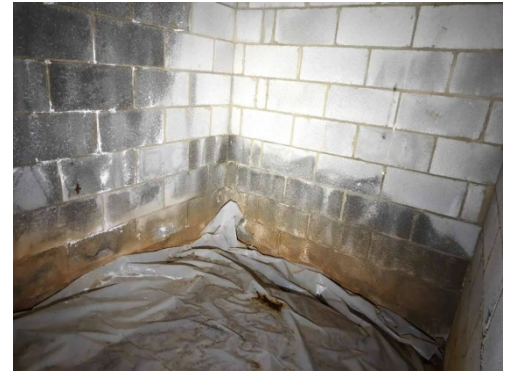
**23. Observation/Information: Foundation Walls - Efflorescence Present -**  
Observed efflorescence in the block foundation wall of the home. As long as no other adverse conditions are present such as ponding water or mold, small amounts of efflorescences should be considered an acceptable side effect of minor moisture around the foundation. If any concerns with this condition are present, it is recommended consulting a foundation moisture control specialist.  
>>> Note: Efflorescence is caused when moisture migrates through the wall and pushes minerals to the surface of the block. Efflorescence is symptomatic of a water infiltration concern at the foundation wall. Efflorescence is a common and expected behavior inside a crawlspace and garage due to retained moisture from the exterior foundation walls caused by; grade sloping toward the foundation; irrigation systems; at the HVAC condenses lines and gutter systems that discharge water directly at the foundation wall and where landscape mulch is piled up against the foundation. Please understand that most contractors want to sell their services and will suggest that repairs should be provided..

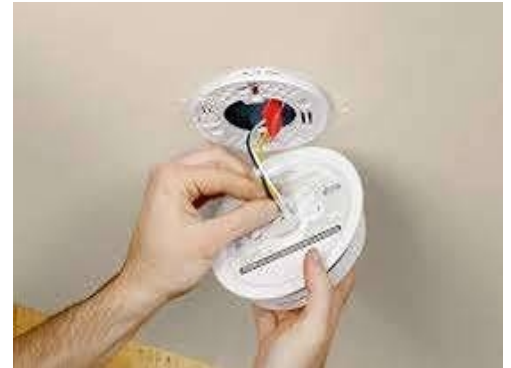
**24. Needs Repair: Electrical - Aging Smoke Detectors -**  
Smoke detectors are present in the home; however, based on the age of the home, the units are likely original and have exceeded their typical service life of approximately 10 years. Aging detectors may not respond effectively in the event of a fire, increasing the risk of delayed warning. Recommend replacement of all smoke detectors by a licensed electrician or qualified professional to ensure proper operation and improved safety.

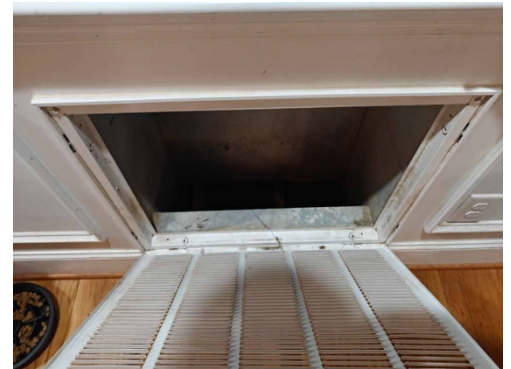
**25. Suggestion: Whole System Filter w/ No Interior Filters -**  
No filters are present at the entrances to the HVAC return air ducts at the interior walls of the house. This will allow dust to build up in this duct system before the whole system cartridge filter. Suggest that filters be added in the return air grills at the beginnings of the return air ducts as a preliminary filtering system to help maintain a cleaner air duct system.  
>>> Note: The whole system filter cartridge was pulled and viewed and appeared to be clean. This type of filter can only be properly tested for by evaluating the rate of air flow through the filter with an air flow meter and is not part of a general home inspection testing equipment. Refer to the manufacturer for expected times between replacement of this filter.

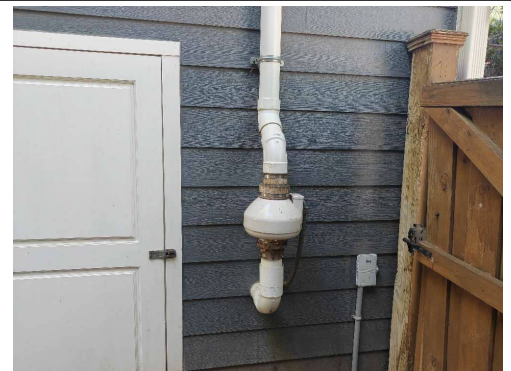
**26. Not Inspected/Information: Radon Remediation Device (No Radon Test) -**  
Observed a radon mitigation system on the home. The presence of the device indicates either previous high levels of radon, or it was installed as a precaution by the builder/homeowner. A radon mitigation system requires regular service every 2-5 years. The inspection of this system is beyond the scope of the home inspection. The homeowner should be consulted regarding system warranties and previous maintenance. A qualified radon mitigation system specialist should perform a complete evaluation of this system.  
>>> Note: A radon test is not part of the standard home inspection, and one was not ordered with this home inspection. Radon is a naturally occurring radioactive gas that is the second leading cause of lung cancer in the U.S. The EPA recommends testing all homes, regardless of age or type of foundation. If elevated levels are found, remediation typically involves a venting system, with costs usually between \$1,200 and \$2,500. A professional radon test is recommended to determine whether corrective measures are needed. For more information - <https://www.epa.gov/radon>
