Cody Johnston, PE  
Stonewall Structural Engineering, PLLC  
4800 Falls of Neuse Rd. #120  
Raleigh, NC 27609  
(919)407-8663

Re: Structural Observation — 306 Burgwin Wright Way, Cary, NC 27519

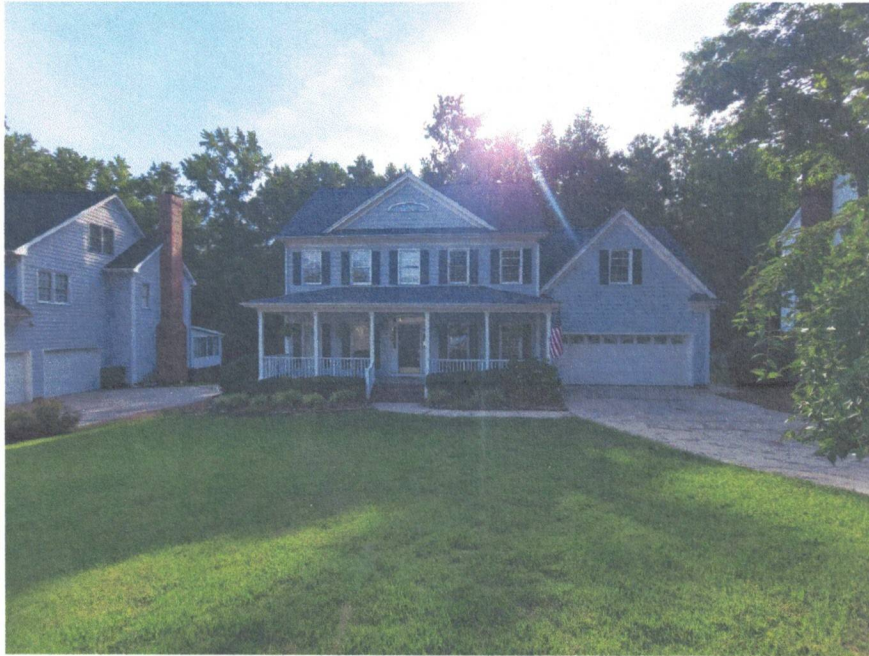
*Picture 1 – 306 Burgwin Wright Way, Cary, NC*

At your request, on July 15, 2022 we performed a visual structural observation of foundation cracks at the Cary residence noted above. The structure is a conventionally framed, detached, single family residence with raised first floor framing over a pier/girder foundation system with perimeter masonry foundation walls (*see picture 1*).

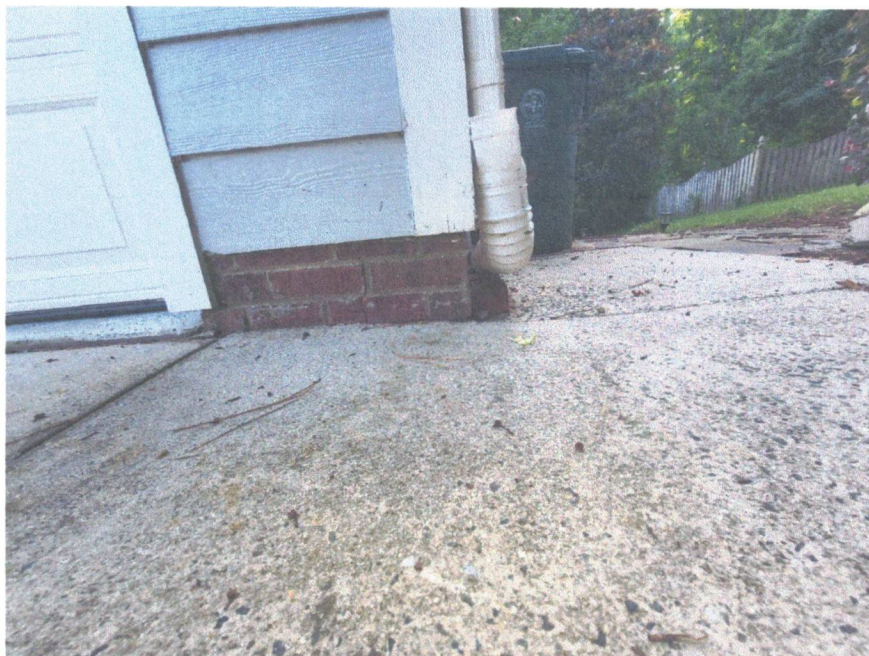
- A foundation crack was noted at the front-right of the garage (*see picture 2*).
  - Measurement by laser level indicated back right of the garage was down by as much as approximately  $\frac{5}{8}$ " relative to the front right.

*Picture 2 – Foundation crack*

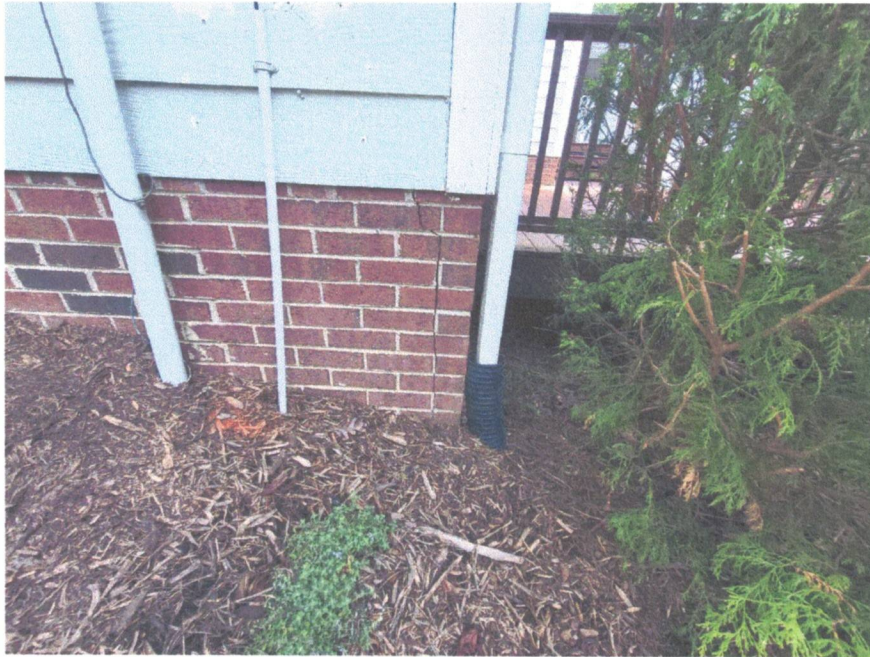
- No significant signs of significant distress were noted in the garage.
- A foundation crack was noted at the back-right of the garage (*see picture 3*).

- The crack measured approximately  $\frac{1}{8}$ " wide. Additionally, measurement by laser plumb indicated the foundation wall was not leaning outward.

- The garage slab was noted to have settled into the supporting fill material (*see picture 4 for example*).
    - The crack in the wall was reported to have been as wide as approximately  $\frac{1}{8}$ " in a report written by Woodard Sease & Associates, P.C. dated 4/24/2022.

- Upon completion of our analysis, we believe the crack on the back garage foundation wall was caused by minor movement of the back wall and back-right corner toward the back of the property most likely due to a combination of inadequate management of rainwater runoff around the perimeter of the structure, and cyclical loading by vehicle loads in the garage area.
  - Due to the minor evidence of distress within the finishes of the home and due to the lack of continued structural movement since the time of the previous engineer's report, we do not believe these cracks represent a matter of significant structural concern at this time.
  - Any cracks in exterior masonry should be closed with a clear or color-matching flexible sealant and should be monitored for signs of further movement.

*Picture 3 – Foundation crack*

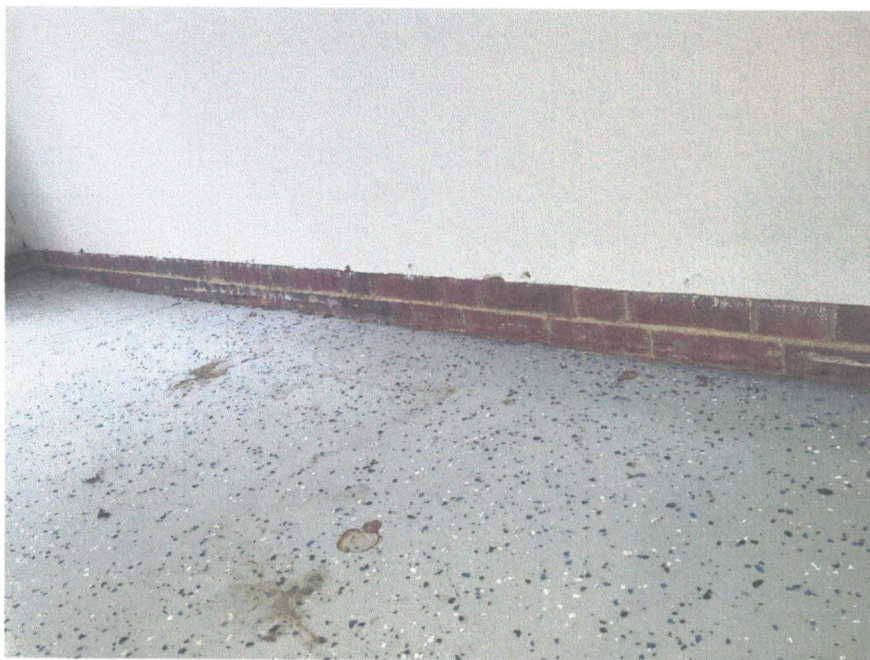
*Picture 4 – Slab settled into fill material*

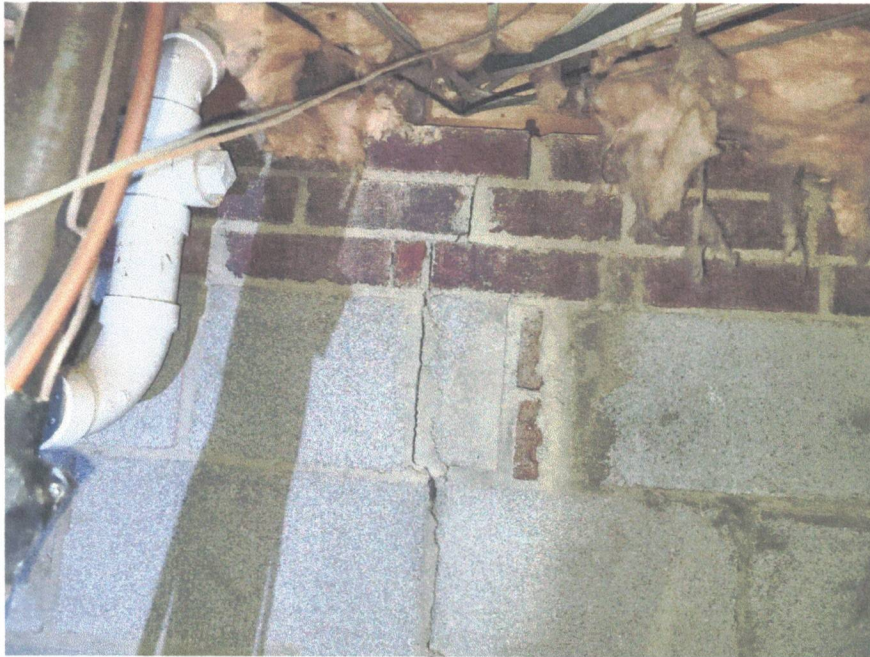
- A foundation crack was noted at the back right of the home where the garage foundation wall intersects the home (*see picture 5*).
  - Measurement by laser level indicated the foundation wall level within  $\frac{1}{8}$ " in this area.

- No signs of structural distress were noted in the home above this area.
- A foundation crack was noted behind the back leftmost pier (*see picture 6*).

*Picture 5 – Foundation crack*

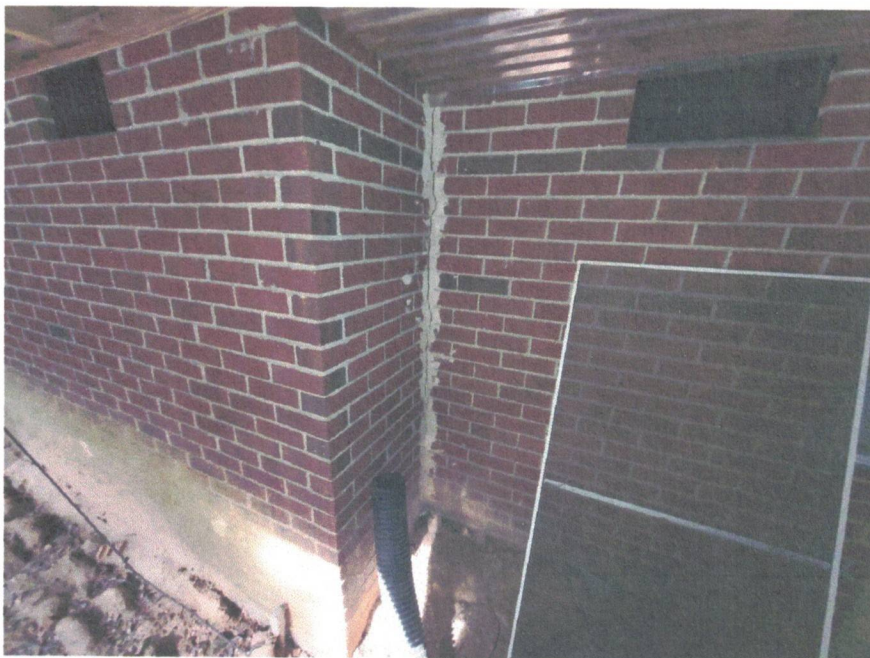
- No signs of significant structural distress were noted in the finishes of the home above this area.

*Picture 6 – Foundation crack*
