Ambassador Inspections  
Robert Smith  
[Ambassadorinspections1@outlook.com](mailto:Ambassadorinspections1@outlook.com)  
919.339.5633  
PO Box 337  
Bunn, NC 27508

| 10-24-2024 11:50:56 | |
|---|---|
| Street: | 6108 Hope Farm Lane |
| Date of Inspection: | 2024-10-24 |

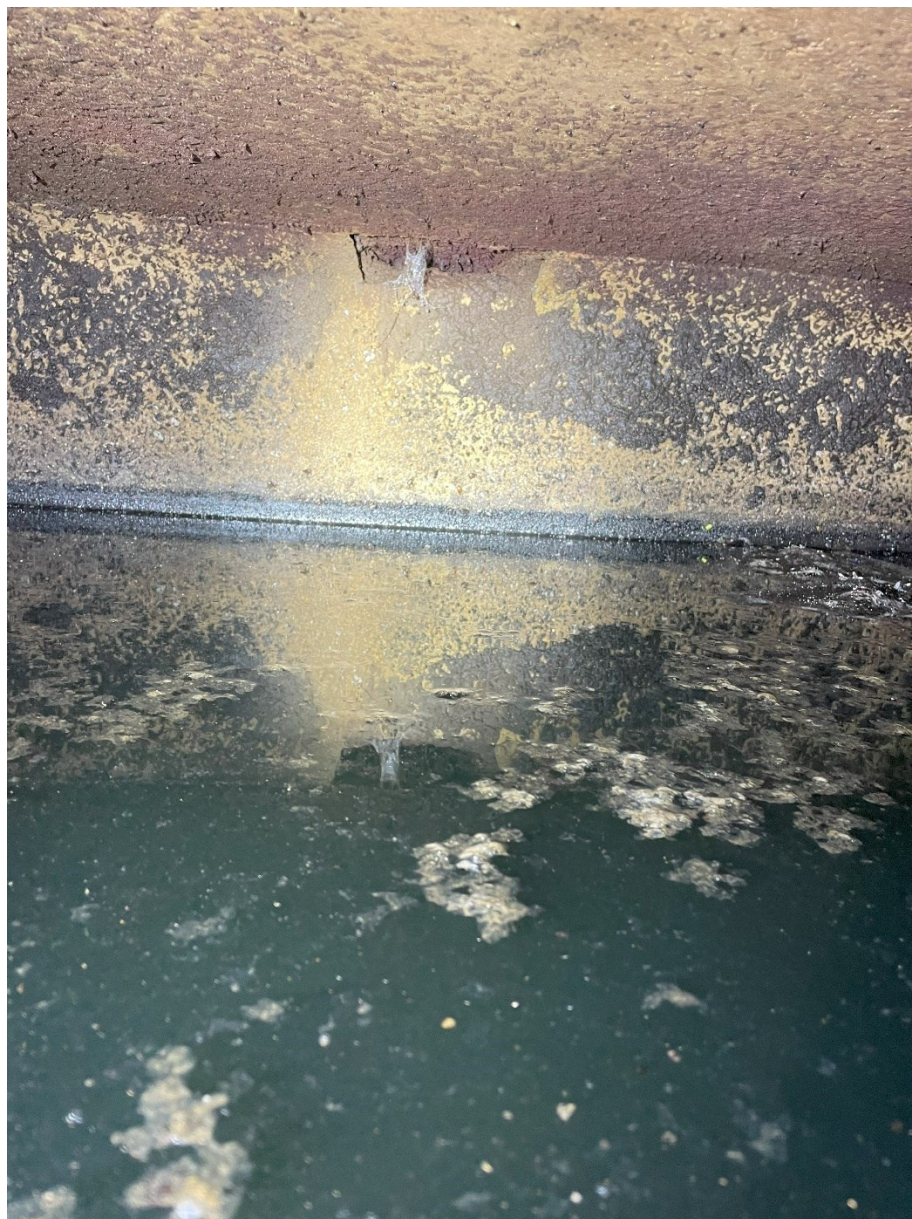
This is the inlet end of the septic tank. The tank does not need to be pumped.

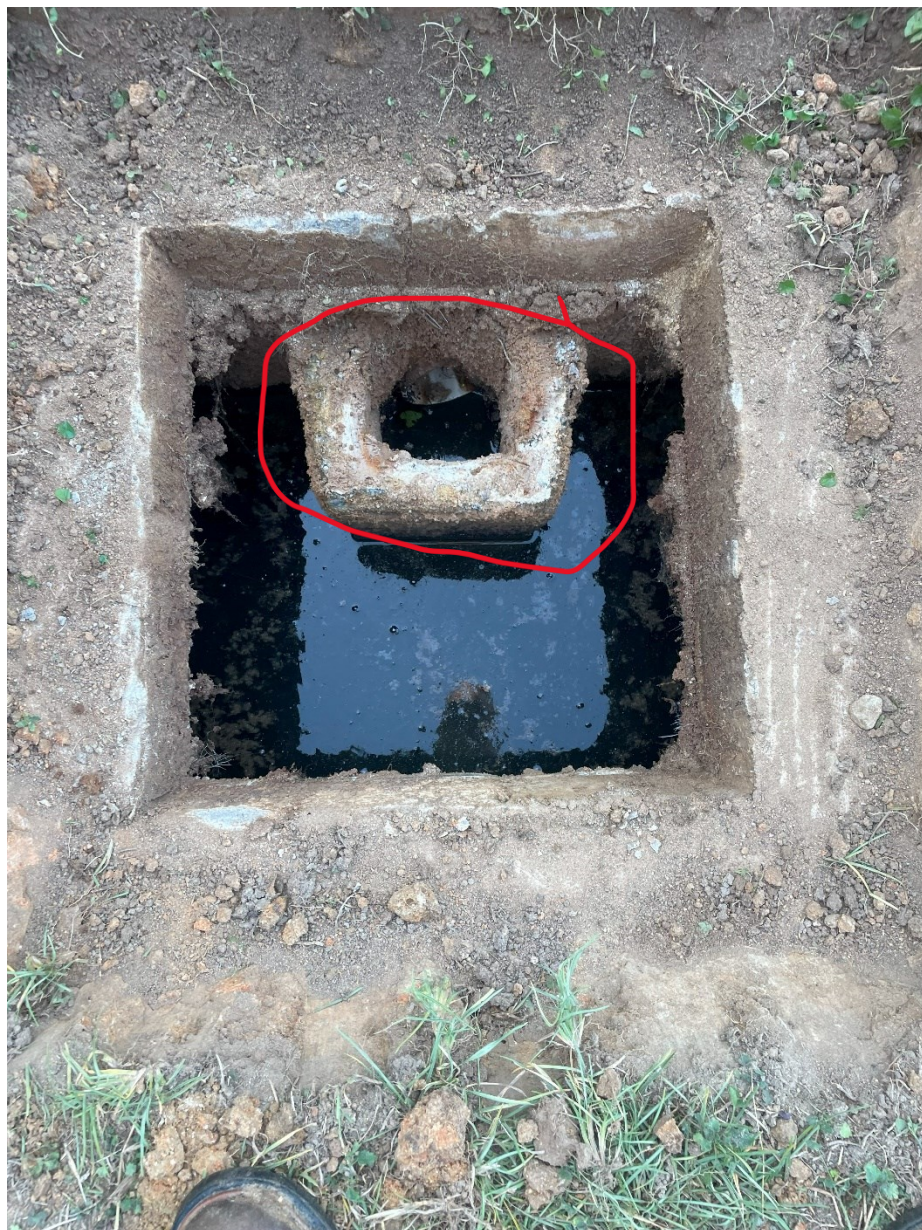
This is the outlet end of the septic tank with the outlet tee. The outlet tee is in good condition.

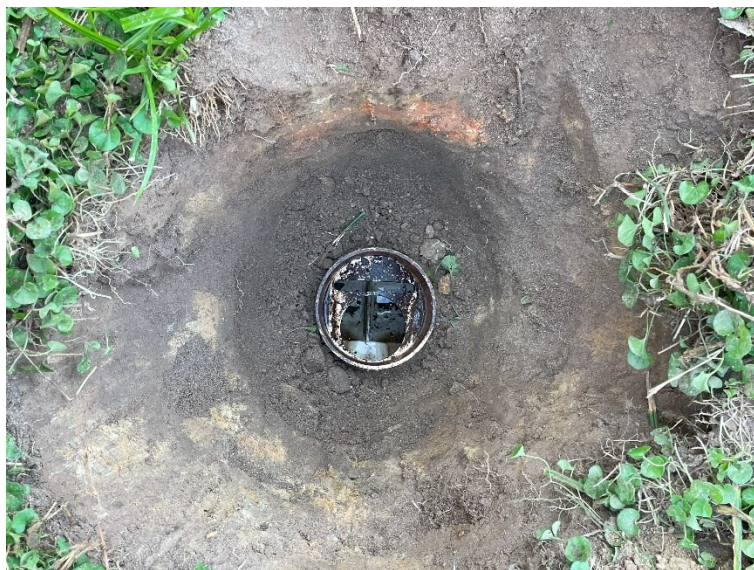
This is the inside of the flow diverter. The flow diverter is in good condition.

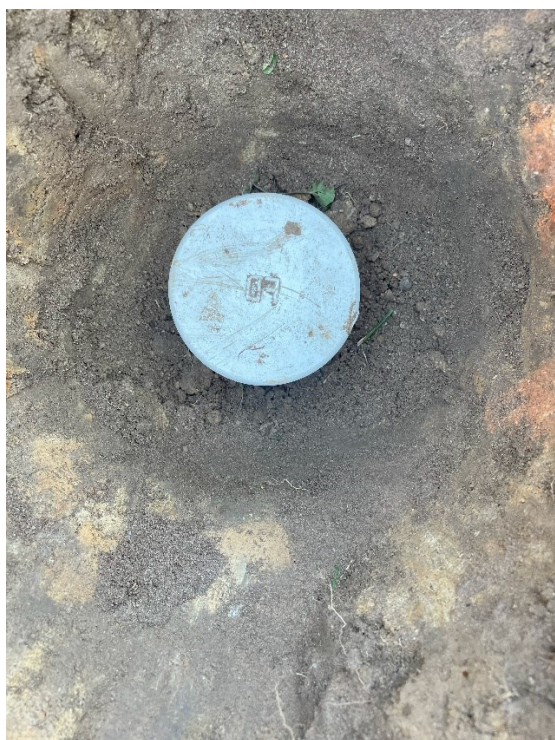
This the flow diverter with the cap on.

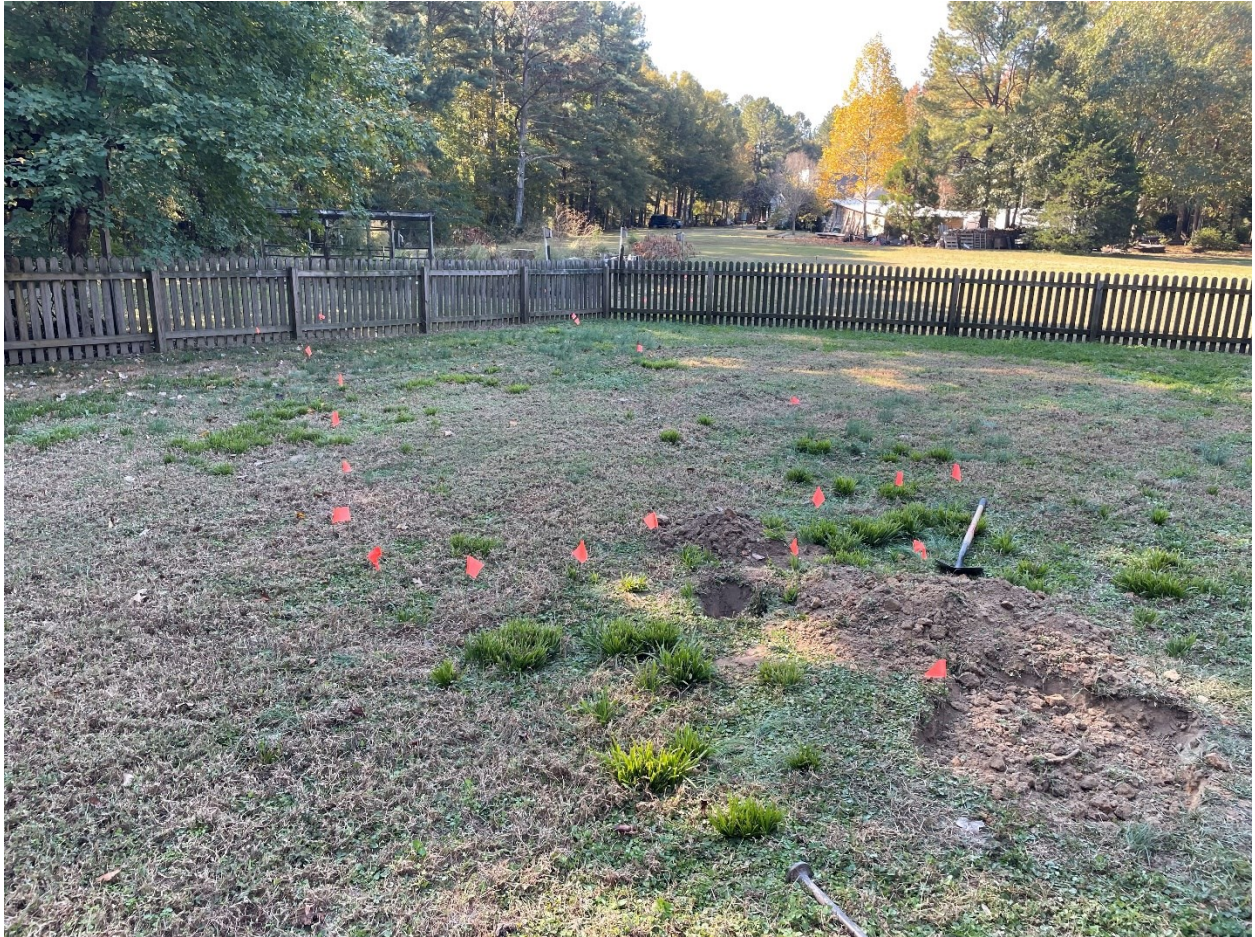
This is the front half of the leach field. No signs of surfacing in leach field. The orange flags represent each of the 2 lines.

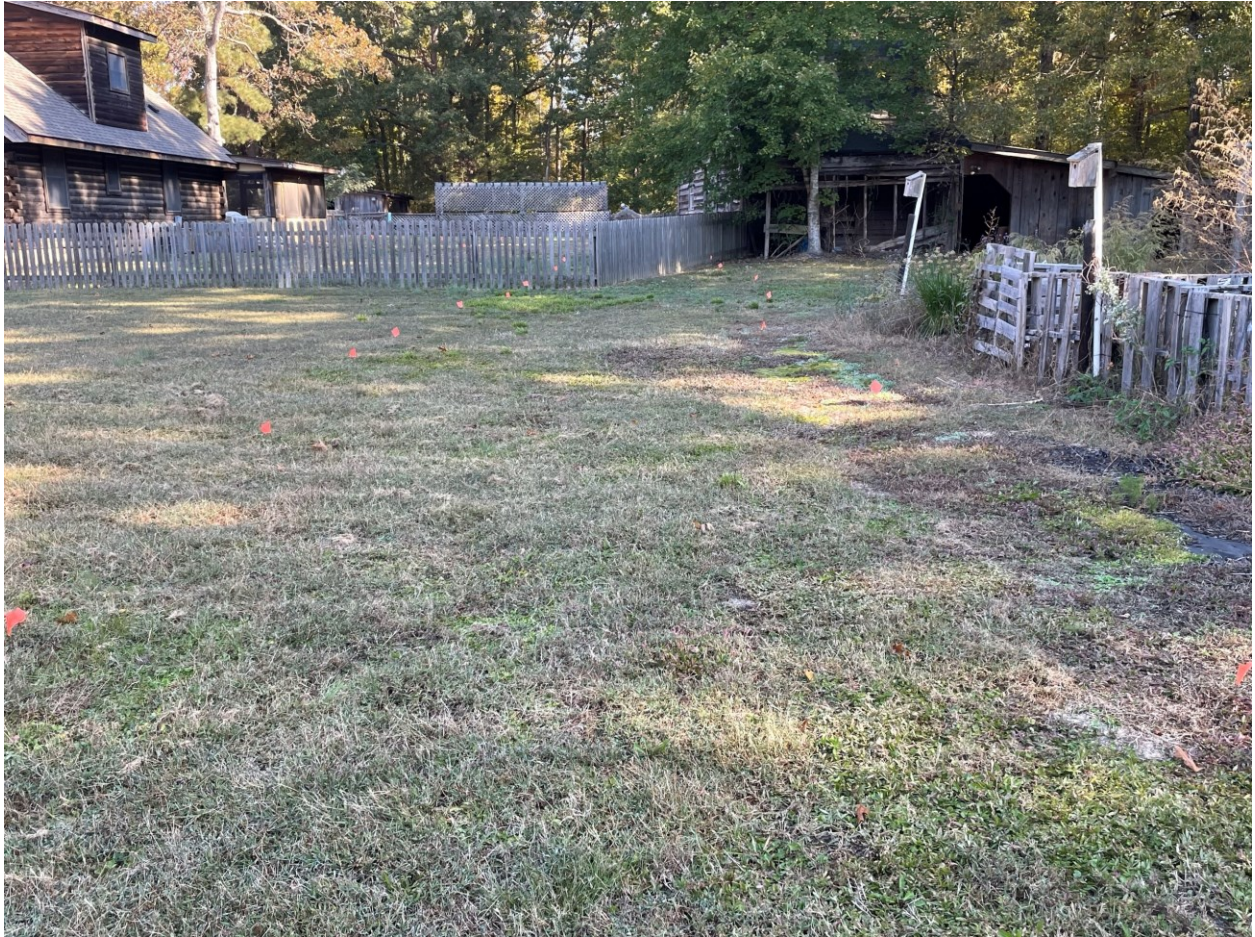
This is the back half of the leach field. There were no signs of surfacing in the leach field. The orange flags represent the 2 lines of the leach field.
