# Takla Engineering, PLLC

**Project:** 309 Maple St Renovation **Job #:** 2-0841-26  
**Address:** 309 Maple St **Page #:** 1 of 1  
**Care Of:** Bret Beaman **City:** Cary, NC  
**Company:** Triangle Homes Inc. **Report Date:** 02/16/2026  
**Engineer:** Andy A. Takla, PE **Date on Site:** 02/16/2026  
**Subject:** 3rd Party Inspection - Beam and Dropped Girder

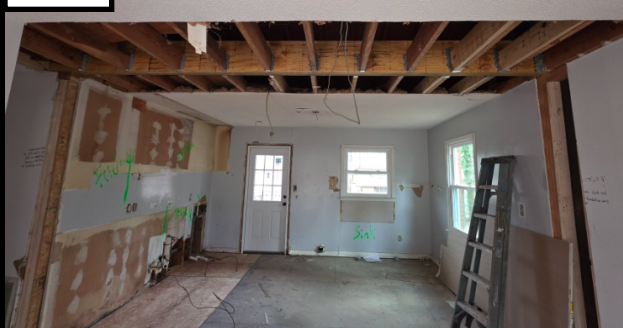
Item 1

1- The (2) 11-7/8" LVL flush beam installed between the living room and kitchen (right side of house) to accommodate removal of the center bearing wall was reviewed. See Picture 1 below for reference. Based on our review, the beam has been installed in accordance with our recommendations, including required end supports and attachment of ceiling joists thereto. **No further action is required.**

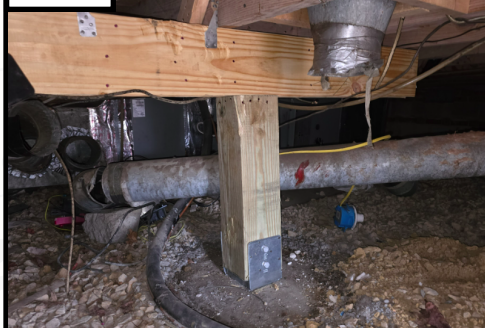
Item 2

2- The (3) 2x8 dropped girder installed within the crawlspace at approximately midspan of the floor joists supporting the hallway bathroom was reviewed. This girder was intended to reduce floor deflections resulting from an offset center girder and bearing wall. Based on our review, the girder has been installed in accordance with our recommendations, including required supports and attachment of floor joists thereto. Although the girder is shorter than originally specified, the previously under-supported areas are now adequately supported by new posts spaced at appropriate intervals. **No further action is required.**
