July 24, 2019

Re: Limited Structural Inspection  
113 Stokesay Court  
Cary, NC

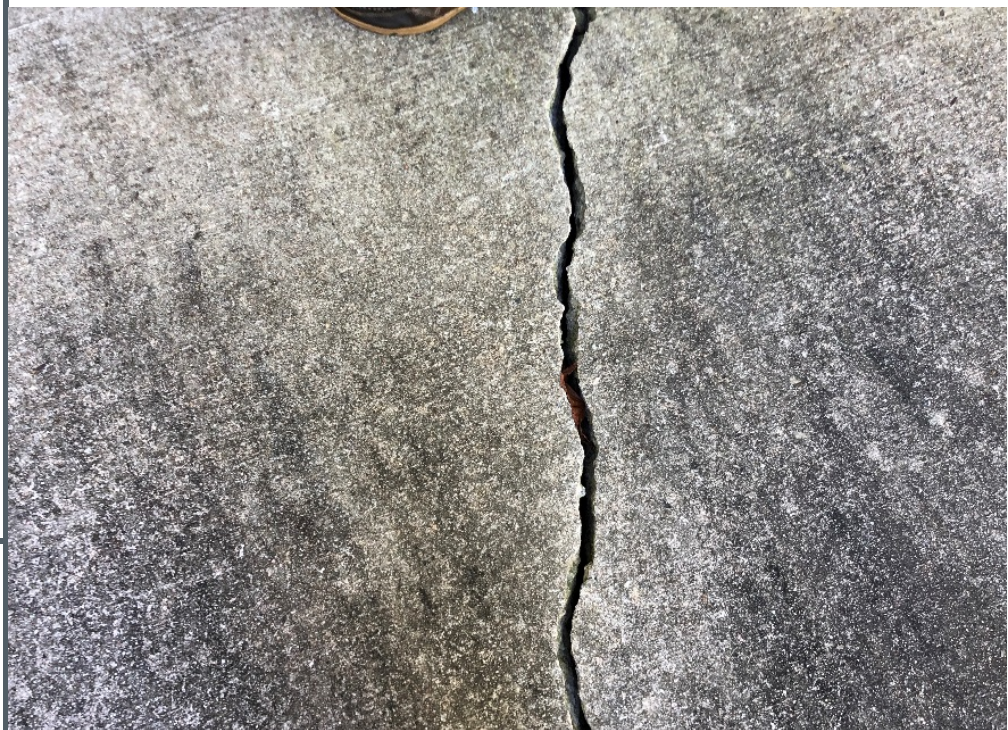
**Photo No.**  
**2**

2. At the driveway, consisting of concrete slab on grade, uncontrolled cracks up to 5/8" were observed. The slab was observed with vertical displacement at the aforementioned crack.

The movement of the driveway slab is likely the result of the aforementioned soil consolidation in combination with poor compaction with subgrade. The concrete slab of the driveway is not an integrated structural component of the home and as such is not a significant structural concern. The slab may be repaired as desired for aesthetic purposes; however, no structural repairs are required.

Crack in concrete slab  
on grade driveway.

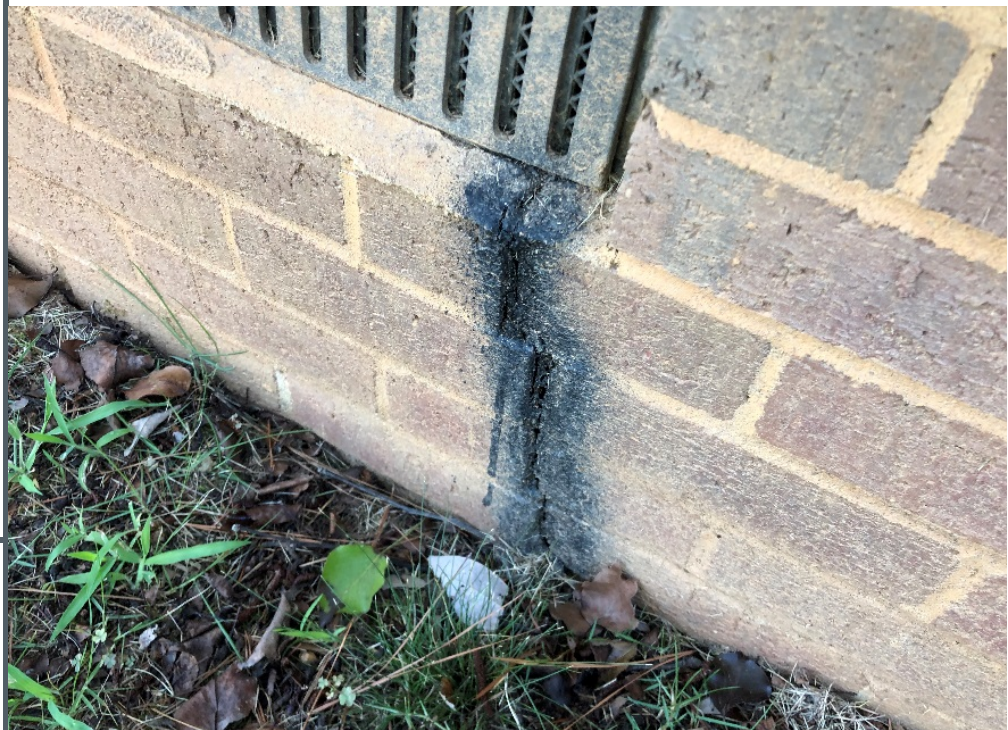
**Photo No.**  
**3**

- b. A vertical/stair-step crack up to 1/8" was noted in the front perimeter wall near the right corner.
  - c. A previously sealed crack was noted on the right perimeter wall approximately 12' from the front perimeter wall and was observed to be approximately 3/16" out of plane.

Crack in the front  
perimeter wall.

1. No structural repairs required at this time.
2. Monitor the cracks in the brick veneer and foundation walls. If the cracks widen significantly (expand by additional 1/8") or additional significant cracks (greater than 1/4" wide) propagate, then further evaluation and/or additional stabilization may be required. Special care should be taken to monitor the front right corner of the garage as further movement at this location will likely result in the need for stabilization. Note, if further movement is observed at the location of the existing helical piers, readjustment of those piers may be required.

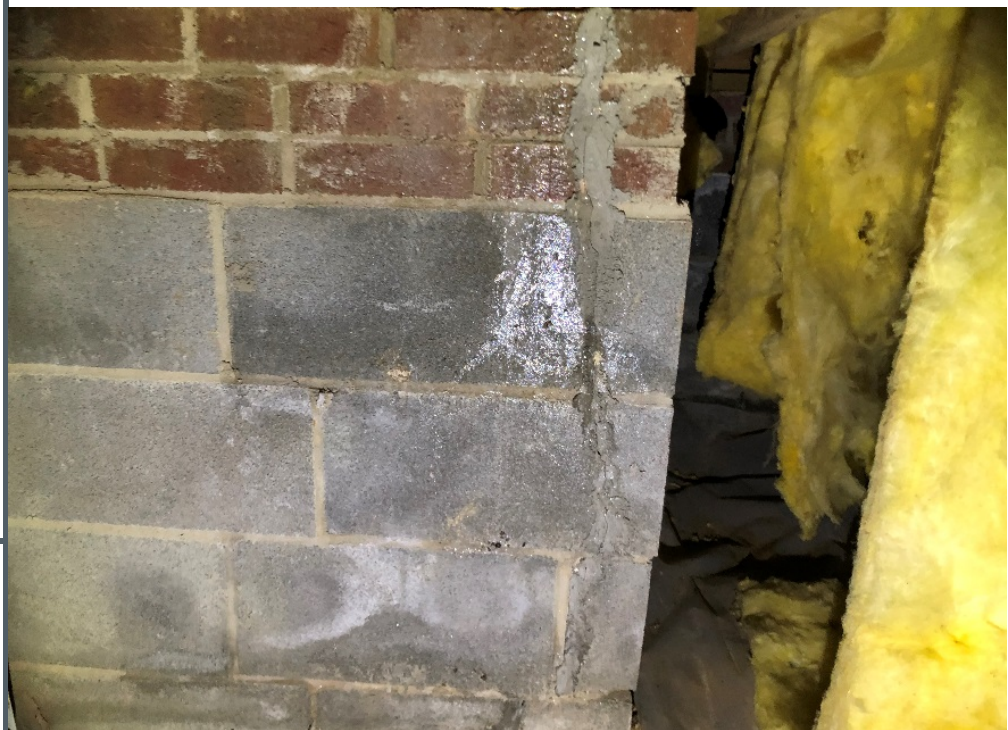
**Photo No.**  
**4**

- b. A previously sealed crack was observed adjacent to the right reentrant corner along the front perimeter wall. No significant propagation since the previous inspection was observed.

Previously sealed crack  
in crawlspace at front  
right reentrant corner.

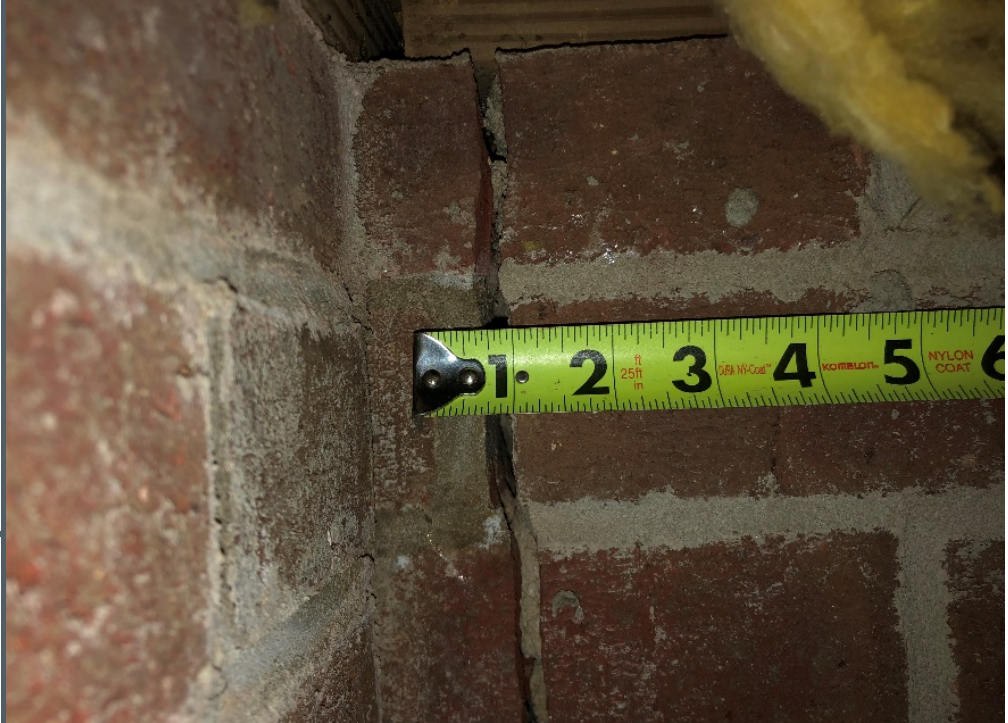
**Photo No.**  
**5**

- c. A vertical crack, up to 1/4" was noted at the front left reentrant corner. The crack expanded in size along the height of the wall. A corresponding crack was noted in the garage during the 2016 inspection.

Vertical crack at front  
left reentrant corner  
(adjacent to the garage).

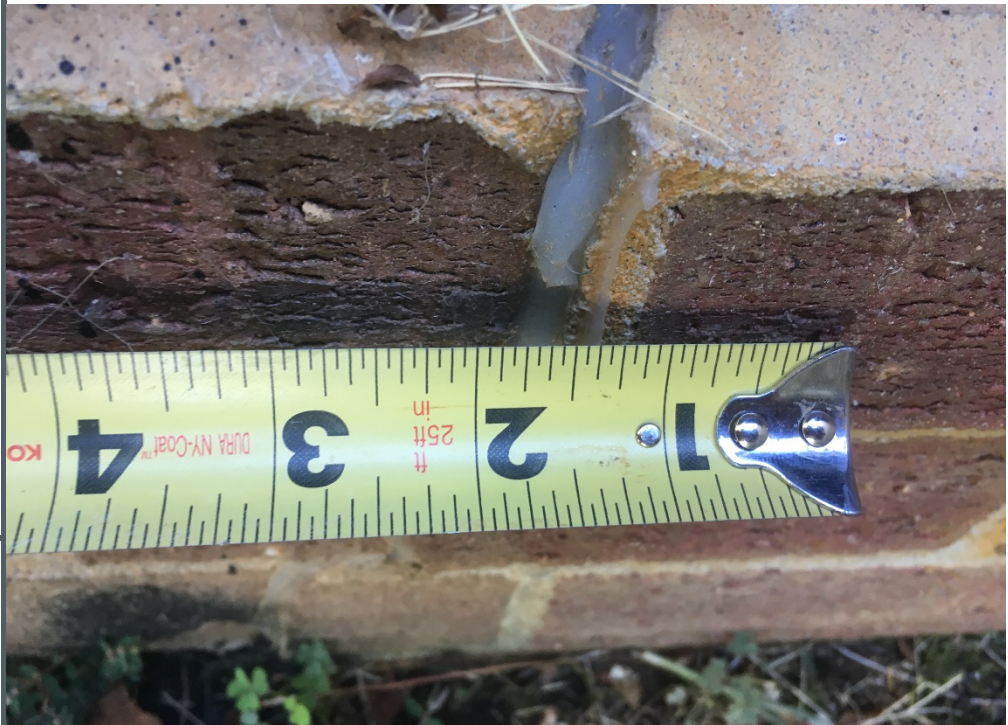
**Photo No.**  
**6**

Typical previously sealed  
crack
