October 10, 2016

Re: Limited structural inspection  
113 Stokesay Court  
Cary, NC

### OBSERVATIONS

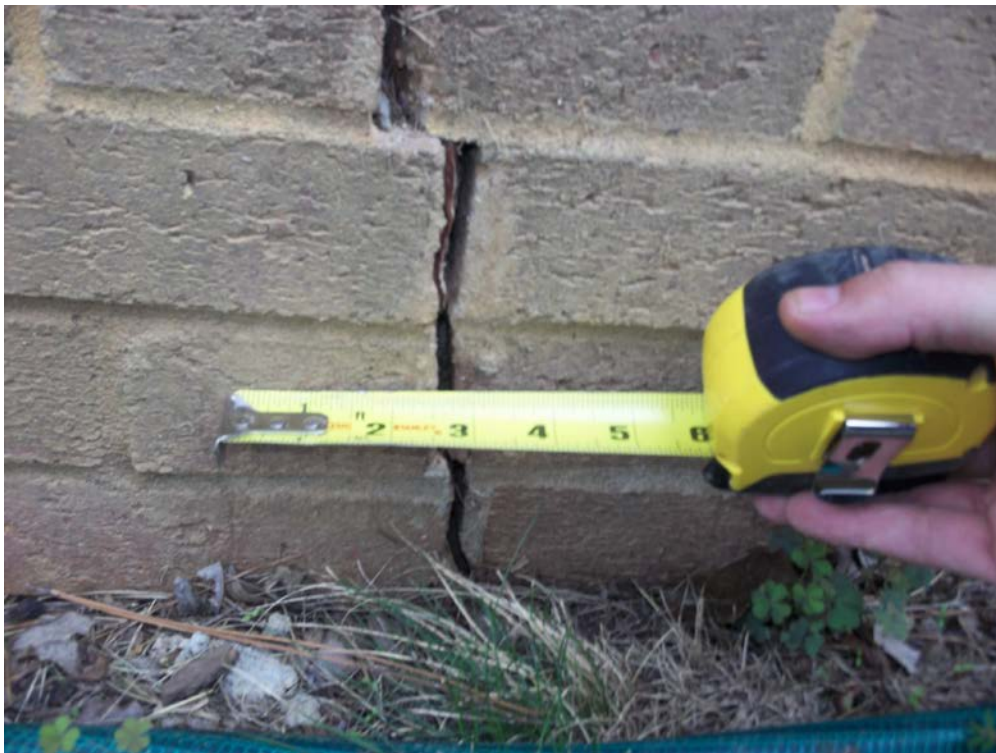
**Photo Number**  
**2**

1. On the exterior, a repaired vertical crack noted in the brick veneer was observed at the right side foundation near the right rear corner of the home. This crack has been previously sealed and no widening of the crack since the January 2014 inspection was observed.
2. On the exterior, a significant crack (approximately 1/4-inch wide) with 1/4-inch out of plane displacement was observed in the brick veneer on the right perimeter wall. The crack had not expanded since the November 2014 inspection.
3. In the crawlspace, vertical crack (approximately 1/8-inch wide) with 3/8-inch displacement was noted on the right foundation wall. The crack had not expanded since the November 2014 inspection.

**Description:**  
Crack in the brick  
veneer on right  
perimeter wall

- 1) The right side cracking in the CMU foundation should be monitored. If additional widening (approximately 1/8-inch) of the foundation crack or propagation of additional cracks in the foundation is observed, additional foundation stabilization may be required.
- 2) If additional movement in the right side foundation is observed, we recommend hiring an experienced foundation contractor to stabilize the center area of the right side foundation. We believe (2) helical piers will be sufficient to stabilize the foundation. Locate (1) pier at the crack on the center of right perimeter wall. The remaining pier shall be installed up to 6-feet on the right perimeter wall toward the front right corner.

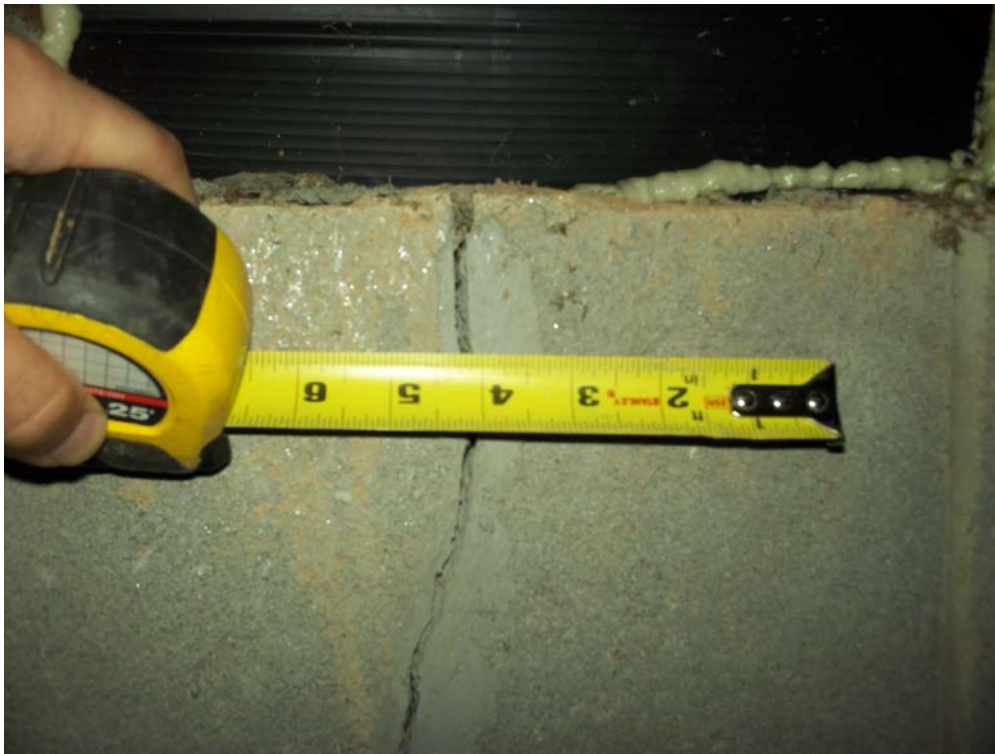
**Photo Number**  
**3**

Our evaluation of the current conditions revealed no significant movement in the right side CMU foundation since our previous inspection in November.

These cracks on the right foundation wall are **not** considered significant structural deficiencies at this time. Monitoring cracks for additional settlement is an acceptable approach. If cracks widen significantly or additional significant cracks propagate then evaluation by a structural engineer and possible foundation stabilization may be needed at that time.

**Description:**  
Crack in CMU  
foundation in right  
foundation wall
