## GILES ENGINEERS

November 17, 2014

Re: Limited structural inspection  
113 Stokesay Court  
Cary, NC

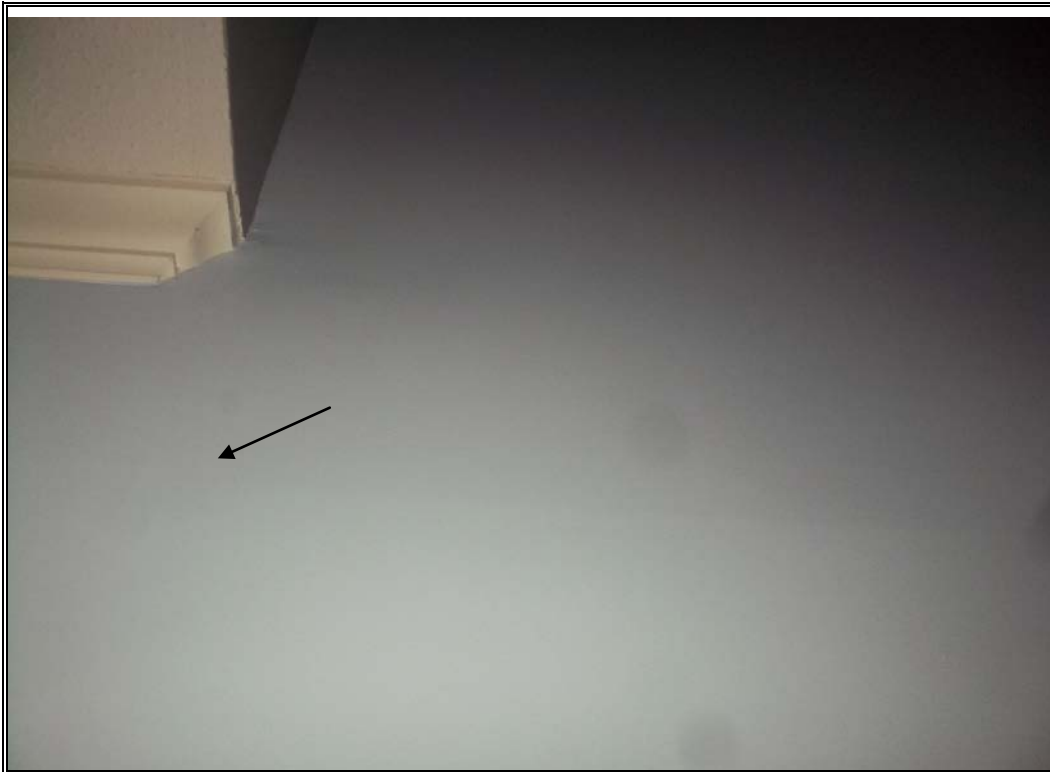
**1**

4. We also observed hairline vertical cracking in the right side drywall below the 2<sup>nd</sup> floor front wall.
5. No significant floor slope was observed in the right side of the 1<sup>st</sup> floor room.

Hairline vertical  
crack in front wall  
below 2<sup>nd</sup> floor

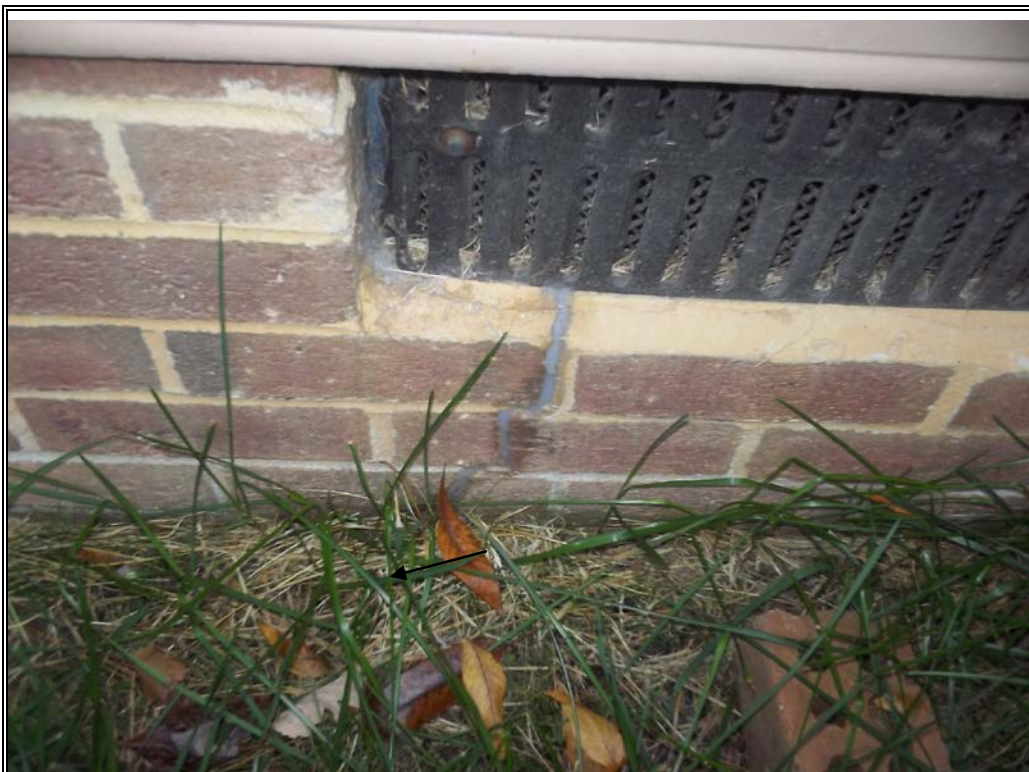
**2**

1. An approximately 1/4-inch wide vertical crack noted in the brick veneer at the right side foundation near the right rear corner of the home. This crack has been previously sealed and no widening of the crack since the January 2014 inspection was observed.

View of previously  
sealed crack in  
brick at right  
foundation wall  
near right rear  
corner

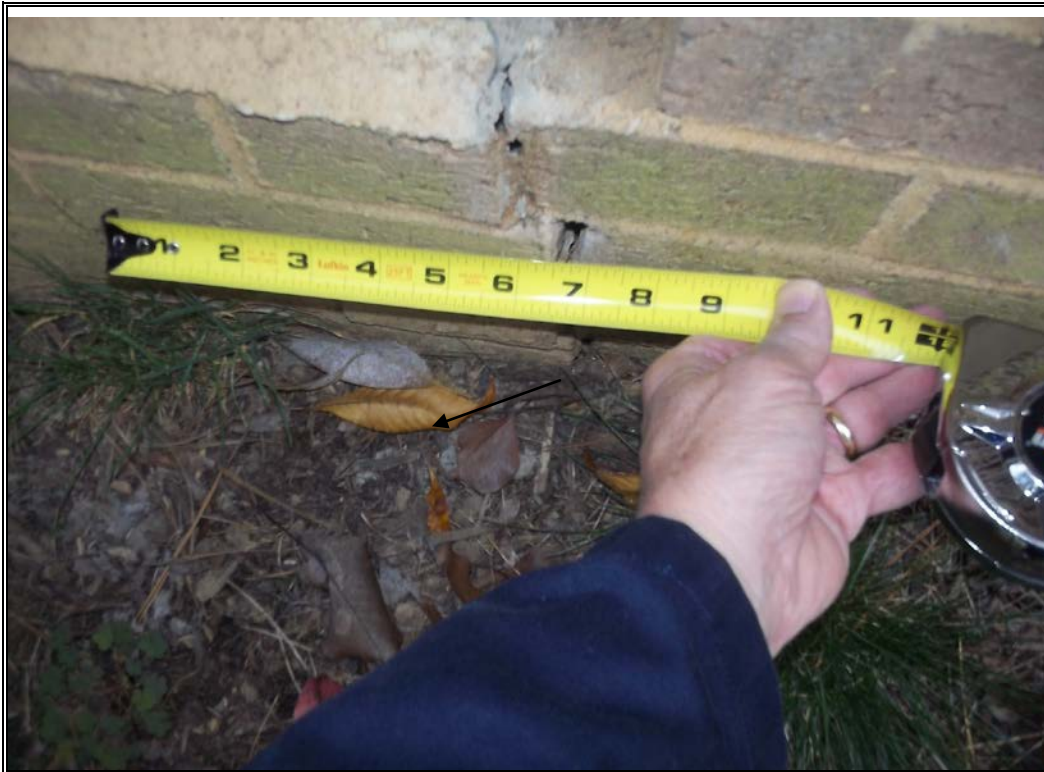
**3**

3. The cracking in the brick opposite the crack described above has widened since the original inspection. Note that missing mortar in part of this crack makes the crack width difficult to measure, but the brick crack appears to be at least 1/4-inch wide.

Our evaluation of the current conditions revealed no significant movement in the right side CMU foundation since our previous inspection in January. Although the crack in the brick at foundation level appears to have widened, this brick does not support the right side walls.

View of staircase  
crack under  
foundation vent on  
right side of home

- 1) The right side cracking in the CMU foundation should be monitored. If significant widening (approximately ¼-inch) of this CMU crack or propagation of additional cracks in the foundation is observed, additional foundation stabilization may be required.
- 2) If additional movement in the right side foundation is observed, we recommend hiring an experienced foundation contractor to stabilize the center area of the right side foundation. Installation of approximately 2 helical piers will be required to stabilize this section of foundation as required.
- 3) Resealing the crack in the right side foundation (under the vent) is recommended. Note that this resealing has no structural impact to the foundation.

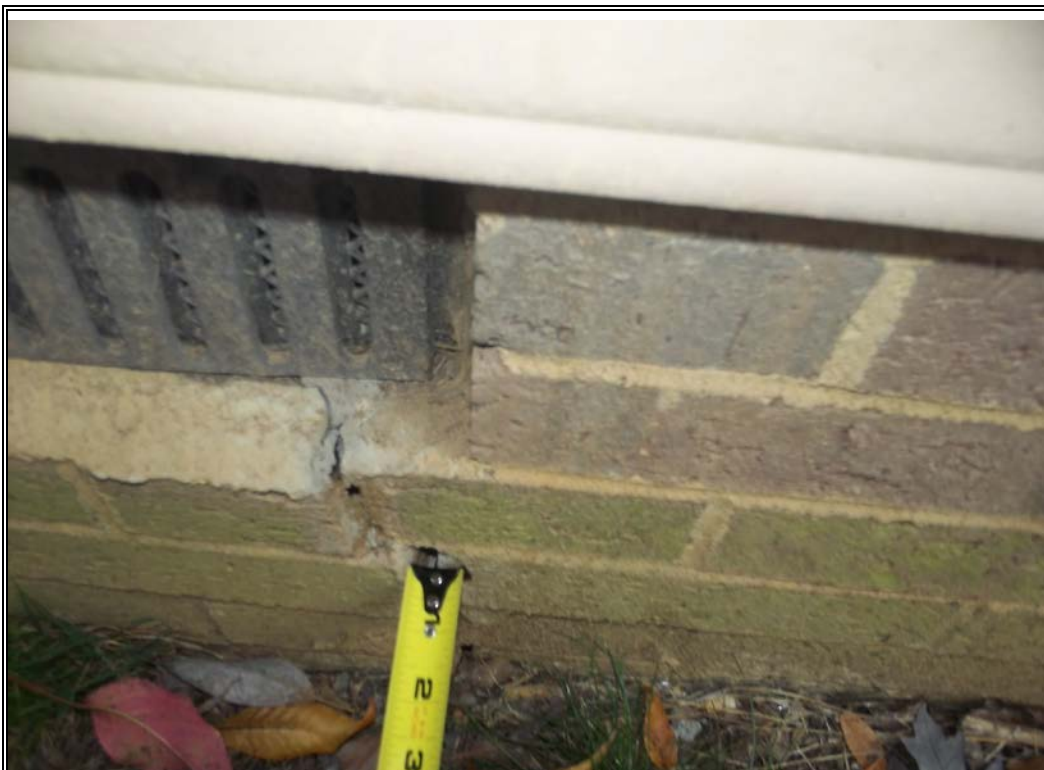
**4**

View of horizontal  
displacement of  
brick at crack  
shown in Photo 3

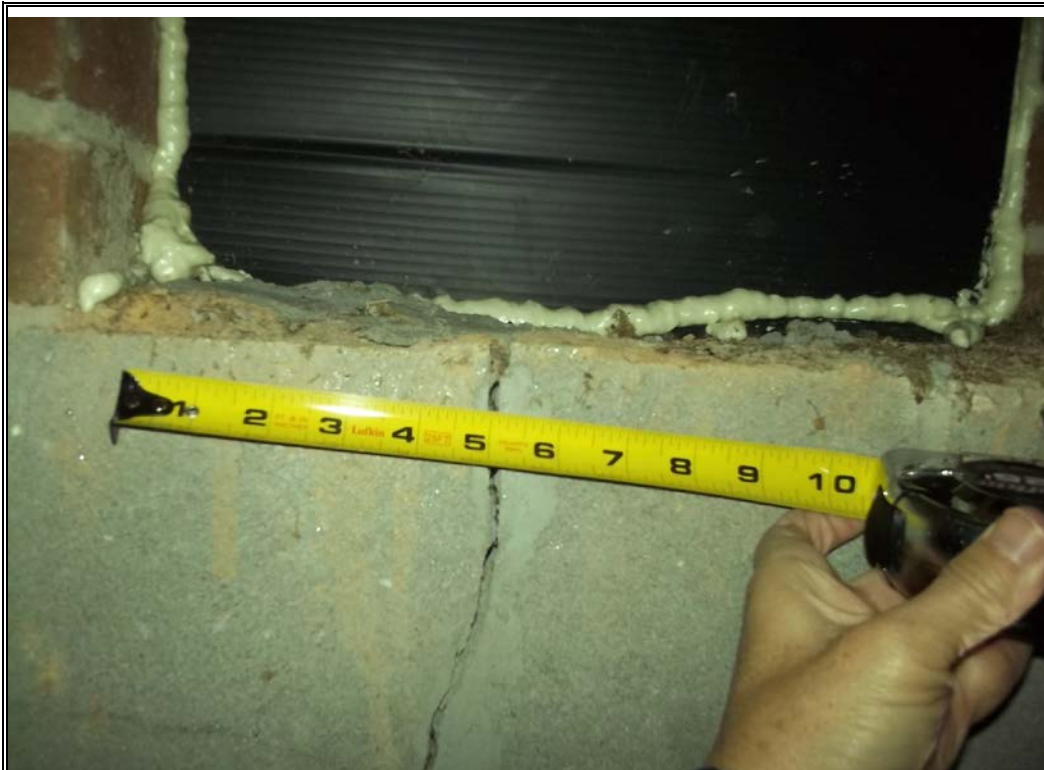
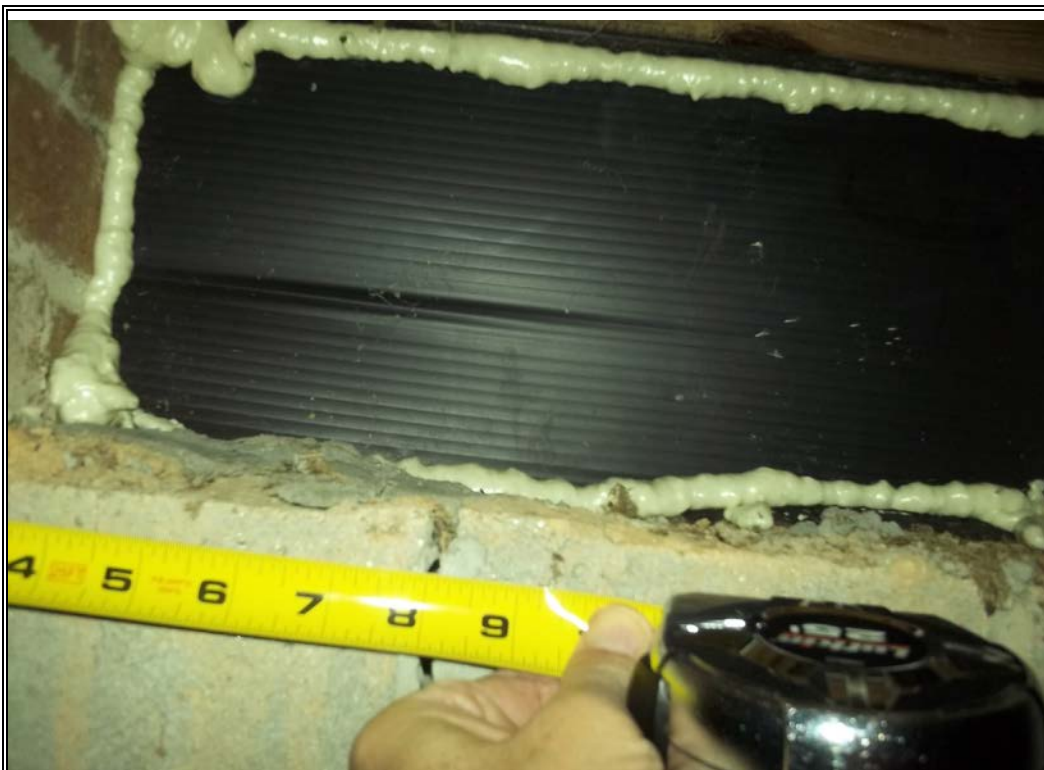
2. We also observed a crack in the brick and the opposite concrete masonry unit (CMU) in the center section of the right side foundation under a foundation vent. The crack in the CMU is approximately 1/8-inch wide (same width as noted in January) and approximately 3/8-inch horizontal displacement was noted in the CMU at this crack (same displacement as noted in the CMU in January).

This crack and other observed previous cracks in the foundation walls are **not** considered significant structural deficiencies at this time. Monitoring cracks for additional settlement is an acceptable approach. If cracks widen significantly or additional significant cracks propagate then further evaluation by a structural engineer and possible foundation stabilization may be needed at that time.

View of  
approximately 1/8-  
inch wide crack in  
CMU  
approximately 12-  
feet from front  
right corner -

Another view of  
same crack shown  
in Photo 5

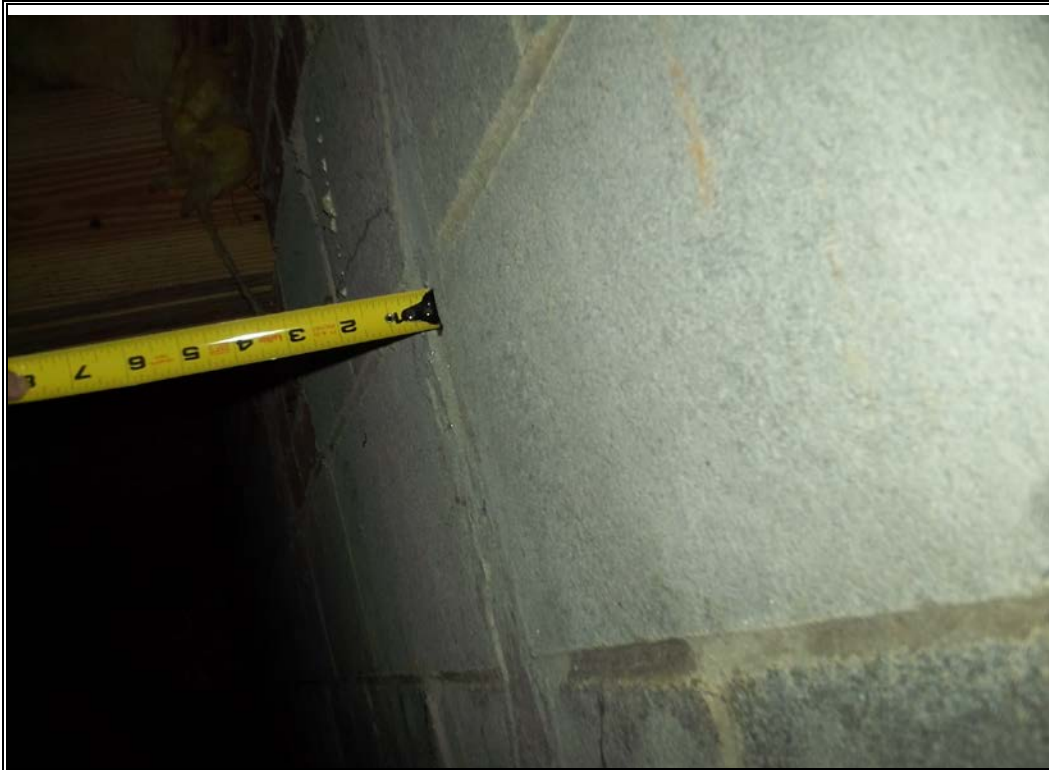
**7**

Note  
approximately 3/8-  
inch horizontal  
displacement of  
CMU at crack  
shown in Photos 5  
and 6
