## LIMITED STRUCTURE EVALUATION REPORT

4340 Bona Court  
Raleigh, North Carolina 27604

**Assessment Date:** 10 June 2026

**CARTER ENGINEERING & CONSULTING, PLLC  
STRUCTURAL + CIVIL**

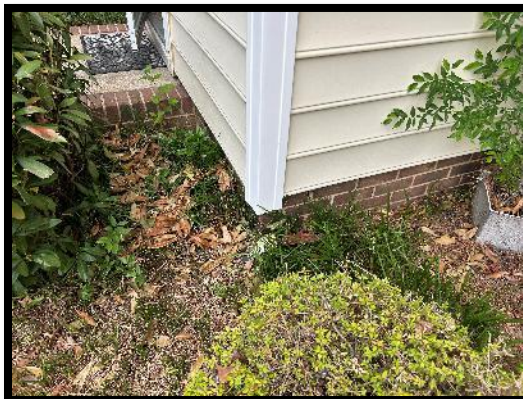
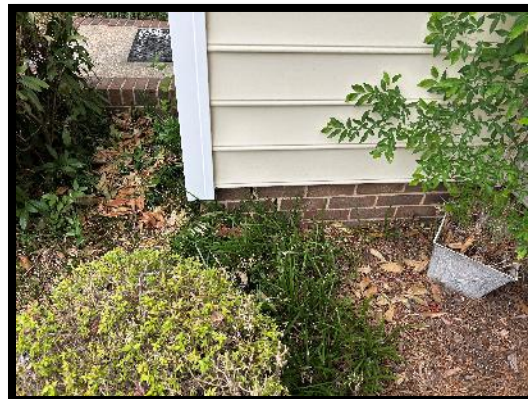
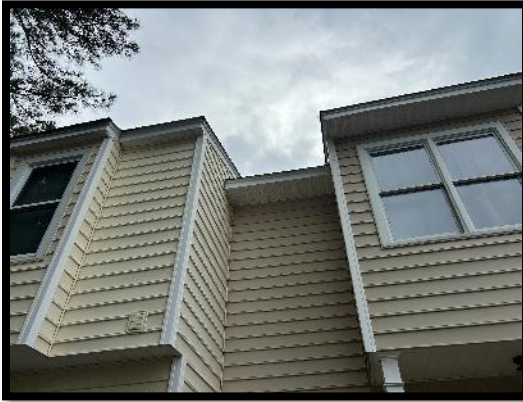
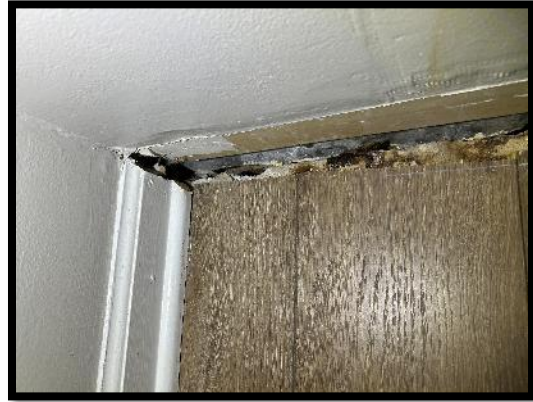
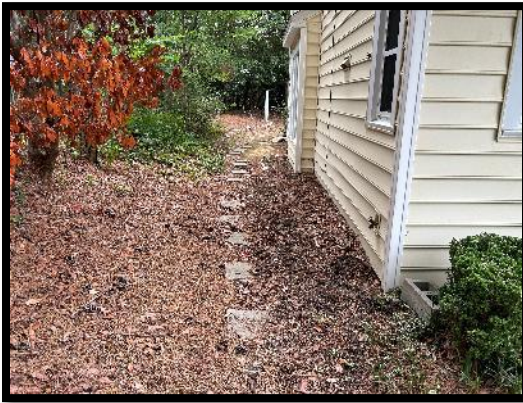
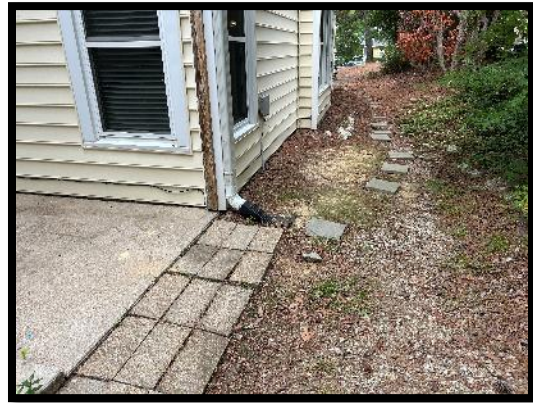
The townhouse incorporates a combination slab-on-grade and stem wall foundation system. The front portion of the structure is supported by a brick masonry stem wall foundation. Along the front right section of the building, extending from the front entry door to the front right corner, the stem wall has displaced outward approximately 1/2 inch. This movement has caused corresponding displacement of the base of the exterior wall framing and has resulted in misalignment of the front entry door and the front right bathroom window.

The observed condition is consistent with a combination of foundation settlement and lateral soil pressure acting against the stem wall over an extended period. The movement is attributable to historically deficient yard grading and roof drainage that allowed surface water runoff to accumulate adjacent to the foundation, increasing soil moisture and lateral earth pressures against the front corner of the structure.

The stem wall displacement has not compromised the structural integrity of the townhouse. However, the movement has produced noticeable distortion of the wall framing at the front entry door and front right bathroom window. Similar foundation cracking and stem wall movement were observed in other portions of the building complex serving adjacent townhouse units.

The moisture appears to be historically from the rear left corner downspout that ties into a buried collector pipe with unknown discharge location and unknown clear flow, and to front roof surface water runoff above this right corner.

To improve wall alignment, the base of the front exterior wall may be carefully pushed inward until satisfactory vertical alignment is achieved. Once aligned, install four new anchor bolts through the wall framing bottom plate into the stem wall foundation at 2-foot on-center spacing to secure the wall in its corrected position.

Cracks within the brick masonry stem wall should be filled with grout to restore continuity of the masonry and limit water infiltration. Along the interior face of the front wall, gaps between the concrete slab and stem wall should be sealed using a polyurethane sealant to reduce moisture migration and air infiltration.

For the rear left roof gutter downspout, locate the discharge point of the buried collector pipe system and ensure unobstructed flow. If the system is obstructed then replace with a new buried 6" diameter PVC collector pipe with a clear discharge location.
