# SIERRA DELTA HOME INSPECTIONS LLC

## RESIDENTIAL INSPECTION

515 E Cornwall Rd  
Cary, NC 27511

Cathy Williams  
07/28/2026

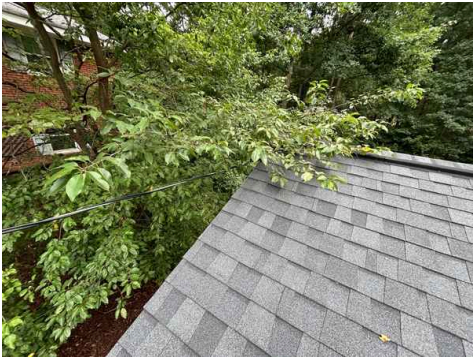
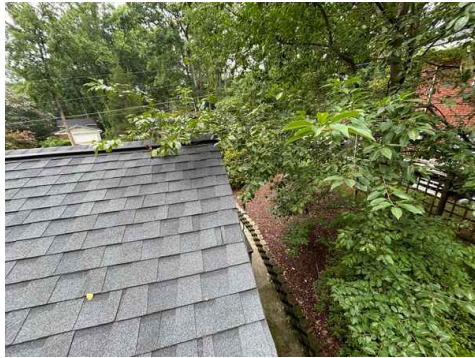
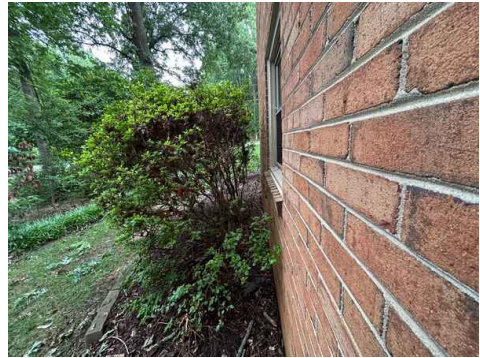
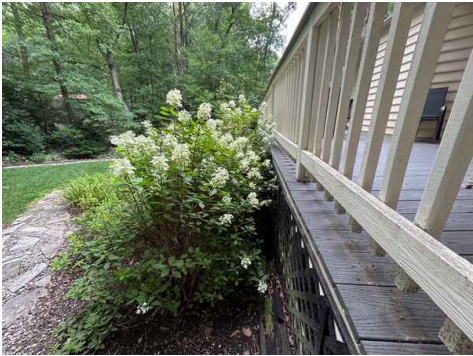
There was vegetation in contact with, or in close proximity to the home in areas. Pruning or removal of any plants within 1-2 feet of the home is recommended to be conducted by a qualified person to eliminate pathways of wood-destroying insects and allow moisture to adequately dry behind these areas after rainfall events.

Contact a qualified landscaping contractor

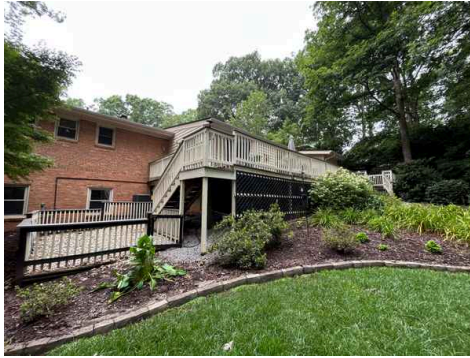
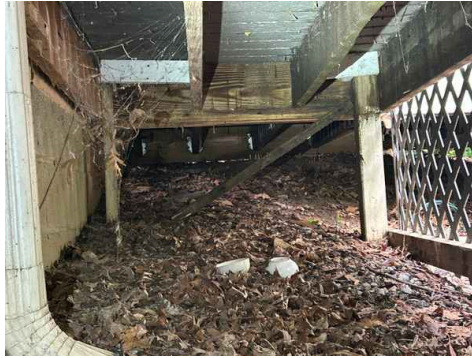
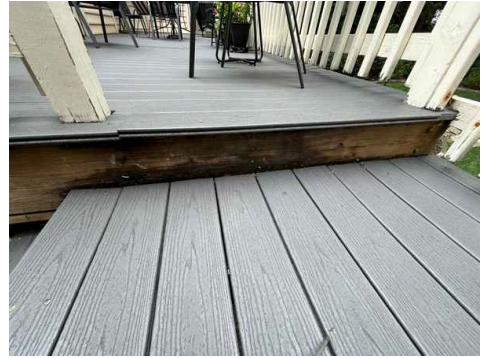
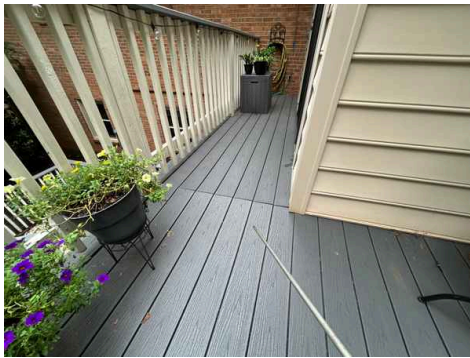
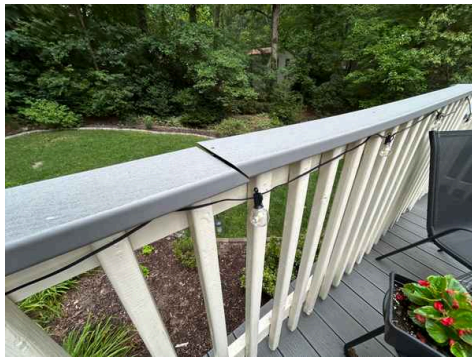
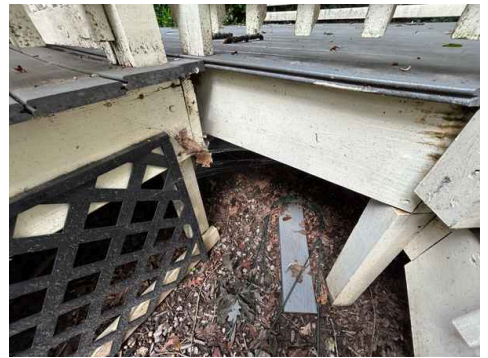
## 3.4.1 Decks &amp; Porches

**UNEVEN DECK SURFACE**

The deck has localized unevenness and minor areas of deflection consistent with age and normal wear. While the deck appeared generally serviceable at the time of the inspection, these conditions should be monitored and repaired as needed to help maintain structural performance and prevent further deterioration.

Contact a qualified professional.

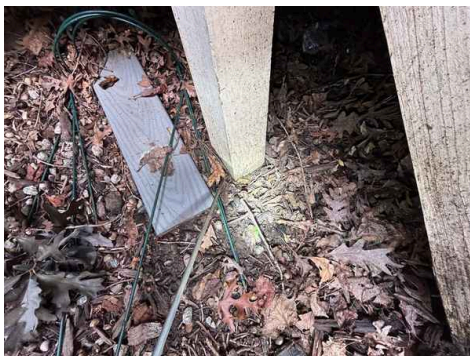
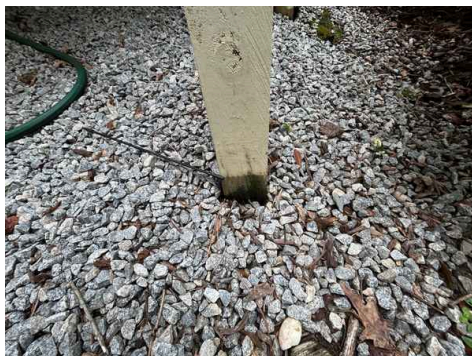
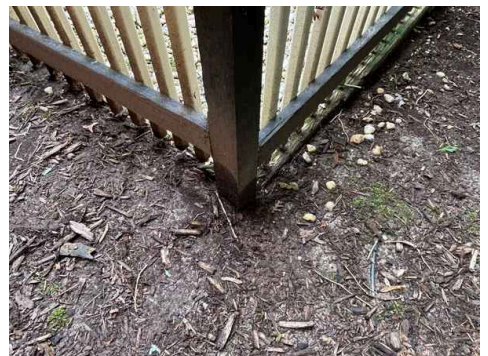
## 3.4.2 Decks &amp; Porches

**DECK – SUPPORT POSTS**

The deck support posts are in direct contact with the ground and exhibit early signs of moisture-related deterioration at the bases. Wood in ground contact is more susceptible to decay and insect damage, which can reduce its service life over time. Consider having a qualified contractor evaluate the affected posts and make repairs or improvements as needed to help protect against further deterioration.

Contact a qualified professional.

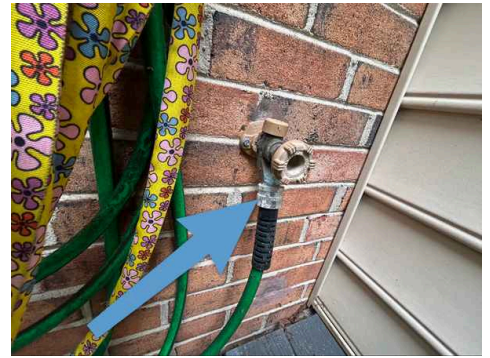
## 3.9.1 Exterior Spigots

A hose was attached to the rear hose bibb and could not be removed at the time of the inspection, preventing evaluation of the spigot for leaks or proper operation; remove the hose and inspect the hose bibb for leaks during normal use, repairing as needed if leakage is observed.

Contact a handyman or DIY project

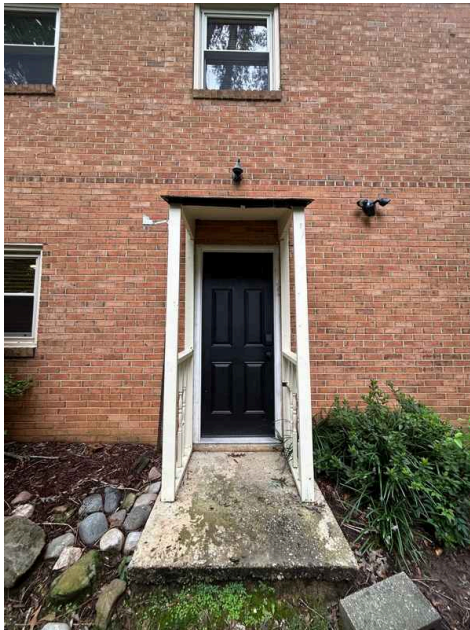
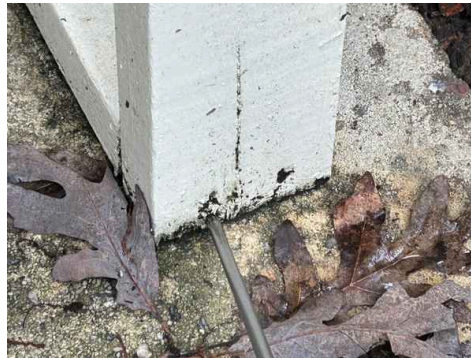
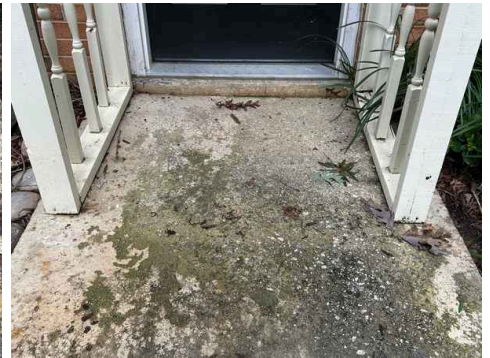
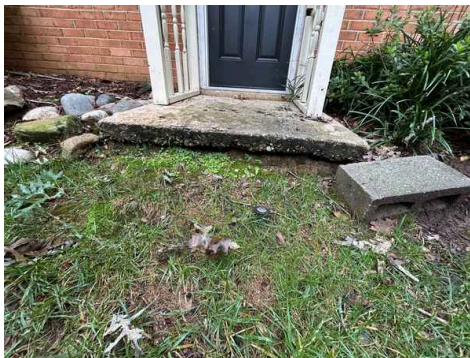
## 3.13.1 Concrete/Masonry Surfaces

The concrete landing at the basement exterior door has settled, resulting in a noticeable downward slope toward the right side. Minor wood deterioration was also observed at the bases of the porch support posts where they contact the concrete. While no significant structural concerns were evident at the time of the inspection, the settlement and wood deterioration should be monitored and repaired to help prevent further movement and moisture-related damage. Consider having a qualified contractor evaluate the landing and repair the affected wood components as needed.

Contact a qualified professional.

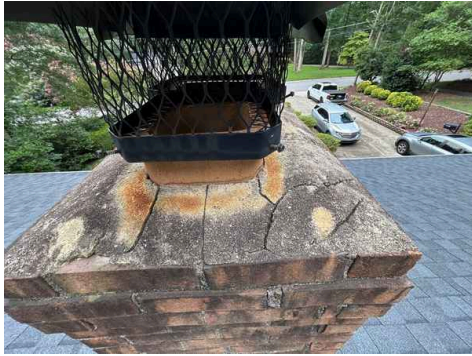
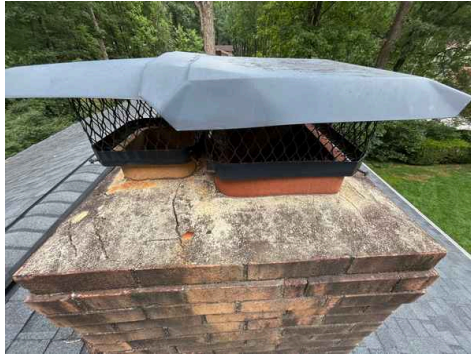
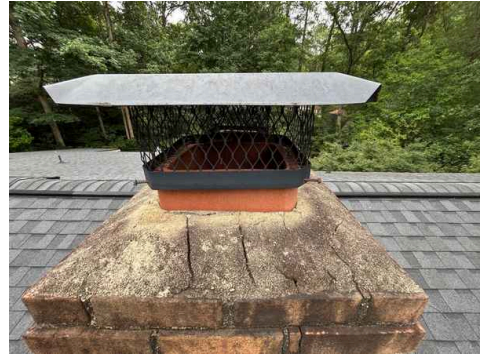
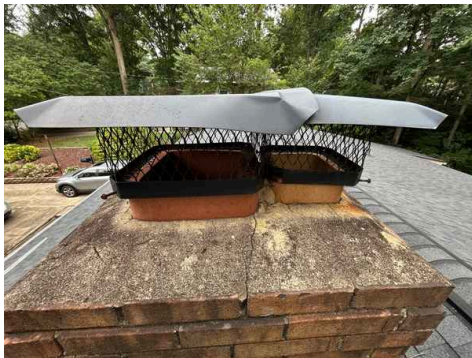
**CHIMNEY CROWN – DETERIORATED MASONRY CROWN**

The masonry chimney crown exhibits age-related cracking and surface deterioration around the flue openings. These conditions can allow moisture to enter the chimney structure over time, contributing to continued deterioration if left unaddressed. Consider having a qualified chimney contractor evaluate the chimney crown and make repairs or apply an appropriate sealant as needed to help extend its service life and reduce future moisture intrusion.

Contact a qualified professional.

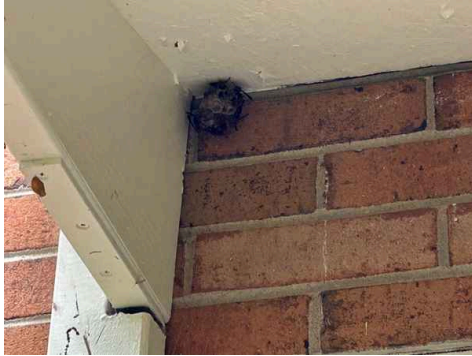
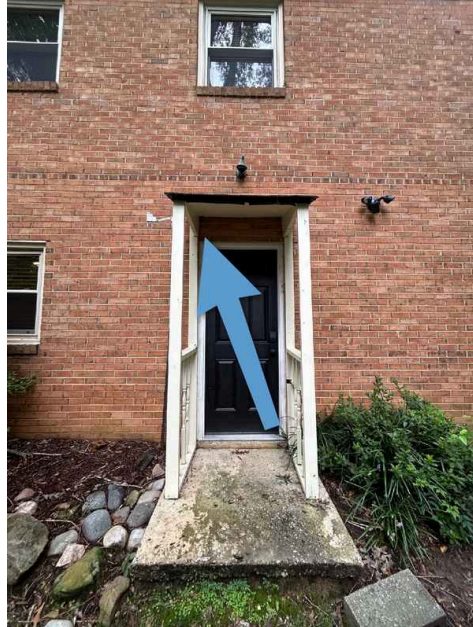
## 5.1.2 General Info

**EXTERIOR – WASP ACTIVITY**

Contact a qualified professional.

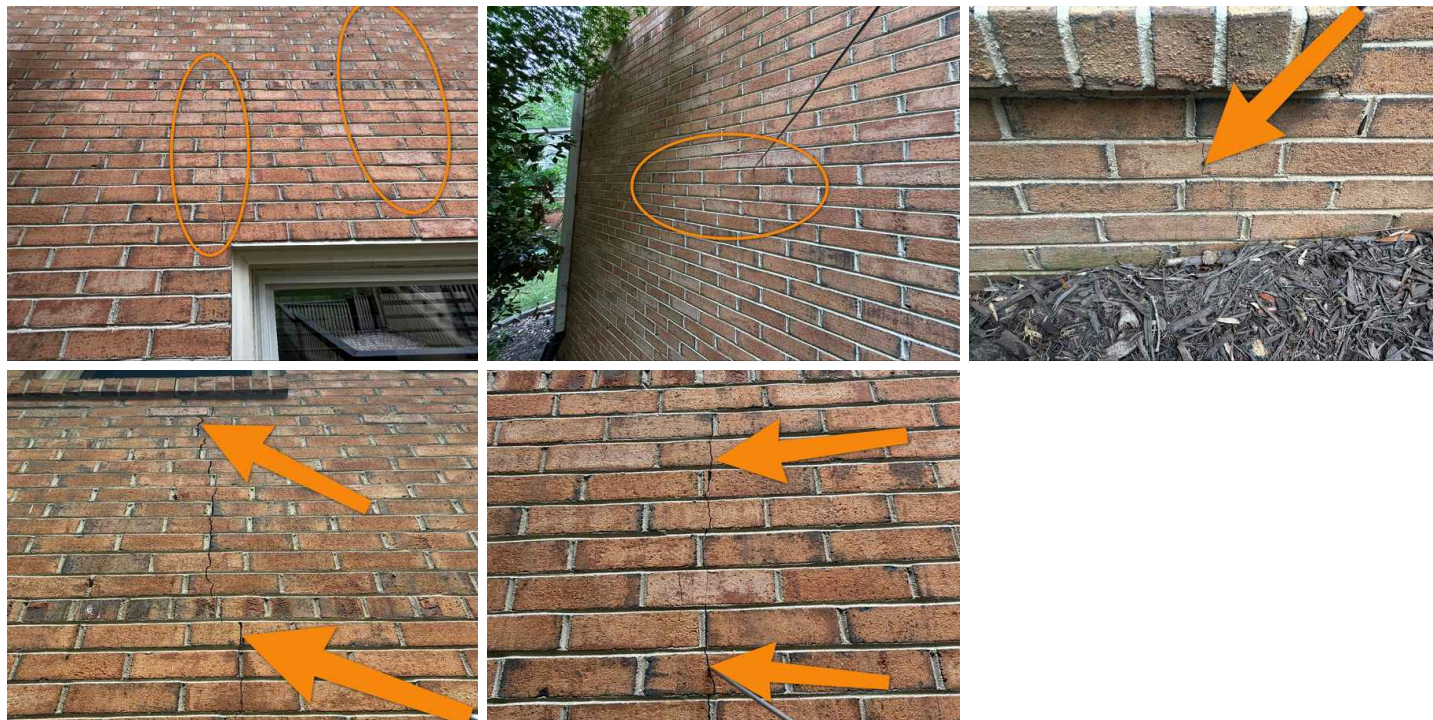
## 5.2.1 Walls/Cladding

**BRICK CRACKS**

Contact a qualified professional.

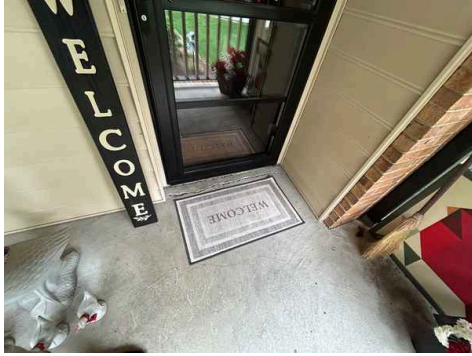
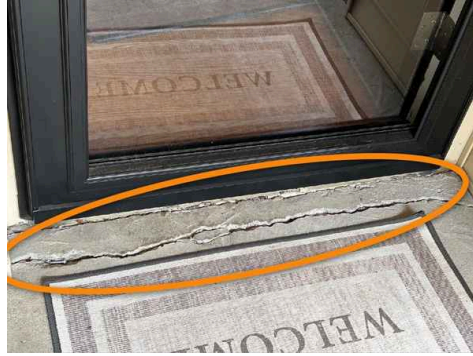
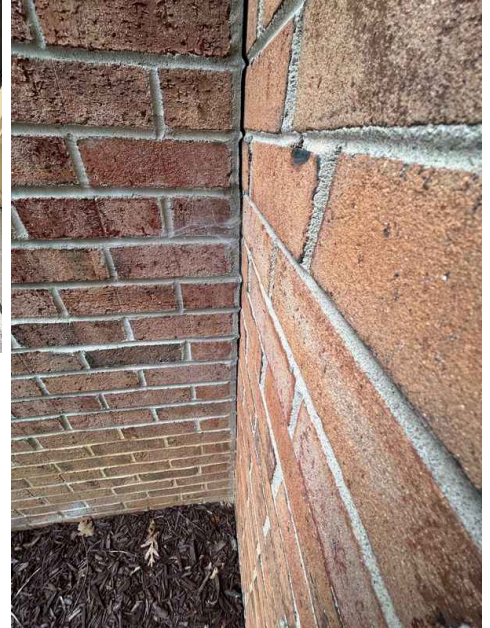
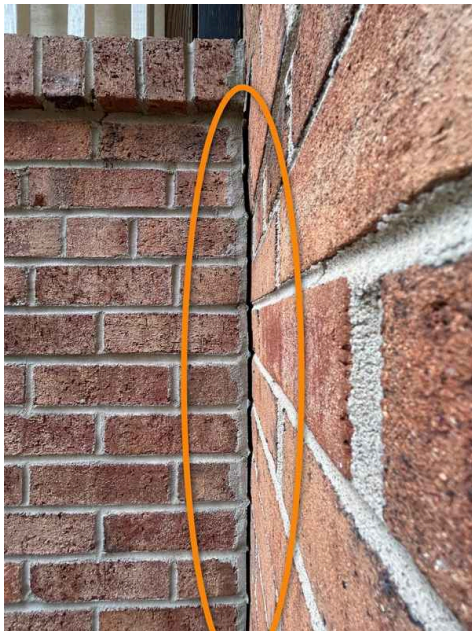
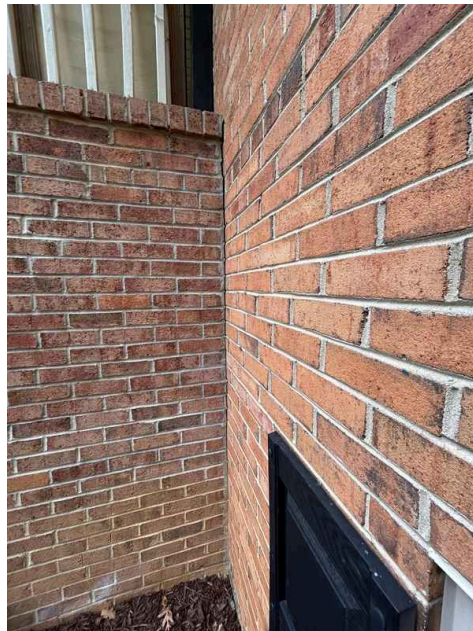
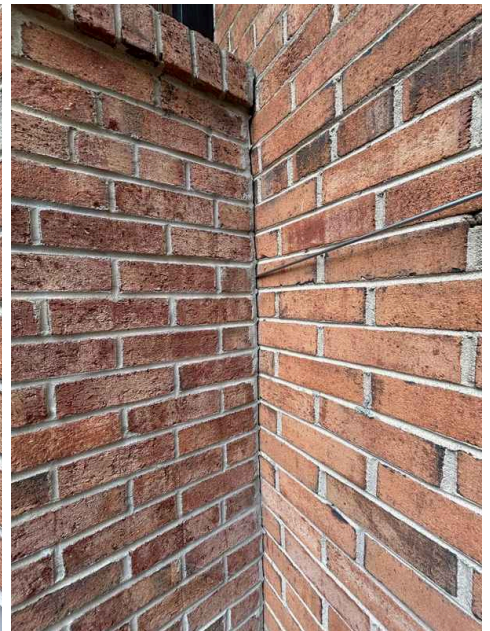
## 5.2.2 Walls/Cladding

**EXTERIOR – BRICK VENEER MOVEMENT / SETTLEMENT**

Contact a qualified professional.

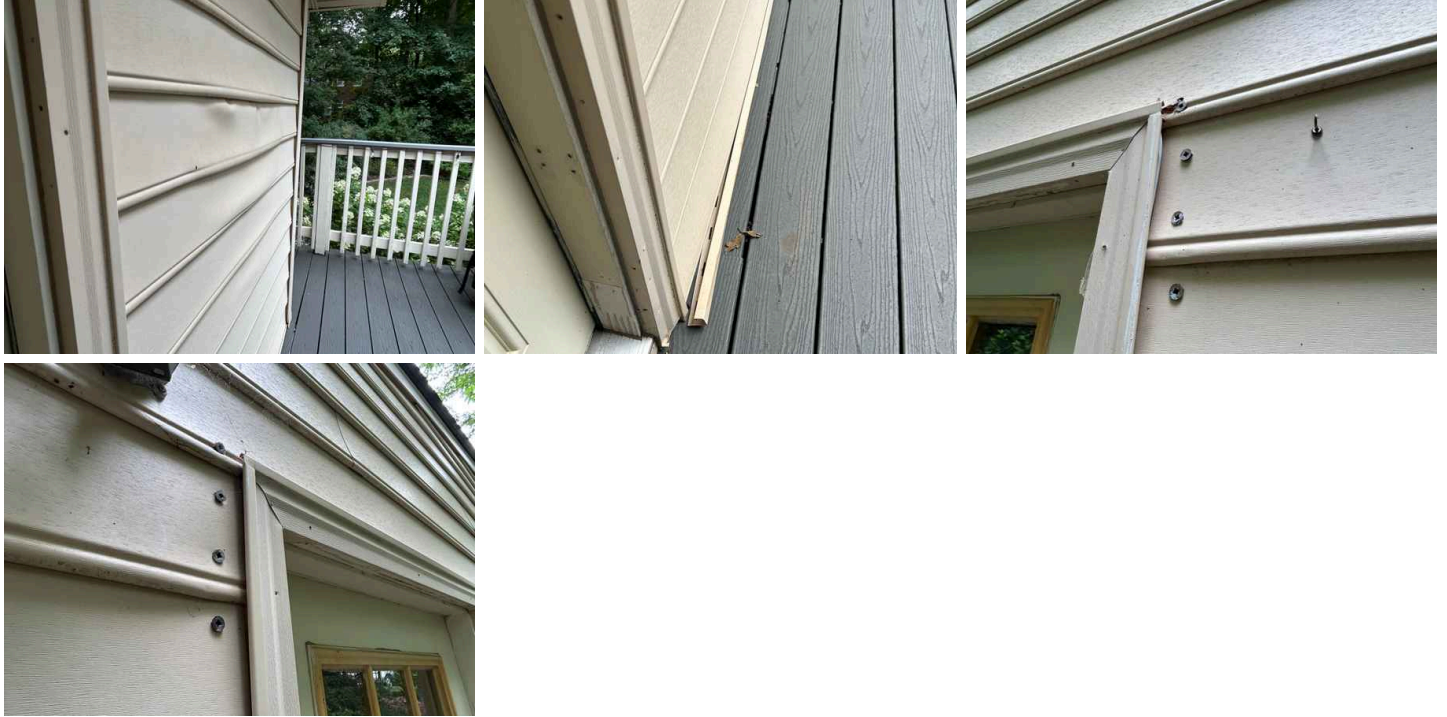
## 5.3.1 Vinyl Siding

**SIDING DAMAGE**

Contact a qualified professional.

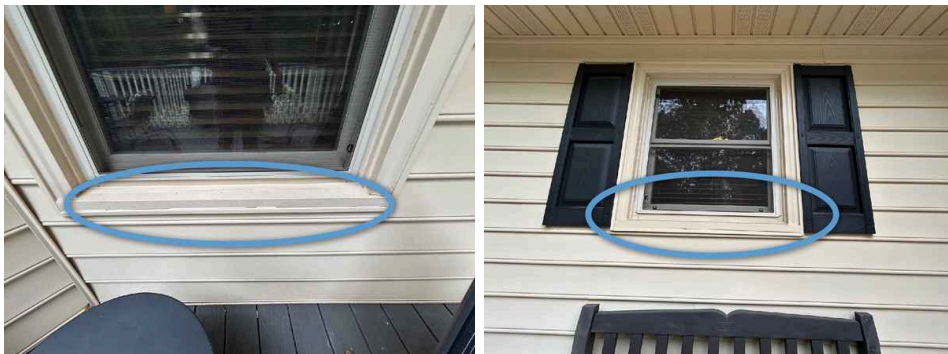
## 5.4.1 Window Exteriors

**EXTERIOR – WINDOWS**

Contact a qualified professional.

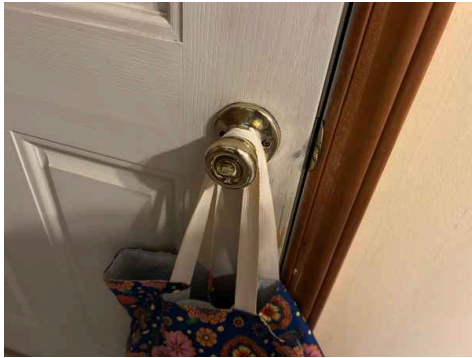
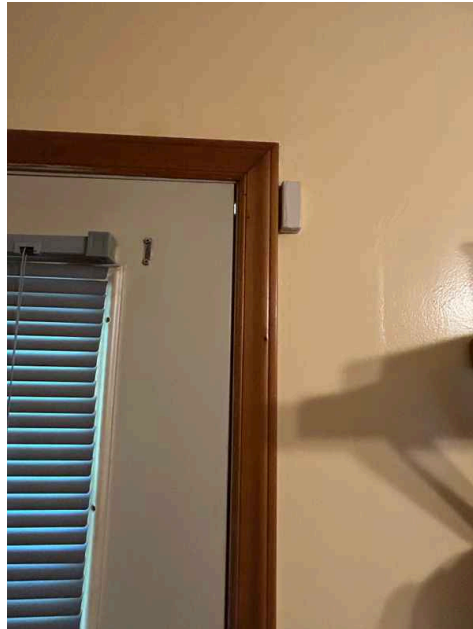
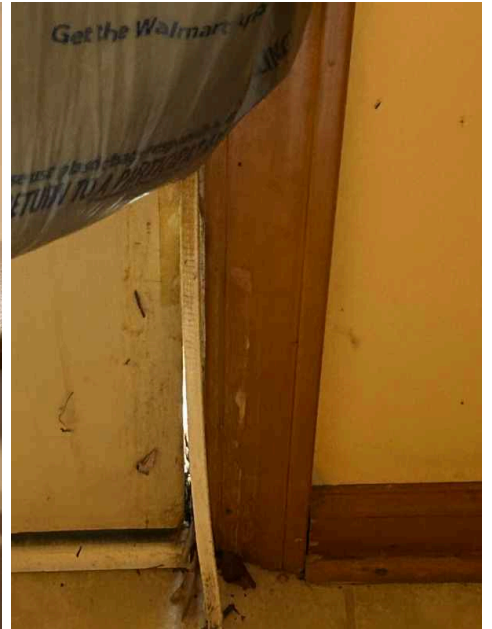
## 6.2.1 Exterior Doors

**LAUNDRY ROOM EXTERIOR DOORS – OPERATIONAL DEFICIENCIES**

Contact a qualified professional.

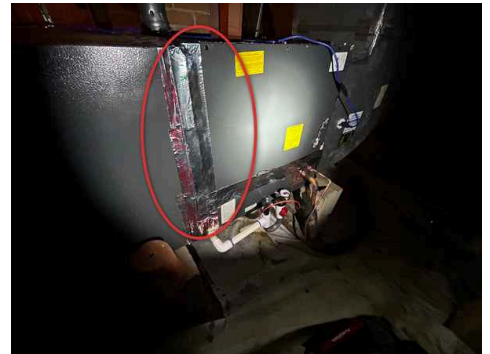
The HVAC air handler cabinet located in the crawlspace had gaps and deteriorated sealing, particularly along the rear of the cabinet, allowing conditioned air to escape. Air leakage reduces system efficiency, can contribute to pressure imbalances, and may allow unconditioned crawlspace air to be drawn into the system. A qualified HVAC contractor should reseal the cabinet and duct connections as needed to minimize air leakage and improve system performance.

Contact a qualified HVAC professional.

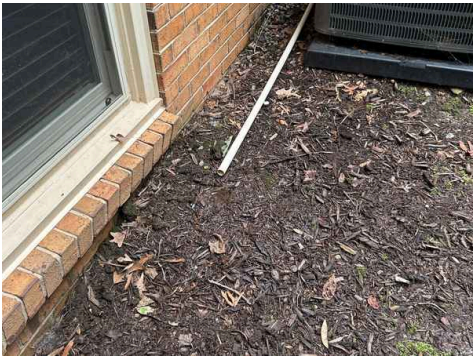
11.7.1 Condensate Drain Pipe

The condensate drain pipe or tubing terminated at or near the foundation of the home. This can allow water to saturate the soil in this area, possibly entering back into or under the structure. Extending the drain away from the foundation is recommended to be conducted by a qualified person.

Recommendation  
Contact a qualified professional.

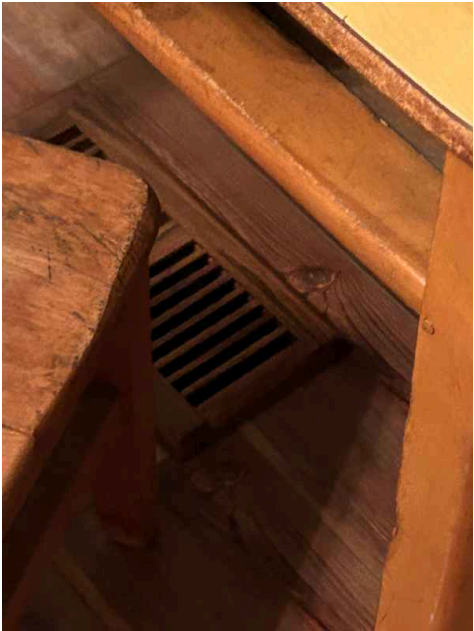
11.17.1 Cooling Source In Each Habitable Room

No conditioned air was observed discharging from the supply registers in two rooms located on the left side of the home while the HVAC system was operating. This condition may indicate disconnected or damaged ductwork, a blocked duct, an improperly balanced system, or another distribution issue that can reduce comfort and system performance. A qualified HVAC contractor should evaluate the system to determine the cause and repair as needed.

Recommendation  
Contact a qualified HVAC professional.

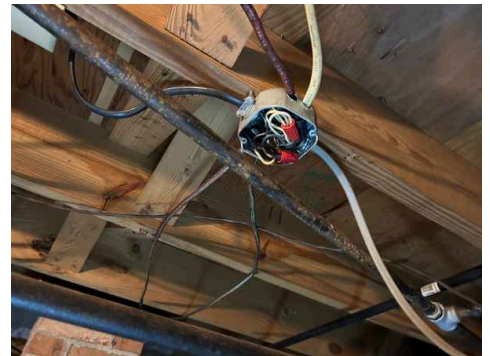
## 14.1.2 General Electrical Information

**OPEN JUNCTION BOX – CRAWLSPACE**

Contact a qualified electrical contractor.

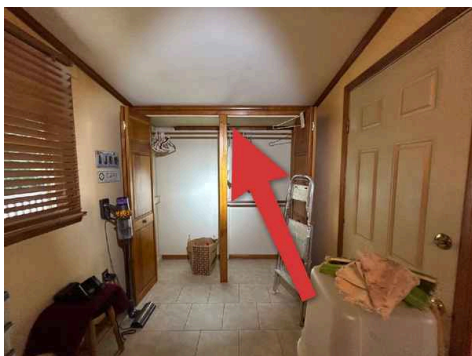
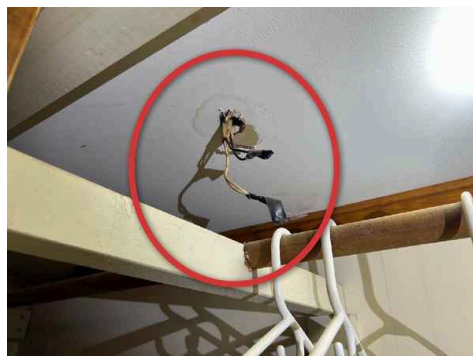
## 14.1.3 General Electrical Information

**ELECTRICAL – LAUNDRY ROOM CLOSET**

Contact a qualified electrical contractor.

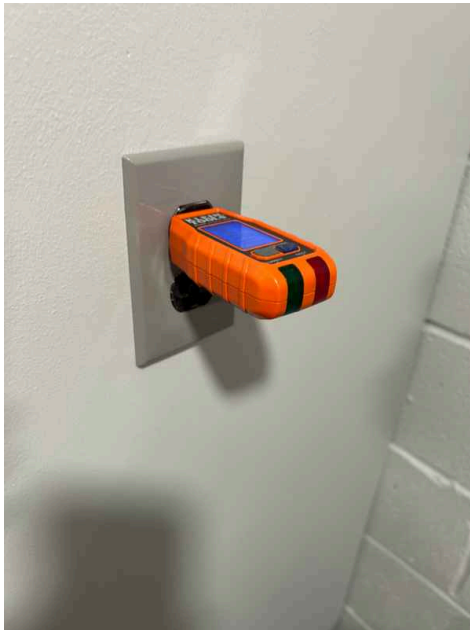
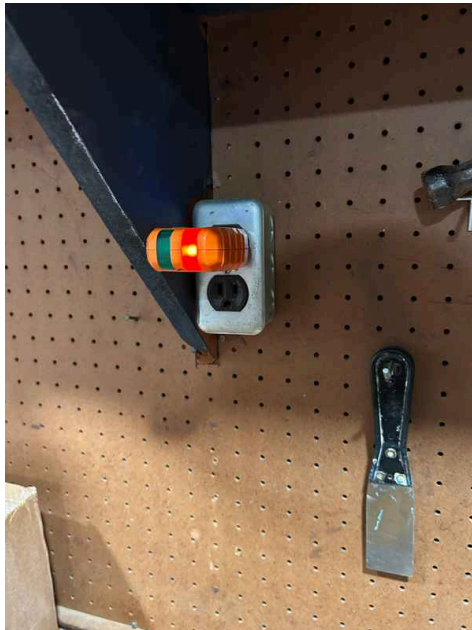
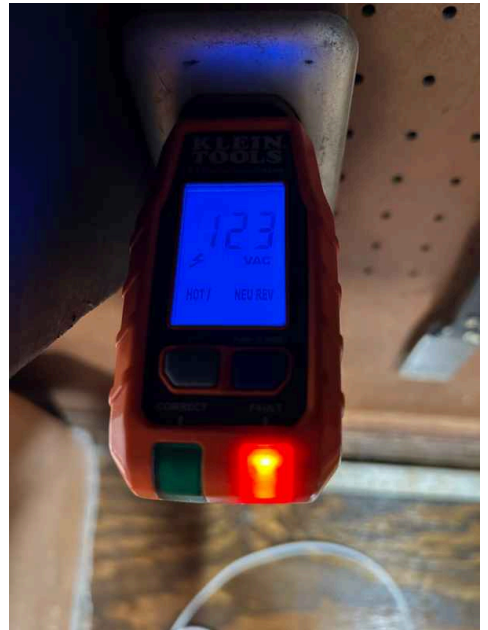
## 14.10.1 Receptacles

**REVERSED POLARITY – BASEMENT UTILITY ROOM RECEPTACLES**

Contact a qualified electrical contractor.
