Stonewall Structural Engineering, PLLC  
Raleigh Office  
9203 Baileywick Rd. #200  
Raleigh, NC 27615  
(919) 407-8663

Re: Structural Observation — 2113 Port Royal Road, Raleigh, NC 27609

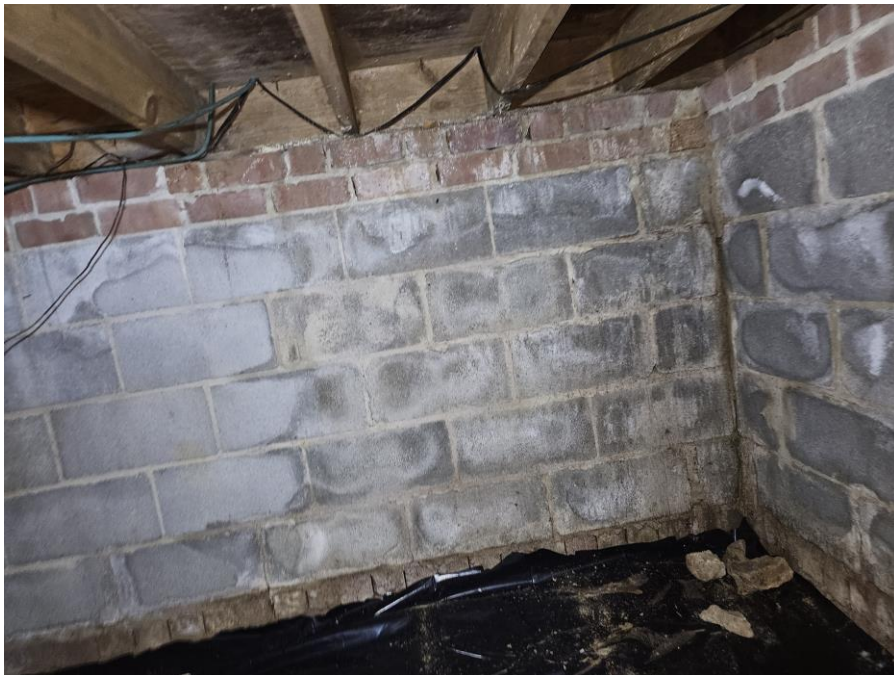
- Efflorescence and signs of water intrusion were noted at the front-right corner of the frontmost part of the crawlspace (*see picture 2*).
  - No signs of significant structural distress were noted in the foundation wall at this area.
  - Standing water was noted at this area of the crawlspace. Additionally, HVAC ducts had built-up condensation at the time of our inspection (*see picture 3*).
  - Roof gutter downspouts were set for discharge at foundation soils (*see picture 4*).
  - Vapor barrier edges were not sealed at the bases of piers throughout the crawlspace.

- Due to the lack of signs of significant structural distress at the areas of water intrusion, we consider the perimeter foundation to be adequately performing at those areas.
- The above-noted damaged floor framing has been the result of rot due to prolonged exposure to moisture in the crawlspace.
  - The damaged rim beam and sill plate have likely been the result of a deficiency in the waterproofing at the front porch slab.
- Our calculations indicate that the girder noted above with (3) continuous plies has the structural capacity to support design loads per the 2018 edition of the *North Carolina Residential Building Code*. Therefore, no additional structural modifications are required.

*Picture 2 – Efflorescence and signs of water intrusion*

- 9) Provide drainage improvements around the perimeter of the structure such that rainwater runoff is adequately diverted from the perimeter of the home. Drainage improvements are intended to help avoid the need for extensive foundation repair/stabilization work in the future.

- a) Current building standards require 6" of fall within the first 10' from a structure or use of drains and swales. A system of exterior or interior perimeter "French" drains and/or catch basins installed at low points in the grade may be necessary to achieve adequate drainage. Any low spots in the grade adjacent to the home should be filled for positive drainage away from the structure.

- b) We recommend installing a perforated interior perimeter crawlspace drain system with discharge through the low point of the perimeter foundation system at least 5' from the perimeter of the home onto soils adequately graded away from the structure. Transition to non-perforated pipe outside the footprint of the structure.

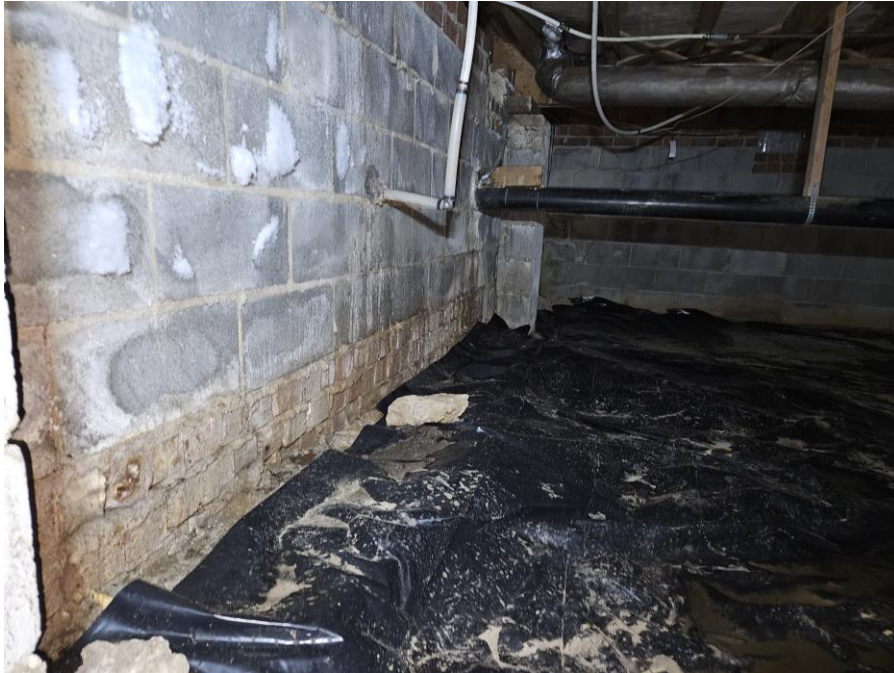
*Picture 3 – Standing water in the crawlspace*

- 8) Improve vapor retarder coverage such that the entire crawlspace floor is covered and edges are sealed around the bases of masonry piers.

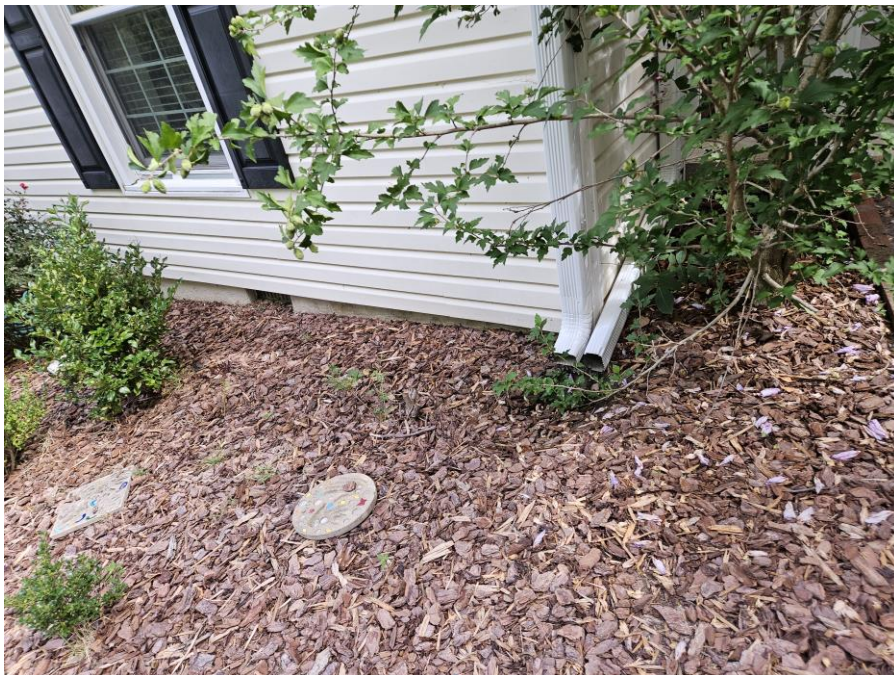
*Picture 4 – Roof gutter downspouts set for discharge at foundation soils*

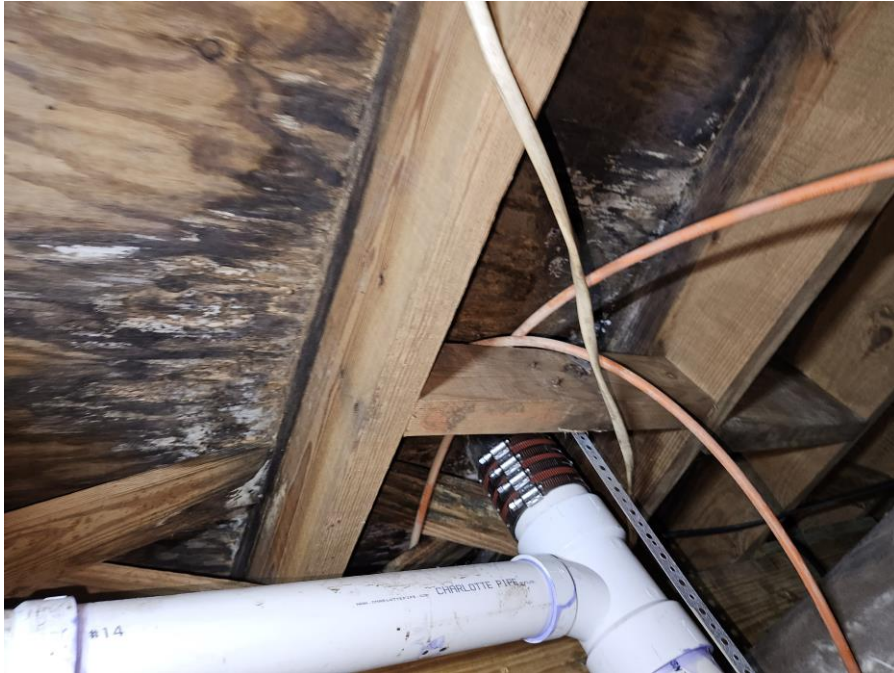
- A section of subfloor at the left side of the crawlspace was noted to be damaged beyond salvageable limits (*see picture 5*).

*Picture 5 – Damaged subfloor*

- 2) Remove deteriorated portions of sheathing and replace with sheathing of matching thickness, fastened to framing members with 8d common nails at 6" o.c. at panel boundaries, and 12" o.c. to joists within the panel field. Splice panels over centerlines of joists as needed with 1/8" minimum edge nail distance. No section of new or remaining sheathing should be smaller than 2'-0" in any direction.

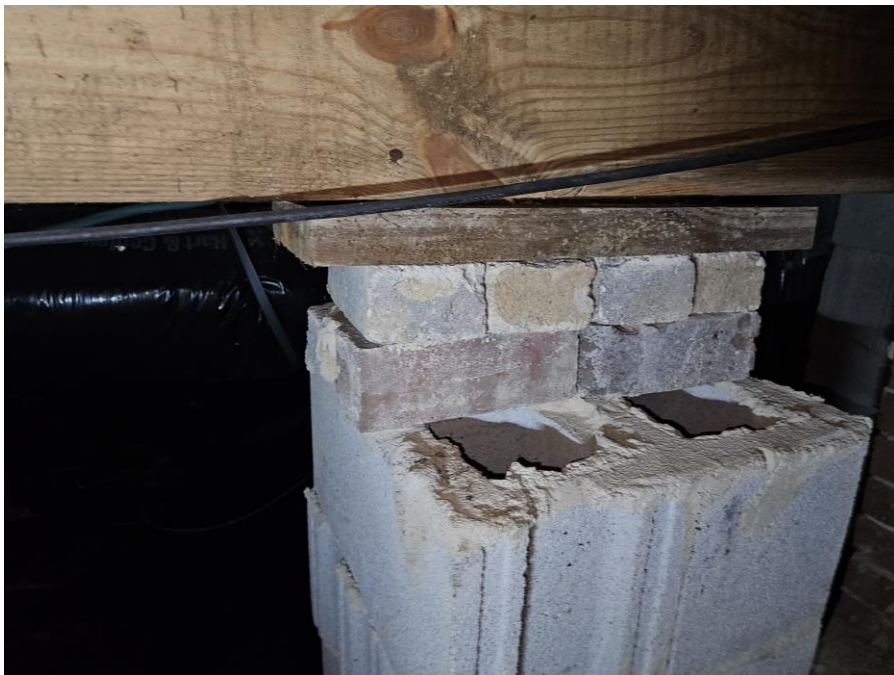
- Numerous CMU piers were noted to be missing solid caps, have loose shim material, or have crushed shim material (*see picture 6 for example*).
- The 2<sup>nd</sup> girder span from the front along the leftmost dropped girder was noted to consist of (2) non-continuous girder plies between end supports and (3) continuous girder plies between end supports (*see picture 7*).
- The dropped girder at the middle of the crawlspace approximately 30' from the left foundation wall was rotated and the plies were separating (*see picture 8*).
  - The rightmost (2) piers supporting this girder were noted to be leaning, improperly constructed, or an undermined footing (*see picture 9*).

*Picture 6 – Example of hollow pier missing solid caps*

- 3) The tops of the masonry piers should be reconstructed such that they have solid caps and tight-fit, treated, full-width, and full-length shim material.

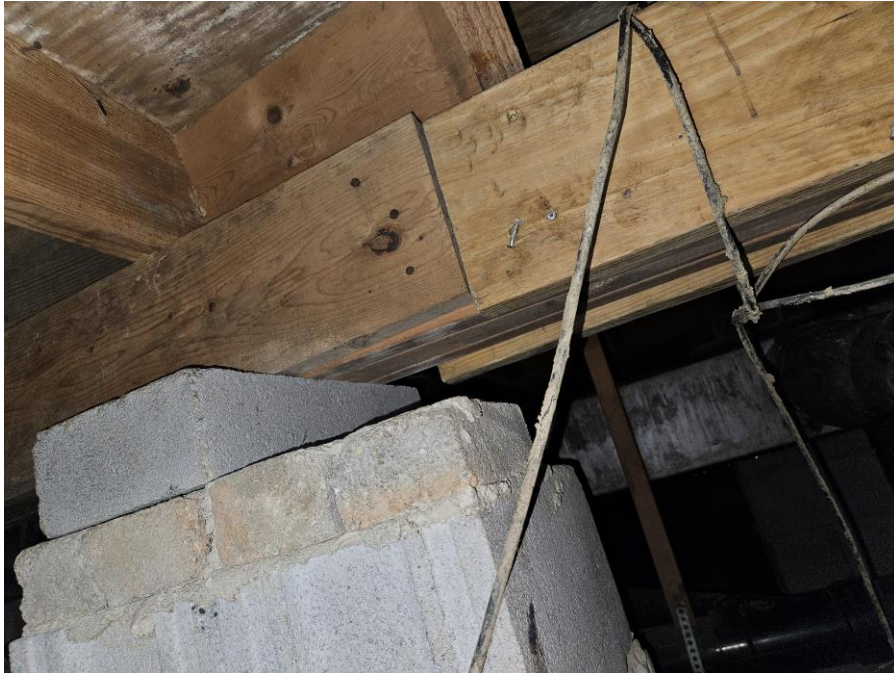
*Picture 7 – Non-continuous plies of dropped girder*

- 4) Replumb and build up the rotated and separated girder noted above.
- 5) Remove the damaged rim band noted above and replace it with full depth treated 2x #2 SYP tight fit beneath the floor sheathing.

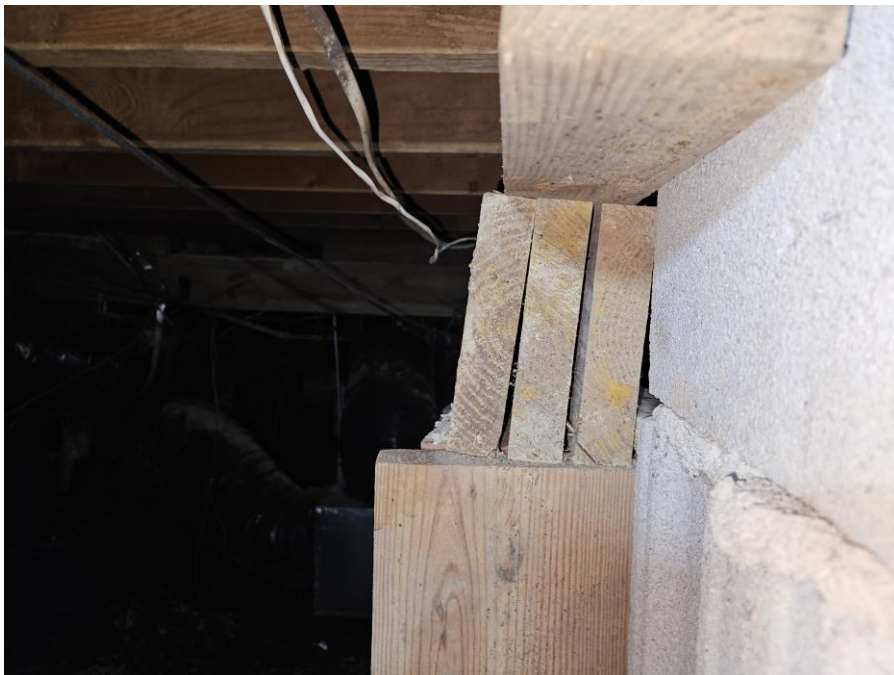
*Picture 8 – Rotated and separated plies*

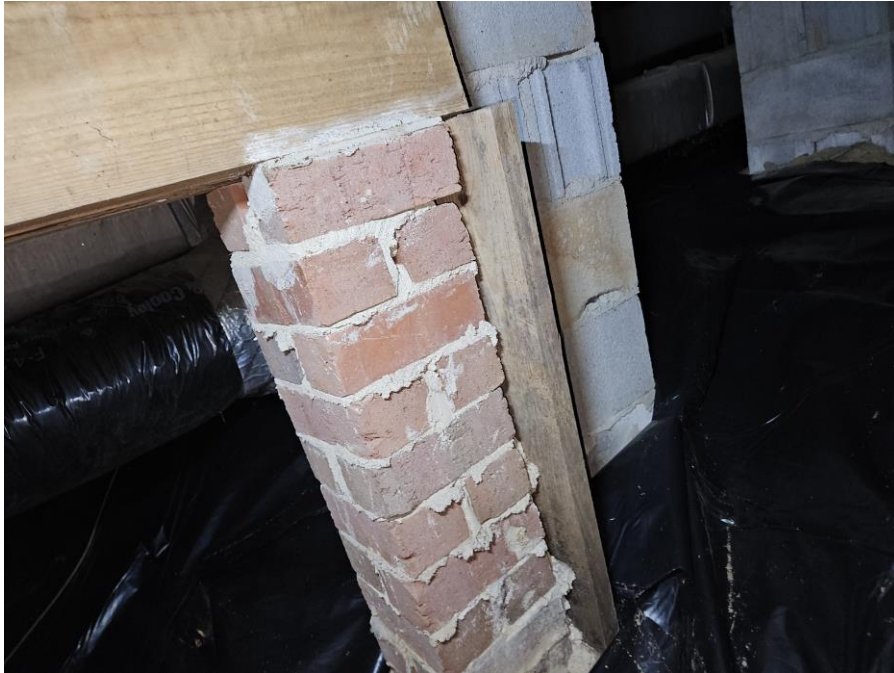
*Picture 9 – Leaning pier with undermined footing*

- 1) Remove the (3) leaning piers, improperly constructed piers, or piers with undermined footings and replace them with new CMU piers per the attached detail. The new piers should be centered over 24"x24"x10" thick poured concrete footings set at least 12" into suitable bearing soils.

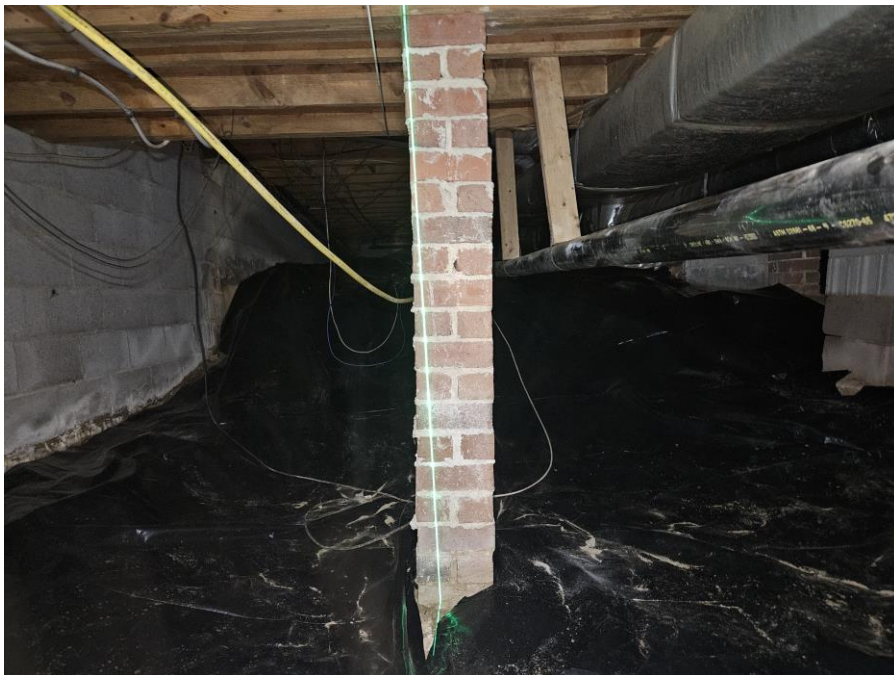
- The backmost interior masonry pier at girder approximately 25' from the left foundation wall was visibly leaning (*see picture 10*).

*Picture 10 – Leaning pier*

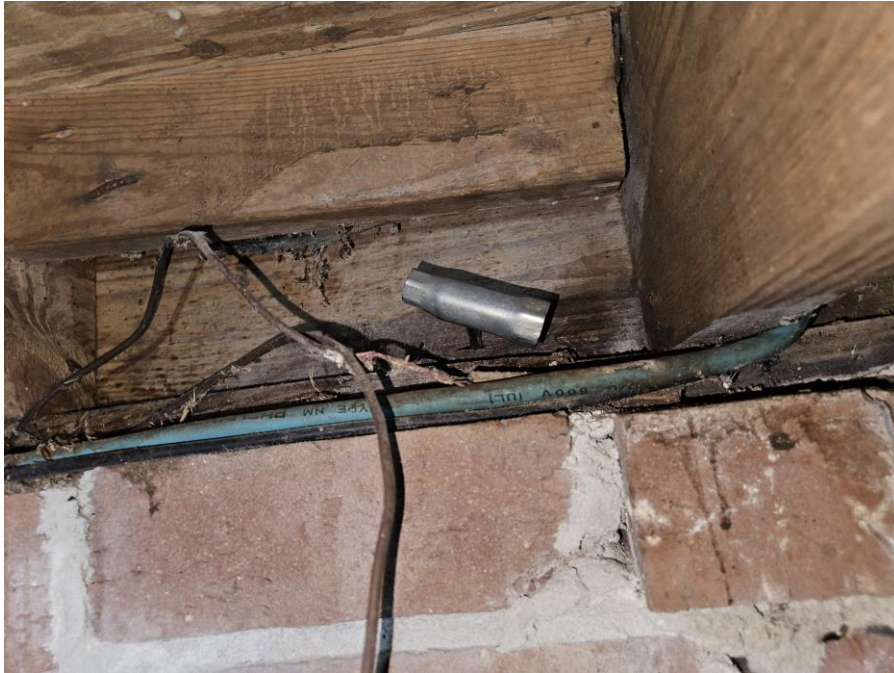
- The rim band and sill plate were damaged beyond salvageable limits at the right wall of the front-left portion of the crawlspace (*see picture 11*).
- The ledger strips at the 2<sup>nd</sup> and 3<sup>rd</sup> girder spans from the back along the flush girder approximately 13'-6" from the left foundation wall were noted to have slipped (*see picture 12*).

*Picture 11 – Damaged sill plate and rim band*

- 6) Remove the above-noted sections of deteriorated sill plate and replace using treated 2x #2 SYP material and fasten with Simpson "Universal Retrofit Foundation Plates" (or other approved anchor bolt alternative) at 6' on center max spacing and 12" from sill plate ends and breaks with at least (2) foundation plates installed per sill plate segment.

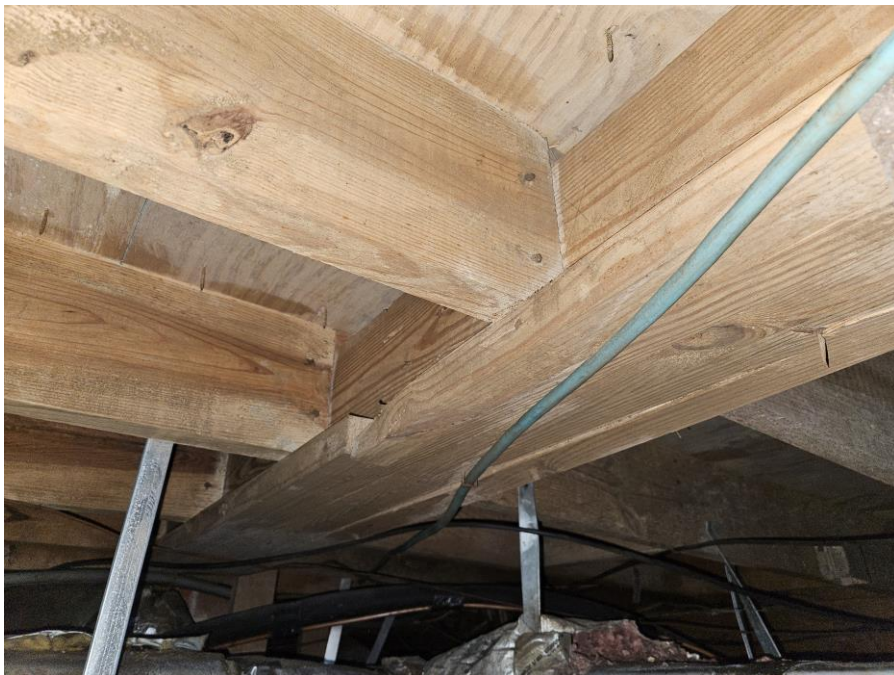
*Picture 12 – Example of slipped ledger*

- 7) Raise and refasten the slipped ledger strips noted above with (4)10d common nails per joist or remove the failed ledger strips and fasten joists directly to the sides of the girders using Simpson face hangers.
