# 7225 Rex Rd

# Holly Springs, North Carolina 27540

| Type | <b>Home Inspection and Floor Plan Report - 7225 Rex Rd</b> |
| Inspected by | <b>Spectris Inspections</b> |

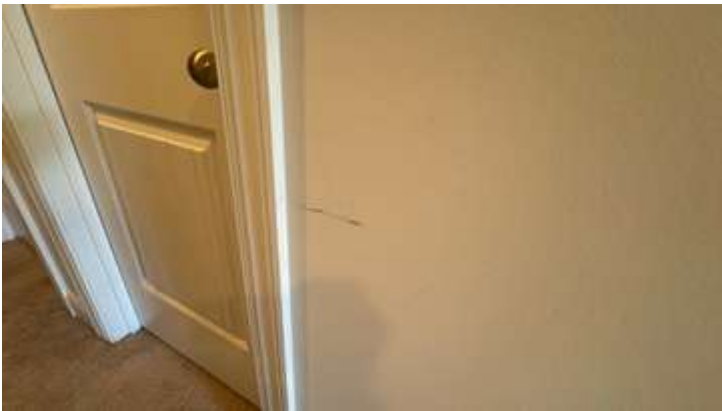
The interior paint needs to be touched up.

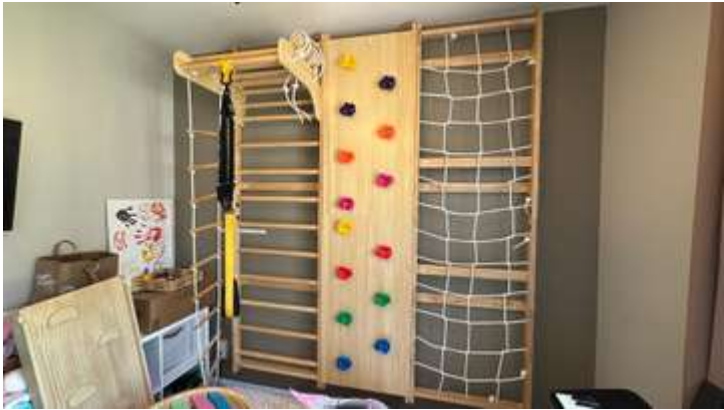
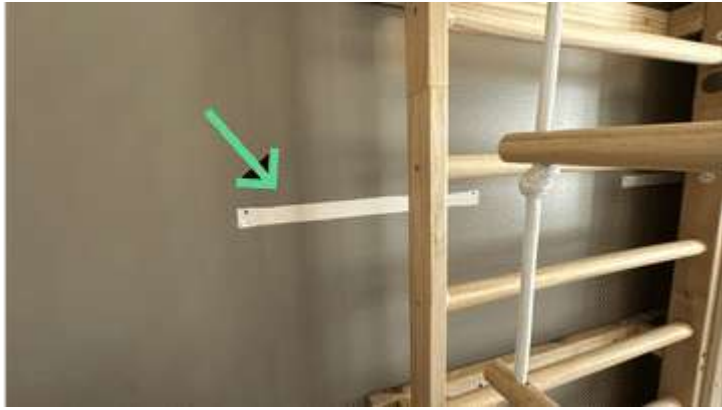
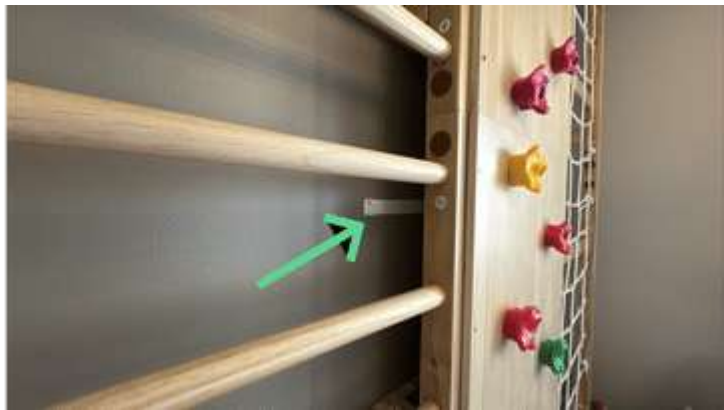
**Damaged Drywall**

The drywall is damaged.

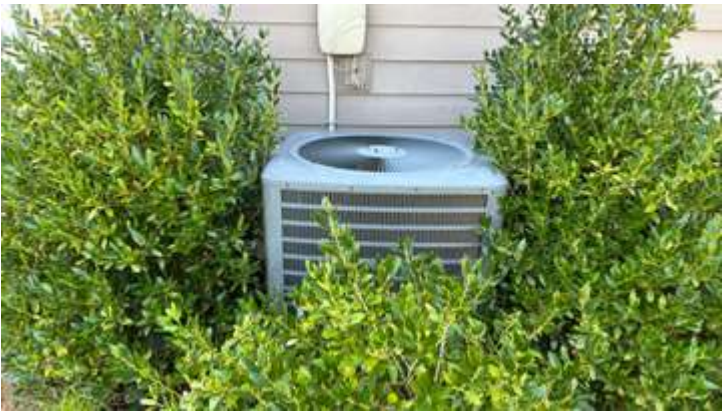
The vegetation is too close to the air conditioning compressor.
