## SUMMARY

104 Wedgemere St, Cary, NC 27519  
Aoife Hammersmith  
July 6, 2026

Natalie Spinella  
NC License #6235  
New Leaf Home Inspections  
3134548747  
[natalie@newleafinspections.com](mailto:natalie@newleafinspections.com)

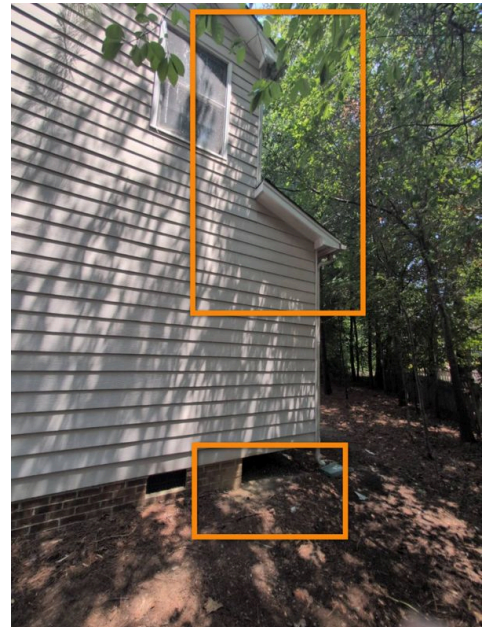
There are no or partial gutters present on the structure. This can allow water to impact the foundation of the home or increase moisture levels in crawlspace areas over time. We recommend a qualified contractor install gutters on the entire structure, or missing areas if so desired and possible.

No gutters at this particular spot is causing rain to fall here and erode the soil + efflorescence on brick foundation

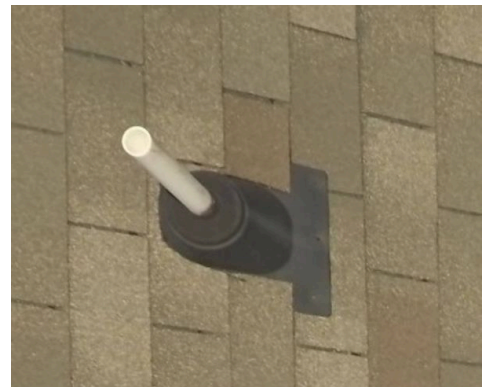
One or more roof penetrations may be installed in a questionable manner based on the location. This may allow moisture intrusion or damage to surrounding components. Recommend further evaluation by a licensed professional and or repairs made if necessary.

Missing nails on pipe boot

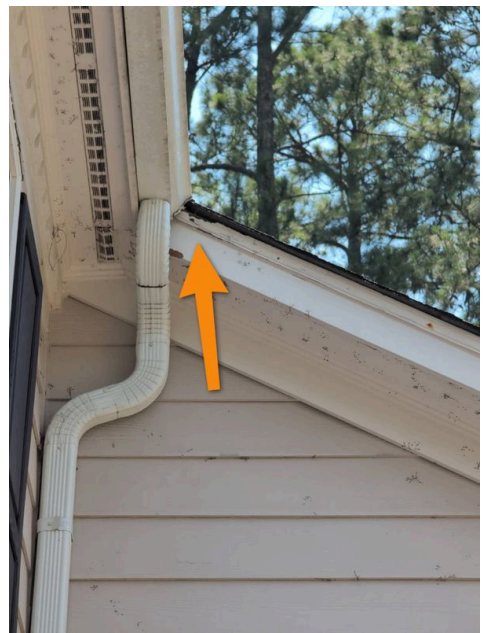
One or more sections of the fascia or soffit are deteriorated. This can allow moisture intrusion into the roof structure and damage surrounding components. Recommend qualified roofing contractor evaluate all areas & repair as necessary.

Front of house - deterioration

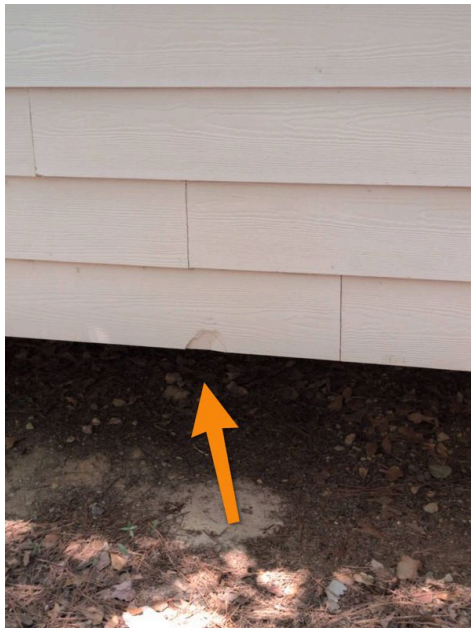
A component of the exterior was damaged. Anywhere water is able to come in contact with the sheathing of the home, accelerated deterioration is possible. Recommend evaluation of all exterior siding and possible repairs or remedies to prevent further damage by a qualified contractor.

Back of home, damaged siding

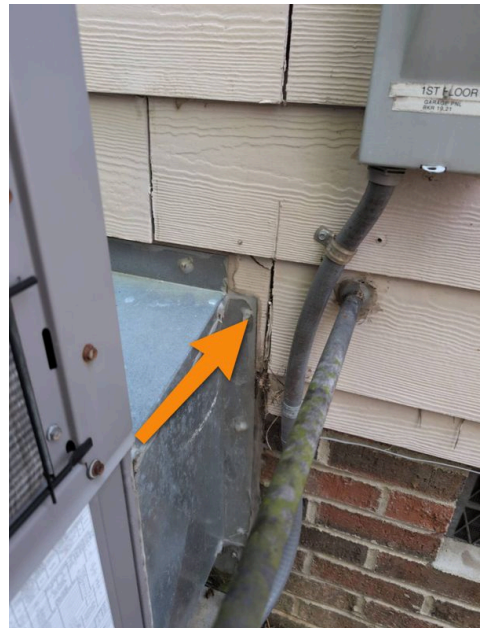
Damage near package unit

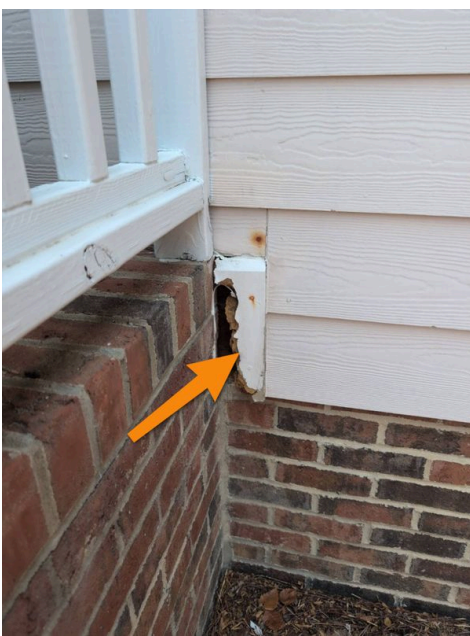
Sheathing exposed under this piece of damaged siding

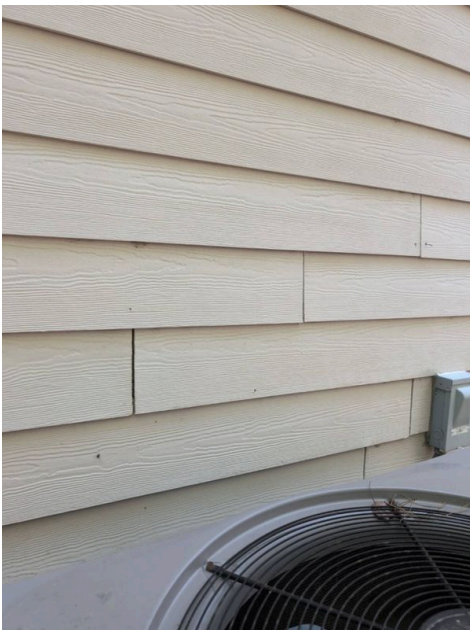
One or more siding components were loose, which could result in moisture intrusion, or in some cases not perform as intended aesthetically. Recommend a qualified siding contractor repair as needed.

Left side of home - loose siding

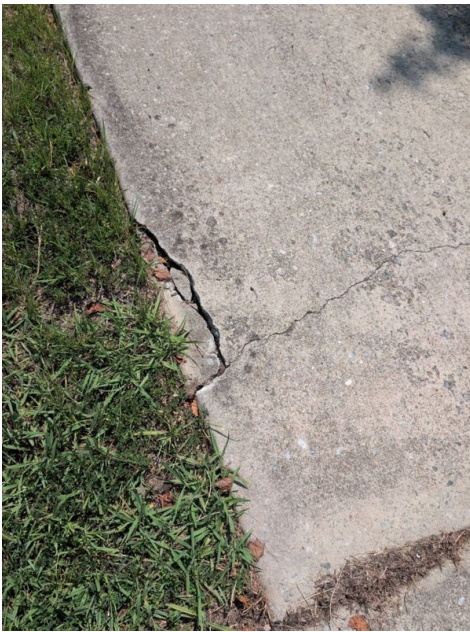
There was cracks / settlement in areas of the poured driveway or walkway slab. This can prevent proper drainage, or indicate other underlying issues such as tree roots, incorrect soil compacting, ect. This is fairly common in older structures. A qualified contractor should be consulted for possible repairs, keeping crevices sealed and keeping moisture out is important.

Slab cracks on driveway

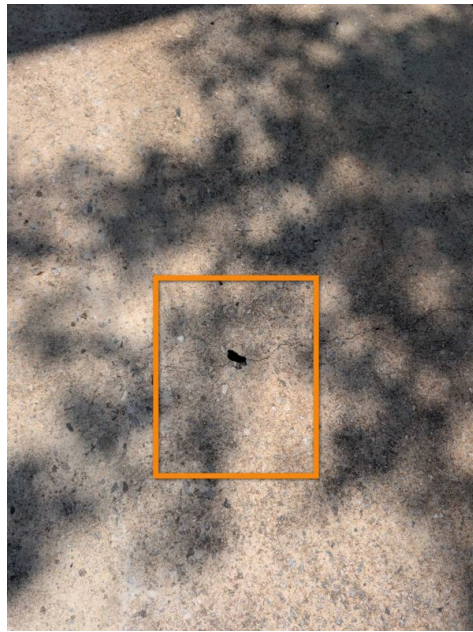
Area under the slab here is more hallow and may give way to more settlement

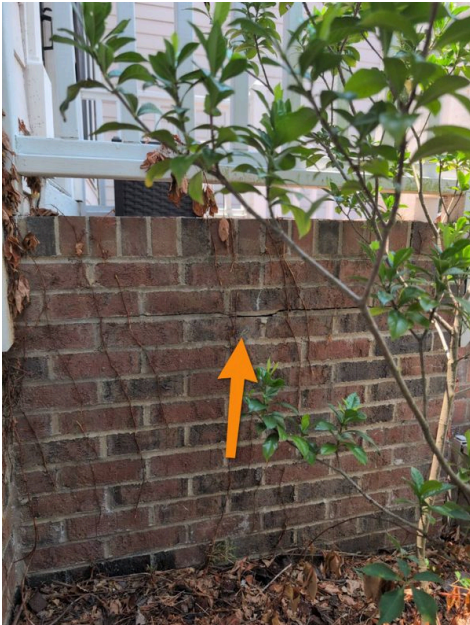
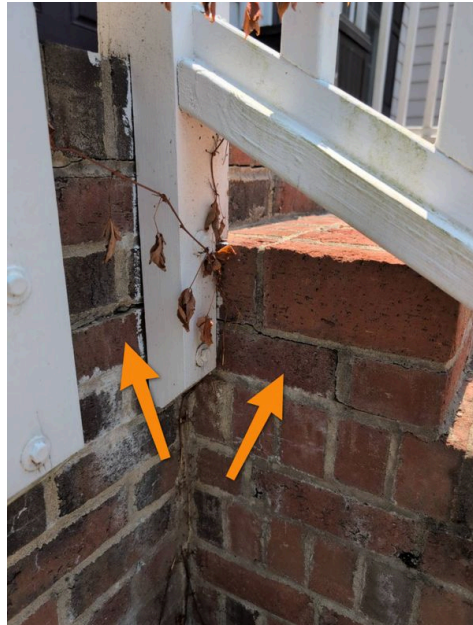
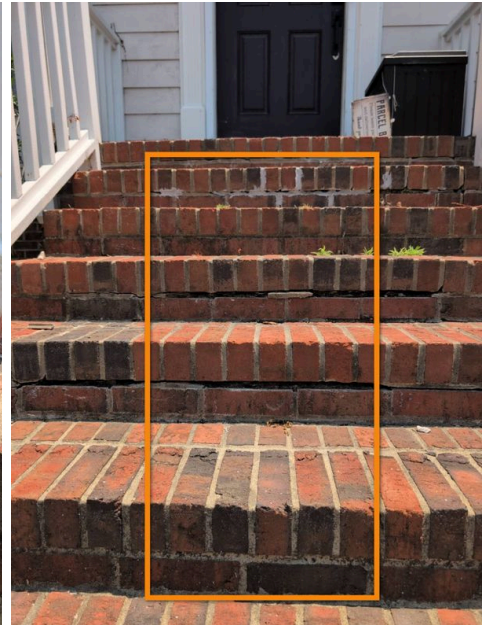
Mortar appears to be deteriorated or missing. This can cause loose steps, stones, and allow moisture intrusion in some scenarios. Recommend qualified contractor further evaluate and repair as necessary.

Missing mortar - check all areas where brick exists

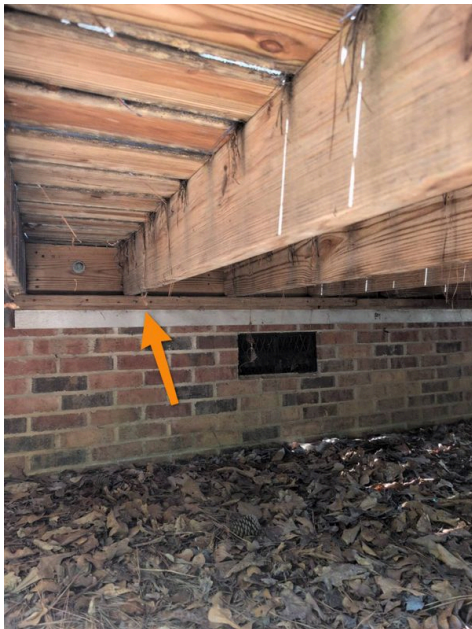
There appears to be settlement or signs of movement in one or more areas. This can sometimes pose a safety concern or indicate improper installation. This can also indicate differential settlement which is a common occurrence in the area. Recommend qualified contractor or structural engineer further evaluate and recommend next steps if so desired.

Some joists are twisted in place

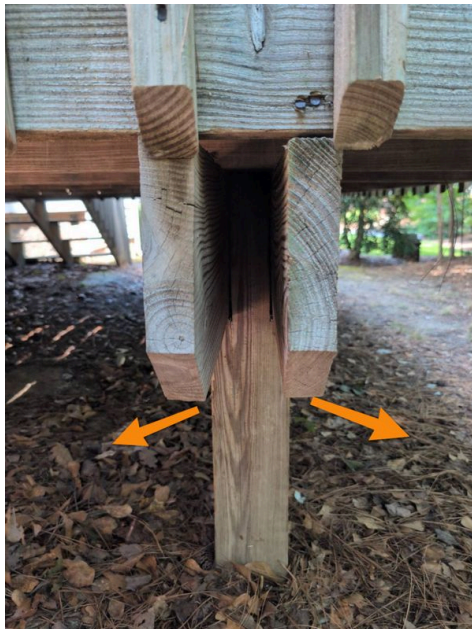
These beams are slightly shifted

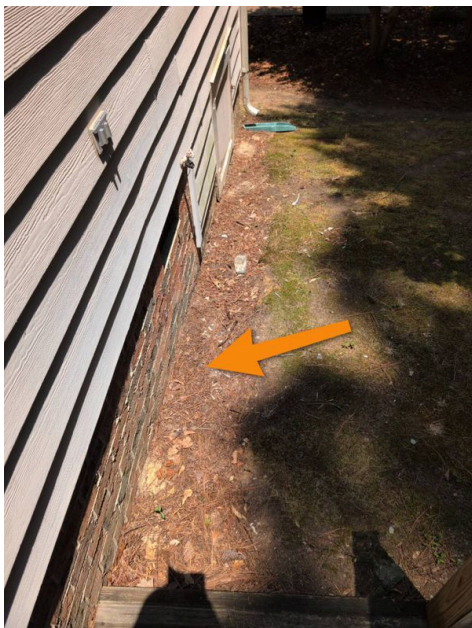
Grading is sloping towards the home or is near level to the home in some areas. This can lead to water intrusion and foundation issues. Recommend qualified landscaper or builder verify adequate drainage and slope according to local rules so water flows away from home.

Back of home, negative grading - during a heavy rainfall, check the effectiveness of the gutter system

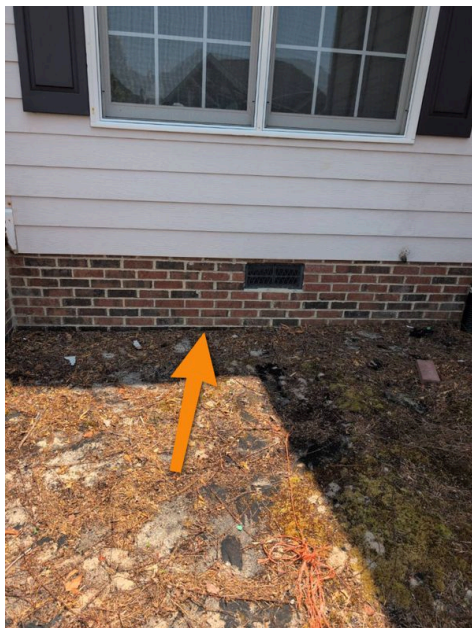
Front of house - again, check gutters for functionality

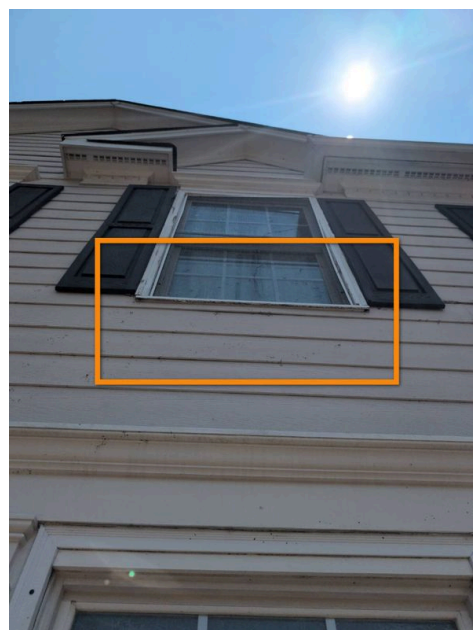
Members of wood around the exterior of the window appear to be deteriorated in some areas. This is normally caused by moisture being allowed to enter the wooden members from lack of finish, damage, ect. Recommend qualified window contractor further evaluate all windows, and repair / replace as needed.

Wood deterioration on windows

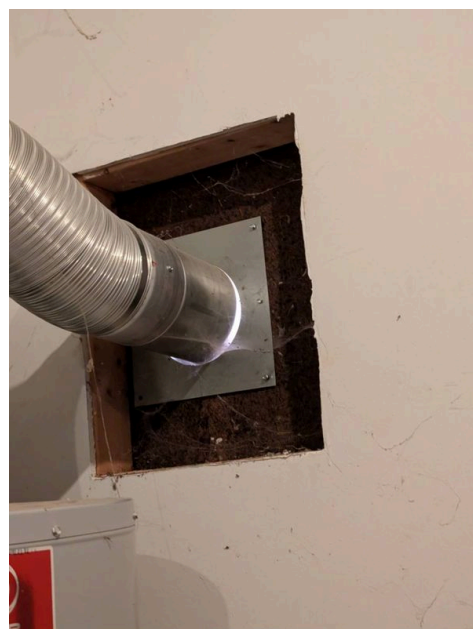
The vent is not properly installed in some way. This can prevent proper operation and also pose a safety concern in some scenarios. We recommend a licensed plumber further evaluate and repair or replace as needed.

Vent should be sealed with fireproof sealant

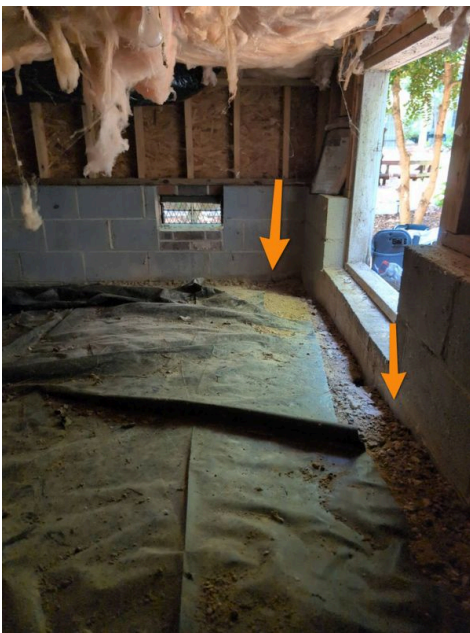
Vapor barrier was incorrect in some way. This can contribute to increased moisture levels and can also accelerate deterioration, organic growth etc. We recommend a qualified professional further evaluate and replace as needed.

disturbed in some areas

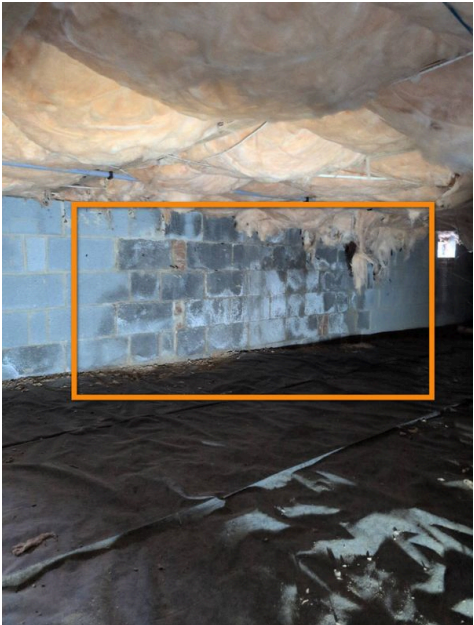
There was moisture staining in one or more locations. This could indicate a current or past leak and can contribute to damage to surrounding components. This can also indicate poor drainage or installment if along foundation walls in some scenarios. We recommend further evaluation of the area to determine the source and make appropriate replacements / repairs by qualified personnel.

Front of the house - moisture Intrusion

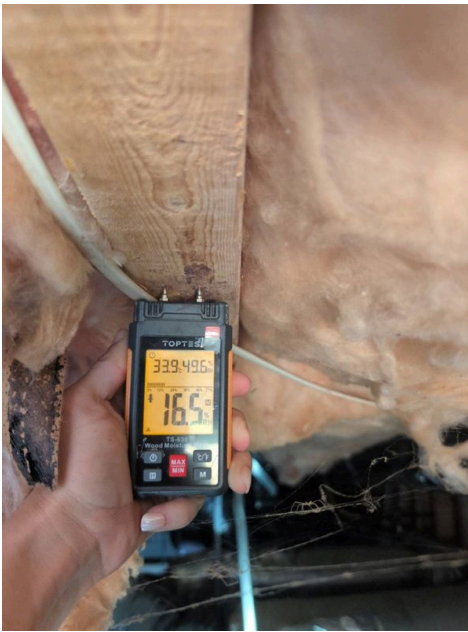
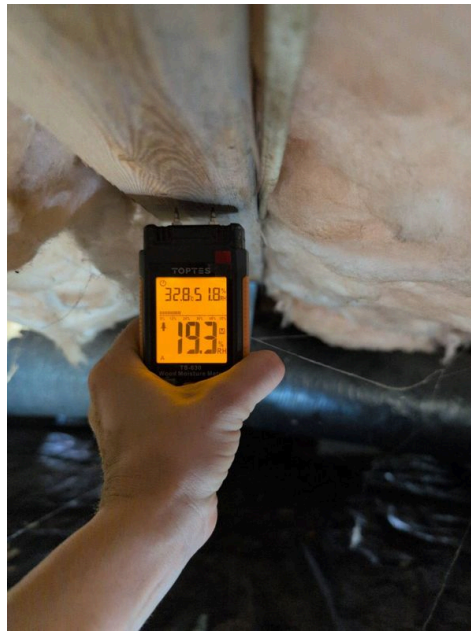
Elevated levels of moisture were measured in areas of the crawlspace or basement. Recommend a qualified contractor isolate the source of moisture intrusion, and remediate to prevent damage to structure.

Any reading above 15% is considered high

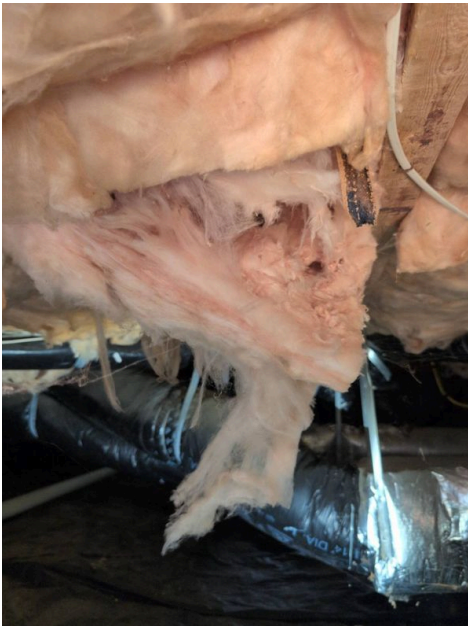
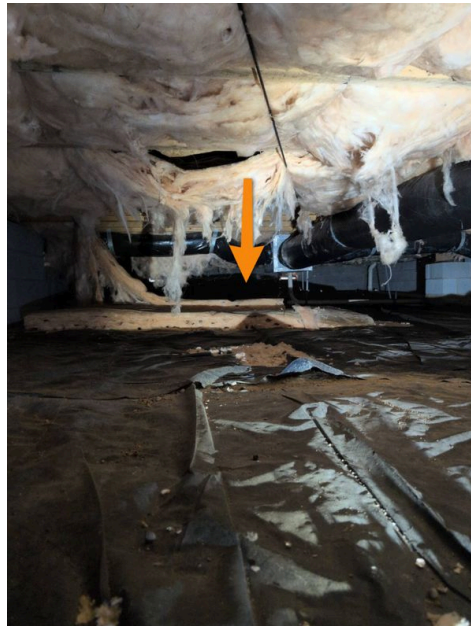
Insulation under the floors was falling or missing in areas. If the insulation is "spider webbing" this can indicate high moisture levels during the warmer months. This can decrease the energy efficiency of the home. This also limits visibility for the inspector. Recommend a qualified insulation contractor repair or replace as needed.

Insulation falling down in areas

Check whole crawlspace

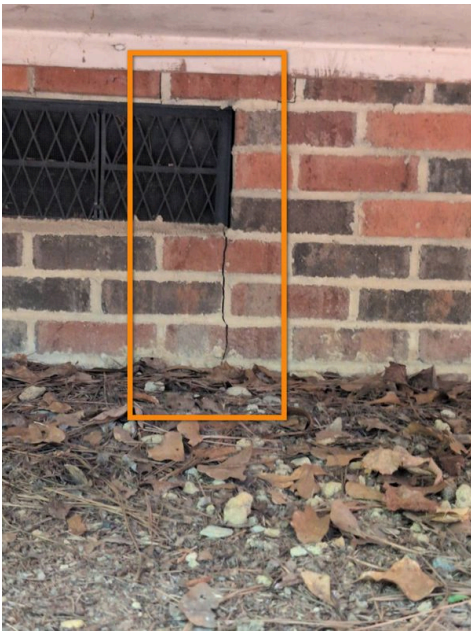
Mortar was missing, damaged, or cracked during the time of inspection due to prolonged exposure to moisture. This accelerates deterioration in foundation members and can pose structural issues. Recommend consulting a structural engineer for further evaluation / repairs.

Back of home - brick facade is cracked at crawlspace vents

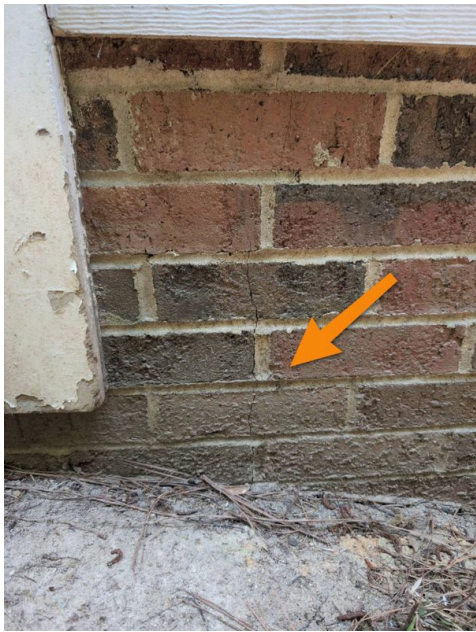
Small cracking on right side of crawlspace entrance
