## RESIDENTIAL STRUCTURE INVESTIGATION

**MR. & MRS. MACILVENNIE**

1403 Maple Avenue  
Apex, North Carolina 27502

**CARTER ENGINEERING & CONSULTING, PLLC  
STRUCTURAL + CIVIL**

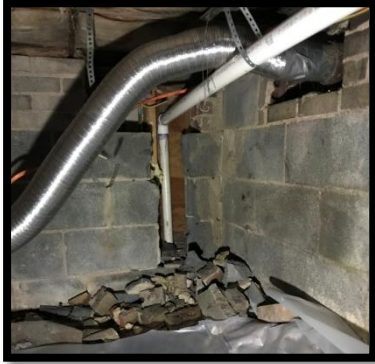
1. Within the crawlspace at the rear left corner an 8-inch section of the masonry block foundation wall has been removed apparently for access to plumbing. This has compromised the structural performance of the foundation system. Repair the first three courses of the foundation by:
  - a. Setting a row of three 16-inch #4 dowels horizontally and embedded 4-inch into the remnant blocks on each side of the knockout at one dowel per course;
  - b. Filling the first cell of each remnant block on each side of the knockout with non-shrink structural mortar or concrete (3500-psi);
  - c. Fill the knockout with solid poured concrete (3500-psi) using temporary forms to contain the concrete.

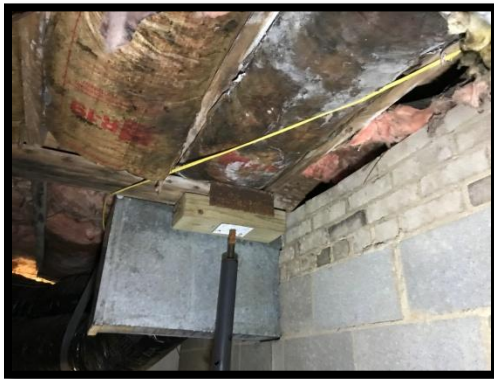
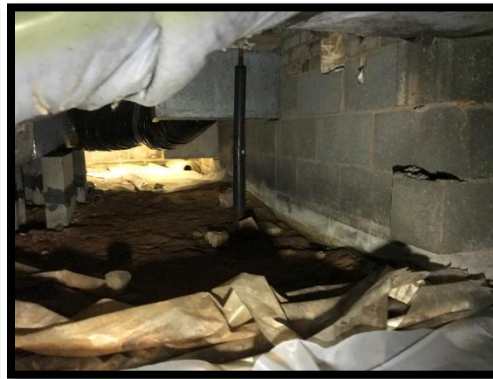
The North Carolina Residential Building code requires permanent structural steel columns to be at minimum 3 inches in diameter, be corrosion resistant, the top and bottom plate secured to the supported joist and foundation block, have less than 3 inches of the screw thread exposed, and the screw and telescoping junctions welded. Failing these conditions, the jacks can buckle and collapse and cause serious injury and damage.

2. Within the crawlspace at the left side and 12-ft from the front, a metal telescopic screw jack is positioned to provide primary support to the main floor beam [girder]. This jack is rusting, the screw head is over-extended, the base and top are not secured, and the base is undersized and inappropriate for permanent use. This jack does not meet the NCBC standards for permanent structural use and has no documentation to validate use as a permanent structural member. To minimize potential for personal injury and costly structural damage, replace this jack with a compliant structural member, such as a mortared 8x16 masonry pier on a solid poured 12x20x8 concrete (3500-psi) footing. At the time of replacement, adjust the supported girder to satisfactorily level the first floor surface.

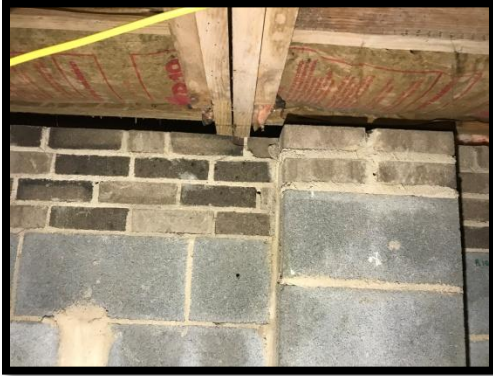
3. Within the crawlspace at the right side 11-ft from the front wall exists a perimeter masonry pier original to construction. The central side-to-side girder is not bearing on the pier. This is likely a construction layout flaw that was never corrected. The girder exhibits splaying between the two lumber plies, typical of deflection that result from improper end bearing. To minimize potential for personal injury and costly structural damage, construct a mortared 8x16 masonry pier on a solid poured 8-inch thick concrete (3500-psi) footing with a minimum 2-inch project from the pier. At the time of replacement, adjust the supported girder to satisfactorily level the first floor surface.

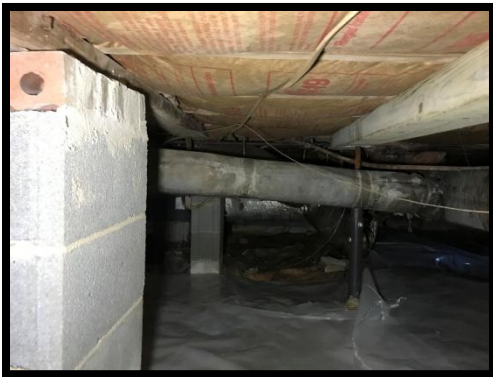
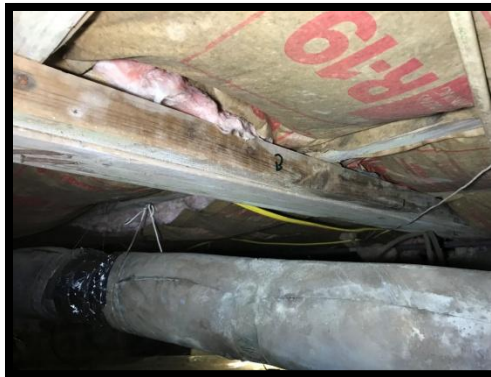
4. Within the crawlspace, the interior ends of the floor joists are supported by ledger strips that are attached to the center side-to-side oriented girder. The ledger strips exhibit slip and deflection, attributable to age and loading. This slip promotes floor surface irregularities and other interior distresses. Press the ledger strip upward and snug to the girder and floor joist, removing and floor surface sag, and secure in place with three 10d framing nails generally below each supported joist. Alternatively, install metal mechanical joist hangers that correspond to the joist dimension and with hanger manufacturer specified fasteners.

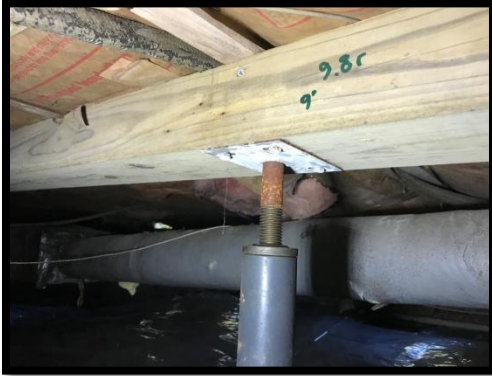
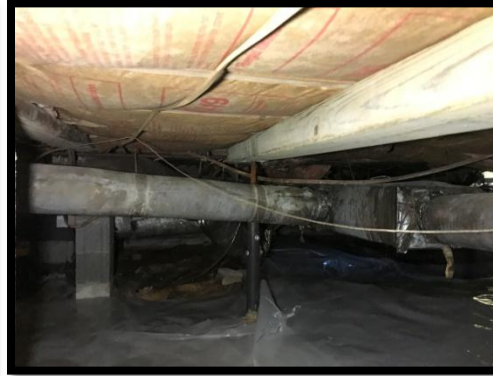
5. Within the crawlspace at the right wall and 9.8-ft from the rear wall exists a frame consisting of a 4x4 beam set on metal telescopic screw jacks. The frame is perpendicular to and within the interior span of the floor joists. This is a typical response to improve floor framing sag or deflection resulting from a heavy load or fatigue. In this location the frame is considered to be providing supplemental deflection resistance to the floor joists. These screw jacks do not meet the NCBC specifications for use as structural supports and is not installed in accordance with “off-the-shelf” product specifications.

Visual examination found no immediate structural concern with the intent of this frame. However, to comply with the building code and minimize the occurrence of structural damage related to deterioration of these jacks, at minimum replace these telescopic jacks with foundation grade 6x6 lumber posts, set on minimum 10”x10”X6” solid placed 3000-psi concrete bases. Adjust the post height to correct floor sags.

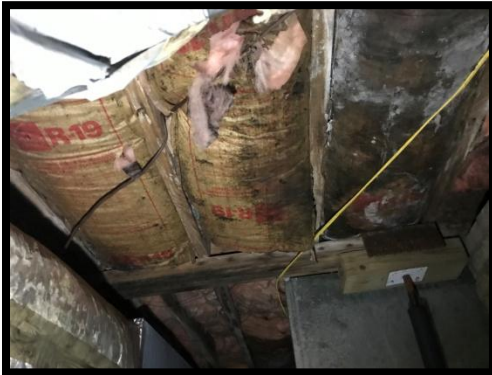
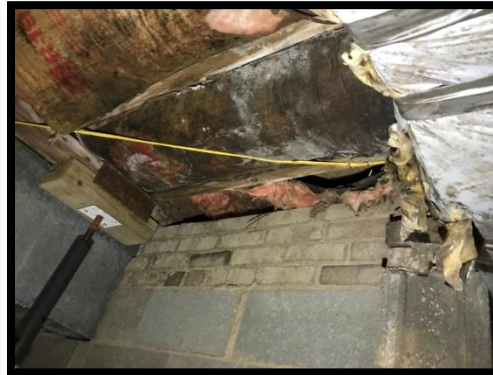
6. Within the crawlspace, wood floor framing exhibited elevated moisture content with initial stages of wood deterioration. Normal wood moisture content values for commodity lumber in fair condition and that has been in place for over a year should average 12%. Wood with high moisture content deteriorates and promotes organic growth, as is evident. Wood moisture content is influenced by the relative humidity levels in the crawlspace. A relative humidity level in the crawlspace above 50% creates an environment for organic growth and pest/insect presence. Install a dehumidistat controlled crawlspace fan [toward the left middle of the crawlspace area] to improve air circulation. Consider installation of a programmable dehumidifier set to achieve 40% relative humidity to help condition the crawlspace air. Ensure all foundation vents and other foundation wall penetrations are closed when operating a dehumidifier.

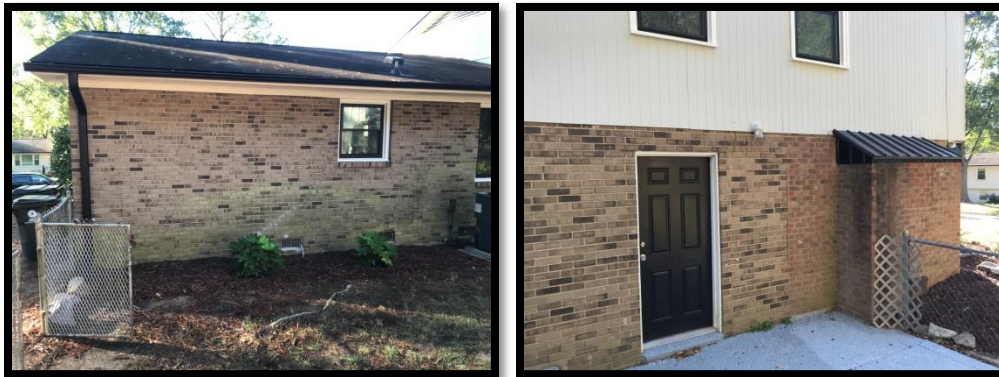
8. Cracks have developed through the perimeter brick veneer bonded to the masonry foundation wall:
- Ext. rear wall 11.2-ft from the right corner, stair-step sealed with mortar;
  - Ext. rear wall 27.3-ft from the left corner, stair-step sealed with caulk, with openings at the window sill;
  - Ext. left wall at upper front corner of side door, vertical/stair-step sealed with caulk;
  - Ext. left wall behind fireplace base, brick infill;
  - Ext. left wall at front of fireplace base, vertical construction joint with house filled with mortar;
  - Crawlspace right wall at front corner, stair-step measured 0.5-mm wide;
  - Crawlspace right wall 10.3-ft from the front wall, vertical/stair-step measured 5.0-mm wide.

Generally, these cracks are indicative of perimeter foundation movement (settlement) attributable to soil conditions influenced by moisture saturation that reduces the surface bearing capacity of the immediate foundation soil. The walls exhibited no abnormal distortions (bulging, shearing, sagging, etc.), but increased moisture exposure indicated from the buildup of efflorescence and staining. The moisture is related to deficiencies in yard and roof drainage controls.

The grade adjacent to the foundation presented a generally firm condition. Soil testing or coring was not part of this scope of work. The dynamic expansion and contraction of the soils in this area may react to large fluctuations of moisture presence, which leads to relief cracks along the perimeter foundation. Relative to the crack developments, visual assessment within the living area of the inside face of the exterior walls and adjacent floors found insignificant distress suggestive of excessive movement or settlement related to this matter.

Noted cracks through the foundation wall presented no current structural concern. Cracks above the foundation and along window sills allow moisture into the wall assembly where moisture can cause organic growth, wood rot, and insect/pest presence concealed within the walls. Treat cracks and separations by removing any loose debris and debonding agents from openings, cleaning and drying the openings, and sealing with a suitable mortar. Grout patching compounds include Quickrete Mortar Mix or any non-shrink grout. Application of products shall be in conformance with the manufacturer's recommendations. Address yard and roof drainage control improvement measures and regularly maintain to promote foundation soil stability that influences foundation movement and prevent concentrated overflow that can penetrate behind the brick veneer.

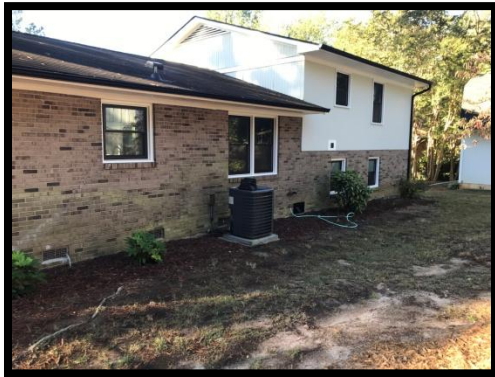
9. Generally, the grade slopes down from the rear yard, across the foundation footprint, and down to the front yard. Exterior yard and roof drainage has the potential to pond and accumulate along the foundation, particularly along the rear by the HVAC unit. When yard and roof drainage is allowed to pond and accumulate along the foundation, the moisture exposure often leads to erosion and unstable oversaturated soil conditions that creates foundation issues (settlement, shifting, cracking, rotation, etc.), as noted. Periodically ensure stormwater flows around and away from the foundation. Raise the grade [particularly along the rear] where depressions develop along the base of the foundation to flow surface drainage away from the foundation. Fill depressions and build up flat areas against the foundation with compactable dense soils that is free from organic material. Ensure soil, not mulch or stone or gravel, at the base of the foundation slopes down and away from the foundation. Perform regular maintenance to ensure proper drainage and promote foundation soils and constructed foundation stability. Underground drainage catchment systems [French drains] are not recommended.

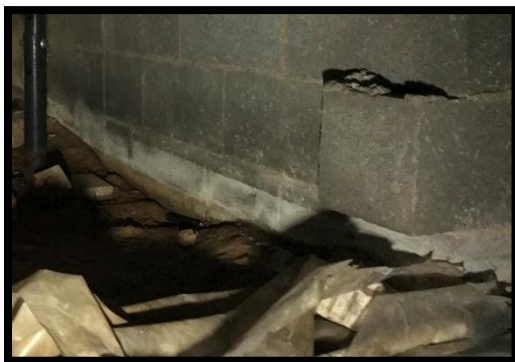
11. Within the crawlspace the base of the perimeter foundation walls exhibit indications (discolorations, efflorescence, soil depressions, damp soil, etc.) of moisture [past or present] along the foundation. These are results of exterior surface drainage moisture accumulation along and penetration through the foundation, into the crawlspace, which can overtime develop into structural movement and concerns. This moisture can navigate toward interior piers, evident by paths of soft soils. The foundation supporting soils overall presented a firm condition. Excessive moisture in the crawlspace promotes pest/insect presence and organic growth, which deteriorate the structural wood framing that leads to costly damage repairs. Improve and maintain exterior yard and roof surface drainage controls to promote foundation soil stability and to minimize moisture entry into the crawlspace.
