Stonewall Structural Engineering, PLLC  
Raleigh Office  
9203 Baileywick Rd. #200  
Raleigh, NC 27615  
(919) 407-8663

Re: Structural Observation — 202 Briardale Avenue, Cary, NC 27519

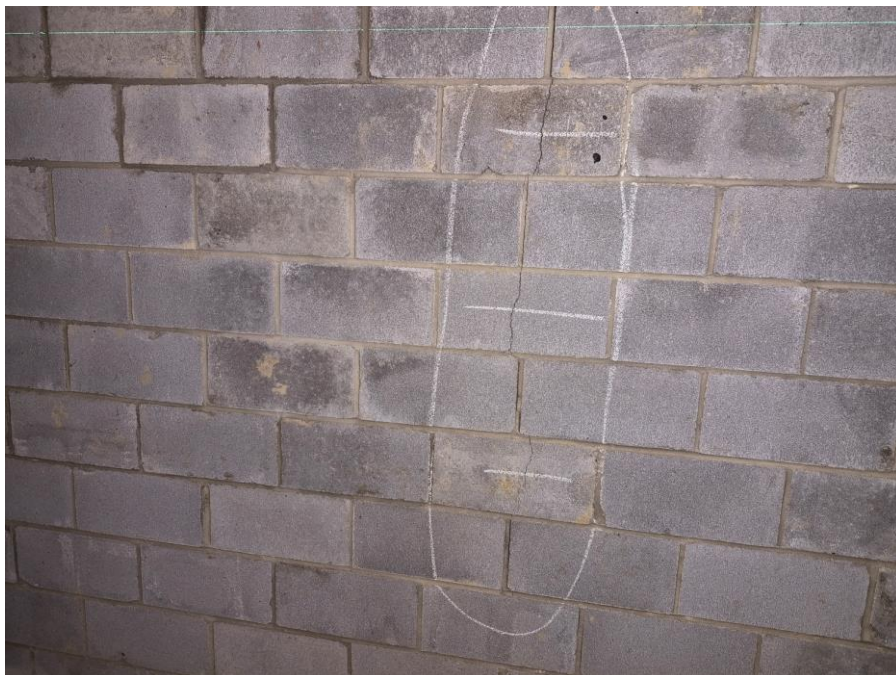
- A crack in the foundation was noted on the right side of the crawlspace as well as at the front-right of the crawlspace (*see pictures 2-4*).
  - Measurement by laser level indicated the foundation wall along the right side of the crawlspace as well as the right portion of the front foundation wall was level within  $\frac{1}{2}$ ".
  - The crack on the right foundation wall was reported to have been circled during a past inspection. The crack does not appear to have significantly changed based on the circle drawn on the foundation wall.
- Cracks were noted in the back wall of the retaining wall located at the back of the driveway (*see pictures 5-6*).
  - Measurement by laser plumb indicated the retaining wall was bowing by as much as approximately  $\frac{1}{2}$ " over the height of the wall.

- The above-noted foundation cracks have been the result of a combination of minor differential settlement of the perimeter foundation and potential consolidation of the soils being retained by the wall at the back of the driveway.
  - Soils in this area tend to expand when wetted and contract when dried. These minor cyclical movements can cause short term cosmetic damage and long term structural damage at areas around the structure with poor exterior drainage which can cause differential settlement to occur as parts of the structure settle at faster rates than at other locations.

*Picture 2 – Foundation crack reported to have previously been circled*

- 1) All cracks in the retaining wall and home foundation walls should be closed with a clear or color-matching flexible sealant and monitored for signs of additional movement. If settlement continues to significantly worsen despite adequate maintenance of site drainage, the affected portions of the structure may require structural reinforcement which may be designed upon request.

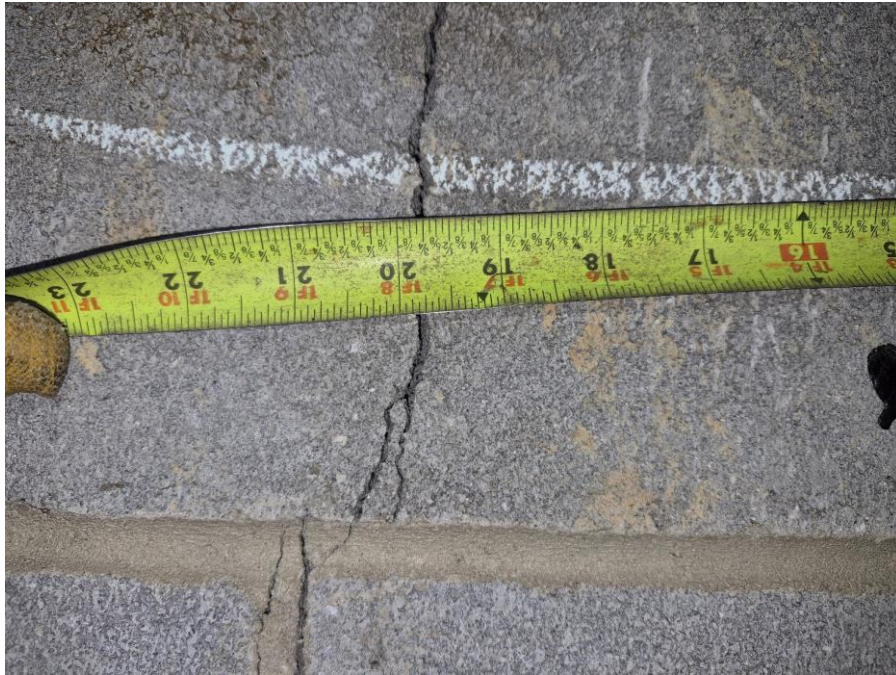
*Picture 3 – Approximately 1/16" wide (foundation crack same as shown in picture 2)*

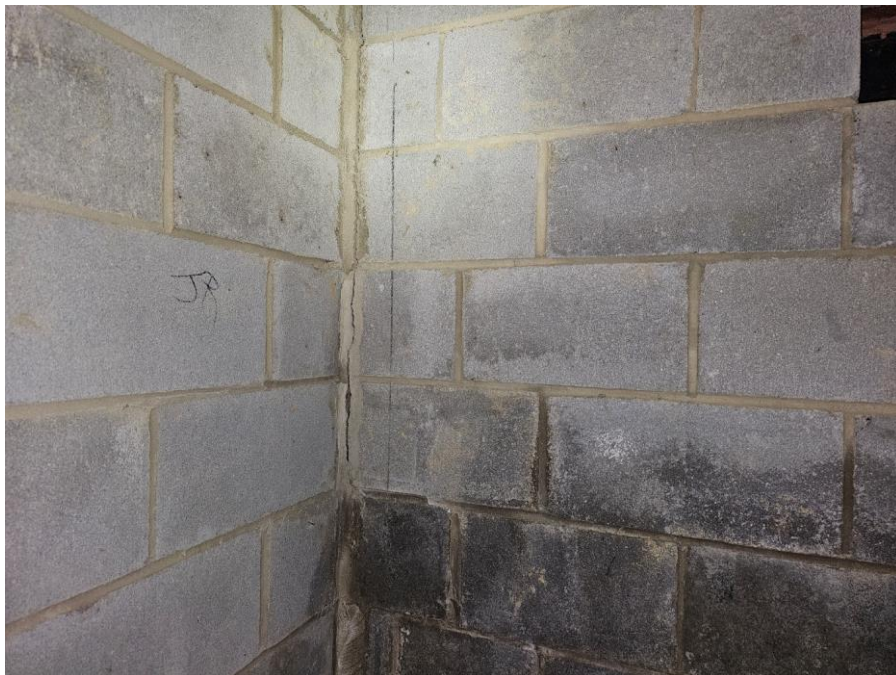
*Picture 4 – Foundation crack*

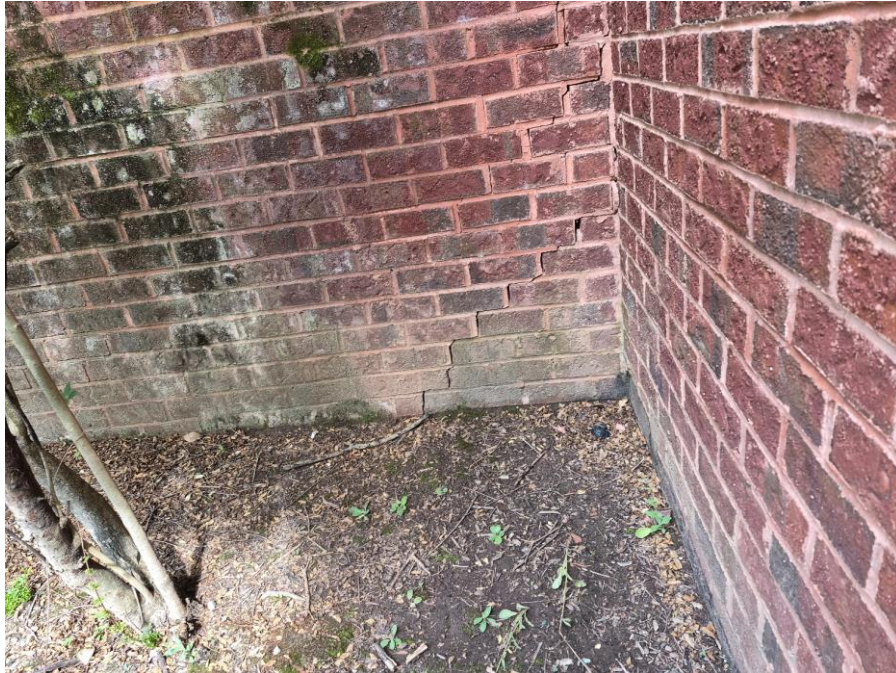
*Picture 5 – Retaining wall crack*

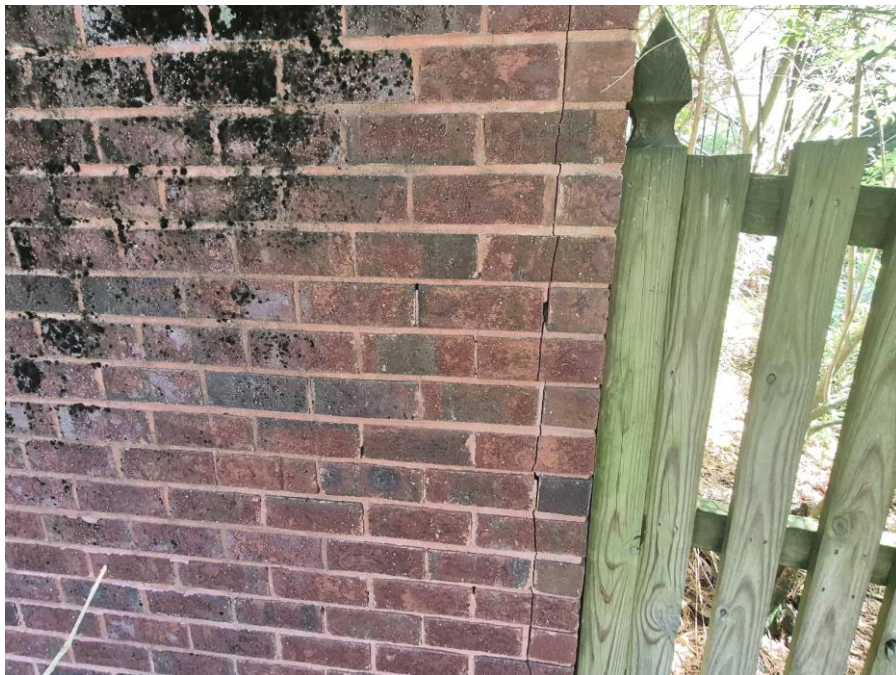
*Picture 6 – Retaining wall crack*
