RE: Wall Removal Assessment  
7925 Brown Bark Place  
Raleigh, NC 27613

Cody Johnston, PE  
Oakline Structural Engineering, PLLC  
1 Glenwood Avenue, Suite 05-126,  
Raleigh, NC 27603

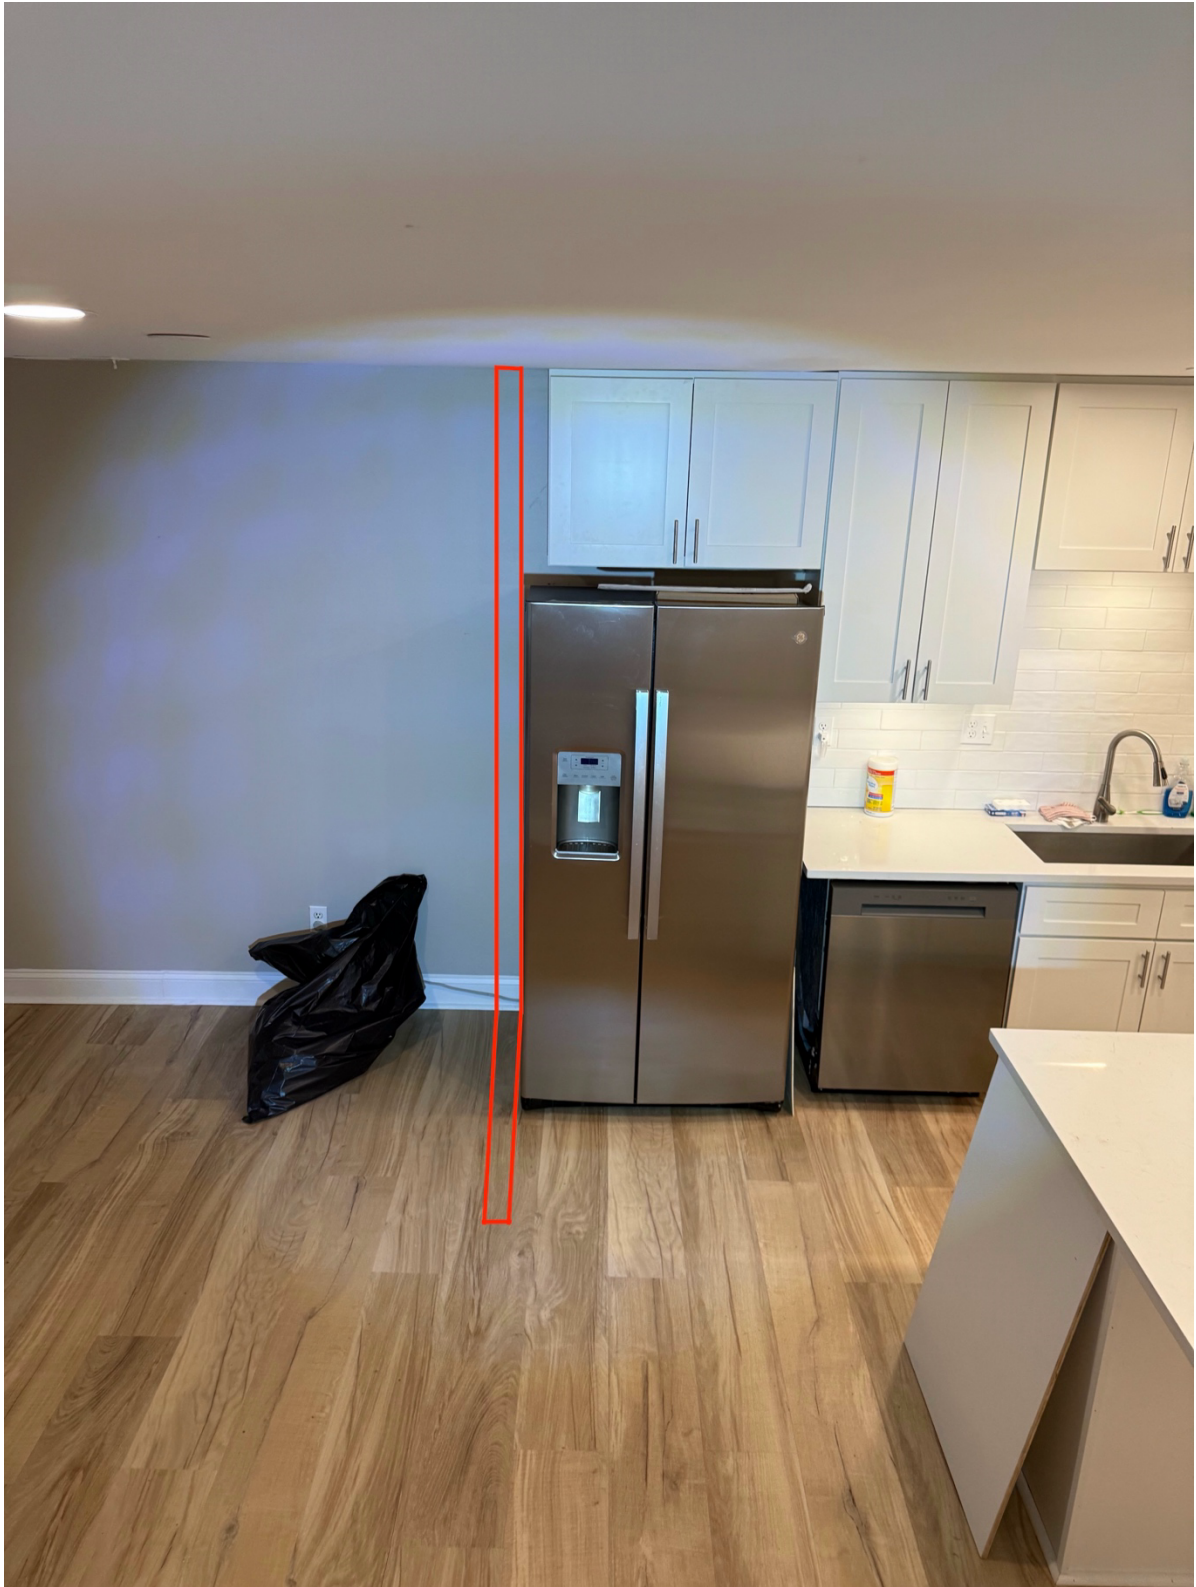
At your request, we performed a structural assessment of a wall that was previously removed in the kitchen of the home at the address noted above (*see picture 1 for the location of the removed wall section*). Our assessment was performed by virtual consultation on 6-1-26. The following is a summary of our observations and recommendations.

PICTURE 1 – APPROXIMATE LOCATION OF REPORTED REMOVED WALL SECTION

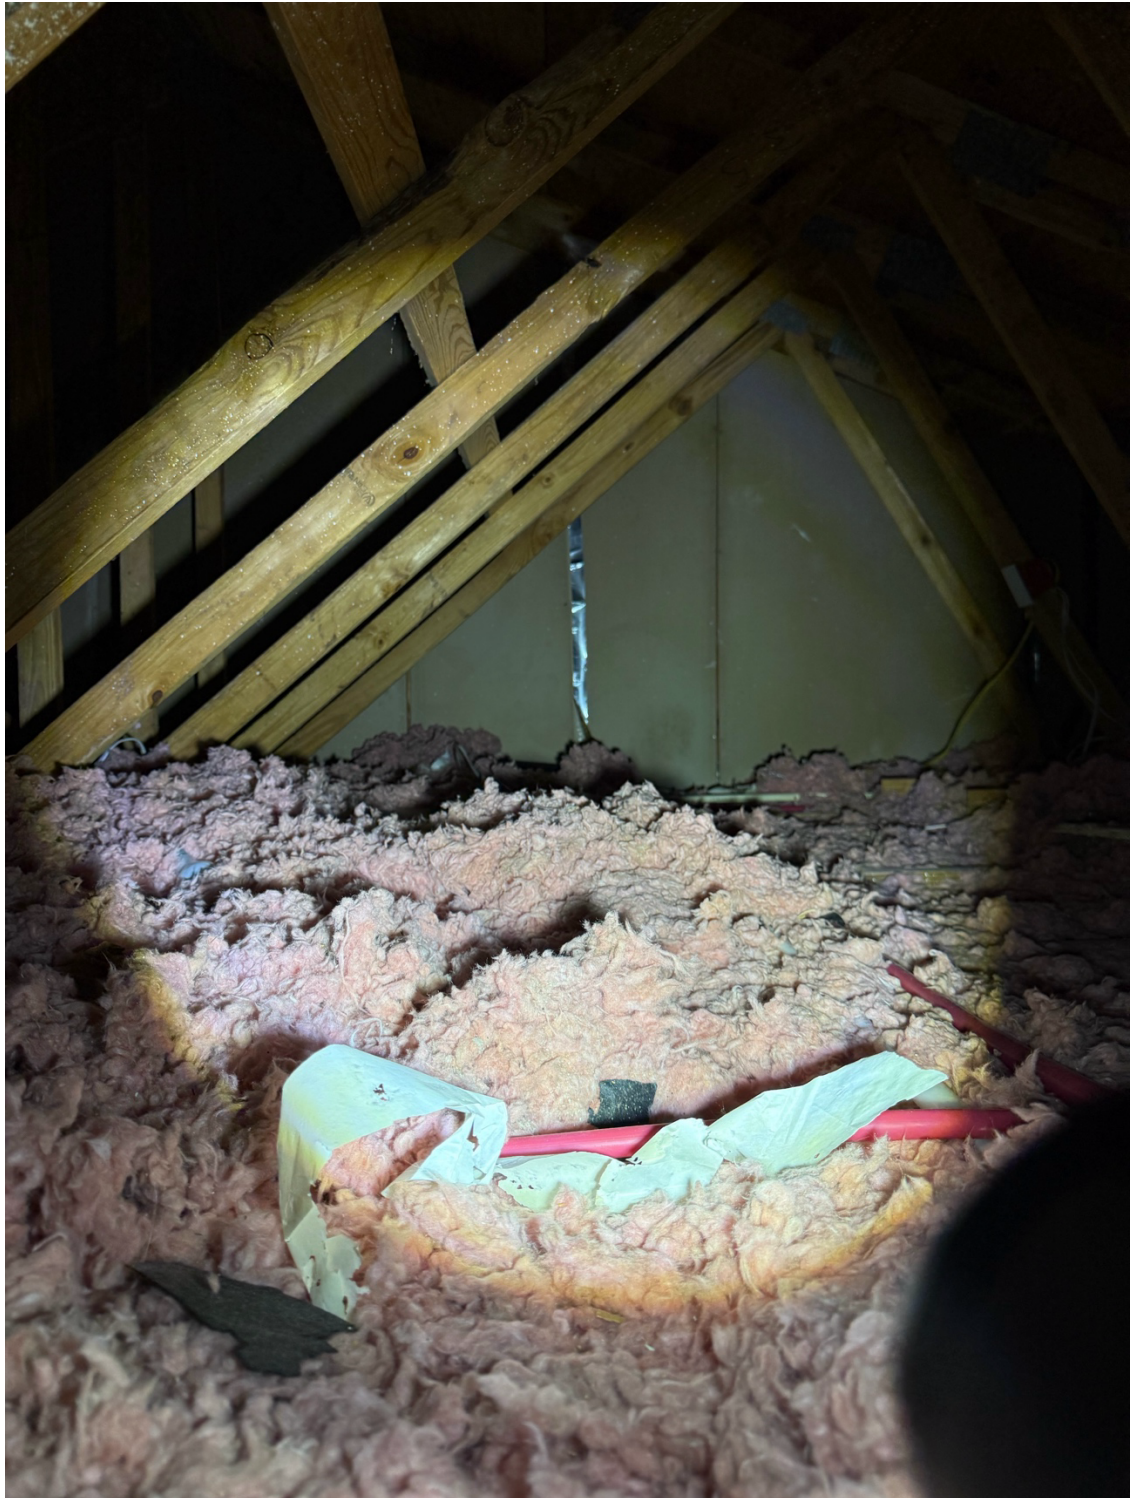
- **Removed Wall Section:** An approximately 4-foot long wall section adjacent to the refrigerator in the kitchen has reported to have been removed. The wall was oriented perpendicular to the roof trusses above (*see picture 2*).
  - Investigation in the attic revealed that the roof trusses have the same profile where the wall section used to be as where the wall section was not. This confirms that the removed wall section was not loadbearing, as the trusses were designed to span independently without relying on the wall for intermediate support. **This reported wall section detailed above was not load bearing and did not require structural modification to have been removed. No structural work is necessary for this item.**

PICTURE 2 – ROOF TRUSSES WITH CONSISTENT PROFILE ACROSS LOCATION WITHOUT WALL AND WHERE WALL WAS REMOVED
