# Inspection Report

10611 Friendly Neighbor Lane  
Raleigh, NC 27614

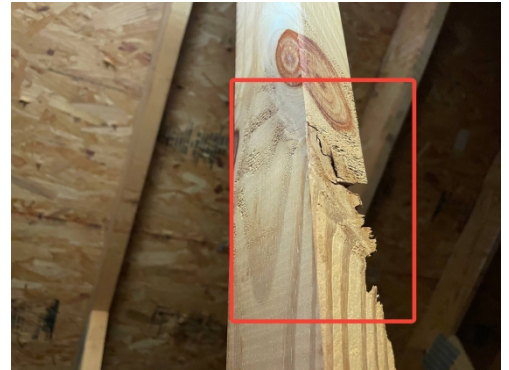
1. Needs Repair/Further Evaluation: Roof Framing - Truss Damage - Observed a cracked/split web member on a roof truss in the attic above the primary bedroom/closet area. It is not uncommon to have some areas of damage on a truss due to packaging and shipping from the manufacture and installation at the time of the home's construction. The damage to the web may not be significant but the web has been damaged. Only a registered engineer can certify structural integrity. Further evaluation and repairs specified by a structural engineer and contractor are recommended in order to ensure that the intended structural integrity of the truss is provided.

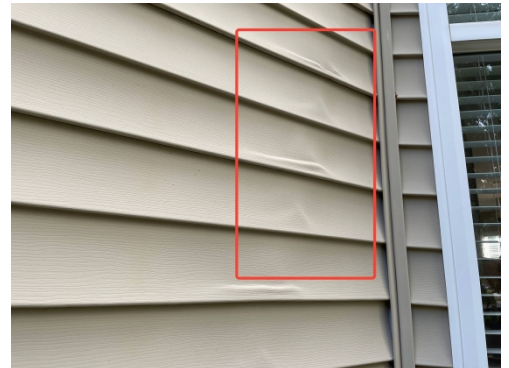
2. Needs Repair: Vinyl Siding Melting/Warping: Concentrated heat from a window/sun reflection has resulted in an adverse reaction of the right elevation siding causing it to warp/waving/deform. (See Photo) Warped panels can crack and allow water to get behind the siding over time. Recommend a professional siding contractor evaluate/replace damaged siding and measures be taken to prevent damage from reoccurring.

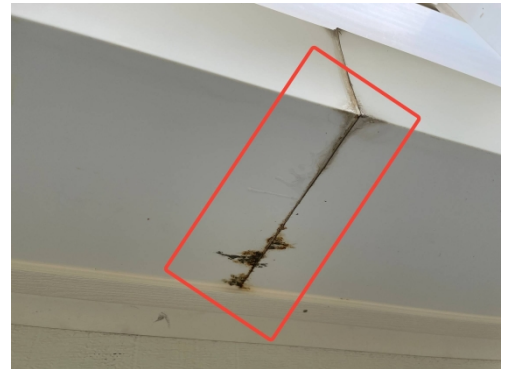
3. Needs Repair: Exterior Trim - Deteriorated Sealant & Rusted Trim - Some of the metal trim at the garage door header has rust and water present at the seams. This can cause damage to the wood over time and the trim can loosen/fall. Unions of doors/window frames/exterior trim to the exterior wall cladding have areas of sealant adhesion failure present. (See Photo) Caulked joints that have cracked and/or separated need to be sealed in order to prevent any possibility of water intruding into the walls where damage can occur. Have a professional contractor properly prepare/reseal all areas where joints have been compromised.

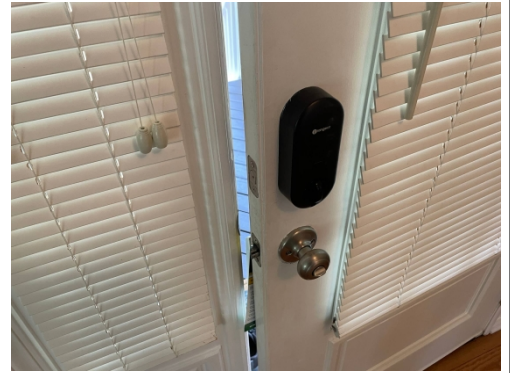
4. Needs Repair: Front Door - Deadbolt Not Engaging & Gap in Seal - The dead bolt locking bolt is not fully engaging/hard to engage the door jamb when locking the front door. This will prevent the door from being properly secured. The front door is not making a good seal on the weather strip insulation provided. This can allow conditioned air to leak from the home, and provide an access point for pests into the home. Have a professional contractor make all necessary repairs or adjustments required so the dead bolt can be easily and fully extended into the jamb when locked.

>>> Note: Electronically engaging dead bolts will not lock properly if any amount of restriction is present.

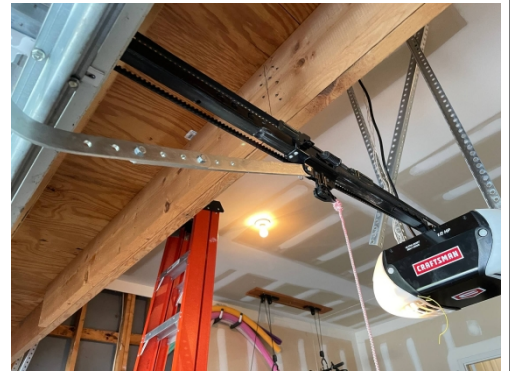
5. Needs Repair: Garage - Operation is Noisy & Not Sealing - The garage door operation is noisy. Noisy operation of the garage door can indicate resistance in the tracks/opener that can result in damage. The garage door seals on the right/left of the frame are warped and do not properly seal the door. This can allow water and pests into the home/area. Recommend a professional garage door service/installation contractor evaluate the garage door/track and service/repair as necessary to allow for proper/smooth operation.

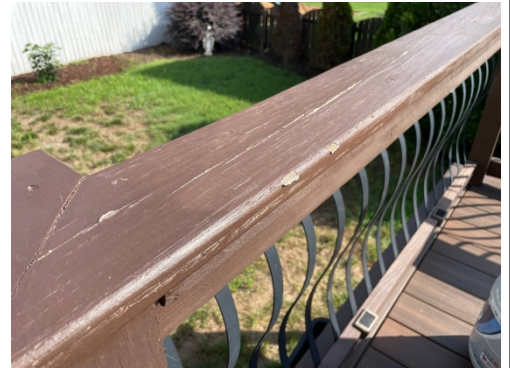
6. Needs Repair: Rear Deck Rails/Post - Peeling Paint - Exposed raw wood surfaces on the rear deck rail system (even on pressure treated wood) is vulnerable to moisture damage and resulting wood deterioration. The exposed wood surfaces can become damaged over time. Have a professional contractor properly prepare, and paint/seal all exterior wood and trim at this time.

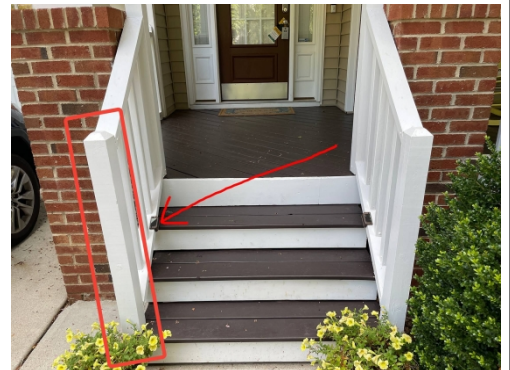
7. Needs Repair: Front Porch Rails - Loose Rails & Peeling Paint - The porch rails are loose and need to be properly secured. The front porch stairs post is loose/not secured. (See Photo) Rails provide a sense of security/protection from falling when present. Loose rails, currently present, may give out if enough pressure is applied to them. Exposed raw wood surfaces on the front porch rail system (even on pressure treated wood) are vulnerable to moisture damage and resulting wood deterioration. Have a professional contractor evaluate the front porch stairs and make any necessary repairs so that proper support is provided if leaned on.

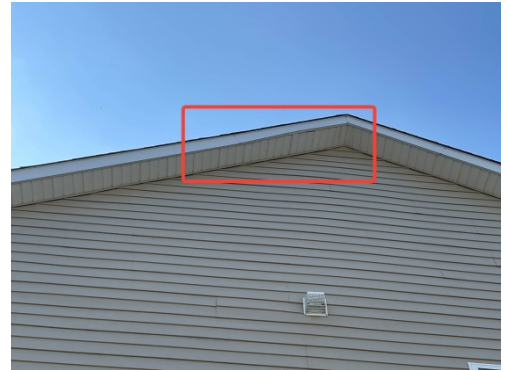
8. Needs Repair: Soffit - Openings in Soffit - Observed some loose/shifted soffit around the left exterior of the home near the ridge/peak of the left gable wall. Openings in the soffit can allow pests to enter the attic/home. Recommend that a professional siding contractor evaluate the soffit around the home and make the necessary adjustments/repairs to prevent possible pest intrusion.

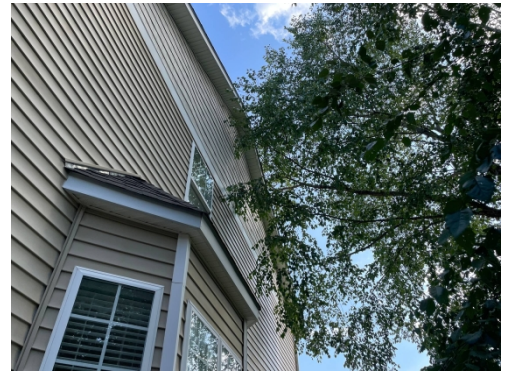
9. Needs Repair: Tree/Shrub Limbs - Limbs In Contact With The House - Observed tree/shrub limbs that are in contact/near contact with the home. Branches in contact with the house can cause damage to the shingled roof covering and water shedding off the trees can divert water toward the house. The canopy under large trees will hold higher moisture levels in them that will over time cause wood to deteriorate. Maintain large vegetation away from the house in order to prevent damage to the house and reduce higher moisture levels that can cause rot on wood surfaces.

>>> Note: Limbs over the fireplace chimney can cause poor drafting/back drafting in the fireplace.

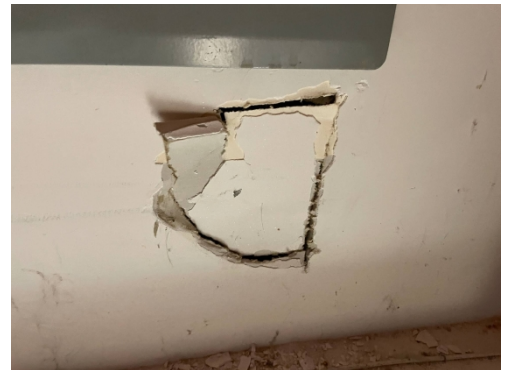
10. Needs Repair: Garage - Openings in Drywall - Observed an opening in the wall board in the garage. (See Photo) Openings in the drywall can allow harmful gasses to enter the home, and can allow for a fire to spread more quickly into the home should a fire occur in the garage - the majority of all reported house fires start in the garage. Have a professional contractor make repairs so that the integrity of the wall board is restored.

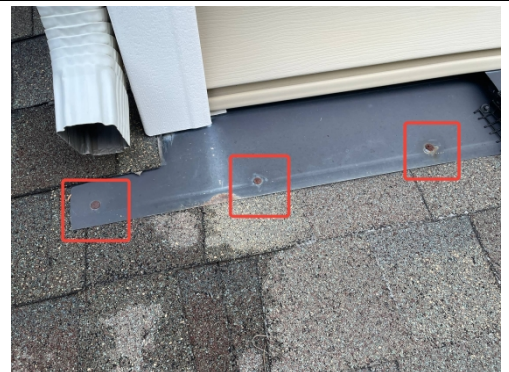
11. Needs Repair: Roof Covering - Unsealed Nail Heads - Observed unsealed nail heads in the shingles/flashings around the roof. Unsealed nail heads can allow moisture to penetrate around the nails shaft which can result in moisture damage to the roof decking. Have a professional roofing contractor evaluate the entire roof area and properly seal all exposed nail heads.

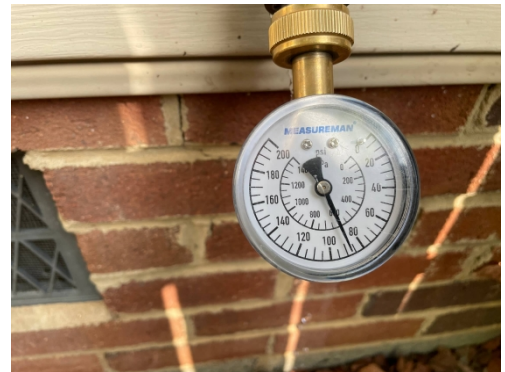
### 12. Needs Repair: Water Pressure - High Water Pressure -

The water pressure is higher than the standard 40 - 80 p.s.i. which could cause leaking in fixtures or older pipes. Have a professional plumbing contractor make any necessary repairs needed to lower the current pressure to within acceptable pressure limits not exceeding 80 psi (preferred pressure is 60 psi). Note: The likely repair required is making an adjustment to the PRV (pressure regulating valve) provided on the water supply system, but additional repairs may be required.

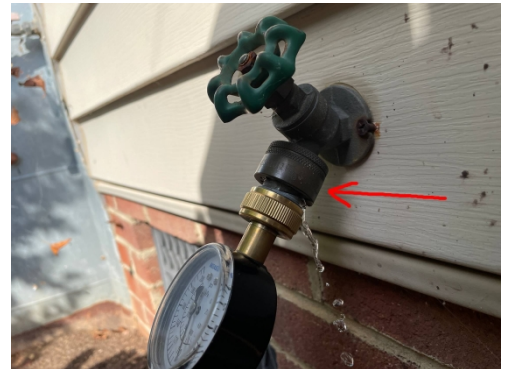
13. Needs Repair: Exterior Faucets - Loose Faucet - Some of the exterior hose faucets around the home are not secured to the wall. Loose faucets are vulnerable to freezing weather conditions and present a possible leaking hazard when excessive movement from the hose that is attached to the faucet is pulled as a result of needed extra length. The right exterior faucet was leaking at the handle/anti siphon device during the inspection. This can reduce pressure and limit use over time. Have a professional plumbing contractor evaluate all of the exterior hose faucets and repair as necessary for proper installation.

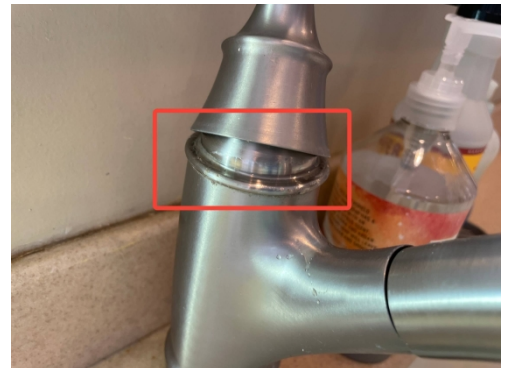
14. Needs Repair: Kitchen Sink - Faucet Leaking at Valve Body/Handle - The kitchen faucet is leaking at the valve stem (faucet lever) or the pivot arm of the faucet spout assembly when turned on. (See Photo) Long term use of this faucet can allow water to leak down into the base cabinet under the sink. Have a professional plumbing contractor service this faucet so that leaking is not occurring when in use.

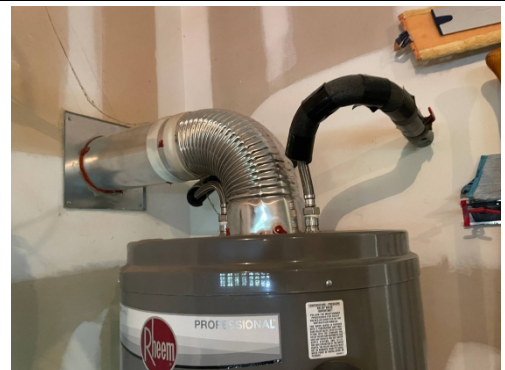
15. Needs Repair: Water Heater Safety - No Thermal Expansion Tank Installed - A thermal expansion tank was not observed on the water supply plumbing system. This tank compensates for increased water pressure due to heated water from the water heater and/or the public utility. At the most recent replacement of the water heater, requirements were in place for an approved thermal expansion control device, a thermal expansion tank (TET), to be installed on the water system as part of this water heater replacement. Have a professional plumbing contractor provide this pressure compensating device for added protection against high water pressure fluctuations in the water system.

>>> No TET was observed in the crawlspace.

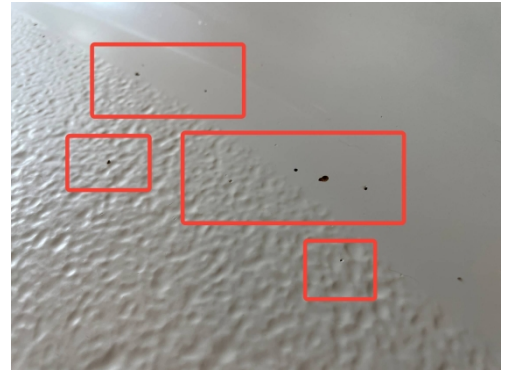
16. Needs Repair: 2nd Floor Hall Bathroom - Damaged Bathtub - Observed areas of damage in the hallway bathroom tub. (See Photo) These areas of damage can allow moisture to leak under the tub where damage can occur. Recommend that a professional contractor make the necessary repairs to prevent any possibility of leaking.

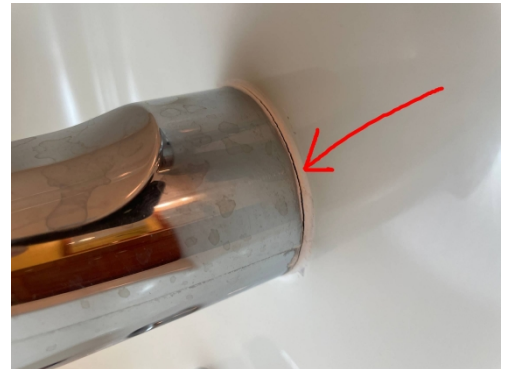
17. Needs Repair: 2nd Floor Hall Bathroom - Tub Spout Not Fully Sealed - The tub spout and water valves need to be sealed/caulked to the wall of the tub/shower in the hallway bathroom. (See Photo) Water is able to get behind the shower wall when turned on. Have a professional plumbing contractor evaluate all of the bathroom fixtures in the home and properly seal any openings.

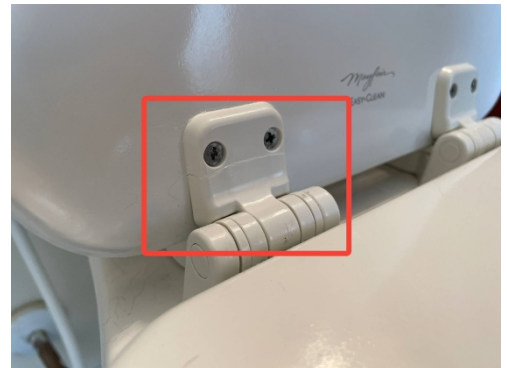
18. Needs Repair: Primary Bathroom - Toilet - The toilet seat hinge was broken/cracked. A broken hinge prevents the seat from being securely attached and may cause the seat to shift during use, creating a potential safety concern and reducing the fixture's functionality. Recommend replacing the toilet seat or repairing the hinge assembly as needed to restore proper operation.

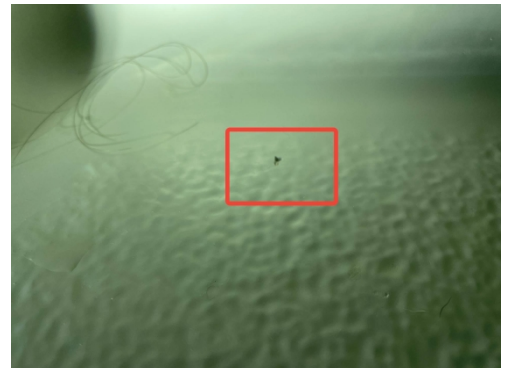
19. Needs Repair: Primary Bathroom - Shower - A chipped area was observed in the fiberglass shower pan in the primary bathroom. Damage to the fiberglass finish can compromise the protective surface, allowing moisture to penetrate the underlying material and potentially leading to further deterioration or leaks over time. Recommend a qualified contractor evaluate the damaged area and repair or replace the shower pan as needed to restore a watertight, durable surface.

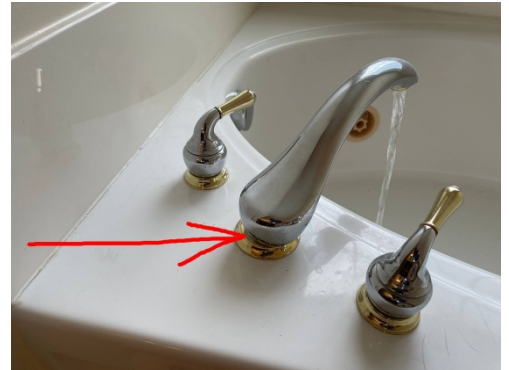
**20. Needs Repair: Primary Bathroom - Tub** - The jetted tub spout in the primary bathroom was loose and not properly secured. Movement was observed when the spout was tested, indicating it is not adequately fastened to the plumbing or finished wall surface. This condition may allow water to enter the wall assembly during use, increasing the risk of concealed moisture intrusion, deterioration of building materials, or plumbing leaks over time. Recommend a qualified plumber properly secure the tub spout, verify there are no leaks or moisture damage associated with the installation, and make repairs as needed.

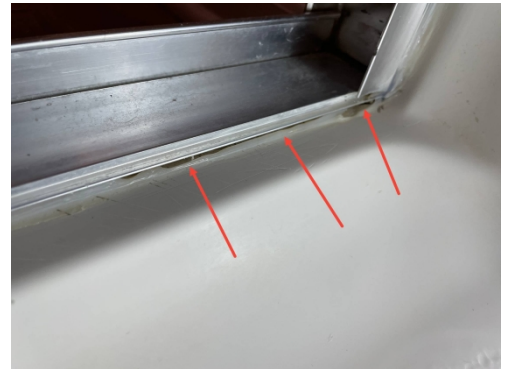
**21. Needs Repair: Primary Bathroom - Shower & Tub Sealant Maintenance Needed** - The shower floor in the primary bathroom needs preventative maintenance (sealant) applied at the union of the wall and floor. The shower handle was not fully sealed at the wall connection. Some of the tub sealant had gaps and separation present. (See Photo) Typically observed small cracks in the grout or sealant in this area should be maintained or sealed by using an appropriate sealant. Gaps at these areas can allow water to intrude under the shower and cause damage over time. Have a professional contractor fully evaluate the tub & shower to properly seal any gaps/cracks.

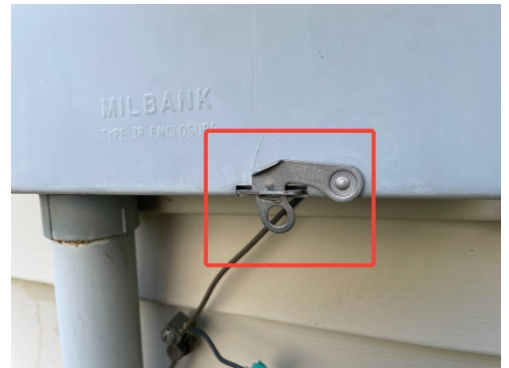
**22. Needs Repair: Meter Box - Unlocked Meter Box** - The electrical meter houses live electrical wires that are not supposed to be accessible to people other than electrical contractors. For that reason these boxes are typically locked with tags that have to be cut off to remove. There is no tag on the latch for this box which allows for easy access to the live wires. Recommend that a professional electrical contractor, or a power company employee properly secure this box to prevent accidental contact with high voltage wires.

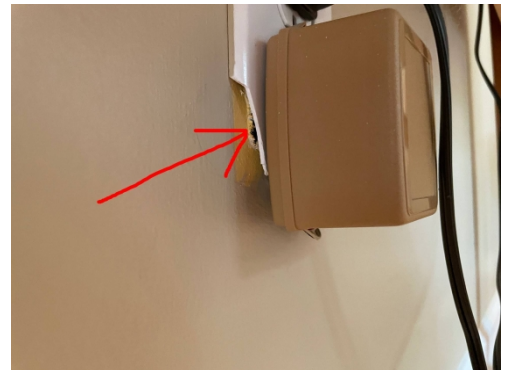
**23. Needs Repair: Outlets - Damaged Outlet Cover** - Observed a damaged outlet cover in the dining area near the HVAC return vent. The damaged cover exposes electrical components which create an electrical hazard. Recommend that a professional electrical contractor make the necessary repairs to allow for safe use.

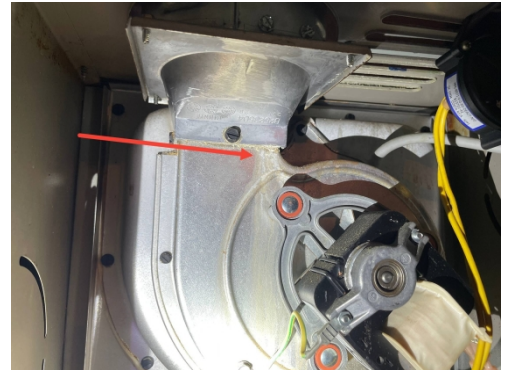
24. Needs Repair/Further Evaluation: HVAC - Rust and signs of moisture leakage were observed inside the attic gas furnace cabinet below the vent pipe connection. This condition may indicate condensate or flue gas leakage from the venting system, improper vent installation, or deterioration of vent components. Continued leakage can accelerate corrosion of the furnace, reduce equipment life, and may indicate a condition that could affect the safe operation of the heating system. Recommend a qualified licensed HVAC contractor evaluate the furnace and venting system, determine the source of the leakage, and make all necessary repairs or replacements prior to continued operation.

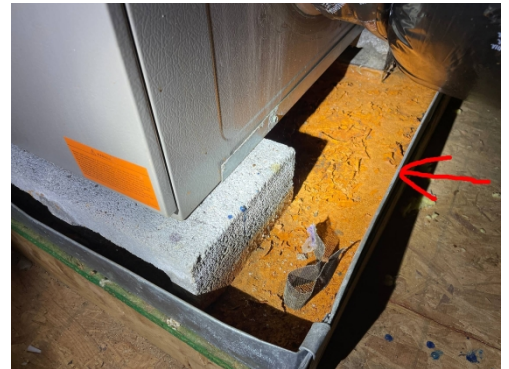
25. Needs Repair: HVAC Unit - Rust in HVAC Drain Pan - Observed evidence of previous standing water in the HVAC unit emergency drain pan in the attic. (See Photo) Prior water/rust in the pan indicates that the primary condensate line is or has been clogged. If this line is still restricting water flow, the system will shut off when the pan refills due to water that is flowing from the evaporator coil during the A/C mode of operation. Rusting in the pan may be caused by standing water in the pan or may have been deposited into the pan from inside the unit. Recommend that a professional HVAC contractor evaluate the HVAC system and make the necessary repairs to allow for proper drainage to the exterior of the foundation wall.

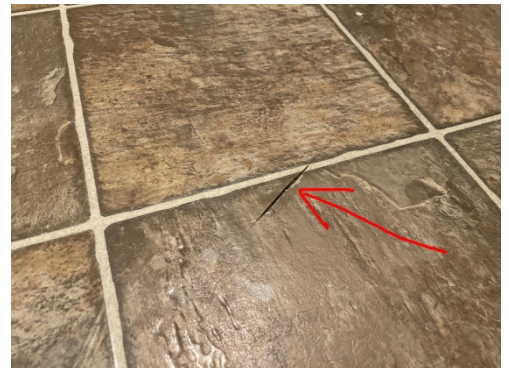
26. Needs Repair/Further Evaluation: Flooring - Some areas of the floor covering were damaged. The damaged floor covering can loosen or deteriorate faster than usual and can cause a tripping hazard. The damaged floor was observed in the laundry room near the sink. Have a qualified contractor familiar with flooring evaluate this area and repair or replace as needed to ensure safe passage and a long service life of the flooring.

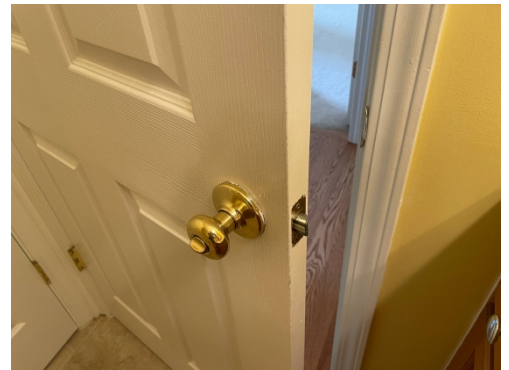
27. Needs Repair: Interior Doors - Not Latching/Rubs Frame - Some of the interior doors throughout the home will not latch properly when closed. - [2nd floor hallway bathroom door not latching & 2nd floor rear right bedroom door rubs the frame at the top] Doors that do not latch properly cannot be properly secured. Have a professional interior trim contractor evaluate all of the doors throughout the home and make any necessary repairs to allow for proper operation.

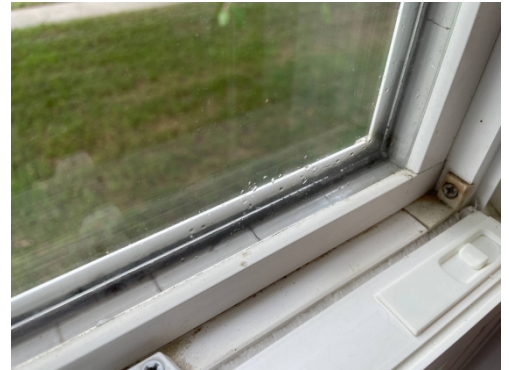
**28. Needs Repair: Windows - Window Glass Unit Seal Failure -** Glass unit window insulation seals were observed to be compromised in various locations throughout the home. - [dining room right windows(3), living room(1), kitchen sliding window(1), 2nd floor front right bedroom(3), Primary bedroom(3)] Compromised glass seals may not necessarily be limited to just the glass units noted. Signs of compromised glass seals can be masked by weather conditions, lighting, and cleanliness of glass at the time of the inspection. Have a professional window pane replacement company evaluate all of the glass units in the home and make the necessary repairs/replacement to restore the insulation integrity of any units determined to have bad seals.

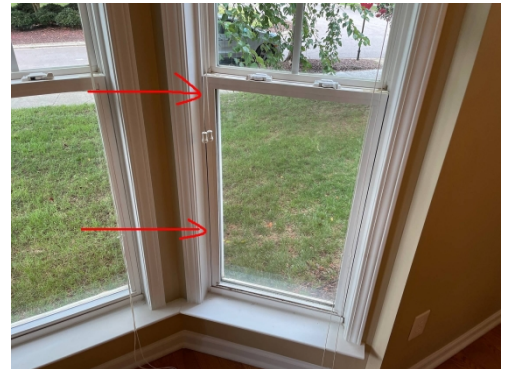
**29. Needs Repair: Windows - Not Holding Position -** Observed some of the window sashes in the home to not hold position once the windows were raised/unlocked. - [dining room right windows(2), 2nd floor hallway(1), 2nd floor front right bedroom(2) & Primary bedroom(1)] Windows that will not stay in position can prevent use/result in damage to the windows. Recommend that a professional window installation/service contractor evaluate all of the windows throughout the home and make any necessary repairs to allow for proper operation.

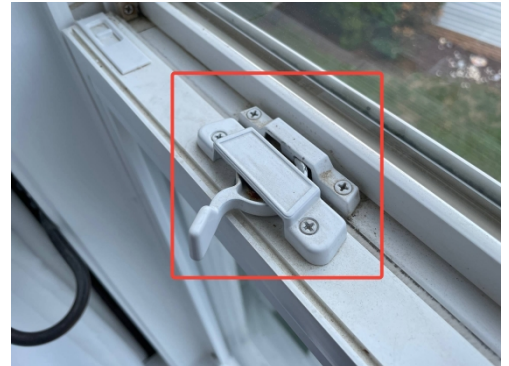
**30. Needs Repair: Windows - Not Locking -** Observed windows in the home to not lock. - [Primary bedroom left windows(2)] The lock and catch appear misaligned which prevents the window from being properly secured. Have a professional window installation contractor evaluate all of the windows throughout the home and make any necessary repairs for proper operation.

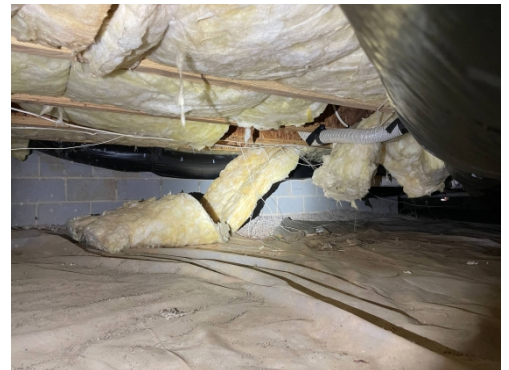
**31. Needs Repair: Crawlspace Insulation - Fallen/Missing Insulation -** Some crawlspace insulation is falling down or missing in various locations inside the foundation. This will reduce the "R" value across the floor. Have a professional contractor evaluate all of the insulation in the crawlspace area and repair/replace insulation at any location where insulation is not properly installed or deteriorated.

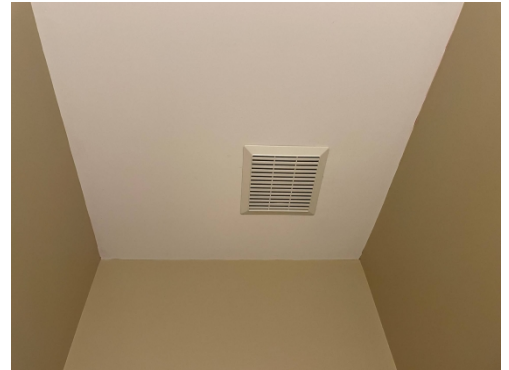
**32. Needs Repair: Bathroom Exhaust Vent - Noisy Fan Operation** - The half bathroom moisture exhausting fan is noisy when operated. Noisy fans indicate components that are not working properly which can result in damage. Have a professional contractor evaluate all of the bathroom exhaust fans in the home and clean/lubricate/service all fans to ensure proper operation.

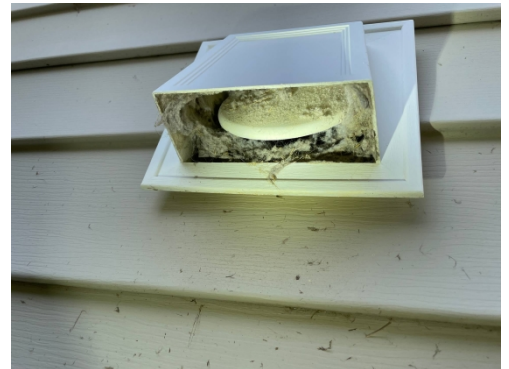
**33. Needs Repair: Dryer Vent - Dryer Baffle Stuck Open/Dirty** - The dryer exhaust vent end cap is not operating properly where it vents to the rear exterior of the home. The baffle that closes when the dryer is not operating is partially open at all times, likely due to being dirty with lint. Being open all the time allows air exchange between the exterior and interior of the house, as well as the possibility of vermin getting in the exhaust duct. Have a professional contractor properly clean the entire duct run and make repairs if necessary so that the baffle closes fully when not being used.

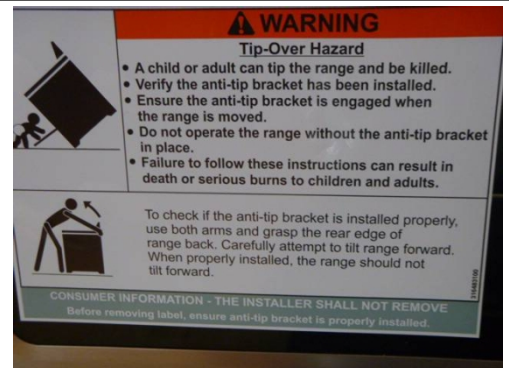
**34. Needs Repair: Range - Missing Anti-Tip Bracket** - The anti-tip bracket required for safety on all freestanding ranges, was not installed at the time of the inspection. The anti-tip device can prevent personal injury/damage caused by the appliance tipping over due to weight added to the open door. Recommend a professional appliance installation contractor install this anti-tip device as required to prevent damage and personal injury.

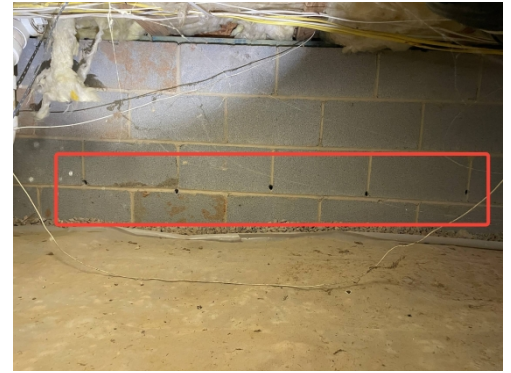
35. Information: Pests - Termite treatment was observed in the crawlspace at the garage foundation areas. Drill holes in the foundation wall/support piers were observed which indicates a previous treatment was completed. No active wood destroying insects were present at the time of the inspection. Suggest asking the seller about the history of treatment or if a pest/termite bond is currently active on the home.

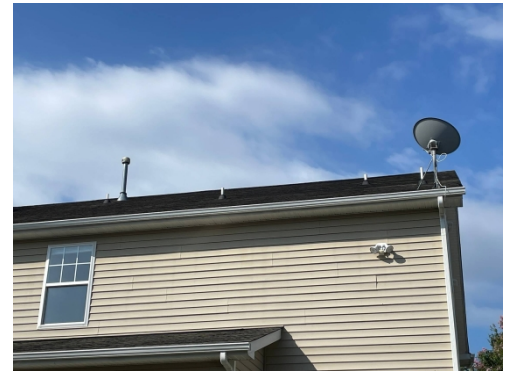
36. Information/Suggestion: Roof Plumbing Vent Pipe Flashings Lifespan- Plumbing waste pipe flashings are currently in good condition where installed on the roof covering. Typically used, rubber boot flashings, around plumbing vents that penetrate the roof covering last (depending on exposure to UV light) about 8 to 10 years before cracking. No evidence of leaking was observed at these vent pipe penetrations from inside the attic but proper preventive maintenance requires replacement of these flashings half way through the expected life of the roof covering. If documentation cannot be provided by the seller that the flashings have recently been replaced, it is suggested that preventative maintenance/replacement be performed at this time by a professional roofing contractor.

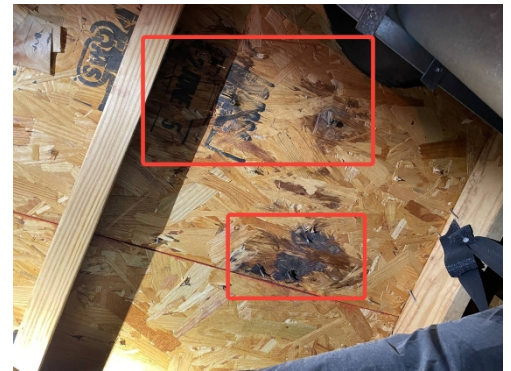
37. Further Evaluation is Suggested - Moisture Penetration/Moisture Stains - New Roof - Water stains were observed in the attic at the roof decking above the HVAC furnace and on the right side gable wall above the 2nd floor front right bedroom area. These stains are assumed to be from leaks before the new roof was installed. Consult the owner about the history of water stains currently present in the attic, or if further concerns are present, suggest that a professional roofing contractor fully evaluate the roof area to determine if additional repairs are necessary.

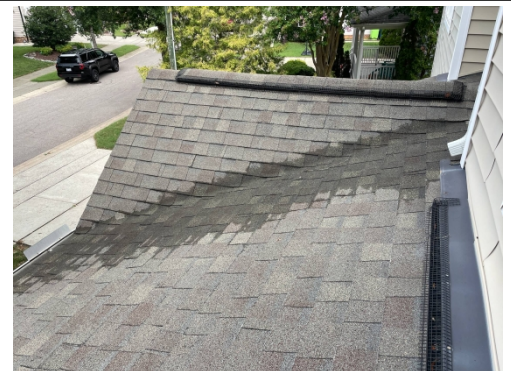
38. Information: Roof – Older Roof - The roof covering and visible components were inspected as part of this home inspection. However, due to the age of the roofing material, you may want to consider further evaluation of the roof. Roof repairs can range from a few hundred dollars for minor fixes to more than \$10,000 for full replacement, depending on size and materials. A professional roof evaluation with drone photography is recommended for further assurance of condition.

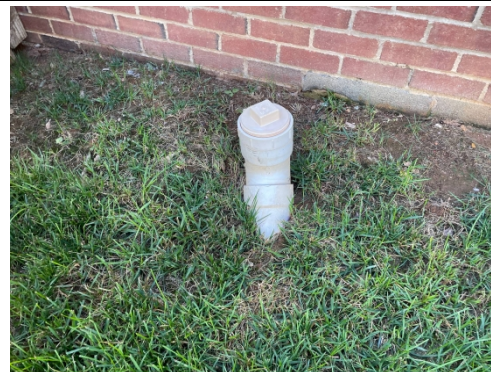
**39. Information/Inspection Limitation: Main Waste Line** – The interior of the main waste line was not inspected as part of this home inspection. Underground plumbing can develop hidden problems such as root intrusion, cracks, poor installation, blockages, or even rodent activity. These issues may result in sewage backups or complete line failure. Repair or replacement of a buried sewer line can range from several thousand dollars to well over \$10,000, depending on location and depth. A professional sewer scope inspection is recommended to determine the current condition of the line before purchase.

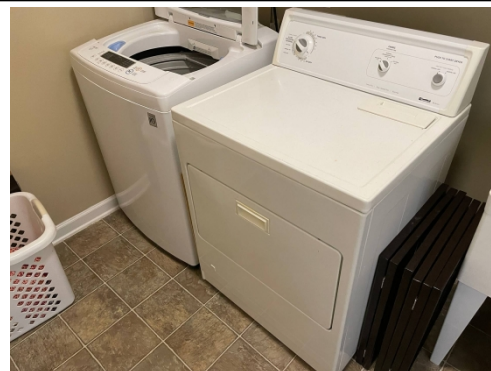
**40. Suggestion: Missing Washing Machine Drain Pan** - There is no washing machine emergency drain pan installed for the washing machine. This can result in water damage to the floor/ceiling below this area should the washing machine or lines leak. Suggest that a drain pan be added so that protection against water damage from leaking appliance can be provided.

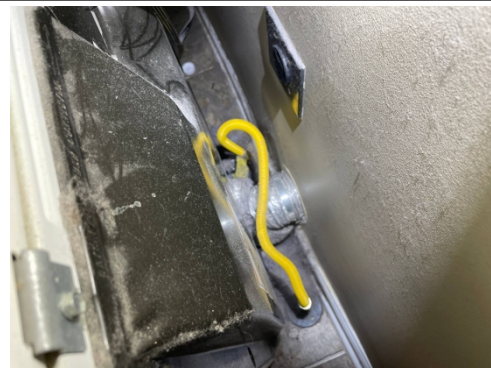
**41. Information: Dryer** - The laundry area is equipped with both electric and natural gas connections for the clothes dryer. This provides flexibility for the homeowner to install either an electric or gas dryer based on personal preference or appliance availability. No deficiencies were observed with the presence of both connection types at the time of inspection. Verify that any dryer installed is compatible with the available utility connection and that the exhaust duct is properly connected and vents to the exterior.

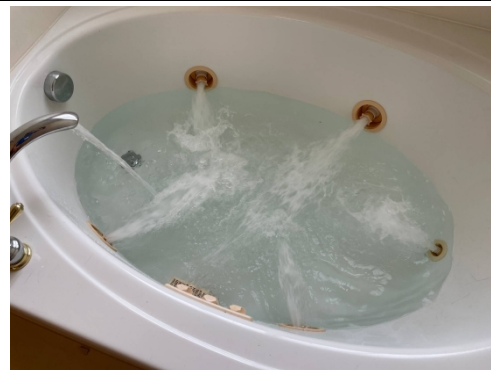
**42. Information: Fungus in Whirlpool Tub Jet Lines** - The whirlpool bathtub in the primary bathroom was filled and tested for proper operation. No adverse conditions were noted with the pump and plumbing pipes. The water circulation lines has some fungus/mildew from the jets when turned on. (See Photo) The stagnant water left in the lines create conditions that are conducive to this fungal growth/algae. Regular maintenance is suggested at this time and regularly before the bathtub jet feature is used.

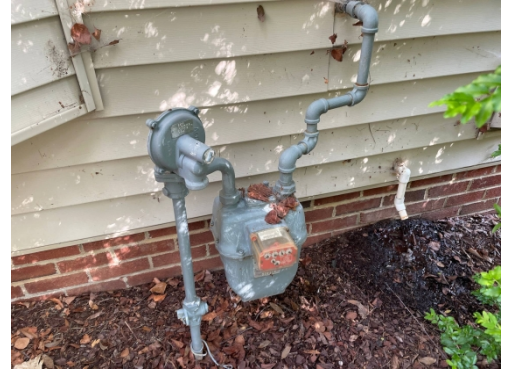
**43. Information/Recommendation:** Pre 2008 Electrical Grounding System - Gas Line Not Bonded - No bonding (ground) wire was observed for the gas line serving the house. Electrical standards at the time of original construction did not require the gas lines to be bonded to the house electrical system. Due to higher levels of safety regarding electrical standards, requirements of bonding the gas line were implemented in 2008 when certain types of corrugated stainless-steel tubing (CSST) gas lines are being used. Due to personal safety concerns, it is suggested that the current standard of bonding the gas lines to the house electrical system be implemented.

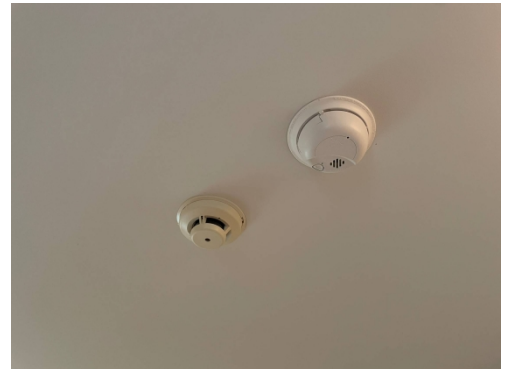
**44. Smoke Detectors** - Smoke detectors were present at the time of the inspection. Smoke detection device installation appears to be typical for the time period of the home's construction. Change out batteries (if provided with a backup power source) on all smoke detectors annually in order to provide a continued backup power source for detectors during periods of interrupted power outages.

>>> Limited Evaluation: Alarm System Connected - The smoke/CO detection system installed in this home has been connected to the alarm system. The seller was present and working from home during the inspection. This prevents testing of the detection system. This limits the inspection of this system.

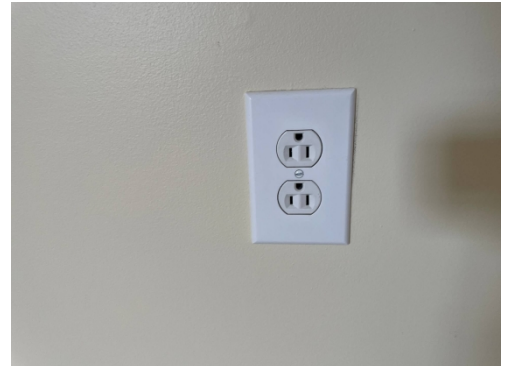
**45. Information:** Upside-down Outlets - Electrical contractors are currently indicating wall receptacles that are controlled by a wall switch by installing the outlet upside down (ground prong opening up rather than down). These were noted in the bedrooms and office.

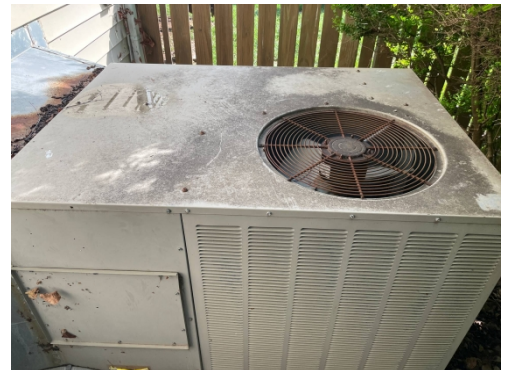
**46. Information/Suggestion - Older HVAC Equipment/System/Maintenance:**

A.) Some of the HVAC components that serve this home are estimated to be at/over 10 years old. As such, they may be nearing the end of their normal life expectancy (13 years). Due to the age of the equipment, it is suggested that a professional HVAC contractor provide a full evaluation of the system to determine its condition. >>> Please note that no one can predict the service life of mechanical equipment, so it is suggested that the owner/buyer be prepared/budget for replacement of the HVAC's system and/or components in the near future.

B.) HVAC components built prior to 2010 may use a refrigerant (R22) that is no longer produced/imported into the US. This can result in increased fees for some repairs, and in some cases, system replacement in lieu of repairs. It is suggested that a professional HVAC contractor provide further evaluation if additional concerns are present.

C.) Normal aging and/or use of dirty filters will put excessive loads on the A/C system which can contribute to premature ageing and dirt build up inside the air handler. This can result in poor performance efficiency. Manufacturers recommend service/cleaning be provided annually on all HVAC systems. If preventative maintenance records can not be provided for the previous year, it is strongly suggested that a professional HVAC contractor provide further evaluation and routine annual service for this system.

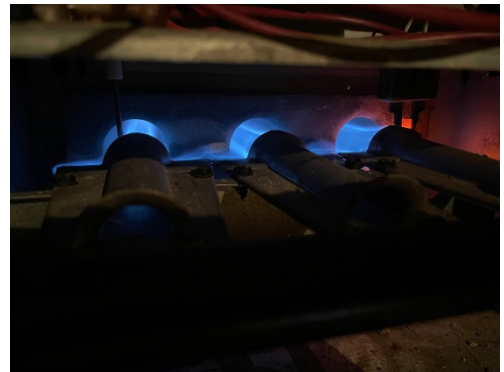
**47. Limited Evaluation: Gas Heat - Outdoor Temperature Above 60 Degrees -** Manufacturers do not recommend operating a gas furnaces for extended time intervals when outside air temperatures are above 60 degrees. When outdoor temps exceed this limit a heating systems will be visually inspected and activated for a short period only. No adverse conditions were observed during the inspection, but this evaluation was limited.

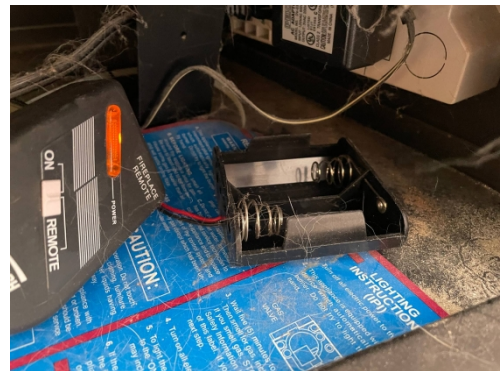
**48. Information: Battery Starter -** The fireplace uses an electronic ignition system to light the burner assembly. A battery cartridge is provided inside the lower cavity, under the firebox itself, that can have batteries put into it when power is not available to the house in order to use the fireplace as a heat source.

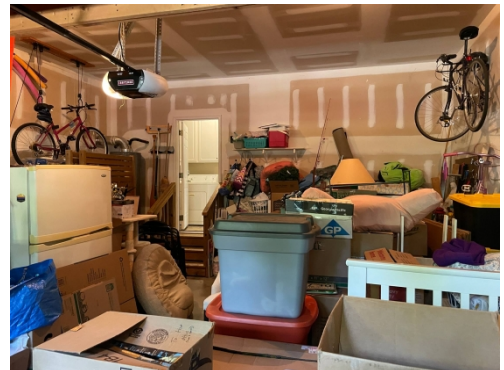
**50. Limited Evaluation: Observed personal items stored throughout the house.** This limits access to various areas, and will prevent inspection of windows and outlets that are covered by personal items. Efforts were made to observe all areas, but the evaluation may have been limited.

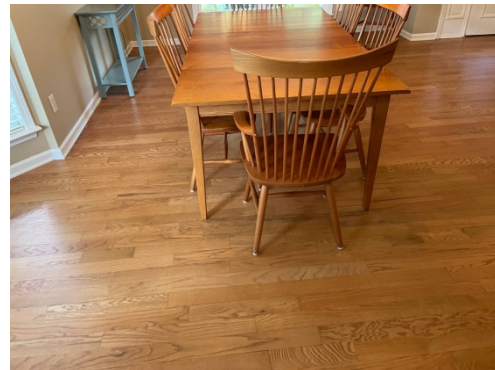
**51.** Observation/Information: Minor Floor Noise Present - Floor coverings prevented full inspection of some floor surfaces. Where visible, floor condition is serviceable and typical for the age of the home. Observed areas in the floor system where the subfloor is loosely secured to the floor trusses/floor joist. This results in some minor floor deflection and/or squeaking in the floor when walked on. This is a common occurrence in many floor systems and can be repaired by pulling up the floor coverings and adding additional fasteners (preferable screws) in the areas of the loose subfloor.

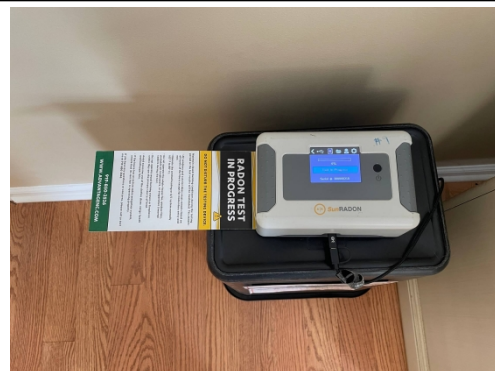
**52.** Information: A separate radon test was started with this home inspection. These test take a few days to complete, and the results are forwarded to the buyer once received/processed. The results will indicate radon levels current in the home. If levels are within normal limits no further action is needed. If levels are high, repairs or upgrades will be required to the radon remediation device.
