# Inspection Report

**Property Address:**  
104 Bergeron Way  
Cary NC 27519

**Fuster Home Inspections, LLC**

| <b>Date:</b> 8/20/2026 | <b>Time:</b> 08:30 AM | <b>Report ID:</b> AB082026-1 |

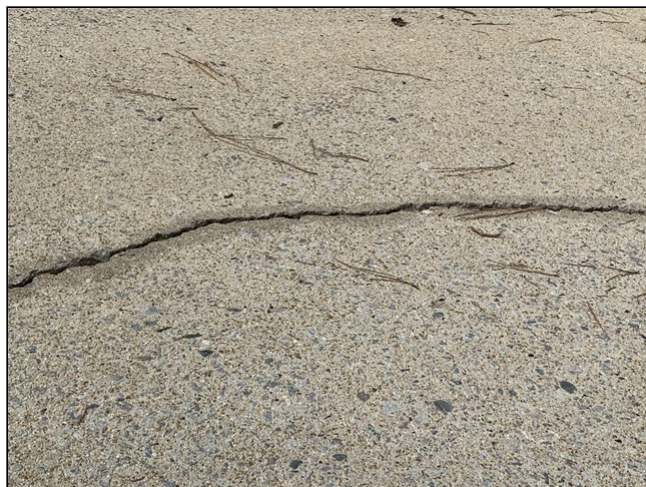
The driveway has cracked and heaved. Uneven walking surfaces are a tripping hazard. Driveway should be properly repaired or replaced as needed for safety by a qualified contractor.

1.0 Item 1(Picture) The driveway has cracked and heaved

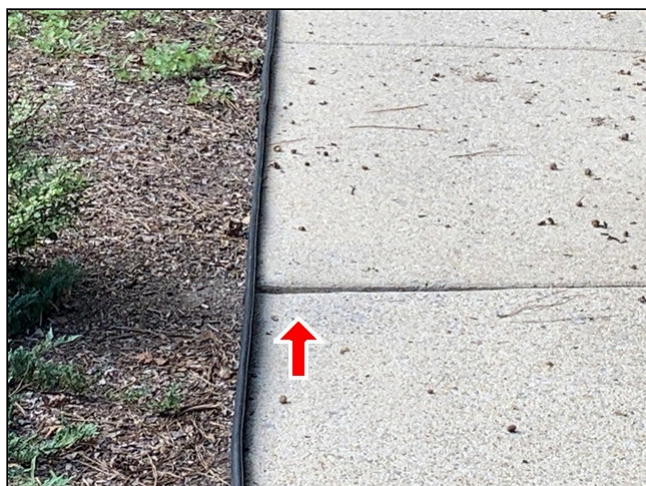
The front concrete walk has cracked and heaved and the right side brick walk is heaved and uneven. Uneven walking surfaces are a tripping hazard. Should be properly repaired or replaced as needed for safety by a qualified contractor.

1.1 Item 1(Picture) The front concrete walk has cracked and heaved

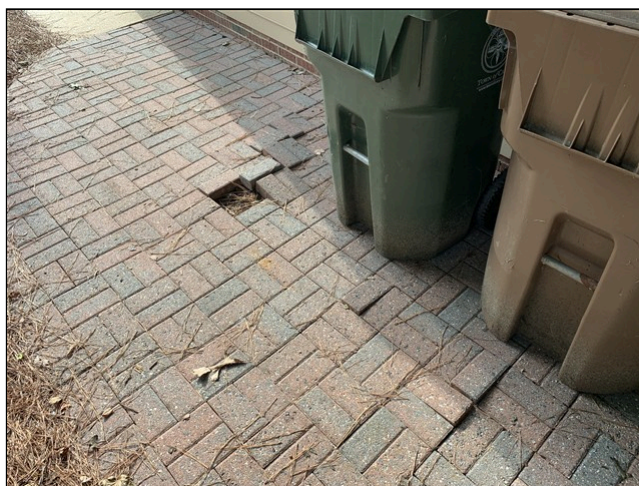
1.1 Item 2(Picture) Right side brick walk is heaved and uneven

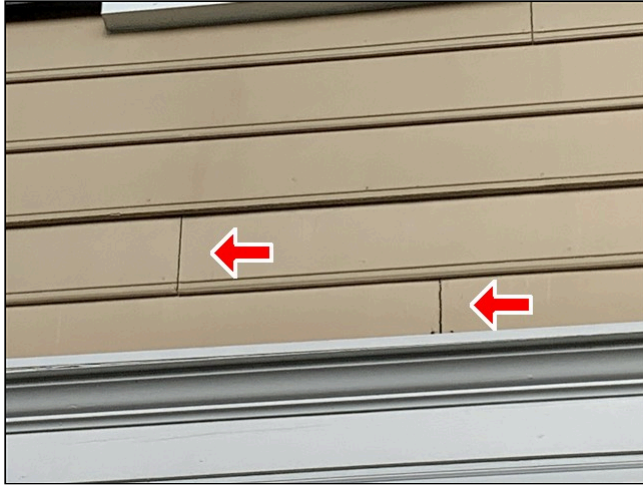
(1) Gaps are visible at joints between sections of hard board siding in several areas around house. These gaps are normally sealed to prevent water penetration which can lead to deterioration and fungus growth. Gaps should be properly repaired as needed by a qualified contractor.

2.1 Item 1(Picture) Gaps are visible at joints between sections of hard board siding in several areas around house

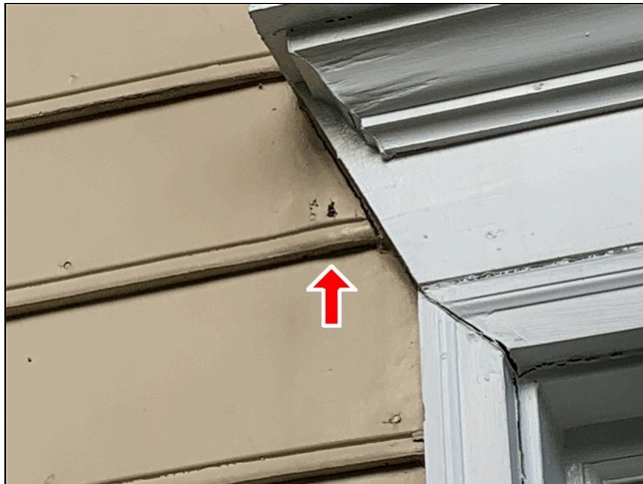
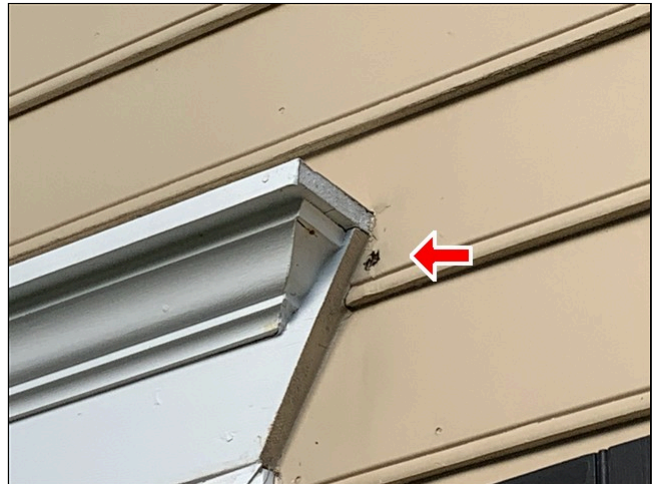
(2) Hard board siding is deteriorated to upper left of fixed window over front door and to upper right of window to left of front stoop. Siding should be fully evaluated and all deteriorated areas should be properly replaced (not filled with putty) by a qualified contractor to prevent continued deterioration, water penetration, structure damage and fungus growth. Any additional deteriorated materials discovered or exposed during replacement of siding should also be replaced.

2.1 Item 2(Picture) Hard board siding is deteriorated

2.1 Item 3(Picture) Hard board siding is deteriorated

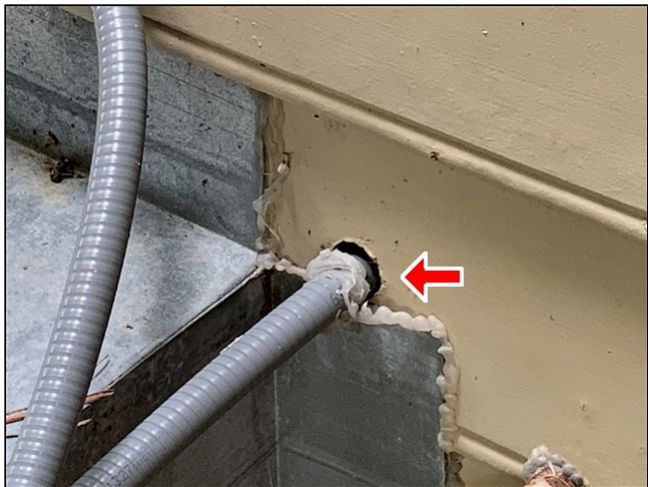
(3) Gap not sealed where gas pack wire conduit penetrates hard board siding at left side of house. Gap should be properly sealed by a qualified contractor to help prevent water penetration and deterioration.

2.1 Item 4(Picture) Gap not sealed where gas pack wire conduit penetrates hard board siding at left side of house

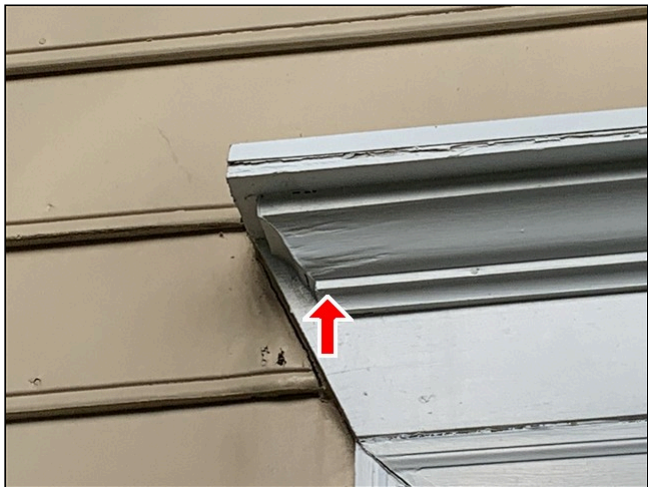
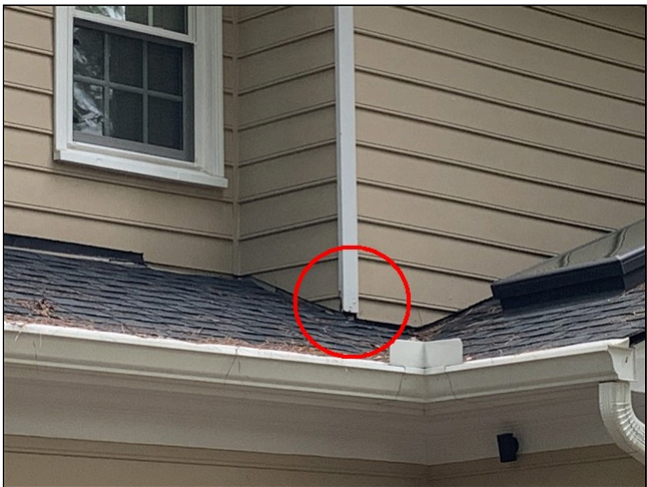
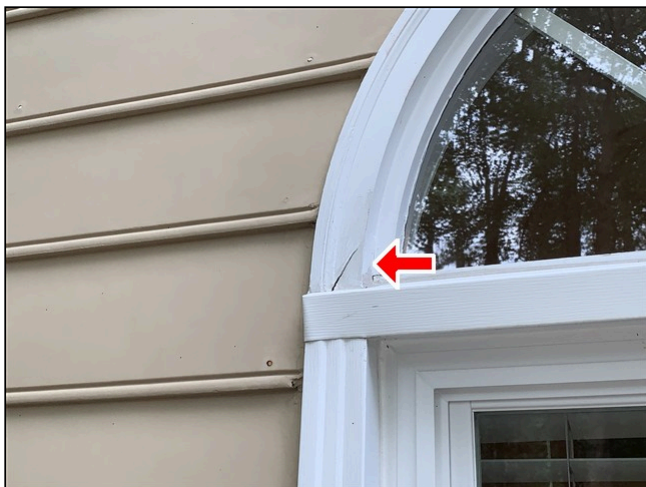
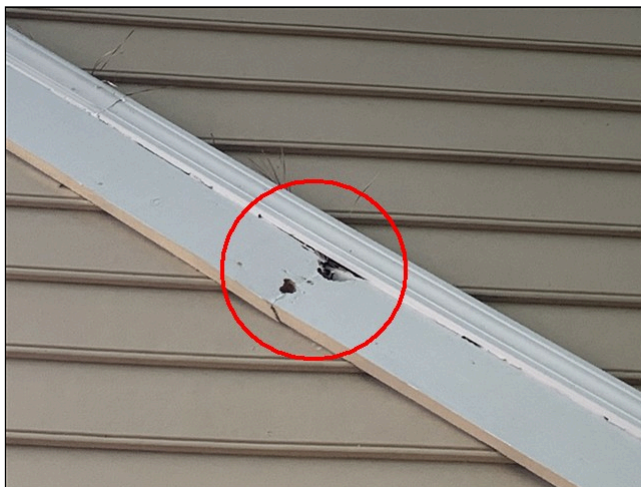
(1) Trim deteriorated at top left over fixed window over front door, at base near shingles at center of rear lower roof, at lower left of left rear curved fixed window (viewed from rear) and near rear of right side of house at angled section. All deteriorated areas should be properly replaced (not filled with putty) by a qualified contractor to prevent continued deterioration, water penetration, structure damage and fungus growth. Any additional deteriorated materials discovered or exposed during replacement should also be replaced.

2.2 Item 1(Picture) Trim deteriorated

2.2 Item 2(Picture) Trim deteriorated

2.2 Item 3(Picture) Trim deteriorated

2.2 Item 4(Picture) Trim deteriorated

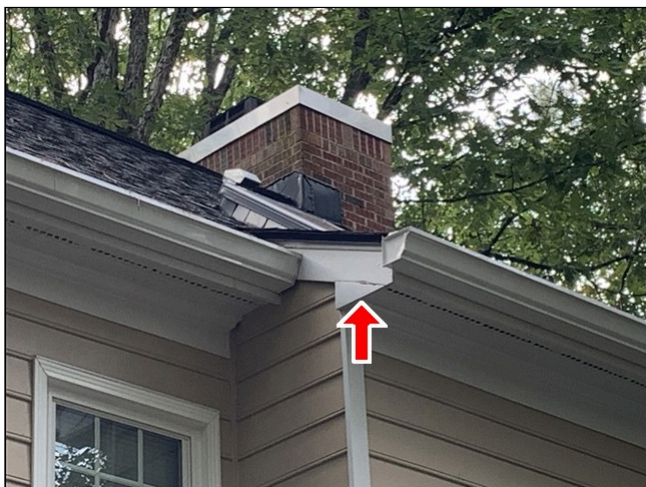
(2) Rake deteriorated at left edge of roof near left end of gutter at lower right of rear upper roof (viewed from rear). All deteriorated sections of rake should be properly replaced (not filled with putty) by a qualified contractor to prevent continued deterioration, water penetration, structure damage and fungus growth. Any additional deteriorated materials discovered or exposed during replacement should also be replaced.

2.2 Item 5(Picture) Rake deteriorated

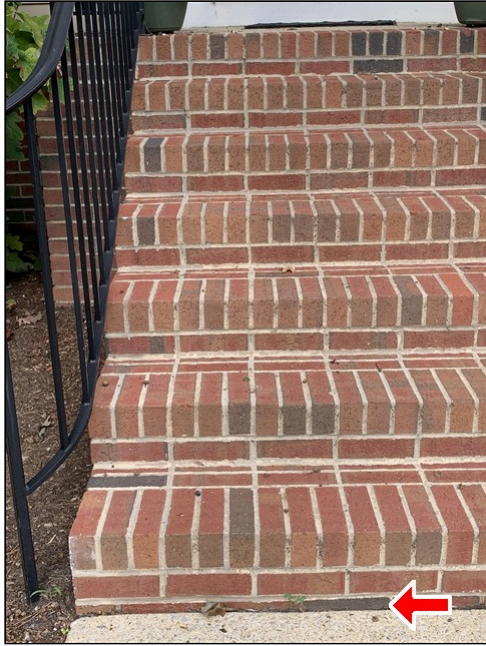
Riser heights are uneven at front steps. Distance from lower step to walk is greater than other steps in run. Uneven riser heights are a tripping hazard. Should be properly repaired as needed for safety by a qualified contractor.

2.6 Item 1(Picture) Riser heights are uneven at front steps

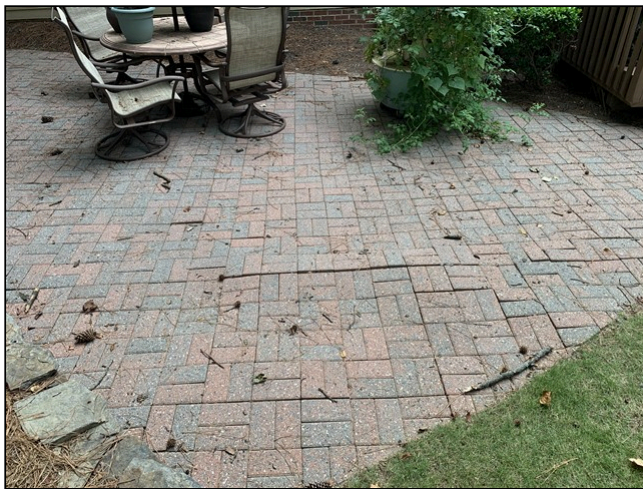
Rear brick patio is uneven. Uneven walking surfaces are a tripping hazard. Should be properly repaired as needed for safety by a qualified contractor.

2.9 Item 1(Picture) Rear brick patio is uneven

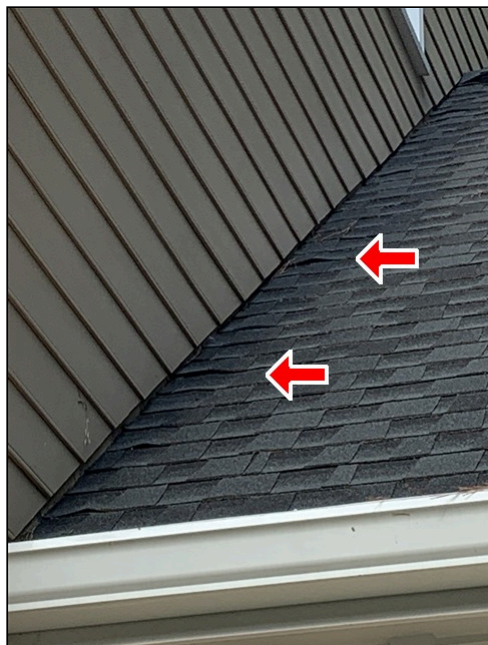
(1) Lifted shingles visible at left edge of right front lower roof. Lifted shingles are more likely to be damaged by high winds and can allow water penetration. Should be properly repaired as needed by a qualified contractor.

3.0 Item 1(Picture) Lifted shingles visible at left edge of right front lower roof

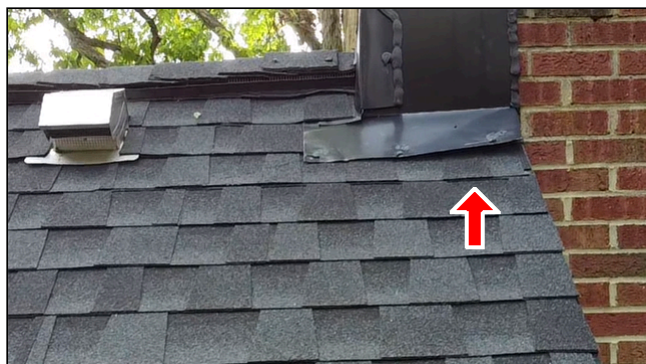
(1) Flashing is lifted on roof at rear of chimney. Lifted flashing is vulnerable to water penetration which can lead to structure damage and fungus growth. Flashing should be repaired as needed by a qualified contractor.

3.1 Item 1(Picture) Flashing is lifted on roof at rear of chimney

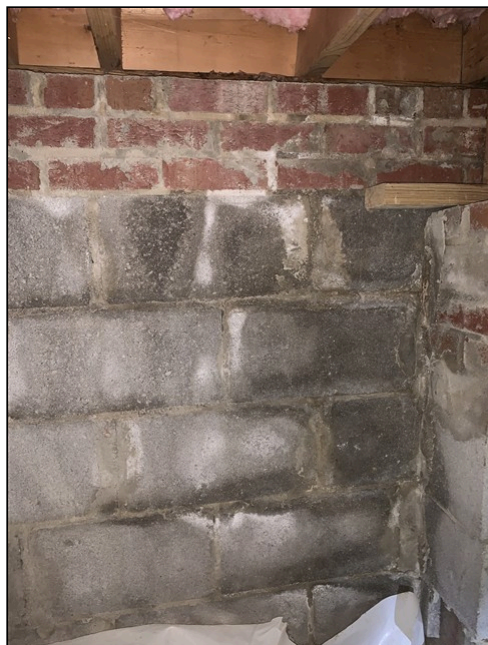
Signs of minor water penetration visible in the crawl space at left front (efflorescence on foundation wall). Water penetration can lead to structure damage and fungus growth. This problem is normally remedied by better control of surface water. A qualified water control contractor should be contacted to determine and take the proper course of action.

4.5 Item 1(Picture) Signs of minor water penetration visible in the crawlspace at left front (efflorescence on foundation wall)

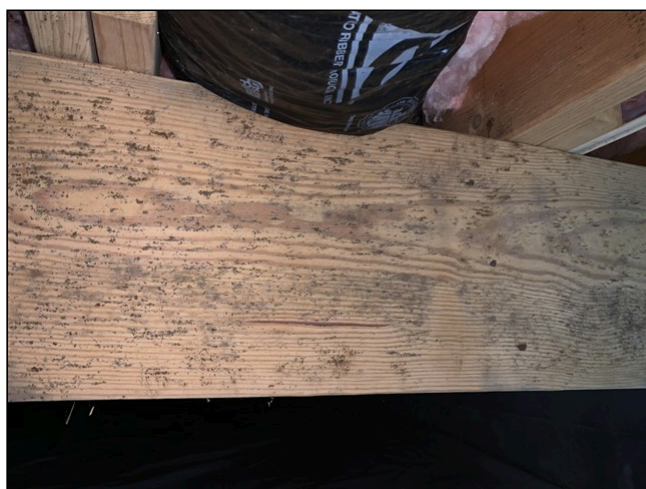
(1) Light fungus growth visible on main left to right girder at right front of crawlspace. When the building components have surface discolorations and decay typical of fungal growths, such as mold, mildew and wood destroying fungi, the home inspection focuses on moisture concerns and evidence of wood damage. Health issues related to the presence of mold are beyond the scope of the home inspection. If the client has concerns beyond the scope of the home inspection, a certified professional such as an industrial hygienist should be consulted prior to purchasing the home.

4.6 Item 1(Picture) Light fungus growth visible on main left to right girder at right front of crawlspace

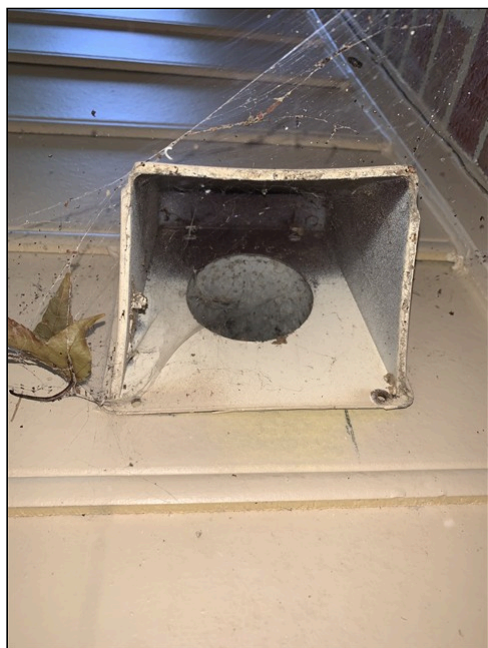
(1) There is no damper or screen installed at duct hood to rear of chimney. It is unclear what this duct hood serves (possibly combustion air supply for fireplace). Should be properly repaired as needed by a qualified contractor to help prevent small animals from entering duct.

5.4 Item 1(Picture) There is no damper or screen installed at duct hood to rear of chimney

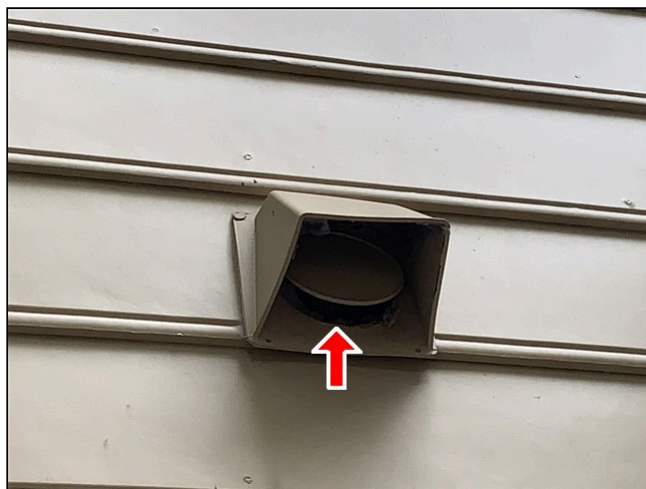
(2) Damper does not fully close at dryer vent duct hood at rear over deck. This can allow small animals to enter and block duct. Duct hood should be properly repaired or replaced as needed by a qualified contractor.

5.4 Item 2(Picture) Damper does not fully close at dryer vent duct hood at rear over deck

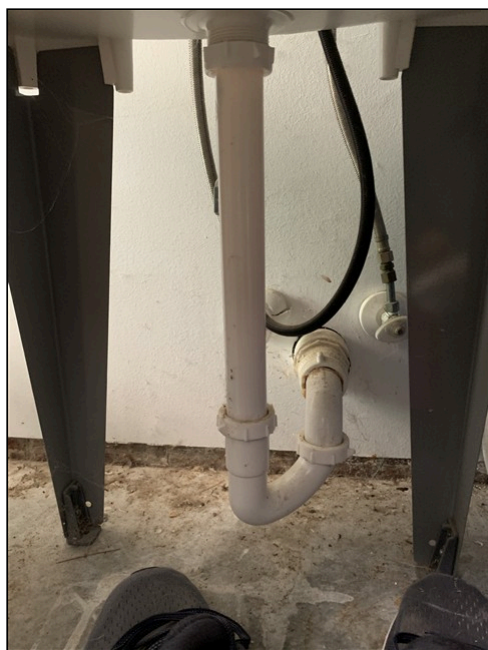
(1) Water lines and drain trap not insulated at garage sink. Pipes in this area are vulnerable to freezing during cold times of year. Frozen pipes can burst resulting in leakage, water damage and

fungus growth. Insulation should be properly added where needed by a qualified contractor.

6.0 Item 1(Picture) Water lines and drain trap not insulated at garage sink

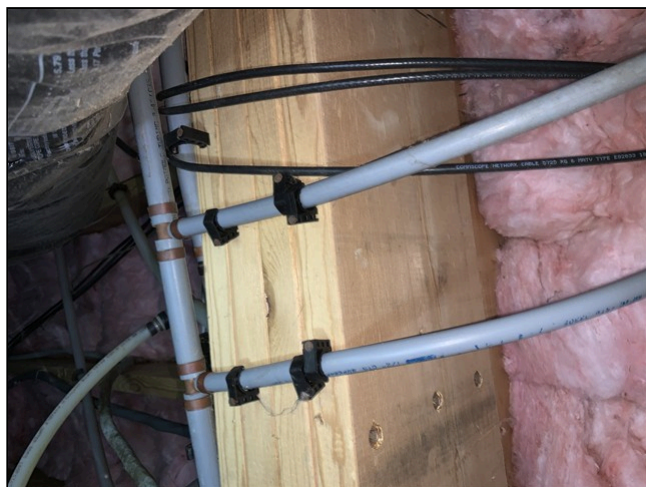
(2) This home has a plumbing supply system that uses polybutylene plastic distribution lines and compression band fittings. Even though this plumbing system was installed in many homes from 1978 until the mid-1990's, it is no longer an approved plumbing system due to a history of material failures. The failures were related to improper installation, improper handling, improper storage and plastic deterioration due to chemical reactions with the water supply. Due to the nature of this latent defect, it was not possible to adequately assess the condition of the plumbing system during the home inspection. A licensed plumbing contractor should be consulted for a complete evaluation of the plumbing system to determine the significance of this concern.

6.0 Item 2(Picture) Polybutylene pipe

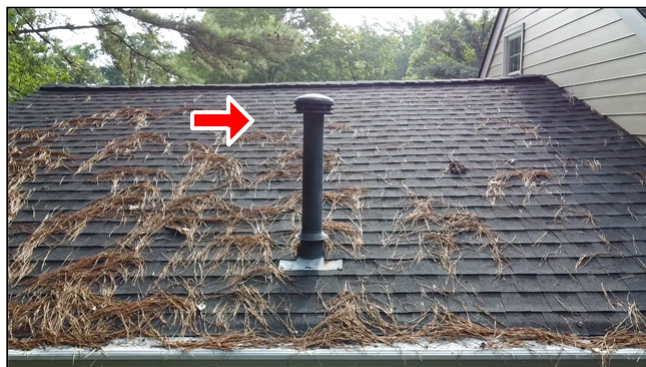
(1) Water heater flue is leaning on left rear roof (viewed from rear). When a flue is leaning this suggests it is loose and/or not stable. Should be properly repaired as needed by a licensed plumbing contractor to help prevent movement, water penetration or detachment.

6.7 Item 1(Picture) Water heater flue is leaning on left rear roof (viewed from rear)

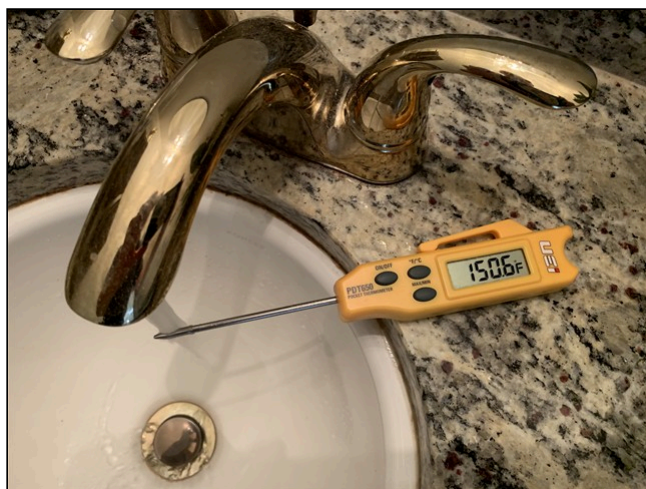
(2) Water temperature over 150°F. when measured at the half bathroom sink, which is a high setting and a scalding hazard. Water heater should be adjusted or properly repaired if needed for safety by a licensed plumbing contractor to ensure a maximum water temperature of 120°F.

6.7 Item 2(Picture) Water temperature over 150°F. when measured at the half bathroom sink

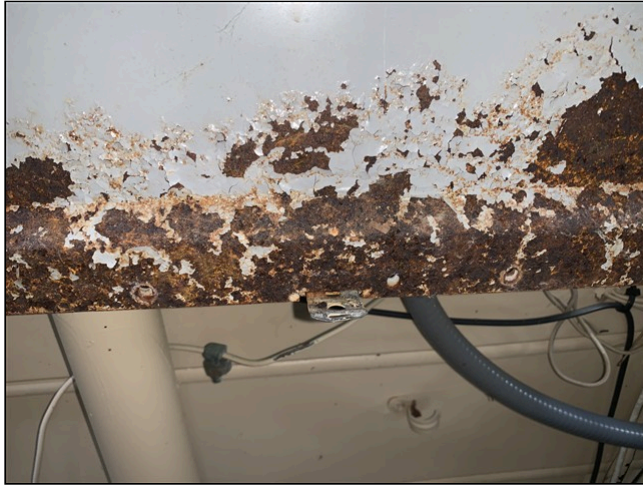
(1) Base of inner cover is heavily rusted at left side main electric panel. Panel should be fully evaluated and properly repaired as needed by a licensed electrical contractor for safety. Heavy rust suggest that water has been moisture within the panel.

7.1 Item 1(Picture) Base of inner cover is heavily rusted at left side main electric panel

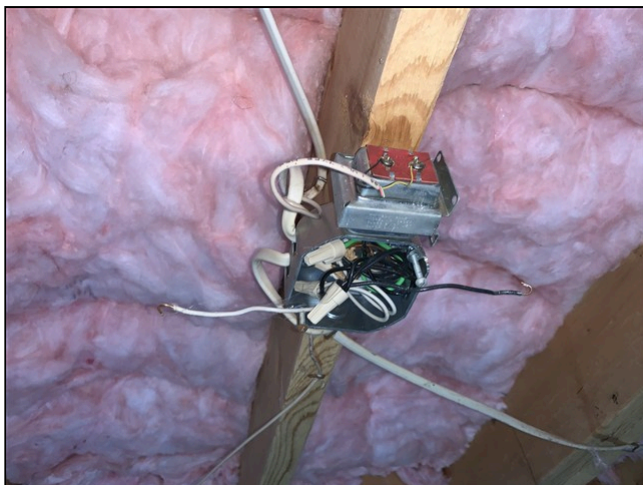
(3) Electrical junction box mixing cover at left front of crawl space. Light fixture looks to have been removed from junction box leaving live wires exposed. Should be properly repaired as needed for safety by a licensed electrical contractor.

7.4 Item 1(Picture) Electrical junction box mixing cover at left front of crawl space

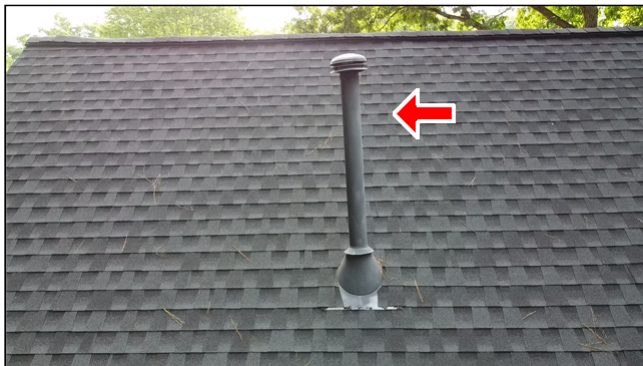
(1) Furnace flue is leaning on rear upper roof. When a flue is leaning this suggests it is loose and/or not stable. Should be properly repaired as needed by a licensed HVAC contractor to help prevent movement, water penetration or detachment.

8.0 Item 1(Picture) Furnace flue is leaning on rear upper roof

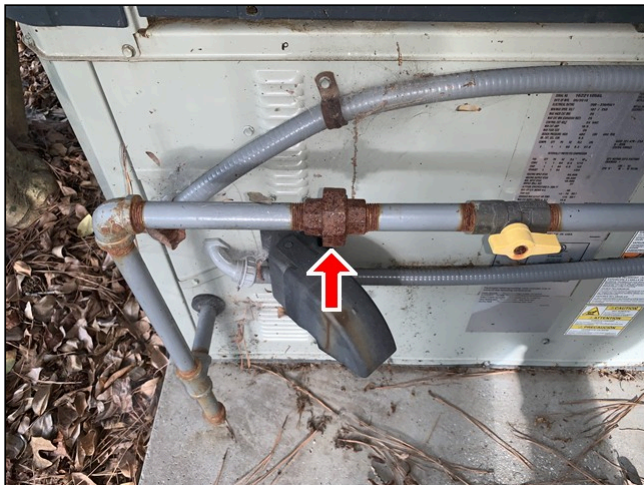
(1) Gas line rusted near left side gas pack. Deterioration of gas line is a safety concern. Should be properly repaired or replaced as needed by a licensed plumbing contractor.

8.3 Item 1(Picture) Gas line rusted near left side gas pack

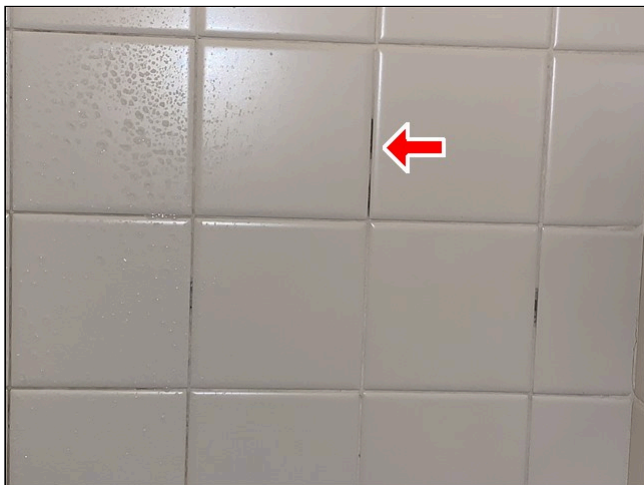
(1) Gaps visible between some wall tiles at the third floor bathroom shower. Should be properly repaired as needed by a qualified contractor to help prevent water penetration which can lead to damage and fungus growth.

9.0 Item 1(Picture) Gaps visible between some wall tiles at the third floor bathroom shower

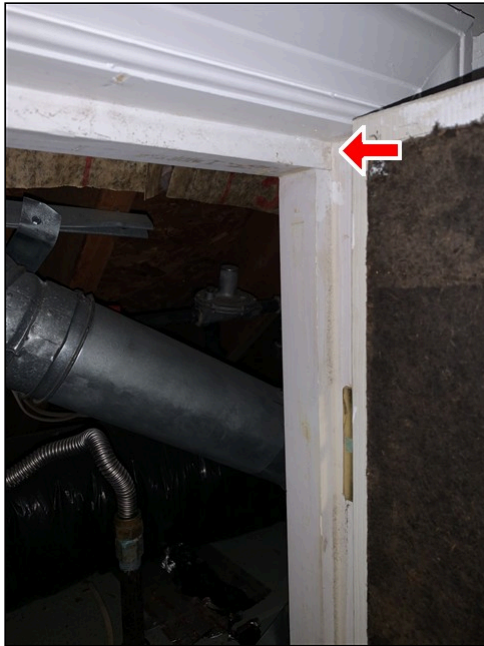
(3) Weather stripping missing at attic access doors at third floor. Weather stripping should be properly added where needed for efficiency and comfort.

9.2 Item 1(Picture) Weather stripping missing at attic access doors at third floor

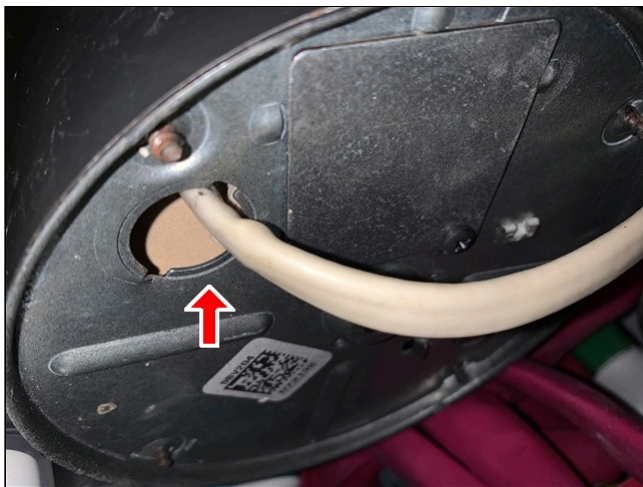
Wire clamp/bushing missing where electrical wire penetrates base of garbage disposal. With clamp/bushing missing wire is vulnerable to damage due to vibration caused by operation of unit. Clamp should be properly installed for safety by a licensed electrical contractor.

10.2 Item 1(Picture) Wire clamp/bushing missing where electrical wire penetrates base of garbage disposal

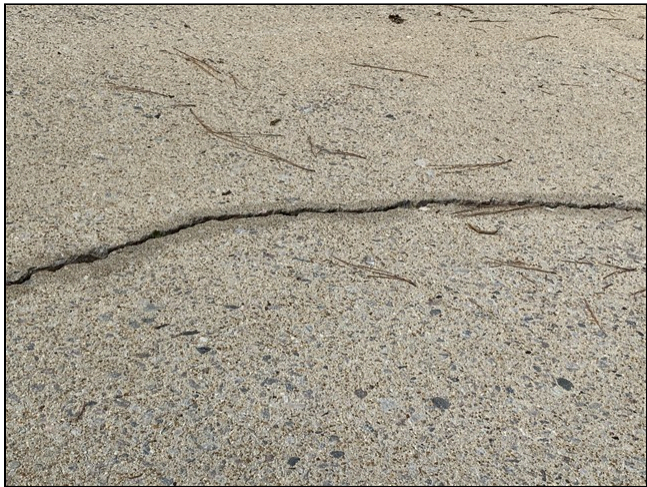
**1.0** The driveway has cracked and heaved. Uneven walking surfaces are a tripping hazard. Driveway should be properly repaired or replaced as needed for safety by a qualified contractor.

1.0 Item 1(Picture) The driveway has cracked and heaved

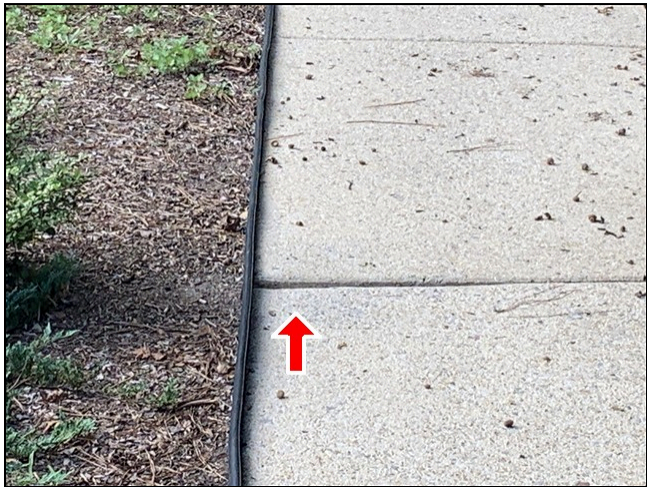
**1.1** The front concrete walk has cracked and heaved and the right side brick walk is heaved and uneven. Uneven walking surfaces are a tripping hazard. Should be properly repaired or replaced as needed for safety by a qualified contractor.

1.1 Item 1(Picture) The front concrete walk has cracked and heaved

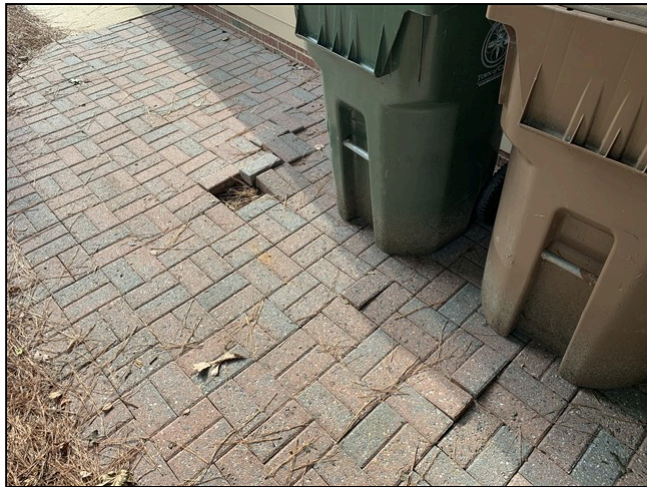
1.1 Item 2(Picture) Right side brick walk is heaved and uneven

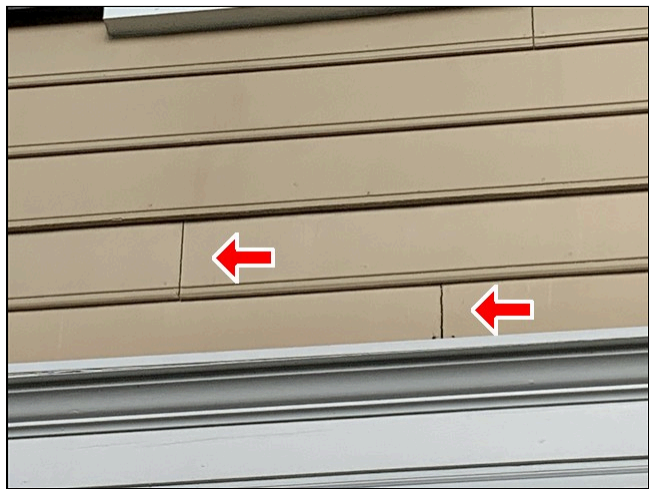
**2.1** (1) Gaps are visible at joints between sections of hard board siding in several areas around house. These gaps are normally sealed to prevent water penetration which can lead to deterioration and fungus growth. Gaps should be properly repaired as needed by a qualified contractor.

2.1 Item 1(Picture) Gaps are visible at joints between sections of hard board siding in several areas around house

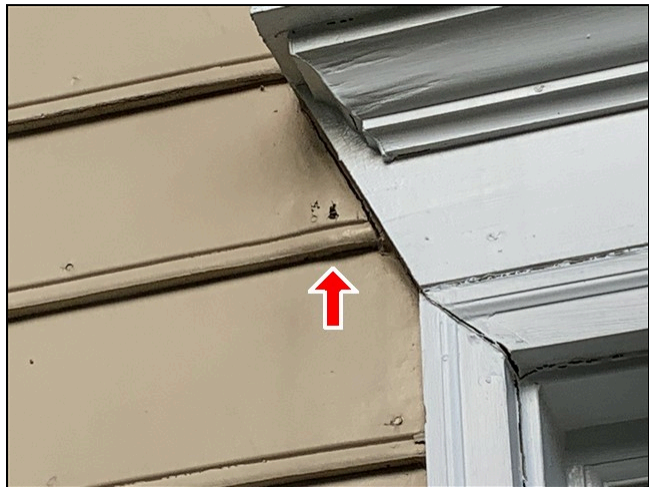
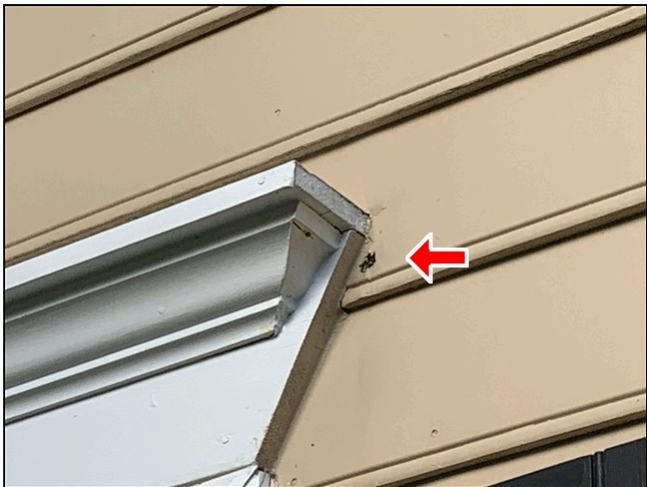
(2) Hard board siding is deteriorated to upper left of fixed window over front door and to upper right of window to left of front stoop. Siding should be fully evaluated and all deteriorated areas should be properly replaced (not filled with putty) by a qualified contractor to prevent continued deterioration, water penetration, structure damage and fungus growth. Any additional deteriorated materials discovered or exposed during replacement of siding should also be replaced.

2.1 Item 2(Picture) Hard board siding is deteriorated

2.1 Item 3(Picture) Hard board siding is deteriorated

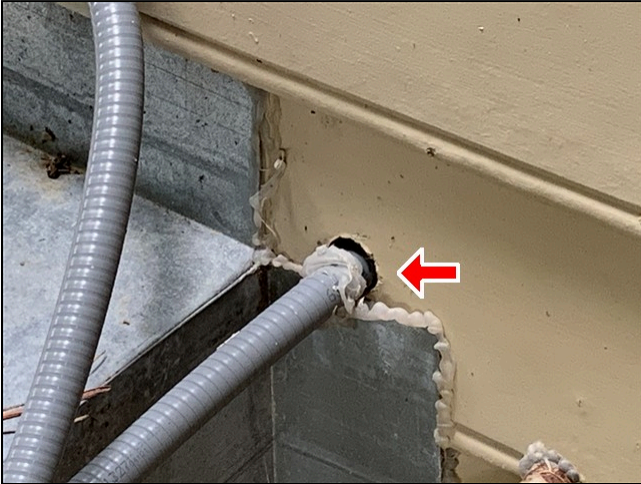
❧ (3) Gap not sealed where gas pack wire conduit penetrates hard board siding at left side of house. Gap should be properly sealed by a qualified contractor to help prevent water penetration and deterioration.

2.1 Item 4(Picture) Gap not sealed where gas pack wire conduit penetrates hard board siding at left side of house

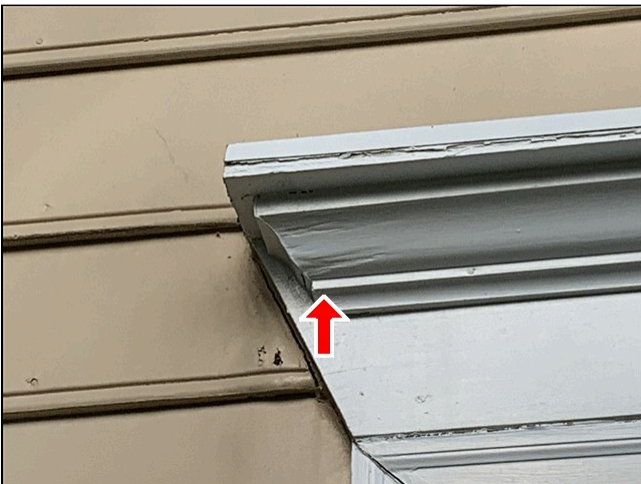
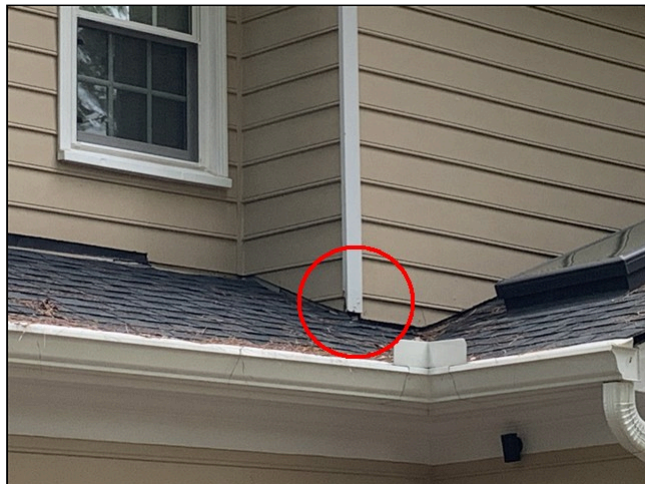
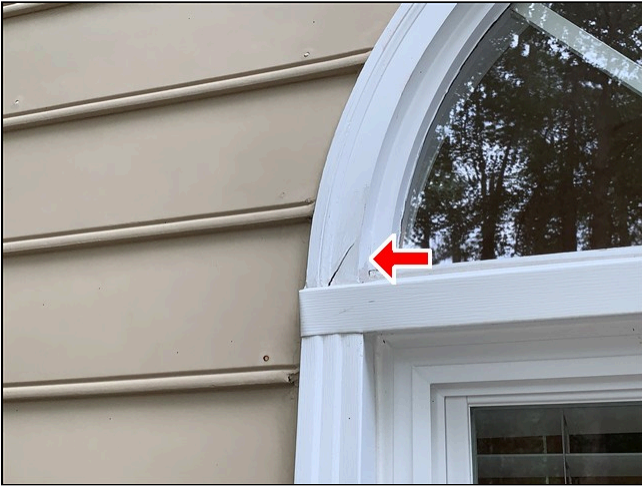
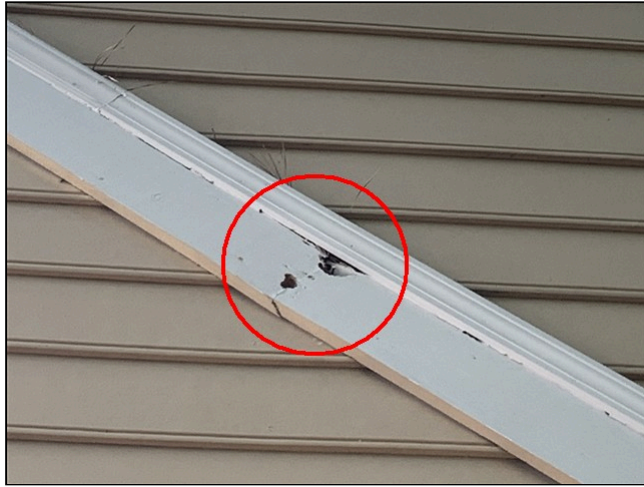
❧ **2.2** (1) Trim deteriorated at top left over fixed window over front door, at base near shingles at center of rear lower roof, at lower left of left rear curved fixed window (viewed from rear) and near rear of right side of house at angled section. All deteriorated areas should be properly replaced (not filled with putty) by a qualified contractor to prevent continued deterioration, water penetration, structure damage and fungus growth. Any additional deteriorated materials discovered or exposed during replacement should also be replaced.

2.2 Item 1(Picture) Trim deteriorated

2.2 Item 2(Picture) Trim deteriorated

2.2 Item 3(Picture) Trim deteriorated

2.2 Item 4(Picture) Trim deteriorated

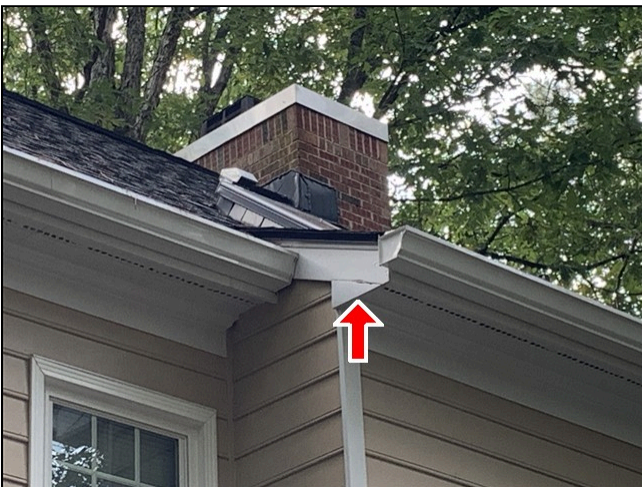
📏 (2) Rake deteriorated at left edge of roof near left end of gutter at lower right of rear upper roof (viewed from rear). All deteriorated sections of rake should be properly replaced (not filled with putty) by a qualified contractor to prevent continued deterioration, water penetration, structure damage and fungus growth. Any additional deteriorated materials discovered or exposed during replacement should also be replaced.

2.2 Item 5(Picture) Rake deteriorated

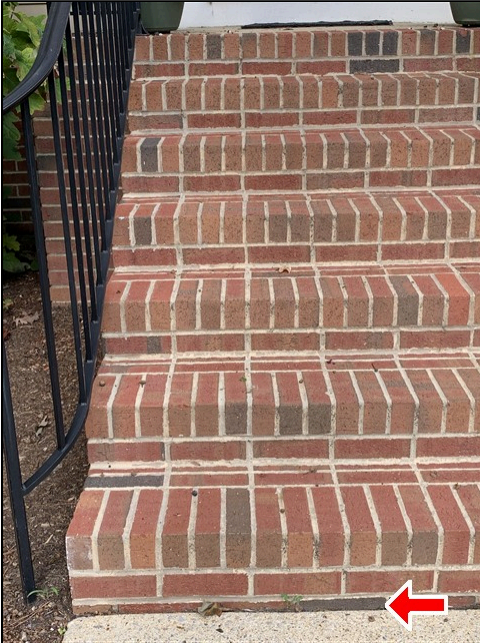
2.6 Item 1(Picture) Riser heights are uneven at front steps

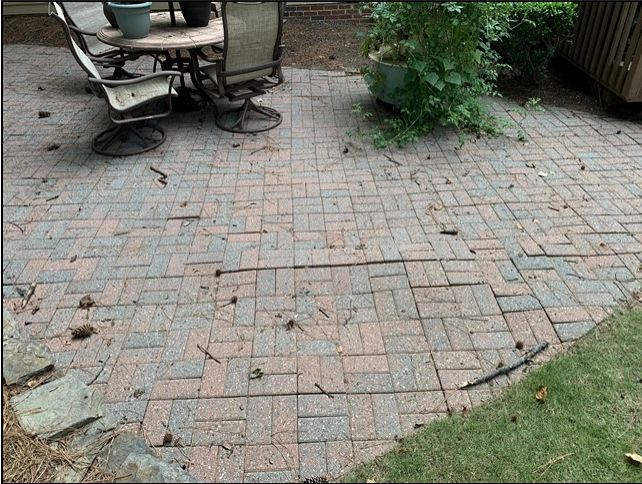
2.9 Item 1(Picture) Rear brick patio is uneven

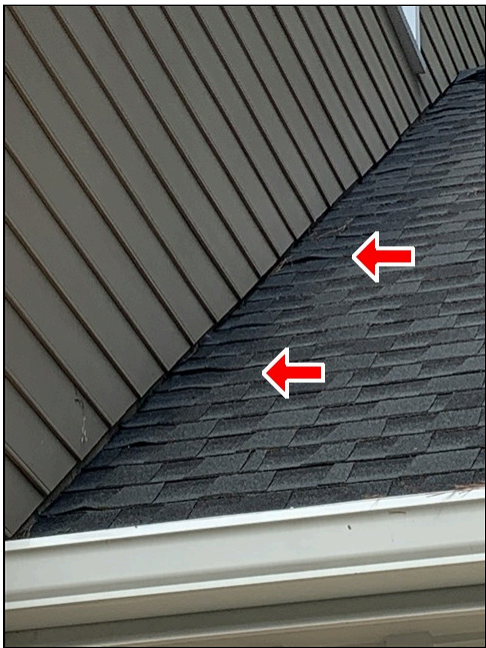
3.0 Item 1(Picture) Lifted shingles visible at left edge of right front lower roof

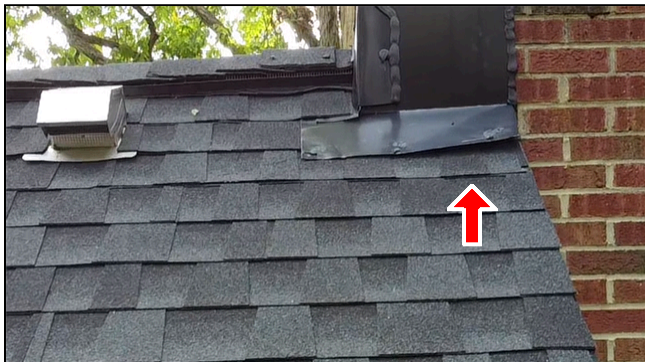
3.1 Item 1(Picture) Flashing is lifted on roof at rear of chimney

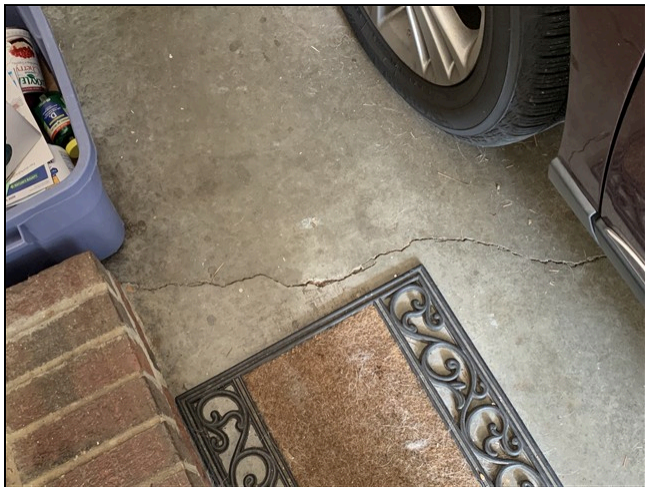
4.2 Item 1(Picture) Minor cracks visible in the garage concrete slab

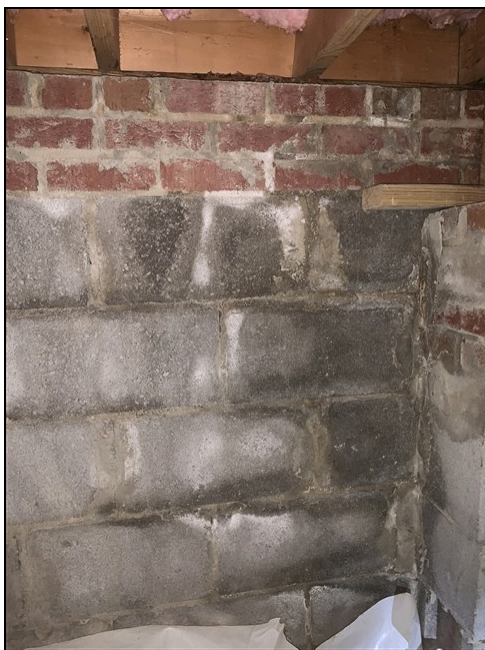
4.5 Item 1(Picture) Signs of minor water penetration visible in the crawl space at left front (efflorescence on foundation wall)

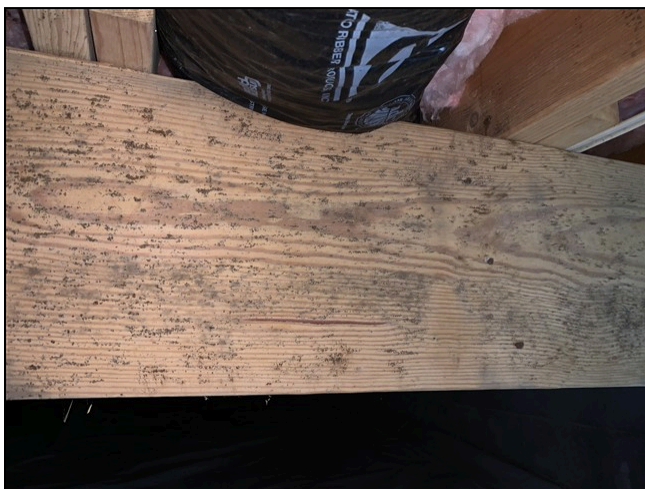
4.6 Item 1(Picture) Light fungus growth visible on main left to right girder at right front of crawlspace

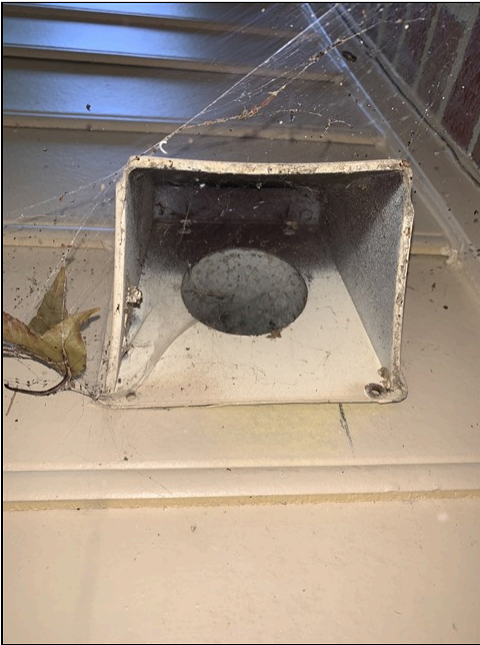
5.4 Item 1(Picture) There is no damper or screen installed at duct hood to rear of chimney

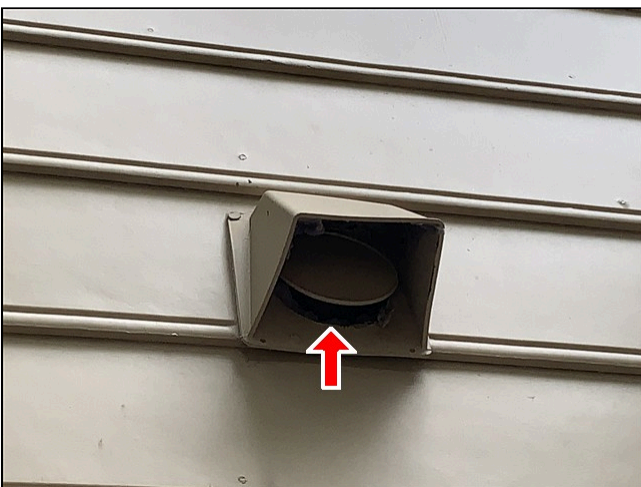
5.4 Item 2(Picture) Damper does not fully close at dryer vent duct hood at rear over deck

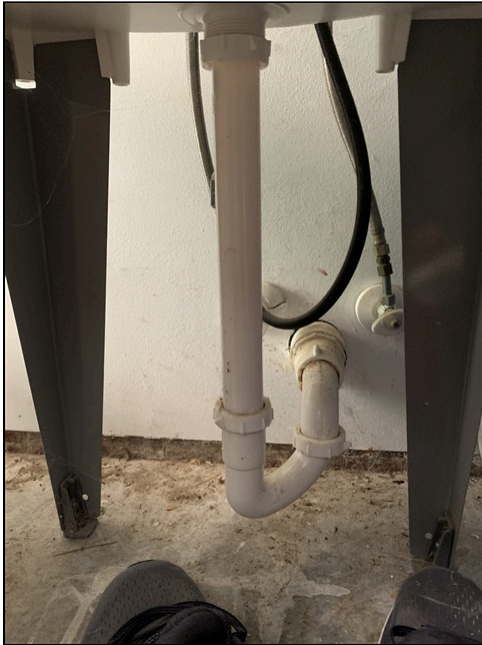
6.0 Item 1(Picture) Water lines and drain trap not insulated at garage sink

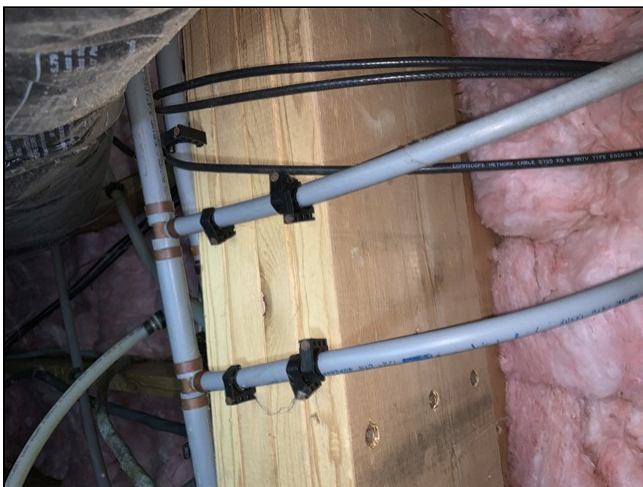
6.0 Item 2(Picture) Polybutylene pipe

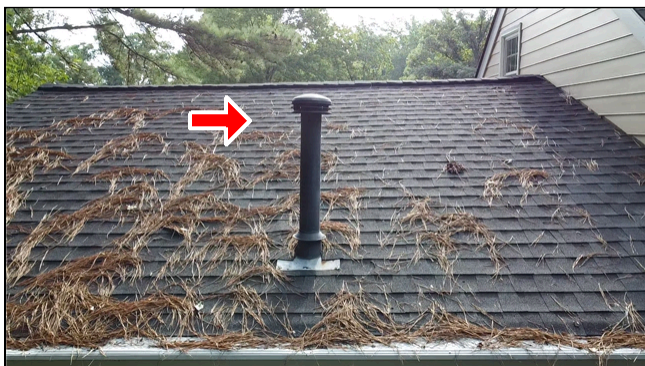
6.7 Item 1(Picture) Water heater flue is leaning on left rear roof (viewed from rear)

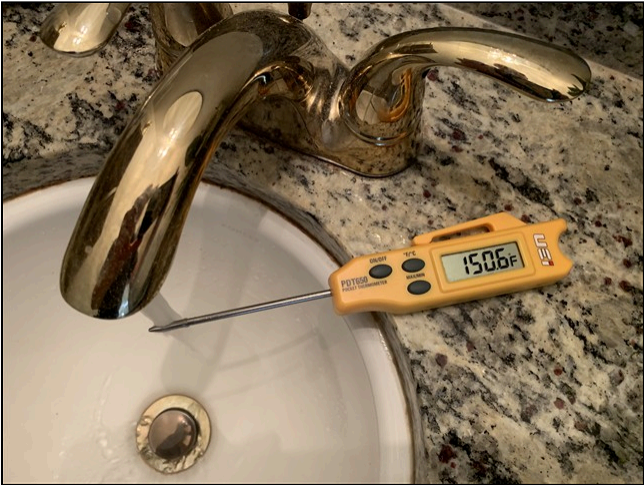
6.7 Item 2(Picture) Water temperature over 150°F. when measured at the half bathroom sink

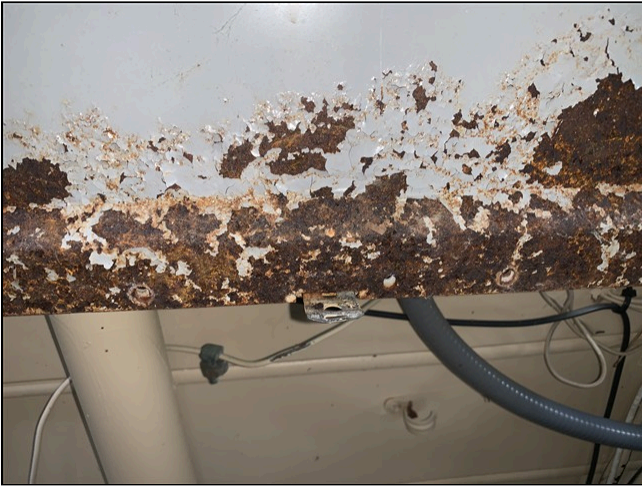
7.1 Item 1(Picture) Base of inner cover is heavily rusted at left side main electric panel

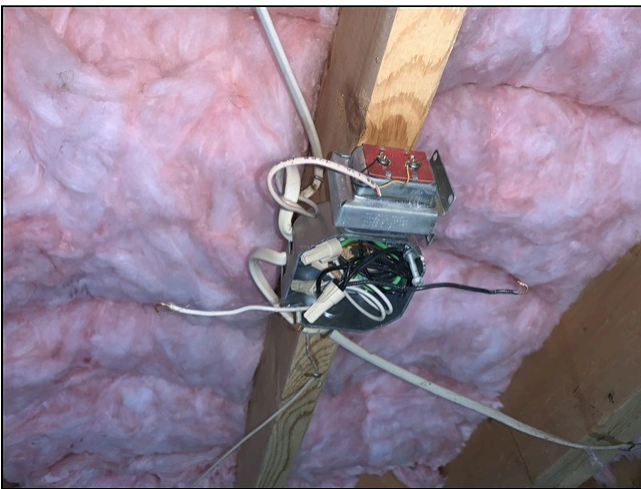
7.4 Item 1(Picture) Electrical junction box mixing cover at left front of crawl space

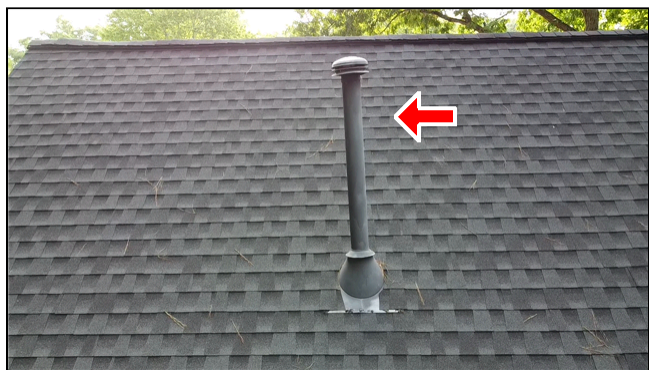
8.0 Item 1(Picture) Furnace flue is leaning on rear upper roof

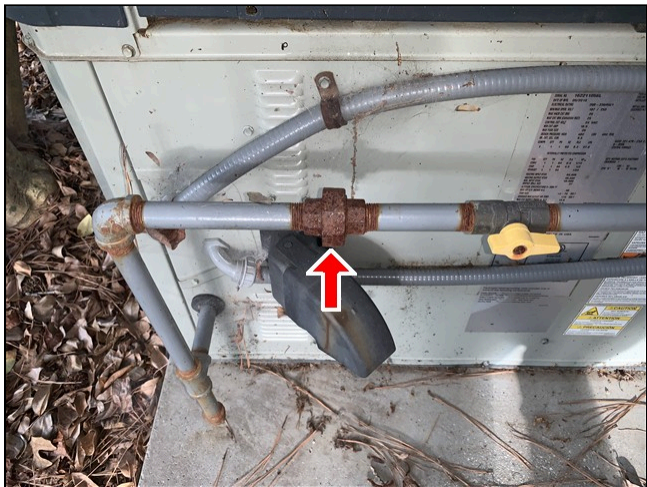
8.3 Item 1(Picture) Gas line rusted near left side gas pack

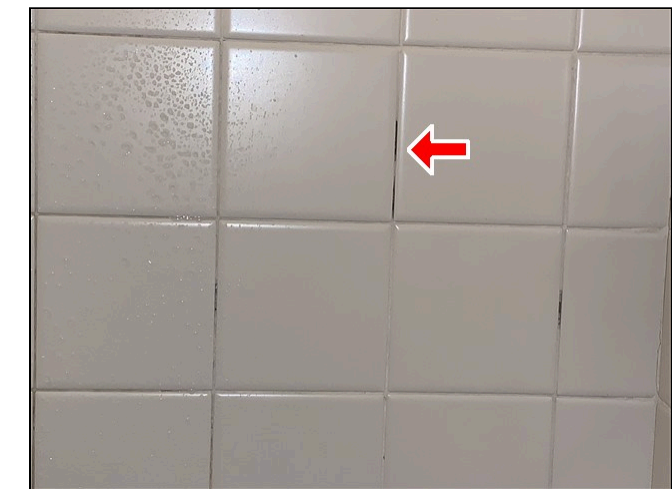
9.0 Item 1(Picture) Gaps visible between some wall tiles at the third floor bathroom shower
