# Inspection Report

**Property Address:**  
104 Bergeron Way  
Cary NC 27519

**Fuster Home Inspections, LLC**

| <b>Date:</b> 8/20/2026 | <b>Time:</b> 08:30 AM | <b>Report ID:</b> AB082026-1 |

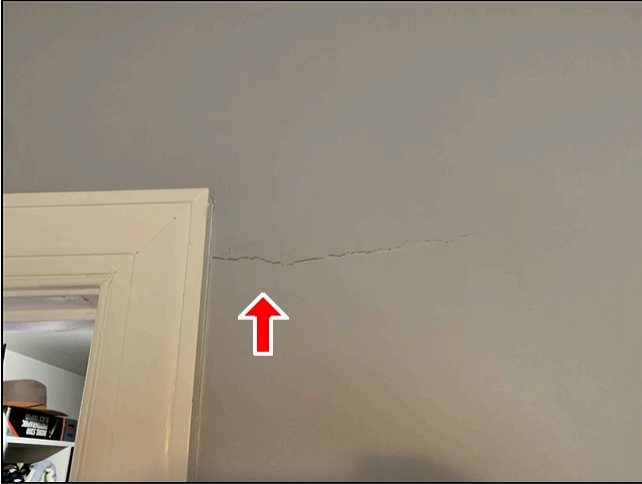
9.0 Item 2(Picture) Minor crack(s) visible in wall sheathing at right top of master bedroom closet door

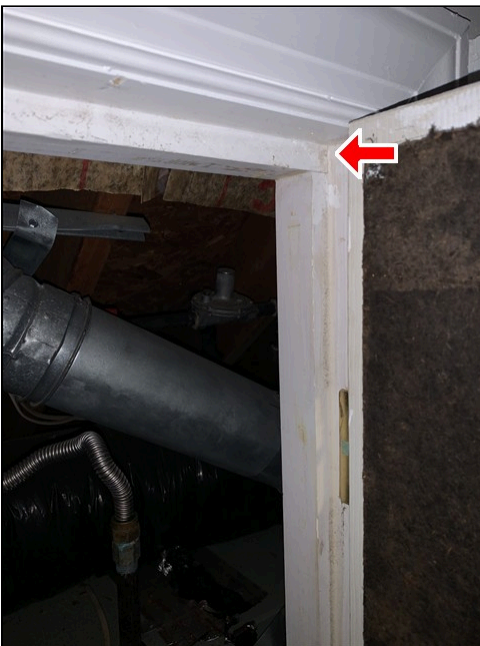
9.2 Item 1(Picture) Weather stripping missing at attic access doors at third floor

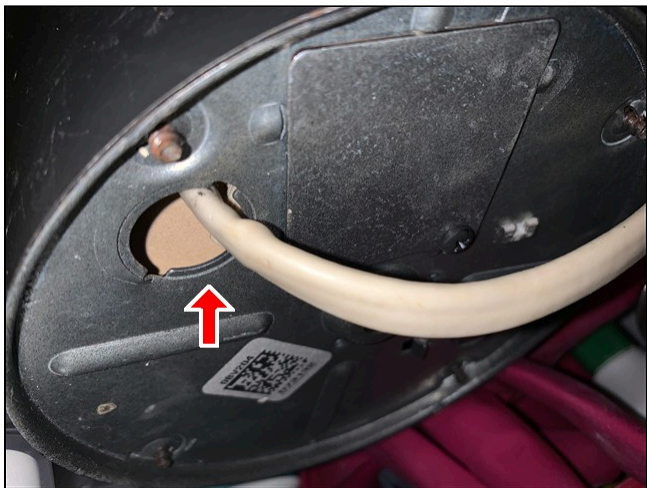
10.2 Item 1(Picture) Wire clamp/bushing missing where electrical wire penetrates base of garbage disposal
