Inspection

January 5, 2023

Re: Limited Structural Inspection  
104 Bergeron Way  
Cary, NC

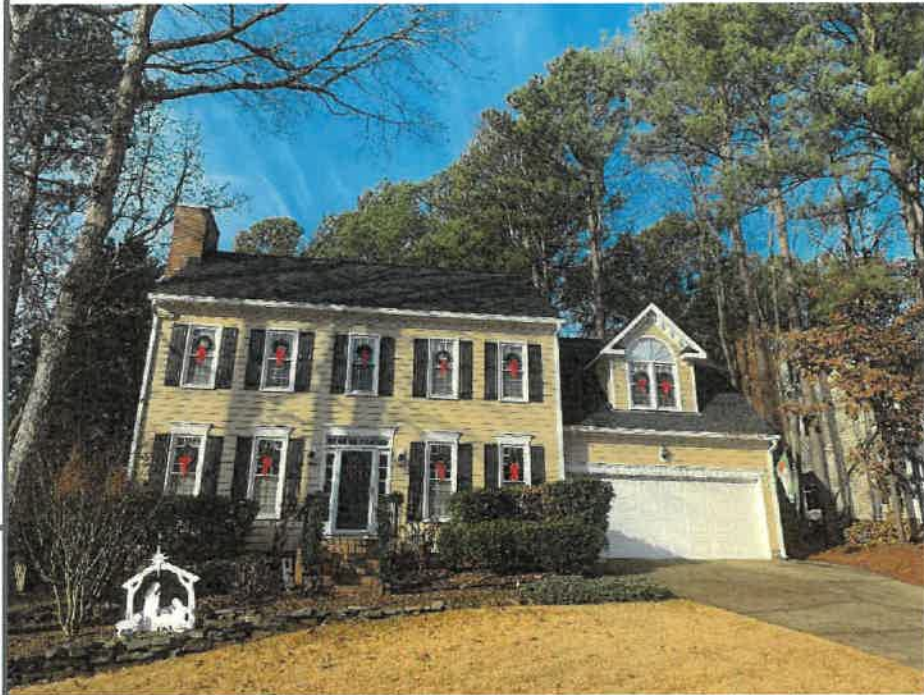
Photo No.  
1

General view of the home.

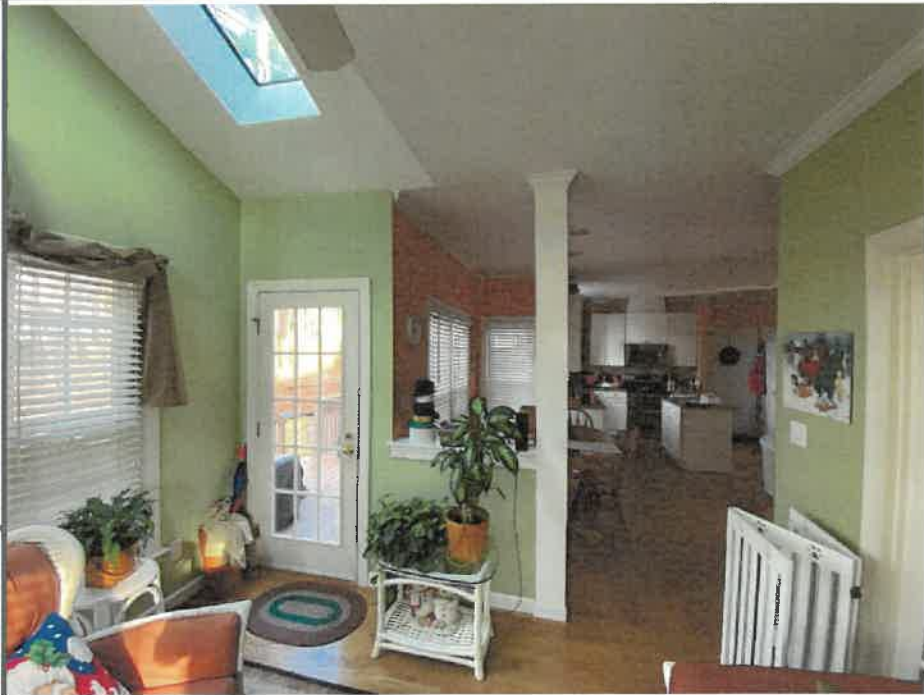
Photo No.  
2

1. Multiple cracks (less than 1/16" wide) were noted in the drywall finish materials adjacent to the access door along the reentrant wall of the rear perimeter wall, approximately 13'-5" from the left perimeter wall and approximately 4'-0" from the rear perimeter wall.

General view of the area along the rear perimeter wall with cracks in the drywall finish materials and an improperly closing door.

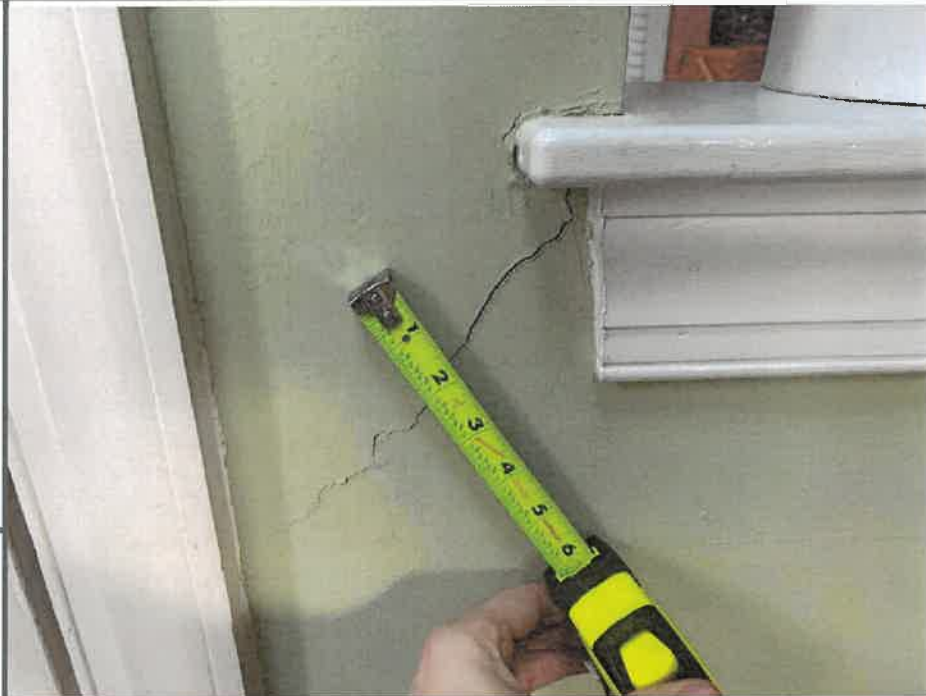
**Photo No.**  
**3**

2. A vertical crack (less than 1/16" wide) was noted in the drywall finish materials of the rear living room wall, approximately 11'-8" from the rear perimeter wall and approximately 11'-4" from the left perimeter wall.

The minor interior drywall cracks and improperly closing doors noted above are likely the result of a combination of the supporting members contracting/deflecting and the limited foundation settlement discussed above. Minor drywall cracking and finish carpentry separations are typically associated with changes in weather, temperature, and humidity causing the wood to shrink and swell with the seasons. When moisture is taken away from wood it has a tendency to contract thus resulting in deflection (or sagging). Any walls, windows, or doors bearing on the deflected members will also move. We do not consider contracting and deflecting wood members and the cracking/separation noted in the interior finish materials to be a significant structural concern at this time.

Typical crack noted in the drywall finish materials.

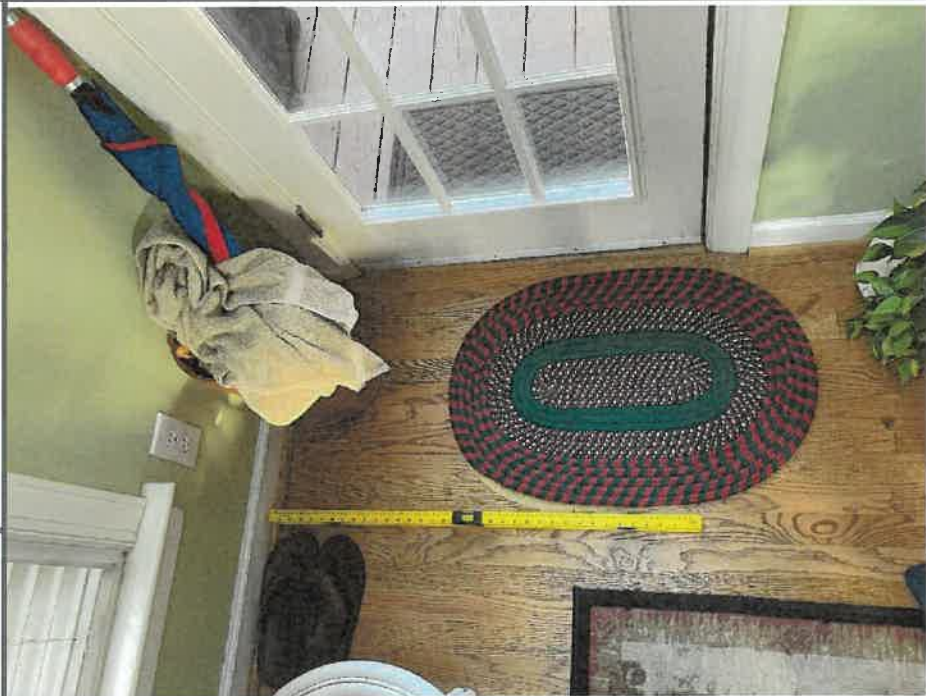
**Photo No.**  
**4**

4. Minor floor slope was measured at approximately 1/4" vertical over 3' horizontal spanning front to rear along the rear perimeter wall, adjacent to the rear access door. The door at this location was noted to improperly close (stick at the top).

The floor slope noted above is likely the result of limited deflection in the framing below. Deflection of supporting members can occur with sustained loads. The floor framing supports the weight of non-load bearing walls, kitchen island, granite countertops, heavy furniture, etc. Deflection of the floor framing will be greater in areas with sustained loads than in areas with movable (live) loads. The floor slope is not a structural concern at this time. Monitoring for additional movement is an acceptable approach at this time.

General area of floor slope noted along the rear perimeter wall.

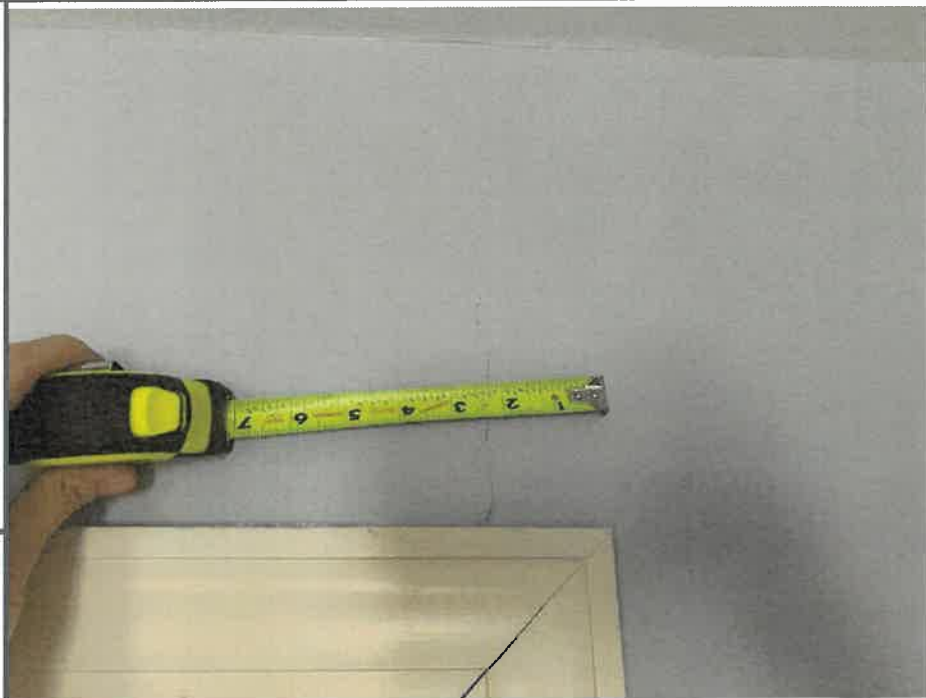
**Photo No.**  
**5**

3. A diagonal crack (less than 1/16" wide) was noted in the drywall finish materials of the rear master bedroom wall on the second floor, approximately 11'-8" from the rear perimeter wall and approximately 10'-0" from the left perimeter wall. The closet door along this wall was noted improperly close (stick at the top).

Crack noted in the drywall finish materials of the rear master bedroom wall on the second floor.

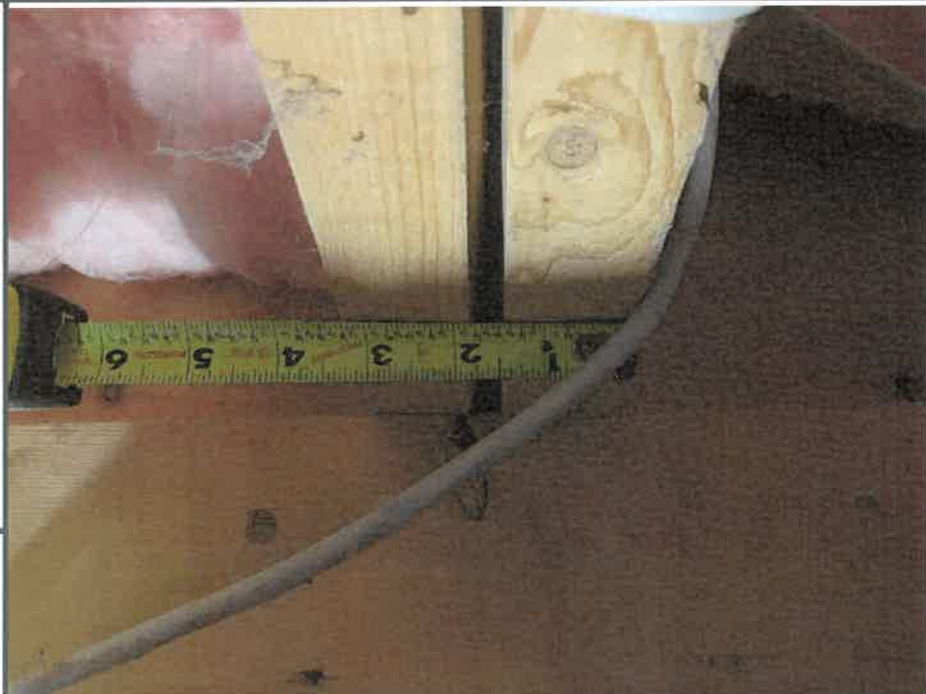
**Photo No.**  
**6**

8. Joist ply flaring/separation (up to 3/8") was noted at the double joist in the left joist bay, approximately 11'-2" from the rear foundation wall.
9. A vertical crack (approximately 1/16" wide) was noted in the front foundation wall, approximately 9'-3" from the left corner.

The flaring noted is likely due to the vertical loads on the beam causing slight rotation in the plies of the member. This effect can lead to increased vertical deflection and improper bearing at the load-bearing supports. The flaring is considered significant and is a structural concern. We have provided a recommendation below to address this issue.

Joist ply flaring noted in the left joist bay.

2. The flaring girder (Observation #7) and joist (Observation #8) spans noted above should be temporarily clamped to bring the plies into full contact, and the plies should be reattached with (3) Simpson SDS Screws (or equivalent) spaced at 16" on center alternating sides.

3. If desired and to help stiffen the floor framing in the area, we recommend installing a pressure-treated 4x4 post at the midspan of the two-ply joist noted in Observation #8. The new post is to bear on a 12"x12"x10"-thick concrete footing and be positively attached at the top and bottom. Provide a Simpson post cap and base (or equivalent).

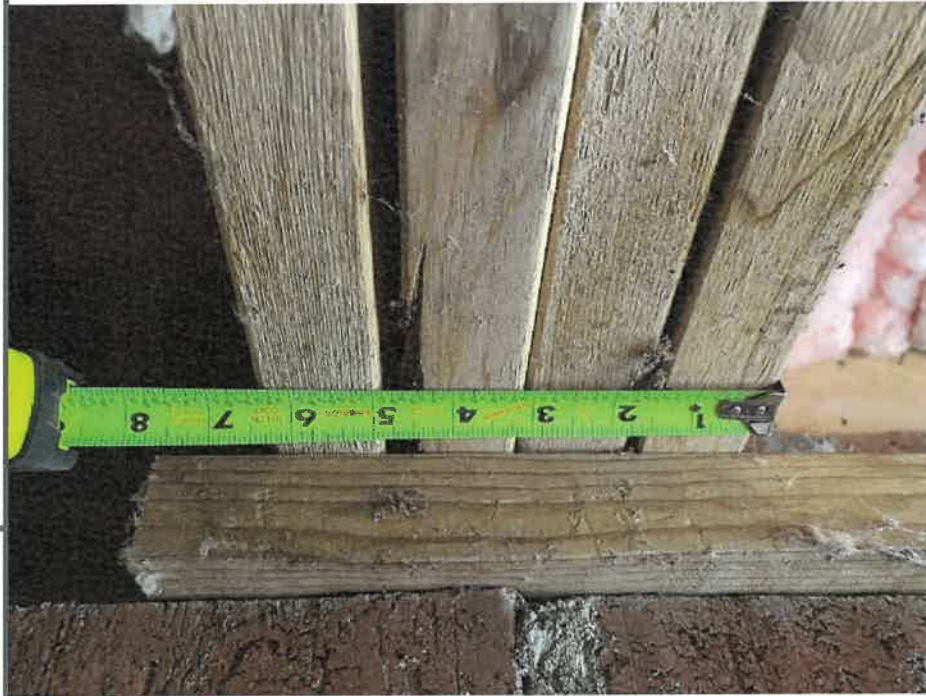
**Photo No.**  
7

7. Girder ply flaring/separation (up to 1/4") was noted in the front span of the left central girder spanning front to rear, approximately 12'-9" from the left foundation wall.

Girder ply flaring/separation noted in the front span of the left central girder spanning front to rear.

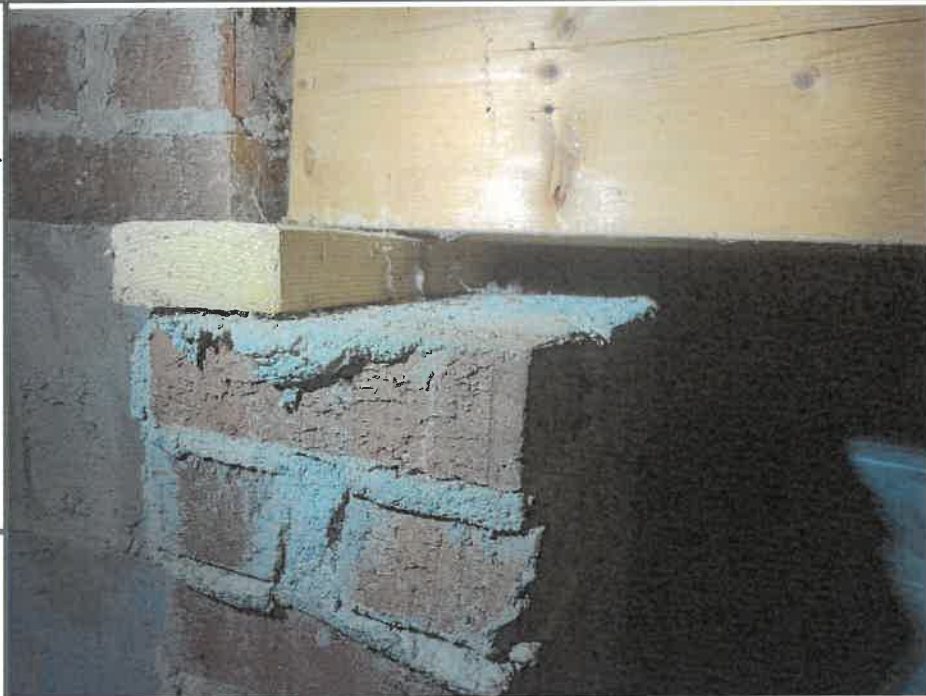
**Photo No.**  
8

6. Limited blocking was noted at multiple piers supporting the left central girder spanning front to rear, located approximately 12'-9" from the left foundation wall. Minor compression of blocking was also noted at the masonry pier at the reentrant corner of the rear foundation wall.

Blocking is a necessary component of framing to allow full contact bearing across the width of the pier for the above floor framing, in this case, the supported girder. The installed blocking does not appear to be providing full uniform bearing of the supported girder onto the pier. If left in the existing condition, vertical displacement resulting in interior floor slope and interior finish material damages may occur. We have provided a recommendation below to address this issue.

Limited blocking noted between a masonry pier and the left central girder spanning front to rear.

1. We recommend installing flat, pressure-treated blocking and metal shims between the masonry piers and girders span noted in Observation #6 to provide tight, full contact bearing across the width of the pier for the above floor framing. Care should be taken while installing the shims so as to minimize damage to interior finishes.

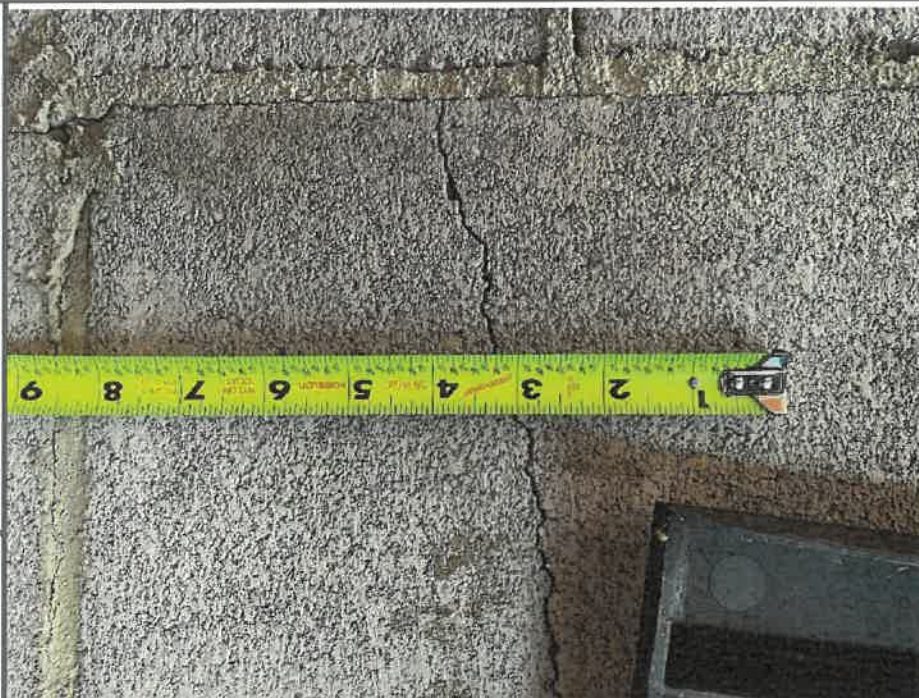
**Photo No.**  
**9**

The crack in the foundation wall noted above is likely due to limited differential foundation settlement. The clay soils in this area are considered "expansive" type soils and will typically expand and contract with fluctuations in the moisture content. This expansion and contraction of load-bearing soil materials can lead to soil consolidation and foundation cracking/movement. If conditions around the foundation remain relatively dry, the likelihood of future significant settlement will be reduced, but we cannot predict the extent of future settlement. The condition of the foundation wall does not appear to be a significant structural deficiency and improving exterior drainage and monitoring cracks for additional propagation is an acceptable approach at this time.

Crack noted in the front  
foundation wall.

4. Monitor the crack in the foundation wall. If the crack widens significantly (expands by an additional 1/8") or additional significant cracks (greater than 1/4" wide) propagate, then further evaluation by a structural engineer may be needed at that time. We recommend sealing the foundation crack with a construction-grade epoxy or exterior sealant in order to prevent moisture intrusion into the foundation and more accurately monitor the cracks for widening.
