# Property Inspection Report

**Report Number: T0273**

534 Siltstone Place  
Cary, North Carolina 27519

Date of Inspection: Monday, April 27, 2026

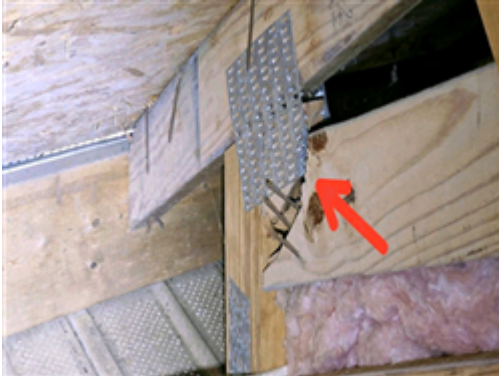
##### (A1 - 1.1) All Accessible Areas

The following structural concerns were noted:

1. Evidence suggests the rear screen porch/deck/patio may have experienced movement away from the home.
2. Damaged flange on I-joist above furnace in unfinished basement

3. Displaced crack at floor in front of front wall in the unfinished basement. Missing nut also noted on superior wall anchor bolt above this area.
4. Cracked truss and damaged truss at middle rear walk in attic.

5. Cracked truss at front left upper attic.
6. Gaps/separation noted where walk in attic trusses meet upper attic trusses and at 2 ply truss member next to upper attic access

7. Large knot hole void at truss in front of furnace in the attic.
8. Cracked truss walk in attic rear right corner. (Pictured)
9. Damaged left curb in the garage.

10. Displaced control joint at left exterior side of home rear of the electrical meter.
11. Several cracks noted at exterior foundation walls.
12. The front left corner of the front porch appears to be floating.

Have evaluated by a structural engineer to determine the significance of the concern, effect on the home, and formulate a repair plan as needed. Any needed repairs should be completed by a licensed general contractor.

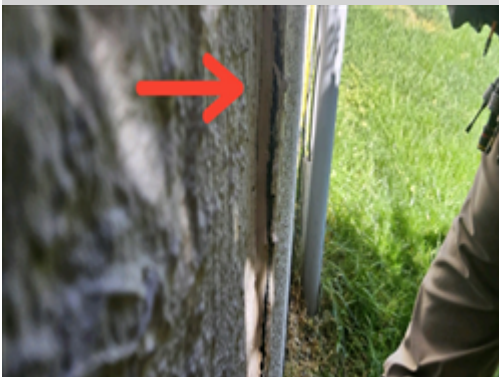
##### (A1 - 1.2) All Accessible Areas

Additional photo of displacement at left exterior control joint.

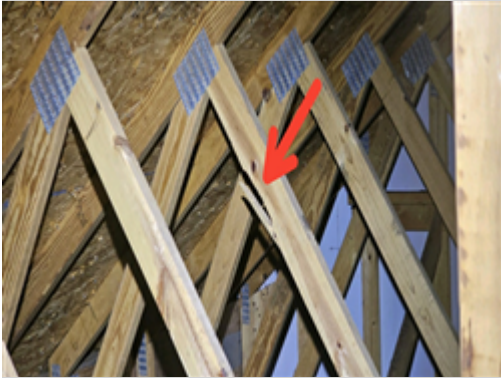
**(A1 - 1.3 ) All Accessible Areas**

Additional photo of a cracked truss.

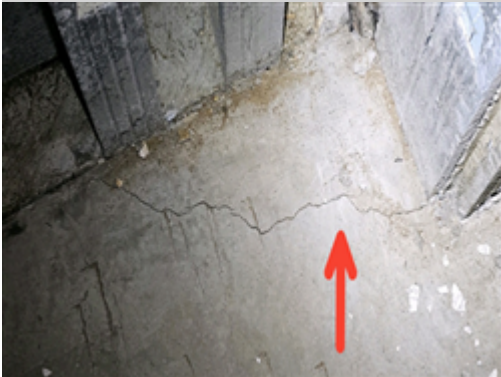
**(A1 - 1.4 ) All Accessible Areas**

Additional photo of displaced crack in the basement.

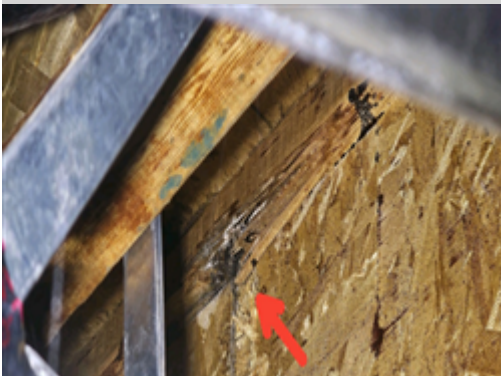
**(A1 - 1.5 ) All Accessible Areas**

Additional photo of damaged I joist flange.

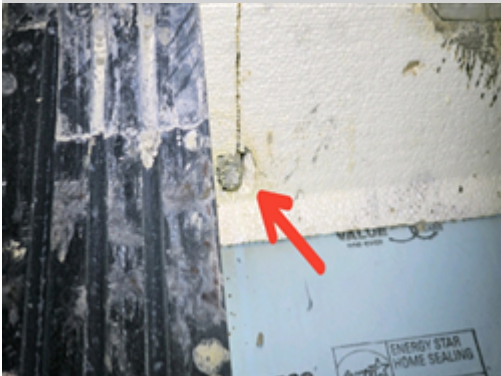
**(A1 - 1.6 ) All Accessible Areas**

Additional photo of missing nut and washer at superior wall.

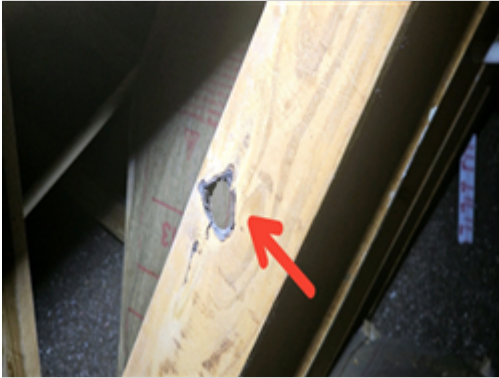
**(A1 - 1.7 ) All Accessible Areas**

Additional photo of large knot hole void in truss.

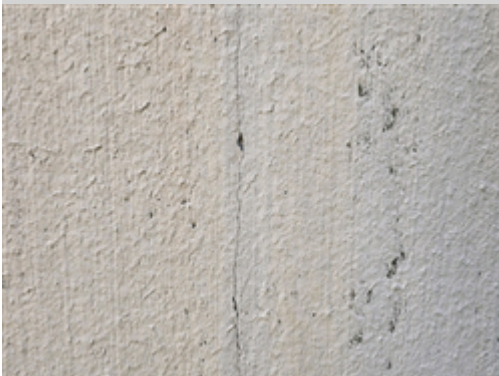
**(A1 - 1.9 ) All Accessible Areas**

Additional photo of a crack.

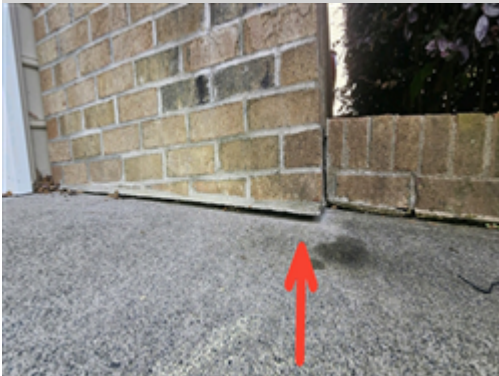
**(A1 - 1.10 ) All Accessible Areas**

Additional photo of the front porch.

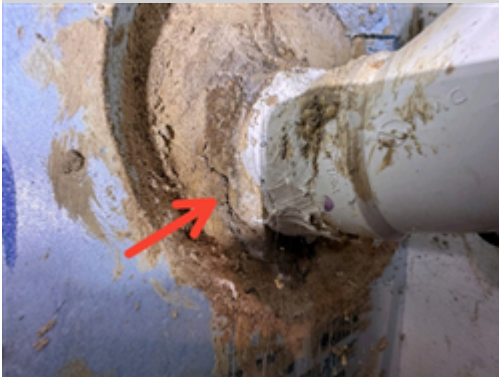
#### **(A4 - 1.2) All Interior Areas**

Cracks noted in concrete at front left basement wall where waste line passes through the wall. This can result in water penetration. Have a licensed contractor evaluate and repair.

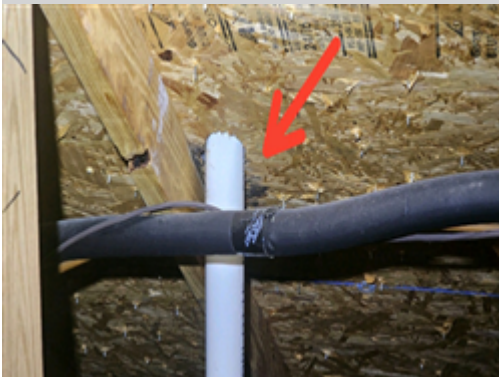
#### **(A6 - 1.1) Main House**

Moisture stains noted on the roof sheathing/framing in a few areas in the attic including but not limited to:

1. Truss under furnace flue.
2. Stack vent behind water heater flue. (Pictured)
3. Unidentified staining noted at roof sheathing and some trusses at rear walk in attic area.

Please have a qualified roofing contractor evaluate the roof structure, follow all leak paths to determine the source of moisture, if this is from a past or present issue, and repair as needed to prevent further damage.

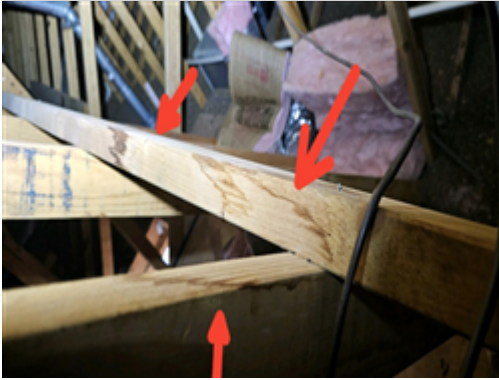
**(A6 - 1.2 ) Main House**

Additional photo of a moisture stain.

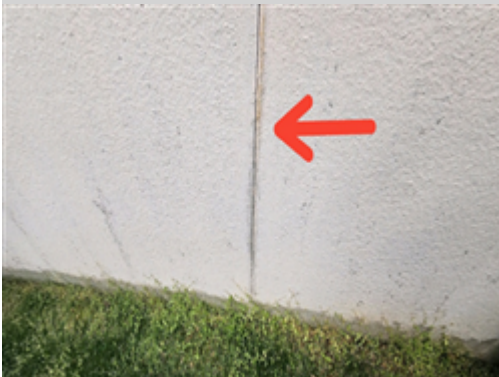
**(B1 - 1.2 ) Main House**

Deteriorated/missing exterior caulking details noted in several areas around the home. Have a painting contractor review the exterior of the home and seal/reseal voids as needed to prevent water reaching unprotected materials.

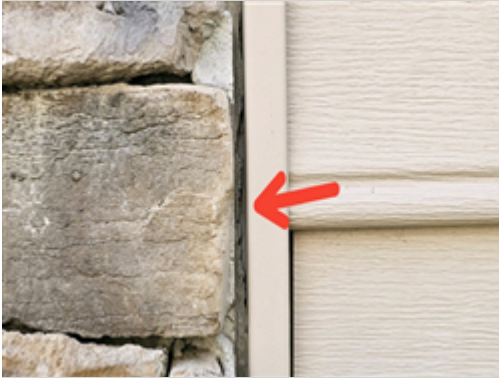
**(B1 - 1.4 ) Main House**

The following was noted at the stone veneer:

1. Cracked stone at veneer.
2. No vertical weeps and mortar voids at dissimilar materials.  
(Pictured)

Have the veneer system evaluated by a qualified masonry contractor and repaired where needed to prevent moisture penetration to unprotected materials and failures.

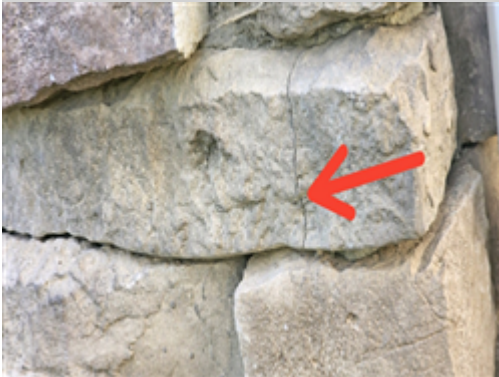
**(B1 - 1.5 ) Main House**

Additional photo of a cracked stone.

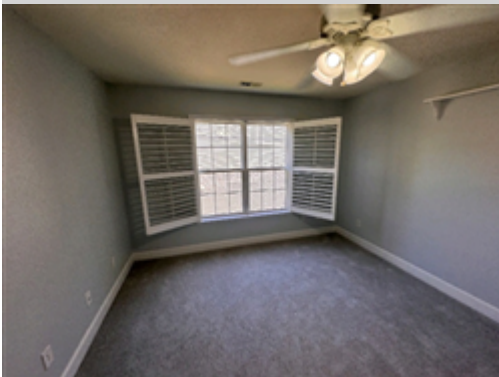
**(B2 - 1.1 ) Windows**

Right window in the upstairs left middle bedroom does not stay in the open position. Have a window specialist evaluate and repair.

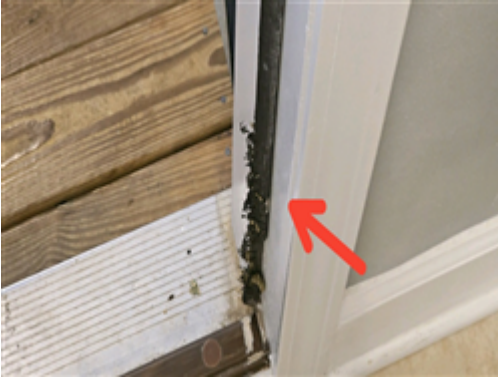
**(B2 - 2.1) All Doors**

Damaged weather stripping noted on the rear door to the screen porch and on the garage man door. Have a general repair specialist replace the stripping to ensure the weather tightness of the doors.

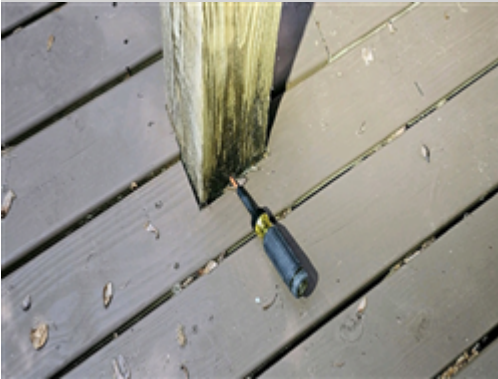
**(B3 - 3.1) Deck**

The following was noted at the homes rear deck/patio/screen porch/playhouse/front porch:

1. Missing guard rail play house deck
2. Moisture staining on posts and subfloor under playhouse
3. Playhouse ladder is weathered
4. Playhouse rear band joist is damaged

5. Front right corner screen porch band joist is not fully bearing on the post.
6. Raised edges and cracks noted at rear patio masonry steps.
7. Screen porch grill access doors do not latch and voids noted between them

8. Unsecured panel at screen porch ceiling.
9. Screen porch door binds on floor and does not latch
10. Displaced tiles and cracked grout at screen porch
11. Screen porch floor appears to be sloped toward the hill

12. Soft areas at rear step treads. The steps are also sloped.
13. Corrosion noted on carriage bolt heads that attach the screen porch to the home.
14. Moisture staining at house band and sub flooring under screen porch.

15. Deteriorated sub flooring at screen porch
16. Good wood scabbed on to bad wood under grilling platform
17. Deteriorated trim noted at grill platform.

18. Deteriorated areas at rear deck posts that support the deck and screen porch. (Pictured)
19. Several deteriorated decking boards at rear deck.
20. Rear area of the patio has dropped.

21. Cracked mortar noted at front porch masonry
22. Missing guard rail rear steps. Larger than typically expected gaps also noted between pickets
23. Damaged trim at play house.

Have all components related to the deck/porches/playhouse/patio evaluated by a licensed general contractor to determine the significance of the concern and repair as needed to prevent further failures and safety hazards.

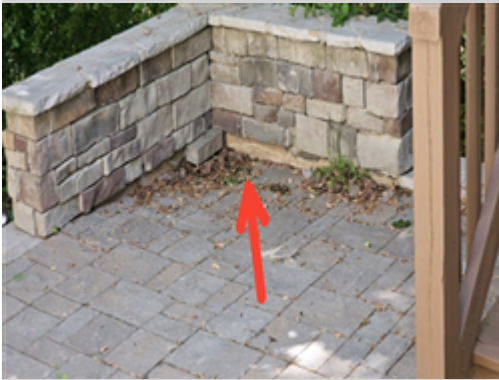
**(B3 - 3.2 ) Deck**

Additional photo of sunken patio

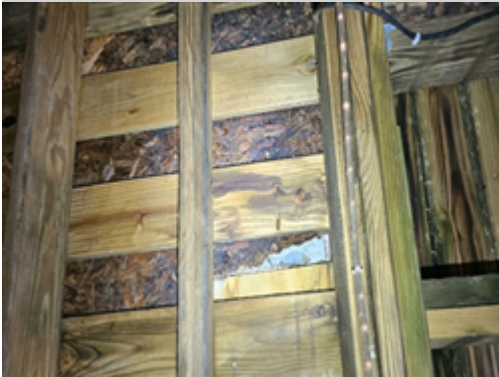
**(B3 - 3.3 ) Deck**

Additional photo of deteriorated subflooring.

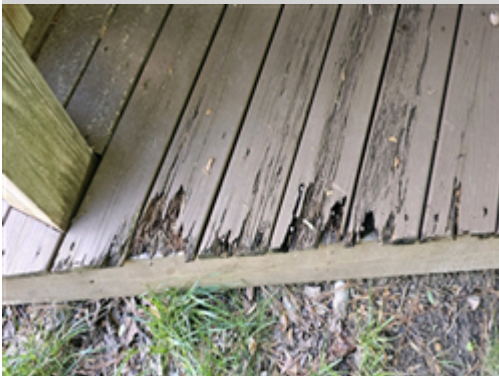
**(B3 - 3.4 ) Deck**

Additional photo of deteriorated decking boards

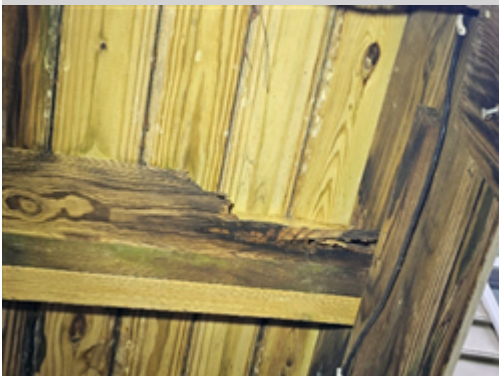
**(B3 - 3.5 ) Deck**

Additional photo of new wood scabbed on to deteriorated wood.

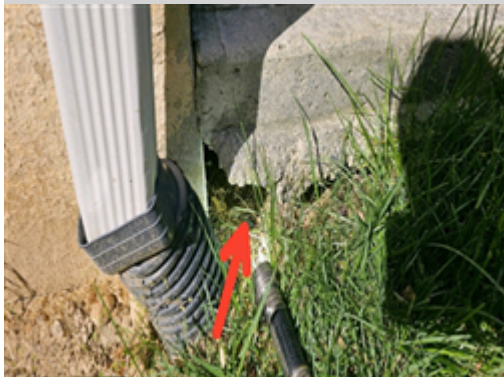
**(B4 - 1.1) Driveway and Front Walk**

The following was noted at the driveway:

1. Large void noted below rear left corner of driveway (adjacent to house). (Pictured)
2. The driveway is cracked and displaced.
3. Deteriorated fiber joint noted where driveway meets the garage slab.
4. Scaling concrete at left garage door trim board

Have a licensed general contractor further evaluate and make repairs to ensure proper support of the driveway and prevent further failures.

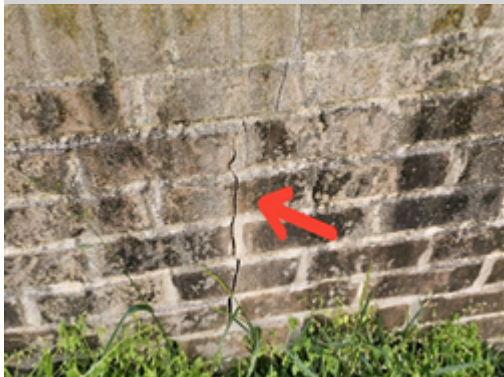
**(B4 - 3.1) Retaining Wall**

Front right side retaining wall is cracked. Have repaired by a qualified masonry contractor to prevent further failures.

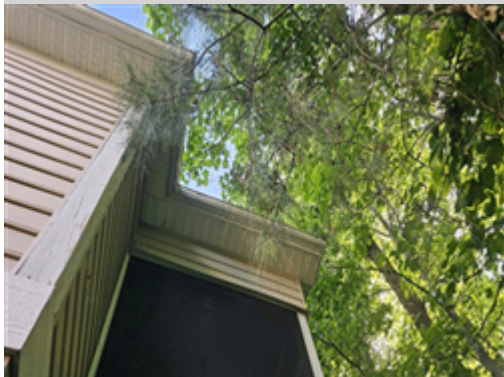
**(B5 - 1.1) Yard**

Trees are in contact with the rear of the home. Have repaired by a qualified arborist to prevent damage to the home.

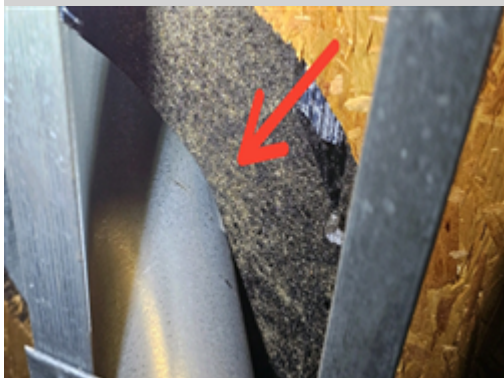
#### (C1 - 1.1) All Accessible Areas

A shingle is in contact with the water heater flue. Have repaired by a qualified contractor to prevent fire hazards.

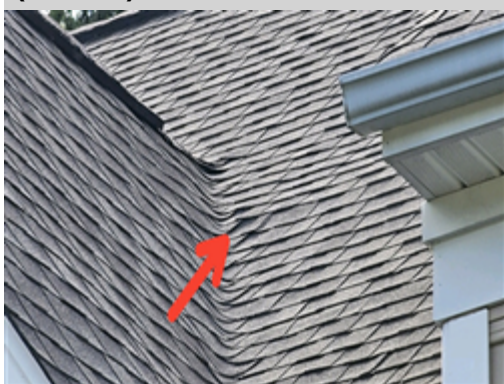
#### (C1 - 1.2) All Accessible Areas

The following was noted at the roof surface:

1. Raised shingles at right side of front left cross gable. Have repaired by a qualified roofing contractor to prevent wind damage and leaks.
2. Dimples noted in front porch metal roof. The dimples are typical of hail damage. Seek seller disclosure. Have a roofing contractor evaluate the roof to determine the significance of the concern and repair as needed.
3. Rear roof surfaces were not visible for inspection due to lot placement and elevation. While onsite, have the roof surface including coverings, flashings, and penetrations evaluated by this qualified roofing contractor and repaired as needed.

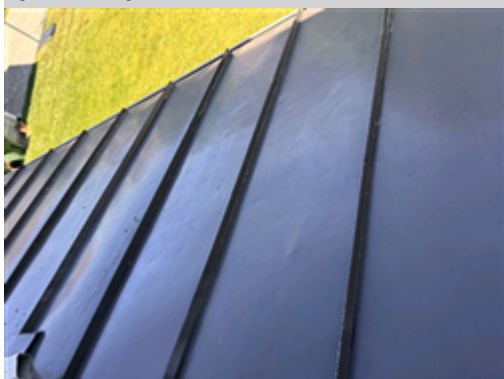
#### (C1 - 1.3) All Accessible Areas

Additional photo of metal roof dimples.

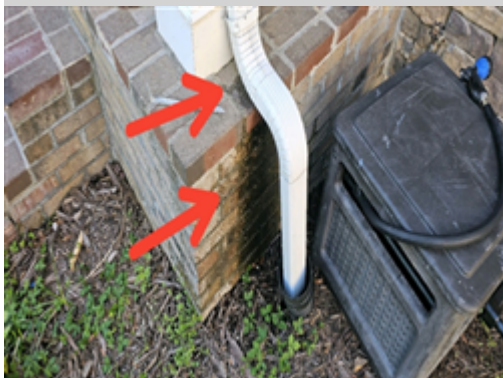
#### **(C2 - 1.1) All Accessible Areas**

Evidence suggests front porch gutter downspout leaks at porch foundation. Have evaluated by a qualified contractor to determine the significance of the concern and repaired as needed to prevent moisture related concerns and damage to the porch foundation wall.

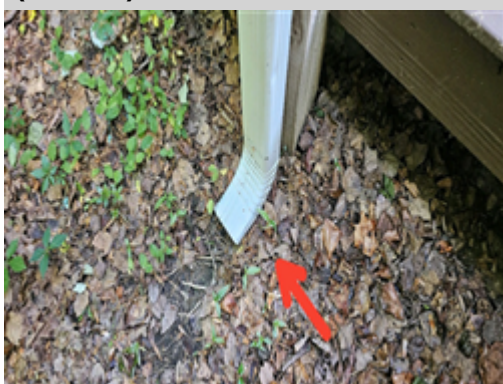
#### **(C2 - 1.2) All Accessible Areas**

Missing splash pan/extension noted on rear screen porch downspout. Please have a qualified professional install a splash pan or extension to help shed water away from the foundation.

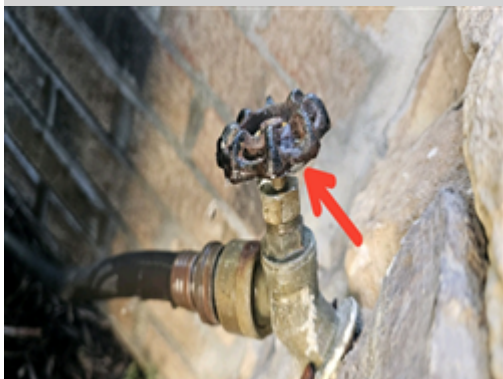
#### **(D1 - 1.2) Main**

Both exterior hose bibs leak at the handle during operation. Please have a licensed plumber review and repair to prevent leaks.

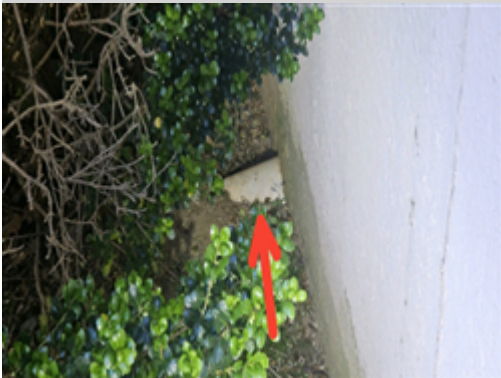
**(D2 - 1.2 ) All Accessible Areas**

Exposed drain line noted at the left exterior of the home. Have repaired by a licensed plumber to prevent damage to the pipe.

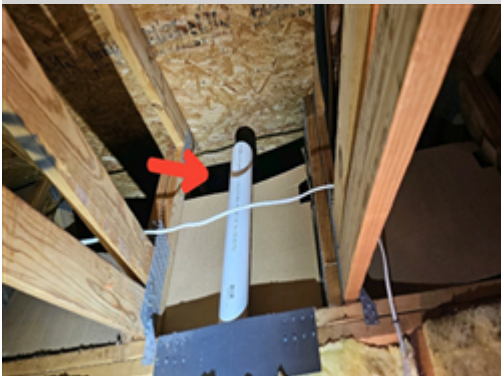
**(D2 - 1.3 ) All Accessible Areas**

Vent pipe in rear walk in attic terminates in the attic. It was not determined if this was a roughed in radon mitigation pipe or a stack vent. Have evaluated by a licensed plumber and repaired as needed.

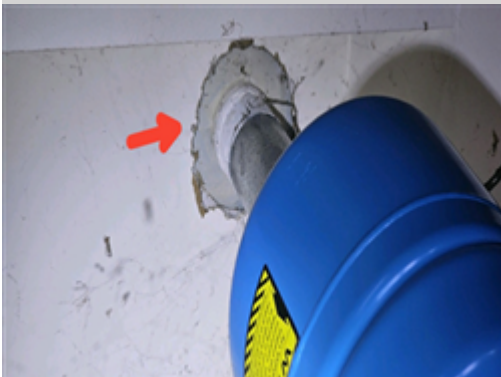
**(D3 - 1.1 ) Unit 1**

The inspection of the water heater was limited due to storage blocking access. However, the following was noted:

1. The hot water temperature for the home was noted to be too high. The recommended temperature to prevent personal injury and burns is 120 degrees F.
2. Flue not sealed at garage ceiling penetration. (Pictured)
3. Corrosion inside drain fitting.
4. Missing drain pan under the water heater.

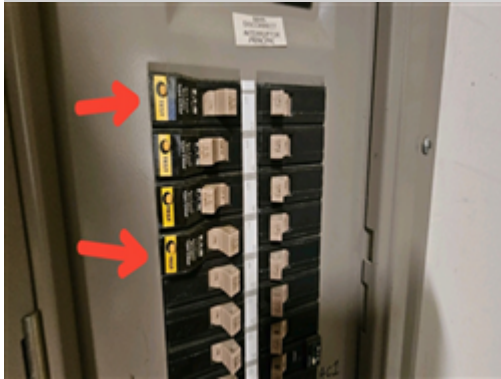
**(E2 - 1.1 ) Main Panel 1**

The following was noted at the main panel:

1. Two breakers did not trip when tested. (Pictured)
2. Breaker labeling is not consistent.
3. Not all breakers labeled.
4. In the panel, the multi-wired circuits were not installed with handle ties to ensure safe repair/ service to the branch circuits by forcing simultaneous disconnect. This condition presents a safety hazard.

Have the main panel evaluated by a licensed electrician and repaired as needed to ensure proper operation.

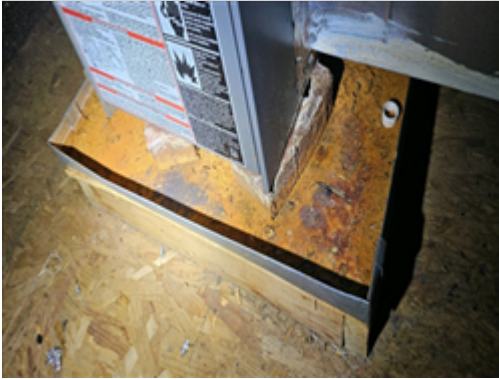
**(F1 - 1.2 ) Heating Unit 1**

The following was noted at the furnace in the attic:

1. Heavy rust in emergency drain pan. (Pictured)
2. Moisture staining on inducer motor. This suggests potential exhaust leaks and carbon monoxide concerns.

Have the attic HVAC system and related components evaluated by a licensed HVAC contractor and repaired as needed to ensure proper safe operation and prevent moisture related concerns.

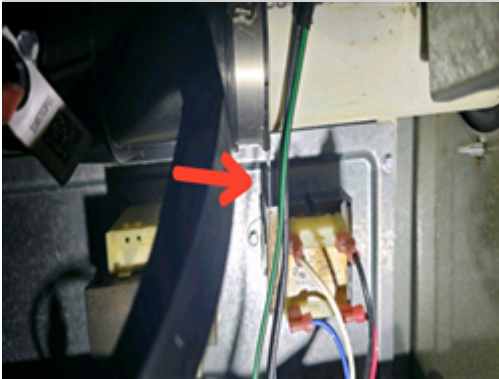
**(F1 - 2.1 ) Heating Unit 2**

The following was noted at the basement furnace:

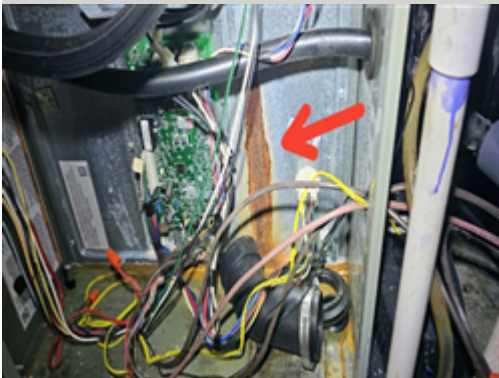
**(F1 - 2.2 ) Heating Unit 2**

Additional photo of rust inside furnace.

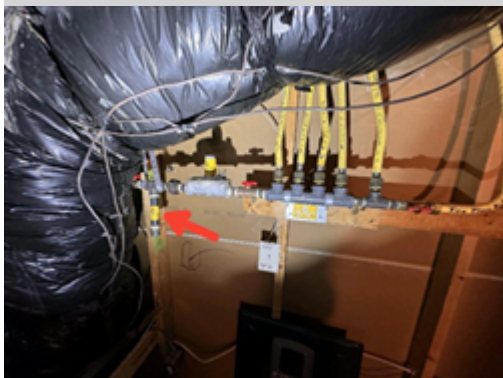
##### **(F3 - 1.1 ) Basement**

Drip leg does not change direction on manifold in hvac closet in basement. Have repaired by a licensed hvac contractor for proper operation.

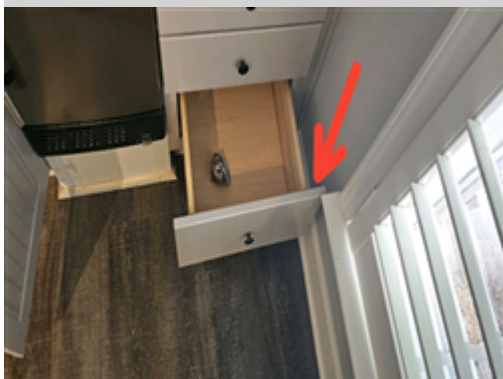
##### **(H1 - 1.3 ) All Rooms**

Third drawer and bottom drawer at basement wet bar four drawer bank bind on the window trim. Have repaired by a general repair specialist for proper operation.

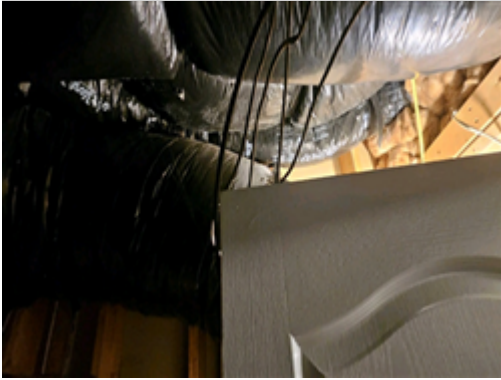
#### (H1 - 1.4 ) All Rooms

The following was noted at the interior doors:

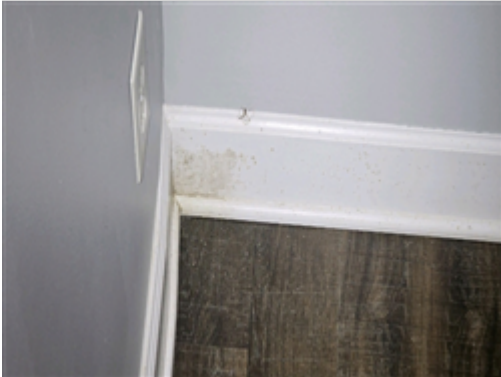
#### (H1 - 1.5 ) All Rooms

Stains noted in the following areas:

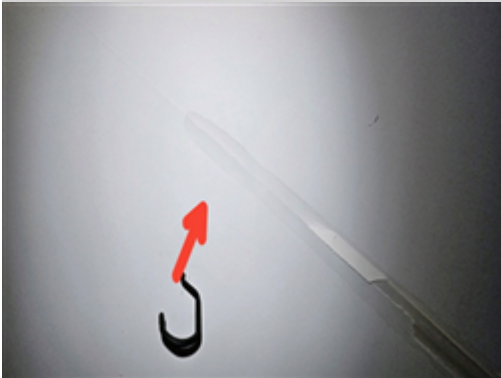
#### (H1 - 1.6 ) All Rooms

Additional photo of a stain.

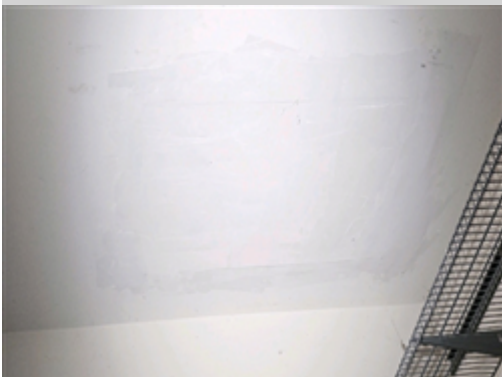
**(H1 - 1.7 ) All Rooms**

Large repair noted at garage ceiling. Seek seller disclosure. Have evaluated by a qualified contractor as needed to determine the significance of the concern.

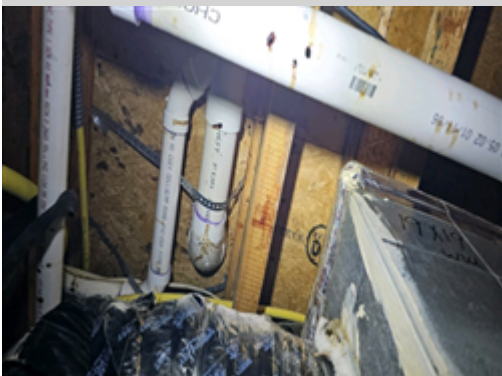
**(H1 - 1.8 ) All Rooms**

Staining in multiple areas on multiple building components around the furnace in the basement. Have evaluated by a licensed general contractor to determine the source of the staining, significance of the concern, and evaluate for hidden damage.

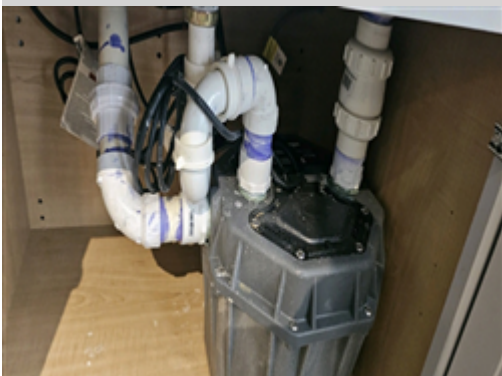
**(H1 - 1.9 ) All Rooms**

The following was noted at the wet bar sink:

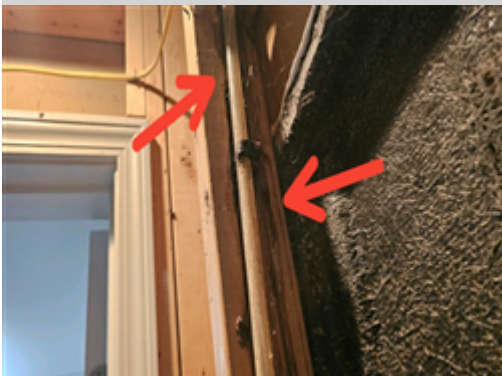
**(H1 - 1.10 ) All Rooms**

Moisture stains and fungal growth noted on stud adjacent to pex water supply line behind basement shower in unfinished closet. Have evaluated by a licensed general contractor to determine source of the staining, follow all leak paths, evaluate for hidden damage, and repair as needed.

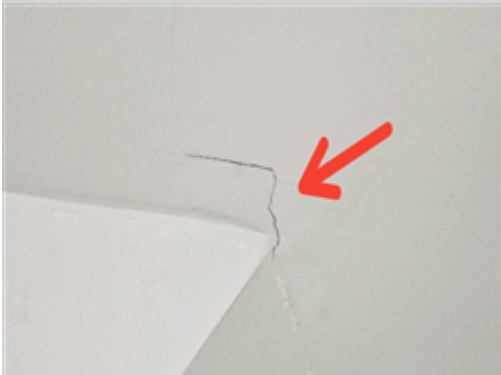
#### (H1 - 1.11 ) All Rooms

Crack noted at front left bedroom second floor ceiling sheetrock. Have evaluated by a qualified contractor to determine the significance of the concern and repair as needed.

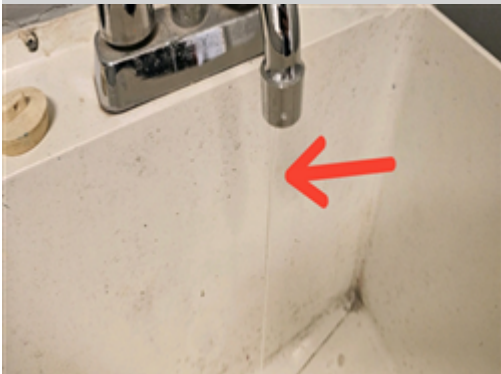
#### (H1 - 1.12 ) All Rooms

The following was noted at the laundry sink:

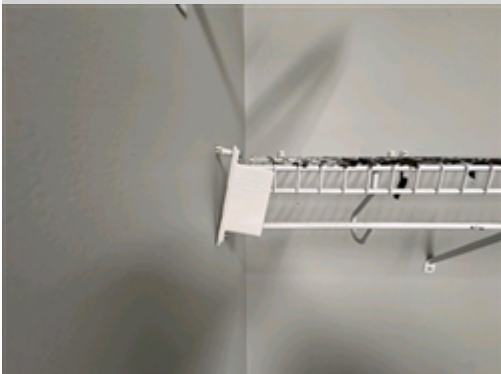
#### (H1 - 1.13 ) All Rooms

Loose shelf bracket at rear wall in master closet. Have repaired by a general repair specialist to prevent failures.

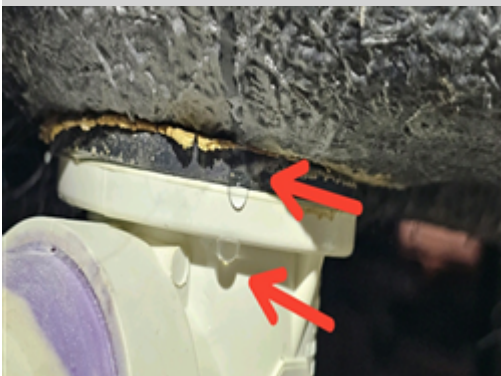
#### (H3 - 1.1 ) Bathrooms

The following was noted at the basement bathroom:

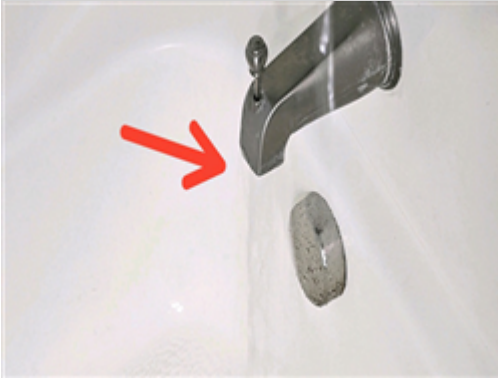
### (H3 - 1.2 ) Bathrooms

The following was noted at the second floor shared bathroom:

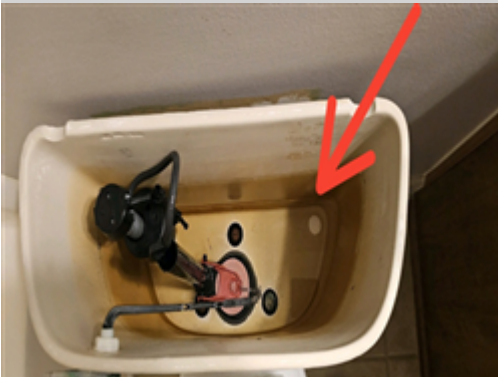
### (H3 - 1.3 ) Bathrooms

The following was noted at the second floor hallway bathroom:

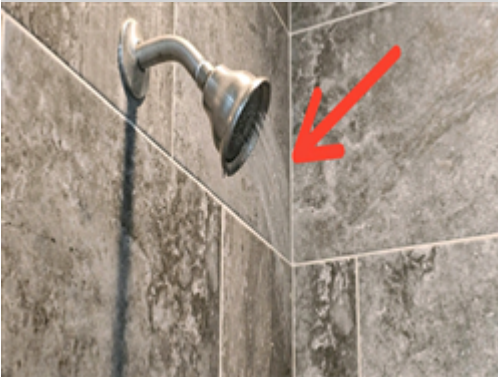
### (H3 - 1.4 ) Bathrooms

The following was noted at the master bathroom:

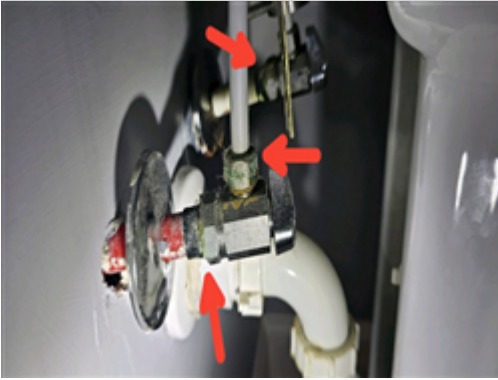
### (H3 - 1.5 ) Bathrooms

The following was noted at the half bathroom:

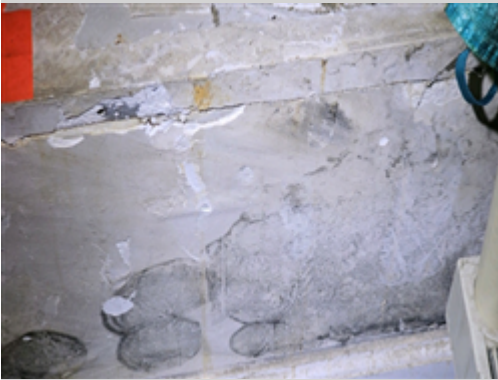
#### (H4 - 1.1 ) Garage

Sheet rock is damaged under the water heater. Staining typical of fungal growth also noted at sheetrock around the water heater. Have evaluated by a licensed general contractor to determine the source of the stain, evaluate for hidden damage, and repair as needed to prevent further damage and moisture related concerns.

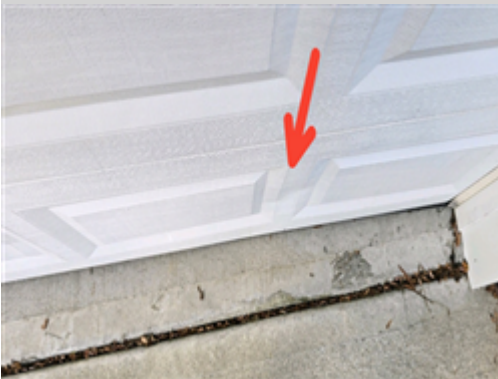
#### (H4 - 1.3 ) Garage

Due to the age of the garage doors and both bottom panels being bent, the auto reverse function was not tested in order to prevent potential damage to the doors. Have the doors repaired and the auto reverse safety feature confirmed by a qualified garage door contractor prior to closing.

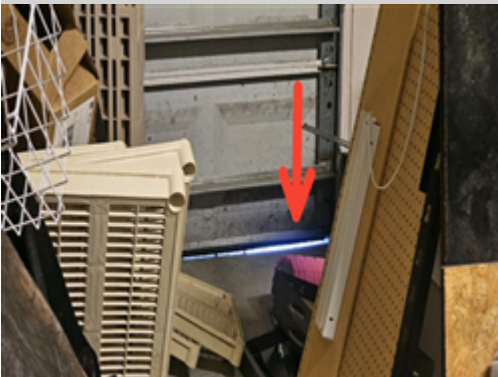
#### (H4 - 1.4 ) Garage

A section of the weather stripping for the garage door is damaged. Daylight also visible below the door. Please have a garage door company repair to ensure the weather tightness of the door.

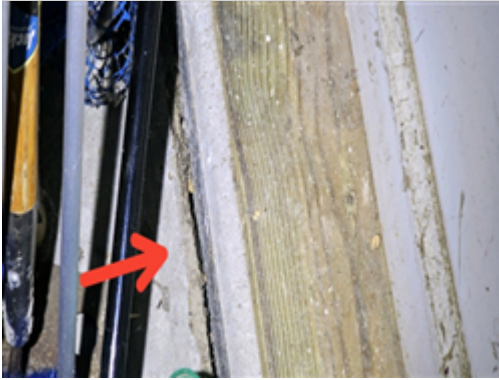
#### (H4 - 1.5 ) Garage

Deteriorated fiber joint noted at garage floor. Have the floor evaluated by a qualified contractor to determine the significance of the concern and repair as needed.

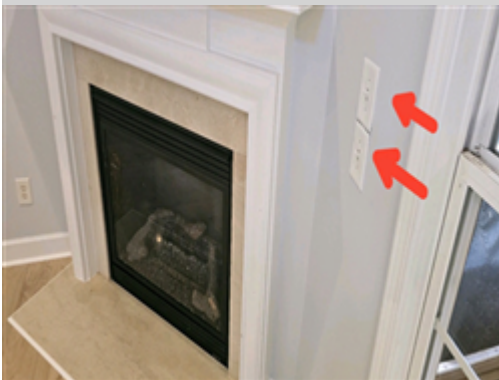
##### (H6 - 1.1 ) Fireplace: Pre-Manufactured: Metal

Gas log unit did not respond to wall switches. Have the appliance repaired by a certified gas technician for proper operation.

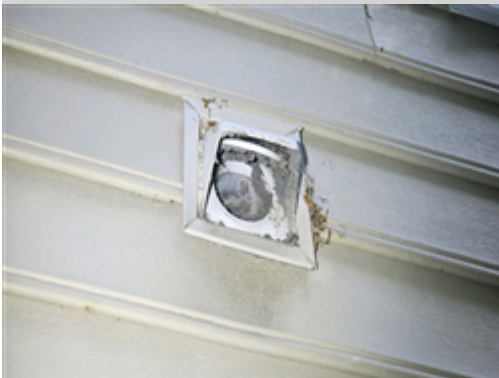
##### (I1 - 1.1 ) Attic: All Accessible

Due to the age of the home, the dryer vent should be cleaned out. Consult a qualified professional as needed to reduce lint built up.

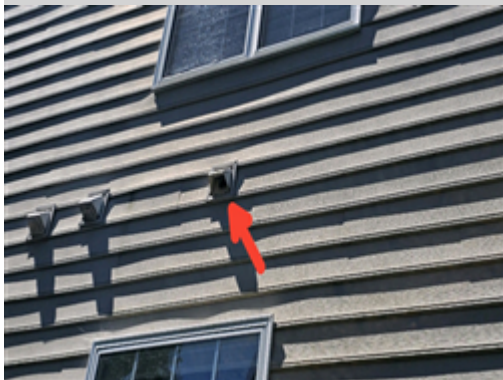
**(I1 - 1.2 ) Attic: All Accessible**

Missing bird guard on left side bathroom exhaust vent. It is recommended that a guard is installed to prevent bird access to the vent. Consult with a general repair specialist as needed.

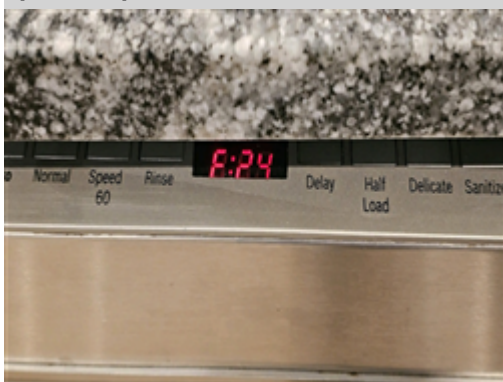
**(J1 - 1.1 ) Dishwasher**

Dishwasher did not fully drain once the cycle was completed. Error message E 24 displayed on the screen. Have repaired by an appliance specialist for proper operation and to prevent moisture related concerns.

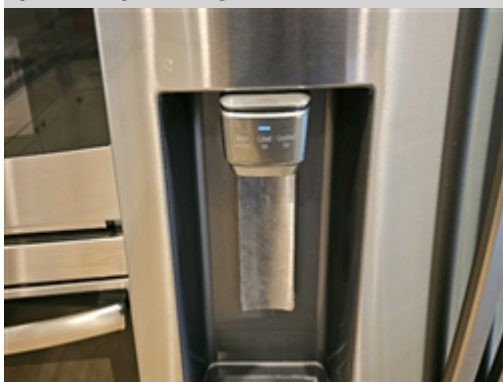
**(J1 - 4.2 ) Refrigerator**

The ice maker for the refrigerator did not dispense ice at the time of the inspection. Have an appliance contractor review and repair to ensure proper operation.

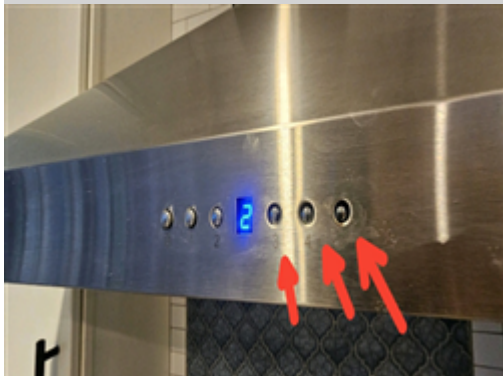
**(J1 - 7.1 ) Range Hood: Exterior Duct**

Buttons on range hood are recessed and not able to be pressed. Have the hood repaired by an appliance specialist for proper operation.

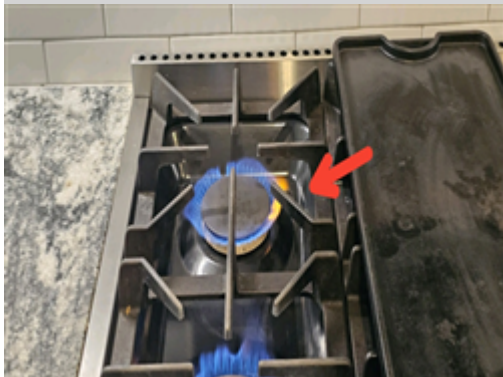
**(J1 - 9.1 ) Range Top: Gas**

Orange flickering noted at the flame at some of the burners during operation. Have repaired by an appliance specialist for proper operation.

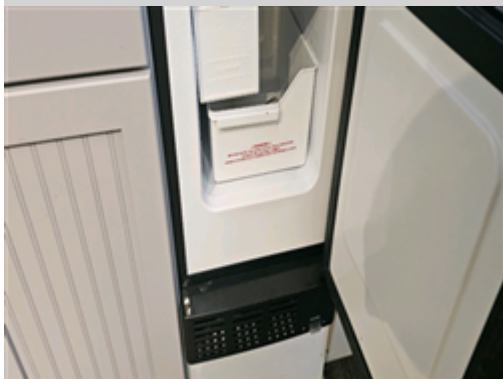
**(J1 - 10.1 ) Ice Maker**

Ice maker was not on at time of inspection. Have proper operation confirmed by seller prior to closing. Consult an appliance specialist as needed.

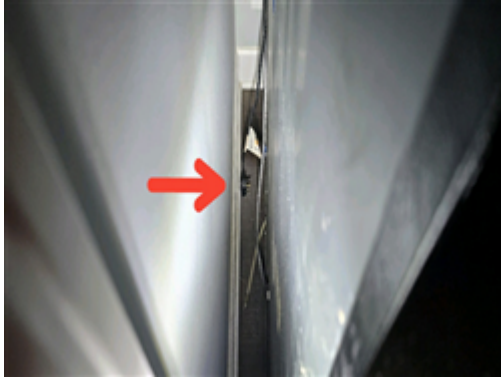
**(J1 - 11.1 ) Refrigerator**

Basement Refrigerators/Freezers were not plugged in at time of inspection. Confirm proper operation with sellers prior to closing if the appliances convey.
