Re: Limited Structural Inspection  
534 Siltstone Place  
Cary, NC

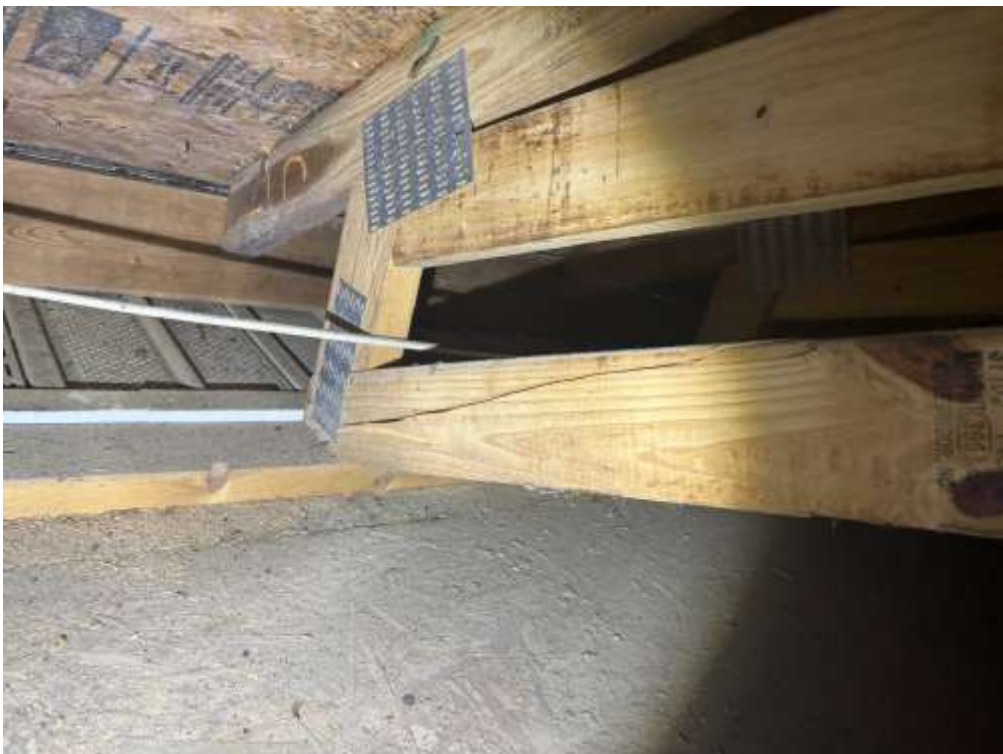
**Photo No.**  
**2**

1. The bottom chord of the truss located approximately 9'-0" from the left gable end wall is cracked at the rear end of the truss.
2. The web member of the rightmost truss located approximately 21'-0" from the left gable end wall is cracked at the rear end of the truss.

Roof trusses are an engineered element of the roof system, and as such, any significant damage or modification to the roof trusses must have a repair sufficient for supporting the design loads incurred on the roof trusses. The roof truss conditions noted above (Observations #1-3) are structural concerns. The minor cracking and knot defect (Observations #4-5) are not considered structural concerns at this time. We have provided recommendations below to address these issues.

| <div><div>Description</div><div>View of the cracked truss web member.</div></div> | A photograph showing a wooden truss web member with a visible crack. The member is surrounded by yellow and pink insulation. A blue mesh patch is applied to the crack. |

1. For the cracked truss members in the rear walk-in attic (Observations #1-2), we recommend the following at both locations:
  - a) Install 3/4"-thick plywood gusset plates, on both sides of the damaged truss, beginning at the rear end and extending a minimum 5'-6" forward. The gusset plates should be aligned to match the sloped truss profile and match the depth of the truss (overlapping the top & bottom chords). Attach each gusset plate to all intersecting truss members with (2) 3/8" beads of Loctite PL Premium polyurethane adhesive (or similar) and (2) rows of 8d nails at 4" O.C.

- b) Prior to gusset plate attachment, the cracked web member in Observation #2 should be returned to its original orientation/placement (to the greatest extent possible without further damage).

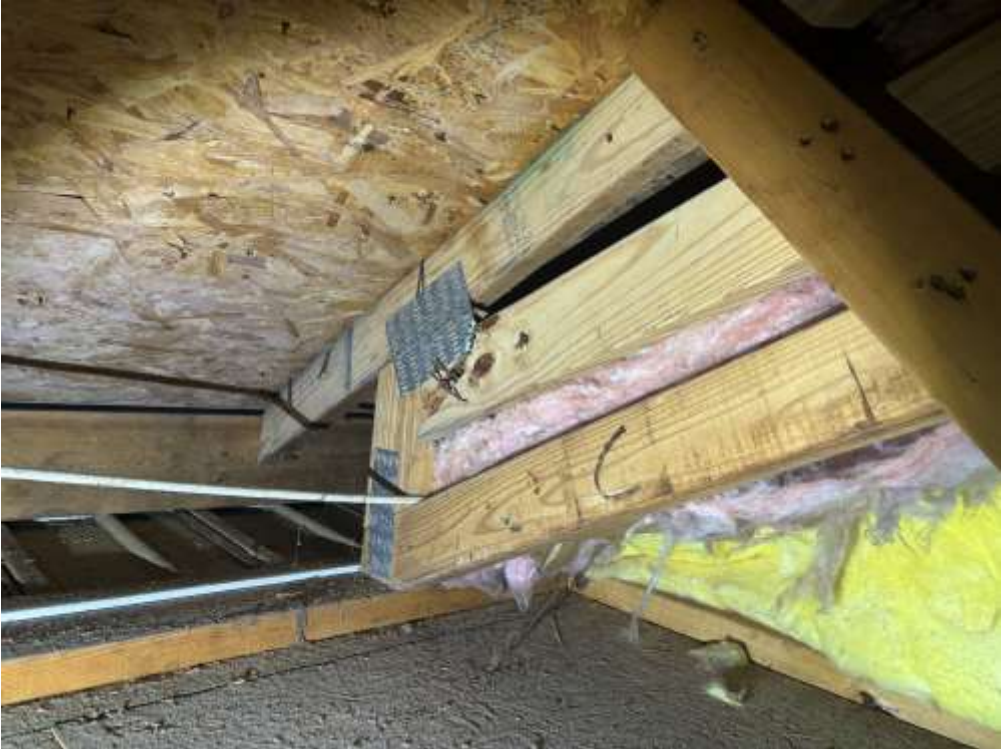
3. The vertical web member in the center of the truss approximately 5'-3" from the left gable end wall is cracked.
4. The diagonal web member in the truss approximately 7'-3" from the left gable end wall has a minor crack with no significant cross-sectional loss of the 2x4.
5. A diagonal web member in the truss approximately 23'-0" from the right gable end wall (rear of the HVAC) has a knot defect hole.

| <div><div>Description</div><div>View of the cracked vertical truss web member.</div></div> | A photograph showing a vertical wooden truss web member with a significant crack. The member is surrounded by yellow insulation. A blue mesh patch is applied to the crack. |

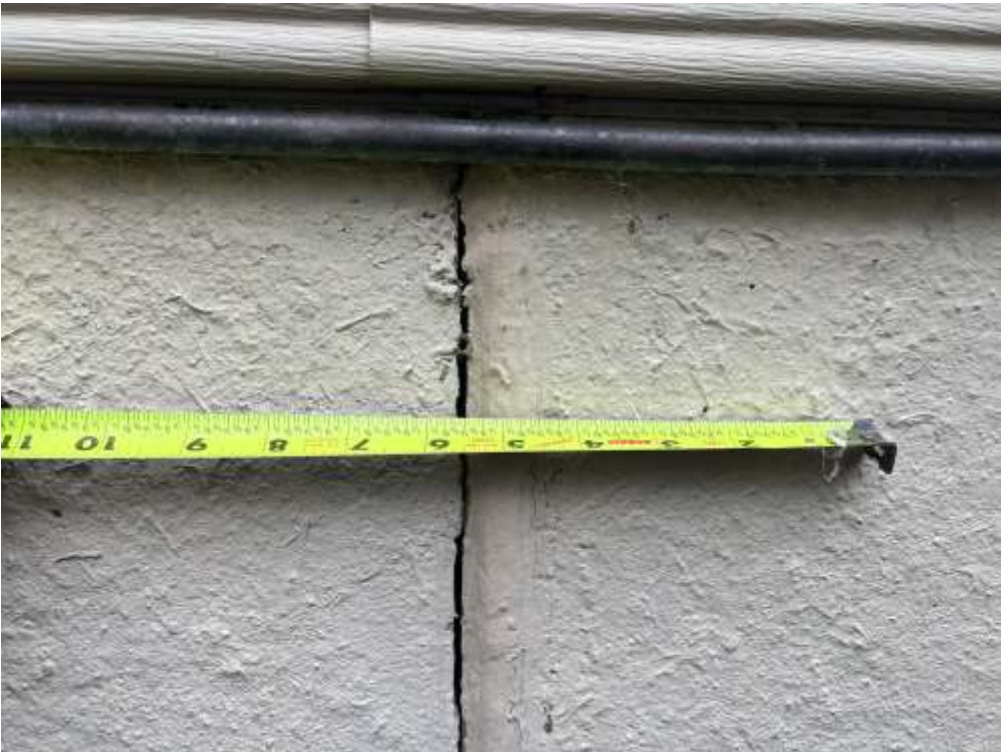
| <p><b>Photo No.</b></p> <p>5</p> | |

10. The following was noted regarding the rear deck structure:
  - a. Multiple instances of damage/rot were noted throughout the deck in the upper subfloor sheathing and deck boards. The floor sheathing does not appear to be pressure treated.

There are multiple concerns in the rear deck structure outlined in Observation #10. The most significant being evidence of movement/settlement towards the rear (away from the home). Covered decks are sometimes constructed with an approximately 1/4" per foot slope away from the structure; however, the slope observed is far greater than normal and believed to be settlement/movement. Due to covering soils and finish materials, all structural elements of the deck structure could not be visually evaluated (i.e. post footing and roof framing); however, there does not appear to be a lateral bracing system in the upper post framing to help resist horizontal wind loading onto the covered deck as part of the main wind force resisting system. This can commonly result in racking of the structure and is a structural concern. With the complex configuration of the deck structure and covering roof system, in combination with unknowns that could not be evaluated in the scope of this limited inspection, we are unable to provide retrofit repair to address the observed deck concerns at this time. Further evaluation by a structural engineer (involving invasive methods such as soil excavation and finish material removing) and design analysis of the deck structure is needed to properly address the concerns in the deck. Note, upon further evaluation, full reconstruction of the deck structure may be the best course of action.

| <p><b>Description</b></p> <p>Typical view of damaged sheathing in the deck.</p> | |

2. We recommend consulting with a structural engineer to perform further evaluation of the deck structure to address the noted concerns in Observation #10 (i.e. lateral bracing, damaged framing, framing bearing concerns, sloped framing). Further evaluation will likely involve soil excavation and selective removal of the finish materials.

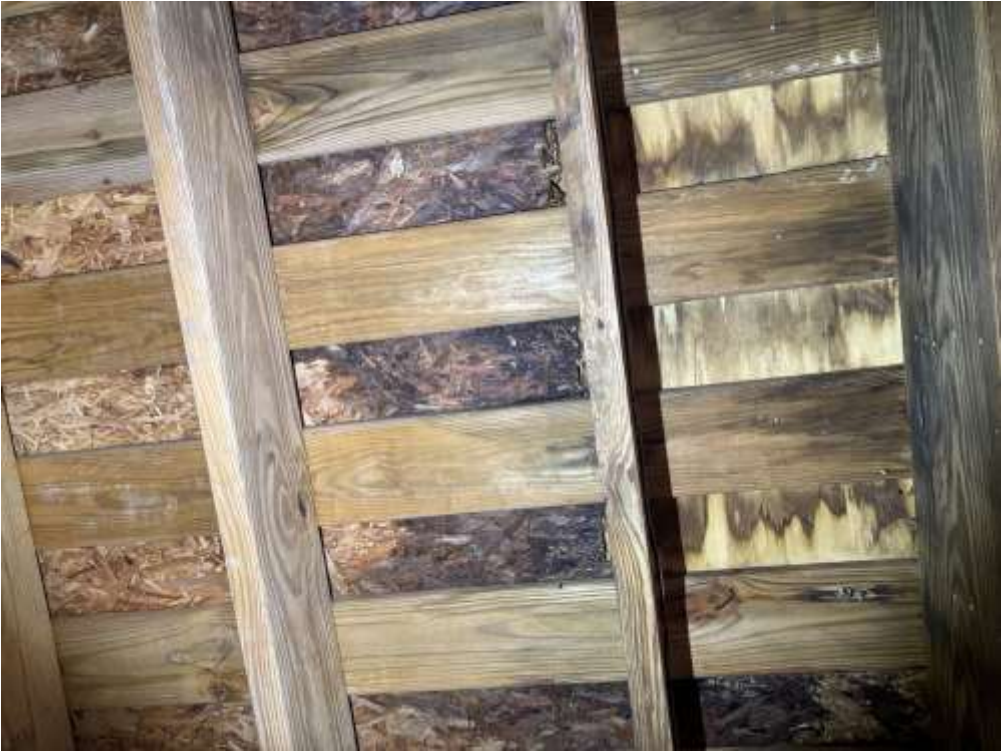
| <p><b>Photo No.</b></p> <p>6</p> | |

| <p><b>Description</b></p> <p>Typical view of damaged boards in the deck.</p> | |

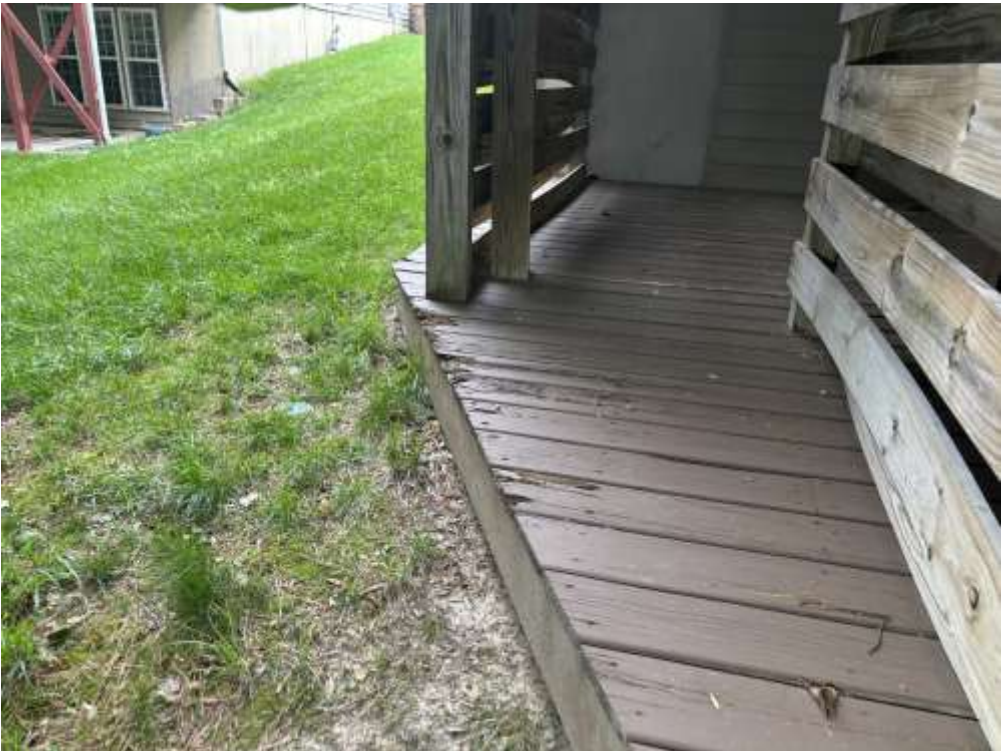
| <p><b>Photo No.</b></p> <p>7</p> | |

- i. Additionally, the tile flooring and underside of the upper joists were observed with similar slope to the rear.
  - e. A middle post on the lower level was measured to be leaning out of plumb (up to 5/8" horizontal over 4'-0" vertical).

| <p><b>Description</b></p> <p>View of slope on the underside of the deck joist.</p> | |

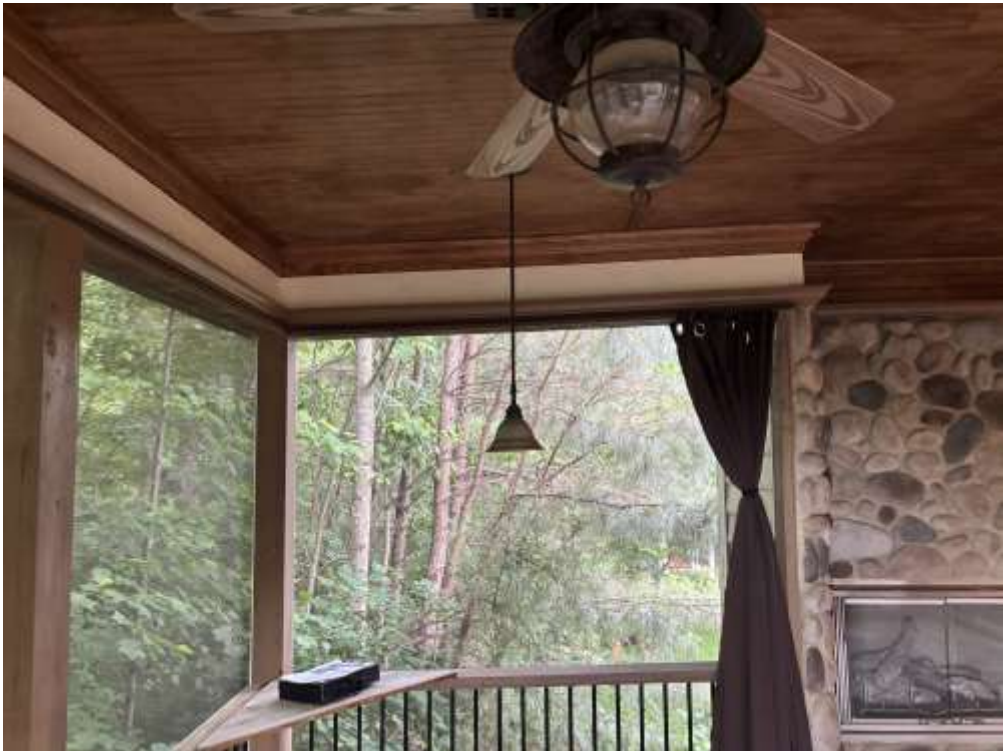
| <div>Photo No.</div> <div>9</div> |

- d. The header framing of the upper roof was visibly sloping towards the rear and was measured to be sloping up to 1-1/2" vertical over 4'-0" horizontal.

| <div>Description</div> <div>View of the visibly sloped deck header framing.</div> |

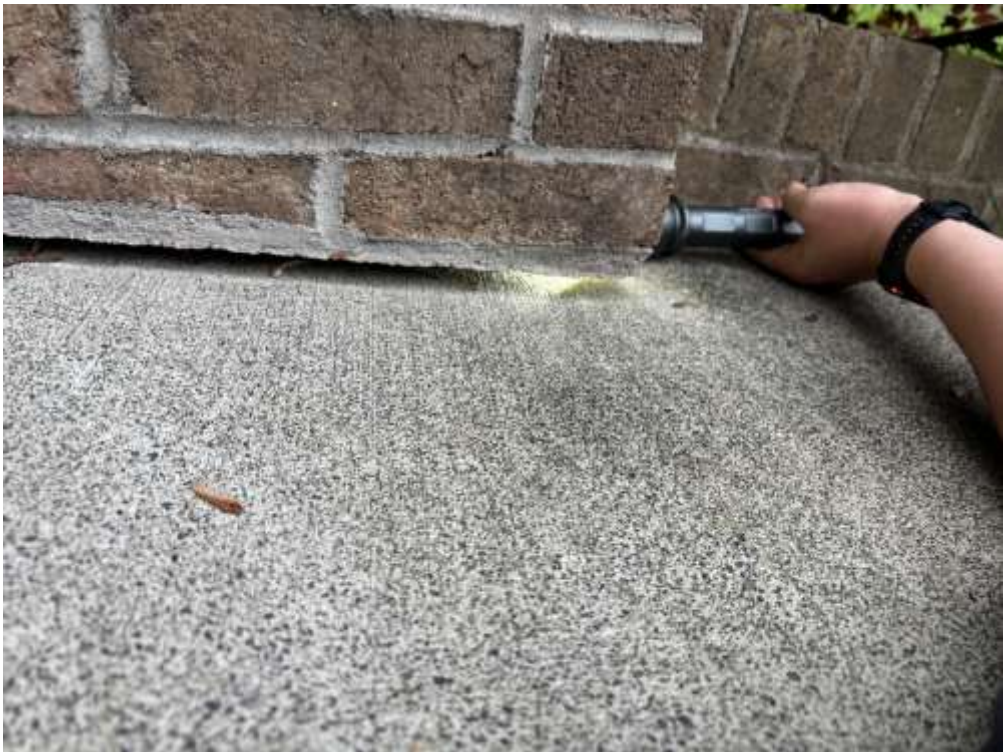
| <div>Photo No.</div> <div>10</div> |

11. The brick masonry at the front-left corner of the front porch is separated from the concrete driveway.
  - a. No significant cracking was observed in the masonry at this location.

The separation at the front-left corner of the front porch (Observation #11) is likely due to settlement of the concrete driveway from consolidation of the underlying soils. Though visibility is limited, the front porch appears to have a CMU foundation inside the brick masonry with the bricks primarily serving as an aesthetic component. Based on the lack of brick cracking and no significant signs of distress in the framing above this corner of the porch, we do not consider this separation to be indicative of a structural concern at this time.

| <div>Description</div> <div>View of separation at the front porch corner.</div> |

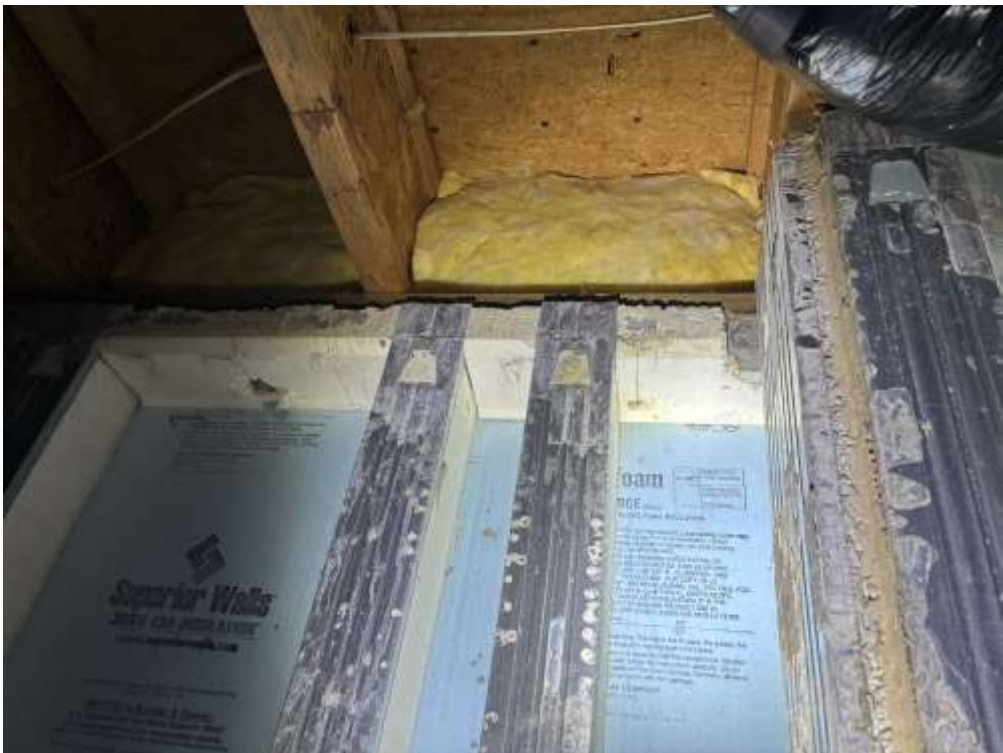
**Photo No.  
11**

The through bolts at the top of the precast foundation walls appear to be anchoring the above framing to the foundation wall. The instance of what appears to be a missing nut and washer could be a deficiency from original construction. We have provided a recommendation below to install a new nut and washer.

View of the missing nut and washer in the foundation wall through bolt.

3. If a nut and washer is determined to be missing (upon removal of the existing insulation), we recommend installing an appropriately-sized nut and washer to secure the through bolt at the top of the foundation wall in Observation #16.
