Subject: Residential Structural Evaluation  
134 Dogwood Lane  
Wake Forest, North Carolina

Project No.: DM-24323

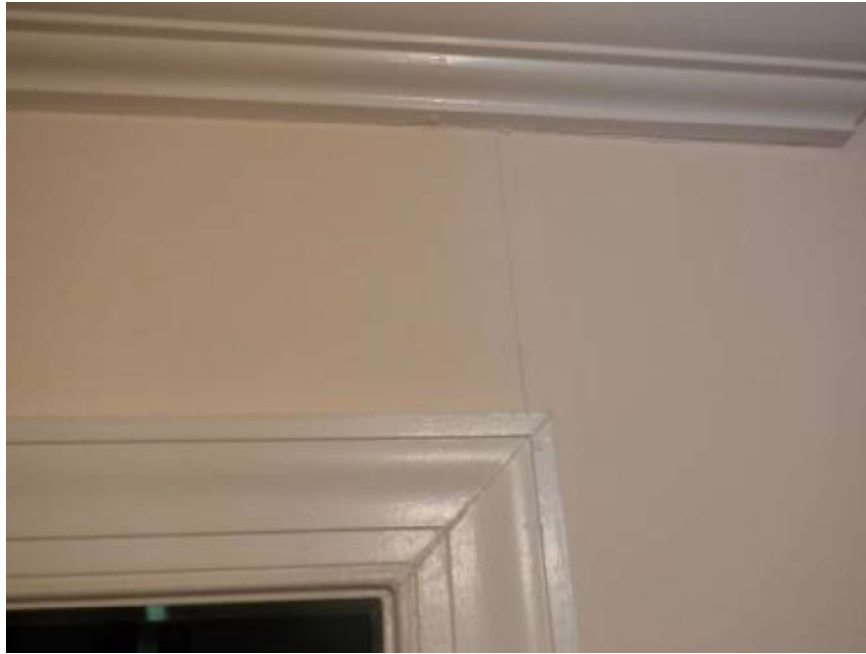
- During our inspection of the home's interior, we observed minor to moderate drywall cracks at isolated locations of upper corners of doorways. Extensive drywall cracks and separations were most noticeable on the third floor, finished attic. Isolated doors were misaligned in their openings. Using a rotary laser level, we recorded minor to moderate vertical floor misalignments up to 1.25- to 1.5-inches with the largest misalignment recorded at the doorway leading from the foyer hall to the kitchen.

**Structural Evaluation** – The vertical floor misalignments, the cracks observed in upper corners of doorways and the misaligned doors are due to gradual, long term, differential settlement of slab/footing support of the basement support walls. The garage area of the slab, which was the only visible area of slab due to carpet covering the finished areas of the basement, showed no signs of cracking or structural failure. We recommend patching all drywall cracks and then monitoring annually for any changes in condition. We do not feel a structural repair is needed at this time. The extensive drywall cracks and separations we observed in the attic are due more to poor installation methods of the drywall with wood backing not being provided along edges of the drywall so that it could be properly secured. We do not feel a structural issue is actively occurring that needs to be addressed.

Photograph Number 1 - Example of drywall crack found in isolated areas. Patch and monitor.

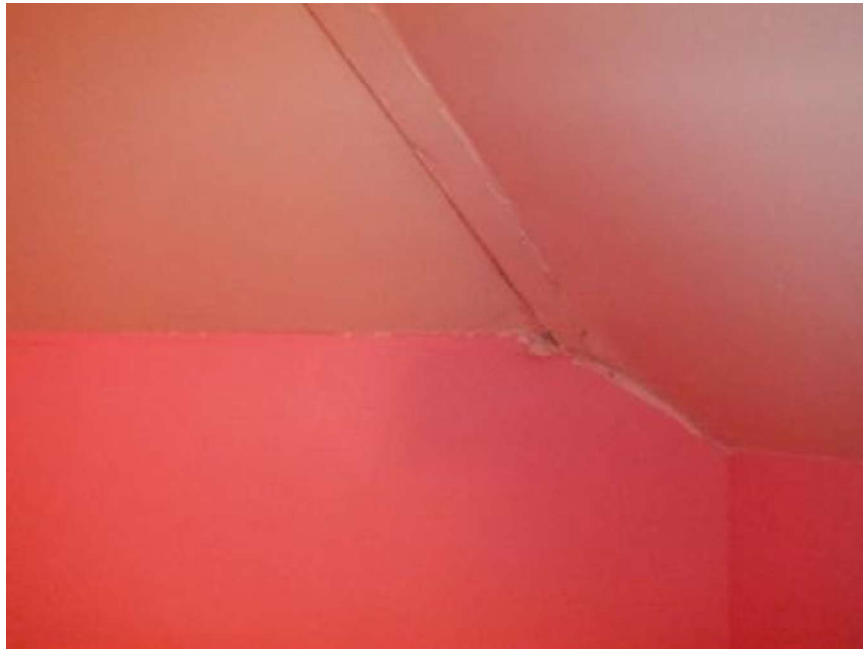
Photograph Number 2 - Separation of drywall in attic. Framing was not present along edge of drywall for properly securing.

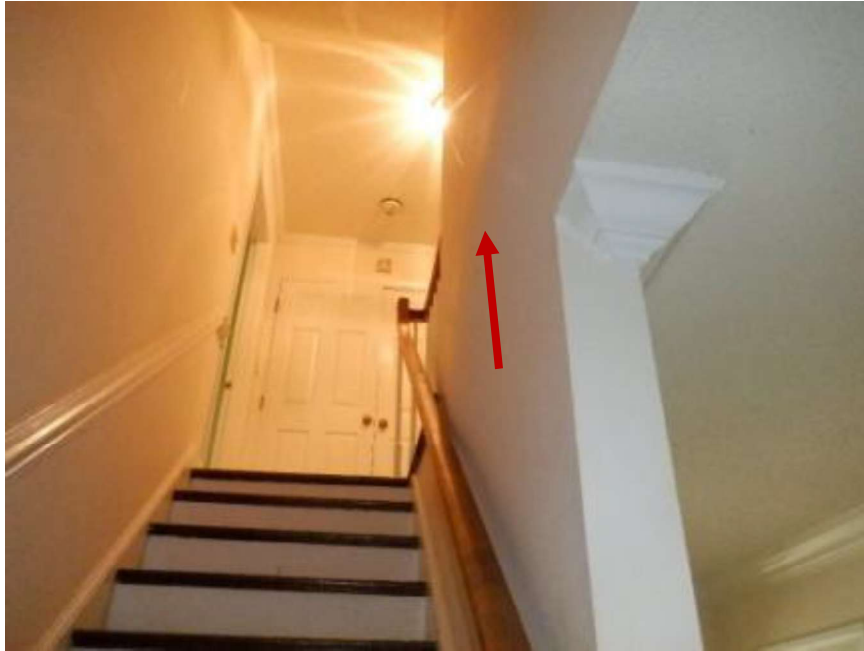
- A large bulge in the drywall was observed on the right-side wall of the stairwell from the first to second floor. The bulge could be pushed inwards in some areas.

**Structural Evaluation** – It is not uncommon for a slight bulge to be present when drywall spans the framing from the first floor to the second floor if the framing is even slightly misaligned. The bulging drywall we observed is more excessive than what is commonly found but the only way to verify if misaligned framing is what is occurring at the stairwell bulge is by removal of a section of drywall to visibly inspect the framing. We believe that misaligned framing and improperly secured drywall is what is occurring and not a structural failure issue, but destructive techniques would need to be performed to provide a definitive structural assessment.

Photograph Number 3 - Bulge in drywall at stairwell.

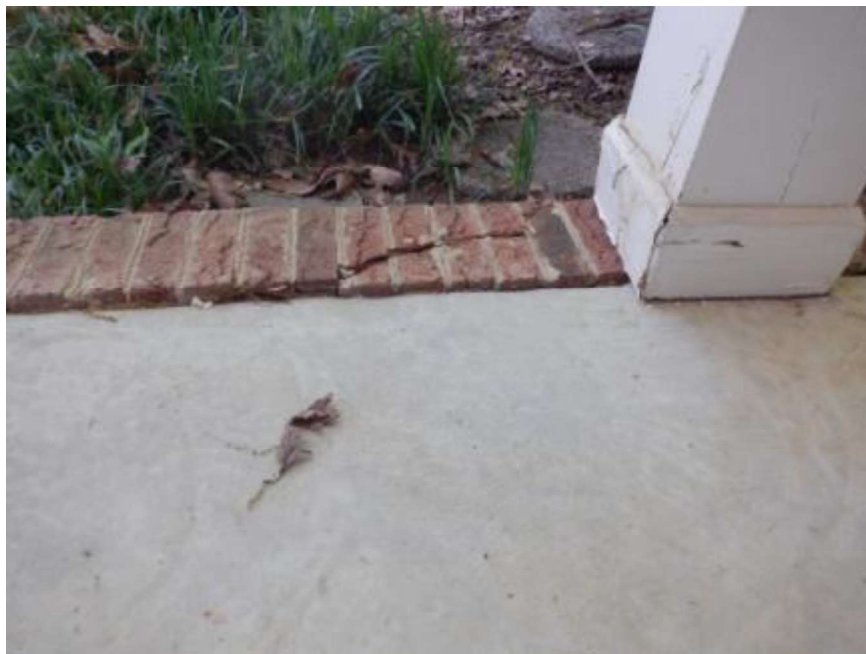
- During our inspection of the home's exterior, we observed cracks, with some displacement, in the brick rowlock of the front porch near the support column by the steps. Other areas of the brick rowlock appeared to have settled slightly creating gaps between the rowlock and some of the support columns. The trim that wraps the support columns had some wood decay present at their base.

**Structural Evaluation** – The crack with displacement in the brick rowlock at the support column near the steps is due to differential settlement and slight rotation of the rowlock off to the side of the support column and not directly below the column. While there is evidence that minor settlement has occurred at isolated areas of the rowlock, resulting in gaps between the rowlock and base of the column, we do not feel a structural repair is needed at this time and instead recommend shimming beneath the columns to eliminate the gaps and then monitoring the brick rowlock support for changes in condition. The decayed trim wrapping at the base of the columns does not create a structural concern as the trim is only cosmetic but it is recommend that the lower trim is removed and the post wrapping cut back so that the base of the actual interior support post could be inspected at its bottom to verify that it does not have wood decay present.

Photograph Number 4 - Brick rowlock rotating to the side of support column.  
Shim columns and monitor.

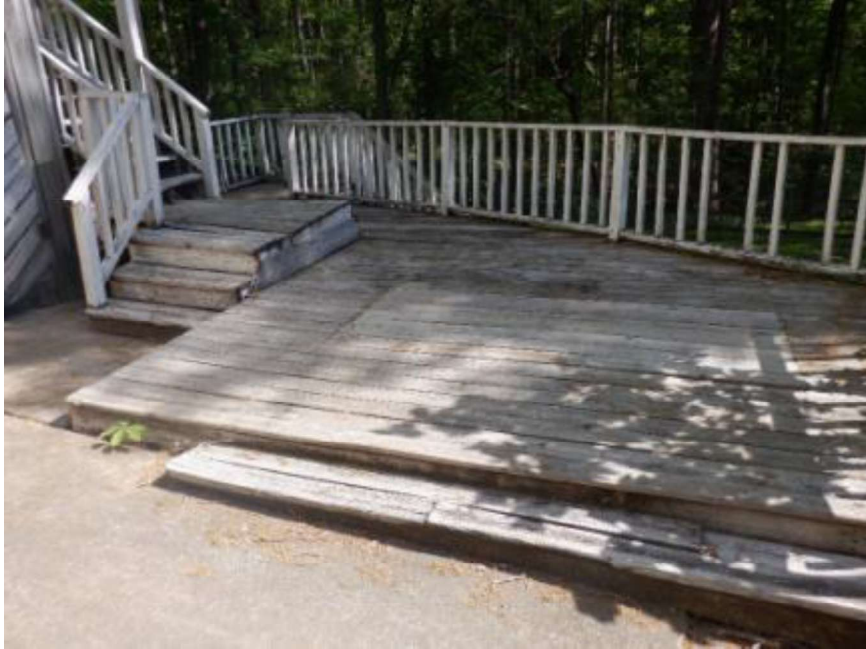
- The rear decks, upper and lower levels were in poor condition with decayed wood present in the decking and handrails. Additionally, the framework does not meet current, or prior structural standards for deck framing.

Photograph Number 5 - Rear decks are in poor condition. Remove and rebuild both levels of the deck.

**Structural Evaluation** – We recommend the complete removal and rebuild of the rear decks given the safety concern of their current condition.

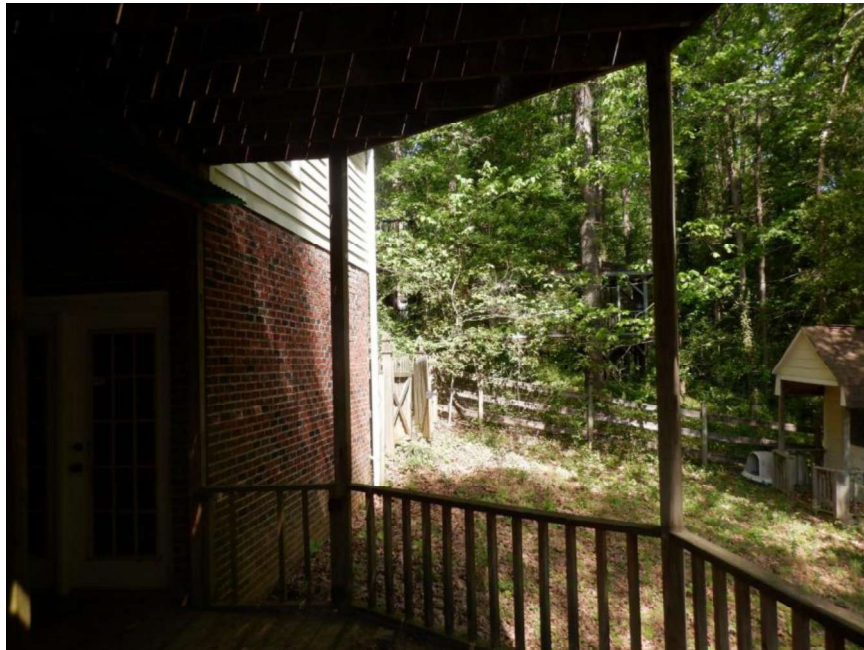
Photograph Number 6 - View of undersized deck posts.

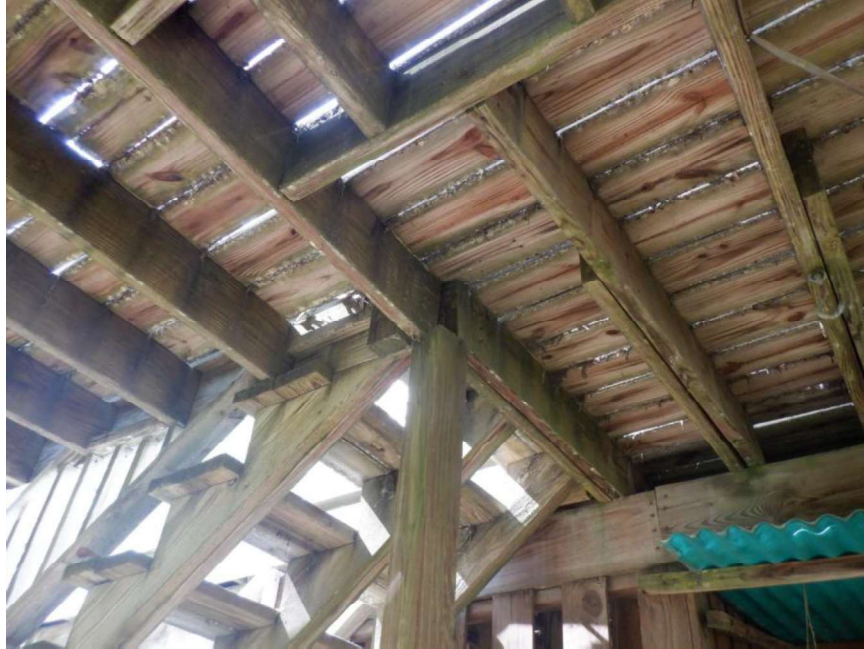
Photograph Number 7 - View of poor deck connections and support details.

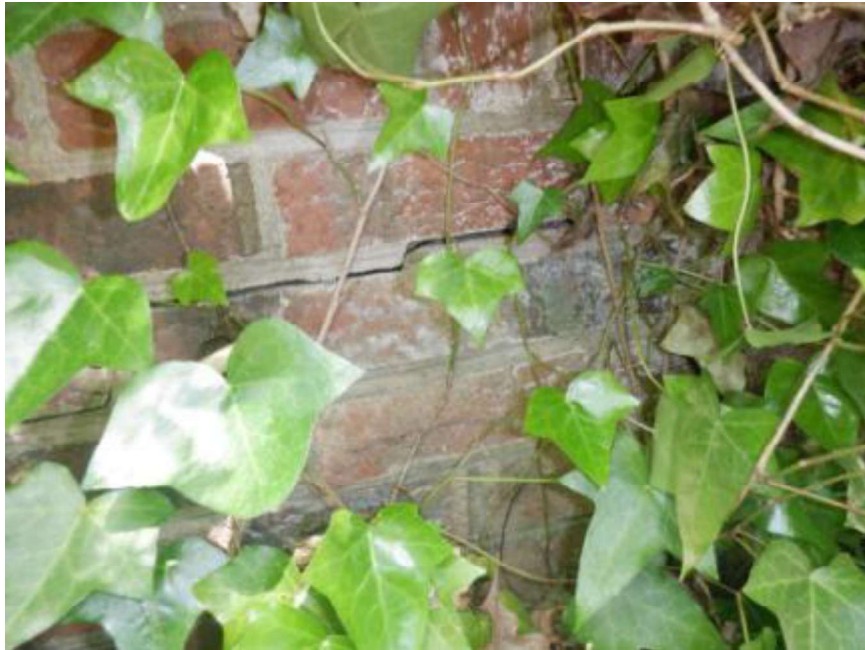
- The brick retaining wall along the left side of the driveway was covered in ivy but in pulling some of it back near the steps a crack was observed in the wall near the bush/tree that's growing in the corner.

**Structural Evaluation** – The crack that was observed in the retaining wall is likely being caused by the root system of the nearby bush/tree and hydrostatic pressure is also likely contributing. The overgrowth of ivy made it impossible to determine if a structural repair is needed to prevent any portion of the wall from falling but the limited inspection we were able to perform did not indicate the wall is in a condition where that is a concern. We recommend cutting the ivy back so that the retaining wall could be fully inspected to determine any necessary repairs.

Photograph Number 8 - Cracks in brick retaining wall.
