Re: Limited Structural Inspection  
205 Bethabara Lane  
Cary, NC

At your request, a limited structural inspection of the above property was performed on July 7, 2026. The report that follows has been prepared based on that inspection. The inspection was performed by Collin Vaughan, EI of Giles Flythe Engineers.

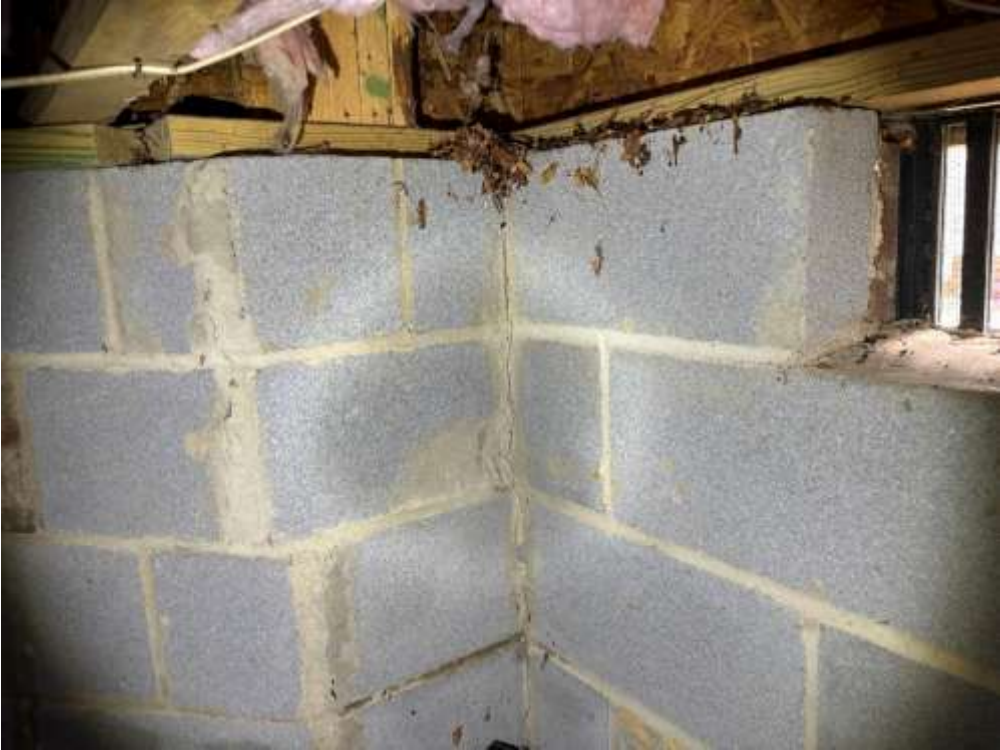
| <p><b>Photo No.</b></p> <p>3</p> | |

- b. Minor cracks (less than 1/16" wide) were noted in the corners of the bay window foundation walls at the front-left corner of the crawlspace.
  - c. A crack (approximately 1/8" wide) was noted in the right-most foundation wall located approximately 8'-0" from the rear foundation wall.

| <p><b>Description</b></p> <p>View of crack in the corner of foundation wall.</p> | |

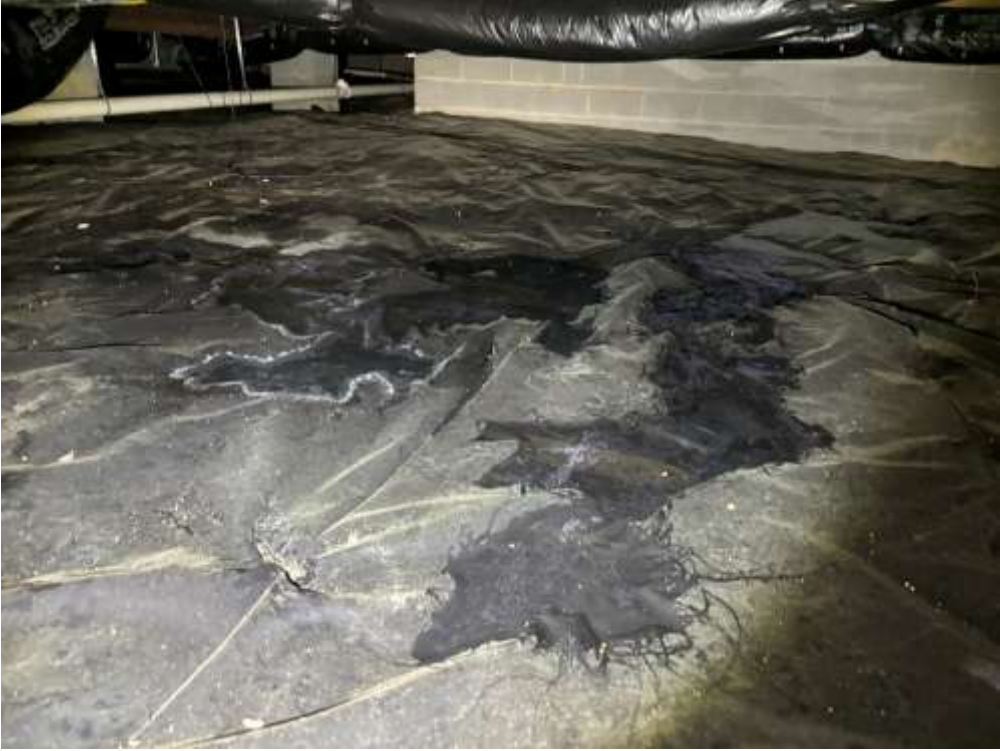
| <p><b>Photo No.</b></p> <p>4</p> | |

7. A vapor barrier was installed at the time of our inspection. Multiple moisture readings were taken during the inspection with a General MMD4E moisture meter and measured lumber moisture contents of up to 18.5%. Note, standing water was noted above the vapor barrier at the front-middle and far-right corners of the crawlspace.

The moisture content of the floor framing noted in the home at the time of the inspection is considered elevated (greater than 15%). Moisture levels of the framing can fluctuate based on weather conditions and seasonal changes in humidity. Prolonged elevated moisture content of the framing can lead to excessive deflection and structural damage. The current warm temperatures and high humidity are likely contributing to the elevated moisture levels. We have provided a recommendation below to help further dry out the crawlspace.

| <p><b>Description</b></p> <p>View of standing water in crawlspace.</p> | |

4. To help further reduce and regulate moisture levels in the crawlspace, we recommend maintaining the existing vapor barrier to cover all exposed soils in the crawlspace and closely monitoring the framing moisture levels through the next seasonal change. If future moisture levels remain elevated (greater than 15.0%), an appropriately sized dehumidification system may be required. Note, framing moisture levels between 9% to 14% are ideal.

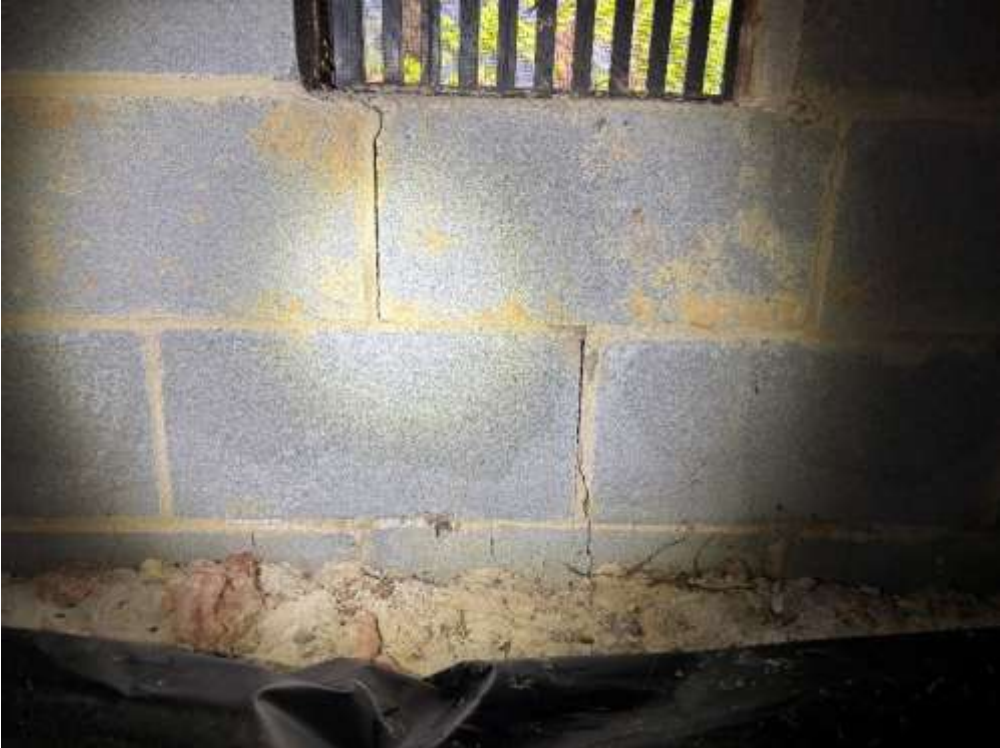
| <p><b>Photo No.</b></p> <p>5</p> | |

5. Cracks were noted in the perimeter foundation walls in the following locations:
  - a. A crack (approximately 1/8" wide) was noted at the front-left corner of the crawlspace.

The cracks in the foundation walls noted above (Observation #2 & #5) are likely due to limited differential foundation settlement. The clay soils in this area are considered "expansive" type soils and will typically expand and contract with fluctuations in the moisture content. This expansion and contraction of load-bearing soil materials can lead to soil consolidation and foundation cracking/movement. The condition of the foundation wall does not appear to be a structural deficiency and improving exterior drainage and monitoring cracks for additional propagation is an acceptable approach at this time.

| <p><b>Description</b></p> <p>Typical view of crack in foundation wall from crawlspace.</p> | |

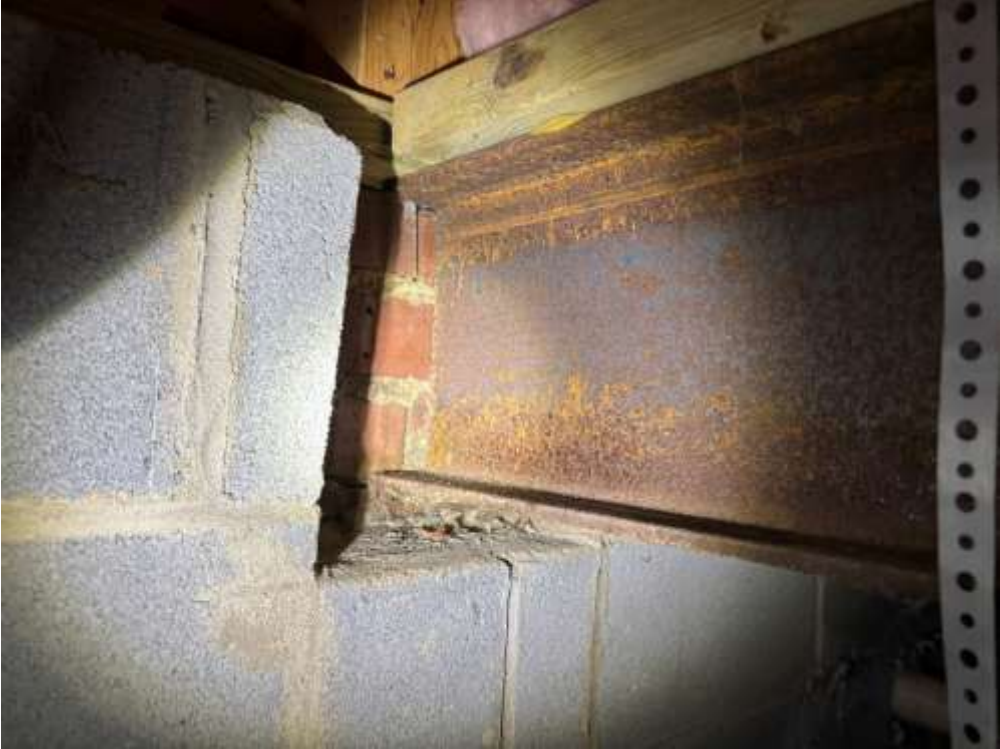
| <p><b>Photo No.</b></p> <p>6</p> | |

- i. Note, this crack is approximately in the same location as Observation #2b.
6. Inadequate girder bearing and missing blocking was noted at the pocket in the left foundation wall, approximately 15'-4" from the front foundation wall.

The inadequate girder bearing noted above (Observation #6) is considered a structural concern. The girder is designed to be supported at the perimeter foundation wall. Due to the absent blocking, no support for the girder is present. If left in the existing condition, additional vertical displacement resulting in interior floor slope and interior finish material damages may occur. We have provided a recommendation below to address this issue.

| <p><b>Description</b></p> <p>View of inadequate girder bearing in crawlspace.</p> | |

1. We recommend installing new flat, pressure-treated wood blocking (min. 3/4"-thick) and/or flat metal shims to provide full-width uniform bearing of the girder onto the foundation wall (Observation #6).
  - a) Care should be taken to not excessively jack the floor framing should it be required during the re-shimming process. Attention should be given to the framing bearing conditions at the nearby piers; adjust as necessary to provide full-width, uniform bearing for the floor framing onto the piers. Damage to the interior finishes during the jacking process is likely.
2. Monitor the cracks in the foundation walls. If the cracks widen significantly (expand by an additional 1/8") or additional significant cracks (greater than 1/4" wide) propagate, then further evaluation by a structural engineer may be needed at that time.
