Emerald  
Home  
Inspections  
of  
NC

## Property Inspection Report

April 17, 2025 (11:00 AM)

4832 Brookhaven Drive Raleigh, NC

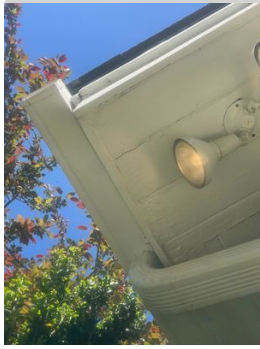
### (A1-2.3) Main House

The exterior trim and boxing of the home need repairs and painting to prevent further damage and water penetration. The following items were noted during the inspection all areas should be evaluated as a repair plan is prepared: Boxing and trim areas (including window trim) were found to have damage in a few areas related to age, boring bees, possible gutter overflow, decay, and roof drainage flowing behind the gutters. A licensed general contractor should be consulted for a complete evaluation of the exterior siding, trim and boxing to determine the scope of the damage and make necessary repairs.

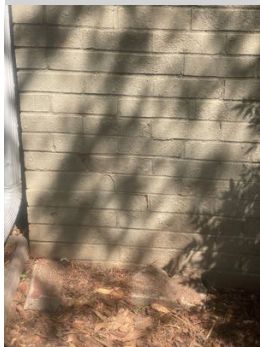
### A1-3 Main House

Cracks were noted on every side of the home in the brick veneer in stepping patterns. Cracks in brick veneer indicate a deficiency that can change or progress over the life of the home. The cracks on this home were closed at the time of the inspection and presented possible evidence of progression to the foundation areas, additionally, the cracks could open or change seasonally. The owners should be asked for disclosure related to the progression, history of repairs, or seasonal changes of the cracks. Even closed or minor cracks can cause consumer or buyer concerns at the time of resell. The buyers should observe the cracks and assess their concerns related to the presence of the cracks, the number of cracks, and possibility of the condition worsening over the life of the home. The cracks should be noted, repaired by a general contractor, and monitored to establish a history of stability. If additional information is needed an engineer should be consulted. **Structural Engineer Analysis Provided**

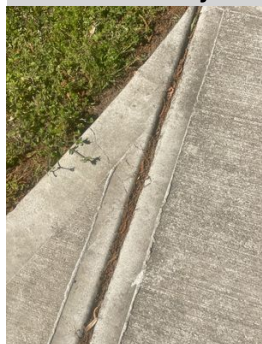
### A4-2 Driveway *(Location: Main House Front)*

The driveway has a few small cracks. A licensed general contractor should be consulted for further evaluation and repair.

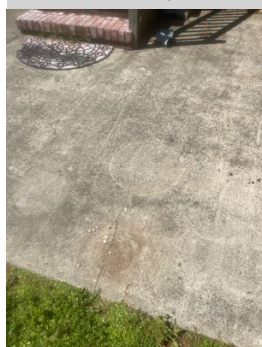
### A4-5 Patio *(Location: Main House Rear)*

The patio pad is cracked in a few places creating a path for water penetration under the slab and a potential future trip or fall hazard. A licensed general contractor should be consulted for further evaluation and repair.

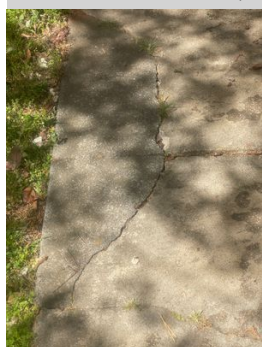
### A4-7 Side Walk *(Location: Main House Right)*

The sidewalk is cracked in a few places creating a path for water penetration under the slab and a potential future trip or fall hazard. A licensed general contractor should be consulted for further evaluation and repair.

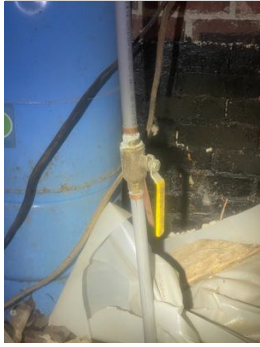
**(D2-1.2) All Accessible Areas**

This home has a plumbing supply system that has some polybutylene plastic distribution lines and compression band fittings in the crawl space. Even though this plumbing system was installed in many homes from 1978 until mid-1990's, it is no longer manufactured in the original formulation as an approved plumbing system due to a history of material failures. The failures were related to improper installation, improper handling, improper storage, and plastic deterioration due to chemical reactions with the water supply. Due to the nature of this latent defect, it was not possible to adequately assess the condition of the plumbing system during the home inspection. A licensed plumbing contractor should be consulted for a complete evaluation of the plumbing system to determine the significance of this concern.

**Polybutylene lines removed by plumber**

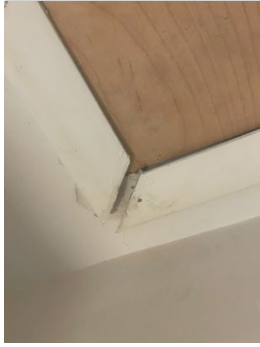
**(H1-2.3) Bedroom 1: Primary: Right**

The attic entrance in this closet is not weather stripped and the trim around the opening is loose. The opening needs repair to prevent air leaks and areas of condensation and to secure the ceiling. A licensed general contractor should be consulted for a complete evaluation and to make necessary repairs.

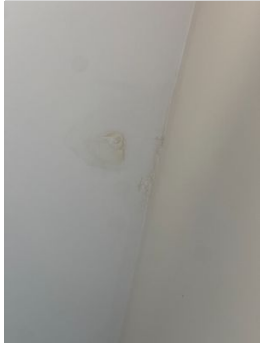
**(H1-7.2) Foyer**

Stains on the ceilings indicate a history of a leak. At the time of the inspection it was not possible to determine if the condition was due to an active or past occurrence. Further investigation by a repair specialist and owner disclosure is recommended. Refer to the Attic section of the report.

**Repaired**

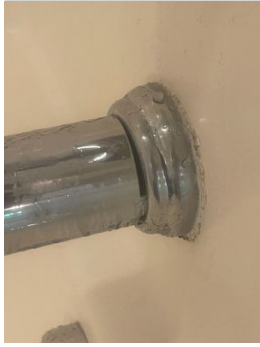
**(H3-1.6) Bathroom 1: Primary: Right**

The tub faucet and handle are not effectively caulked and water can leak behind when it is splashed. A licensed plumbing contractor should be consulted for evaluation and repair to ensure proper service.

**Repaired**

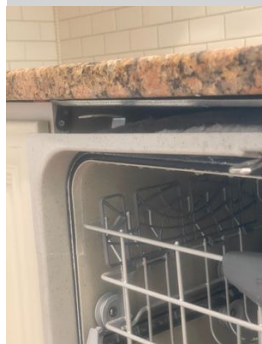
### J1-1 Dishwasher (Location: Kitchen)

The dishwasher is not secure to the cabinet and it moves forward when the door is opened. The appliance needs to be secured to the cabinet to prevent damage to the unit or personal injury. An appliance repair specialist or general contractor should be consulted for repair.

**Repaired**
