Re: Limited Structural Inspection  
9503 Kennebec Road  
Willow Spring, NC

At your request, a limited structural inspection of the above property was performed on December 9, 2025. The report that follows has been prepared based on that inspection. The inspection was performed by Brett Overvold, EI of Giles Flythe Engineers.

LOCATION SKETCH (N.T.S.): 9503 KENNEBEC ROAD, WILLOW SPRING, NC

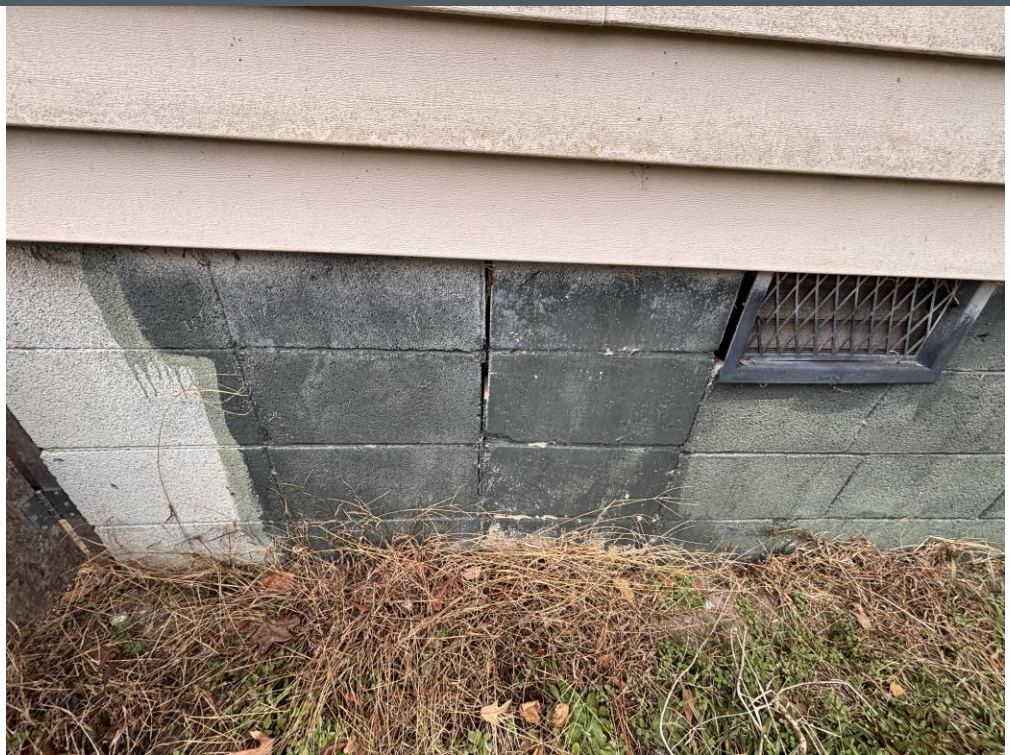
Photo No.  
2

2. Cracks/separations were observed in the perimeter walls in the following locations:
  - a. A separation (up to 1/4" wide) was observed at the rear exterior wall located approximately 6'-9" from the left exterior wall.
  - b. Multiple additional minor cracks (less than 1/16" wide) were observed at the exterior walls.
3. No gutters were noted installed on the home. Grade was noted with a relatively positive slope away from the rear perimeter walls and a relatively neutral slope along the remaining perimeter walls of the home.

The separation in the perimeter curtain walls noted above (Observation #2) are likely due to limited differential settlement. The clay soils in this area are considered “expansive” type soils and will typically expand and contract with fluctuations in the moisture content. This expansion and contraction of load bearing soil materials can lead to soil consolidation and cracking/separations. If conditions around the perimeter walls remain relatively dry, the likelihood of future significant settlement will be reduced, but we cannot predict the extent of future settlement. Improving exterior drainage and monitoring separations for additional settlement is an acceptable approach at this time. It should be noted that the curtain walls are not a load-bearing item in relation to providing support to the structure. The curtain walls are an exterior finish cladding material that protects the structural framing from environmental elements. However, movement of the curtain walls can be indicative of movement in the structural foundation elements.

View of separation in curtain wall.

7. Monitor the cracks in the separations curtain walls noted above. If the separations widen significantly (expand by an additional 1/8") or additional significant cracks (greater than 1/4" wide) propagate, then further evaluation by a structural engineer is recommended.

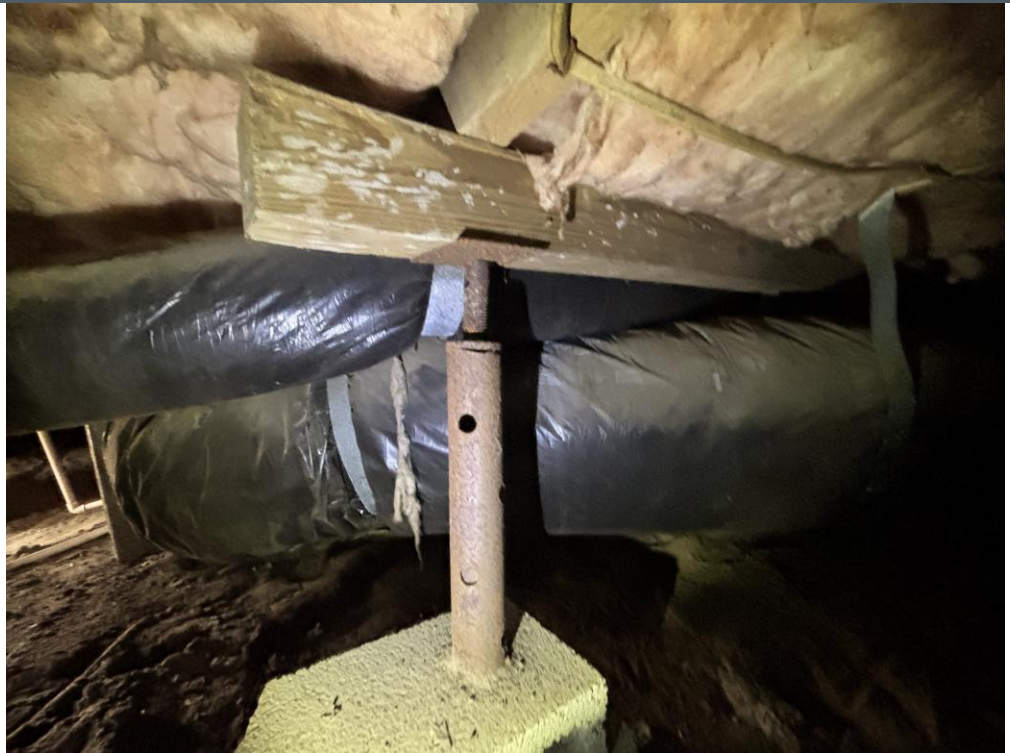
**Photo No.**  
**3**

10. A 4x4 drop girder bearing on screw jack posts with above grade concrete block footings was noted in the rear-left of the crawlspace approximately 7'-6" from the left perimeter wall.

We do not consider the adjustable steel screw-jack posts and drop girders noted above (Observations #10-#12) to be permanent supports. These were likely installed to alleviate minor deflection or “bounce” in the floor and are not required for the structural integrity of the home. No structural repairs are required; however, the supplemental supports may be replaced with permanent drop girder systems if additional rigidity to the floor framing is desired. An optional recommendation is below.

Typical view of drop girder bearing on screw jack post.

4. If additional stiffness in the floor system is desired, we recommend the installation of an auxiliary 3-2x8 drop girder at the midspan of the existing floor joists below the areas of desired stiffness. The new drop girder shall have a maximum clear span of 6'-0" and be supported using new minimum 8x16 mortared and fully grouted CMU block piers bearing on minimum 24"x24"x12"-thick concrete footings. Provide flat pressure-treated blocking (min. 3/4" thick) and/or flat metal shims as required to provide full-width, uniform bearing of the new drop girder onto the new piers.

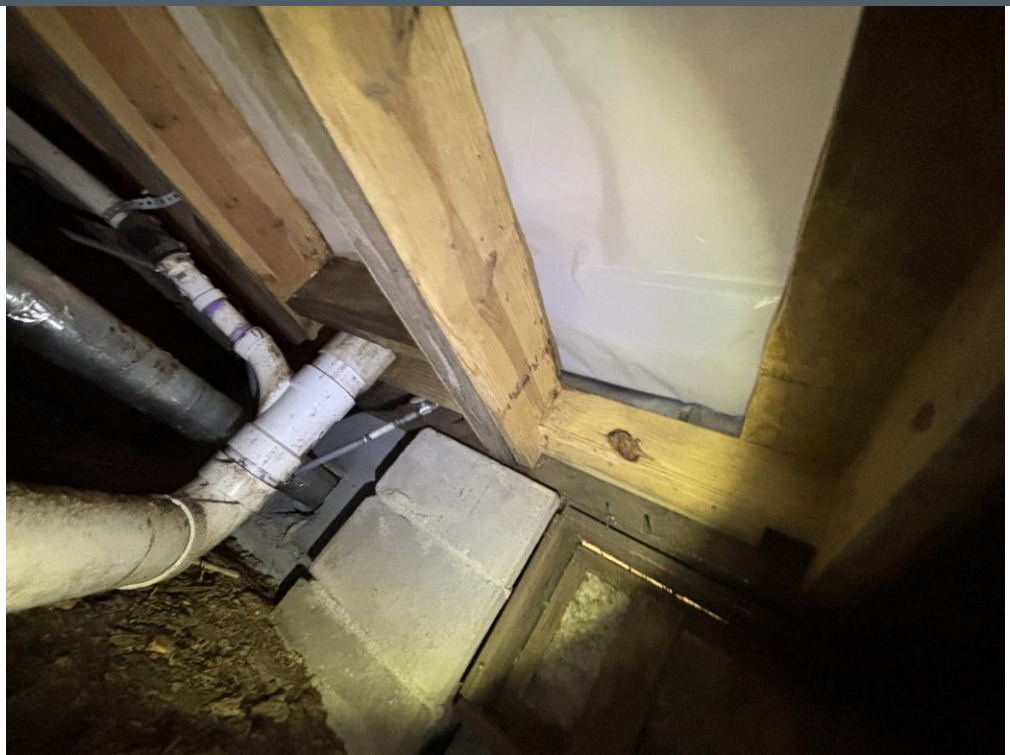
**Photo No.**  
**4**

11. Supplemental screw jack posts and framing supports were noted in the rear-right corner of the crawlspace.
12. A section of floor joists in the left bay of the crawlspace was noted to be previously sistered. The section begins approximately 21'-6" from the rear perimeter wall and extends approximately 8'-0" towards the front of the home. The sisters begin at the left perimeter girder and extend to a new drop girder approximately 6'-6" from the left perimeter wall.

Typical view of previously sistered joists.

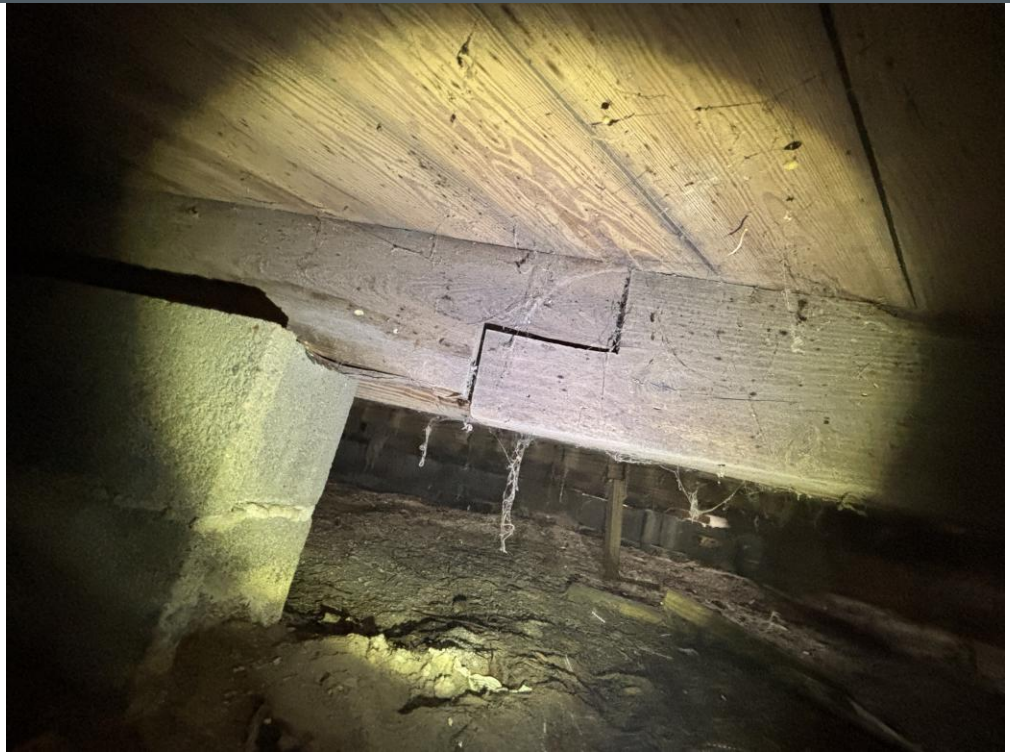
Photo No.  
5

5. An unsupported splice was noted in the front perimeter girder of the home located approximately 9'-0" from the right exterior wall of the home.
6. The front perimeter girder of the home was noted to be damaged beginning approximately 6'-0" from the right perimeter wall and extending approximately 3'-0" towards the left of the home.

The unsupported and inadequately supported splices noted above (Observations #5 & #7) are considered structural concerns. If left in the existing condition, additional vertical displacement resulting in interior floor slope and interior finish material damages may occur. We have provided recommendations below to address the issues.

View of unsupported splice at front perimeter girder.

2. We recommend installing new piers under the unsupported or inadequately supported splices noted above (Observations #5 & #7) with a new mortared and fully grouted 16x16 CMU block piers bearing on minimum 24"x24"x12"-thick concrete footings. Install flat pressure-treated blocking (min. 3/4" thick) and/or flat metal shims as required to provide full-width, uniform bearing for the floor framing onto the piers. Care should be taken to not excessively jack the framing during the installation process. Attention should be given to the framing bearing conditions at the nearby piers; adjust as necessary to provide full-width, uniform bearing for the floor framing onto the piers.

- a) NOTE: Removal of the existing adjacent pier (Observation #5) or dry stacked CMU pier (Observation #7) will be required for installation of this repair. Removal of the adjacent support pier at Observation #7 is **NOT** permitted.

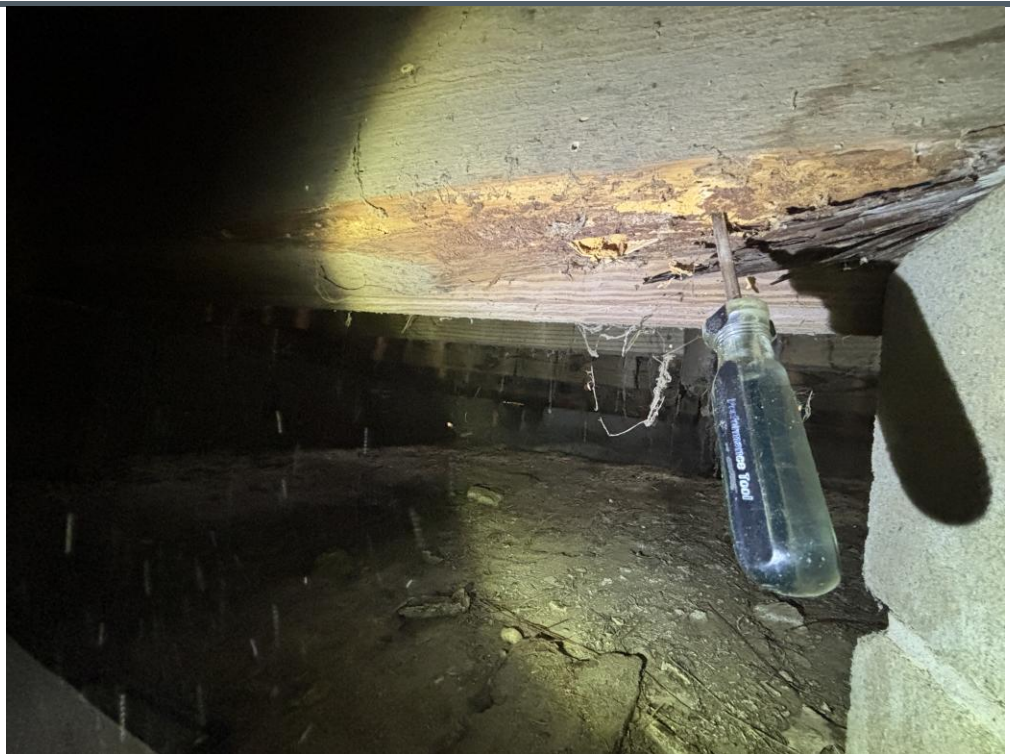
Photo No.  
6

The damaged floor framing noted above (Observations #6, #8, & #9) is likely the result of prolonged exposure to wood destroying insects and elevated moisture levels in the crawl space. Wood destroying insects and excess water intrusion in the building envelope over time can deteriorate the integrity of the wood framing members and cause rot. In addition, the insects and moisture intrusion can further penetrate other components causing significant damage to neighboring framing members. The damaged floor framing noted above is considered a structural concern. We have provided a recommendation below to address the issue.

View of damaged perimeter girder at front of home.

3. We recommend removing and replacing the damaged floor girder span noted above (Observation #6) for the full length (support pier to support pier). The new girder should consist of a 3-2x8 pressure treated member and bear above the new/existing support piers in the

crawlspace (See Recommendation #2). Install flat, pressure-treated blocking (min. 3/4"-thick) and/or flat metal shims to provide full-width, uniform bearing of the girder onto the piers below.

- a) The entire span of the damaged member should be replaced (approximately 9'-0"). The CMU curtain wall may not be used as a bearing point of the new girder.

- b) Note, the new girder should span fully to the new pier in recommendation #2. Additional cutting back of the front perimeter girder may be required. Ensure a minimum 3" of bearing from both girders onto the new pier.

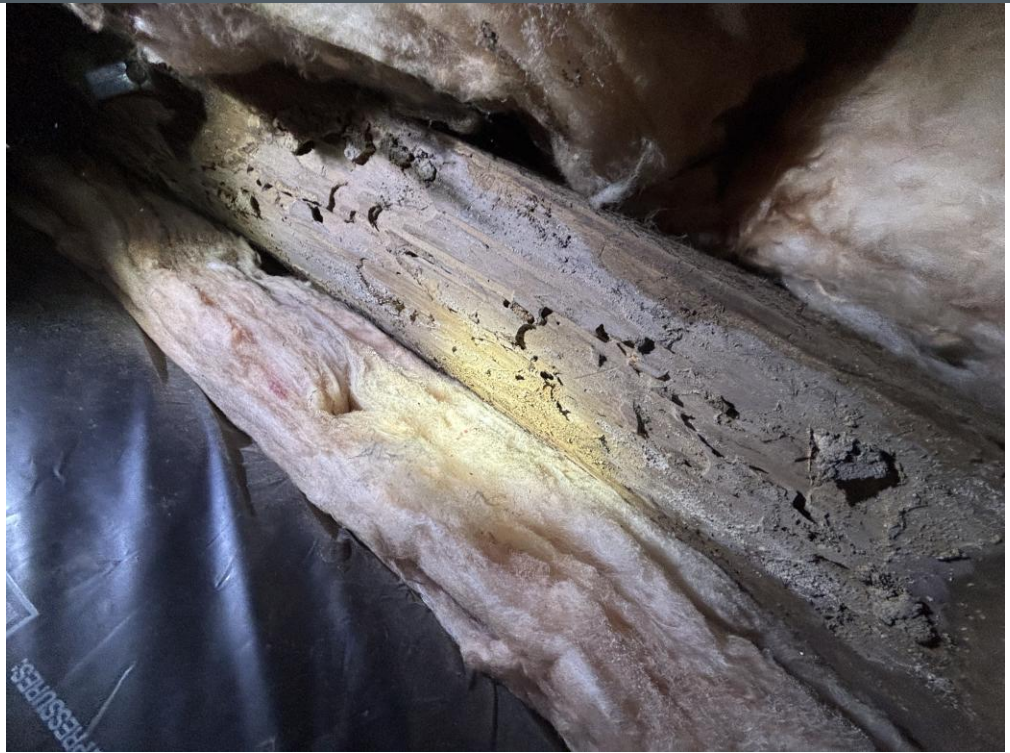
Photo No.  
7

8. The two floor joists spanning front to rear in the rear-right bump-out of the home were noted to be damaged.
9. Evidence of wood destroying insect activity was present on the wood framing throughout the crawlspace.

Evidence of wood destroying insect activity.

5. We recommend consulting with a qualified professional to address the wood destroying insect presence in the crawlspace.
  6. To help further reduce and regulate moisture levels in the crawl space, we recommend installing a vapor barrier throughout the crawl space to cover 100% of the exposed soil. We recommend adjusting the foundation vents as needed. We recommend ensuring the foundation vents are clear of debris to allow air circulation. If moisture levels remain high (greater than 15%), an appropriately sized dehumidification system may be required.

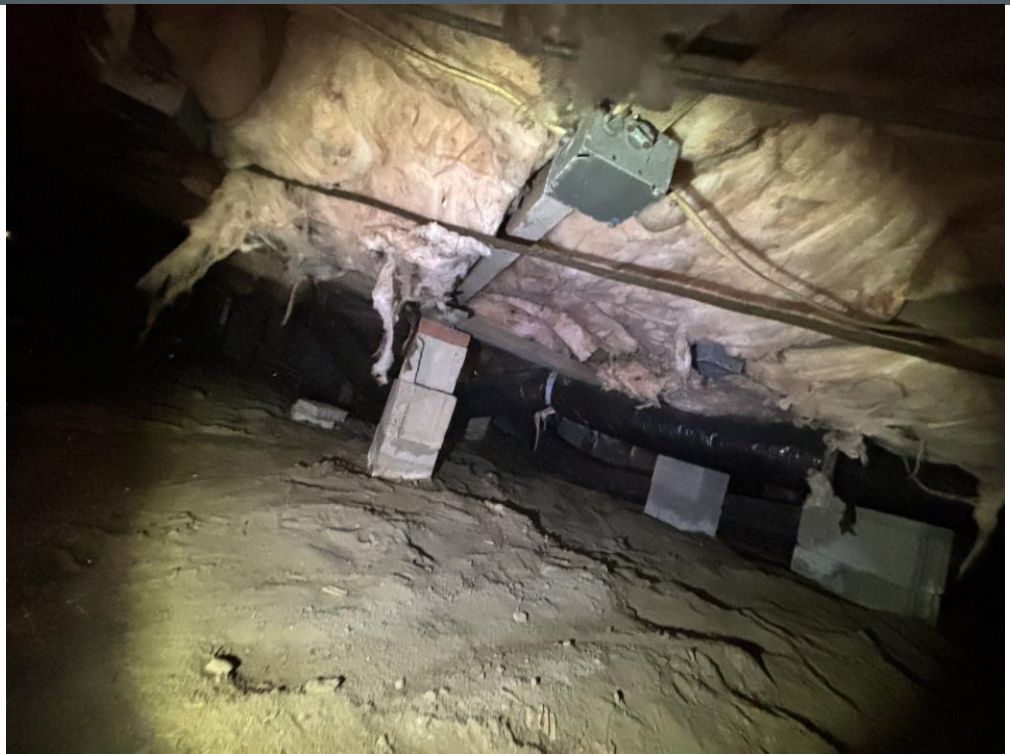
Photo No.  
8

- a. No damage was observed in the visible portions of the original floor joists.
13. No vapor barrier was observed in the crawl space resulting in exposed soil. Evidence of moisture intrusion in the form of efflorescence was noted on the perimeter walls. Water staining and what appeared to be organic substances were also noted on the wood framing. Multiple moisture content readings (up to 19.5%) were taken in the floor framing with a General MMD4E moisture meter.

The moisture content of the floor framing noted in the crawl space at the time of the inspection is considered high (greater than 19.0%). Moisture levels of the framing can fluctuate based on weather conditions and seasonal changes in humidity. Prolonged elevated moisture content of the framing can lead to excessive deflection and structural damage. We have provided a recommendation below to help further dry out the crawl space. Note, additional deflection or movement of the framing may occur as moisture is removed from the wood resulting in finish material cracks above.

View of exposed soils in crawlspace.

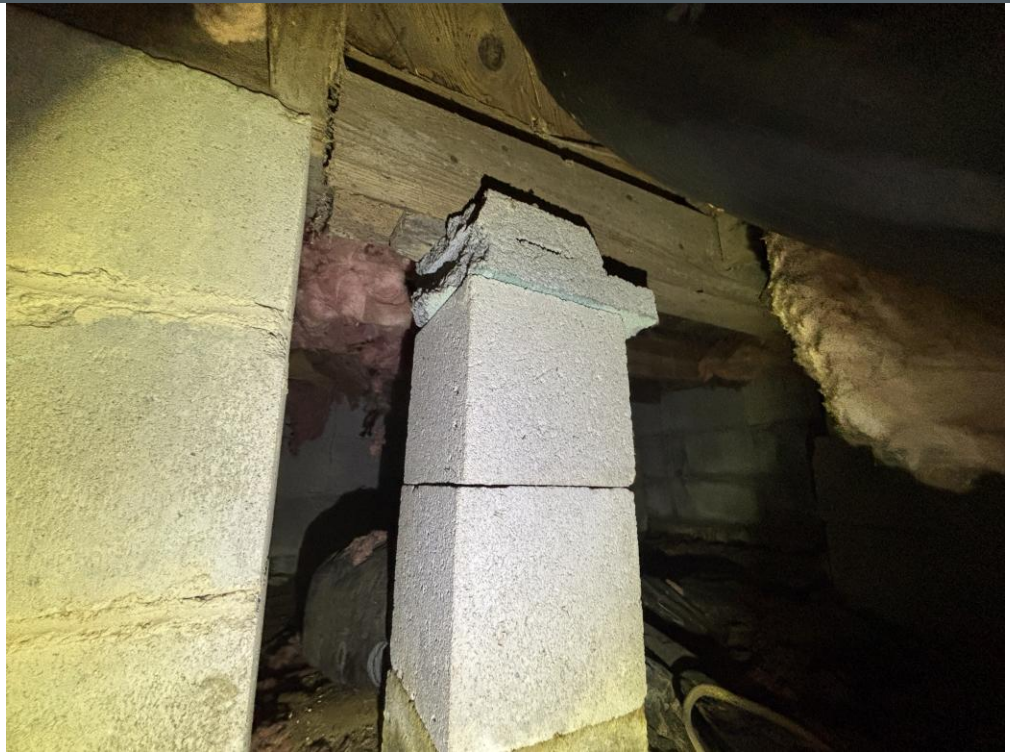
Photo No.  
9

7. The right girder was noted to be cut approximately 10'-0" from the rear exterior wall and 4'-0" from the rightmost exterior wall. The front side of the cut section was noted to be bearing on a dry stacked CMU pier.

View of girder end bearing on dry-stacked CMU.

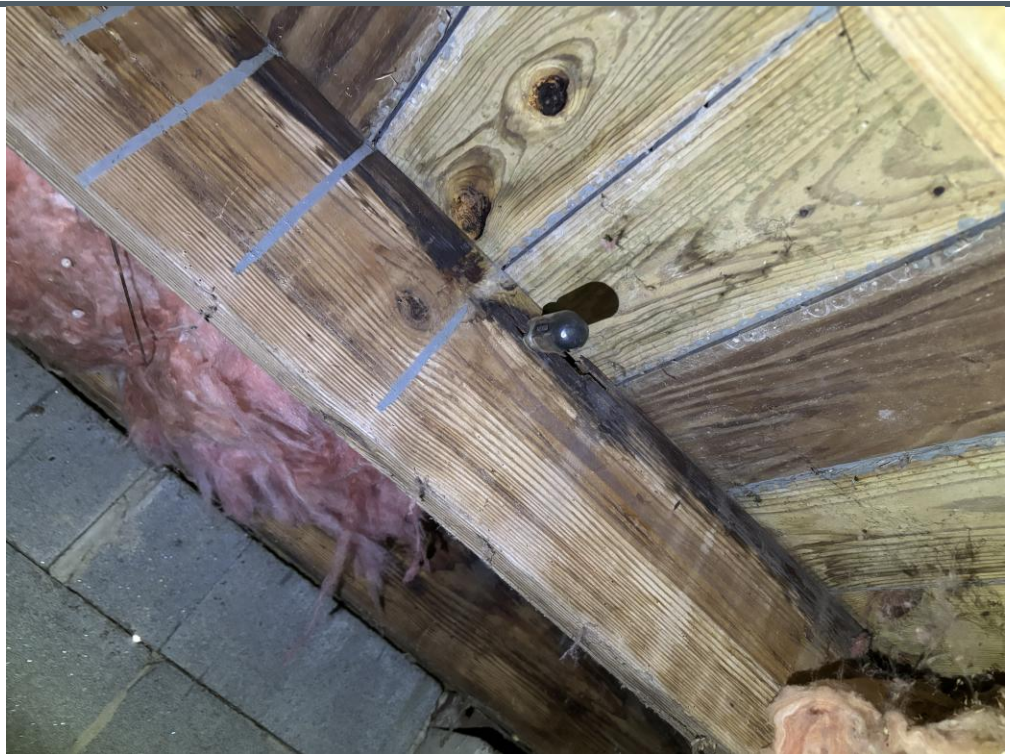
Photo No.  
10

View of damaged floor joists below rear-right bump-out.

1. We recommend fully sistering (bearing point to bearing point) the damaged floor joists noted above (Observation #8) with new equivalently sized members, attached with (3) 10d common nails at 16" on-center. Ensure a snug condition against the subfloor/damaged member(s) and proper bearing at the ends.

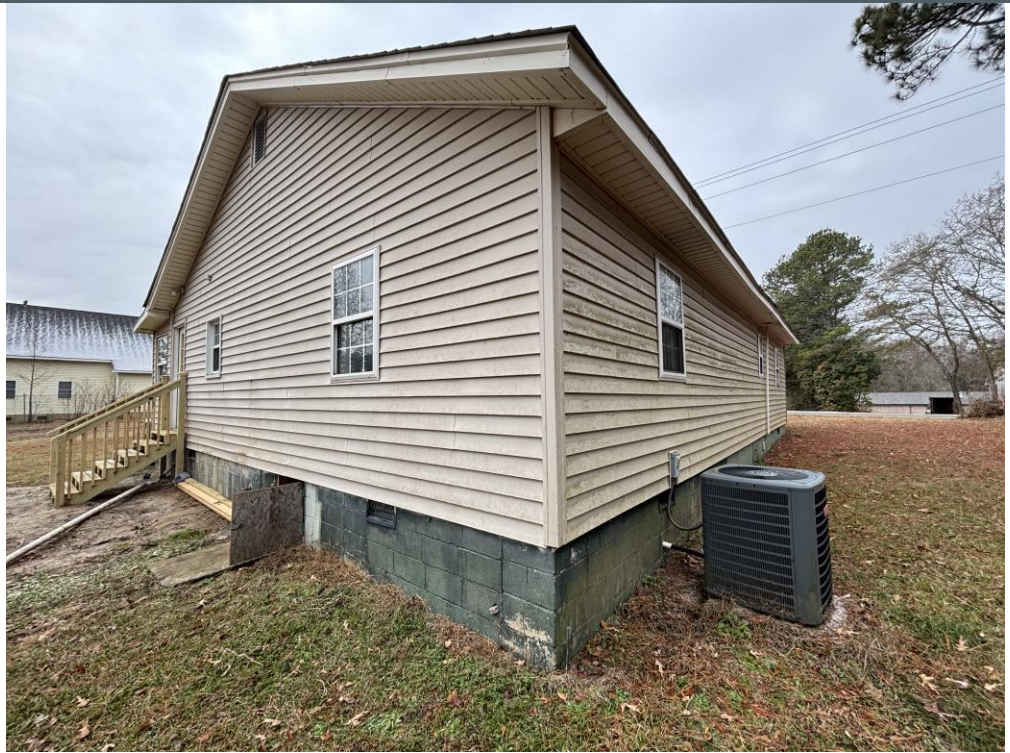
Photo No.  
11

Positive grade away from the foundation should be created to reduce moisture infiltration under the foundation. Additional soil consolidation and foundation movement or settlement can occur due to water infiltration into soils and subsequent drought conditions which dry out the soils below foundations. Maintaining positive drainage away from the perimeter foundation wall(s) is vital to the long term structural integrity of the foundation.

View of home with no gutters installed.

8. We recommend ensuring that stormwater drains positively away from the home to minimize the risk of future water infiltration. This can be accomplished by installing gutters, downspouts with pipe boots, and leaders on downspouts. Discharge the leaders a minimum of 10-feet away from the footings/foundation and ensure gutters, downspouts, and leaders remain clear of debris and properly functioning. Also, creating a positive grade, where possible, away from the perimeter of the home will aid in the stormwater evacuation.
