## PROPERTY DISCLOSURE ADDENDUM

PROPERTY ADDRESS: 8433 Whisper Ridge Place  
CITY/STATE/ZIP: Raleigh, NC 27613

# Worldwide ERC® Relocation Property Assessment

**Property Address: 8433 Whisper Ridge Place Raleigh NC 27613**

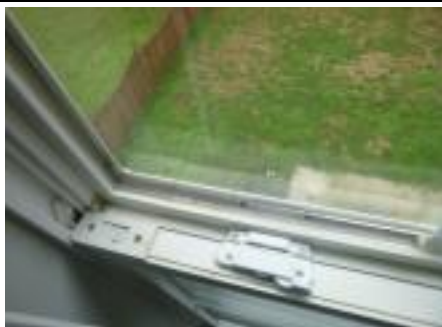
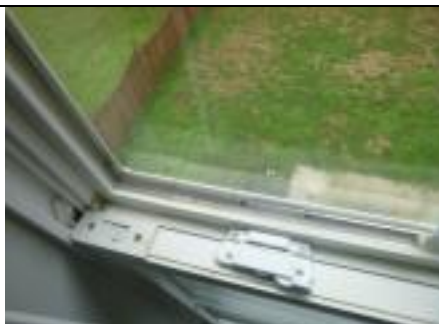
| 7 | <input type="checkbox"/> | <input type="checkbox"/> | <input type="checkbox"/> | <input checked="" type="checkbox"/> | Windows: Failed thermal seal window(s) (fogged glass) were observed at the left rear window in the left rear second floor bedroom and the sash balance is damaged at the left rear window in the left rear second floor bedroom and at the left rear window of the rear kitchen dining area bay window. |

Failed Thermal Seal Window

(ES) 7 Windows: Failed thermal seal window(s) (fogged glass) were observed at the left rear window in the left rear second floor bedroom and the sash balance is damaged at the left rear window in the left rear second floor bedroom and at the left rear window of the rear kitchen dining area bay window.

Corrective Action: Window contractor to confirm and replace all failed thermal seal windows and replace the sash balances at the left rear window in the left rear second floor bedroom and at the left rear window of the rear kitchen dining area bay window.

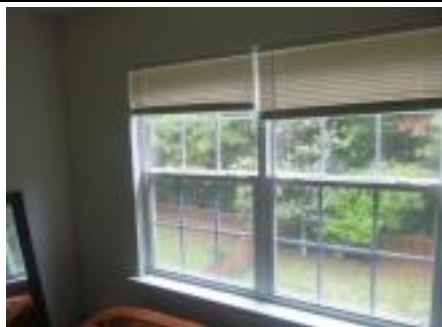
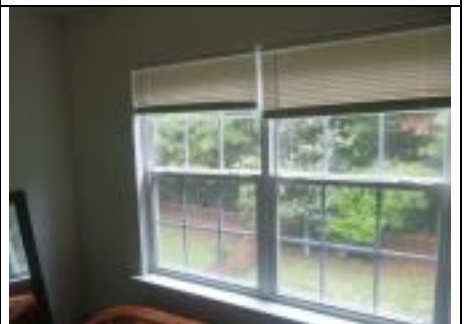
Failed Sash Balance at Bedroom

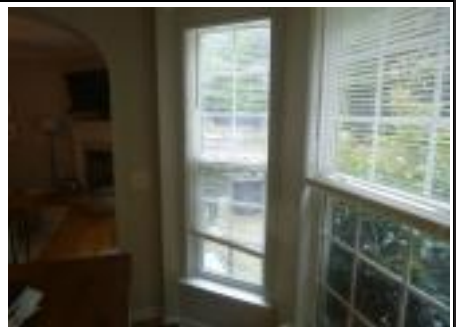
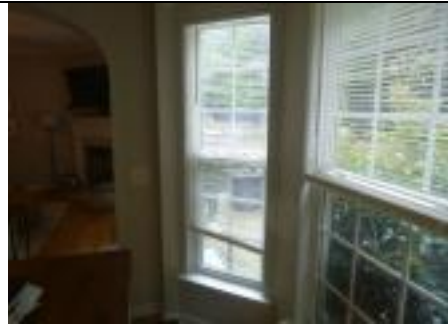
Failed Sash Balance at Bay Window

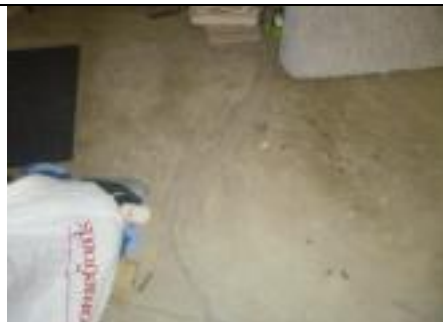
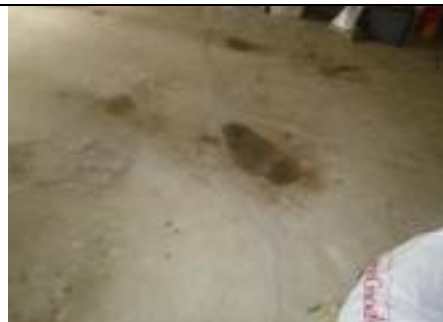
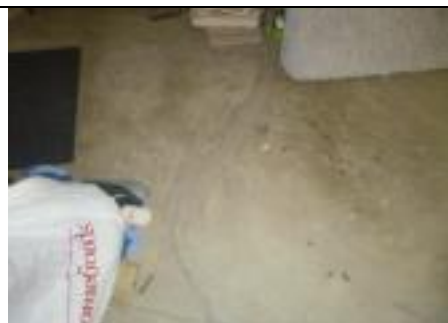
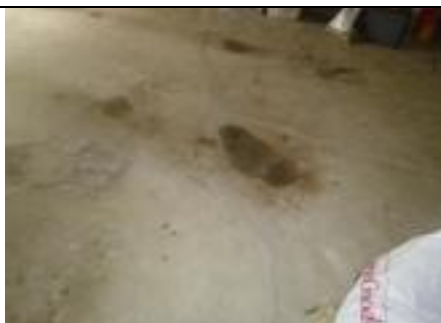
| 4 | <input checked="" type="checkbox"/> | <input type="checkbox"/> | <input type="checkbox"/> | <input type="checkbox"/> | Condition: Please Note: Previous repairs were observed to the garage floor. Recommend obtaining all relevant documentation regarding repairs.<br><br>Limited evaluation of the garage due to storage (90% visible). |

Previous Repairs to Garage Floor

| LIMITED ACCESSIBILITY/NOT ASSESSED |
|---|
| (G/C) 4 Condition: Please Note: Previous repairs were observed to the garage floor. Recommend obtaining all relevant documentation regarding repairs.<br><br>Limited evaluation of the garage due to storage (90% visible). |

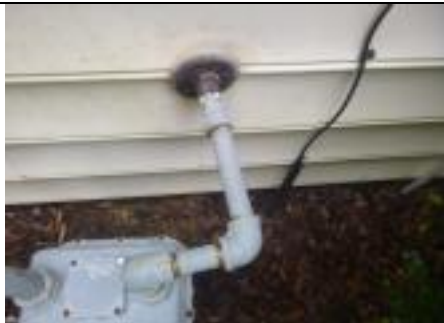
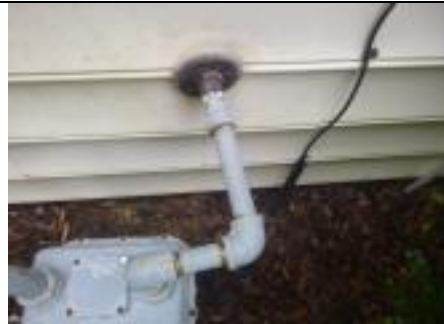
| 5 | <input type="checkbox"/> | <input type="checkbox"/> | <input type="checkbox"/> | <input checked="" type="checkbox"/> | Ground: The CSST (Corrugated Stainless Steel Tubing) does not appear properly bonded / grounded. |

CSST Not Bonded at Gas Meter

(E) 5 Ground: The CSST (Corrugated Stainless Steel Tubing) does not appear properly bonded / grounded.

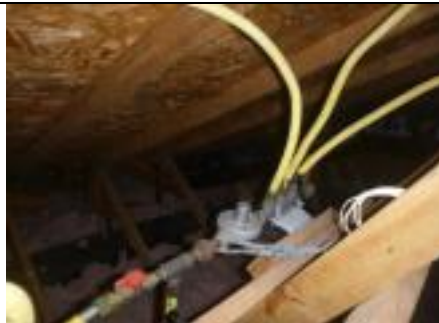
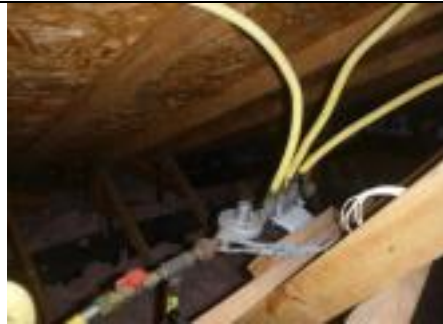
CSST Not Bonded at Gas Manifold

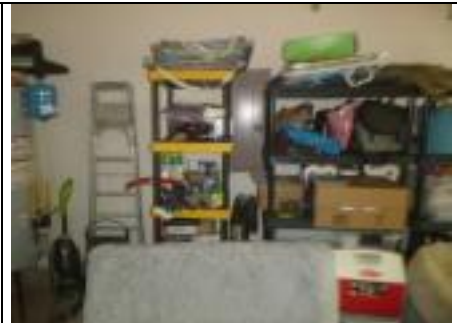
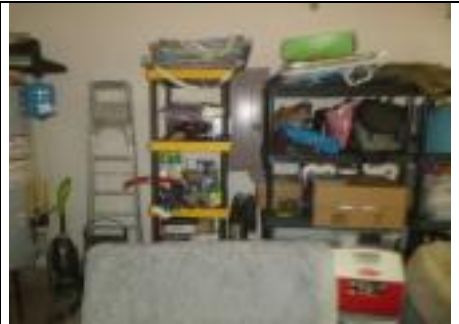
| 3 | <input type="checkbox"/> | <input type="checkbox"/> | <input checked="" type="checkbox"/> | <input type="checkbox"/> | Panel: The main electric panel could not be fully evaluated due to the dead front cover being obstructed by storage. Recommend completing the inspection when full access can be provided. |

Main Panel Obstructed by Storage

| LIMITED ACCESSIBILITY/NOT ASSESSED |
|---|
| (E) 3 Panel: The main electric panel could not be fully evaluated due to the dead front cover being obstructed by storage. Recommend completing the inspection when full access can be provided. |

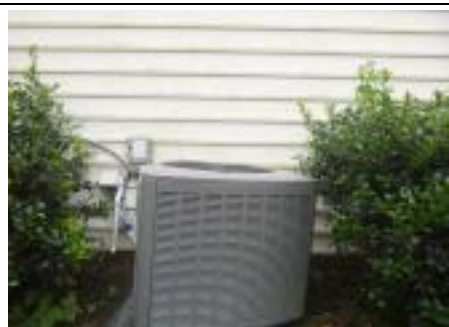
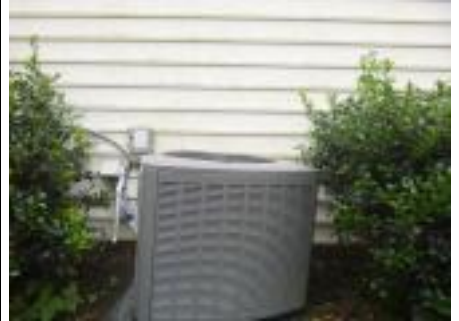
| 3 | <input type="checkbox"/> | <input type="checkbox"/> | <input type="checkbox"/> | <input checked="" type="checkbox"/> | | System: The exterior A/C unit is settled down towards the rear of the house. |

Exterior A/C Unit Out of Level

5. The following conditions conducive to subterranean termites were noted on this property: \_\_\_\_\_  
Standing water against foundation near air conditioner at rear of house.  
Standing water against foundation near air conditioner at rear of house.

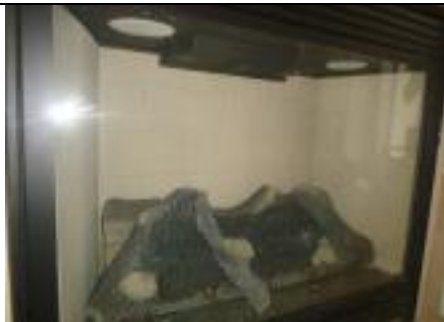
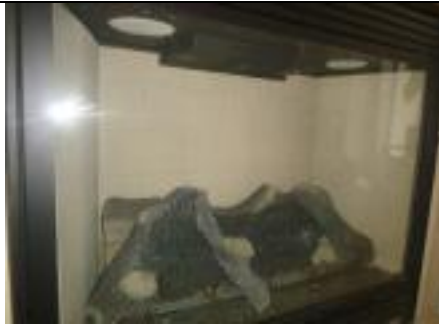
| 1 | <input type="checkbox"/> | <input type="checkbox"/> | <input type="checkbox"/> | <input checked="" type="checkbox"/> | Fireplace: The gas fireplace pilot failed to light using manual controls and the wall-mounted switch. |

Pilot Does Not Light

(F) 1 Fireplace: The gas fireplace pilot failed to light using manual controls and the wall-mounted switch.

Corrective Action: Fireplace contractor to repair the fireplace / pilot to operate properly.
