## Request List for 12835 NC-39 Henderson NC 27537

### Structural Components

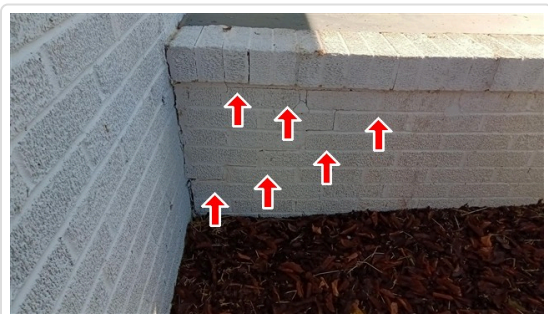
*Stair step cracking in the front porch foundation*

1.0 (1) The foundation wall at the exterior and in the basement of the home has cracks and bulging noted that may have structural implications with through brick cracks and / or long cracks and needs to be reviewed and repaired under the guidance of a licensed structural engineer or a licensed general contractor specializing in foundation structural repairs. A clear structural letter and warranty should be received from the company performing the work.

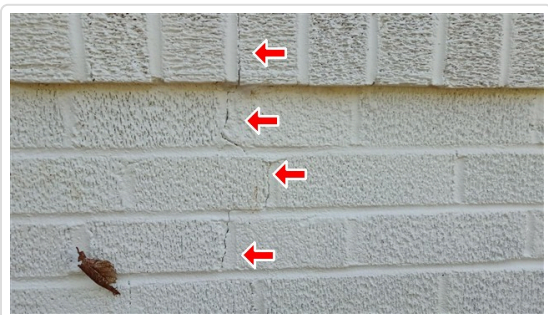
*Cracking with repairs that has been painted*

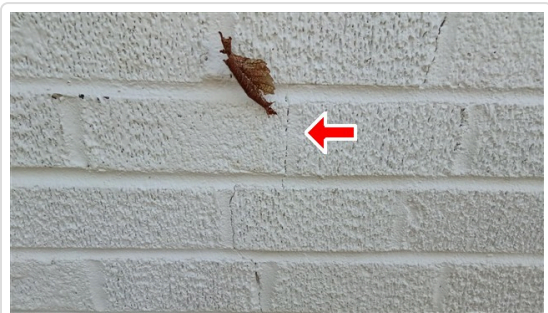
*Cracking with repairs that has been painted*

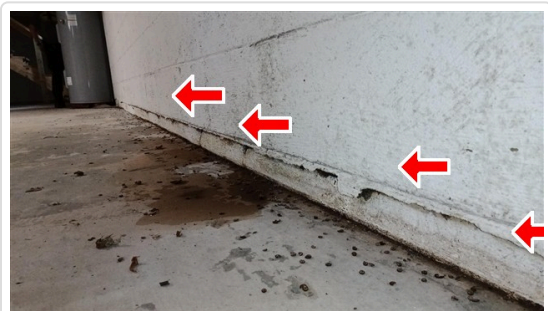
*Straight mortar joint cracking where the blocks are pushed in and are hanging off the supporting blocks*

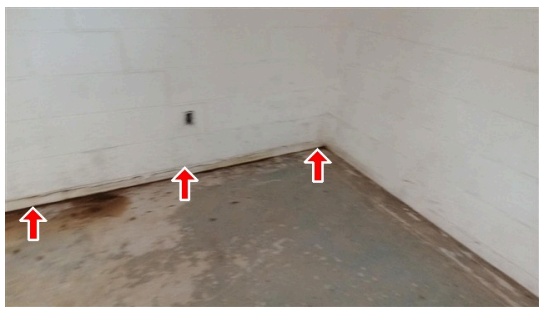
*Straight mortar joint cracking where the blocks are pushed in and are hanging off the supporting blocks.*

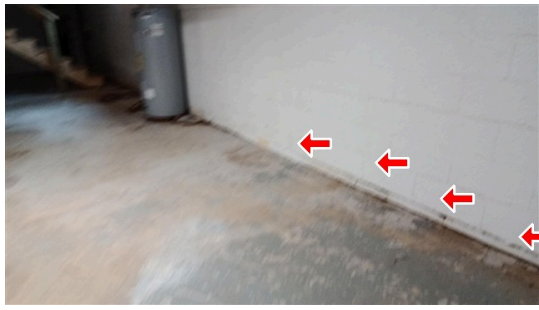
*Straight mortar joint cracking where the blocks are pushed in and are hanging off the supporting blocks.*

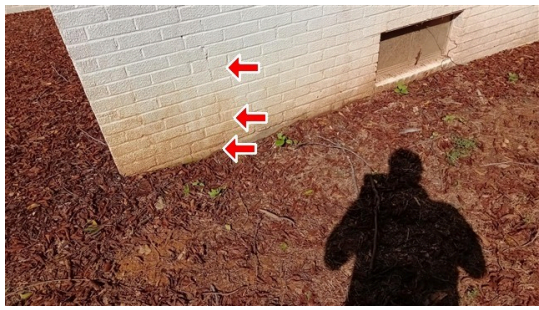
*Straight mortar joint cracking where the blocks are pushed in and are hanging off the supporting blocks.*

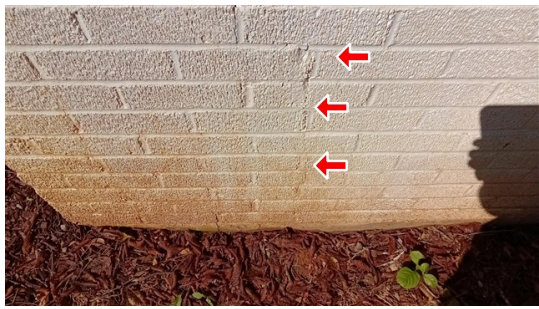
*Cracking with repairs that has been painted*

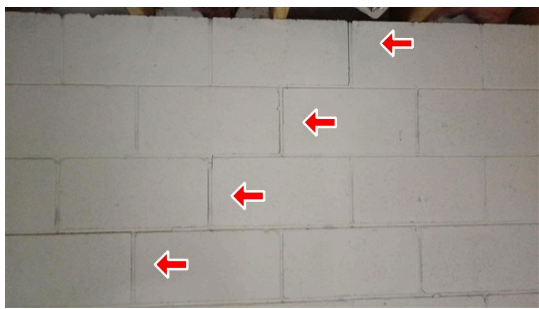
*Long stair step cracks in the basement foundation walls*

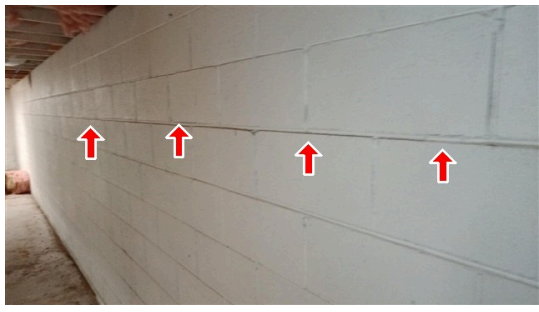
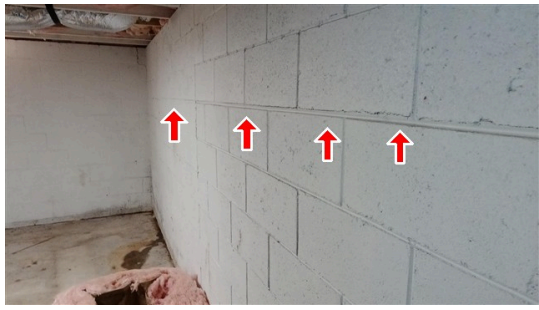
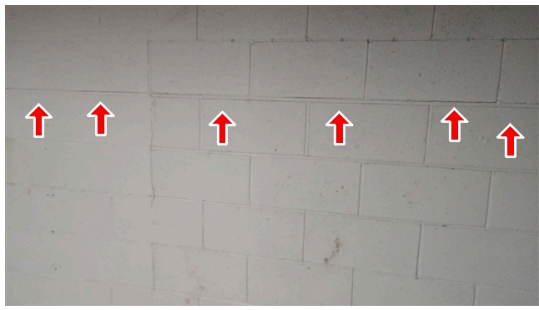
*Hydrostatic pressure has caused the wall to bulge and crack*

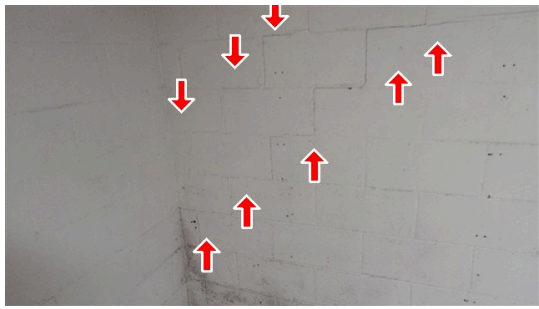
*Long stair step cracks noted*

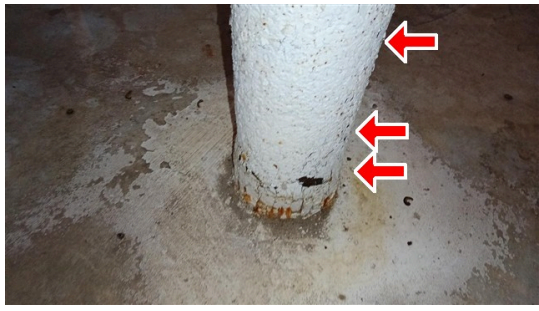
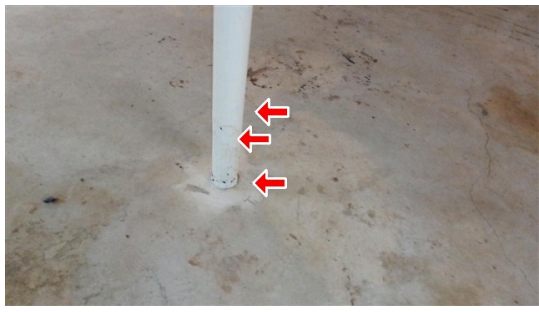
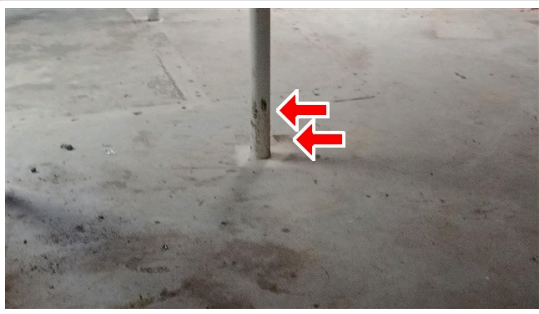
*Rust damaged columns in the basement*

1.1 The metal column in the basement have heavy rust noted to the lower areas and up approximately 10" to 12" up the post and indicates high water at times. This has cause damage that can allow these posts to fail. These posts need to be evaluated and repaired or replaced and the water stoped from entering the basement and causing this damage by a licensed general contractor with all areas made functional.

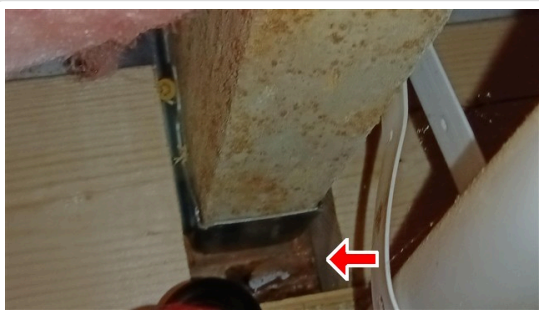
*The girder behind the new wood is believe to be deteriorated and this girder should be exposed and repaired or replaced and made functional by a licensed general contractor.*

1.2 (1) The main girders in the basement that support the center of the floor structure is covered by wood making these areas not visible for inspection. The only gaps in this wood coverings has been probed and the wood is deteriorated. These girders need to be opened up for evaluation by a licensed general contractor and all areas repaired or replaced and made functional.

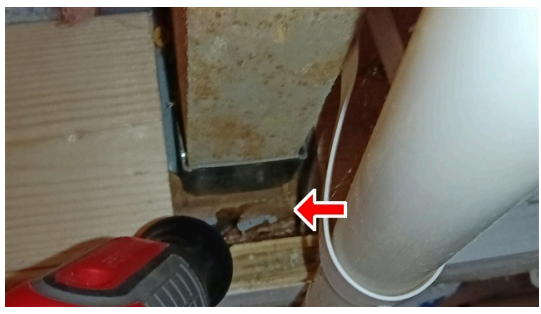
The girder behind the new wood is believe to be deteriorated and this girder should be exposed and repaired or replaced and made functional by a licensed general contractor.

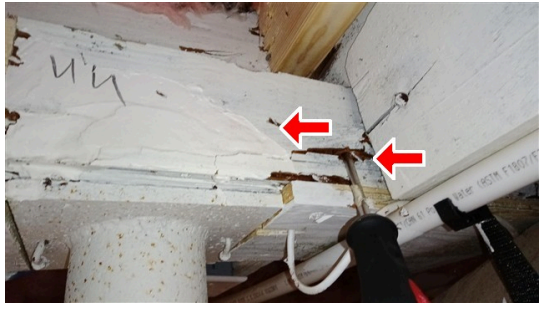
*Deteriorated girders noted*

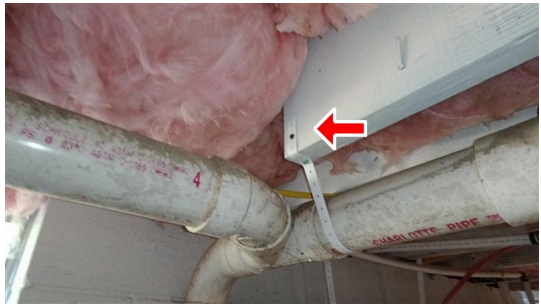
*Cut floor joists noted that are not supported at the ends*

1.2 (2) The floor joists at the center rear of the basement has been notched to install a plumbing drain line and has not been properly supported. All cut joists boards, girders or joists need to be evaluated and properly supported on the ends by a licensed general contractor and all areas made functional.

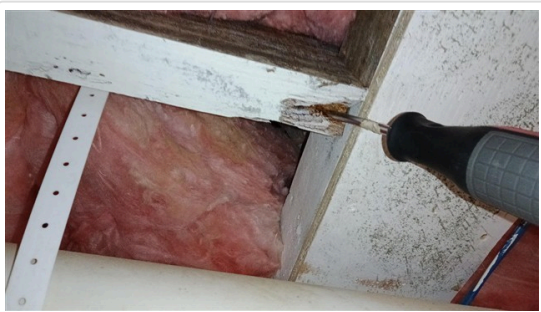
*Deteriorated floor joist on the end*

1.2 (3) The floor joists and other framing members at the center of the basement have deterioration noted from water or moisture and a lack of ventilation. The cause of the moisture and or lack of ventilation needs to be located and repaired and made functional. These areas can get worse with time and needs repaired or replaced and all areas probed for concealed damage. All repairs are to be performed by a licensed general contractor with all areas made functional.

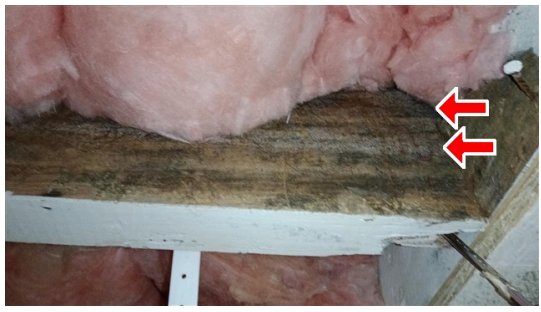
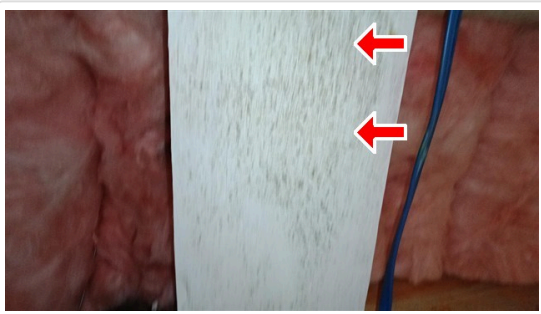
*Fungal growth noted on the floor framing*

*Fungal growth on the floor framing*

1.2 (4) The floor framing in the crawlspace has deterioration and fungus growth from radiant moisture and this can be a health concern and this crawlspace and floor framing needs to be evaluated and probed for concealed damage with proper repairs performed by a licensed general contractor and all areas made functional and safe.
