## HOME INSPECTION REPORT

Luis Turner Inspections, LLC

633 Grace Hodge Drive

Cary NC 27519

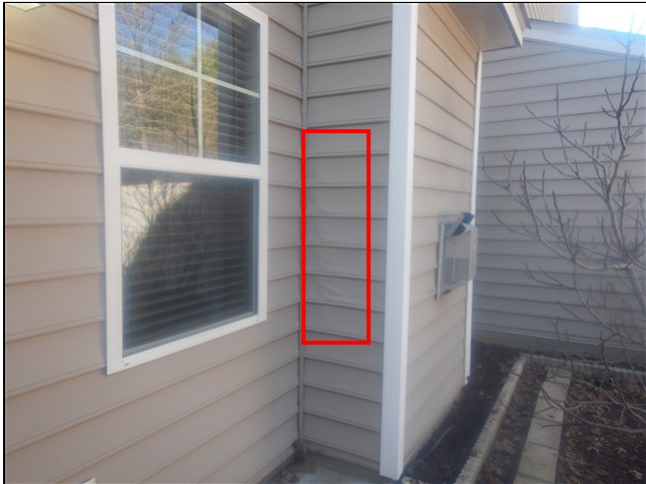
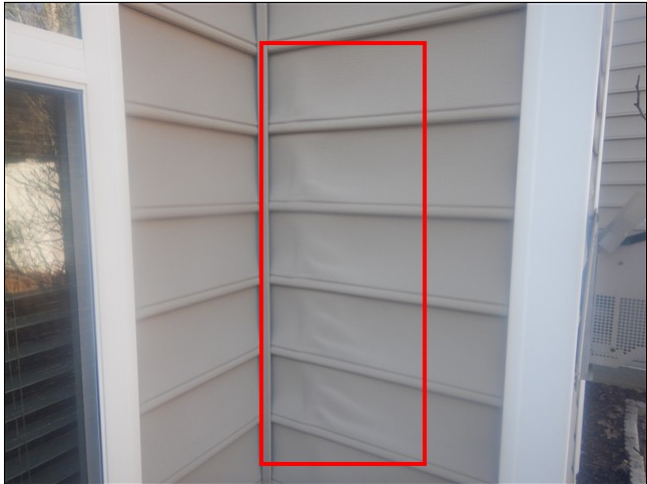
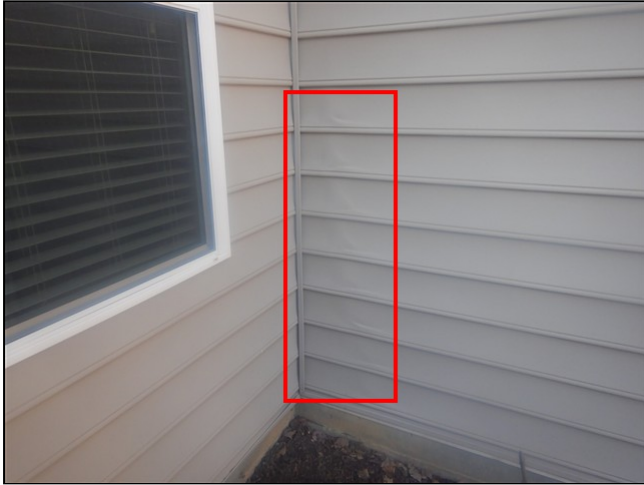
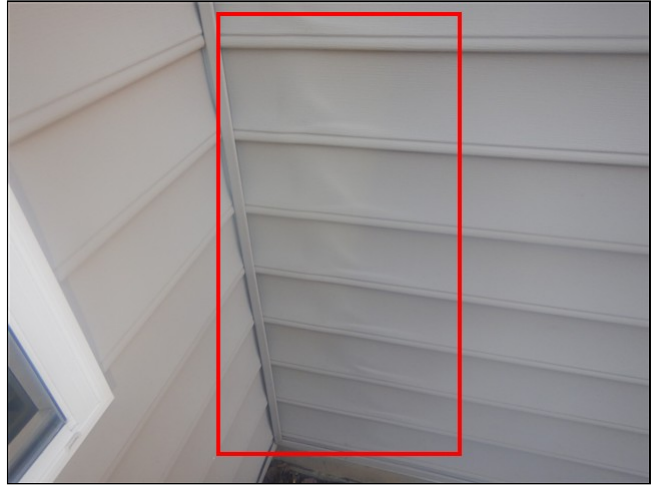
- 1 (1) Vinyl siding is deformed at rear first floor of house at right side of chimney and at left side of house. See photographs below. It is likely that sunlight reflected from adjacent windows has caused thermal distortion at these locations. Further deterioration of the vinyl siding may be anticipated over time. More information on this topic is available at <http://www.greenbuildingadvisor.com/blogs/dept/musings/window-reflections-can-melt-vinyl-siding>. A vinyl siding contractor can provide short-term repairs by replacing the affected vinyl siding. A long-term repair may involve shielding of the window glass.
- 2 (2) Water stained sheathing is noted at rear wall of attached storage room. See photograph below. If further information is needed, a qualified contractor can evaluate, provide further information, and perform repairs as needed.

(1) Vinyl siding is deformed at rear first floor of house at right side of chimney and at left side of house. See photographs below. It is likely that sunlight reflected from adjacent windows has caused thermal distortion at these locations. Further deterioration of the vinyl siding may be anticipated over time. More information on this topic is available at <http://www.greenbuildingadvisor.com/blogs/dept/musings/window-reflections-can-melt-vinyl-siding>. A vinyl siding contractor can provide short-term repairs by replacing the affected vinyl siding. A long-term repair may involve shielding of the window glass.

2.0 Item 1(Picture) Deformed vinyl siding

2.0 Item 2(Picture) Close up of deformed vinyl siding

2.0 Item 3(Picture) Deformed vinyl siding

2.0 Item 4(Picture) Close up of deformed vinyl siding

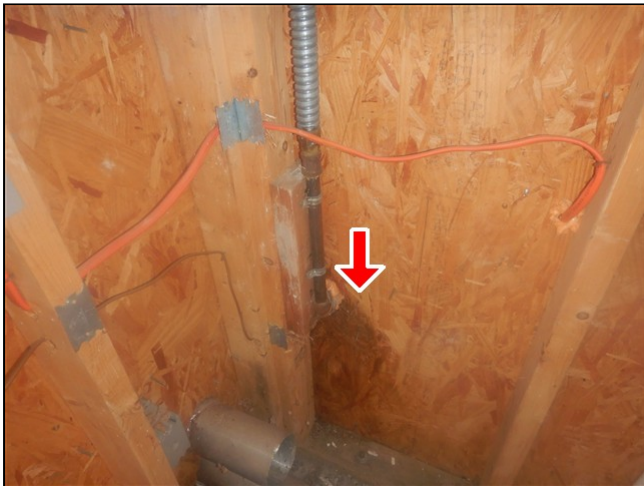
(2) Water stained sheathing is noted at rear wall of attached storage room. See photograph below. If further information is needed, a qualified contractor can evaluate, provide further information, and perform repairs as needed.

2.0 Item 5(Picture) Water stained sheathing

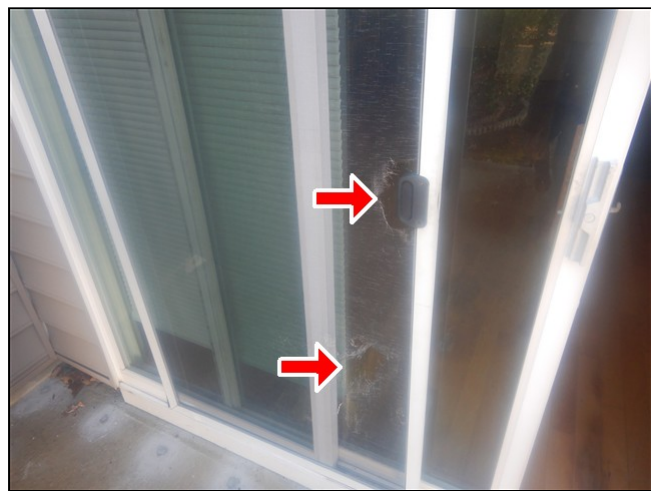
- (1) Sliding glass door requires excess effort to latch and lock. A qualified contractor can evaluate, provide further information, and perform repairs as needed.
- (2) Holes are noted in screen door of sliding glass door. See photograph below. A qualified contractor can perform repairs.

2.1 Item 1(Picture) Holes in screen

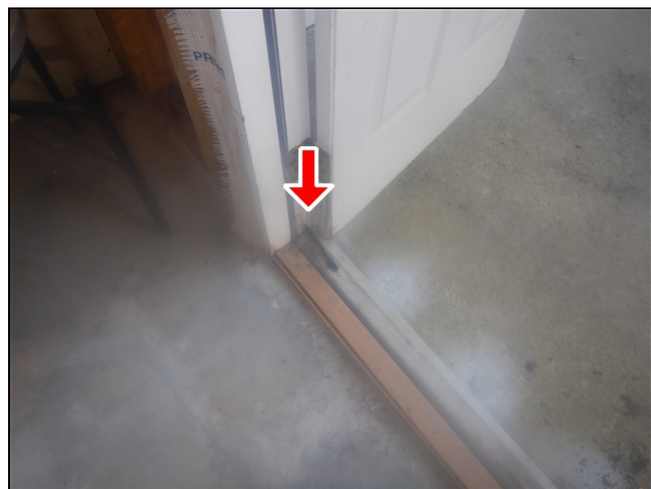
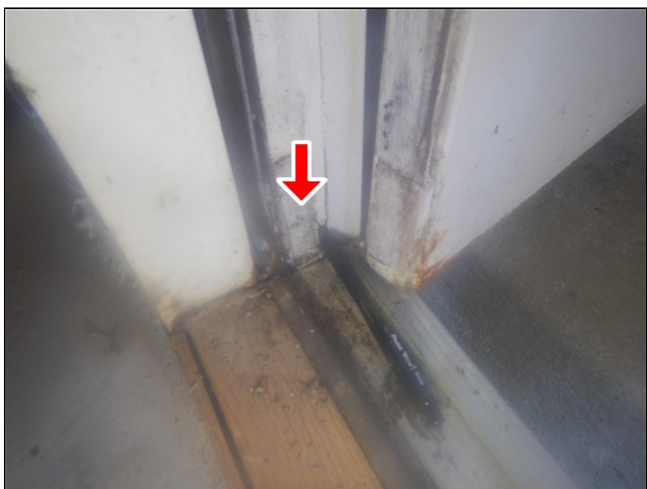
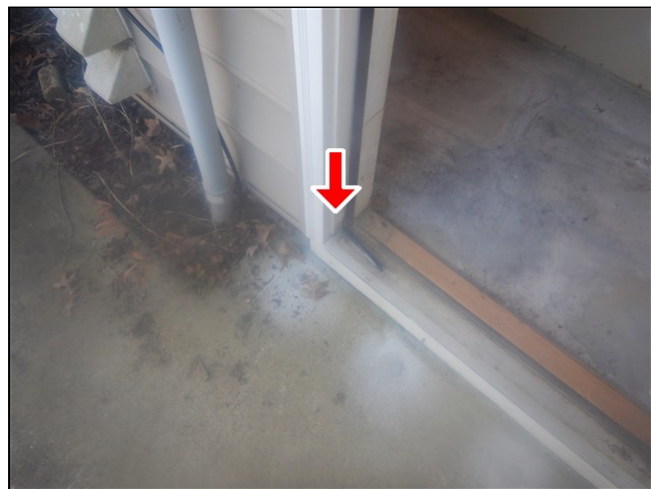
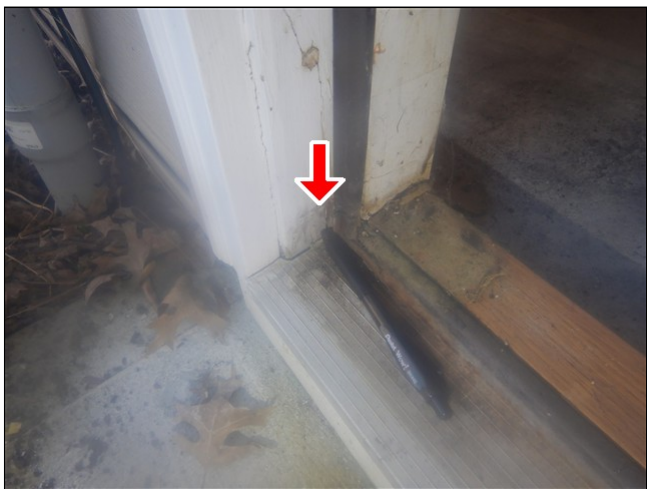
- (3) Water damaged wood is noted at base of door jams at attached storage room door. See photographs below. A qualified contractor can evaluate, provide further information and perform repairs as needed.

2.1 Item 2(Picture) Water damaged wood

2.1 Item 3(Picture) Close up of water damaged wood

2.1 Item 4(Picture) Water damaged wood

2.1 Item 5(Picture) Close up of water damaged wood

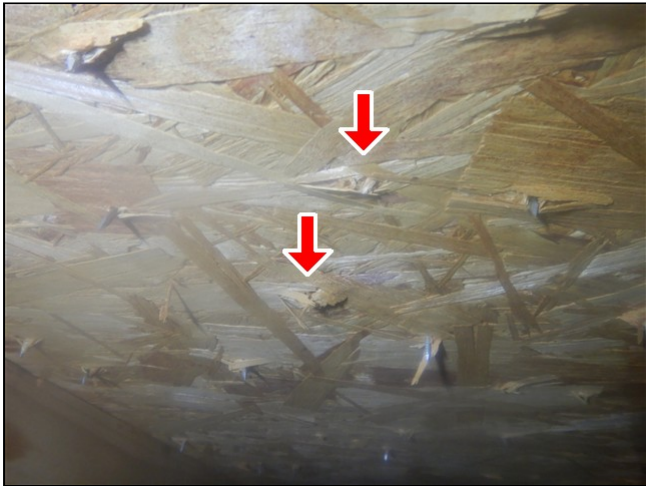
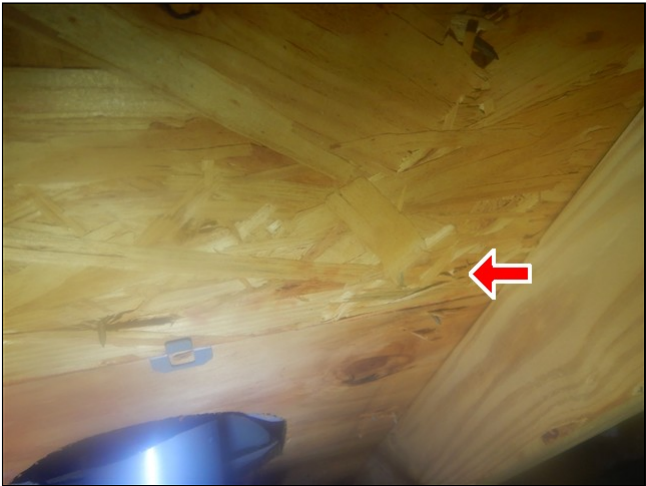
- 7 The roof shingles are not original on this house. Holes are noted in attic roof sheathing where original nails have been removed. See examples in photographs below. The homeowners association may have information on year of roof replacement or a qualified roofing contractor can evaluate the roof system, provide further information and perform repairs if needed.

The roof shingles are not original on this house. Holes are noted in attic roof sheathing where original nails have been removed. See examples in photographs below. The homeowners association may have information on year of roof replacement or a qualified roofing contractor can evaluate the roof system, provide further information and perform repairs if needed.

3.0 Item 1(Picture) Holes where original nails have been removed

3.0 Item 2(Picture) Hole where original nail has been removed

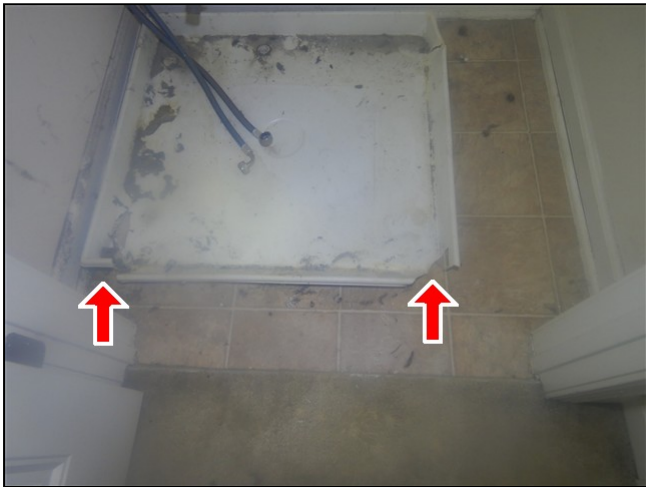
- 8 Base of washing machine overflow pan is damaged. See photograph below. The overflow pan cannot hold spilled water in this condition. A qualified contractor can perform repairs.

**Comments:** Repair or Replace  
Base of washing machine overflow pan is damaged. See photograph below. The overflow pan cannot hold spilled water in this condition. A qualified contractor can perform repairs.

4.0 Item 1(Picture) Damaged overflow pan

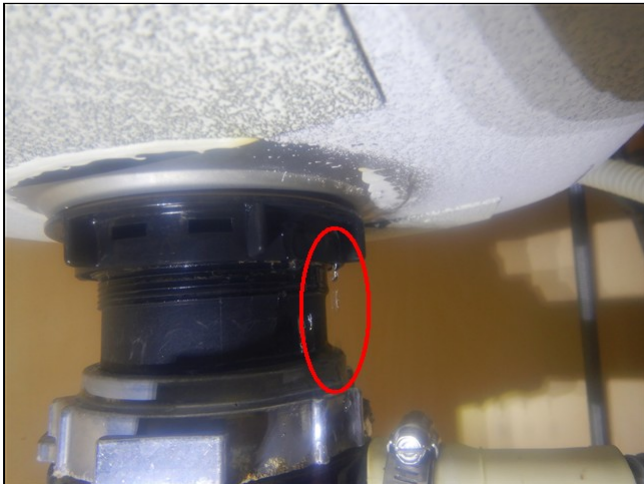
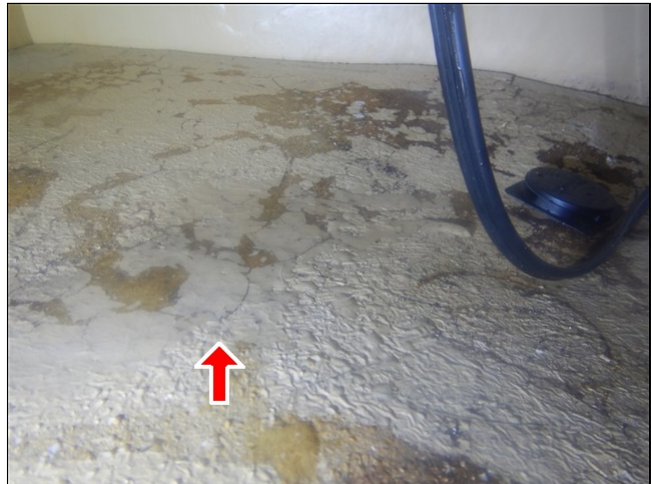
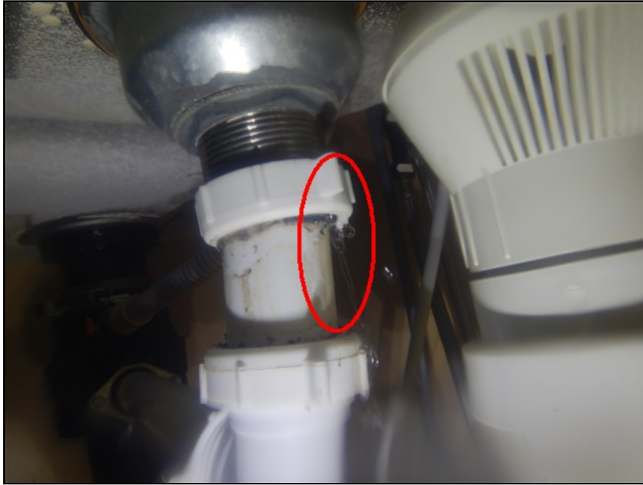
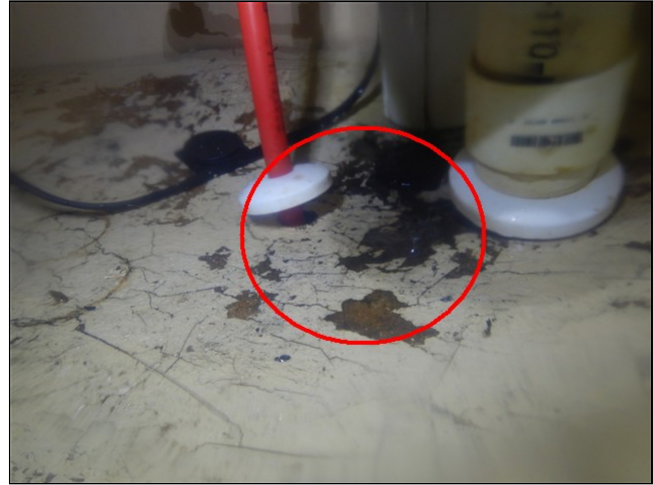
(1) Leaks are noted at drain pipes below both sides of kitchen sink. Puddled water is noted under the leaks. See photographs below. A plumbing contractor can evaluate and perform repairs.

4.4 Item 1(Picture) Leak at disposal side of kitchen sink

4.4 Item 2(Picture) Puddled water

4.4 Item 3(Picture) Leak at rear half of kitchen sink

4.4 Item 4(Picture) Puddled water

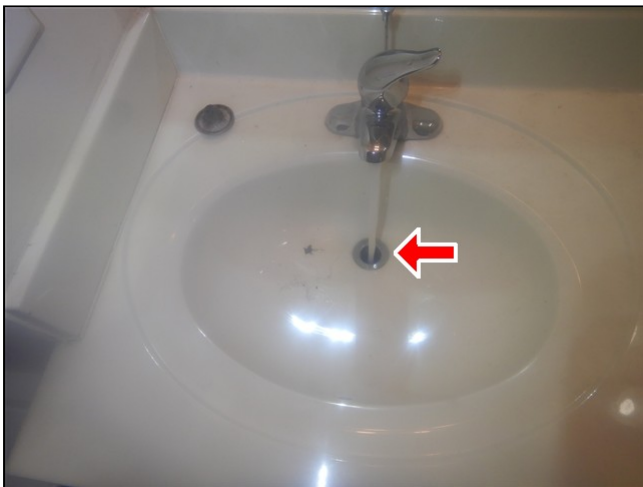
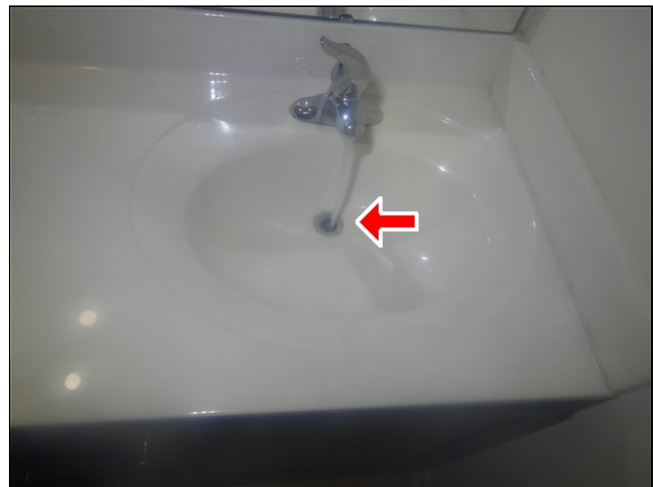
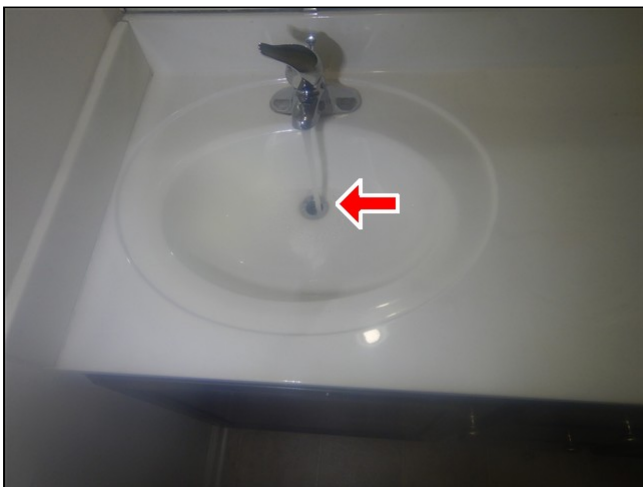
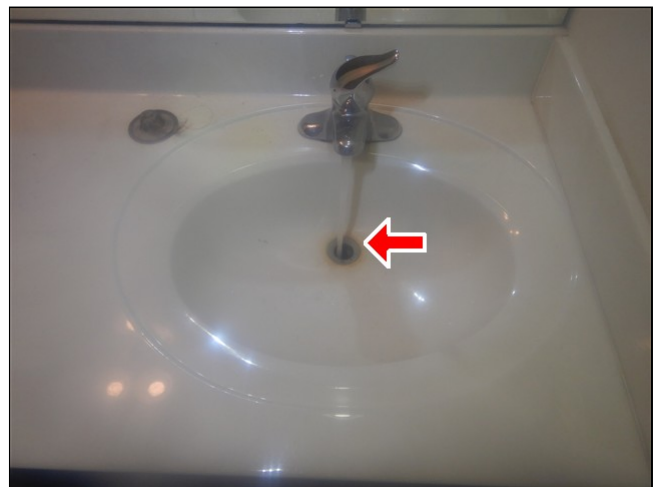
(3) Drain pop-ups are missing at all vanity basins in half bathroom, in master bathroom, and second floor bathroom. See examples in photographs below. The basins cannot be filled with water. The drain pipes and water flow from these vanity basins cannot be fully evaluated because of the missing drain pop-ups. A plumbing contractor can install drain pop-ups and evaluate the fixtures.

4.4 Item 5(Picture) Missing drain pop-up

4.4 Item 6(Picture) Missing drain pop-up

4.4 Item 7(Picture) Missing drain pop-up

4.4 Item 8(Picture) Missing drain pop-up

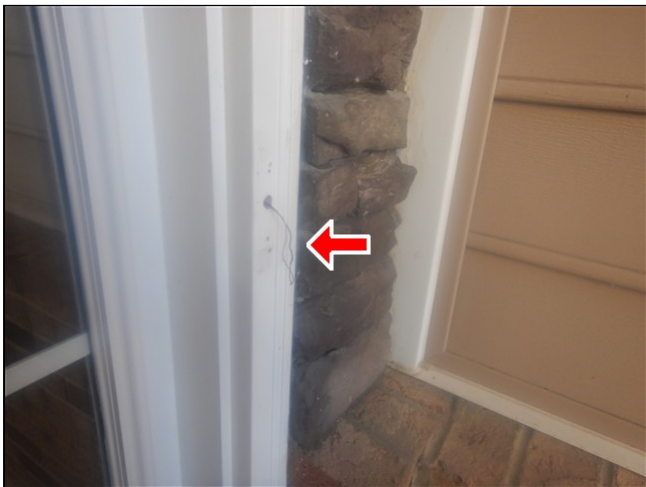
- 13 Doorbell button is missing at front door. See photograph below. An electrical contractor can perform repairs.

5.3 Item 1(Picture) Missing doorbell

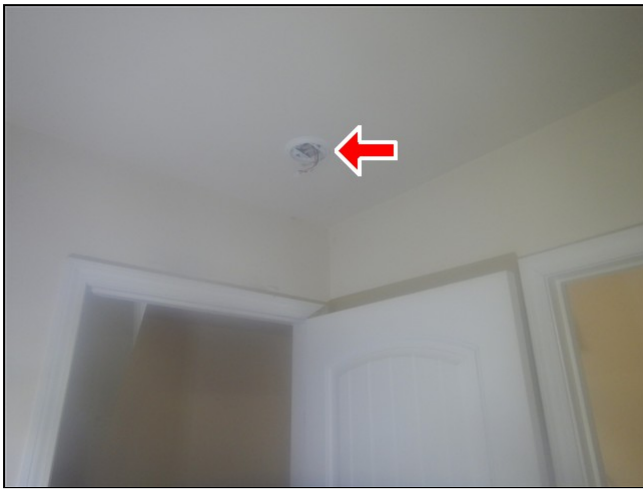
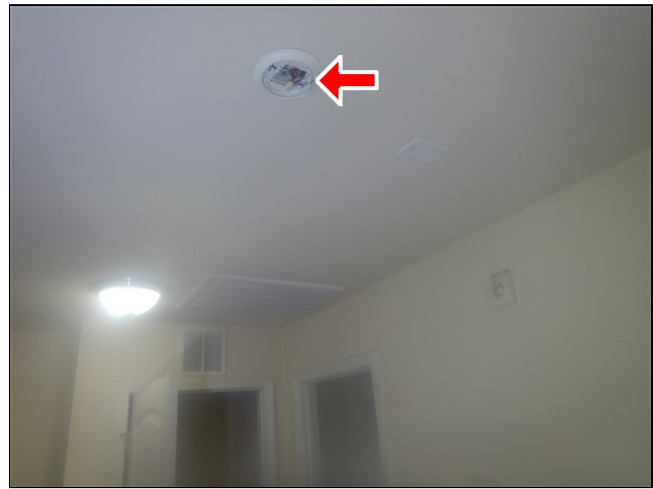
(2) Smoke detector cartridges are not installed in second floor right rear bedroom and in second floor hallway. See photographs below. An electrical contractor can perform repairs.

5.6 Item 1(Picture) Missing cartridge

5.6 Item 2(Picture) Missing cartridge

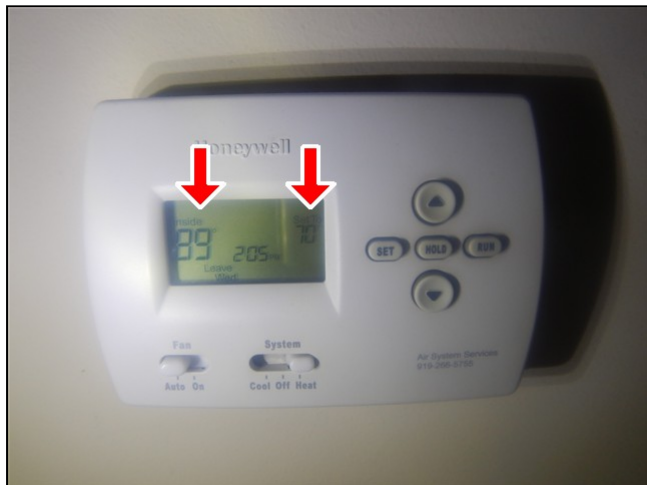
At beginning of inspection, second floor thermostat showed an interior temperature of 89 degrees with a requested temperature of 70 degrees. The first floor thermostat showed an interior temperature of 64 degrees with a requested temperature of 69 degrees. The requested temperature at second floor thermostat could not be adjusted down. The blue flames at the dual-zoned natural gas furnace could not be turned off at second floor thermostat by changing mode from heat to off. See examples in photographs below. The gas furnace was turned off at electrical cutoff switch near furnace and left off for approximately half hour. The cut off switch was turned on and second floor thermostat was turned to heat. Furnace heat could not be adjusted down at thermostat. A mechanical contractor can evaluate thermostats and heat system, provide further information and perform repairs as needed. Heat was left off in house at end of inspection.

6.1 Item 1(Picture) 2nd floor thermostat in heat mode with interior temperature of 89 degrees and requested temperature of 70 degrees

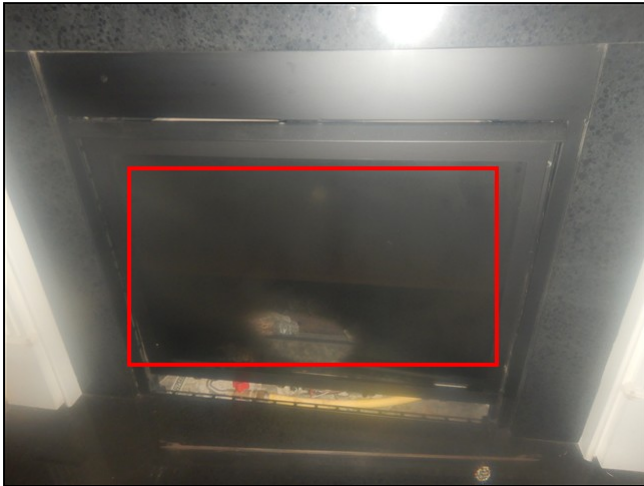
(2) Black smoke residue is noted at interior of fireplace glass. See photograph below. The residue on the interior glass is either dirt or may result from improper combustion of fuel. A fireplace specialist can evaluate, provide further information and perform repairs as needed.

6.6 Item 1(Picture) Residue at fireplace glass

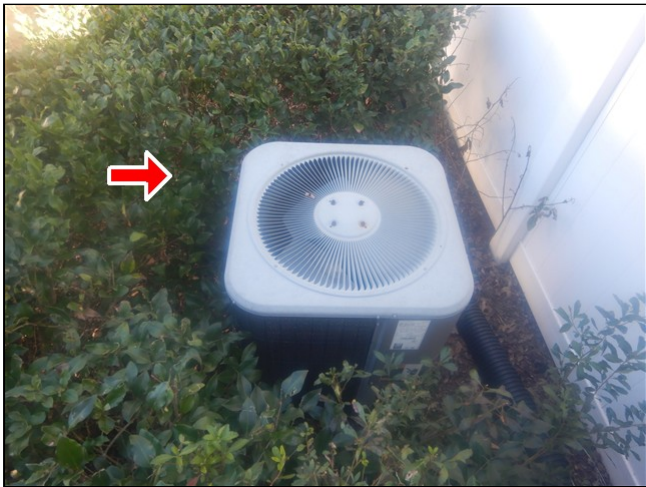
**Comments:** Repair or Replace  
(1) Bushes are too close to heat pump. See photograph below. A heat pump must have proper clearances in order to function properly. A qualified contractor can perform repairs.

7.0 Item 1(Picture) Bushes too close to heat pump  
(2) All heating and cooling equipment should be serviced annually. The heat pump cabinet of the cooling system is seventeen years old. The evaporator coil cabinet of the cooling system is eight years old. The gas furnace for this home is seventeen years old. Since most of equipment is beyond the typical service life of twelve to fifteen years old for this type of equipment, a prudent buyer will have the annual service performed on the heating and cooling equipment prior to closing by an independent mechanical contractor.  
(3) Evaluation of the cooling system is limited to a visual inspection. The system cannot be effectively tested when the outside temperature is 65 degrees or less and may damage the compressor. Outside temperature is less than 65 degrees. Temperature split difference cannot be measured.

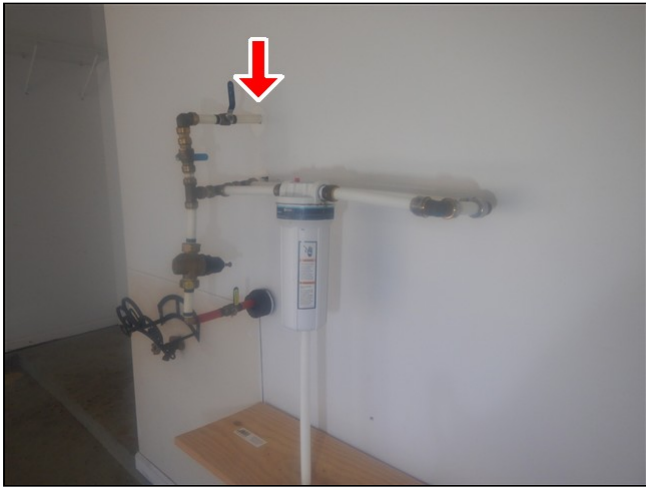
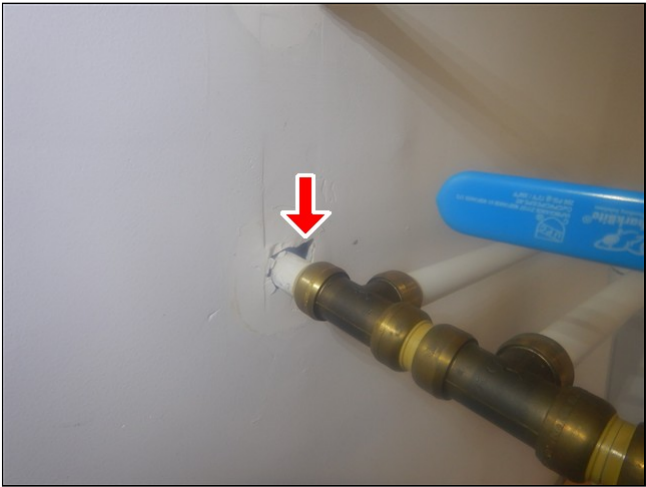
(1) A hole is noted in drywall at rear of garage where water supply pipe penetrates wall. See photographs below. The hole is a breach in the firewall between the garage and the living space. Automobile exhaust gases may enter the living space. A qualified contractor can perform repairs.

8.1 Item 1(Picture) Hole in garage drywall

8.1 Item 2(Picture) Close up of hole in garage drywall

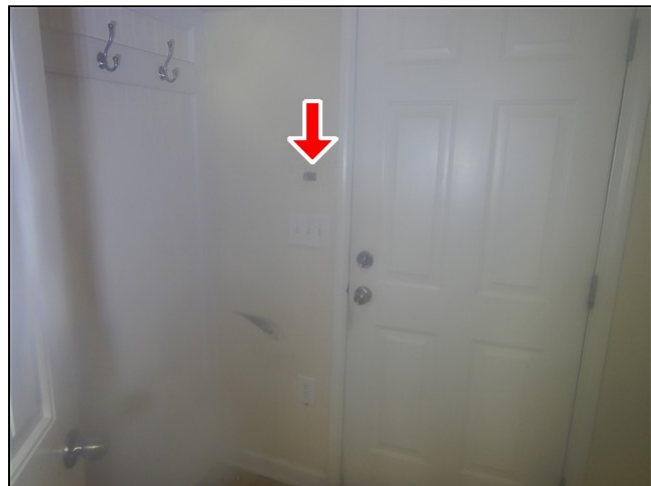
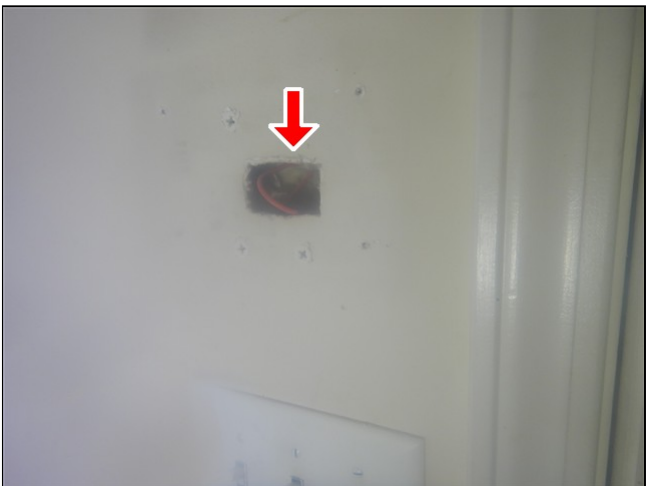
(2) A hole in drywall with approximate dimensions of two inches by three inches is noted beside entry door to garage. See photographs below. Holes in drywall allow passage of pests and increase energy costs. A qualified contractor can perform repairs.

8.1 Item 3(Picture) Hole in drywall

8.1 Item 4(Picture) Close up of hole in drywall

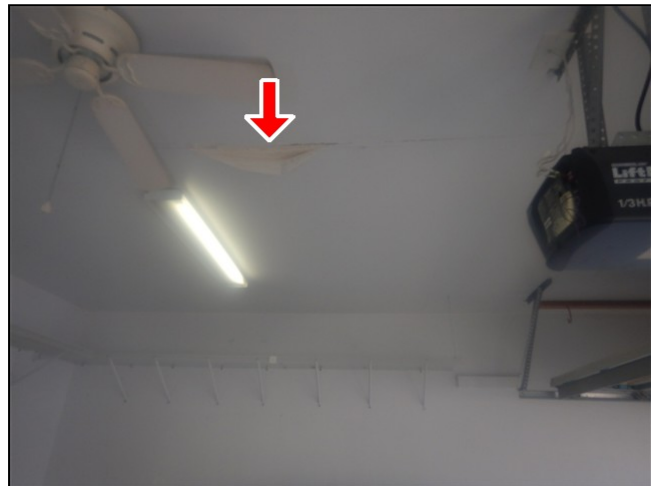
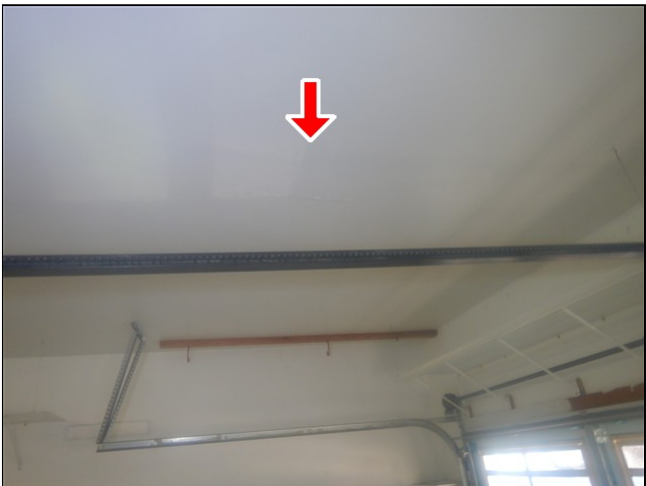
Drywall tape is loose at garage ceiling. See examples in photographs below. A qualified contractor can evaluate and perform repairs.

8.2 Item 1(Picture) Loose drywall tape

8.2 Item 2(Picture) Loose drywall tape

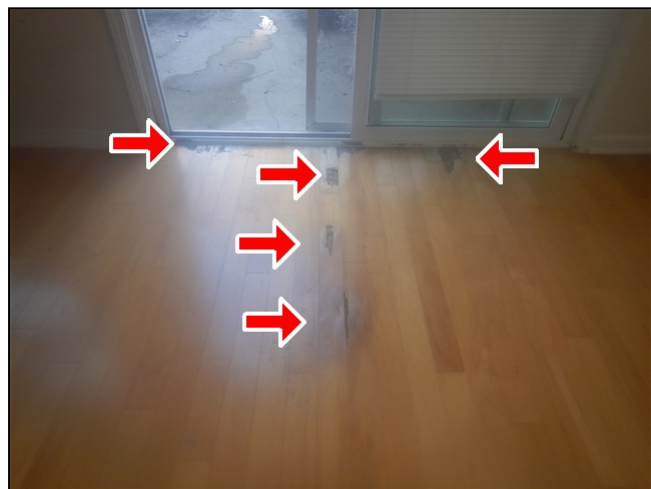
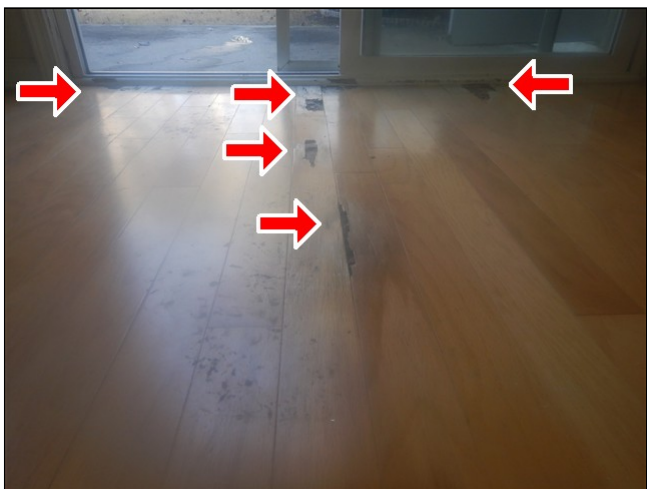
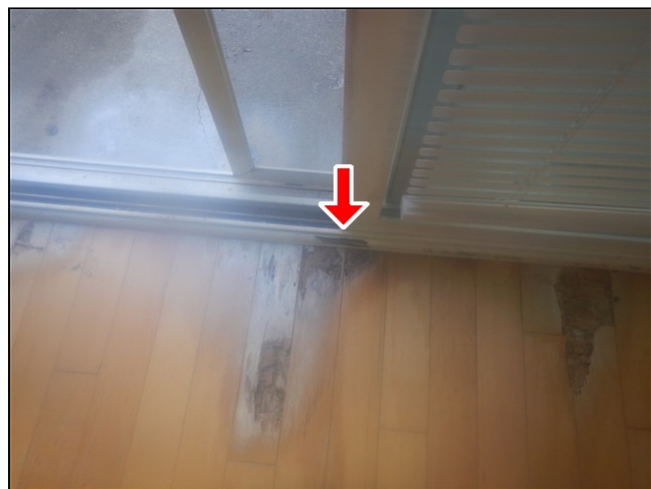
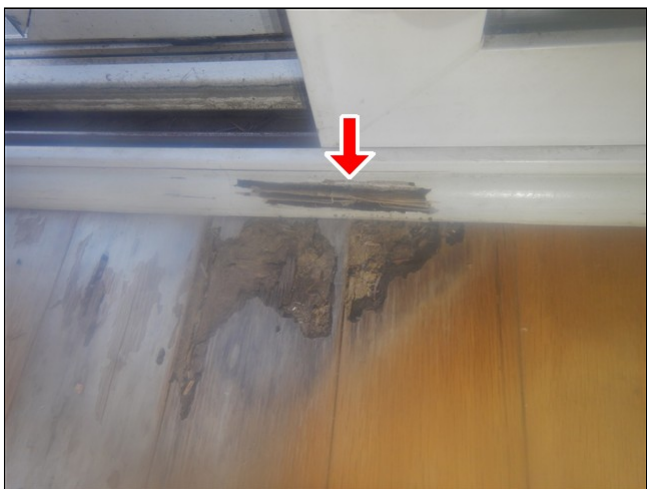
(1) Damaged hardwood flooring and damaged quarter round molding are noted in dining area near sliding glass door. See photographs below. Removal of building materials may reveal more damage than can be determined at time of inspection. The damage is likely due to wood destroying insects. A qualified contractor can evaluate, provide further information and perform repairs as needed.

8.3 Item 1(Picture) Damaged hardwood flooring

8.3 Item 2(Picture) Close up of damaged hardwood flooring

8.3 Item 3(Picture) Damaged quarter round molding

8.3 Item 4(Picture) Close up of damaged quarter round molding

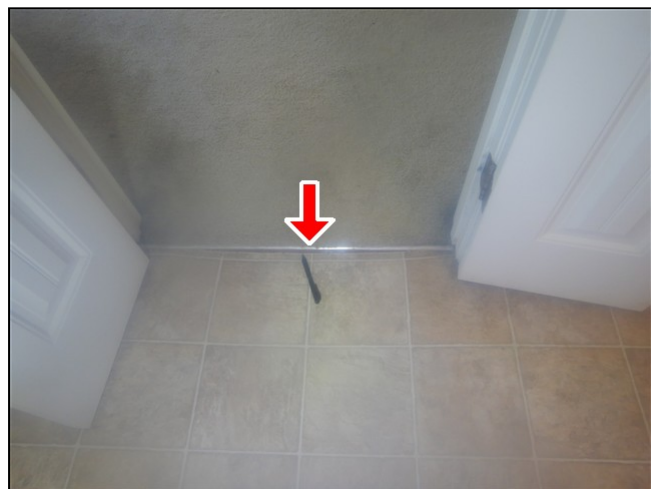
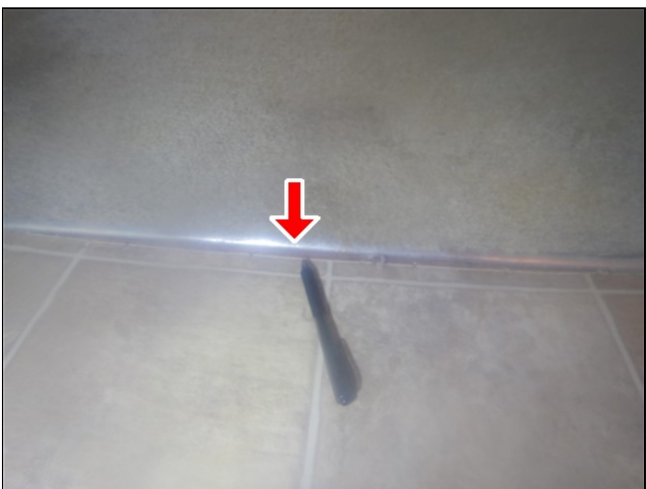
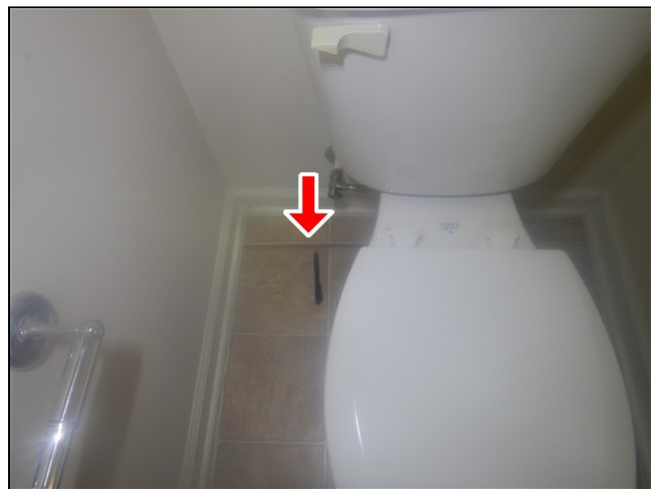
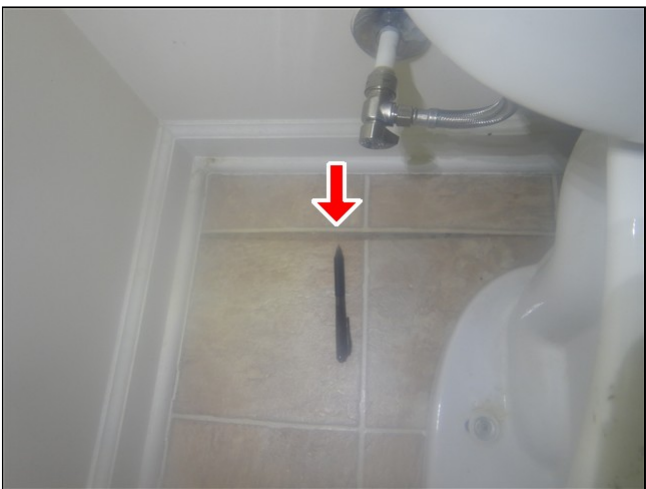
(2) Master bathroom vinyl flooring does not extend to threshold near master bedroom. Vinyl flooring is separated near toilet in master bathroom. See photographs below. A flooring contractor or qualified contractor can perform repairs.

8.3 Item 5(Picture) Vinyl flooring not extending to threshold

8.3 Item 6(Picture) Close up of vinyl flooring not extending to threshold

8.3 Item 7(Picture) Separated vinyl flooring

8.3 Item 8(Picture) Close up of separated vinyl flooring

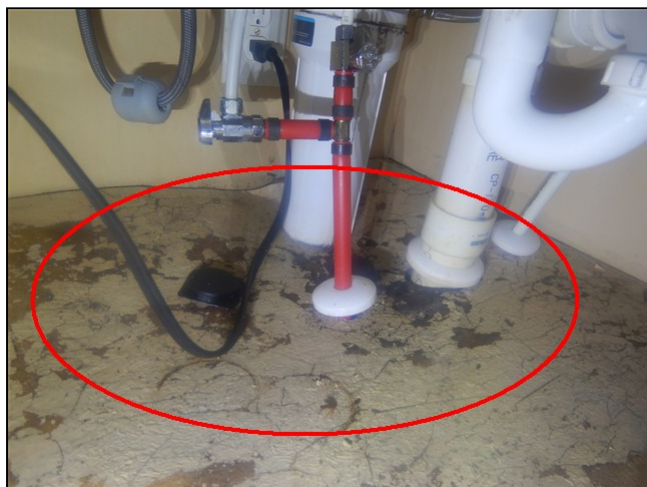
The base of the kitchen sink cabinet has sagged and is damaged. See photograph below. A qualified contractor can perform repairs.

8.4 Item 1(Picture) Sagged and damaged base of cabinet

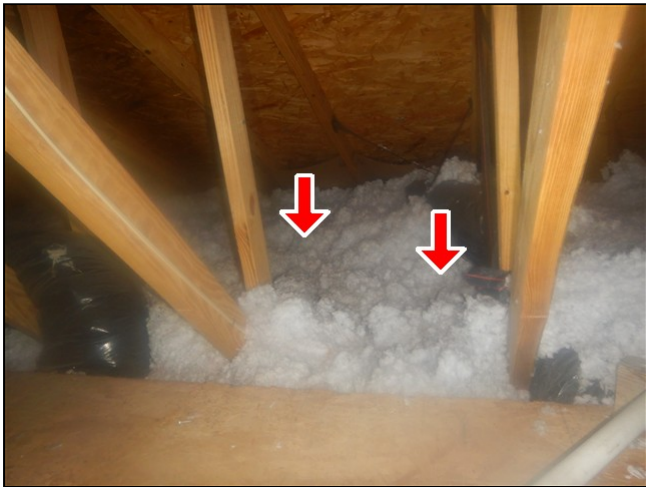
**Comments:** Repair or Replace  
Attic insulation has been disturbed by movement of the insulation. See examples in photograph below. Even distribution of insulation will increase energy efficiency. A qualified contractor can perform repairs.

9.0 Item 1(Picture) Low spots in insulation
