**GREEN AT SCOTTS MILL MASTER  
OWNERS ASSOCIATION  
APEX, NC**

**OCTOBER 5, 2023**

**FULL RESERVE STUDY  
UPDATE WITH SITE VISIT**

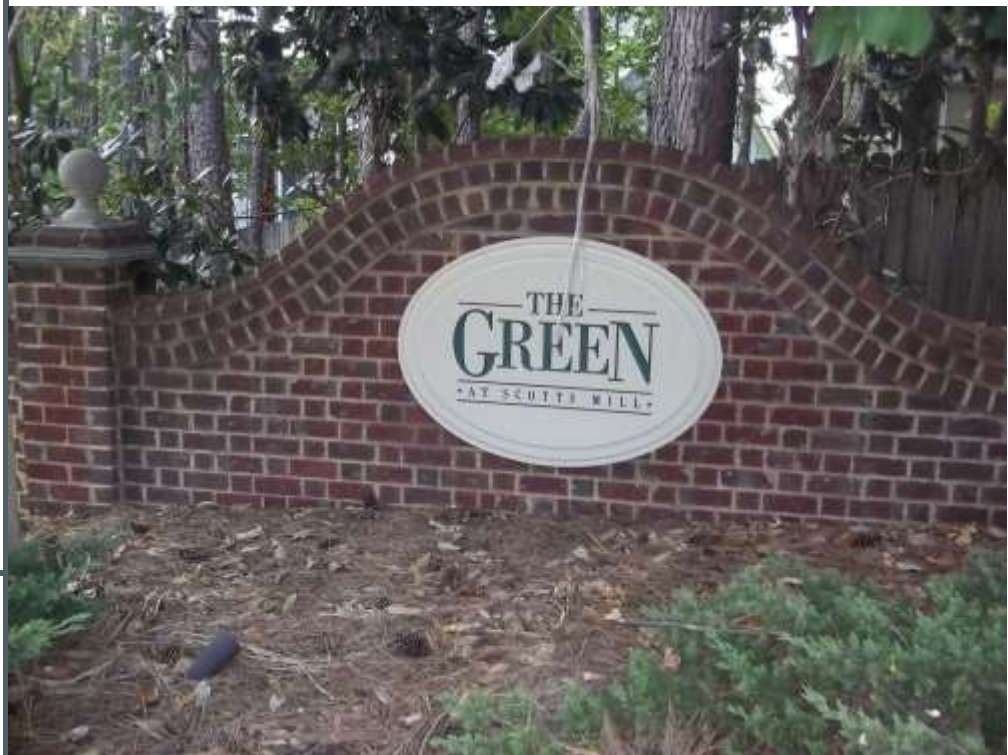
**Photo No.  
1**

Entrance signage

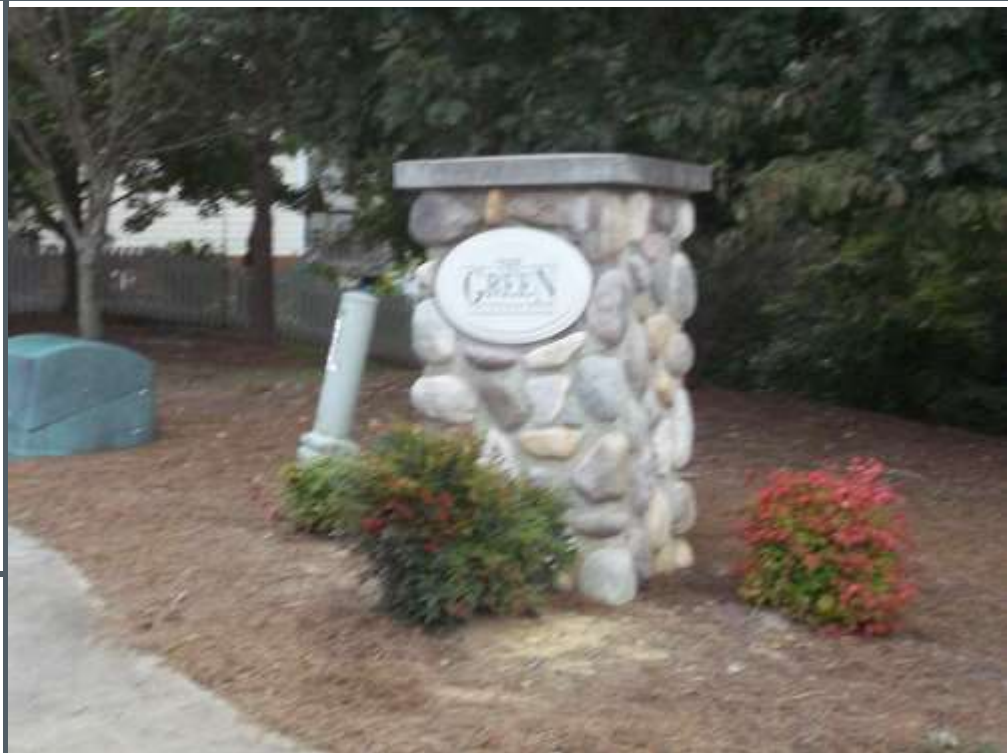
**Photo No.  
2**

Monument pier

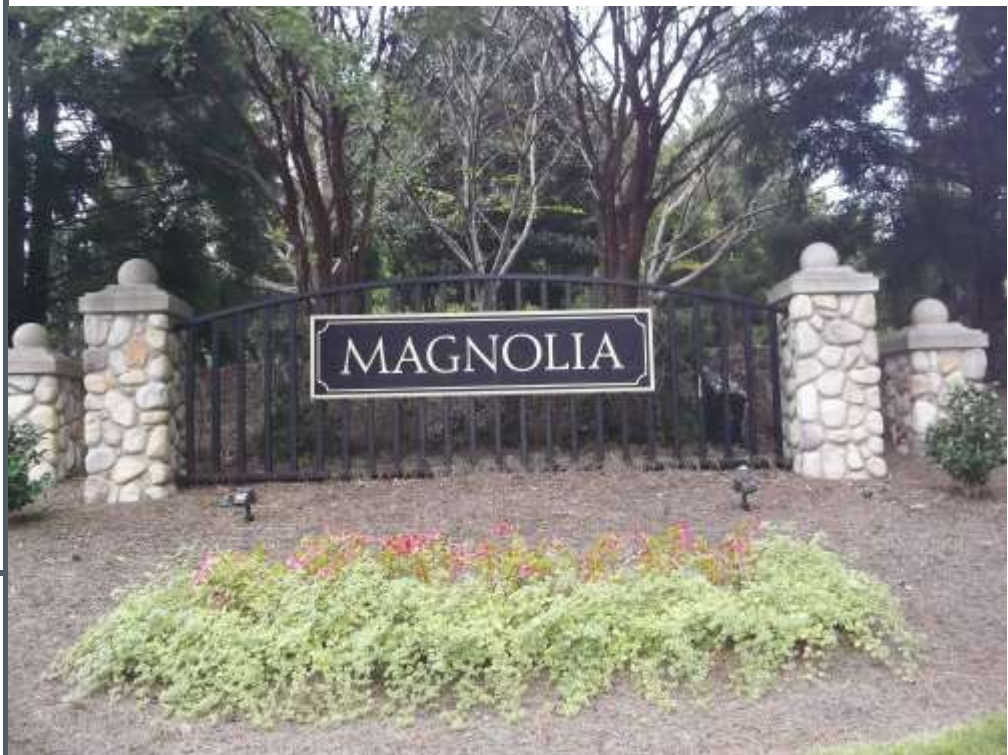
**Photo No.**  
**3**

Entrance signage

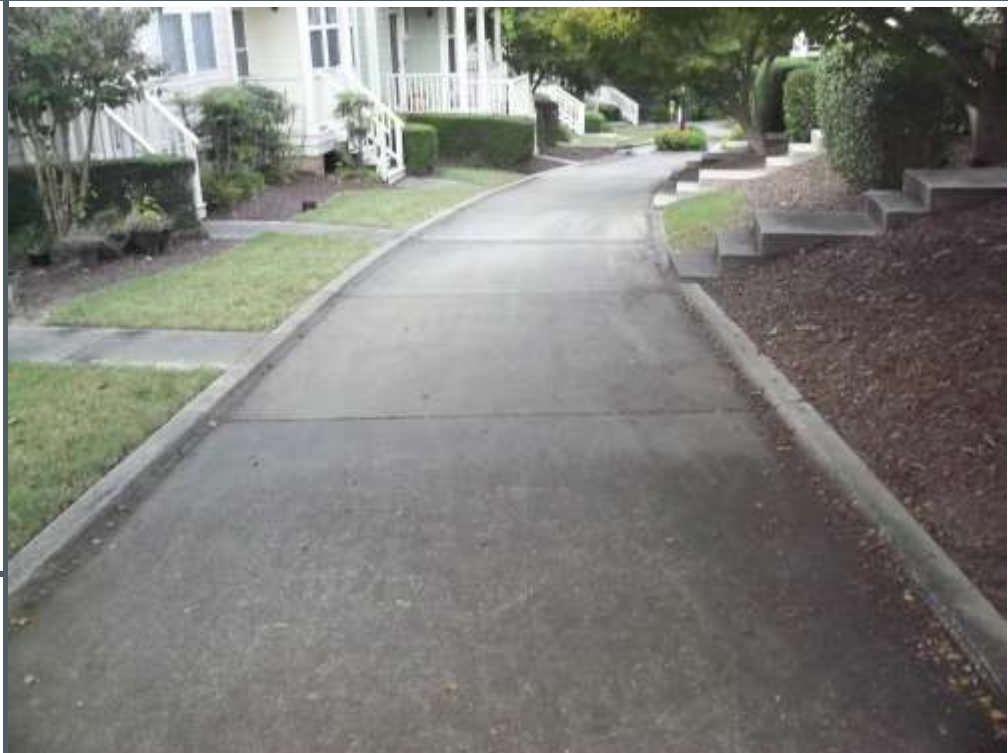
**Photo No.**  
**4**

Paved walkway

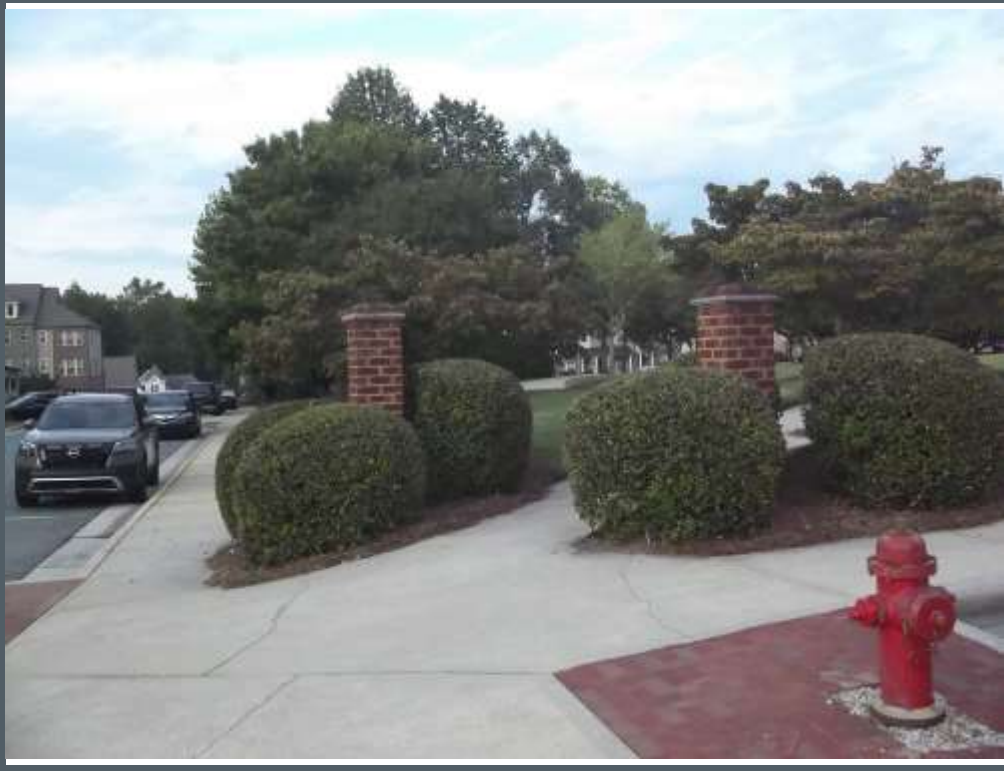
| <p><b>Photo No.</b></p> <p>5</p> | |

| <p><b>Description</b></p> <p>Pavilion area</p> | |

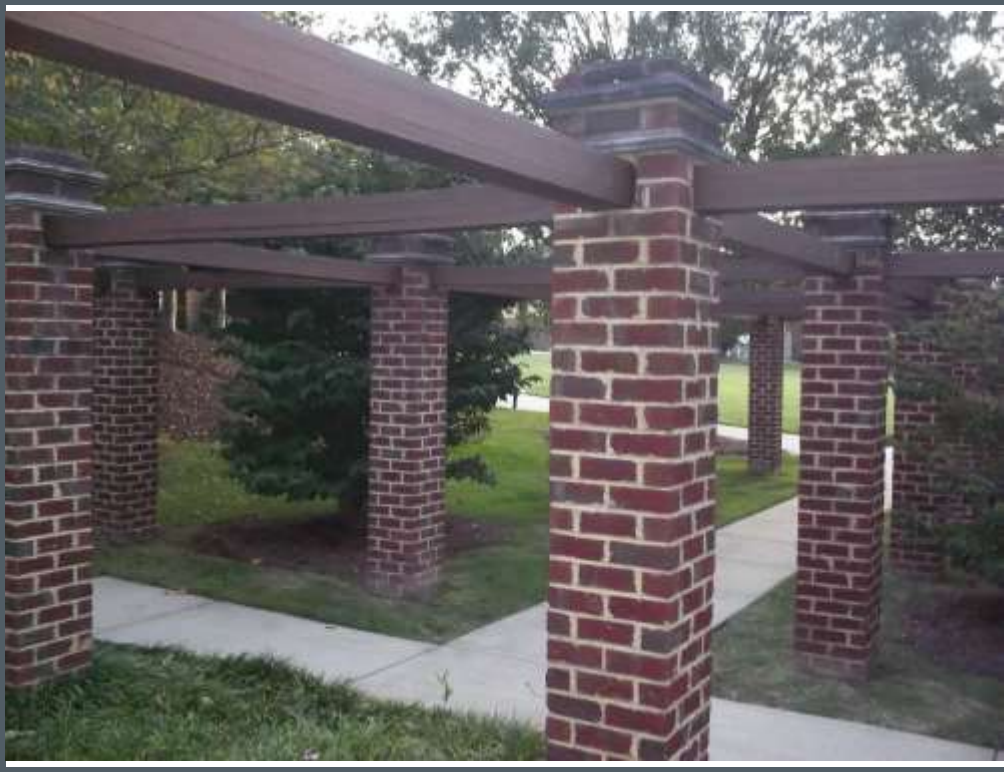
| <p><b>Photo No.</b></p> <p>6</p> | |

| <p><b>Description</b></p> <p>Pavilion</p> | |

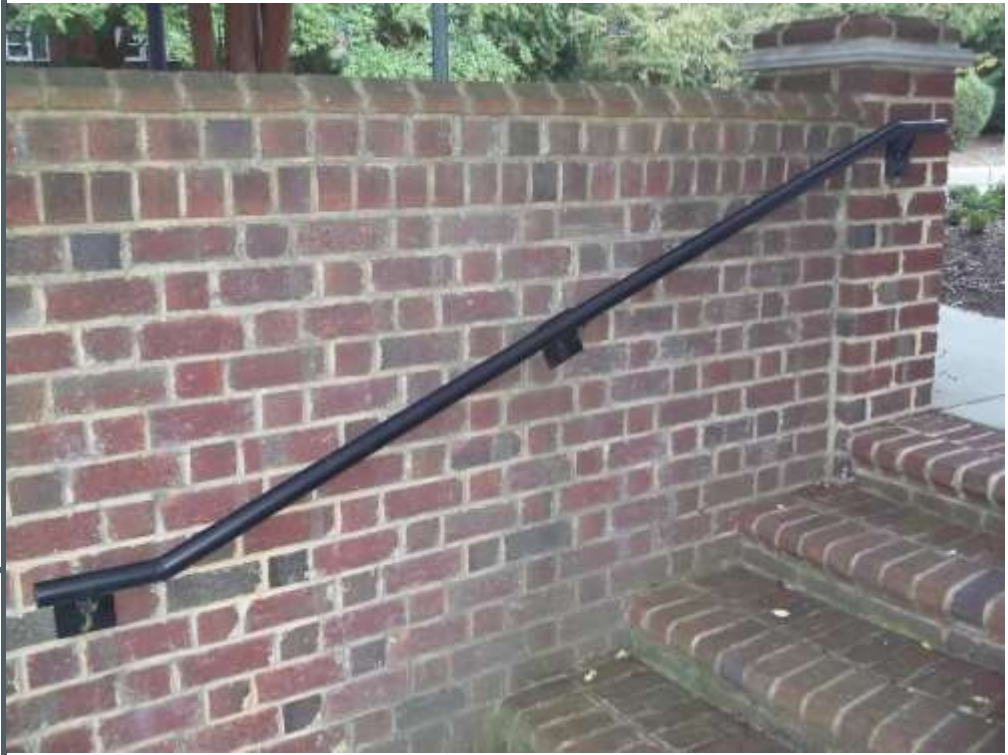
**Photo No.**  
**7**

The pavilion includes several masonry walls and piers with metal railings at the steps. Stained timbers are located across the masonry piers at the northeast corner of the pavilion. We noted limited dislodged, broken, and missing bricks on the masonry piers and at the walls. We have included funds for masonry repairs and painting the metal railings at the pavilion every 5 years beginning in 2027. Additional funds are included to stain and replace the timber beams, as needed.

Railings at pavilion

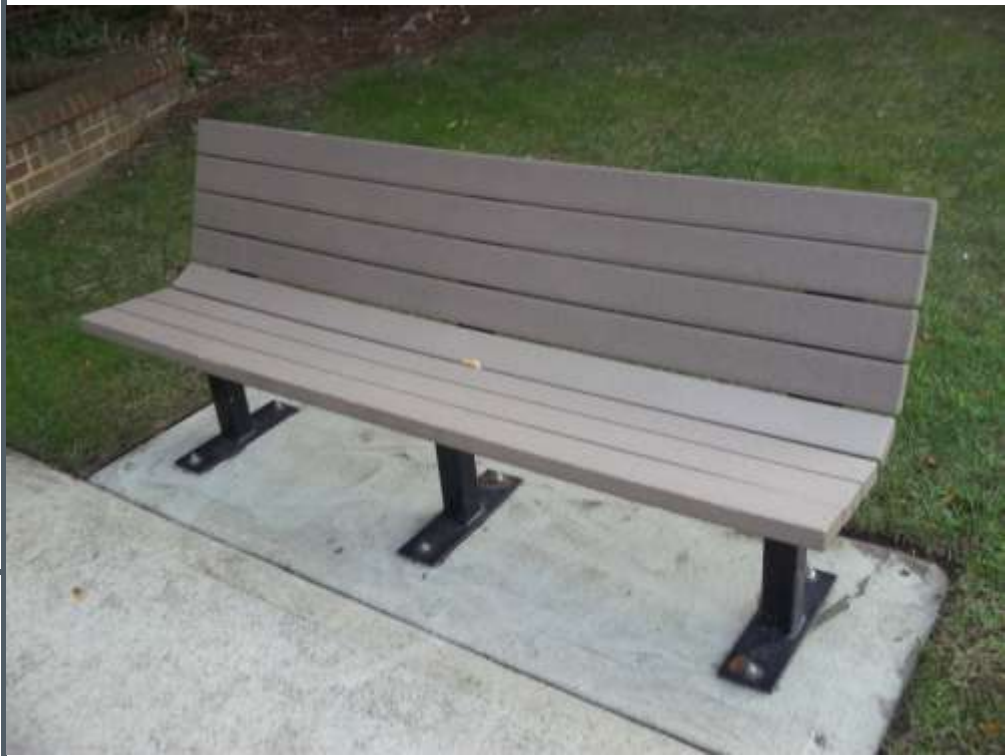
**Photo No.**  
**8**

Bench at pavilion

We have included funds to replace the 4 benches at the pavilion every 20 years beginning in 2030.

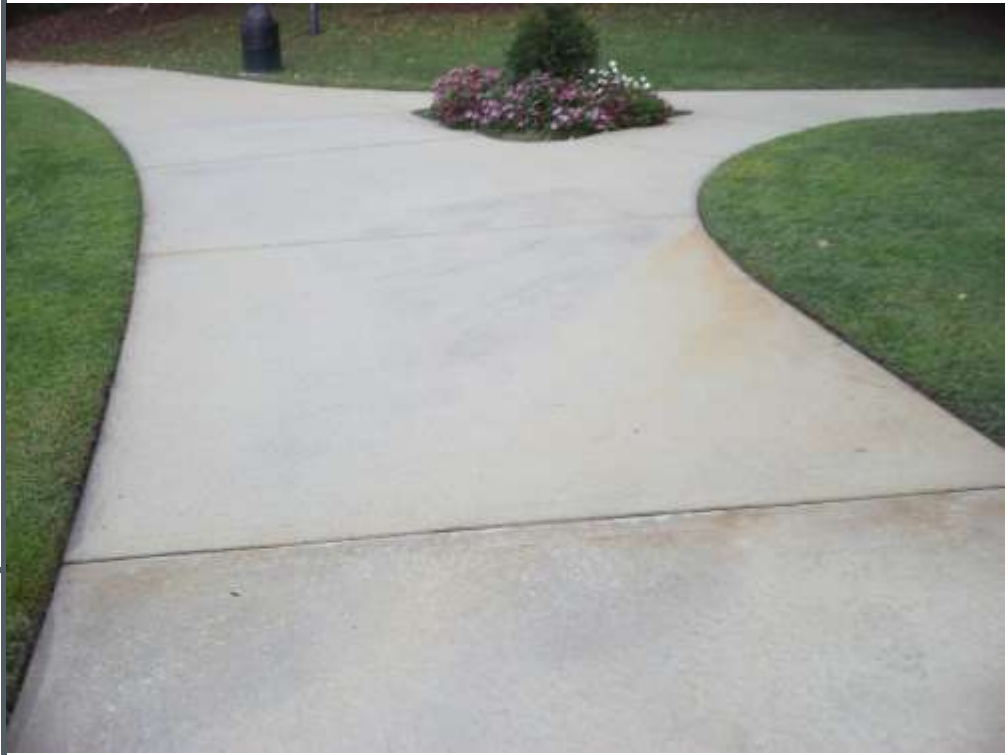
**Photo No.**  
**9**

Flatwork in the community consists of the concrete sidewalks and steps at the pavilion along Town Side Drive. The concrete flatwork generally appears to be in good condition, with some evidence of cracking and minimal vertical displacement occurring. Over time, water will infiltrate below the flatwork and soften the subgrade leading to upheaval or settlement. We have allocated funds for periodic replacement of concrete surfaces as required and have assumed that 5% of the surfaces will require improvement every 8 years beginning in 2030.

Typical sidewalk

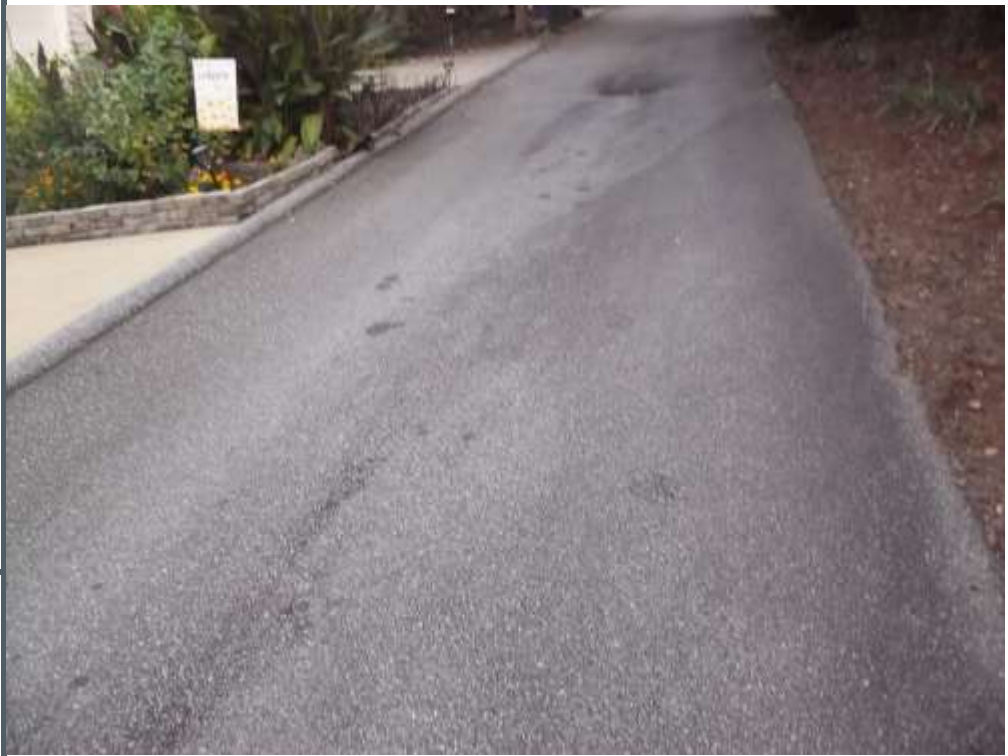
**Photo No.**  
**10**

Typical alley

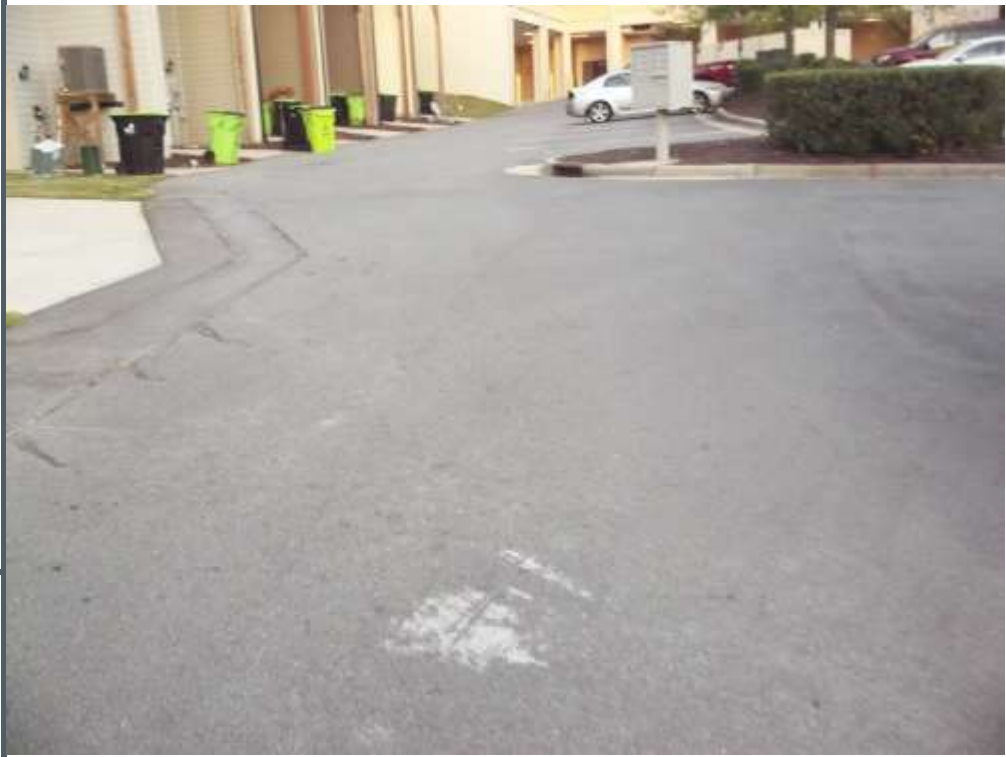
**Photo No.  
11**

Recently resurfaced area  
adjacent to commercial  
building

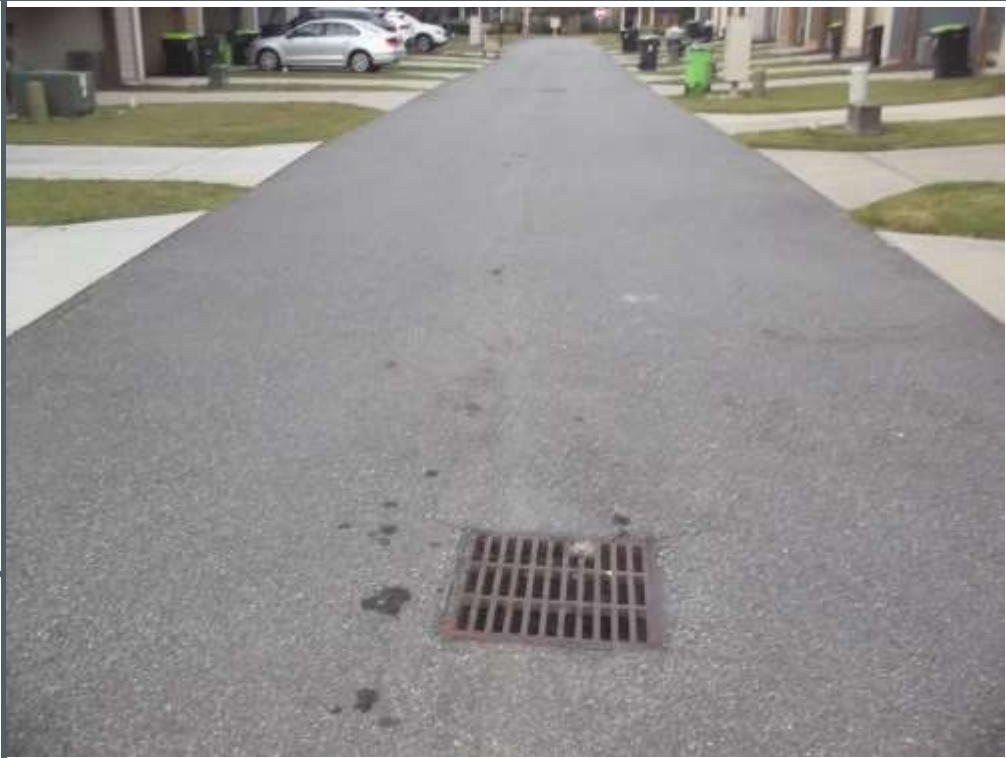
**Photo No.  
12**

Typical alley

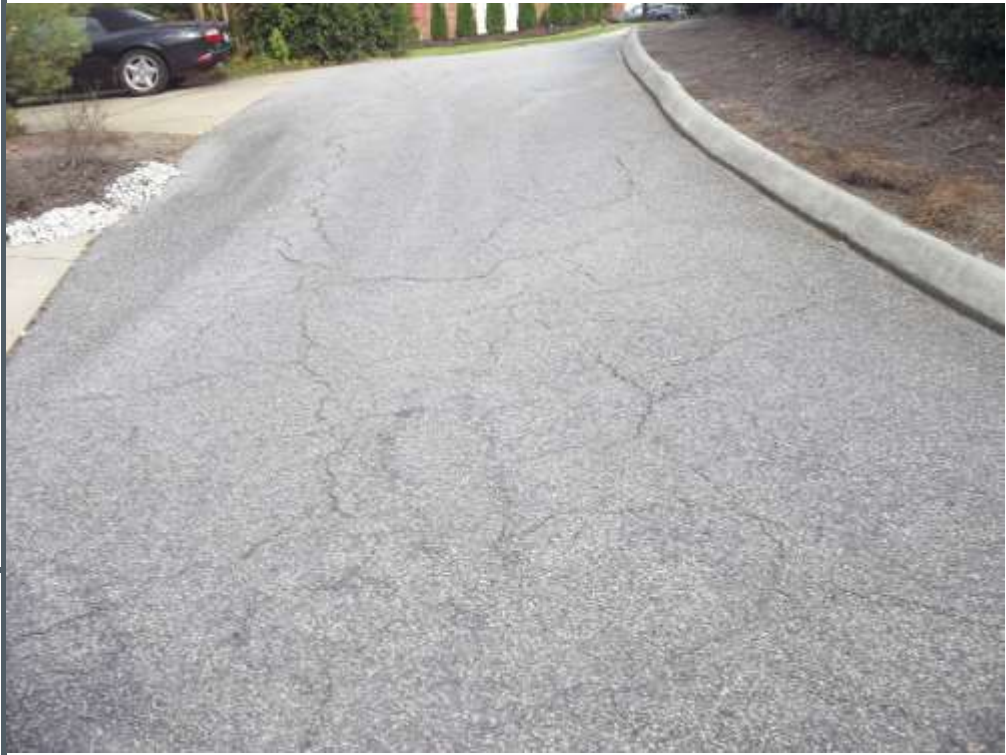
**Photo No.**  
**13**

Area of minor cracking

Over time, limited areas of the asphalt may begin to crack and deteriorate to the point that full depth asphalt patching is required. Asphalt patching consists of sawcutting and removing the affected area, re-compacting the stone subbase, and installing new 2” – 4” asphalt materials. We have provided funds for this in 2028 and every 5 years thereafter. The near-term funds can be utilized for subgrade repairs during the pavement resurfacing projects.

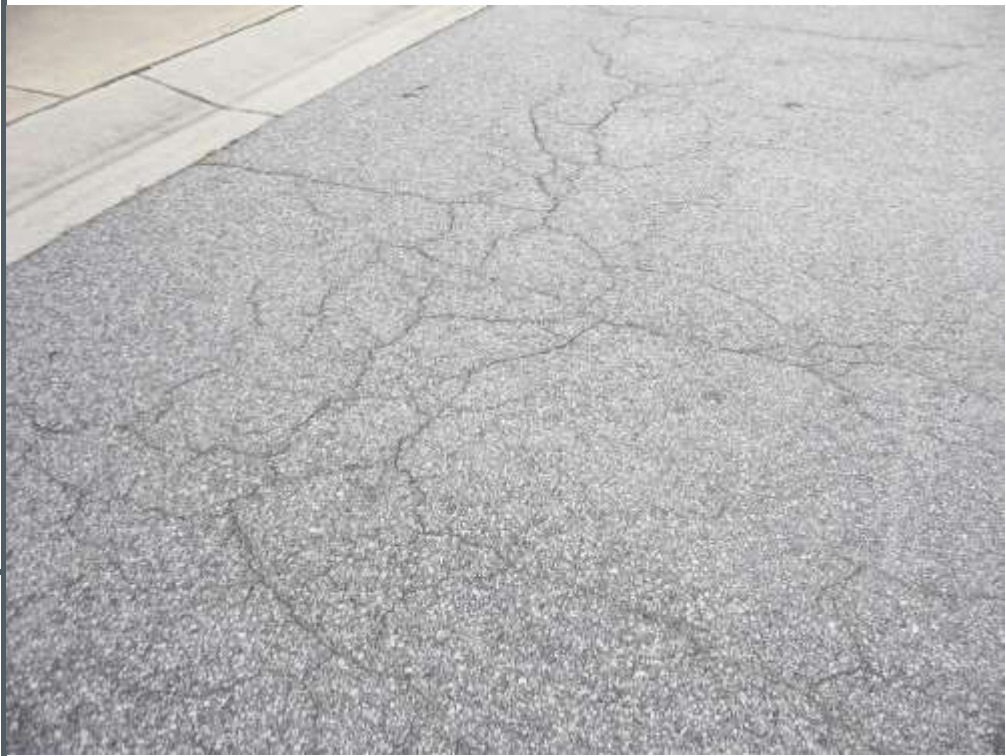
**Photo No.**  
**14**

Typical area of cracking

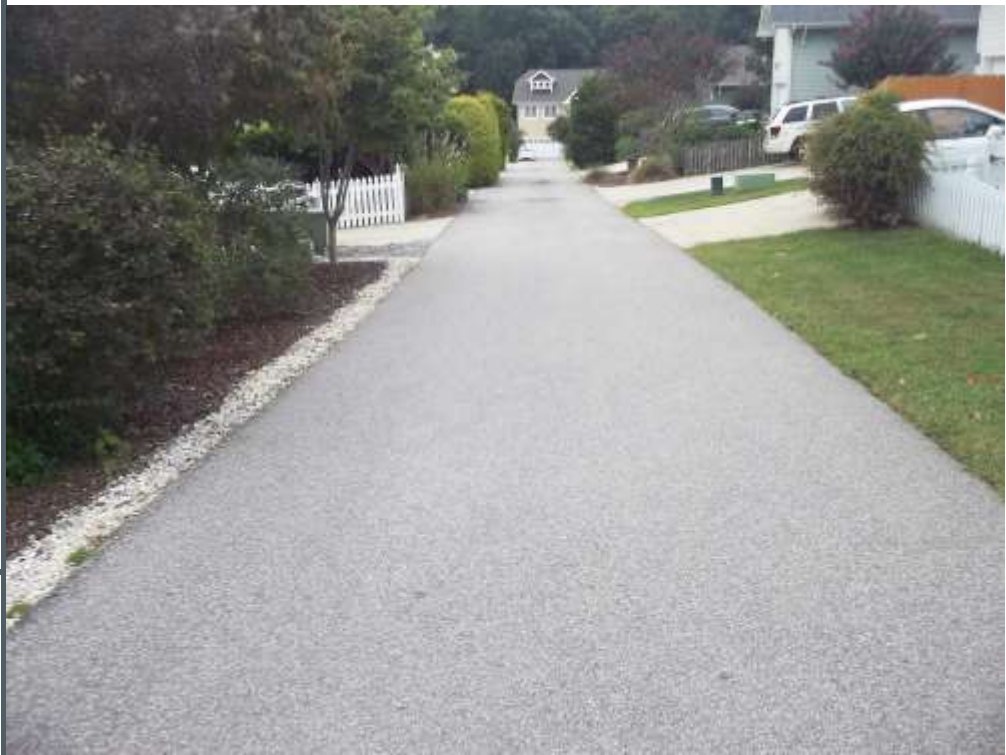
**Photo No.**  
**15**

Alley in generally good condition

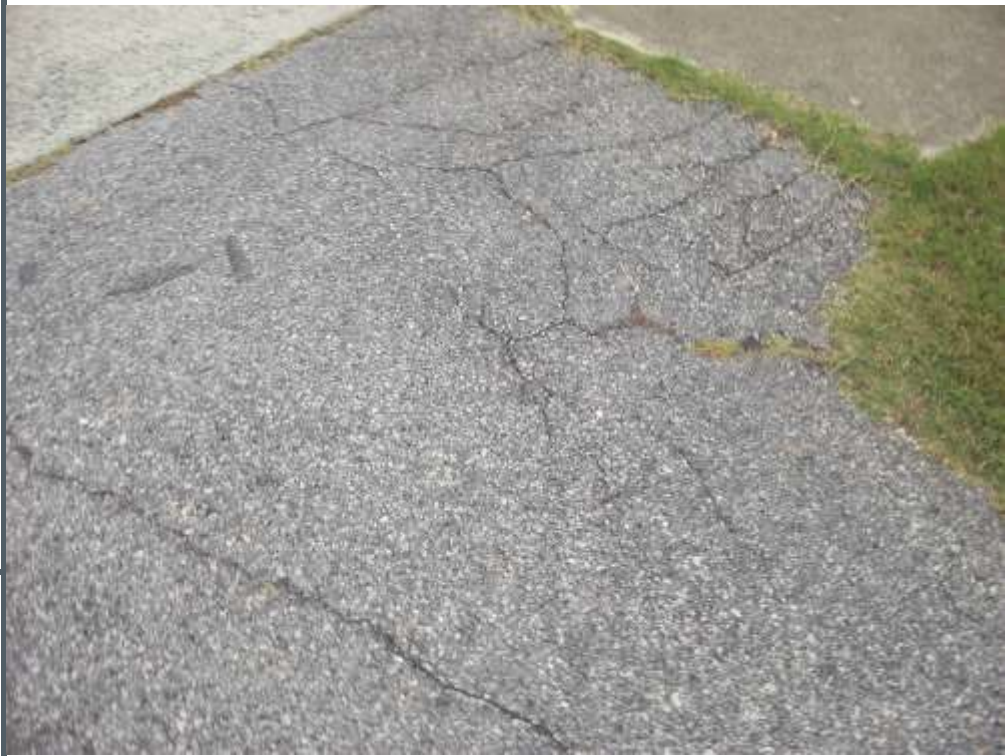
**Photo No.**  
**16**

Small section of cracked asphalt

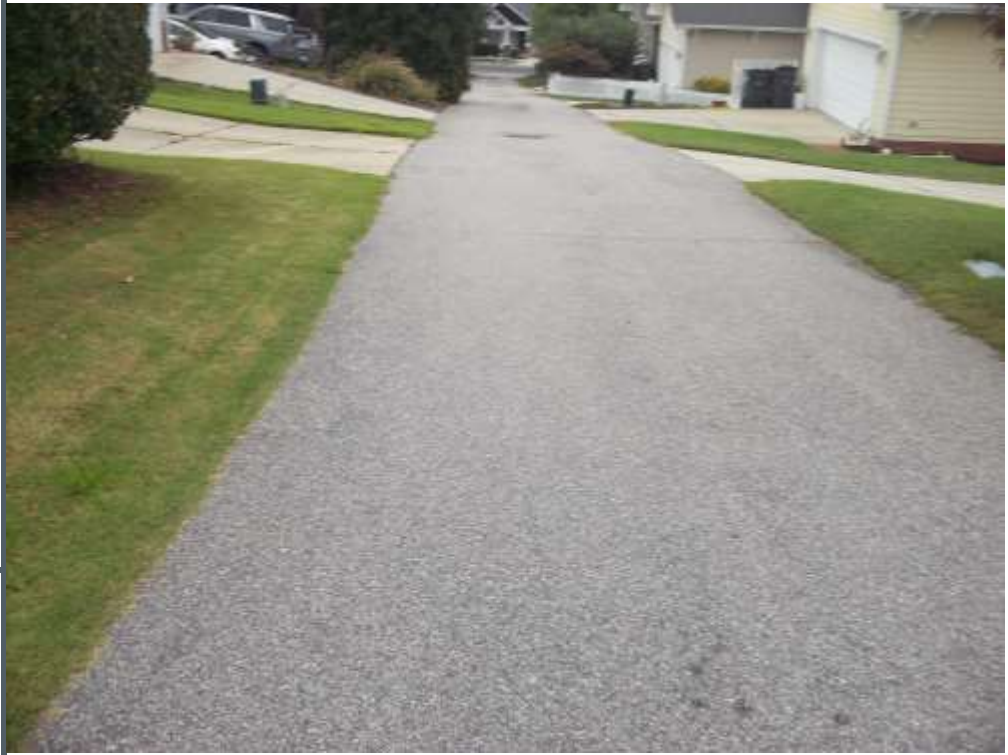
**Photo No.**  
**17**

Alley in good condition

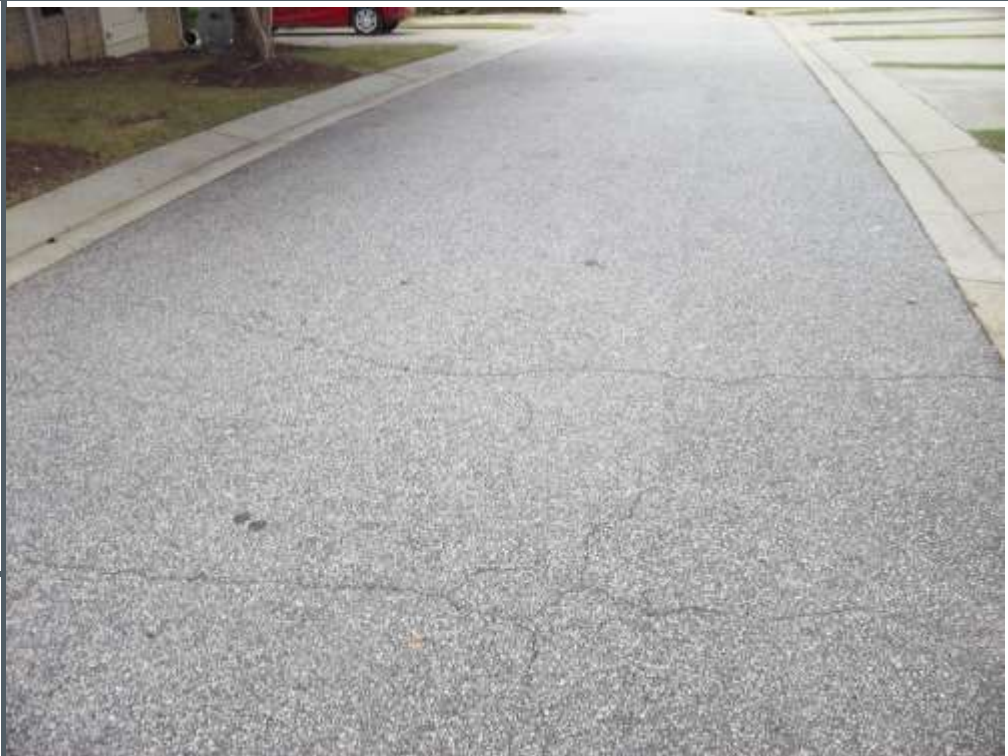
**Photo No.**  
**18**

Alley with limited  
transverse cracks
