# HouseMaster®

## ON-SITE WASTEWATER INSPECTION

120 Carolina Ave, Oxford, NC 27565

10-1-2026

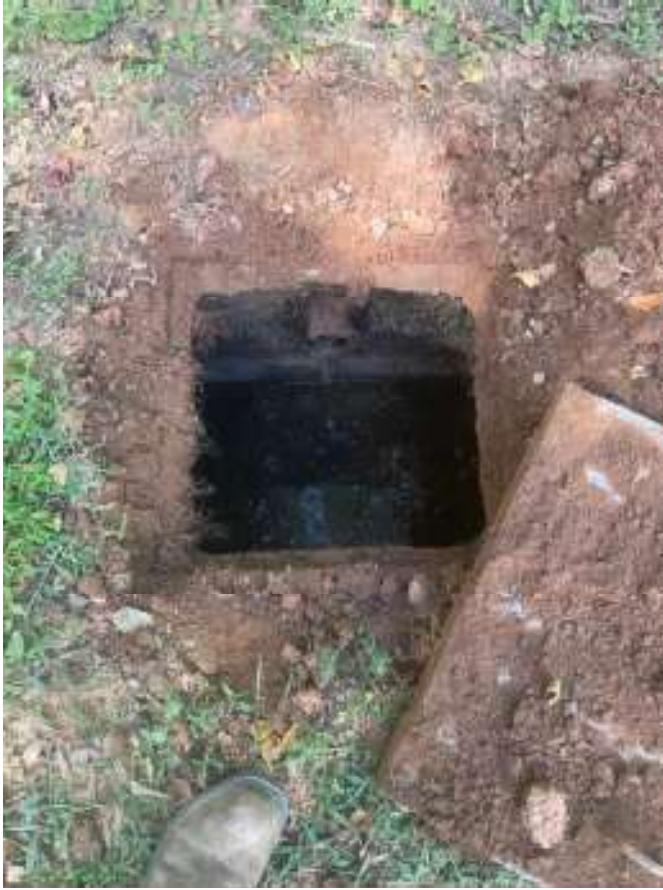
Are roots present in the tank? ☒ Yes \_\_\_\_ No, Describe: Root intrusion noted at the inlet side of tank

intrusion.

Inlet side of tank with root

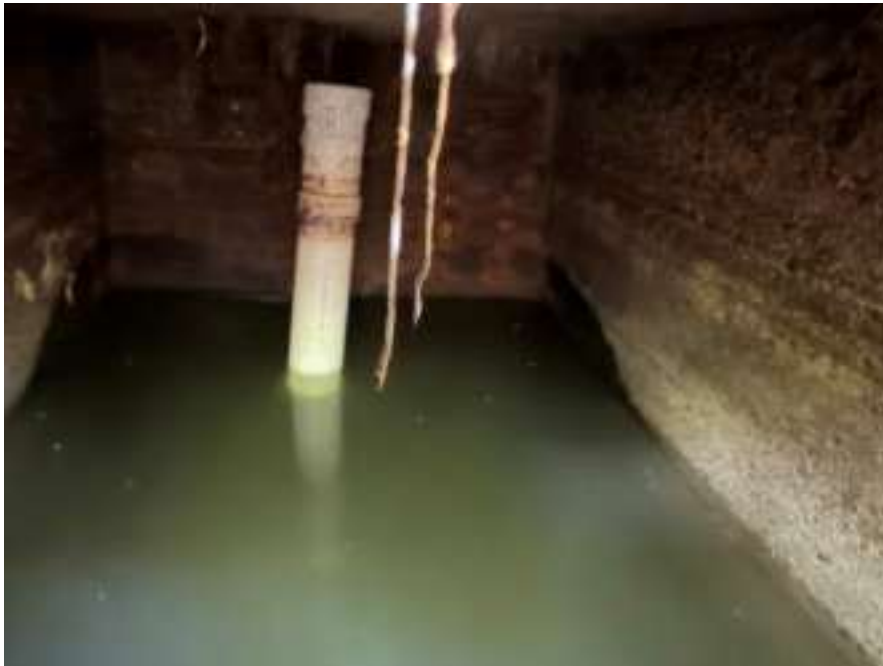
Inside of tank

Comments: Tank appeared to be pumped prior to inspection.

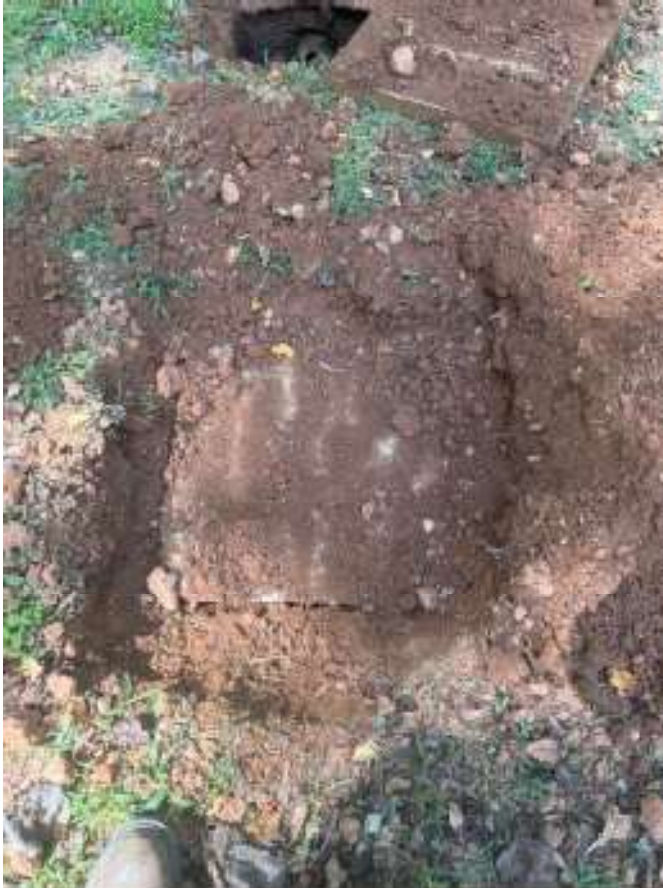
Condition of septic tank lids:   Poor, Outlet side tank lid handle is missing    
\_\_\_\_\_

missing

Outlet side tank lid handle is

Any adverse conditions present that require repair or subsequent observation or warrants further evaluation by a septic contractor or the local health department? ☒ Yes ☐ No  
If yes, describe the conditions: Outlet side tank handle is missing. Debris noted inside the disposal lines. Recommend qualified septic tank contractor repair.

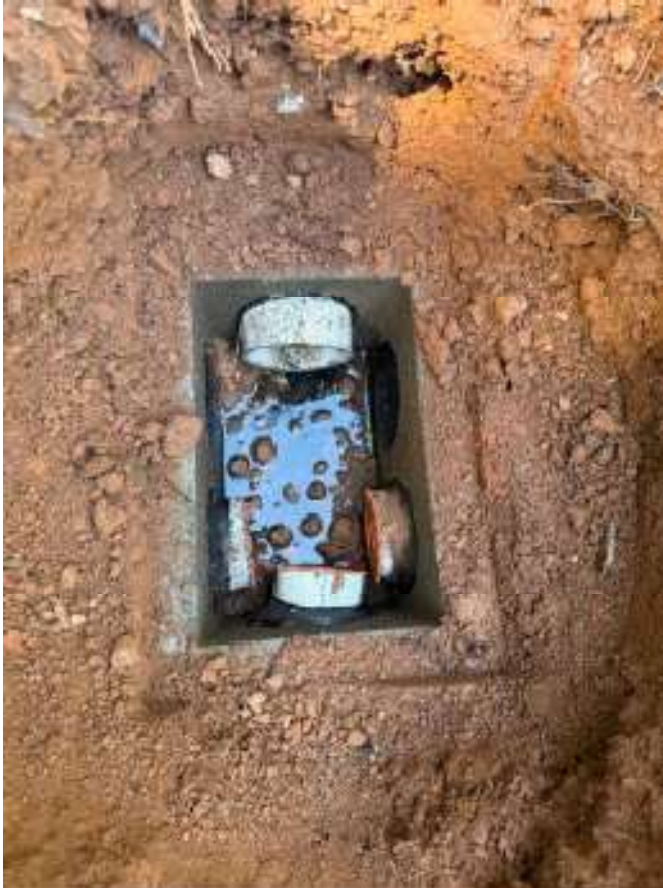
Dbox

If yes, describe the condition: Fair

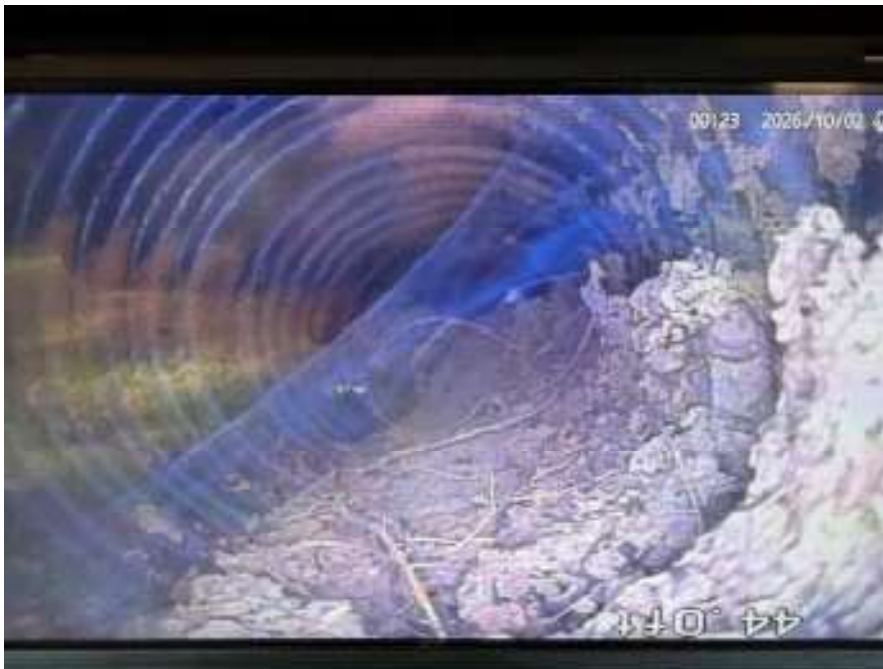
Debris noted inside disposal lines
