## SUMMARY

2946 Glenridge Dr , Raleigh, NC 27604  
Helene Headington  
12/16/2024

Logan Brown  
NCHILB # 5618  
OpenWindow Home Inspections  
(910)898-2626

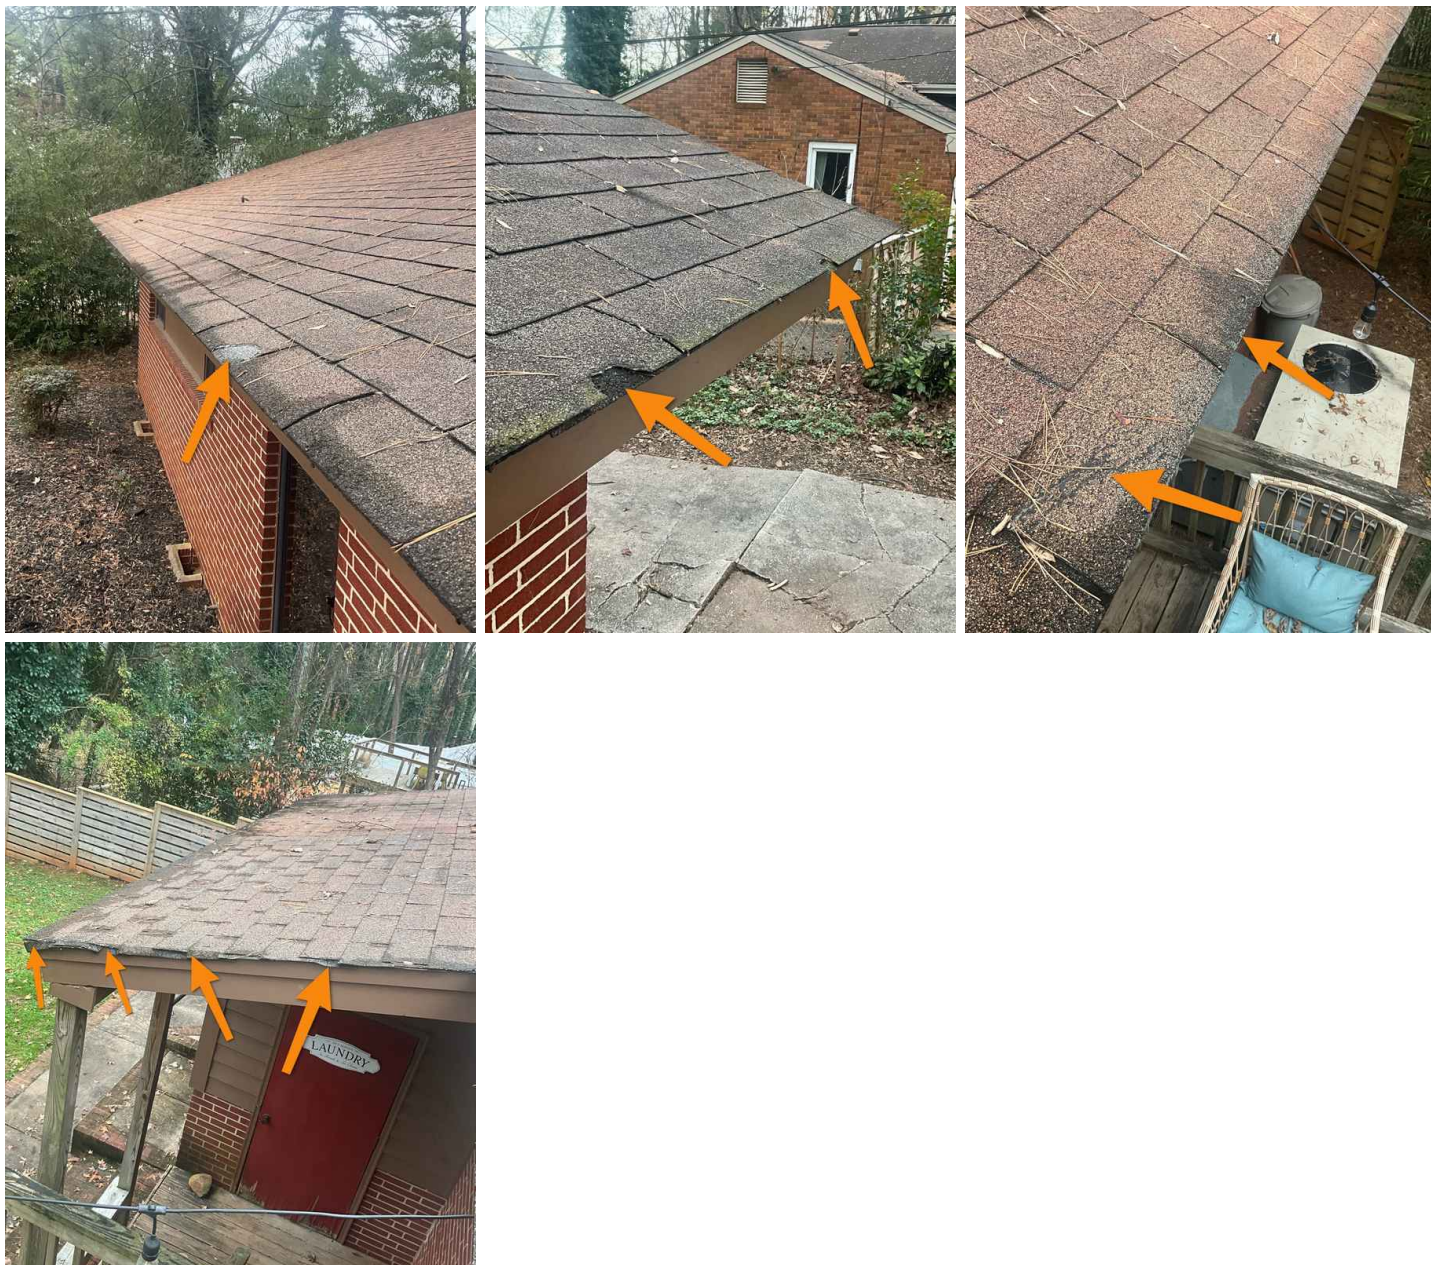
### 2.1.1 Coverings

#### **DAMAGED / CRACKED**

Damaged or cracked shingles were observed across the roofing area. Damaged or cracked shingles can lead to accelerated deterioration and moisture penetration under shingles onto sheathing and deterioration of the surrounding area. The home inspector recommends having a qualified specialist for further evaluation, repair, or replacement as necessary.

**Roof replaced and gutters added in 2025**

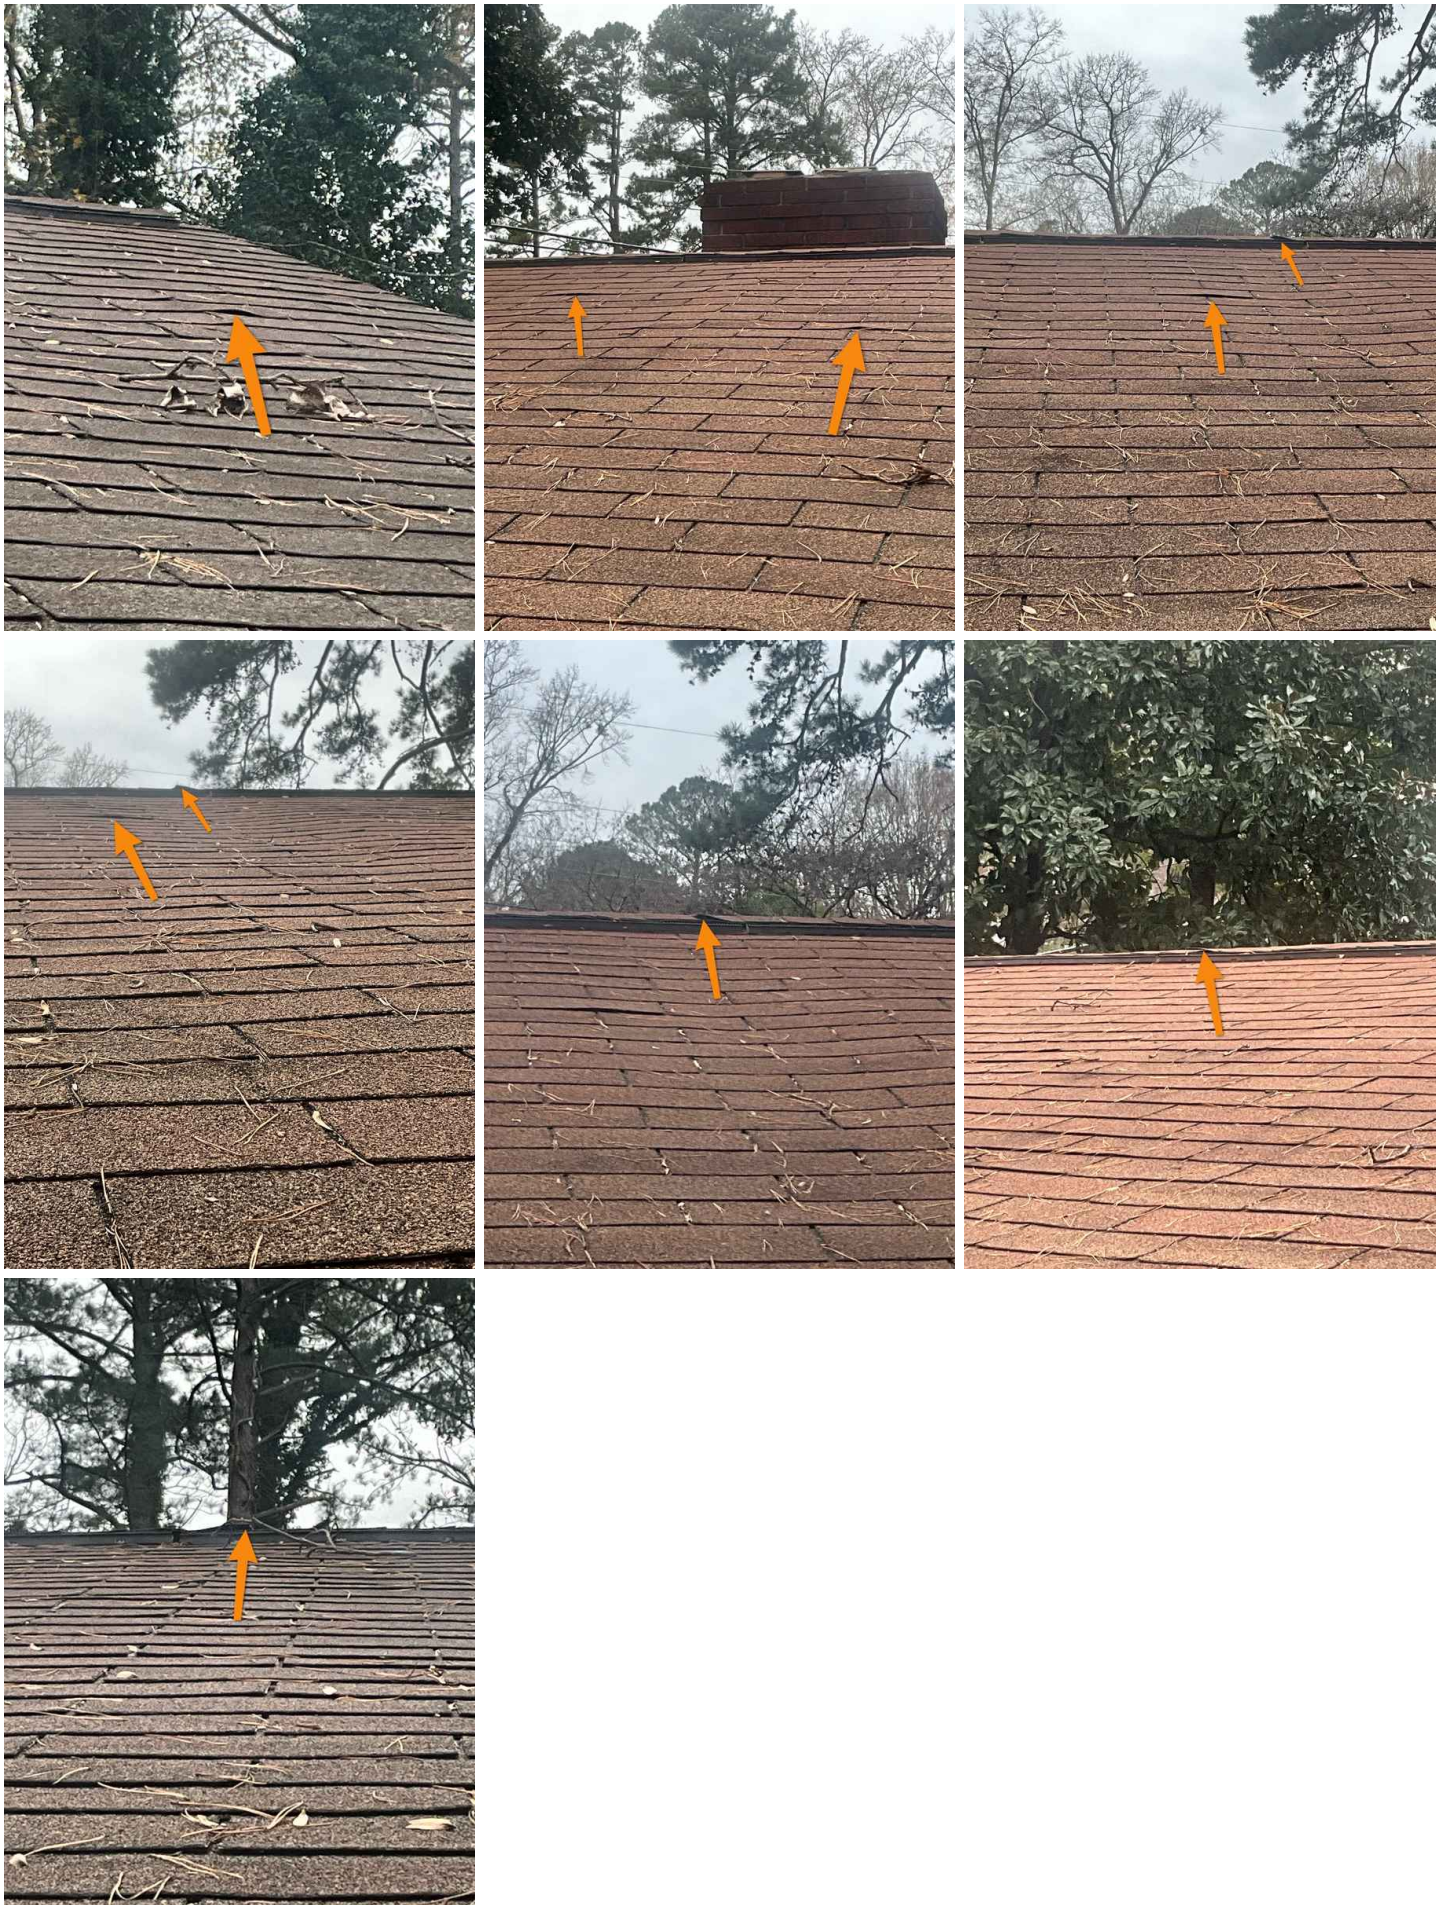
### 2.1.3 Coverings

#### **NAIL POP**

The home inspector observed nail pop(s) under or through the shingles on the roofing area. This is where a nail backs out of a shingle due to expansion and contraction and 'lifts' or protrudes through the overlapping shingle. If left in this condition, damage or further damage may occur to the shingles, which may lead to moisture penetration, causing damage to the underlayment. The home inspector recommends a qualified specialist for further evaluation and repair.

Roof replaced and gutters added in 2025

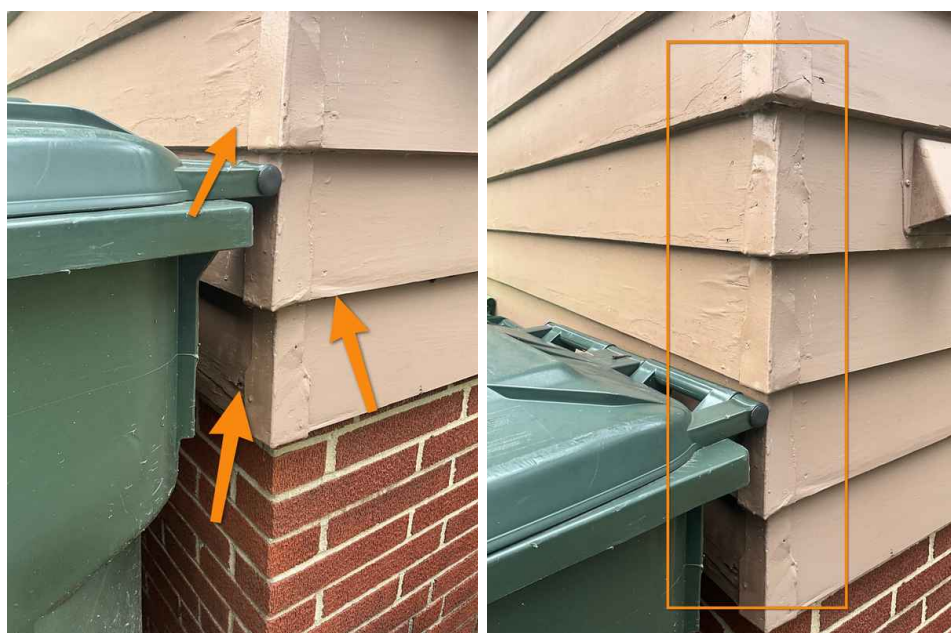
## 3.1.1 Siding, Flashing &amp; Trim

**SIDING/TRIM MOISTURE DAMAGE/DETERIORATION**

There is moisture damage on the siding and/or trim throughout the exterior of the home. This may worsen and cause further damage to surrounding areas, moisture penetration behind the siding causing damage to other systems and components. The home inspector recommends a qualified specialist for further evaluation, repair, and/or replacement of any areas necessary.

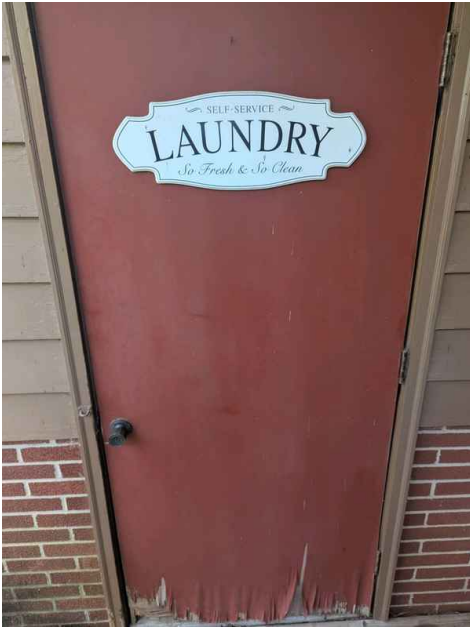
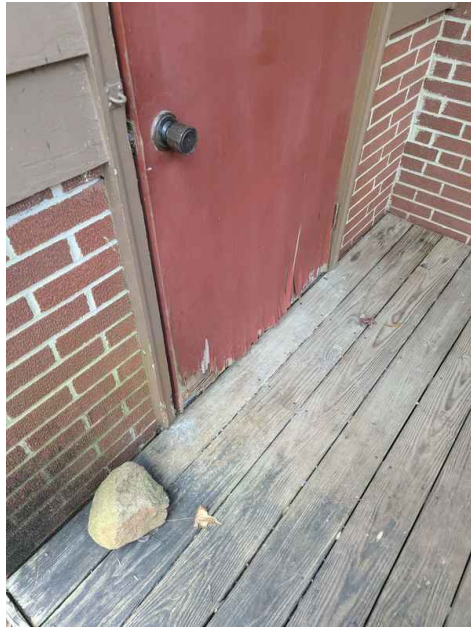
## 3.4.1 Exterior Doors

The laundry room door, door frame, door trim, or door components were observed to have moisture damage during inspection. This will lead to further damage and deterioration of the door system. The home inspector recommends a qualified specialist for repair.

**MOISTURE DAMAGE** Door repaired in 2025

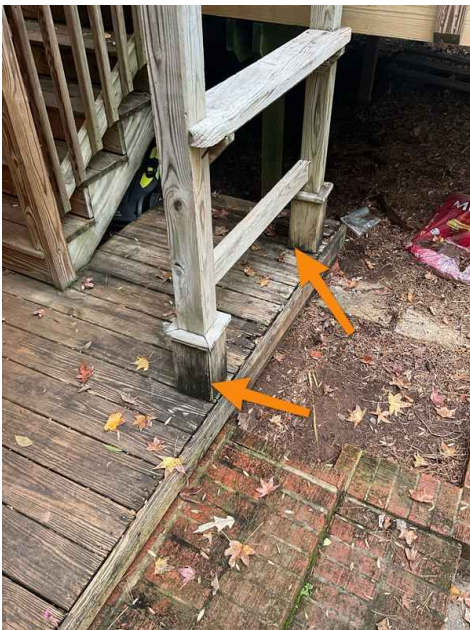
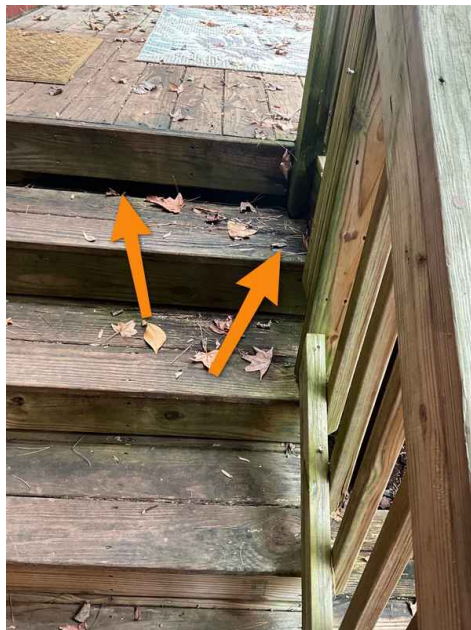
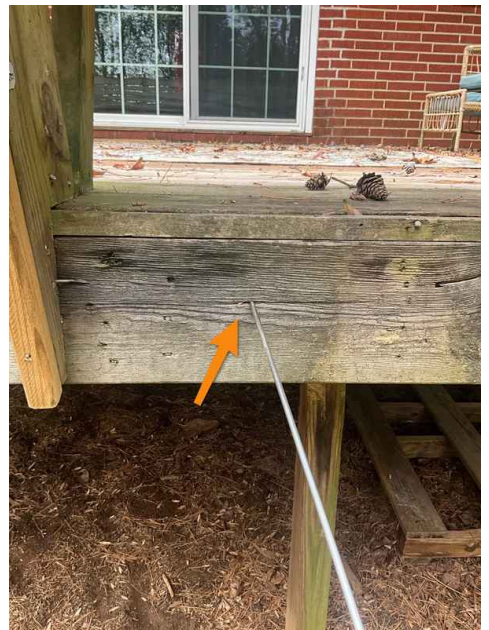
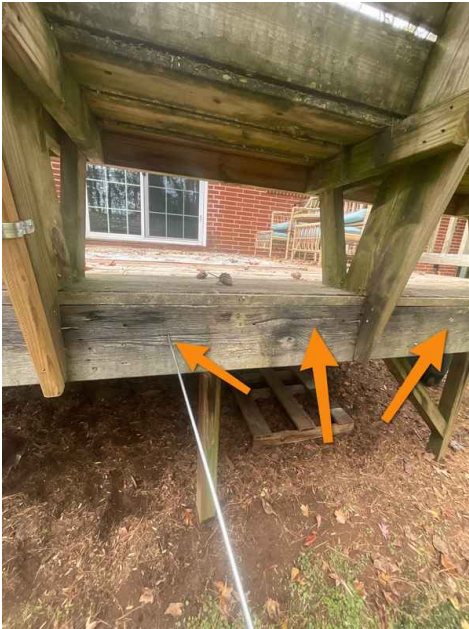
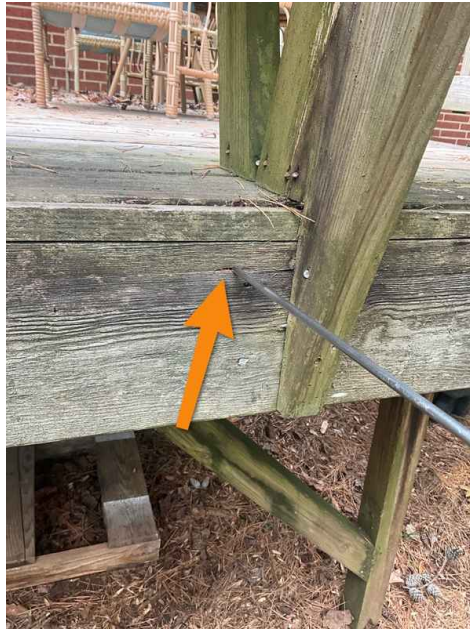
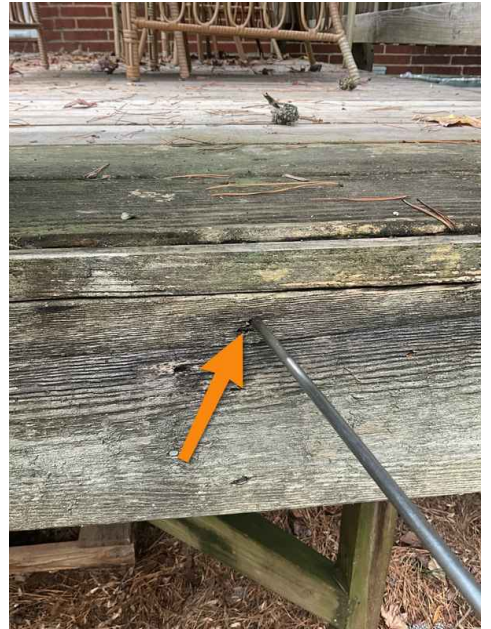
### 3.6.1 Decks, Balconies, Porches & Steps

#### DECK - DETERIORATION

The rear deck, deck stairs, and deck railings show signs of wood deterioration. This can lead to the failure of the deck, deck stairs, and/or railings and cause a falling hazard. The home inspector recommends having a qualified specialist for further evaluation of the deck and making repairs as needed.

Deck replaced in 2025

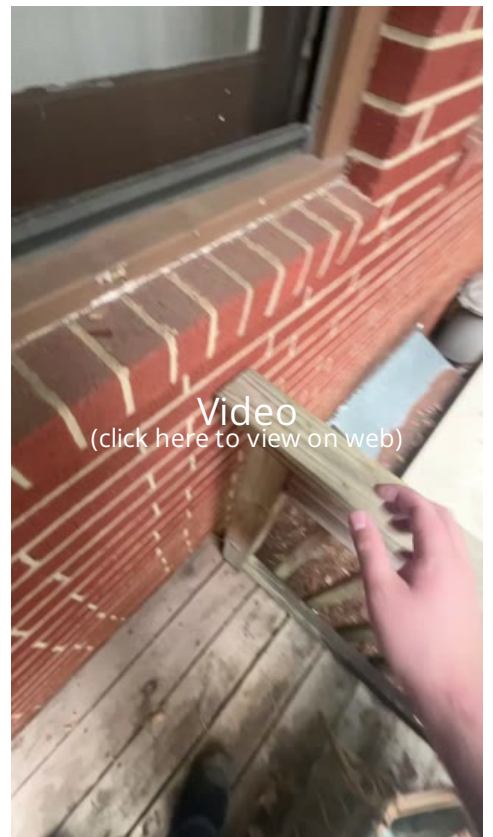
### 3.6.2 Decks, Balconies, Porches & Steps

#### **RAILING(S) LOOSE / WOBBLY**

The rear deck post or railing is wobbly/loose at one or more of the securing points. If not properly repaired this condition could worsen and collapse when used upon. The home inspector recommends a qualified specialist for repair.

**Deck replaced in 2025**

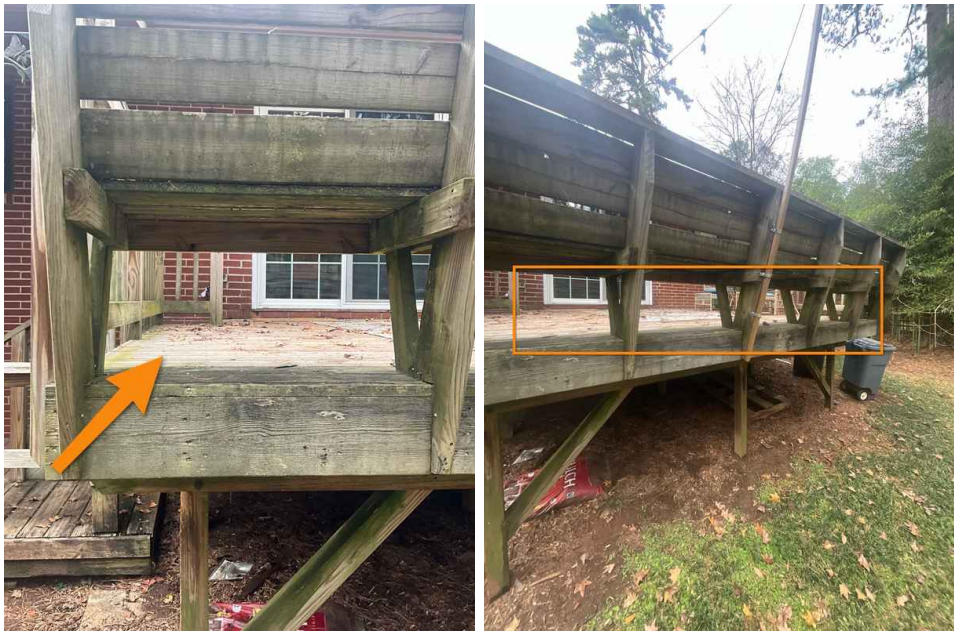
### 3.6.4 Decks, Balconies, Porches & Steps

#### **BALUSTER(S) - LOOSE/NOT PRESENT**

The railing balusters on the rear deck were observed to be not present. This poses a hazard to small children and animals as they may fall between balusters. Balusters are to be placed no more than four (4) inches apart. The home inspector recommends a qualified specialist for repair.

**Deck replaced in 2025**

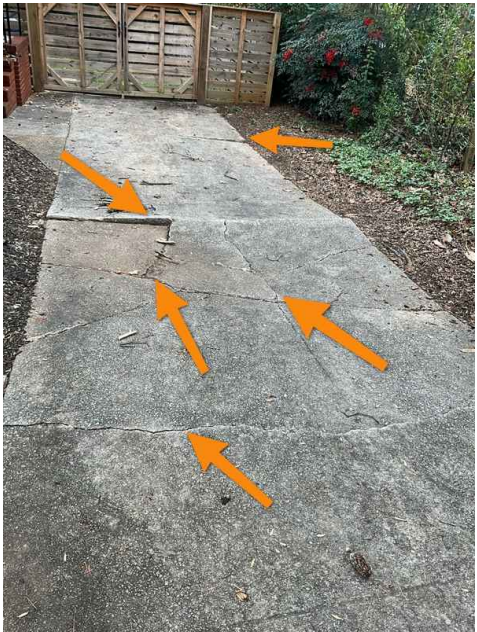
3.7.1 Walkways, Patios & Driveways  
**UNLEVEL DRIVEWAY CRACKING**

Cracking of the concrete in the driveway was observed at the time of the inspection. The damaged areas may worsen and cause unlevel areas. This is an indication of but is not limited to the settlement of the soil underneath. The home inspector recommends a qualified specialist for further evaluation and repair as necessary.

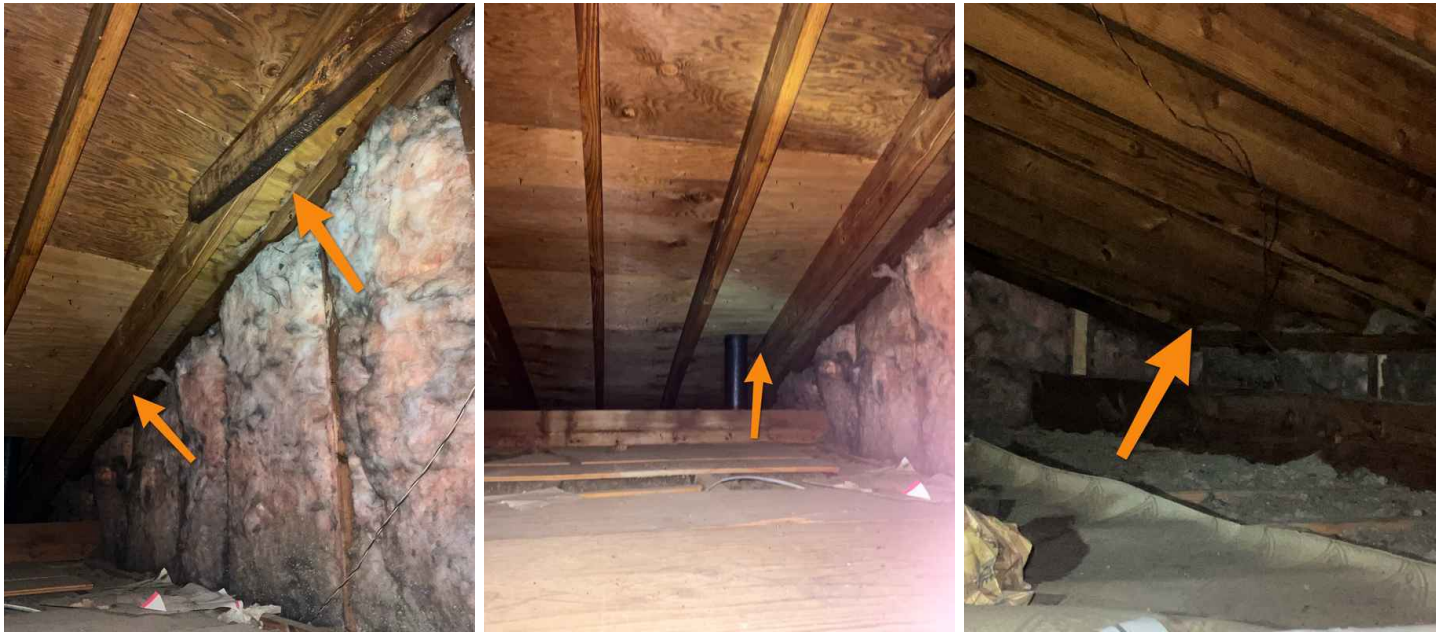
4.6.1 Sheathing    **Roof replaced and gutters added in 2025**  
**SHEATHING WOOD DETERIORATION/MOISTURE STAINING**

The sheathing throughout the attic was observed to show signs of wood deterioration and moisture staining. Continued moisture or water accumulation in these areas could lead to further damage extending to other parts of the structure. The home inspector recommends consulting a qualified specialist for a comprehensive evaluation and subsequent repairs to address this.

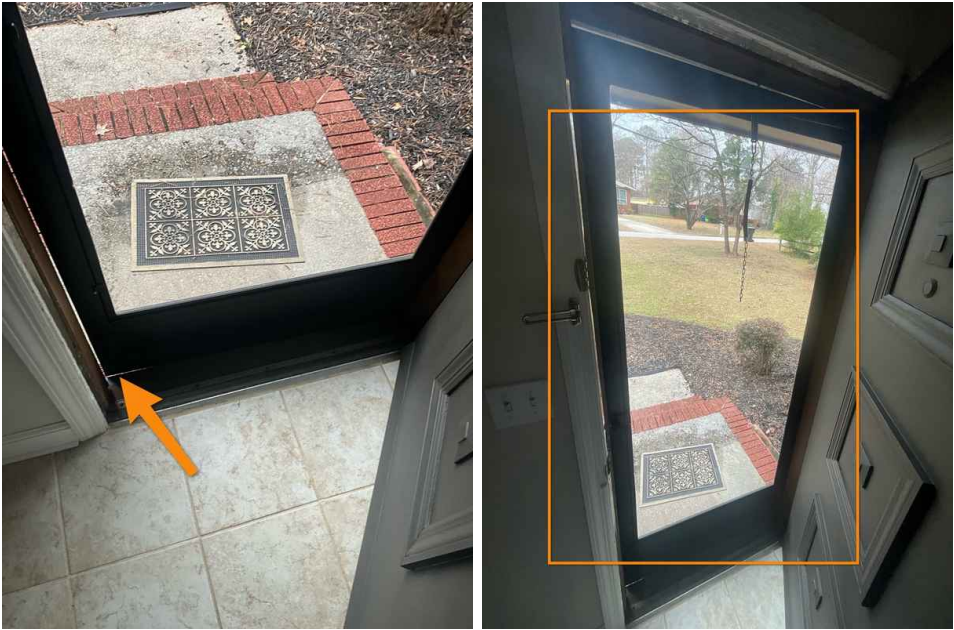
#### 5.1.1 Doors

##### **DOOR UNLEVELED**

The front screen door was observed to be unleveled, which does not allow for it to latch and causes the door to have a gap at the top. This is an indication that the adjustment screws are not properly set. The home inspector recommends a qualified specialist for repair.

Door repaired in 2025

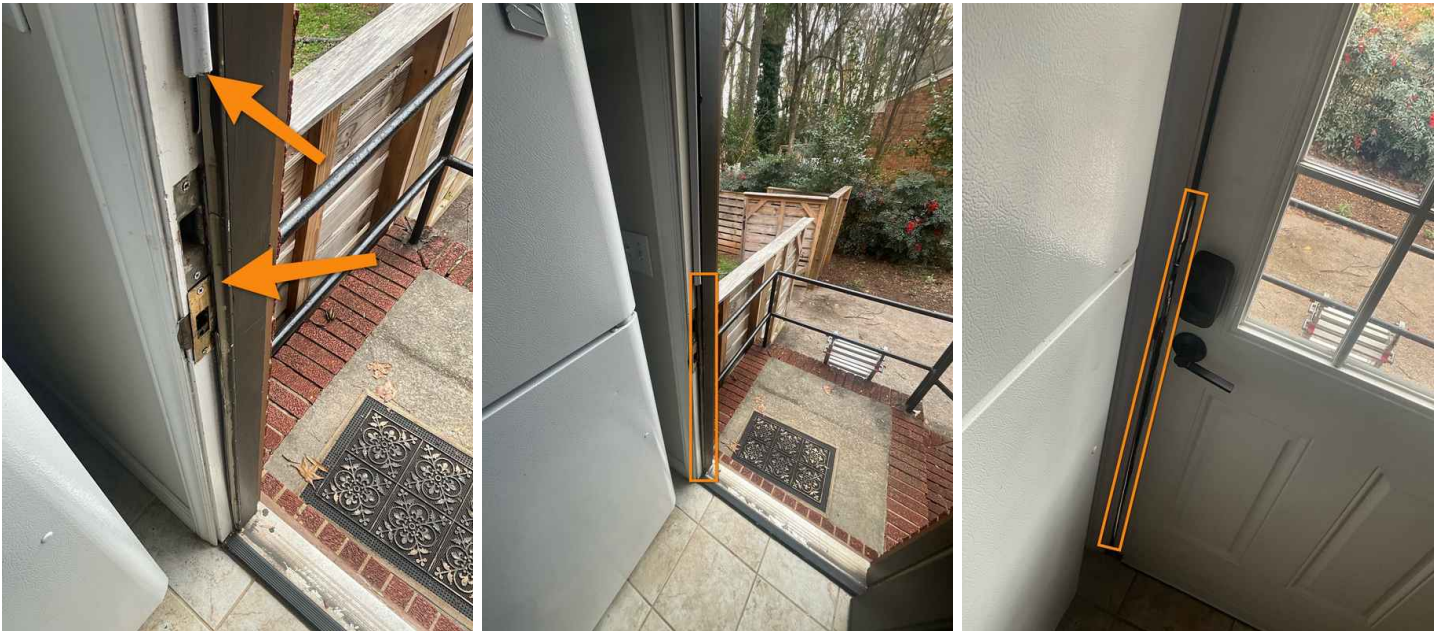
5.1.2 Doors

DAMAGED WEATHER-STRIPPING

At the time of the inspection, the weather stripping on the side entry door was generally damaged or deteriorated. This may lead to moisture intrusion or energy inefficiency in the home. The home inspector recommends a DIY repair by replacement of the damaged weather stripping. The client may wish to have a qualified specialist for repair if so desired.

Replaced door in 2025

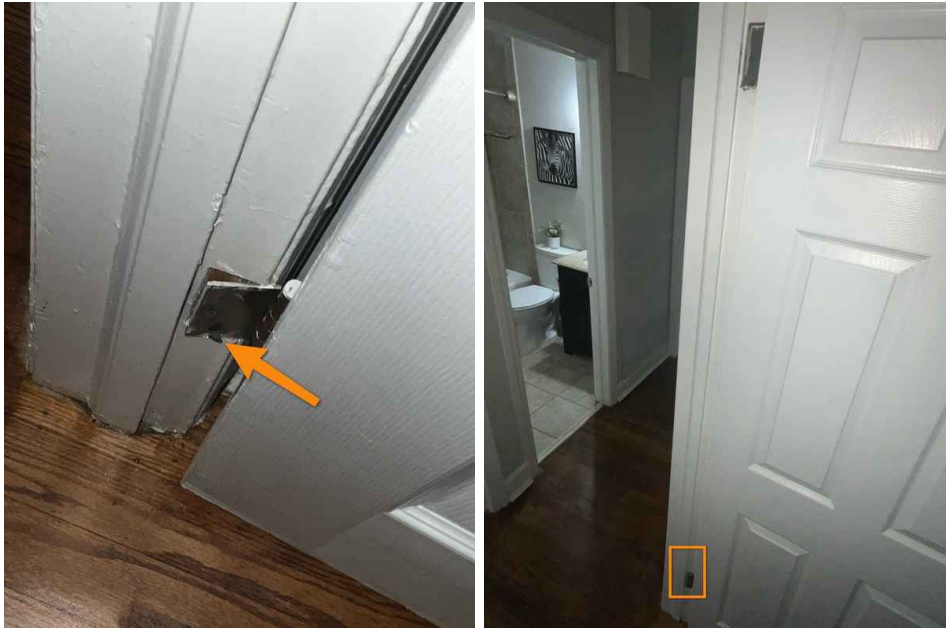
5.1.3 Doors

HINGES LOOSE

The bottom hinge of the front left bedroom door was observed to be loose, which may lead to the door sticking or eventually falling out of place. The screws look to be stripped and causing the issue of the loose hinges. The home inspector recommends the repair be completed by a qualified specialist if desired.

Repaired in 2025

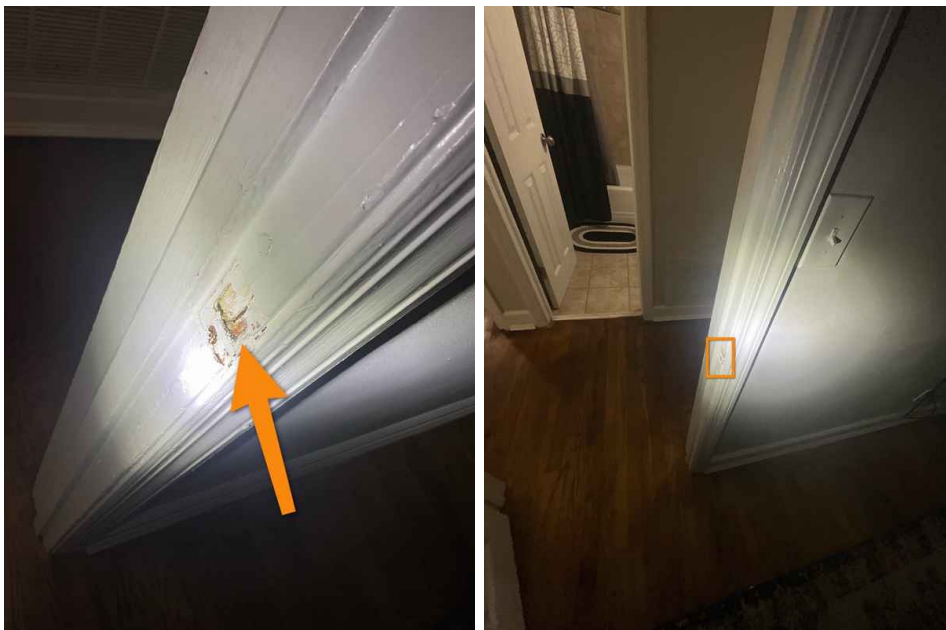
#### 5.1.4 Doors

##### **LATCH PLATE NOT INSTALLED**

The latch plate for the front right bedroom door was observed to not be present. This may lead to damage to the door or door frame. The home inspector recommends a qualified specialist to further evaluate and make repairs.

Repaired in 2025

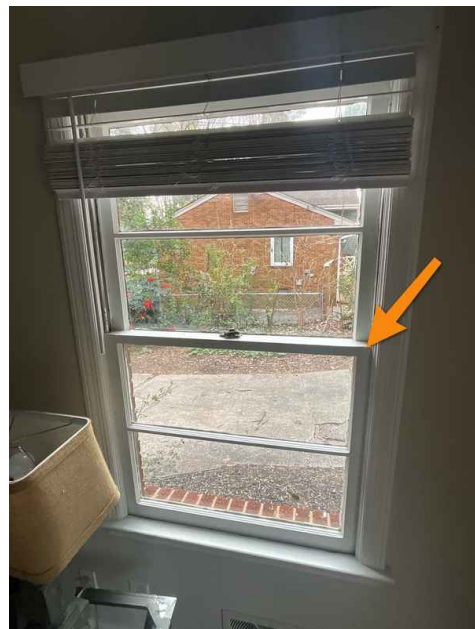
## 5.2.1 Windows

**WINDOW - NOT FUNCTIONING**

The bottom windows throughout the home did not properly open, were hard to open, were painted shut, and/or not properly functioning at the time of inspection. This may pose a safety hazard as it may slow egress in an emergency. The home inspector recommends a qualified specialist for further evaluation and repair.

Repaired in 2025

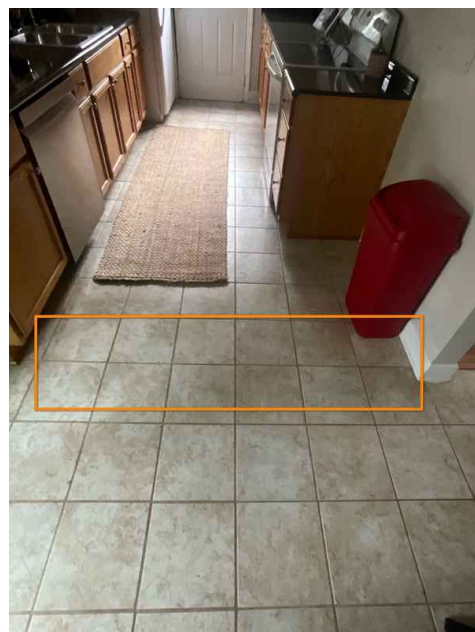
## 5.3.1 Floors

**FLOORING - UNLEVELED/HUMPS/DIPS**

The flooring in areas throughout the home has noticeable humps in the flooring. This may cause the flooring to become unlevelled and can start to separate at the meeting areas. This may worsen and cause a tripping hazard or damage to the flooring. The home inspector recommends a qualified specialist for further evaluation and repair as necessary.

Repaired and replaced flooring in 2025

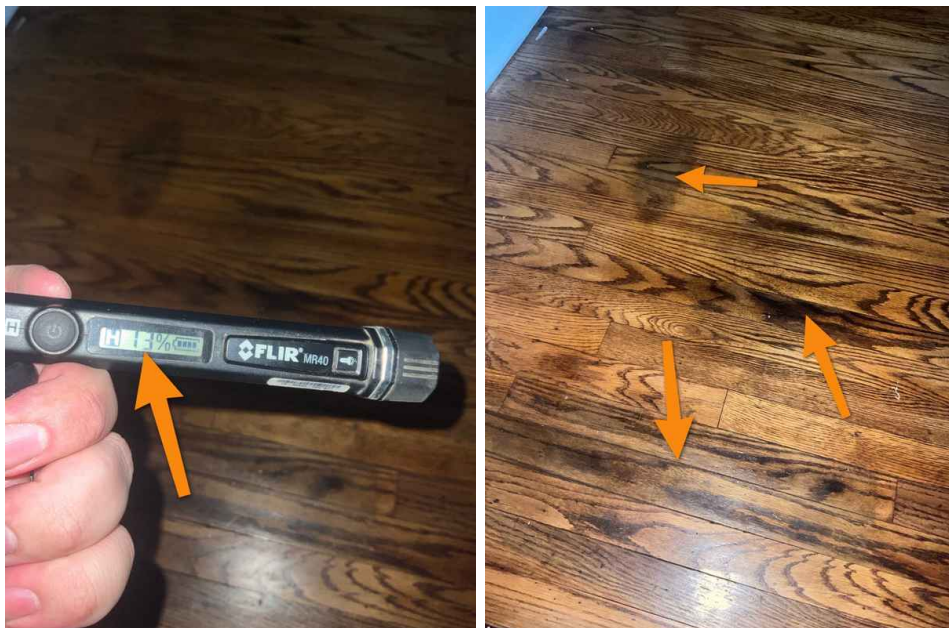
## 5.3.2 Floors

**DAMAGED/MOISTURE INTRUSION**

The flooring near the living room has evidence of moisture intrusion. This may be from past or present leaks around/near area. If left in current condition, further damage may occur to surrounding areas and/or components. When checked with the moisture meter no significant moisture was detected. The home inspector recommends a qualified specialist for further evaluation and repair.

Replaced flooring in 2025

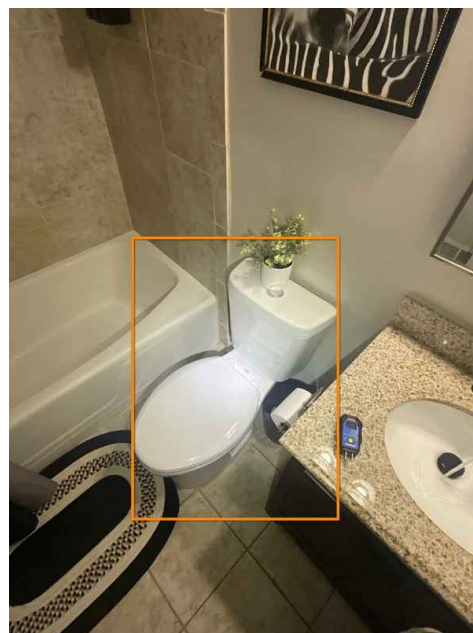
## 5.8.1 Bathrooms

**TOILET LOOSE**

The toilet in the hallway bathroom was loose at the attachment to the floor. This may cause deterioration of the seals, damage to the floor, or cause unseen leaks. The home inspector recommends further evaluation and repair by a qualified specialist.

Repaired in 2025

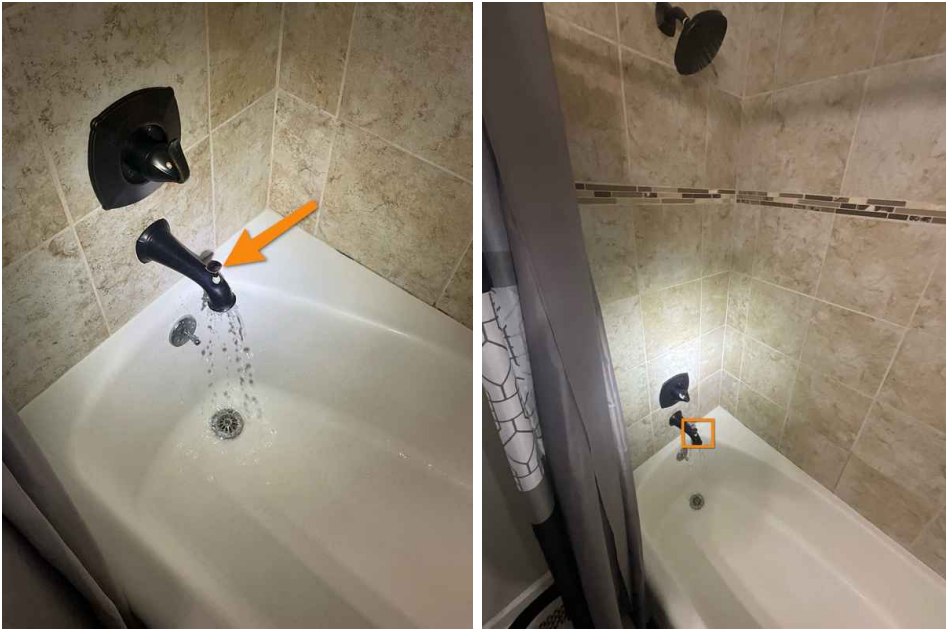
## 5.8.2 Bathrooms

**SHOWER WATER DIVERTER MALFUNCTION** Repaired in 2025

The water diverter in the shower of the bathroom allows water to disperse from the faucet when in use (shower turned on). This may cause, but is not limited to, water to disperse outside of the shower or weak water pressure at the shower head and may cause unseen moisture damage behind the wall. The home inspector recommends further evaluation and repair by a qualified specialist.

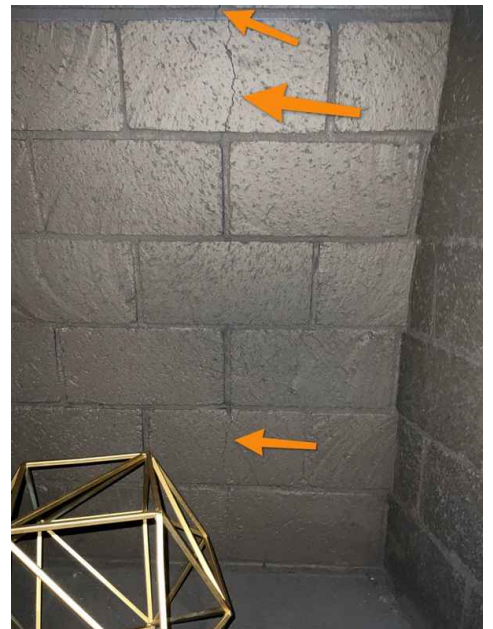
## 5.9.1 Fireplace

**FIREWALL CRACKED**

The fireplace lining was observed to have cracking in the rear. These cracks can lead to chimney damage or allow toxic fumes to enter the home, possibly creating a significant safety hazard. The home inspector recommends a qualified specialist for evaluation and necessary repairs.

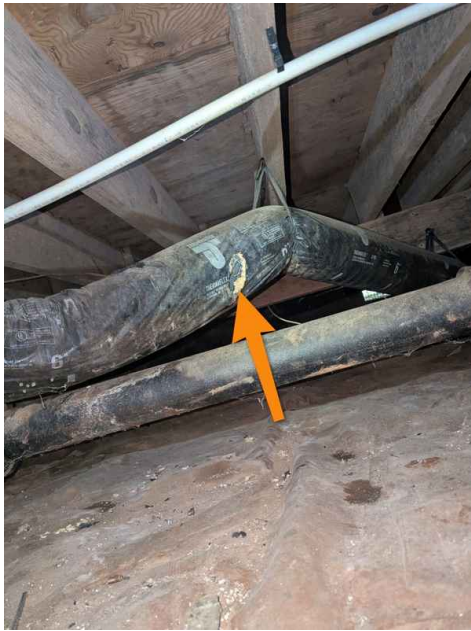
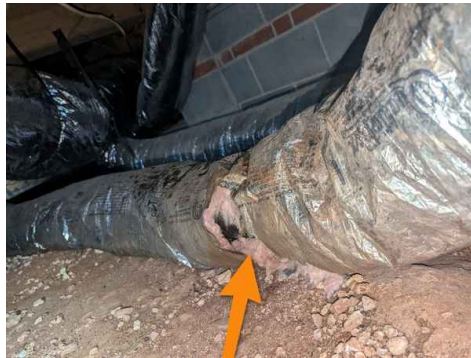
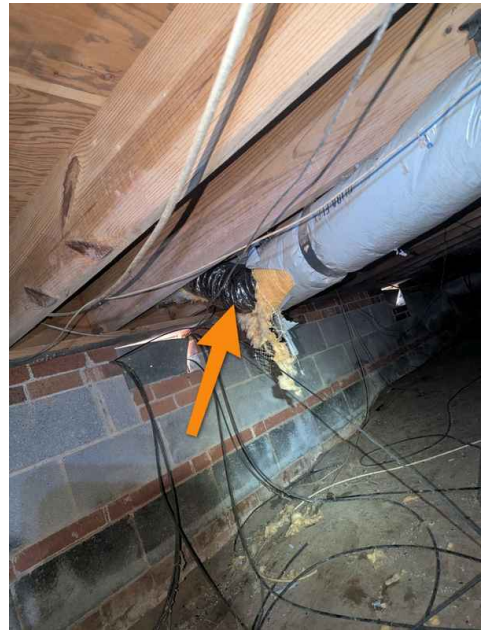
## 7.2.1 Package System

**DUCTWORK DAMAGED****Ductwork replaced in 2025**

Ducts in the crawlspace were observed to be deteriorating, exposing the interior duct. This will lead to energy inefficiency and leave the duct prone to damage. The home inspector recommends an HVAC professional to further evaluate the duct system and make repairs or replacements as needed.

Contact a qualified HVAC professional.

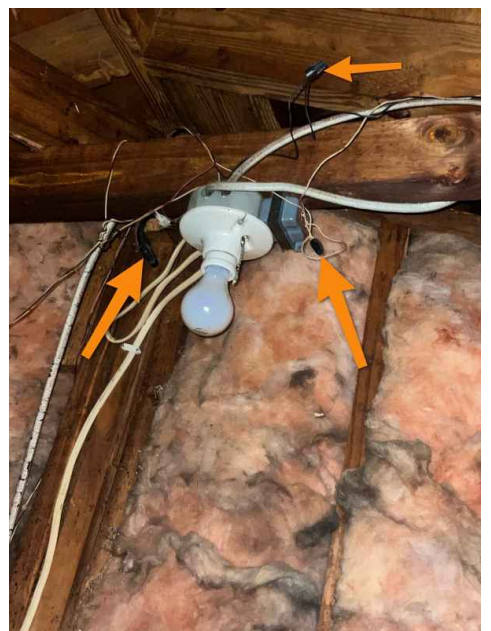
#### 8.3.1 Branch Wiring Circuits, Breakers & Fuses

##### **EXPOSED WIRE CONNECTION**

Wiring connections in the attic are not installed in a junction box. This may cause electrical shock or electrical damage to the circuit. The home inspector recommends further evaluation and repair by a qualified specialist.

Repaired in 2025

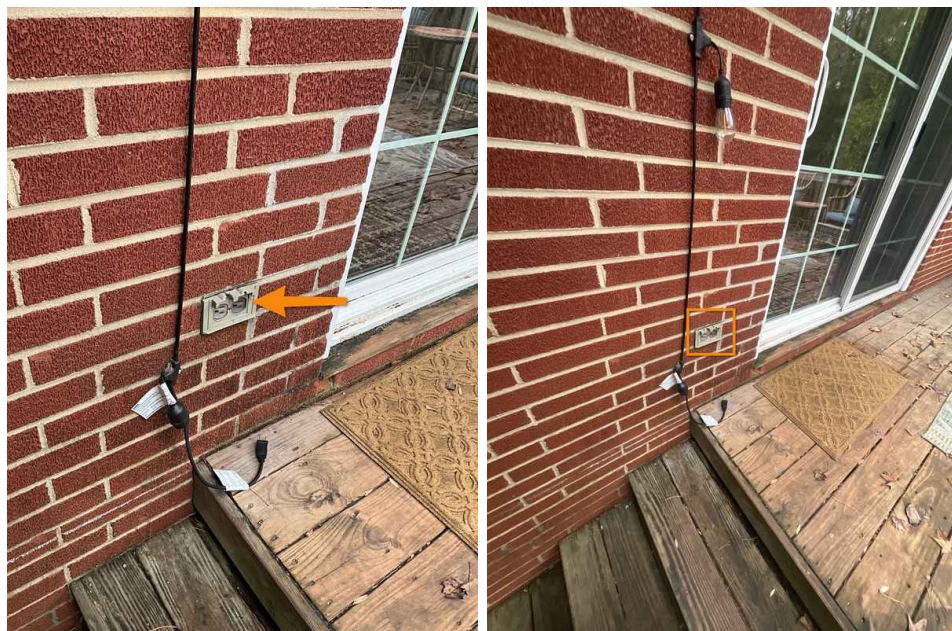
## 8.4.1 Lighting Fixtures, Switches &amp; Receptacles

**EXTERIOR RECEPTACLE WEATHER COVER**

The exterior receptacle weather cover at the rear deck was observed to be damaged during the inspection. This does not allow the receptacle to be completely enclosed and can lead to moisture intrusion of the receptacle and cause electrical hazards. The home inspector recommends a DIY repair by replacement of a waterproof cover. The client may wish to have a qualified specialist for repair if so desired.

Repaired in 2025

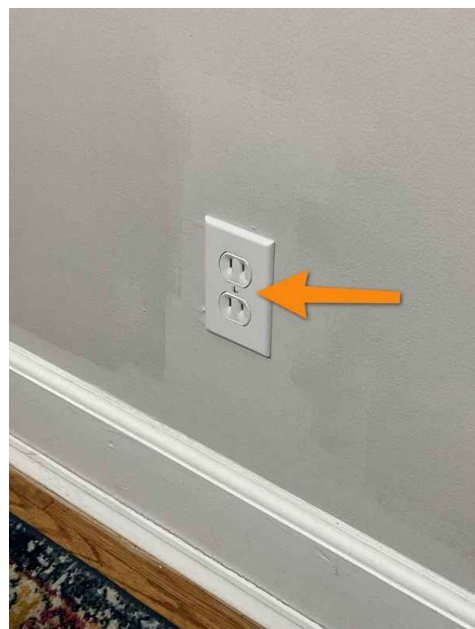
## 8.4.2 Lighting Fixtures, Switches &amp; Receptacles

**TWO PRONG RECEPTACLES**

Some receptacles in the home have two prong receptacles. Two prong receptacles have a hot wire and a neutral wire running to them and are not grounded which may cause stray currents, electrical shock and power surge. The home inspector recommends further evaluation and repair by a qualified specialist.

Repaired in 2025

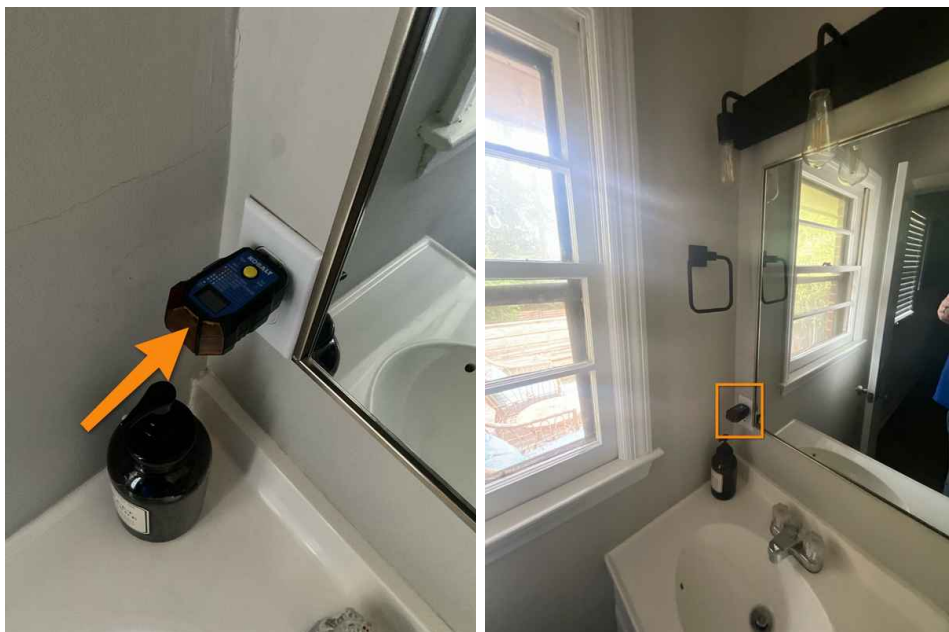
## 8.4.3 Lighting Fixtures, Switches &amp; Receptacles

**WIRING**

The master bathroom receptacle was observed to be turned on and off with the bathroom light. Due to the receptacle being newer, this appears to be an improper wiring of it's GFCI functions. The home inspector recommends a qualified specialist to further evaluate and make repairs.

Repaired in 2025

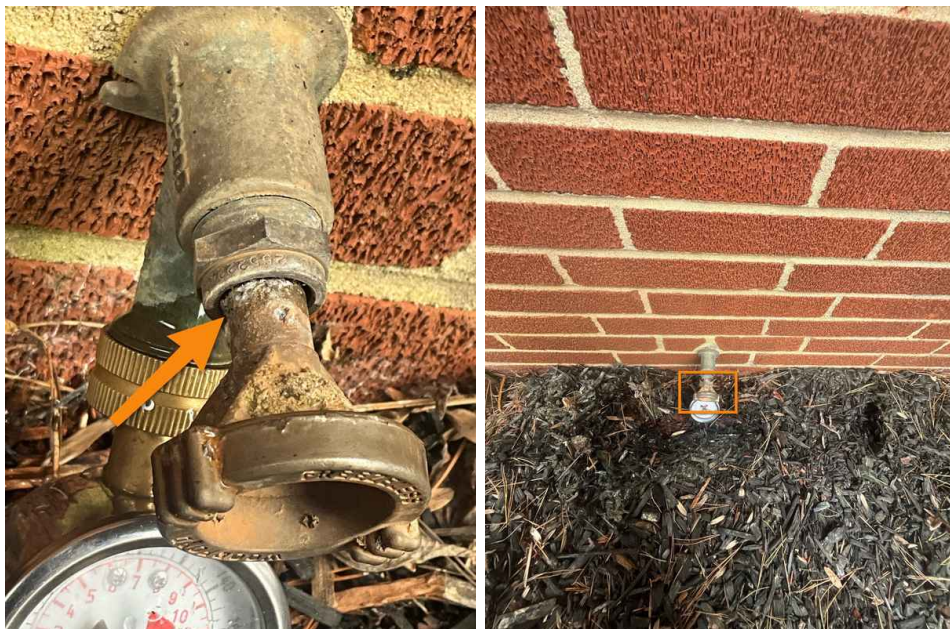
## 9.3.1 Water Supply, Distribution Systems &amp; Fixtures

**HOSE BIB/SPIGOT - LEAKING** Repaired

The front exterior hose bib/spigot was observed to leak from the knob when opened. This will allow water to disperse at the foundation of the home and may cause higher utility bills. The home inspector recommends a qualified specialist for repair or replacement.

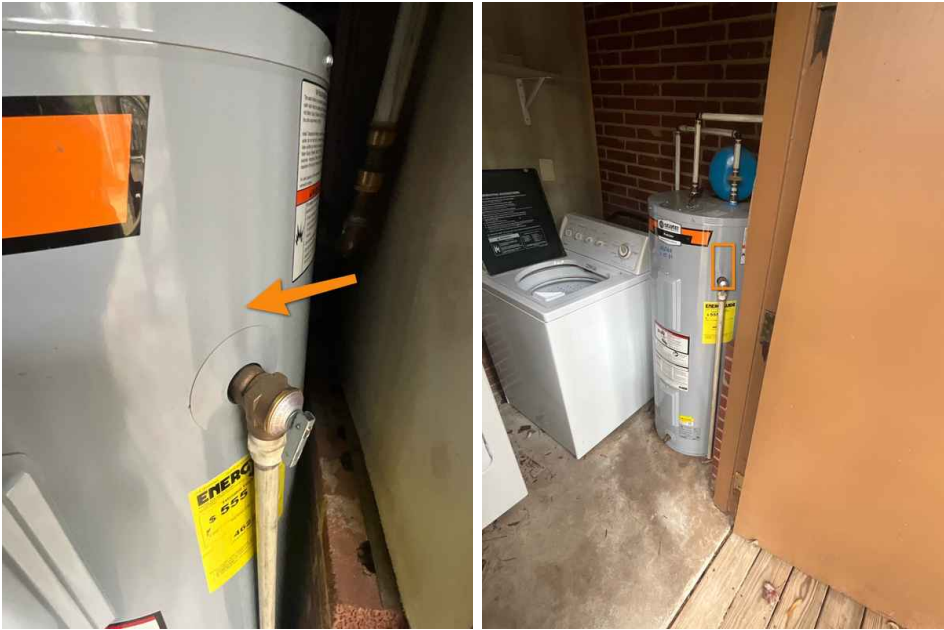
## 9.4.1 Hot Water Systems, Controls, Flues &amp; Vents

**BURN MARK** Repaired

The home inspector observed a burn mark above the temperature pressure relief valve during the inspection. This burn mark is an indication of potential issues such as overheating electrical components, problems with the heating elements, or other related concerns within the water heating system. Such signs should not be overlooked, as they may pose a safety hazard and could lead to more serious problems, including system failure. The home inspector recommends that a qualified specialist be consulted for further evaluation and repair as necessary to ensure the safety and proper functioning of the water heating system.

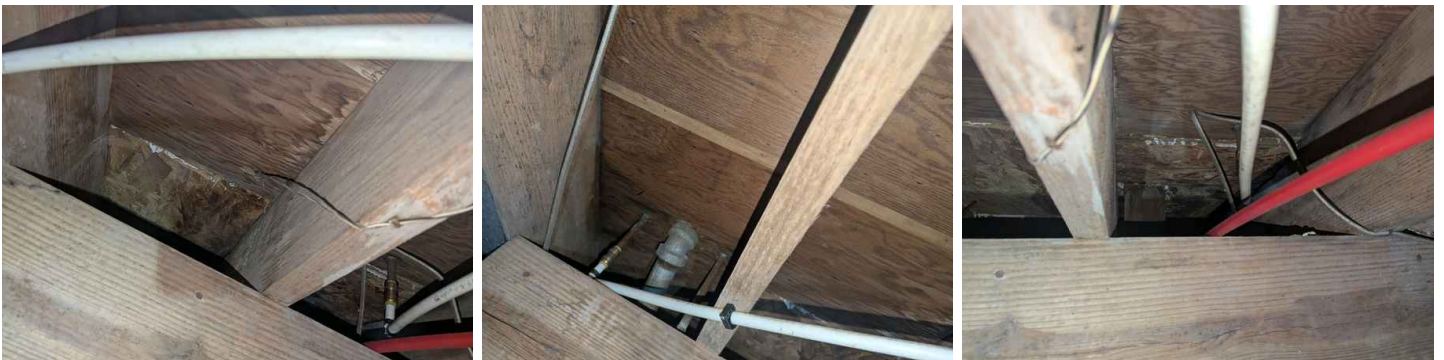
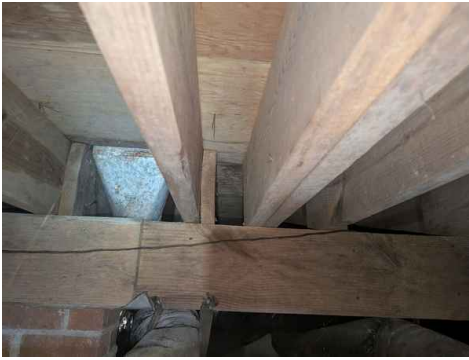
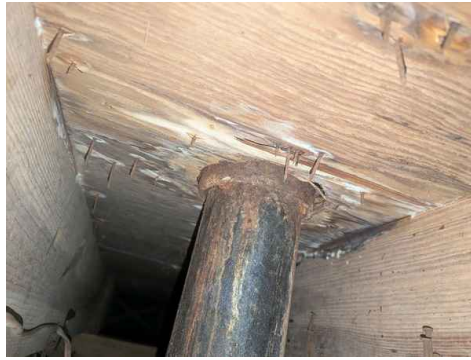
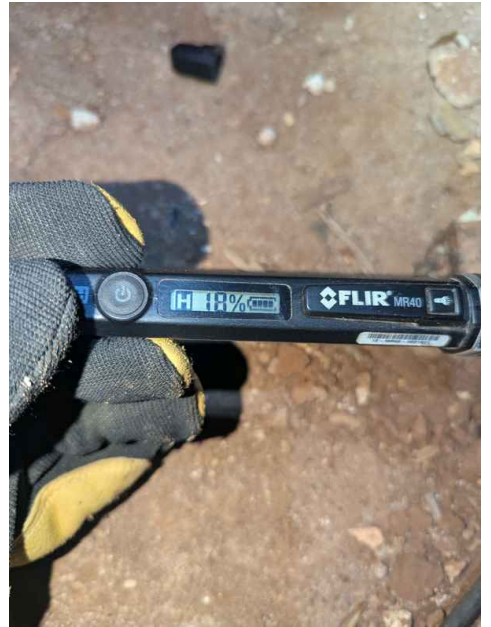
#### 10.4.1 Floor Structure

**FLOOR SYSTEM MOISTURE DAMAGE**

Moisture staining and damage were observed on the underlying floor structure underneath the bathroom areas. The moisture levels taken were observed to be higher than the average indicating a past or present issue. If left in this condition, there is a risk of further deterioration to the flooring system, which could extend to other areas of the home, potentially compromising the integrity. The home inspector recommends that a qualified specialist be consulted for further evaluation and repair as necessary. The specialist should also assess any hidden moisture or other related issues and advise on appropriate remediation.

**Repaired in 2025**
